## Stormwater Inspection Report

<b>Operator:</b>	Laramie Energy, LLC
<b>Project:</b>	Cascade Creek
<b>Location:</b>	Cascade Creek 608-43-31 Pad
<b>Date:</b>	Thursday, November 11, 2021
<b>Weather:</b>	Mostly Sunny, Breezy, 51°, Lo 22°

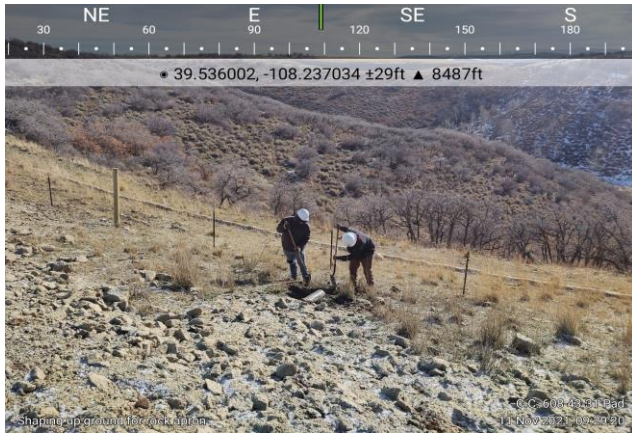
**Photo 1**

**Installing Rock Apron on Pipe Outlet on CC 608-43-31 Pad**

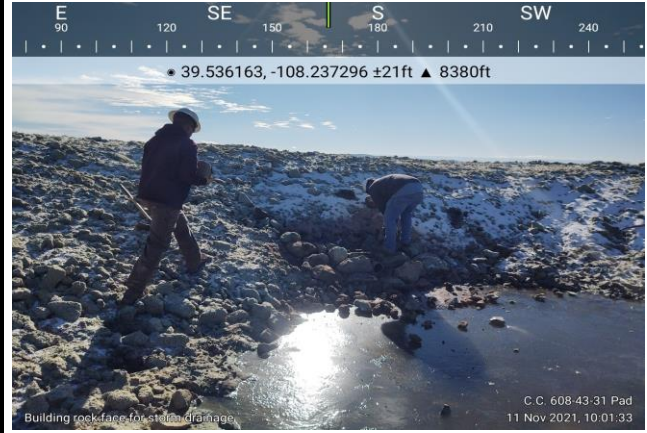
**Photo 2**

**Installing Rock Armor on Pipe Outlet Face**

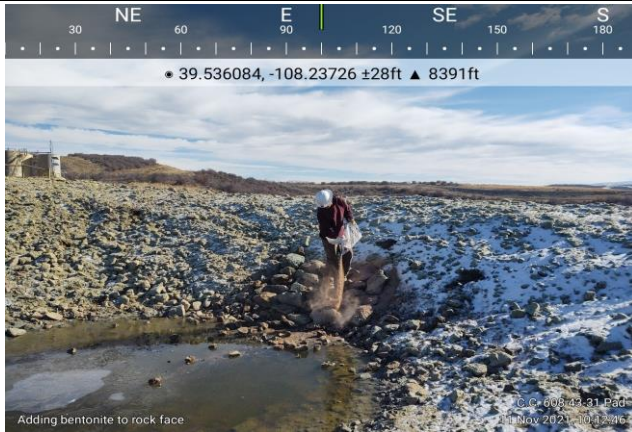
**Photo 3**

**Using Bentonite to Face Pipe Outlet**

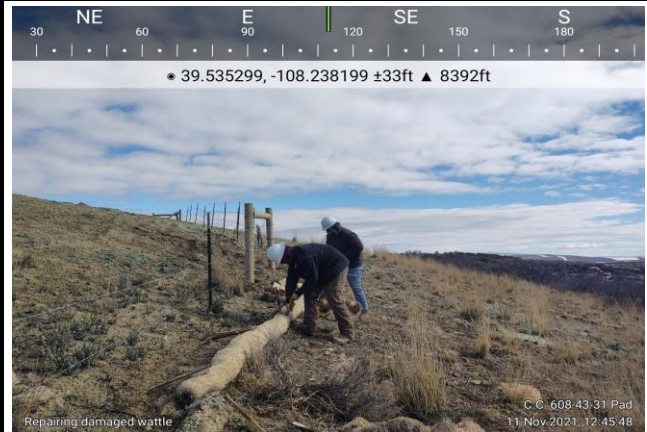
**Photo 4**

**Repairing Existing Wattle Installations**
