Inspection Photos
Location Name: Alex H Miller #1
Location ID: 318376

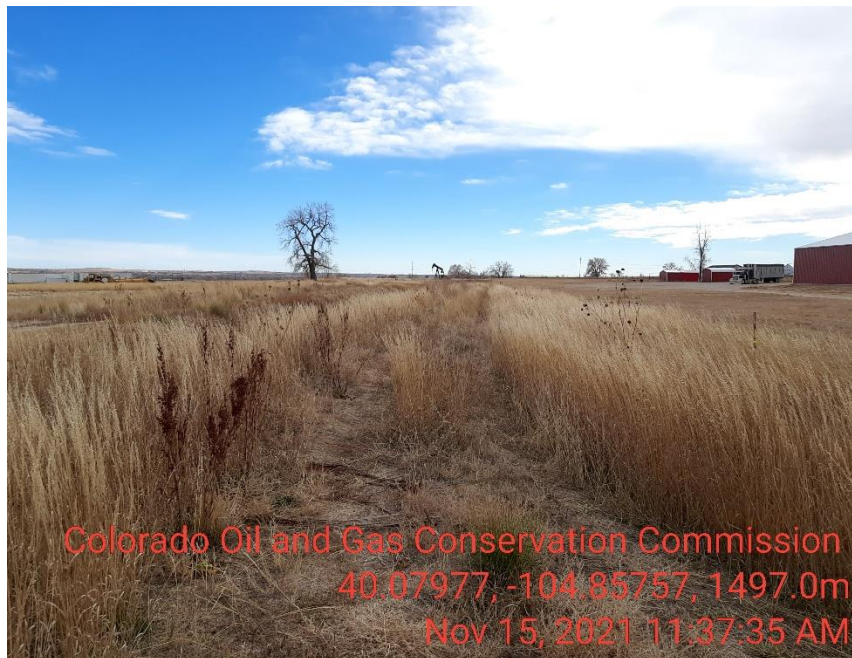
Photo 1 Access road Completely overgrown with vegetation.

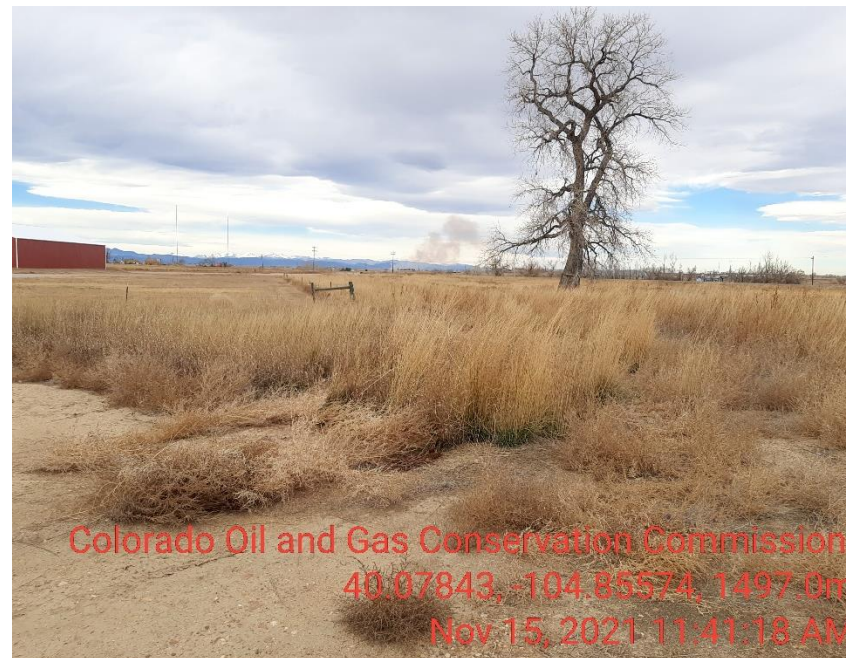
Photo 2 Access road Completely overgrown with vegetation

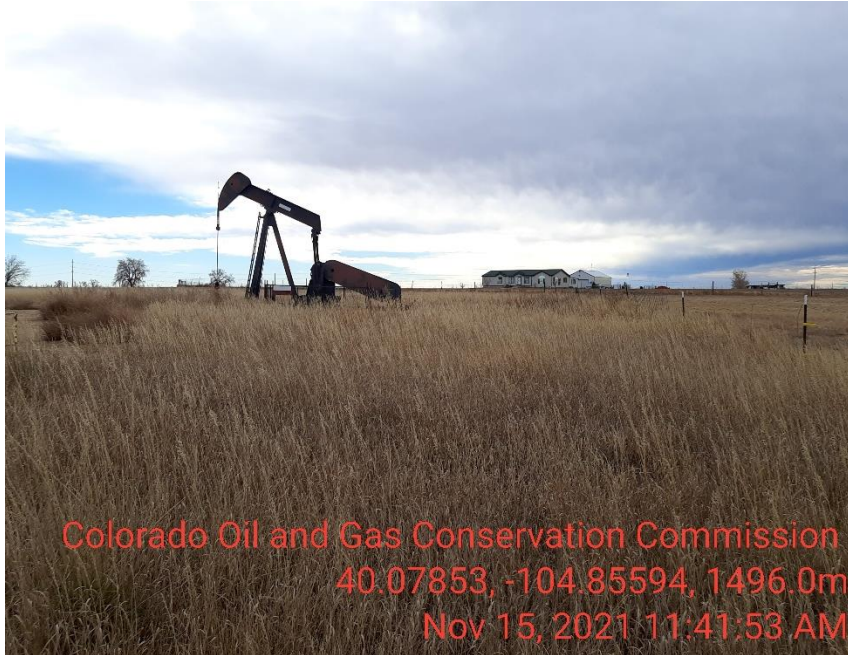
Photo 3 Access road Completely overgrown with vegetation

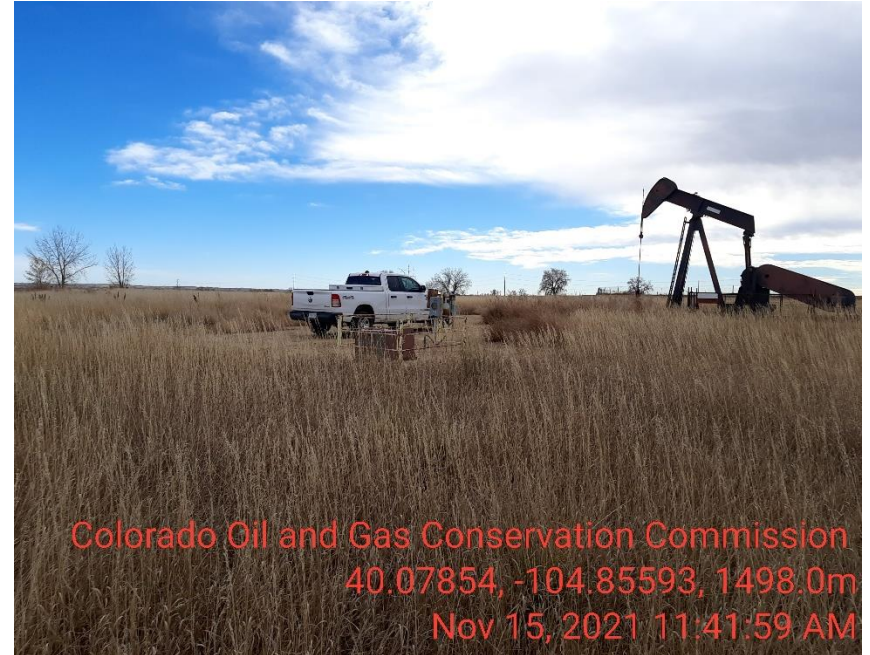
Photo 4 Access road Completely overgrown with vegetation

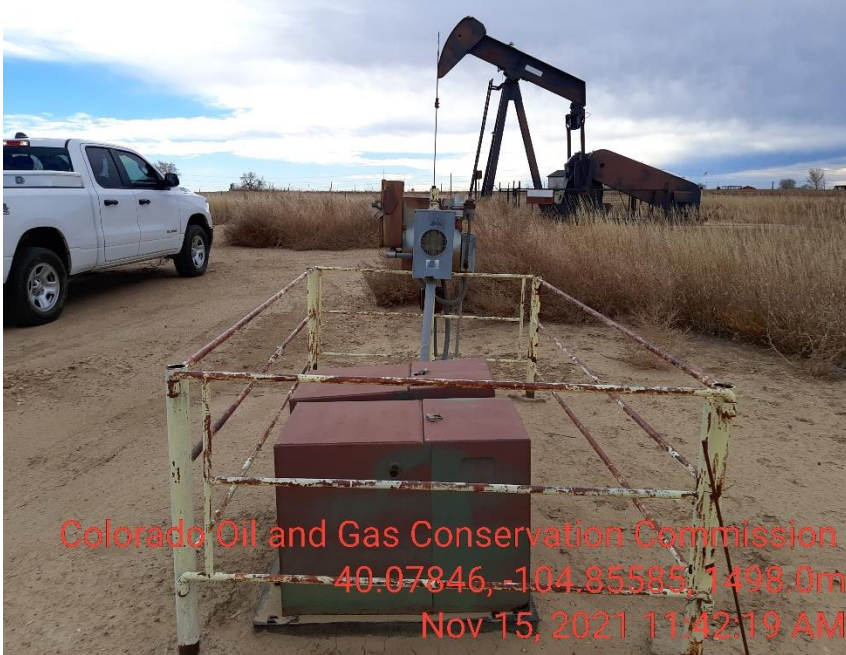
Photo 5 Unused equipment Electric panel with no meter

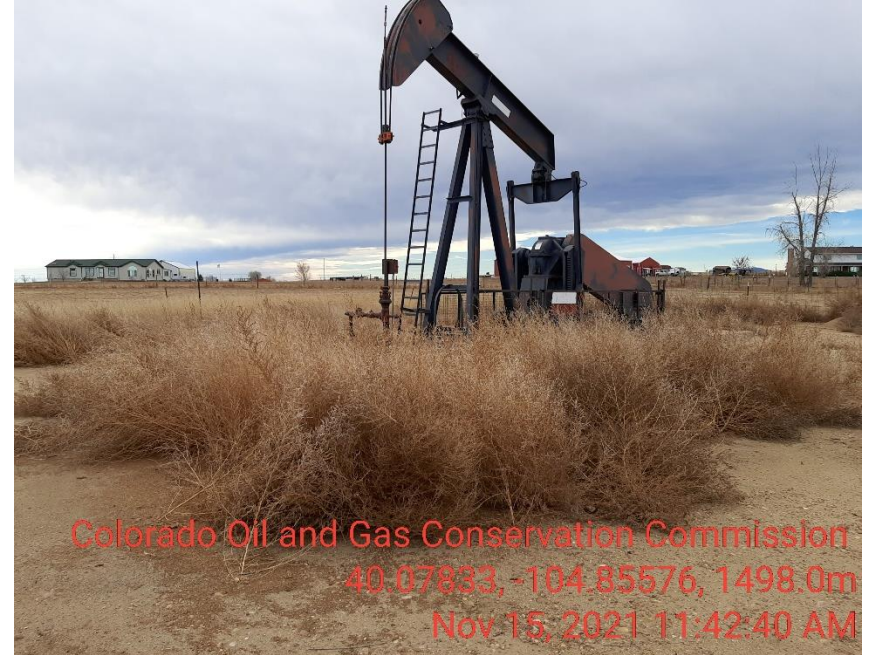
Photo 6 Debris: dead vegetation around well

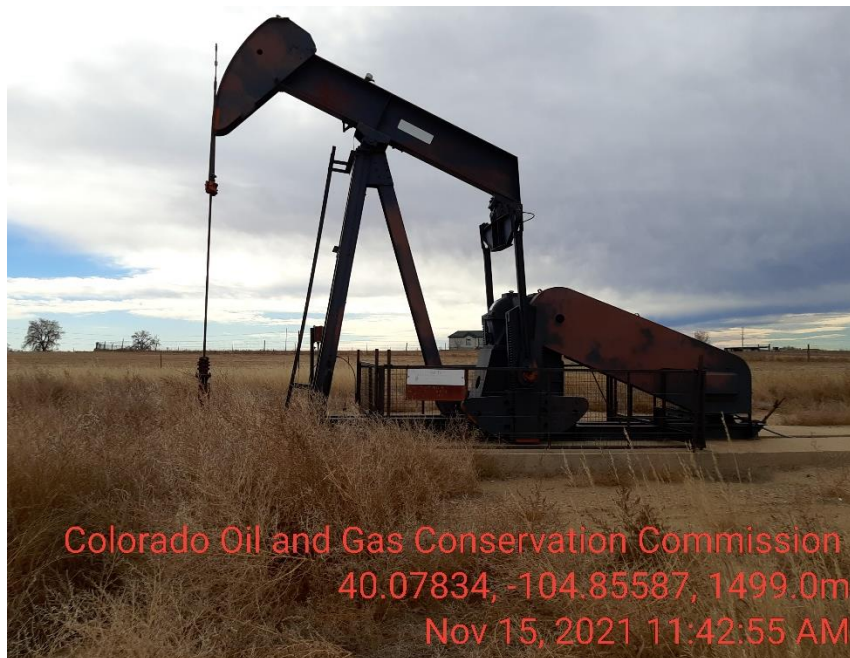
Photo 7 Well head sign is not readable

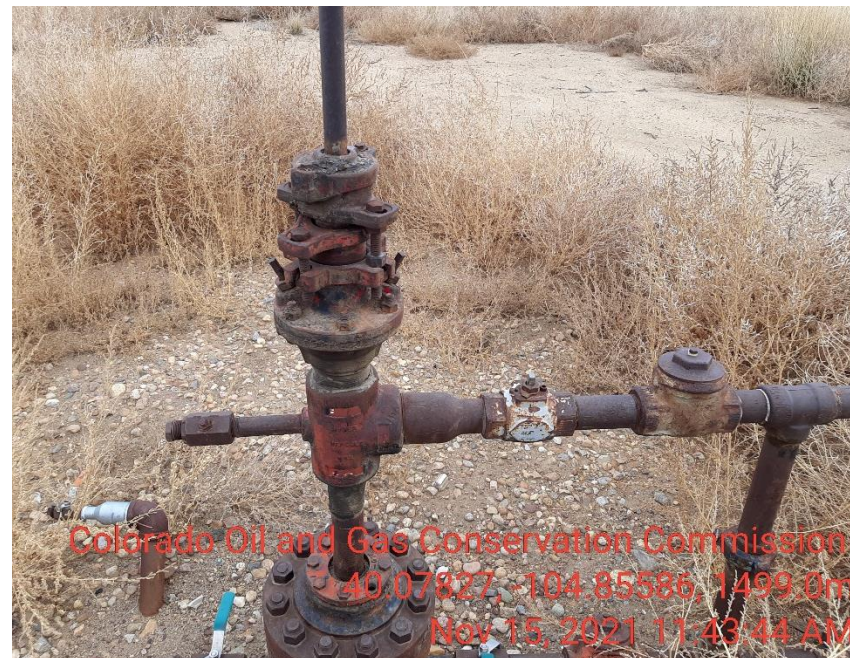
Photo 8 Flow line valves are in the closed position.

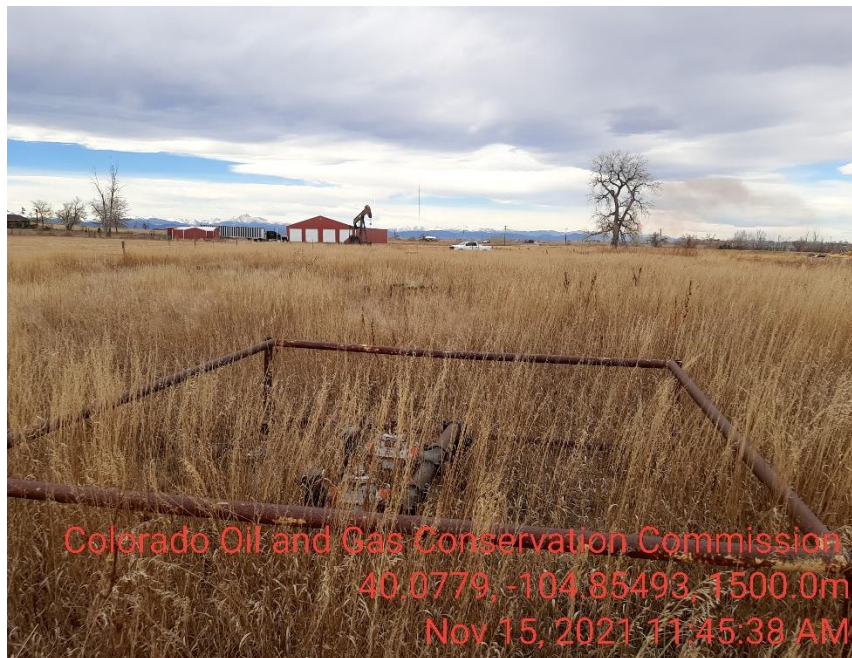
Photo 9 flow line header east of well site

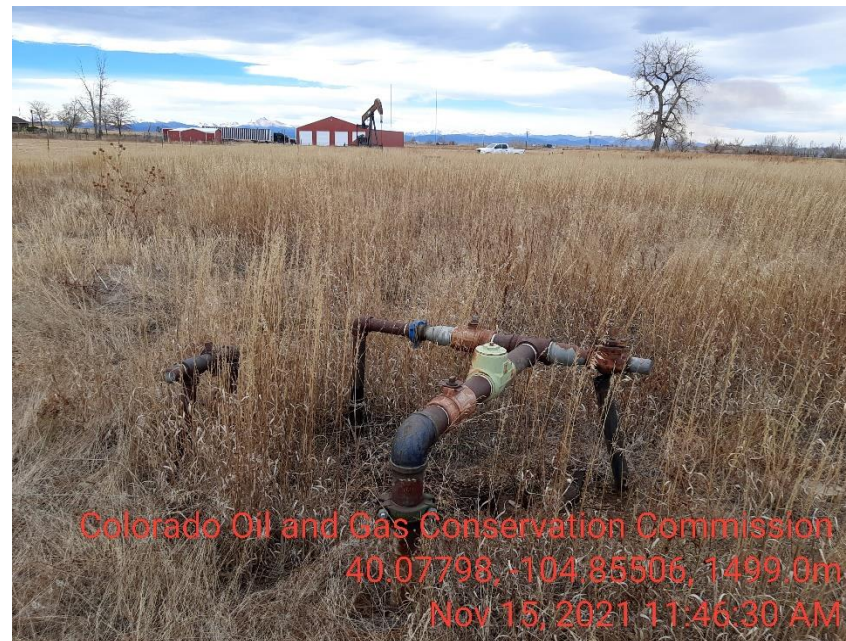
Photo 10 Flow line valves east of site. 2" poly line cut

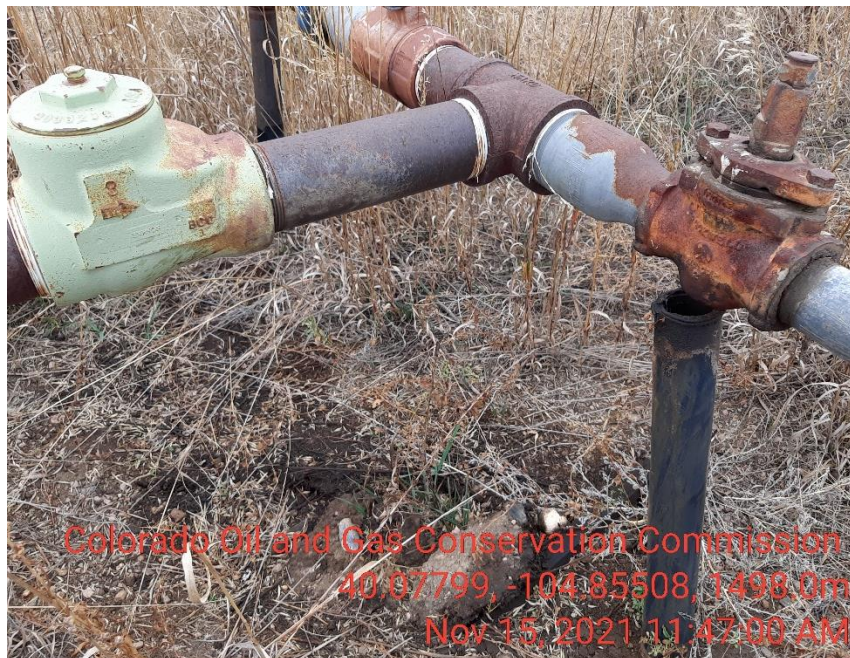
Photo 11 Cut flow line riser and spill underneath

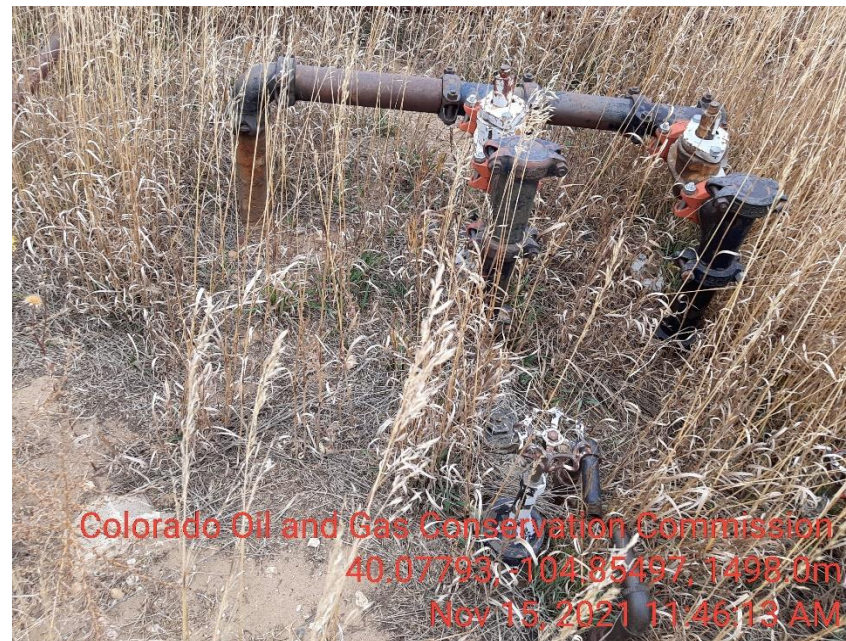
Photo 12 Cut flow line and 1" risers with no caps or valve.

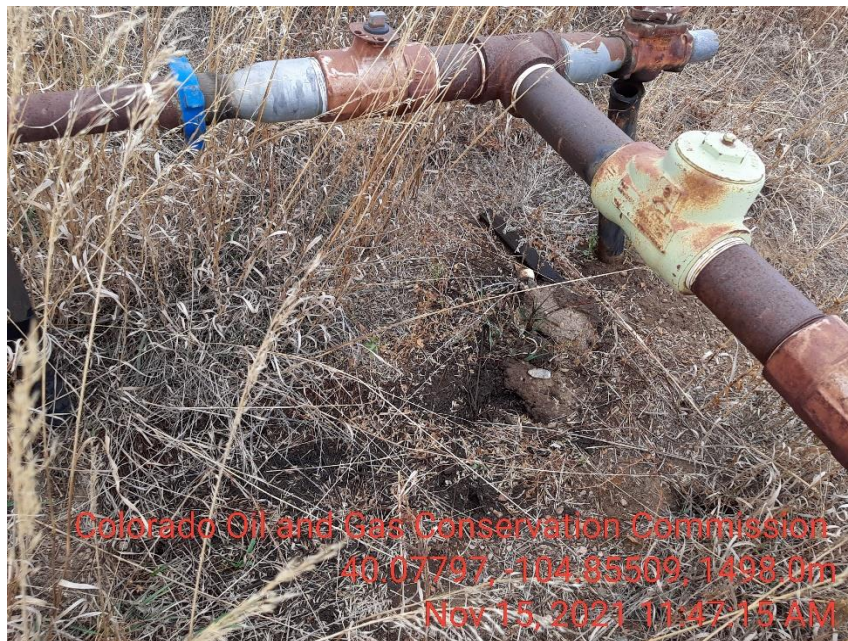
Photo 13 Spill underneath cut riser.

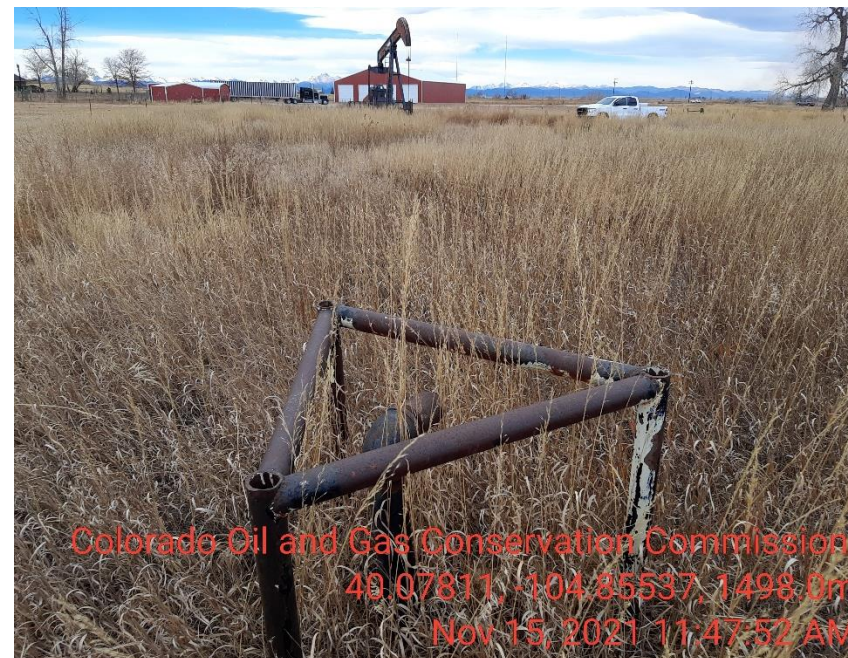
Photo 14 Flow line riser not LOTO

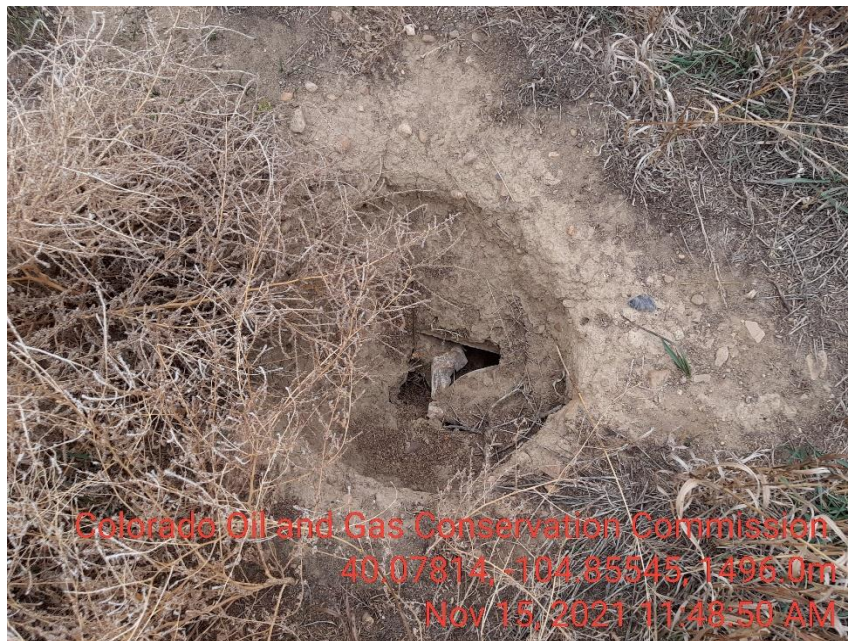
Photo 15 some type of cellar or hole on location or pipeline right a way

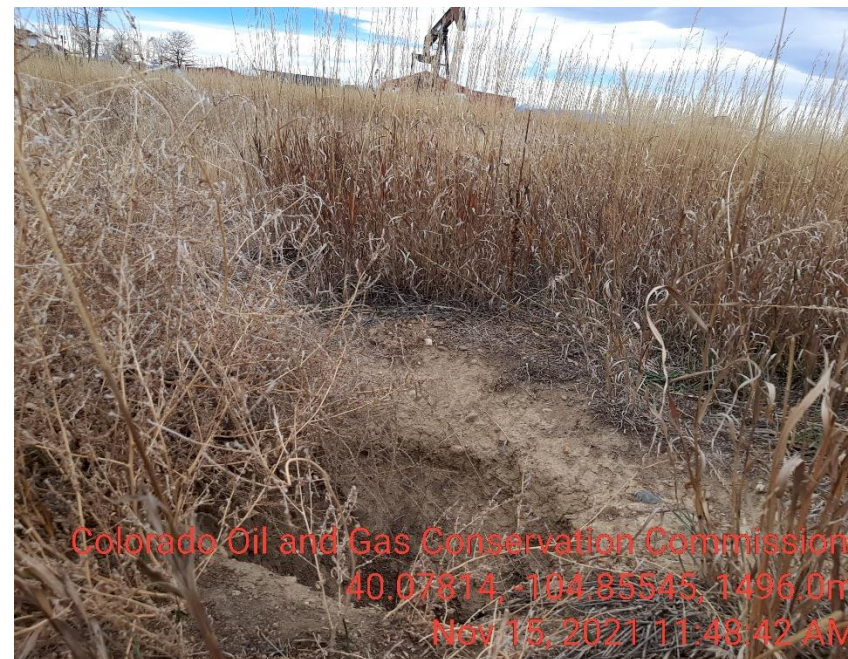
Photo 16 some type of cellar or hole on location or pipeline right a way

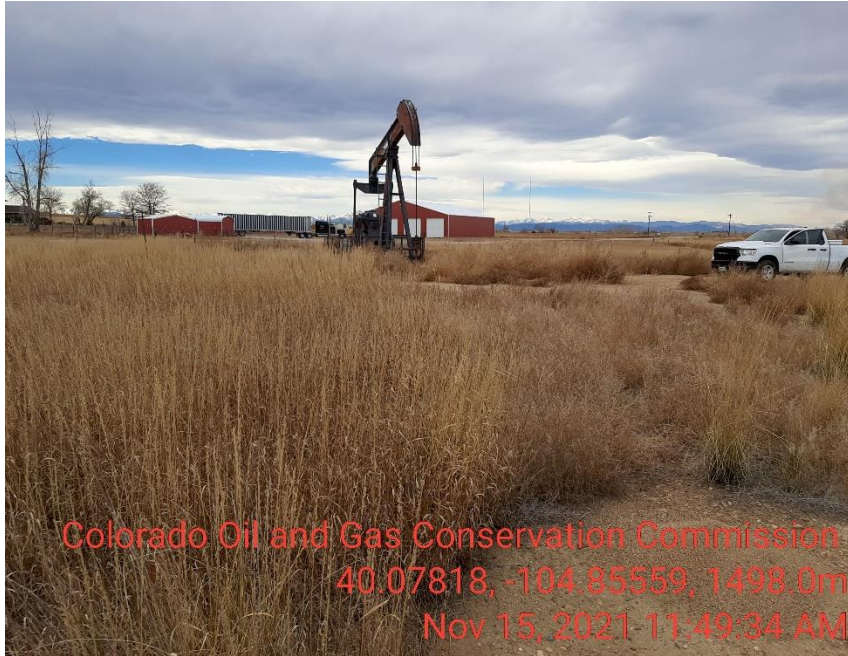
Photo 17 Debris Dead vegetation on location.
