Western Operating – Roper E-1X Tank Battery
Inspection Date: 11/09/2021

COLORADO
Oil & Gas Conservation
Commission
Department of Natural Resources

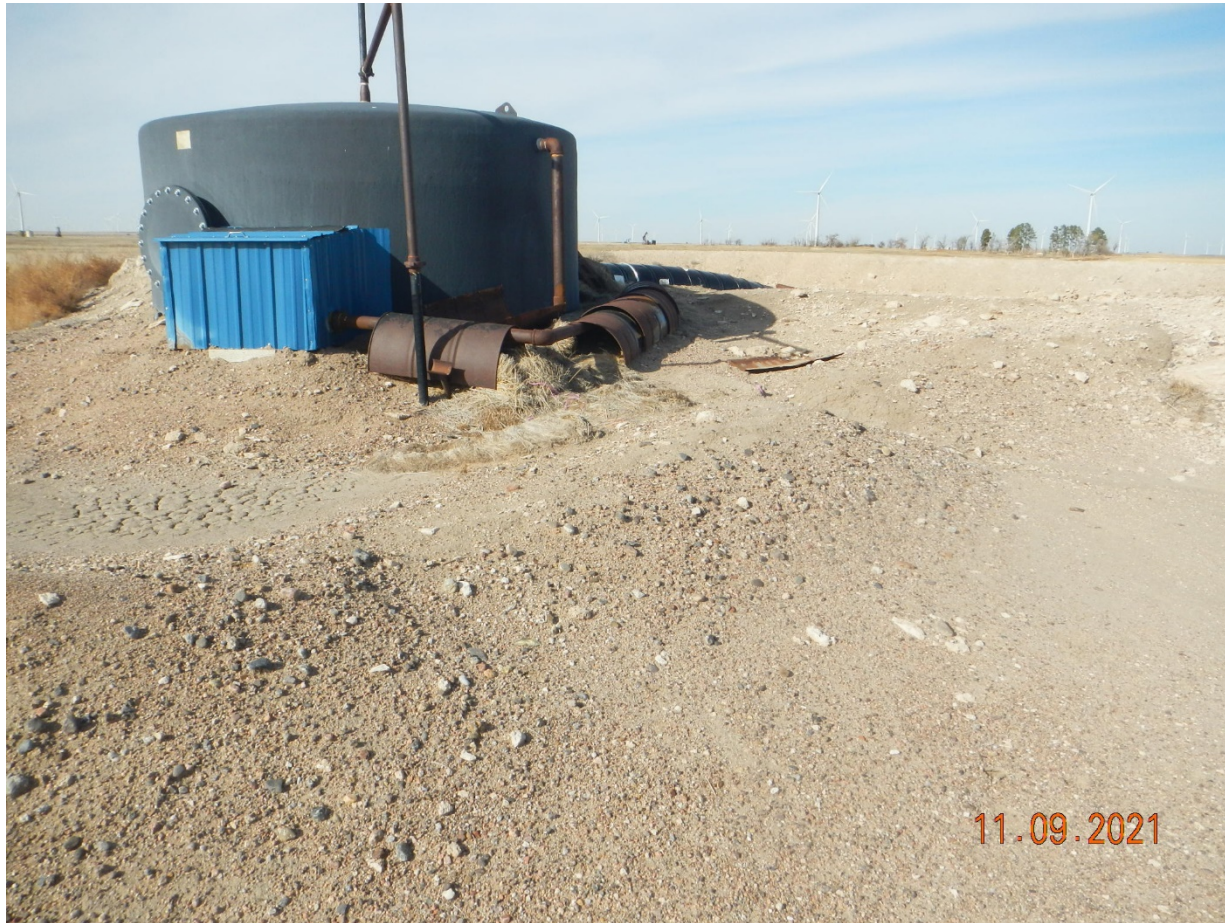
Photo # - 4

Inadequate secondary containment around skim tank, erosion on east side

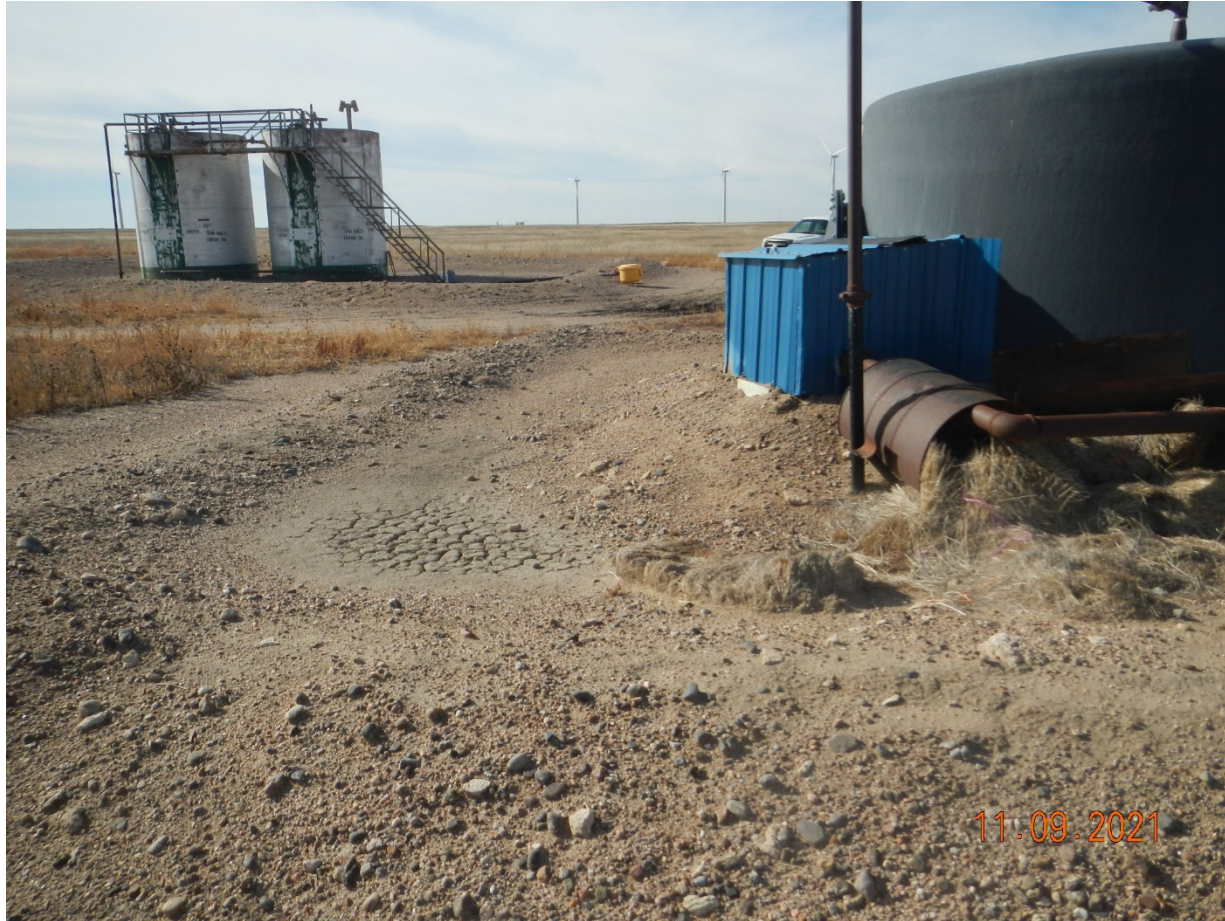
Photo # - 5

Inadequate secondary containment around skim tank

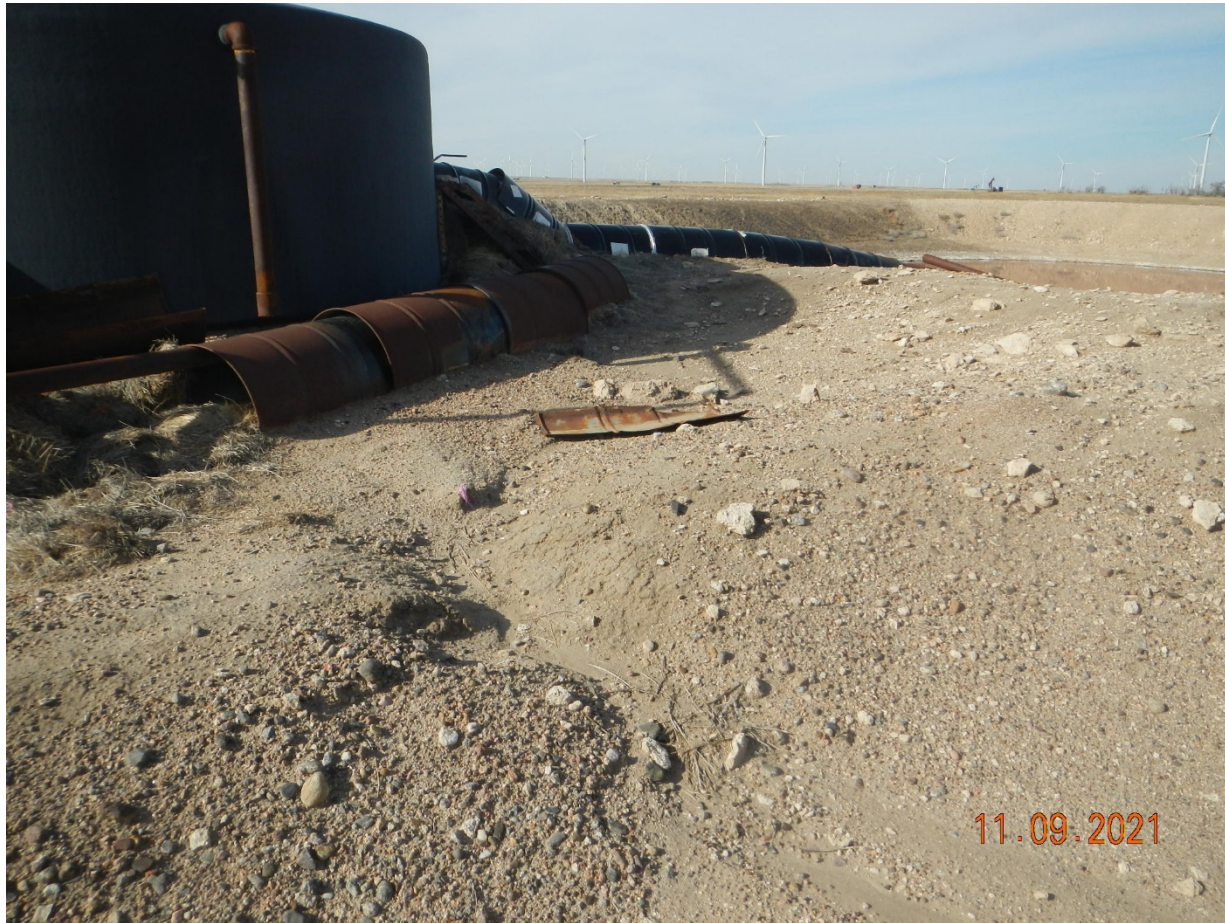
Photo # - 6

Erosion indicates where spilled fluids would be released

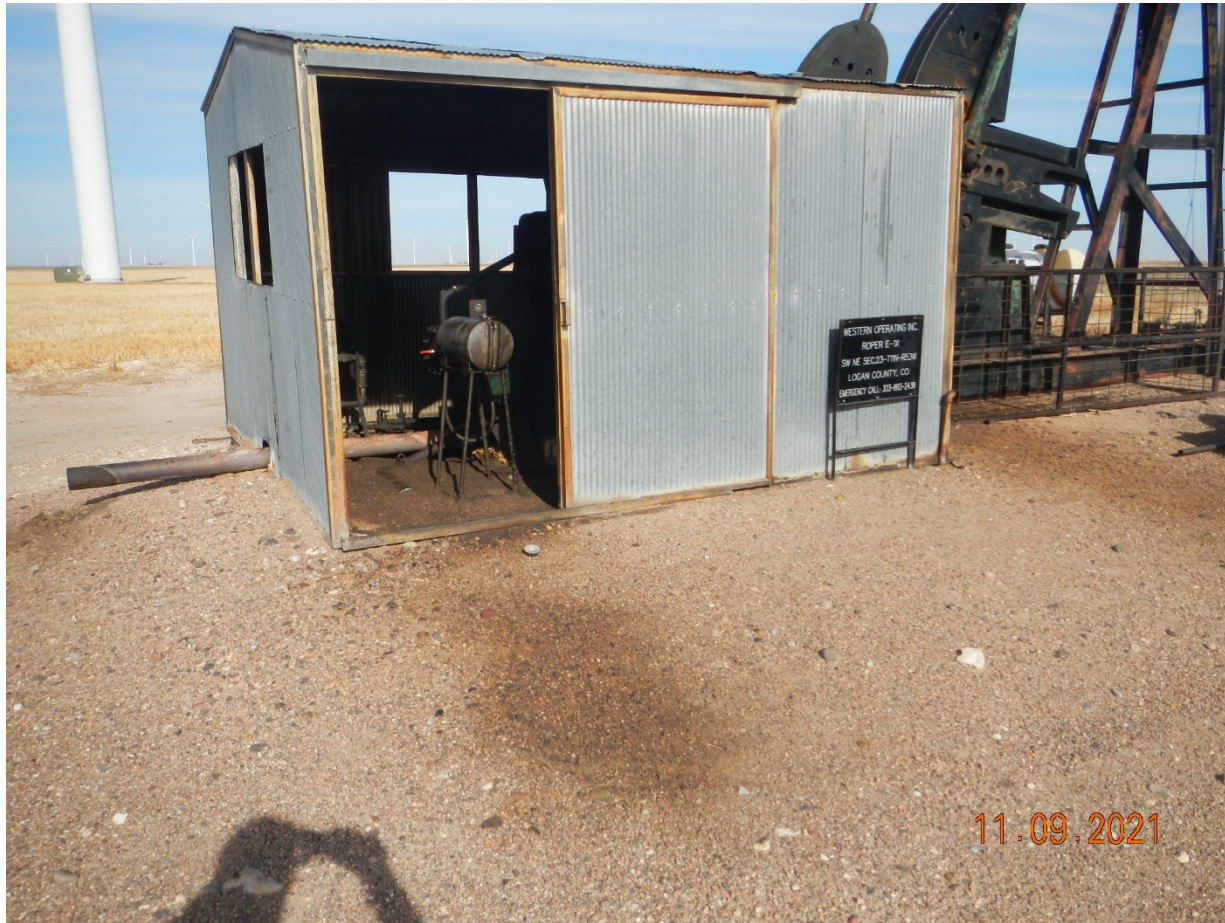
Photo # - 10

Oily soil from oil spray in motor house

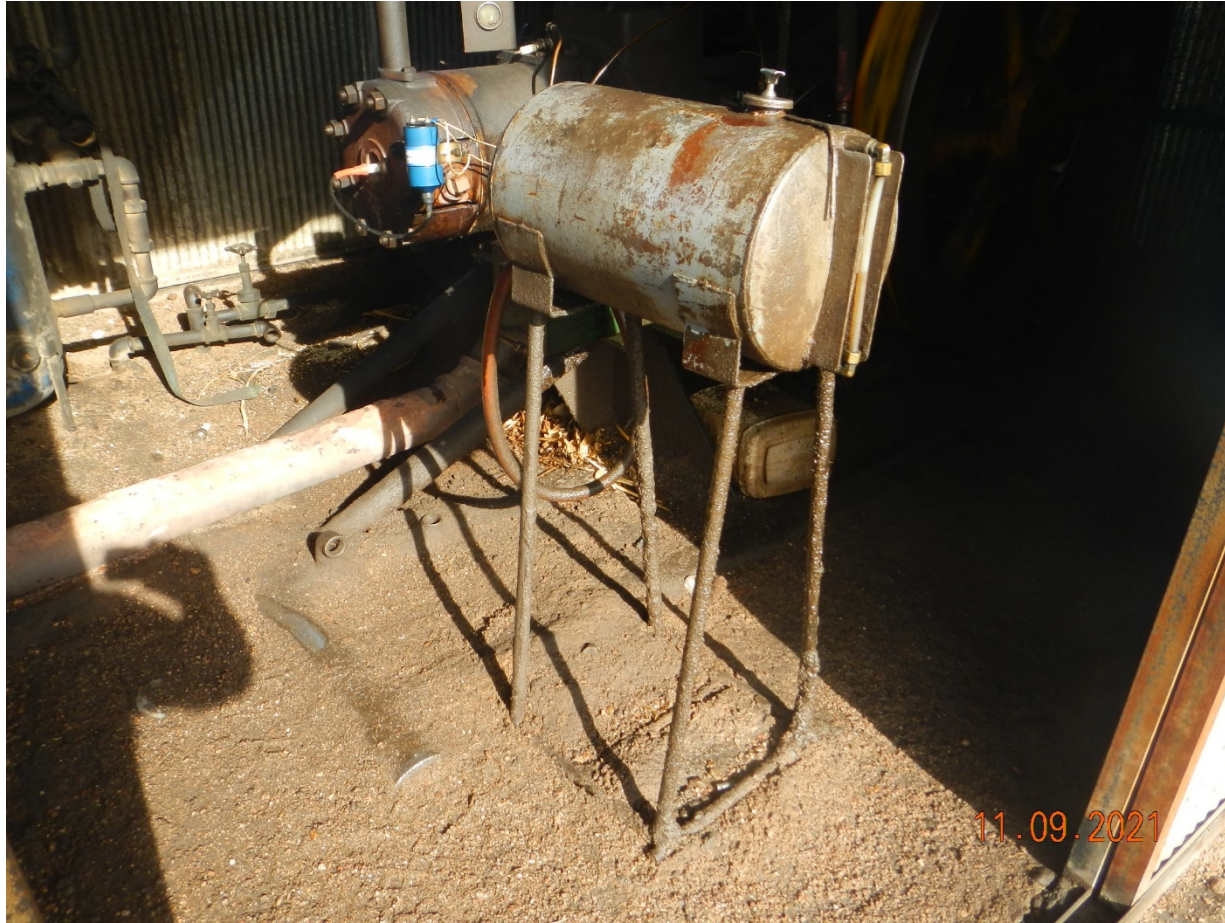
Photo # - 11

Oily soil from oil spray in motor house

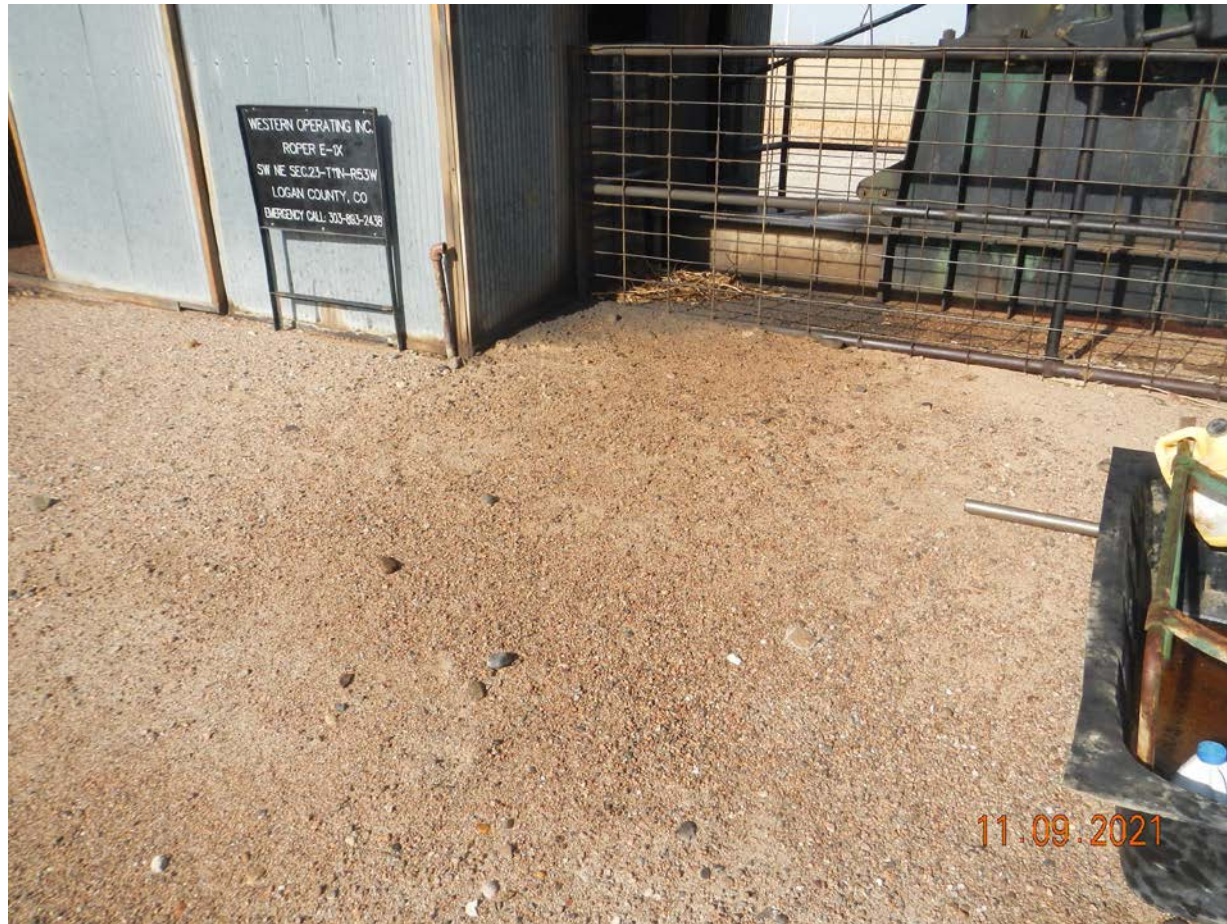
Photo # - 12

Oily soil from oil spray in motor house

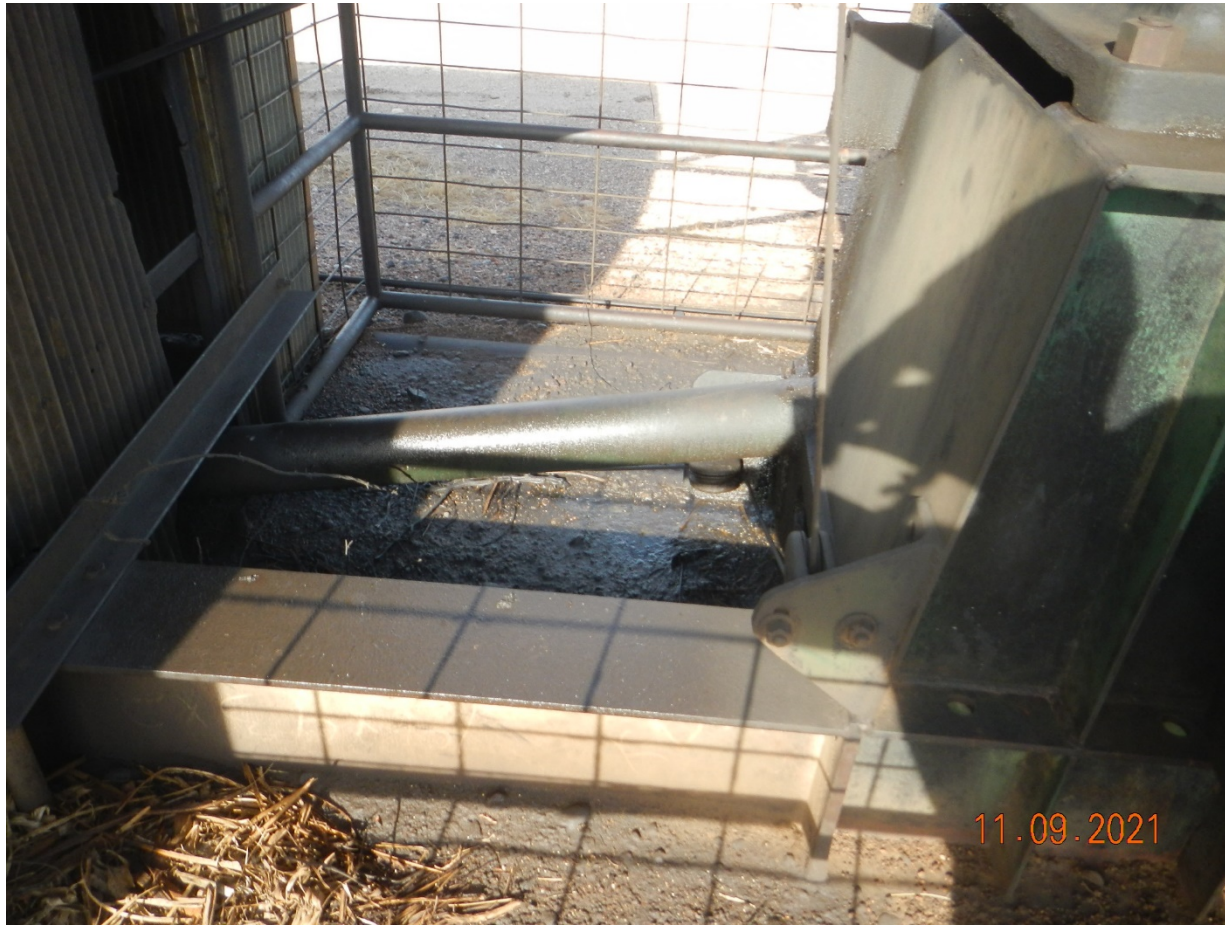
Photo # - 13

Oily soil from oil spray in motor house and/or lube oil

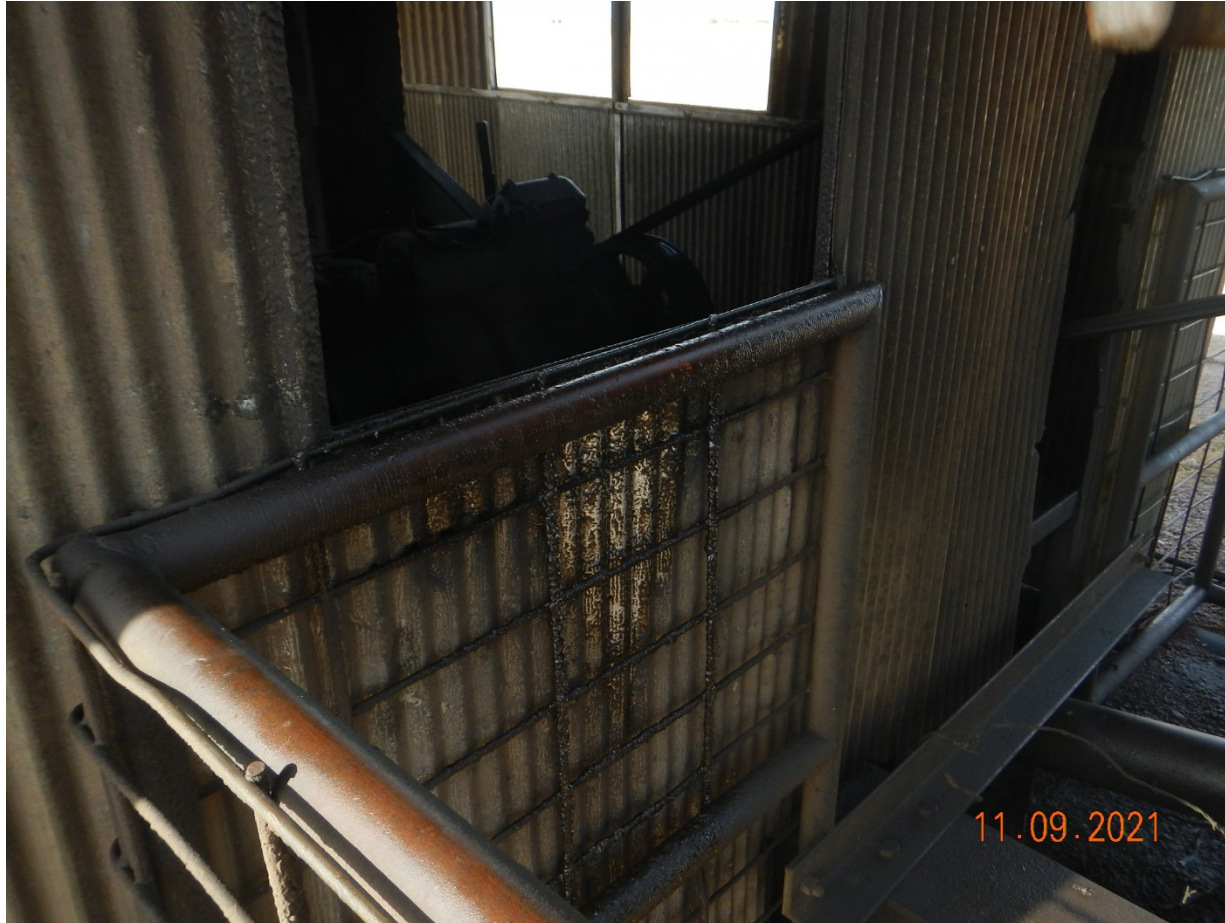
Photo # - 14

Oily soil from oil spray in motor house

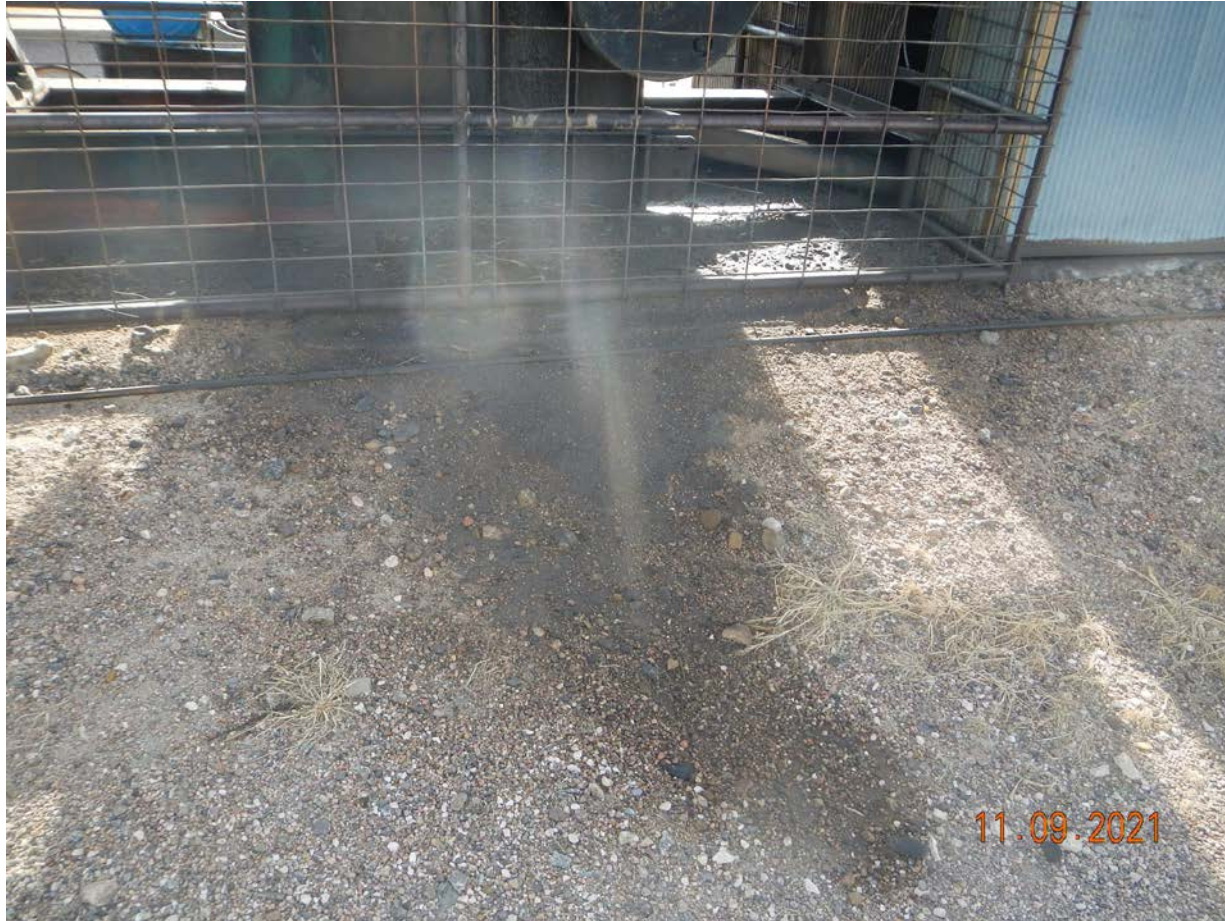
Photo # - 16

Oily soil from leaking lube oil

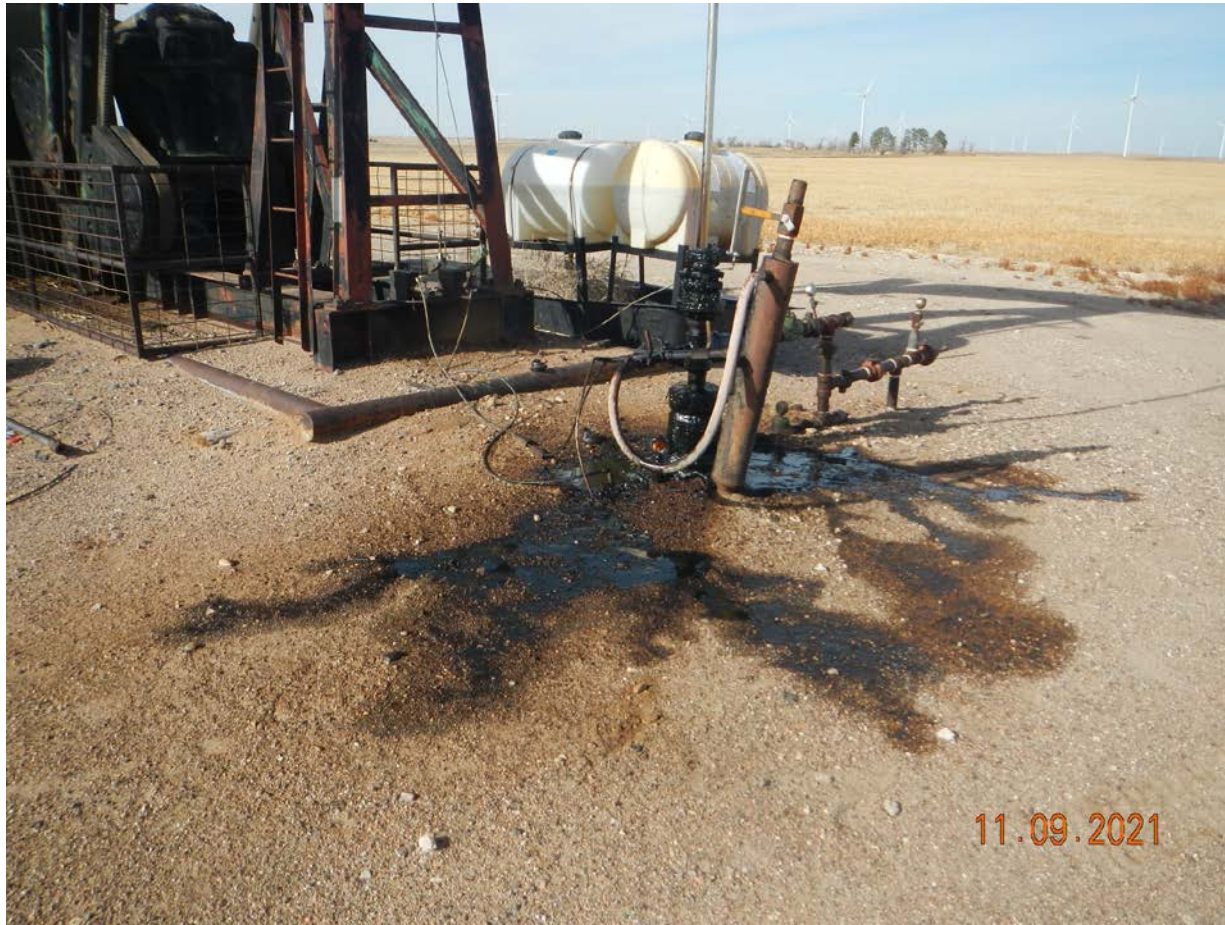
Photo # - 16

Oily soil from leaking stuffing box

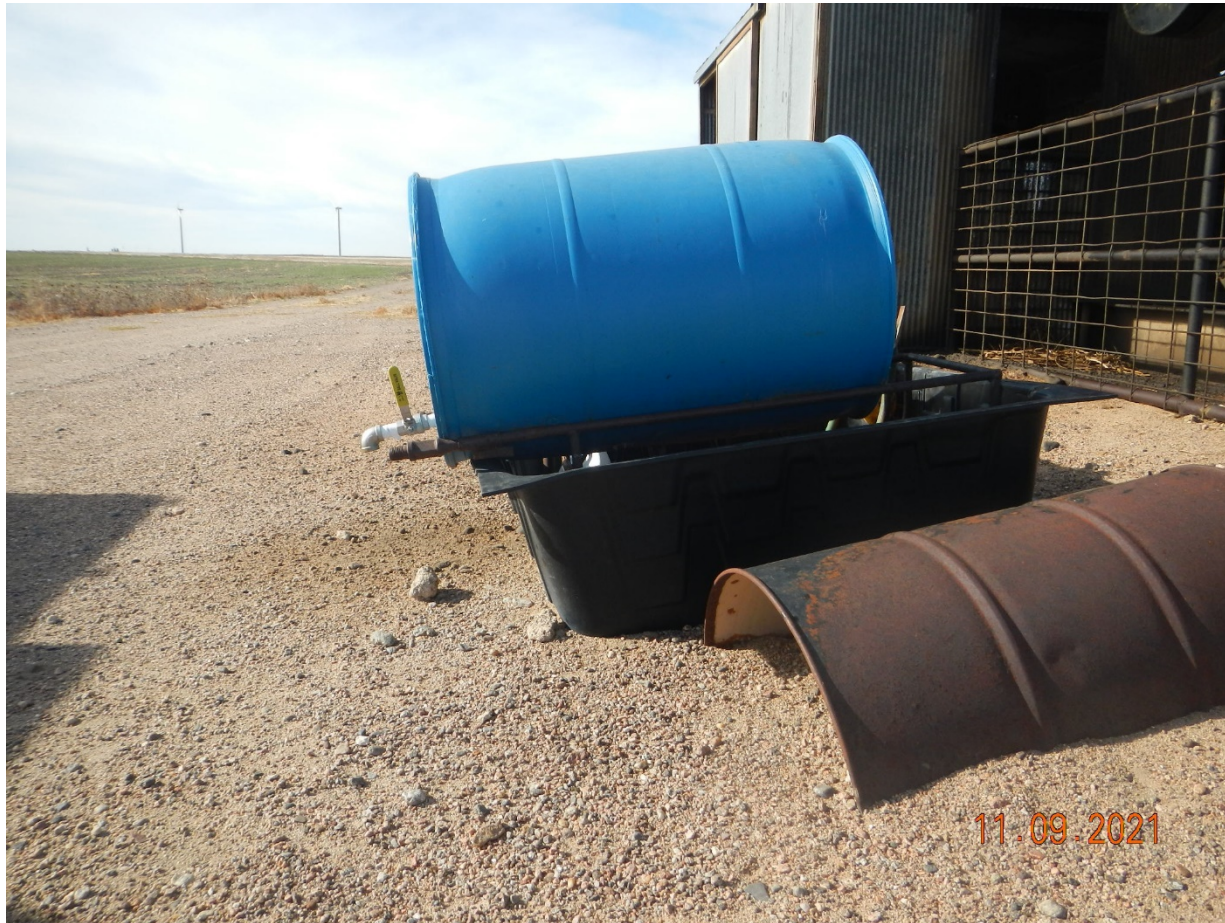
Photo # - 17

Chemical drum extends outside secondary containment
