Inspection Photos
Operator: Simcoe
API: 067-07753
Date: 11/11/2021

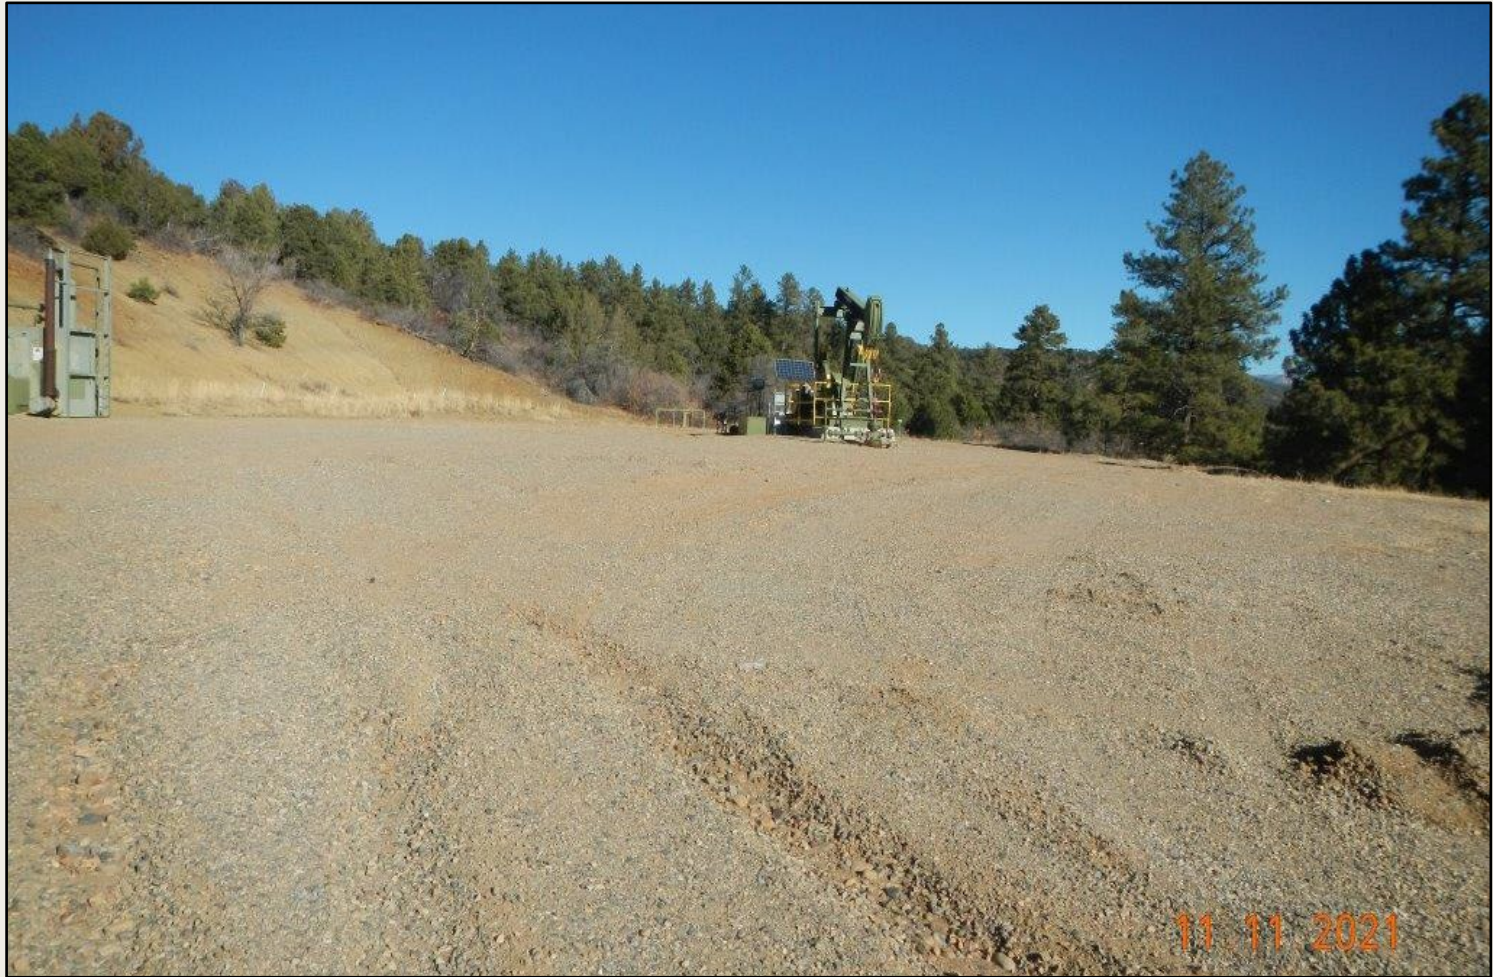
Photo 1. View of the project area from the well pad entrance facing center.

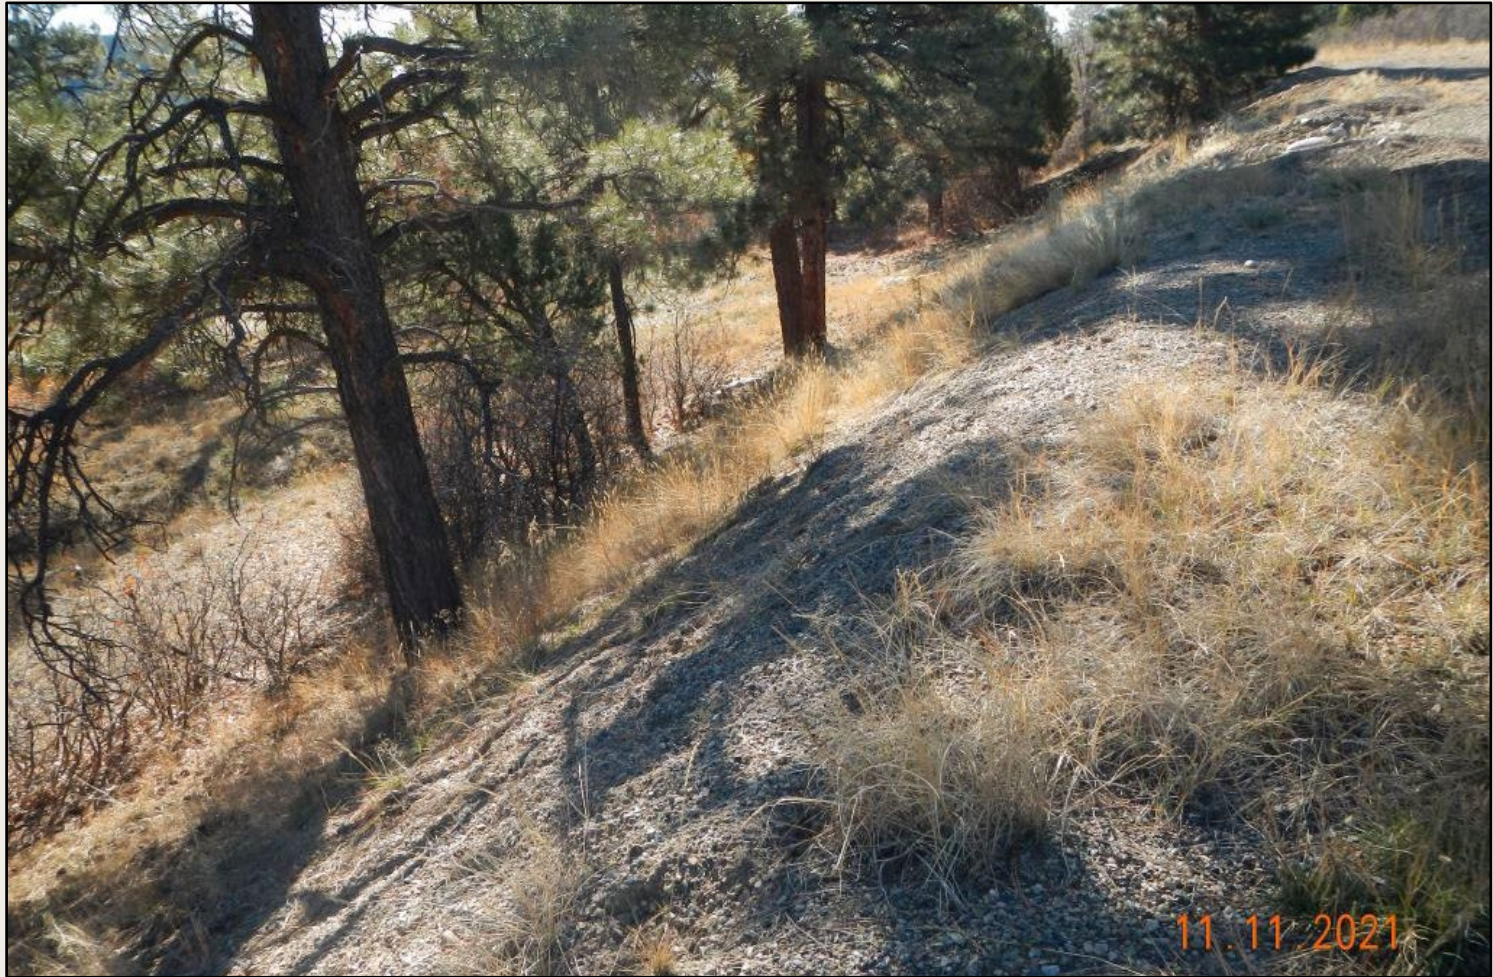
Photo 2. View of the eastern project area from the northeastern corner facing southward. Revegetation is progressing with western wheatgrass, sand dropseed, smooth brome, intermediate wheatgrass, and crested wheatgrass.

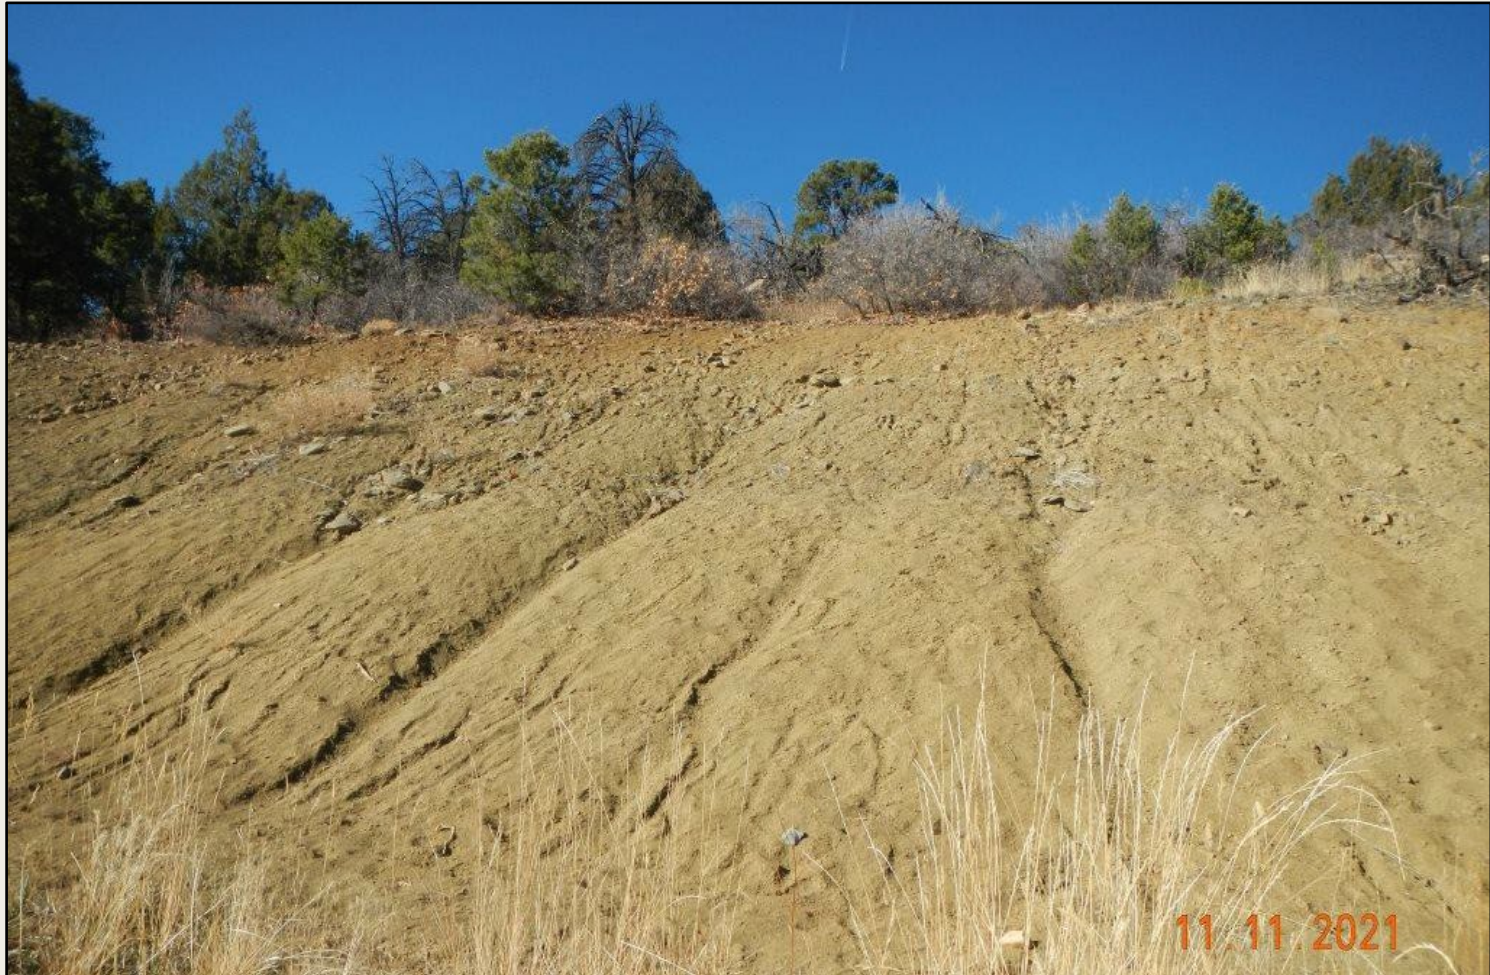
Photo 3. View of bare soils and erosional channels (approx. 10-12 inches wide and deep) on the well pad cut-slopes. .

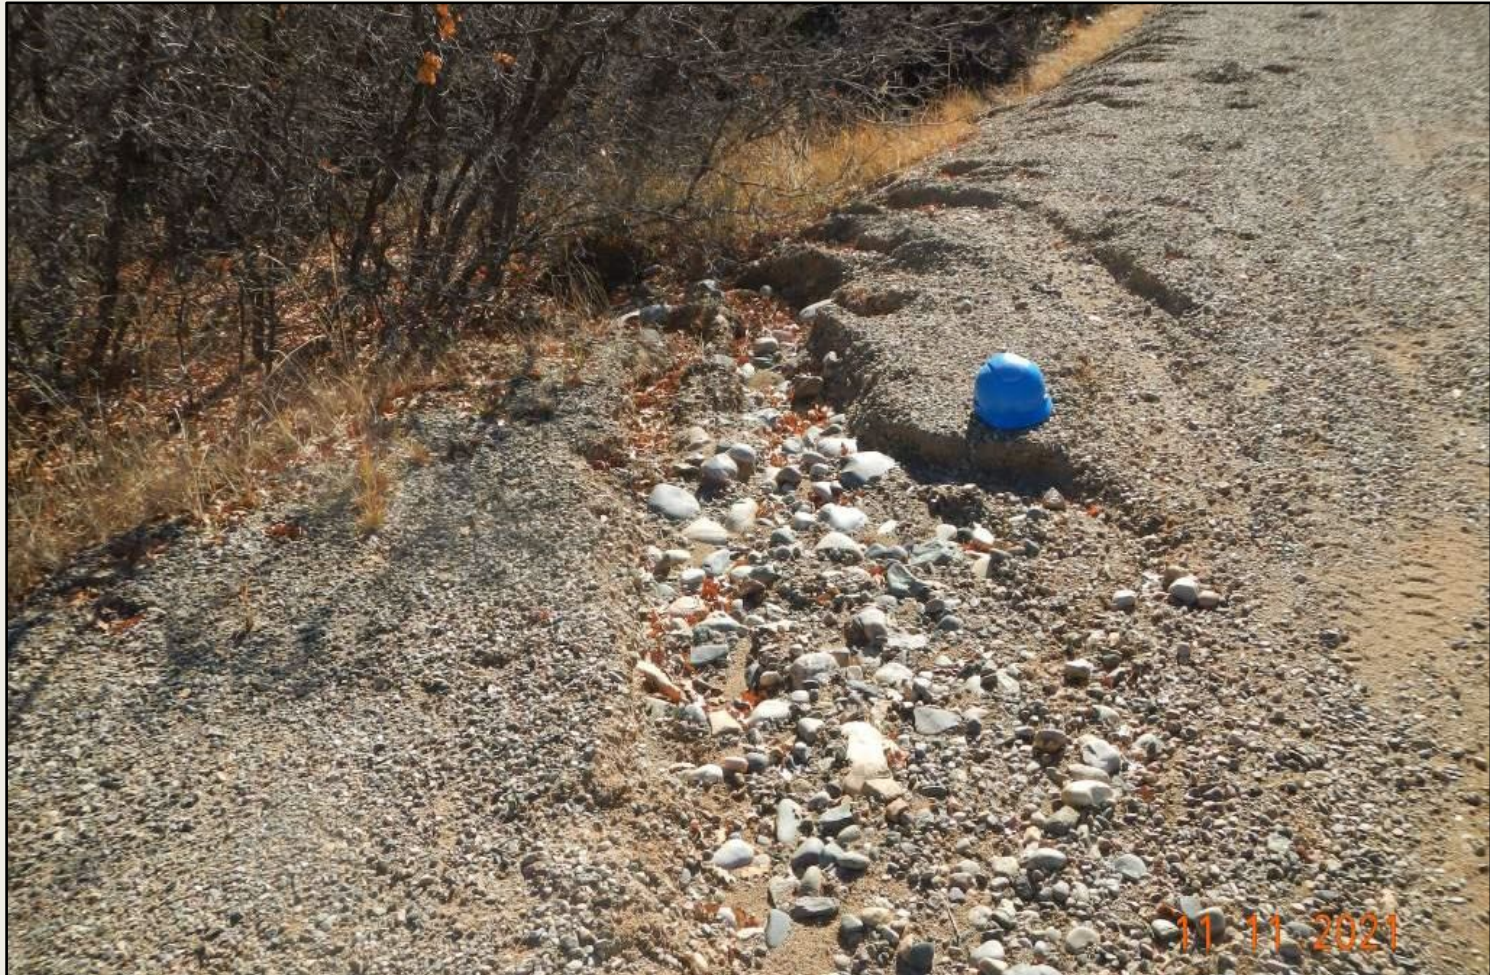
Photo 4. View of erosional channels and sediment transport occurring on the access road where and erosional channel flows down the well pad entrance and is eroding and discharging material down-slope from the project area. Erosion is approximately 1.5ft wide and up to 12 inches deep.

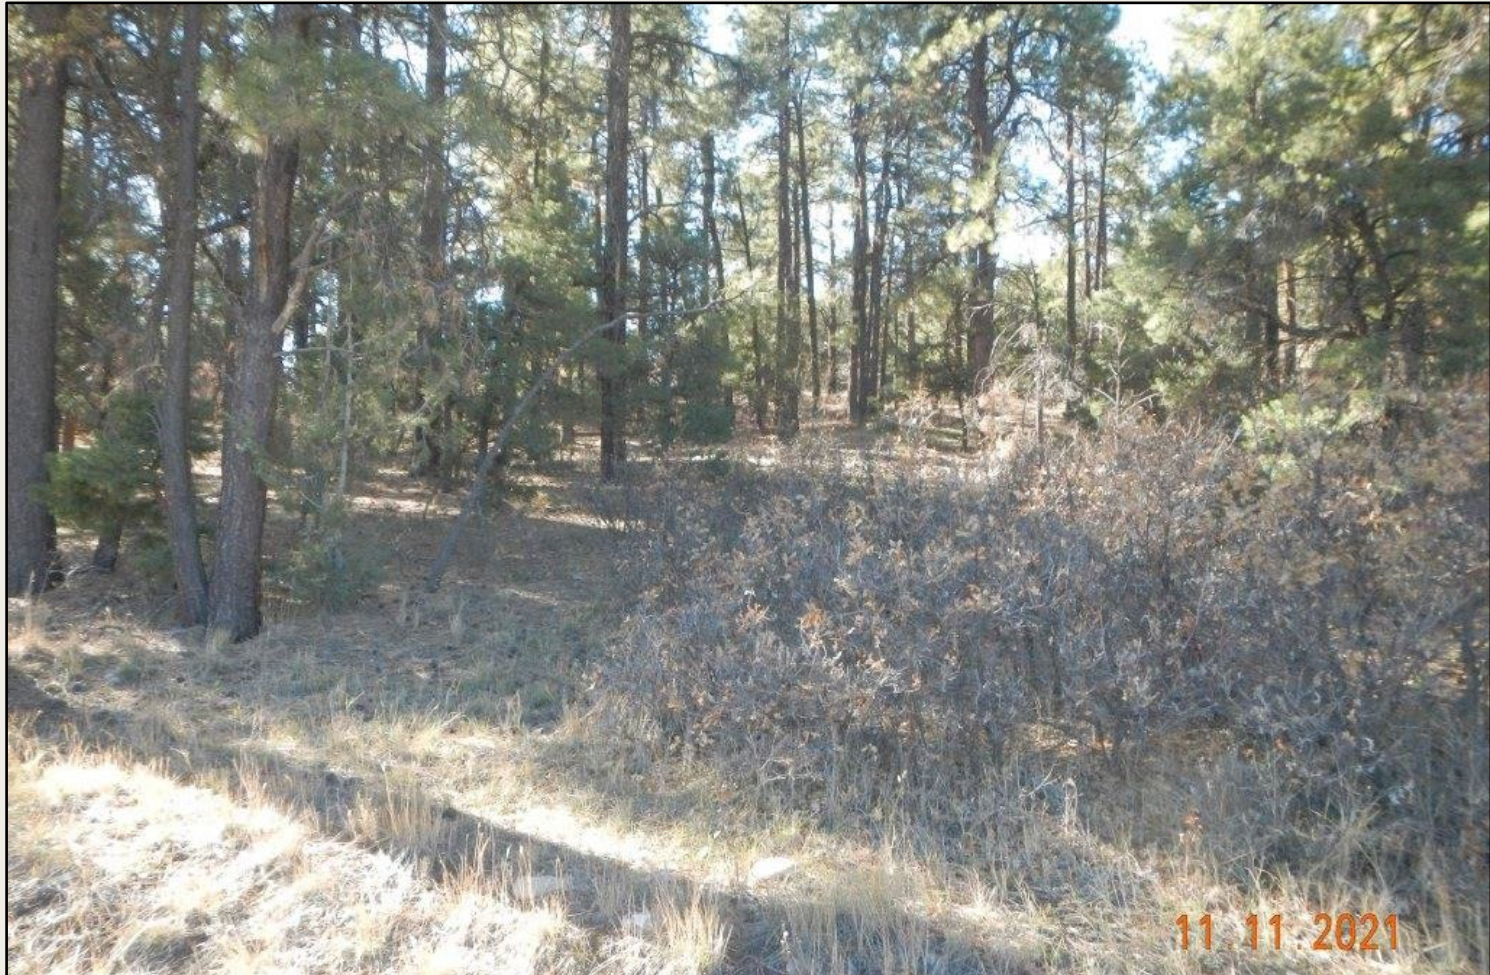
Photo 5. View of the reference area comprised of ponderosa pine, and pinyon and juniper woodland, with and understory of gambel oak, mountain mahogany, western wheatgrass, muttongrass, and threadleaf sunflower.
