Inspection Photos

API: 071-07791

Operator: EVERGREEN NATURAL RESOURCES

Inspection Date: 11/12/2021

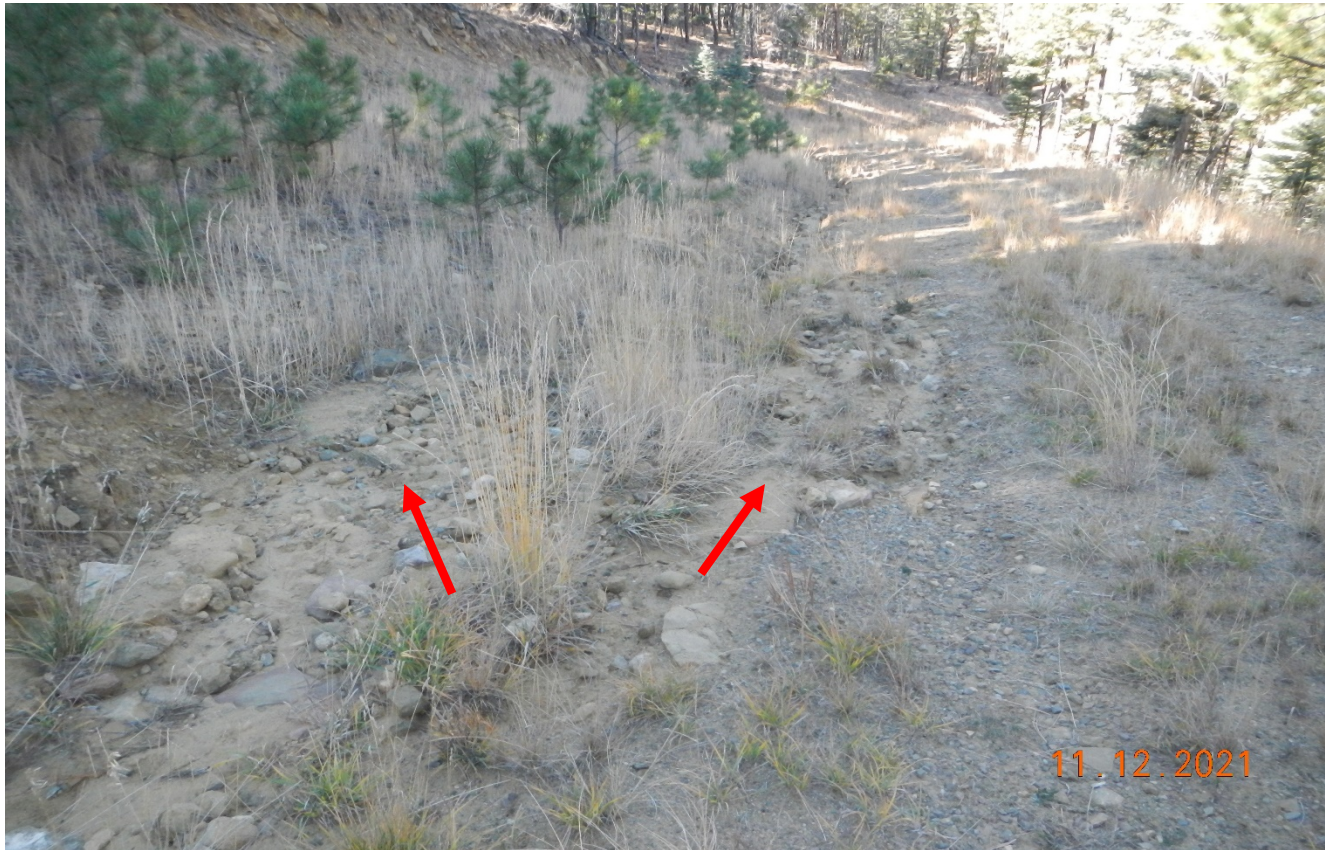
Photo 2. The culvert along the access road is filled in with sediment causing erosion down the road side. Previous corrective action was not performed.

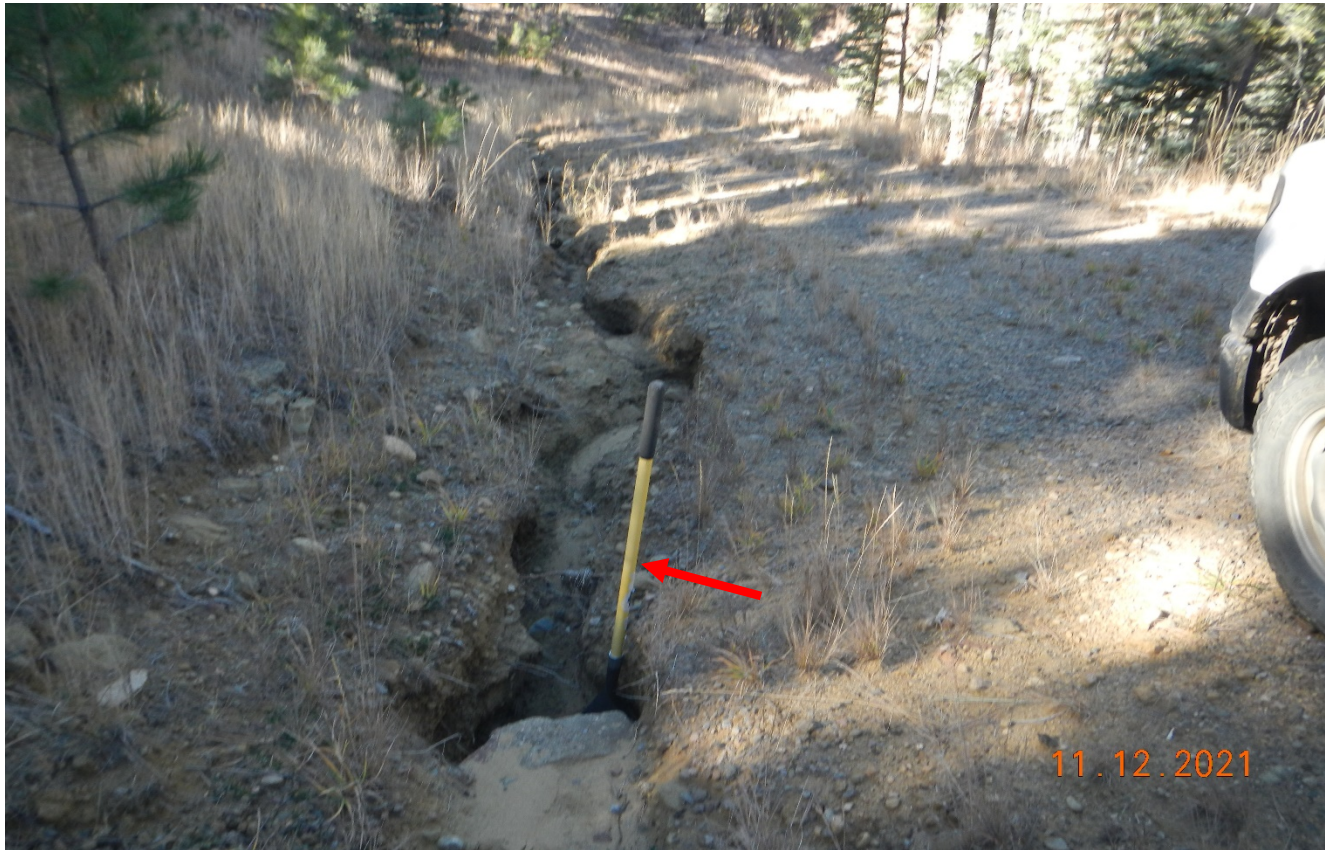
Photo 2. There is erosion along the road side which has not been repaired. Red arrow points to 4.5 ft. shovel for scale.

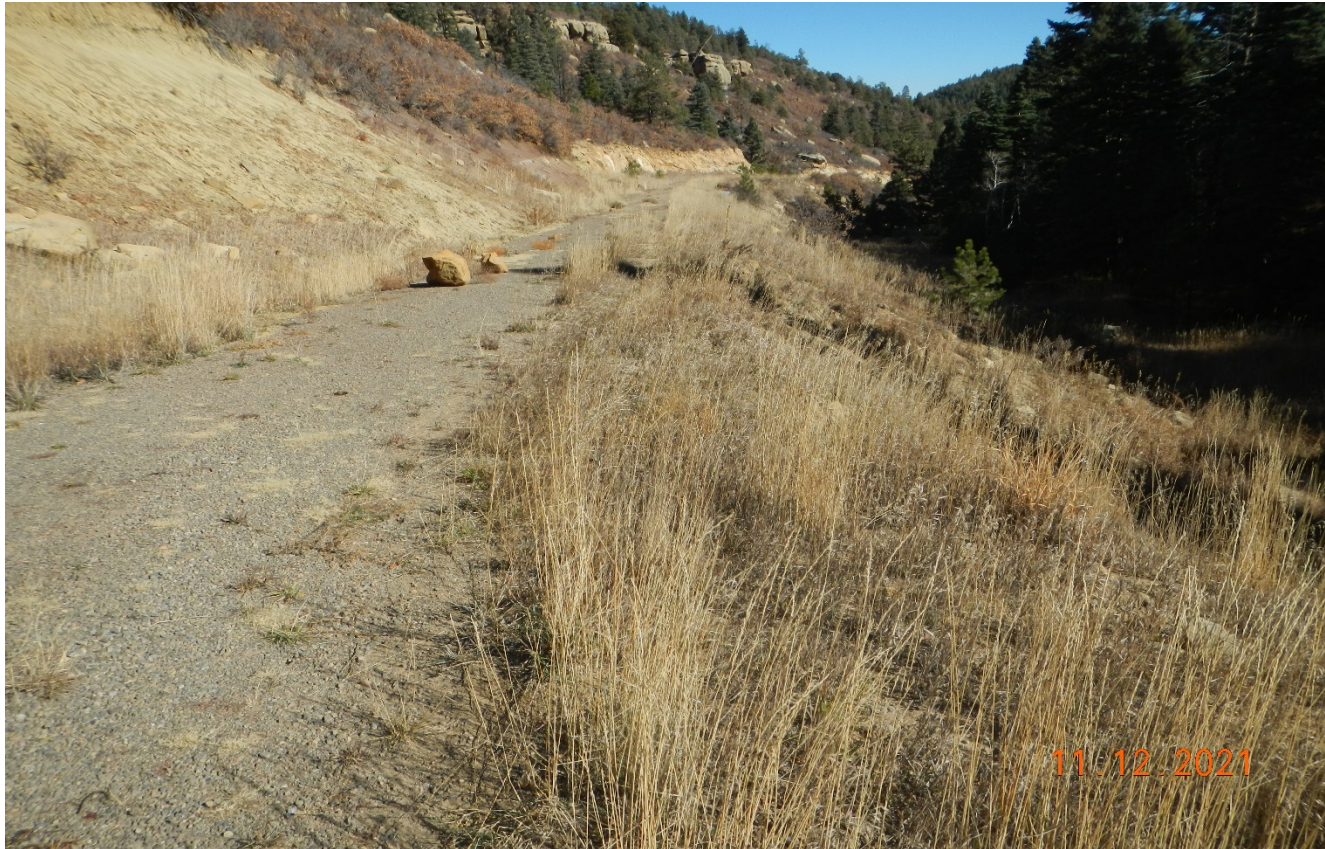
Photo 3. Facing northeast along the access road. The road is not recontoured and rocks have fallen onto the road.

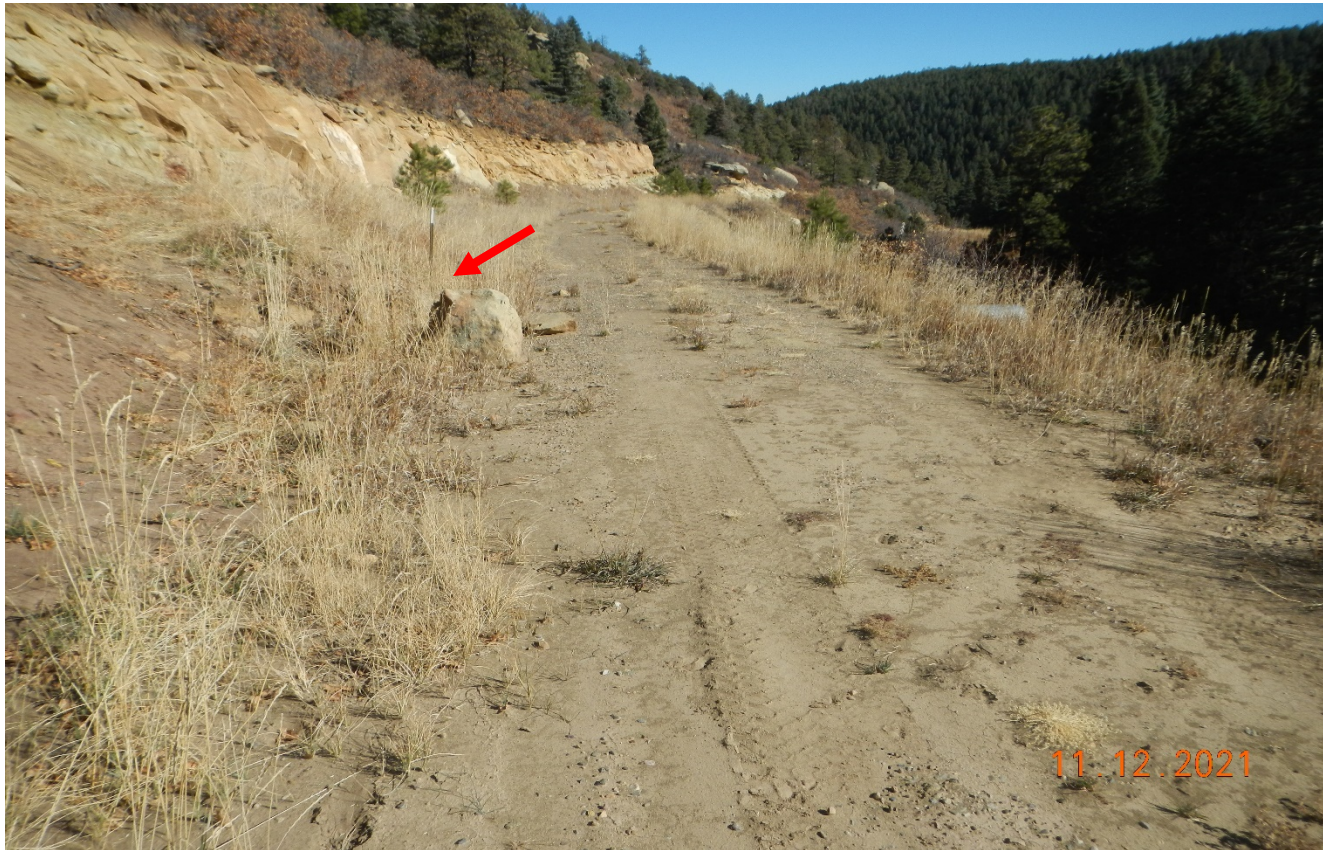
Photo 4. Facing northeast along the access road. The culvert is filled in with sediment shown at red arrow. Rocks have fallen on the road.

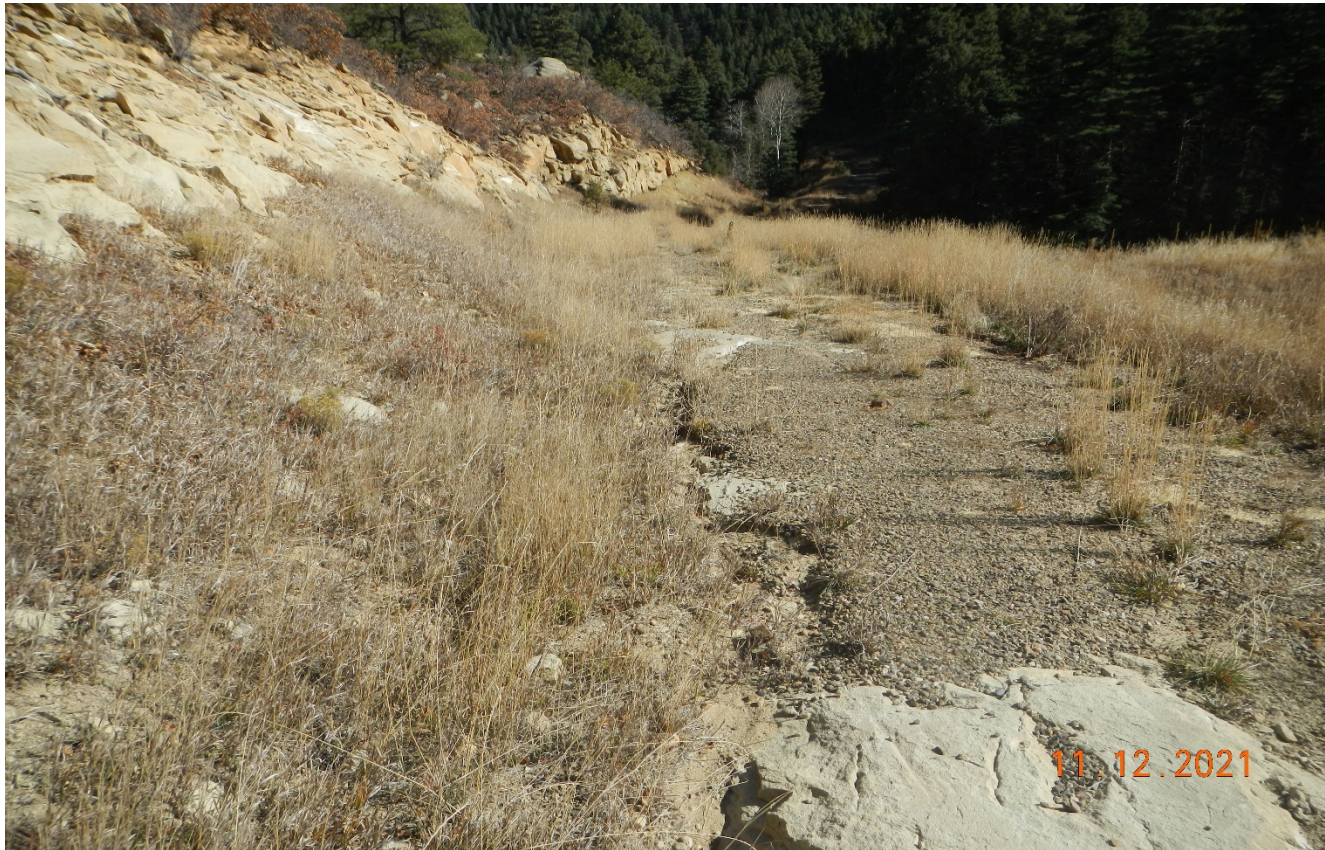
Photo 5. Facing southeast along the access road.

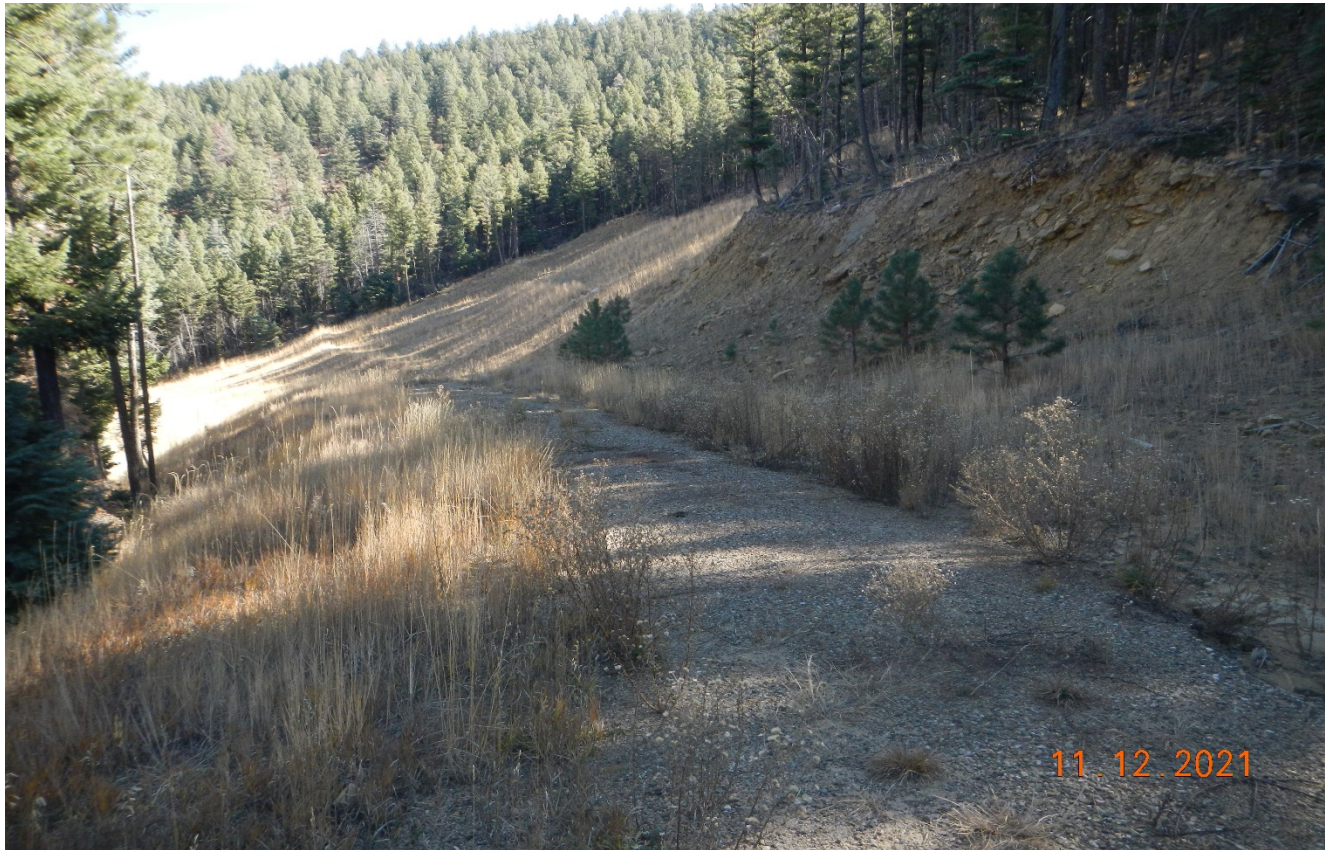
Photo 6. Facing east. There is a steep cut slope at the end of the access road that is not stabilized.

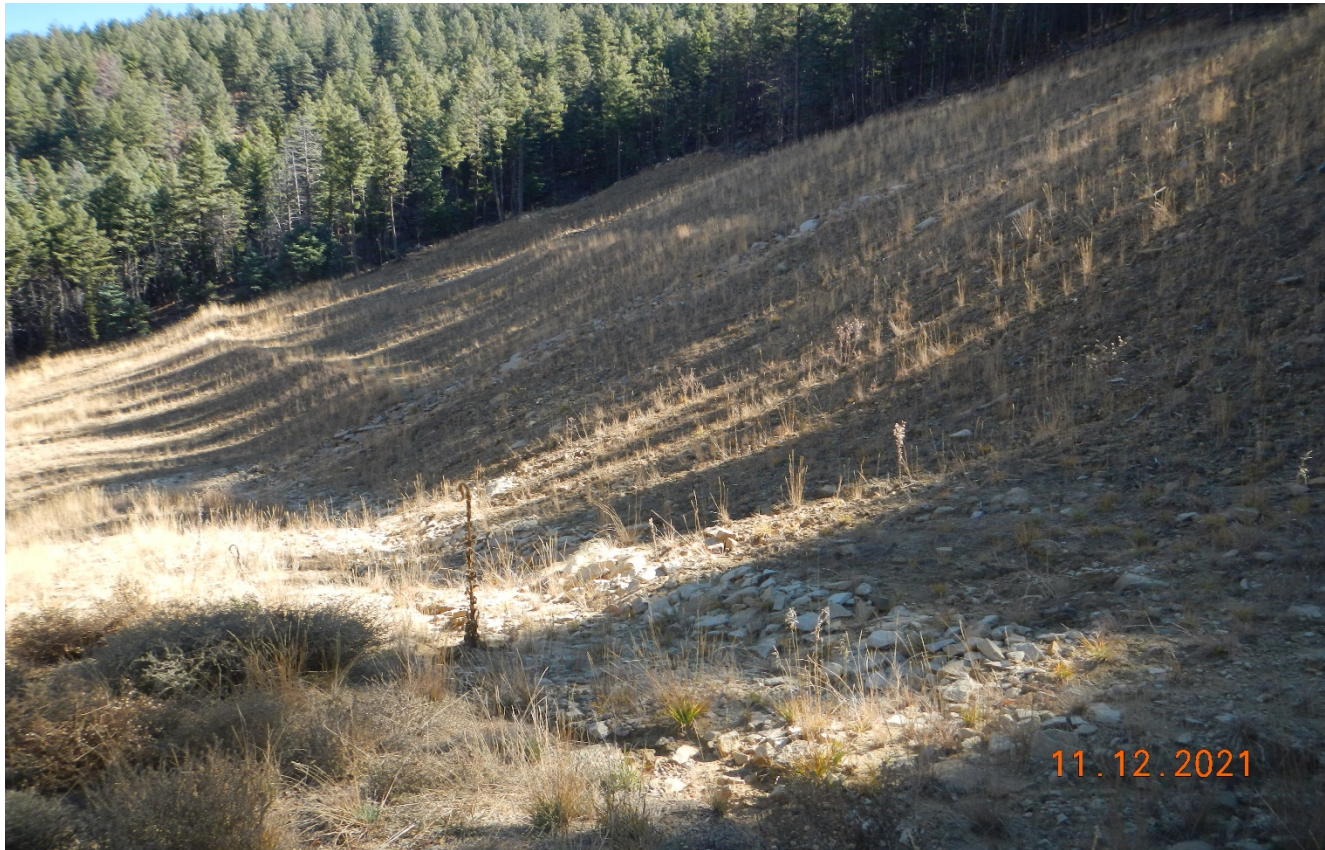
Photo 7. Facing east toward the location. The location has been recontoured and reclaimed but has not yet reached 80% vegetation cover.

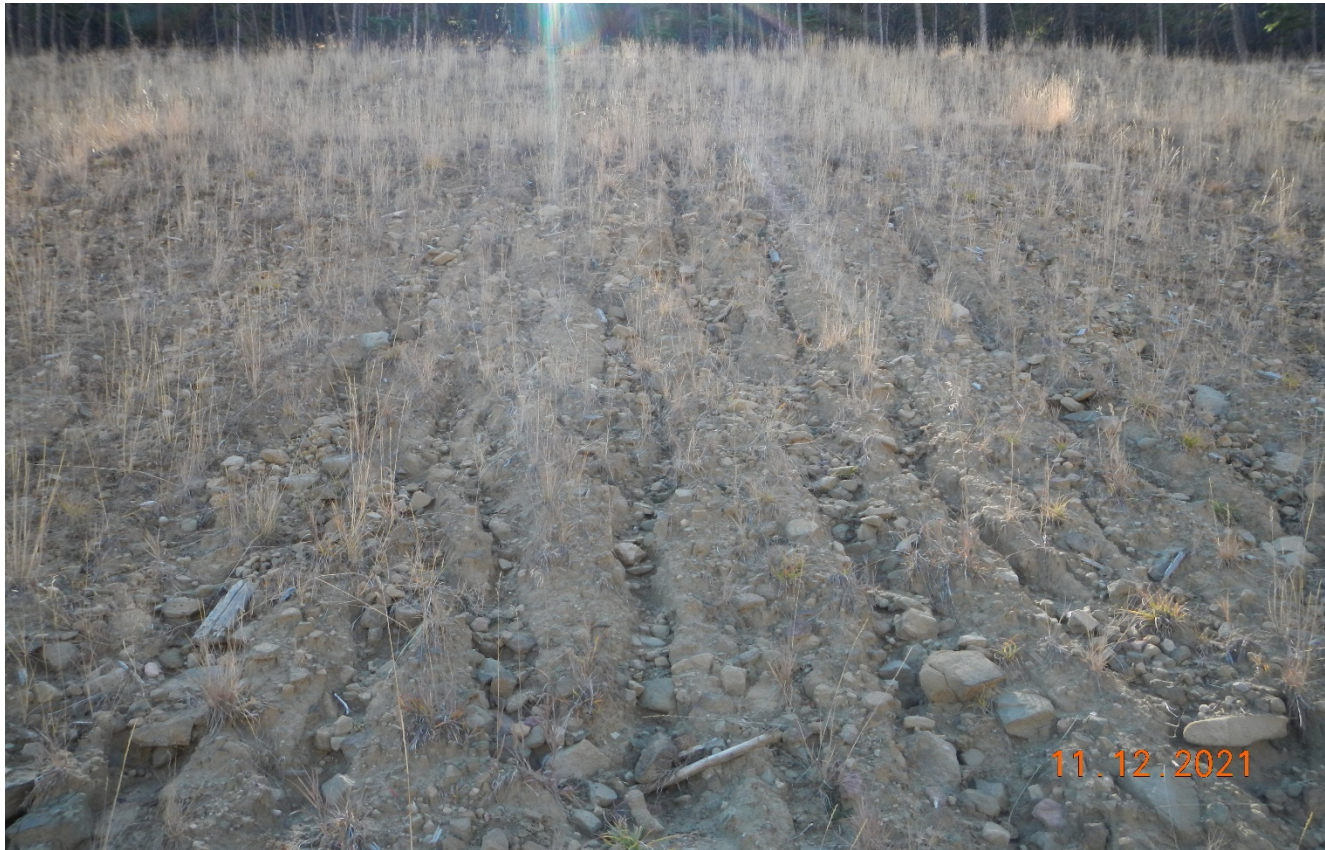
Photo 8. There are areas of erosion along the reclaimed location that need to be repaired and stabilized.

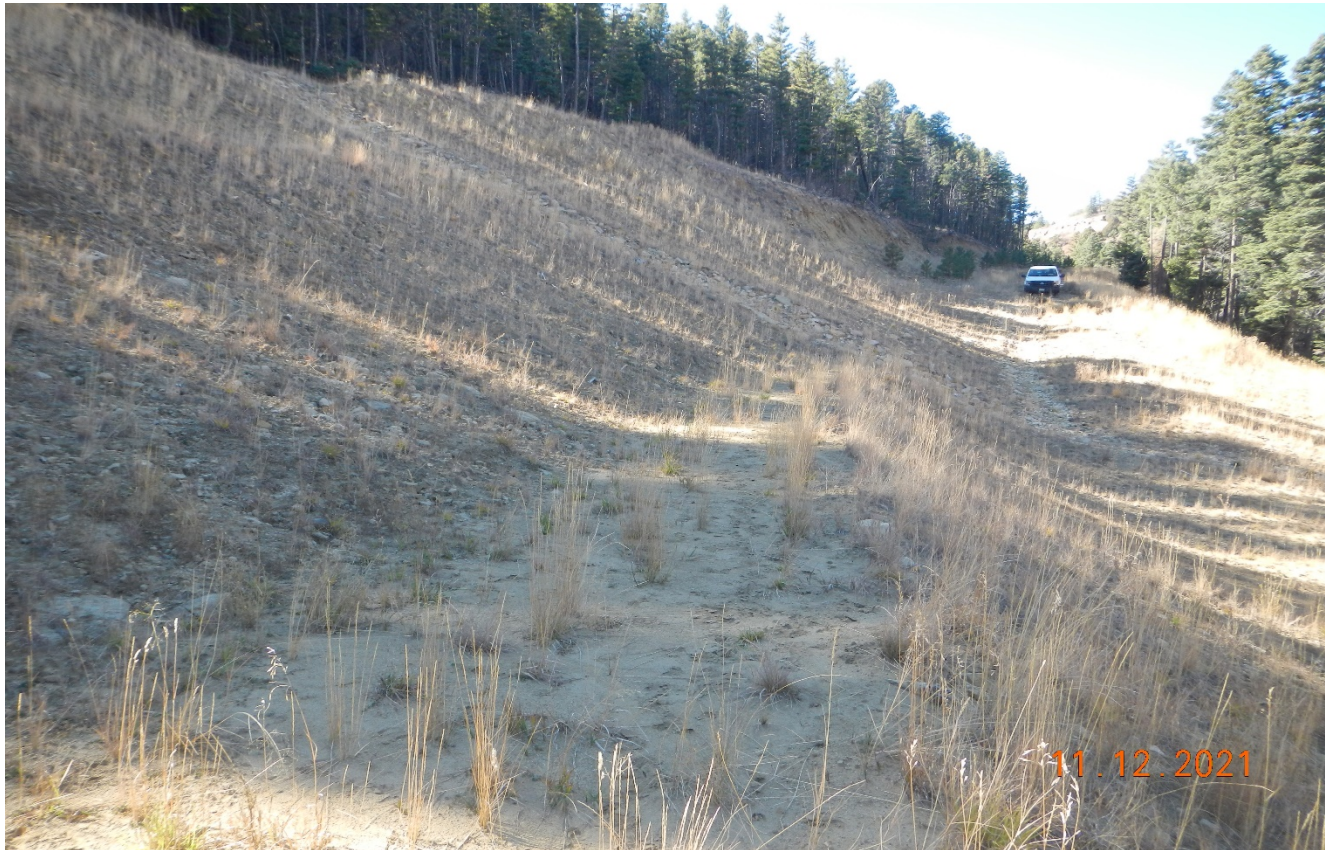
Photo 9. Facing southwest toward the location.
