Inspection Photos
Operator: Logos
API: 067-05515
Date: 7/29/2015

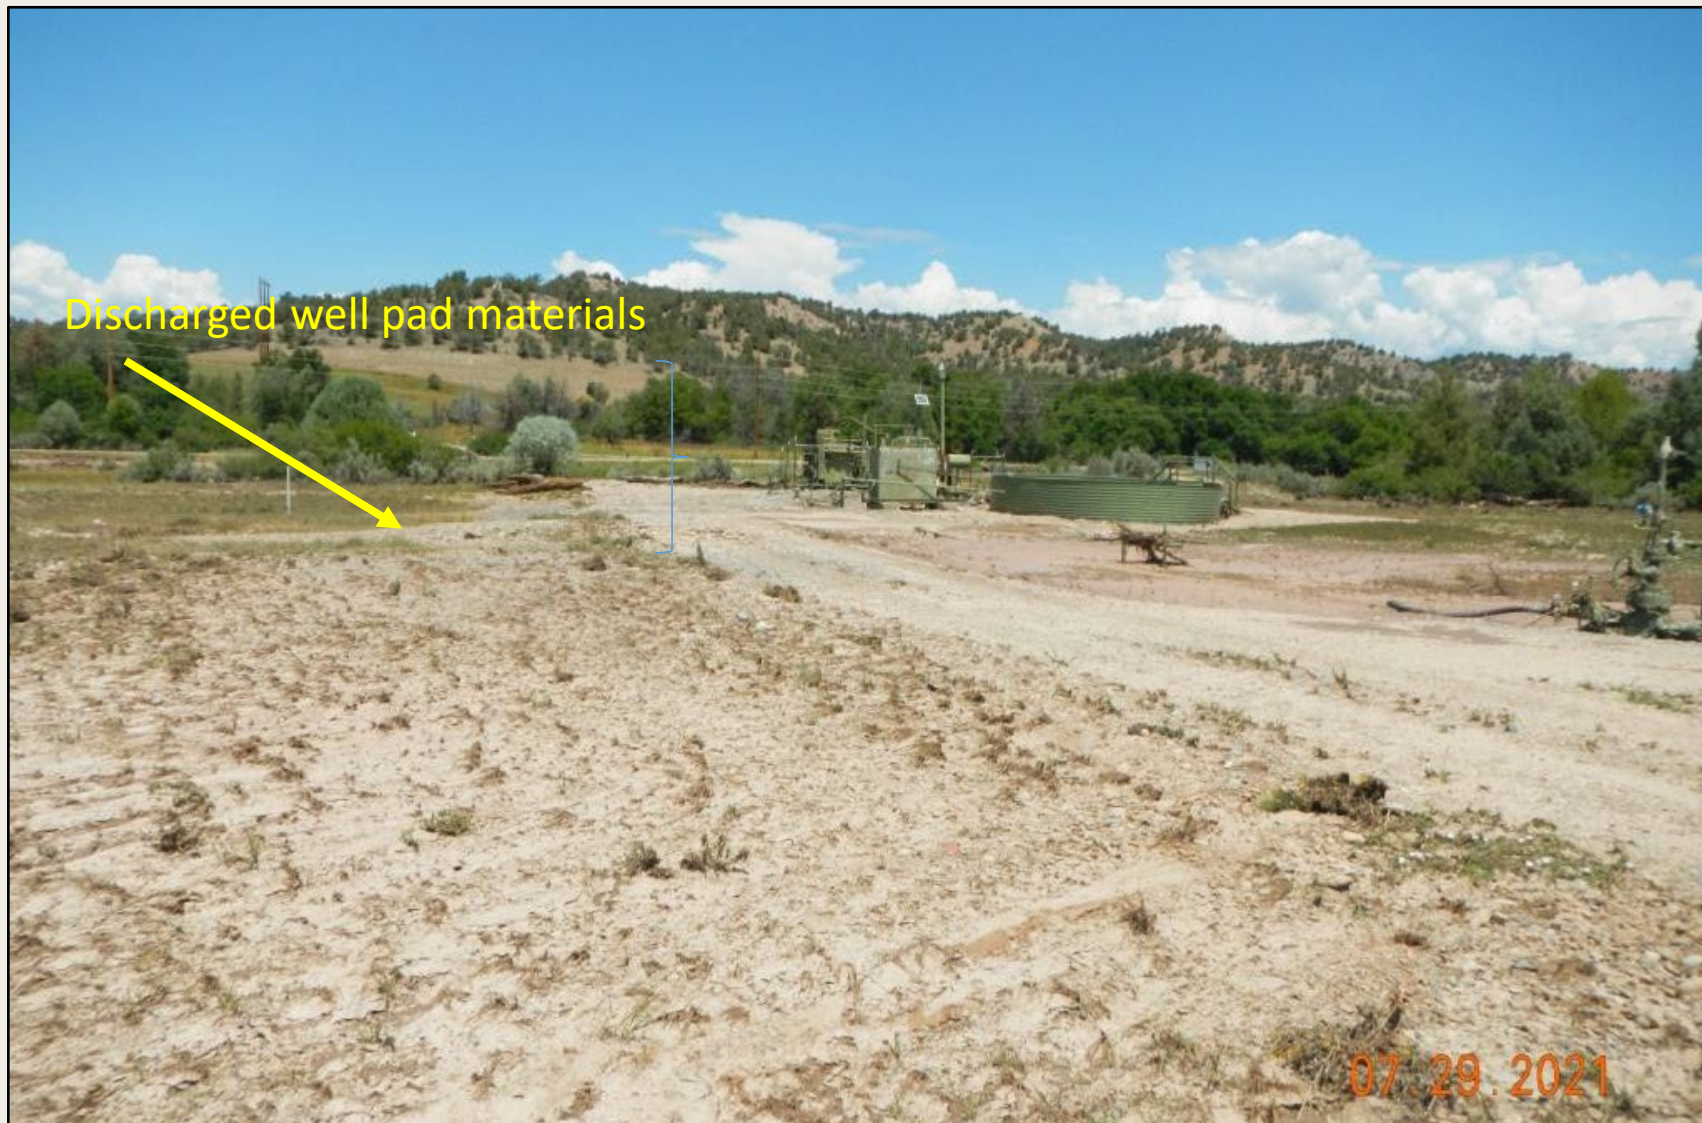
Photo 1. View of the location from the southwestern corner facing center. Stormwater flows have washed well pad material off of well pad and deposited down-slope and likely downstream. Water flows from right to left here.

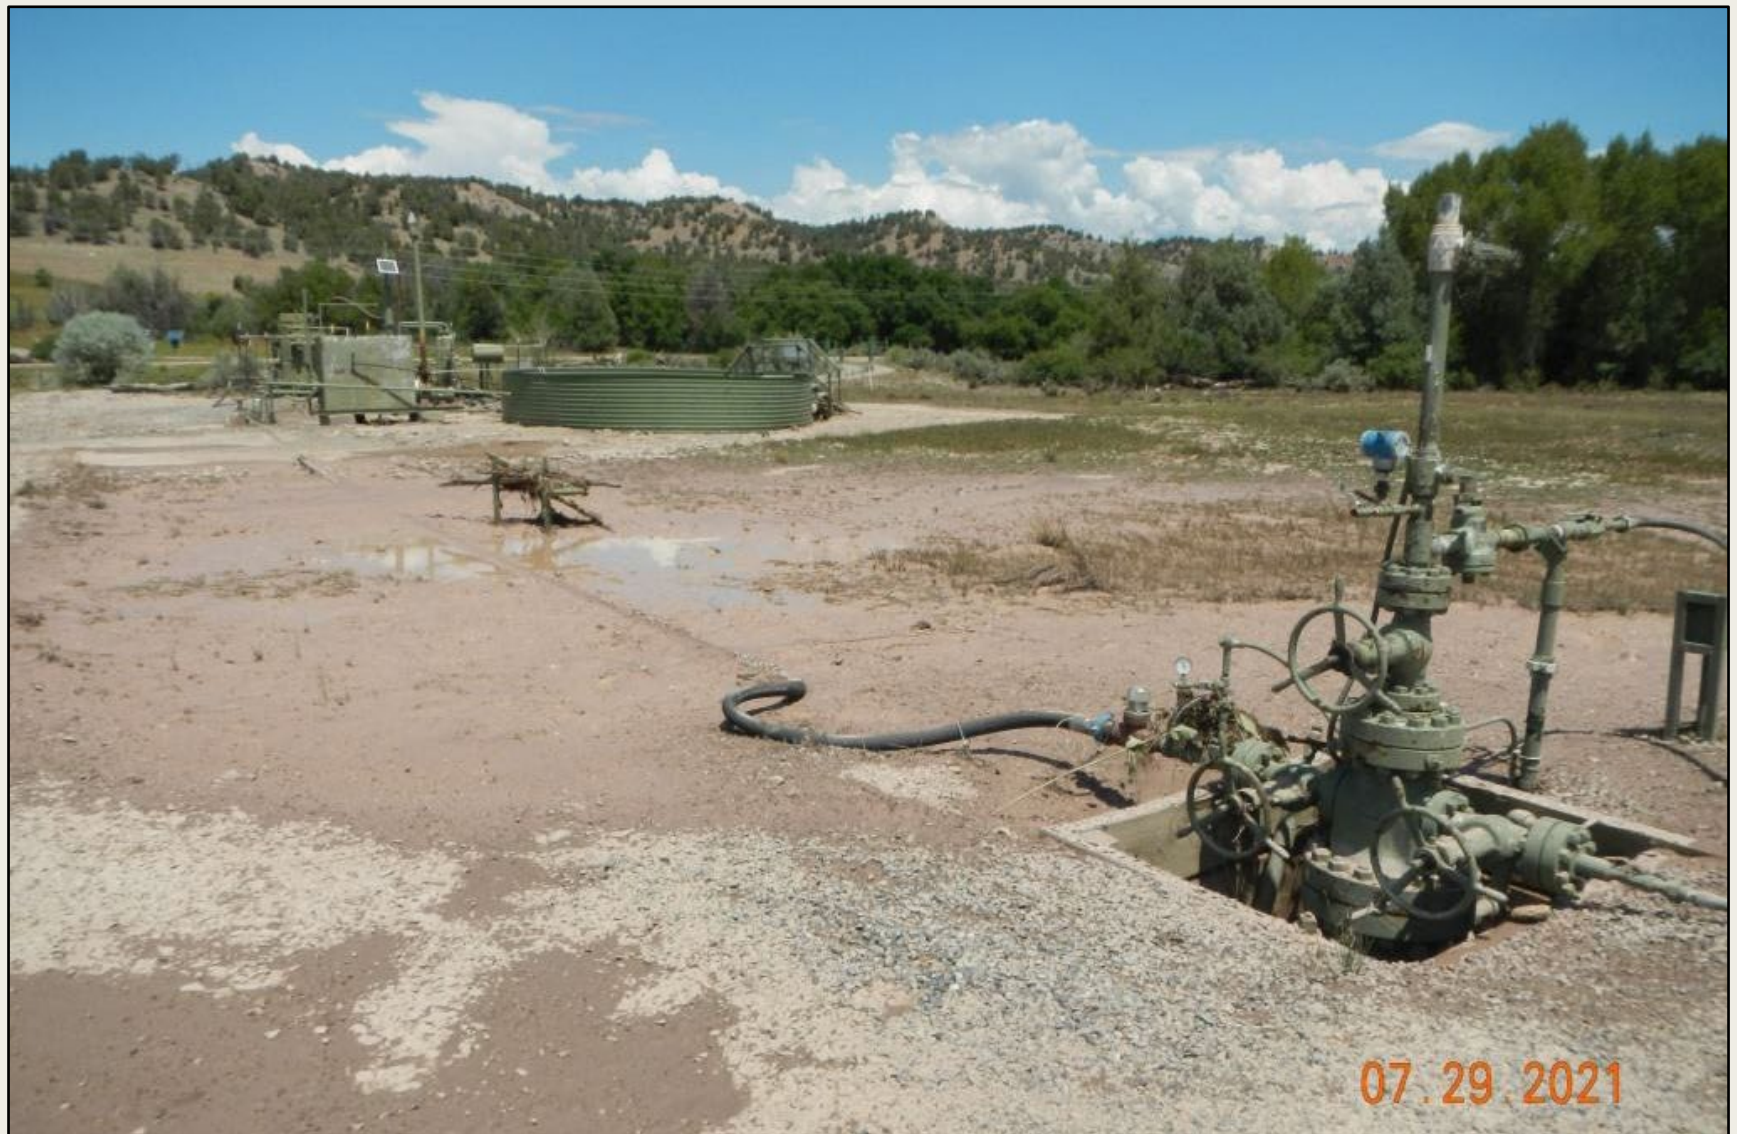
Photo 2. View of well and facilities. Stormwater has washed away material, exposing lines and deposited wood and plant debris on project facilities.

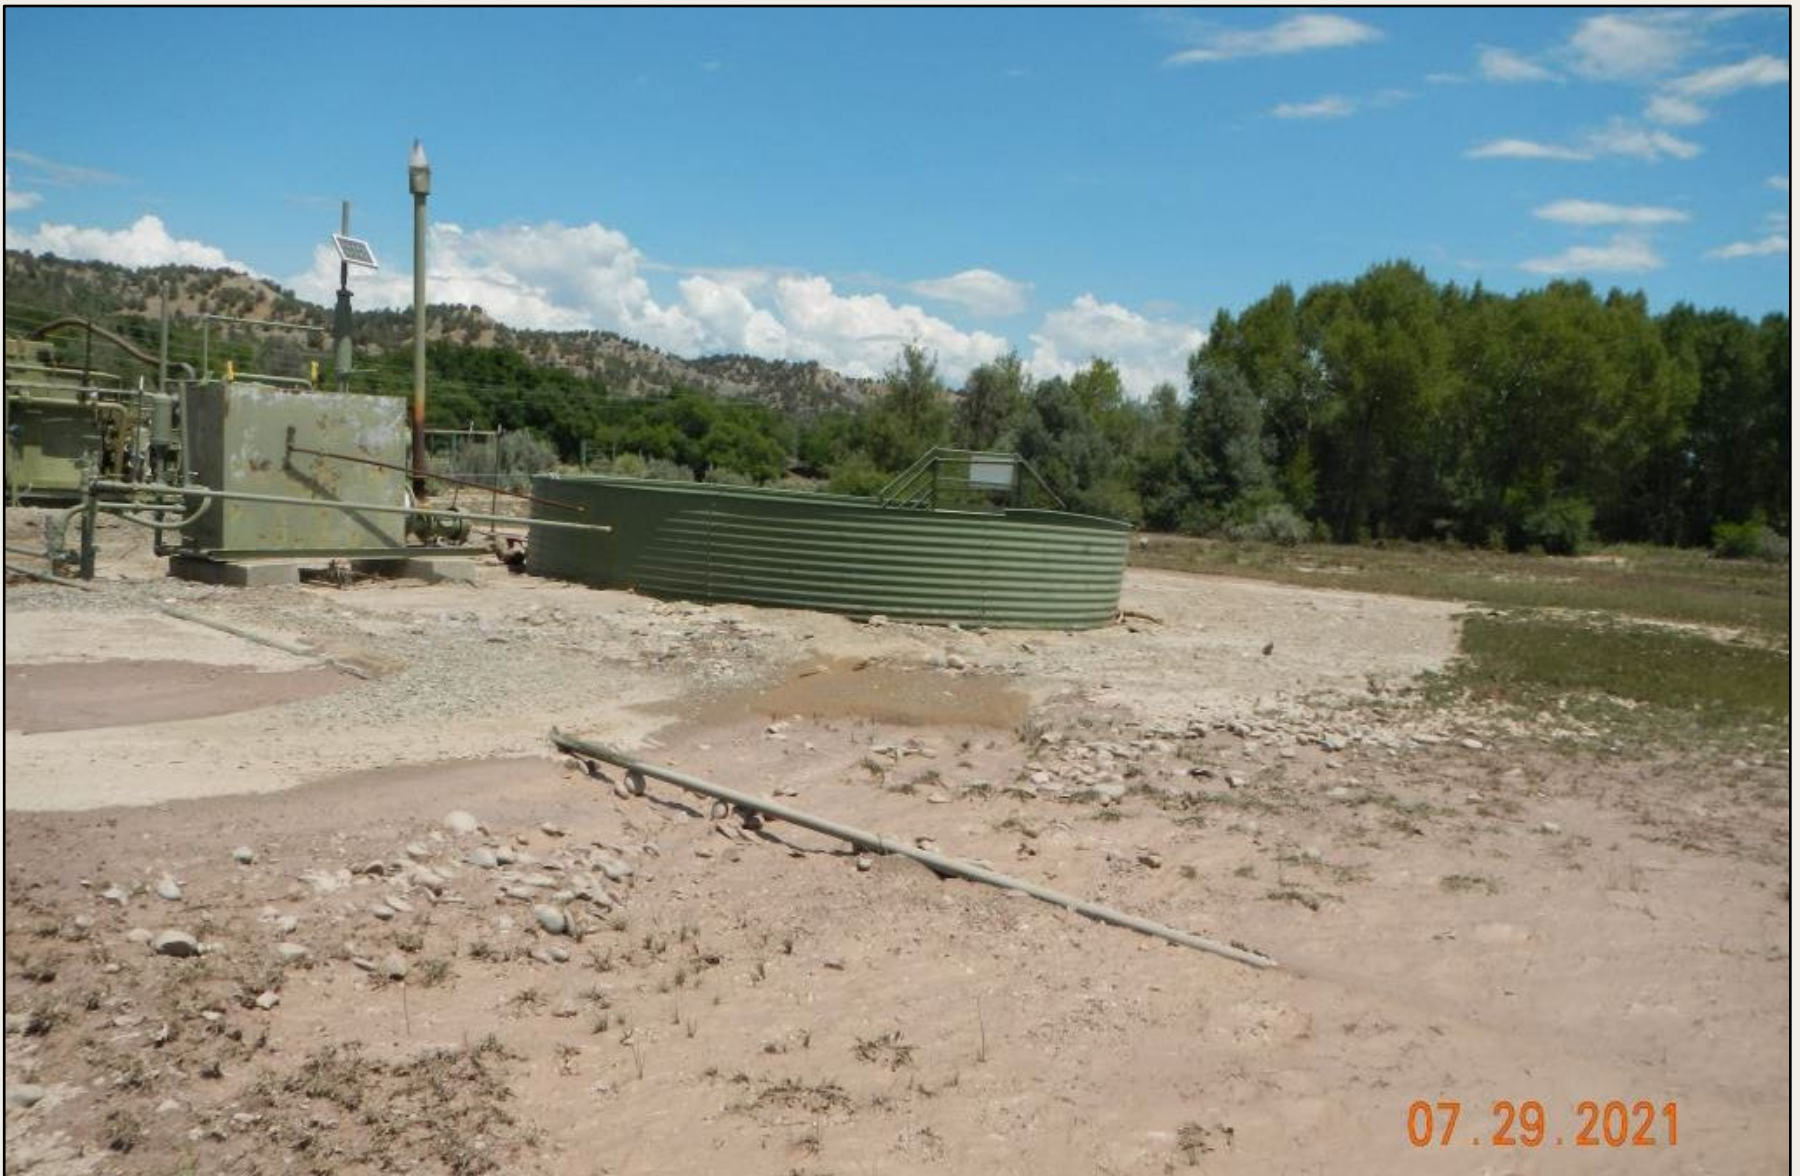
Photo 3. Another view of equipment facing upslope. Gravel is largely washed offsite.

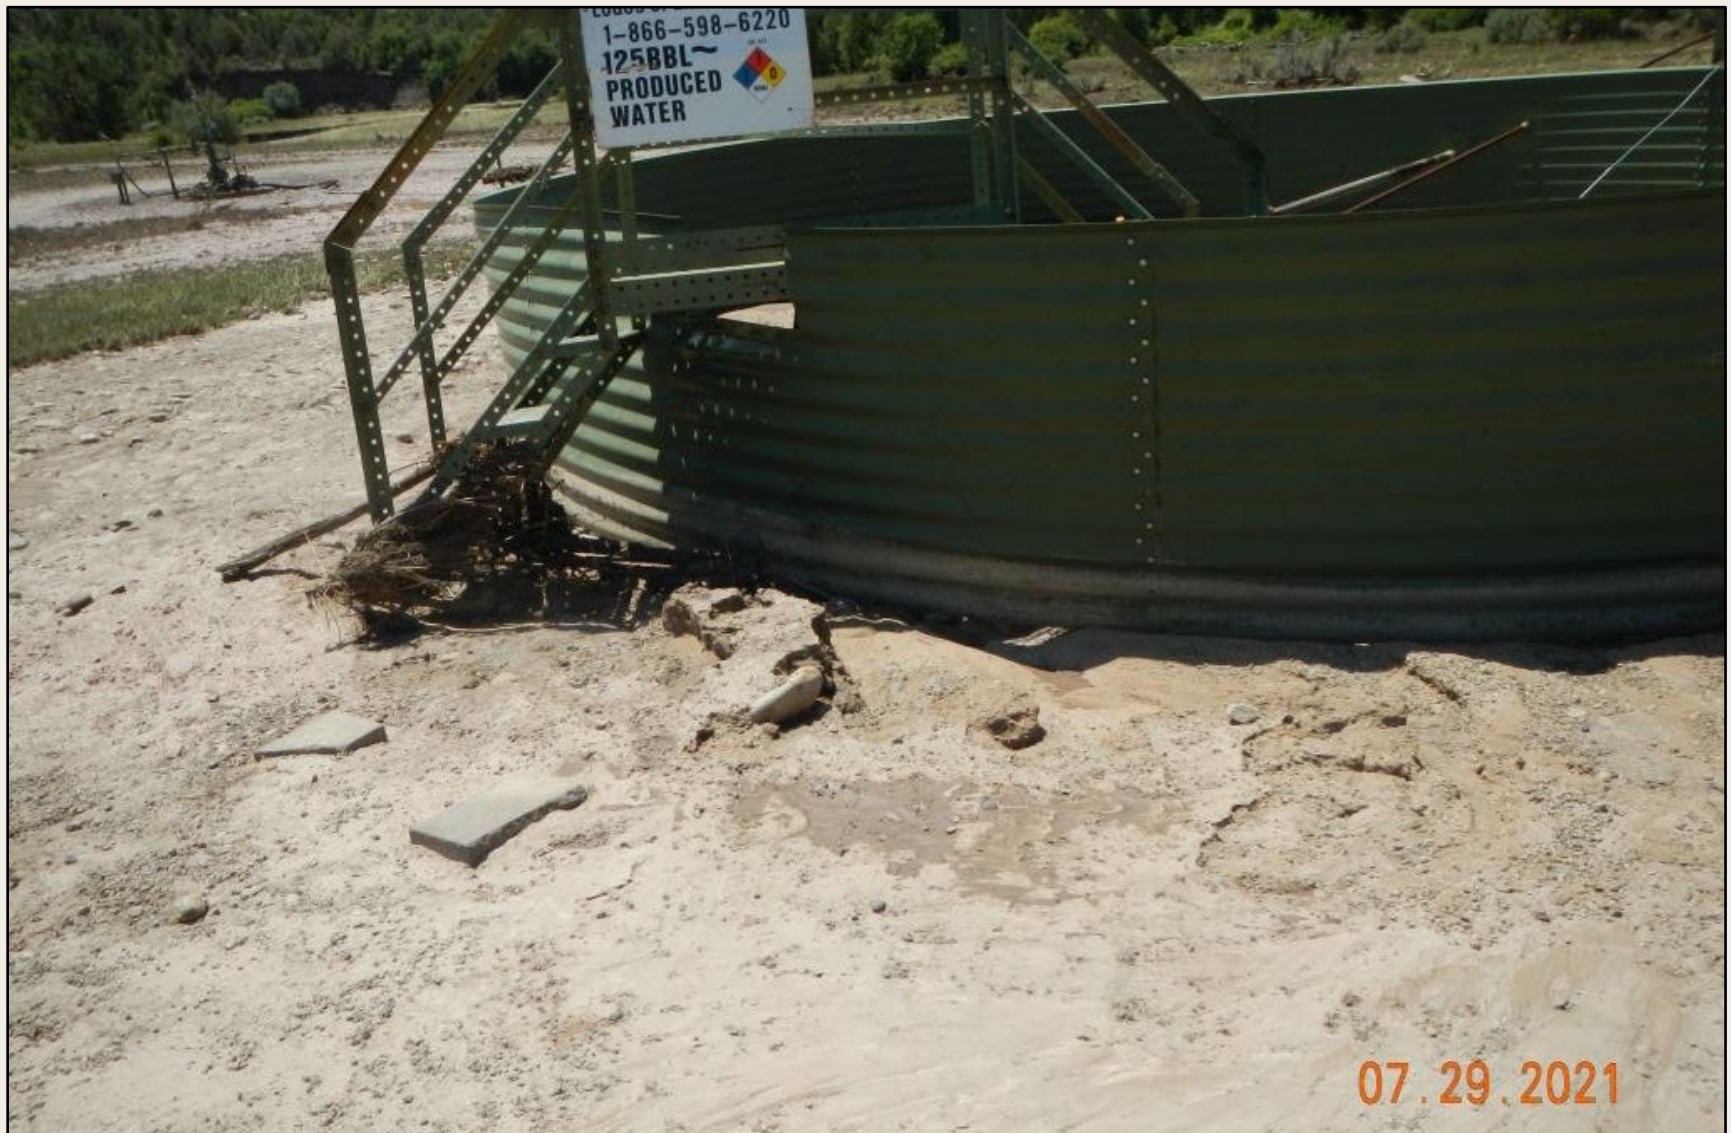
Photo 4. View of erosional scouring and flow pattern eroding beneath and around submerged vessel.

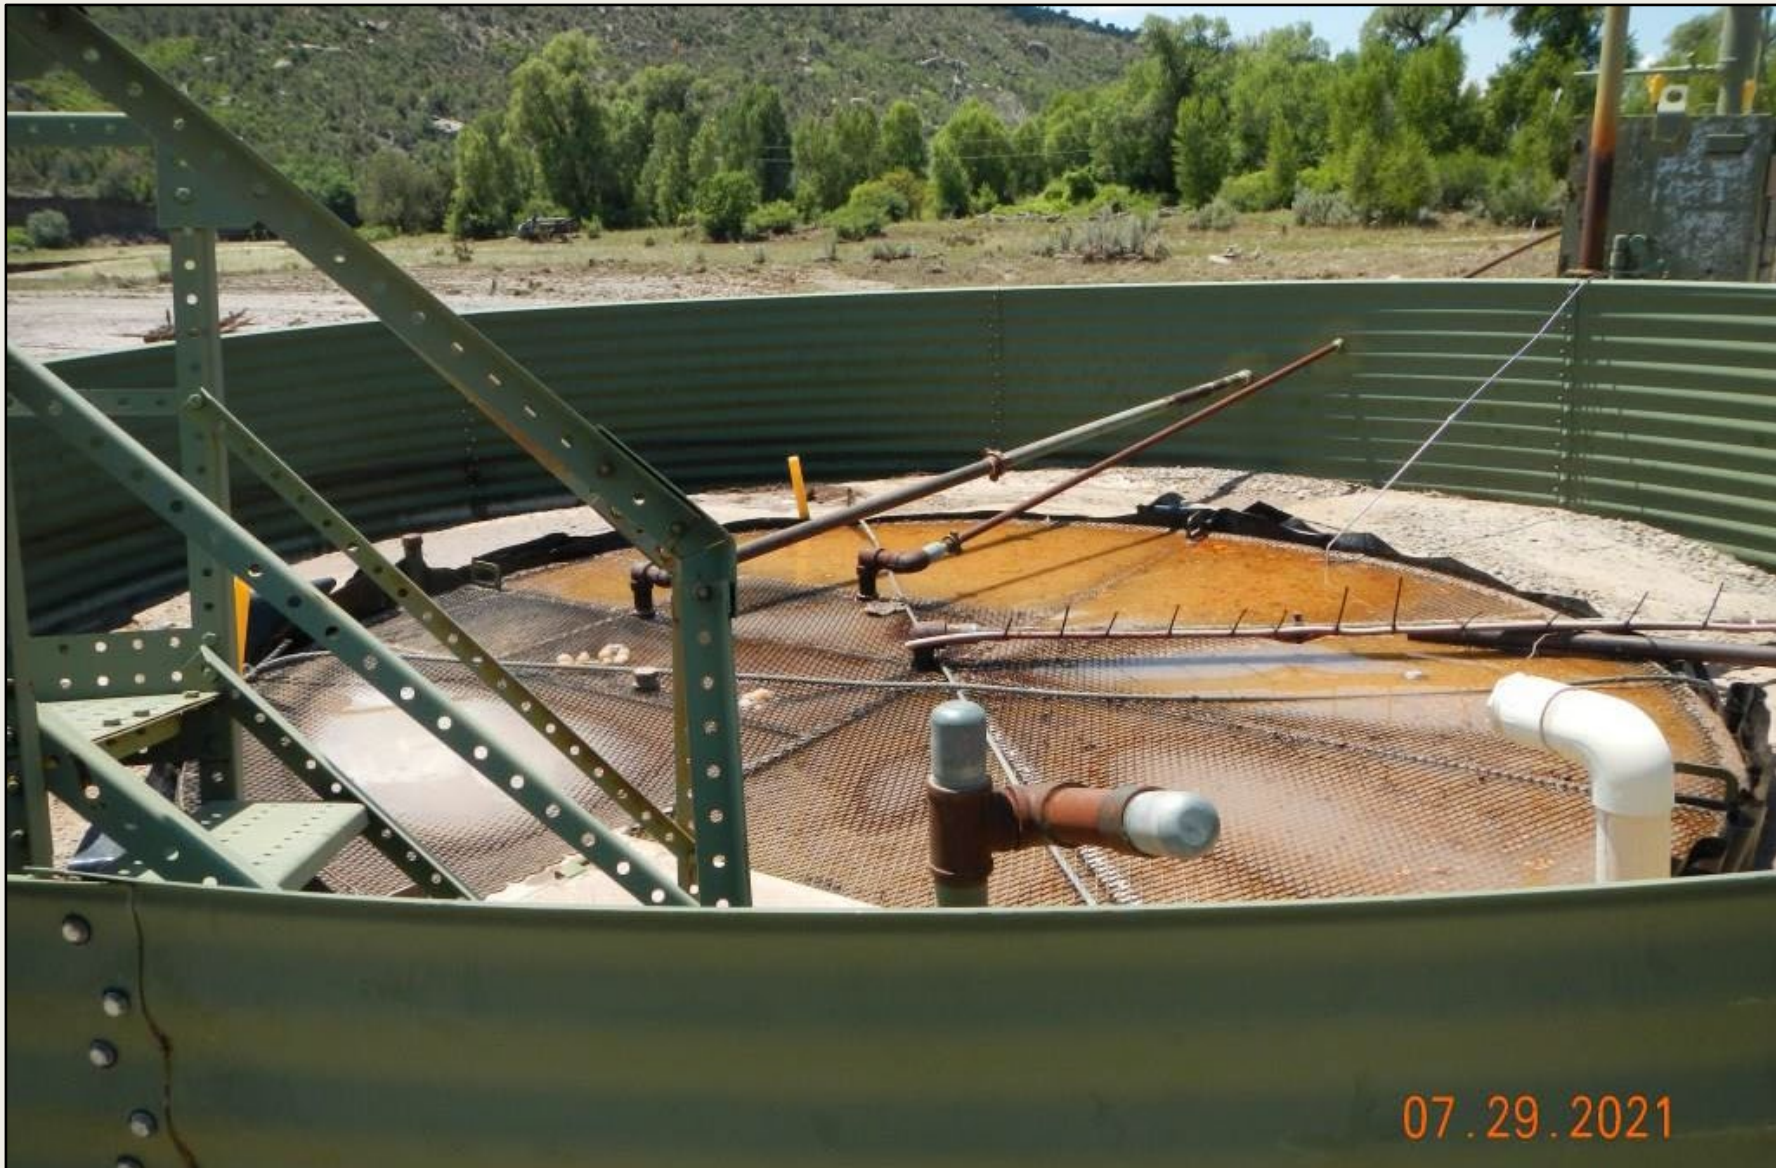
Photo 5. View of open tank full of liquid and bubbling, appears to be overflowing. Debris is floating in tank material and sediment deposition observed.

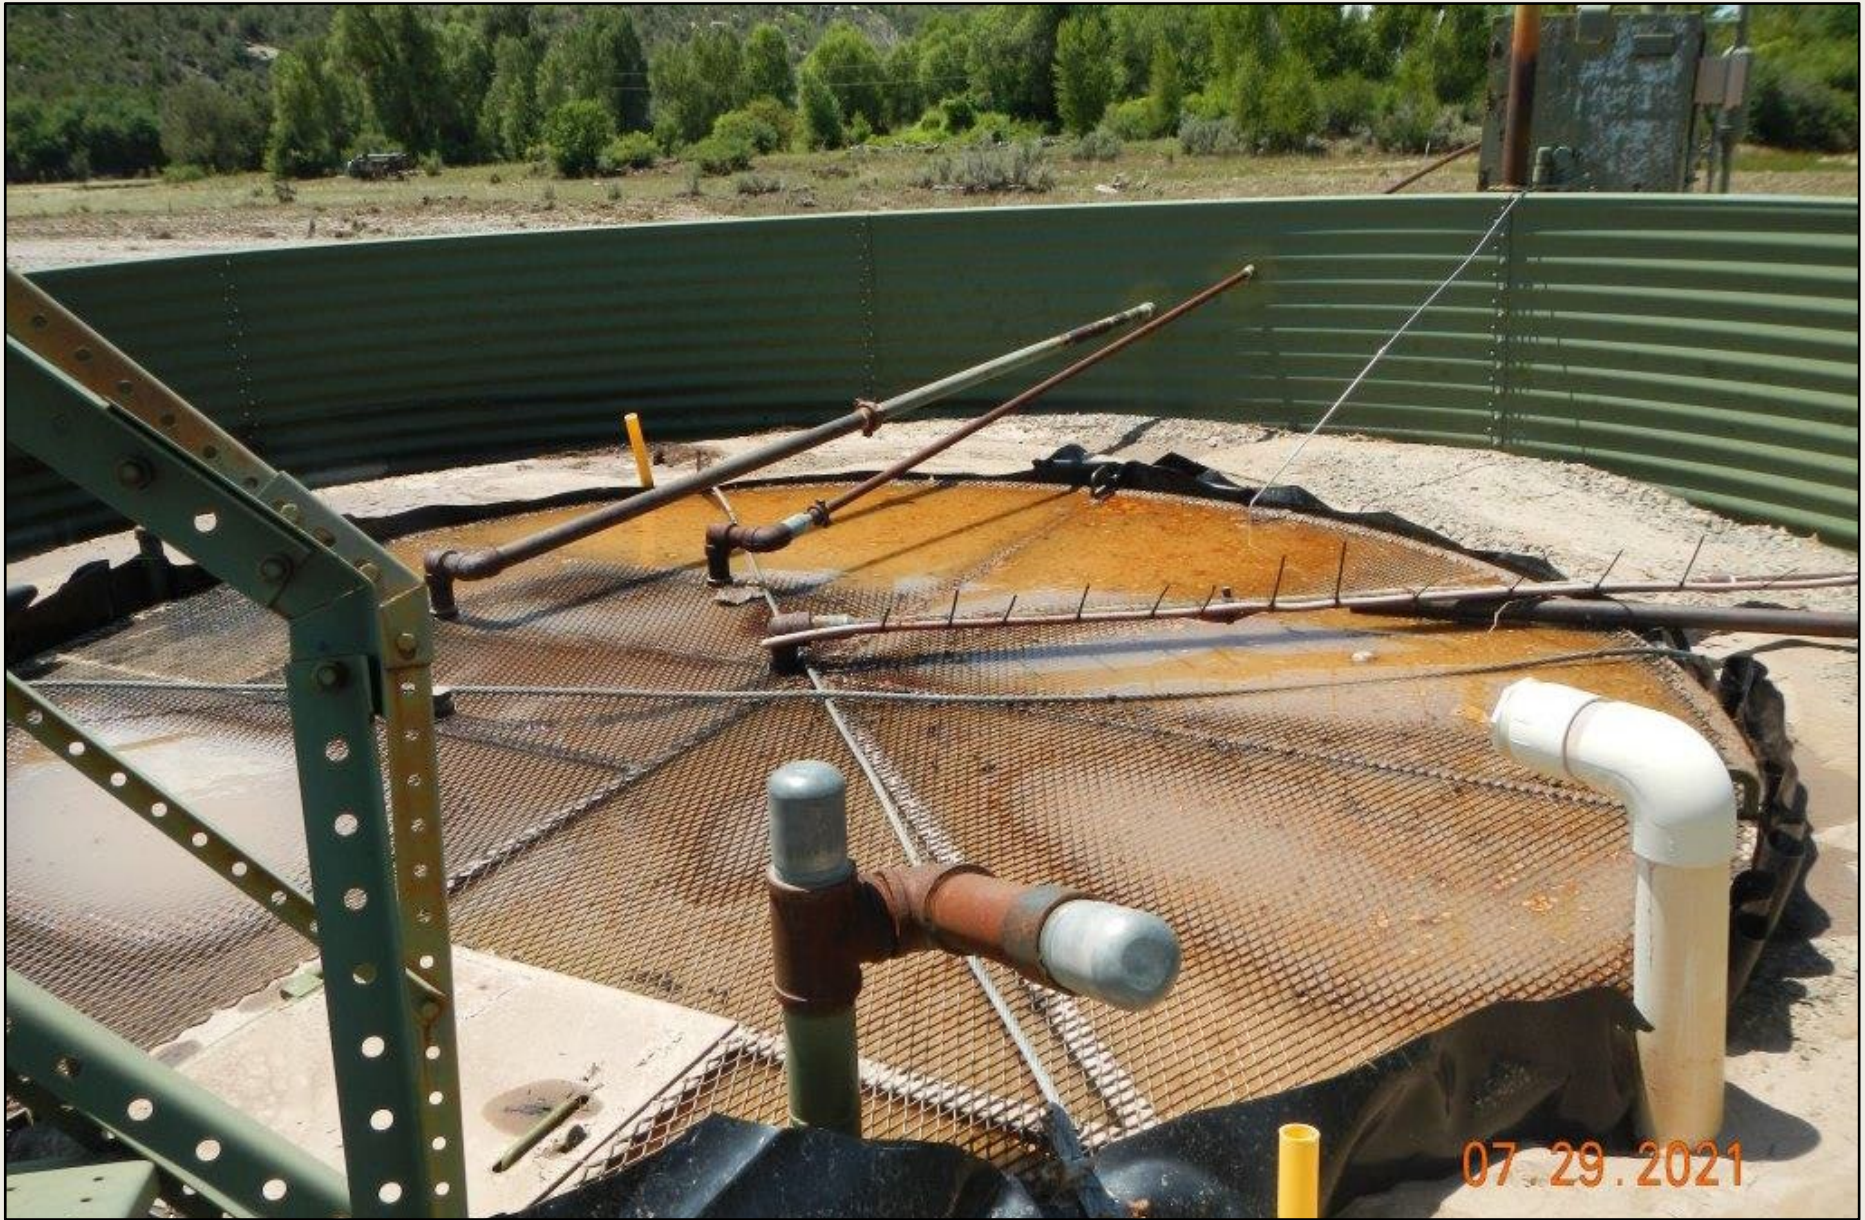
Photo 6. Another view of tank.

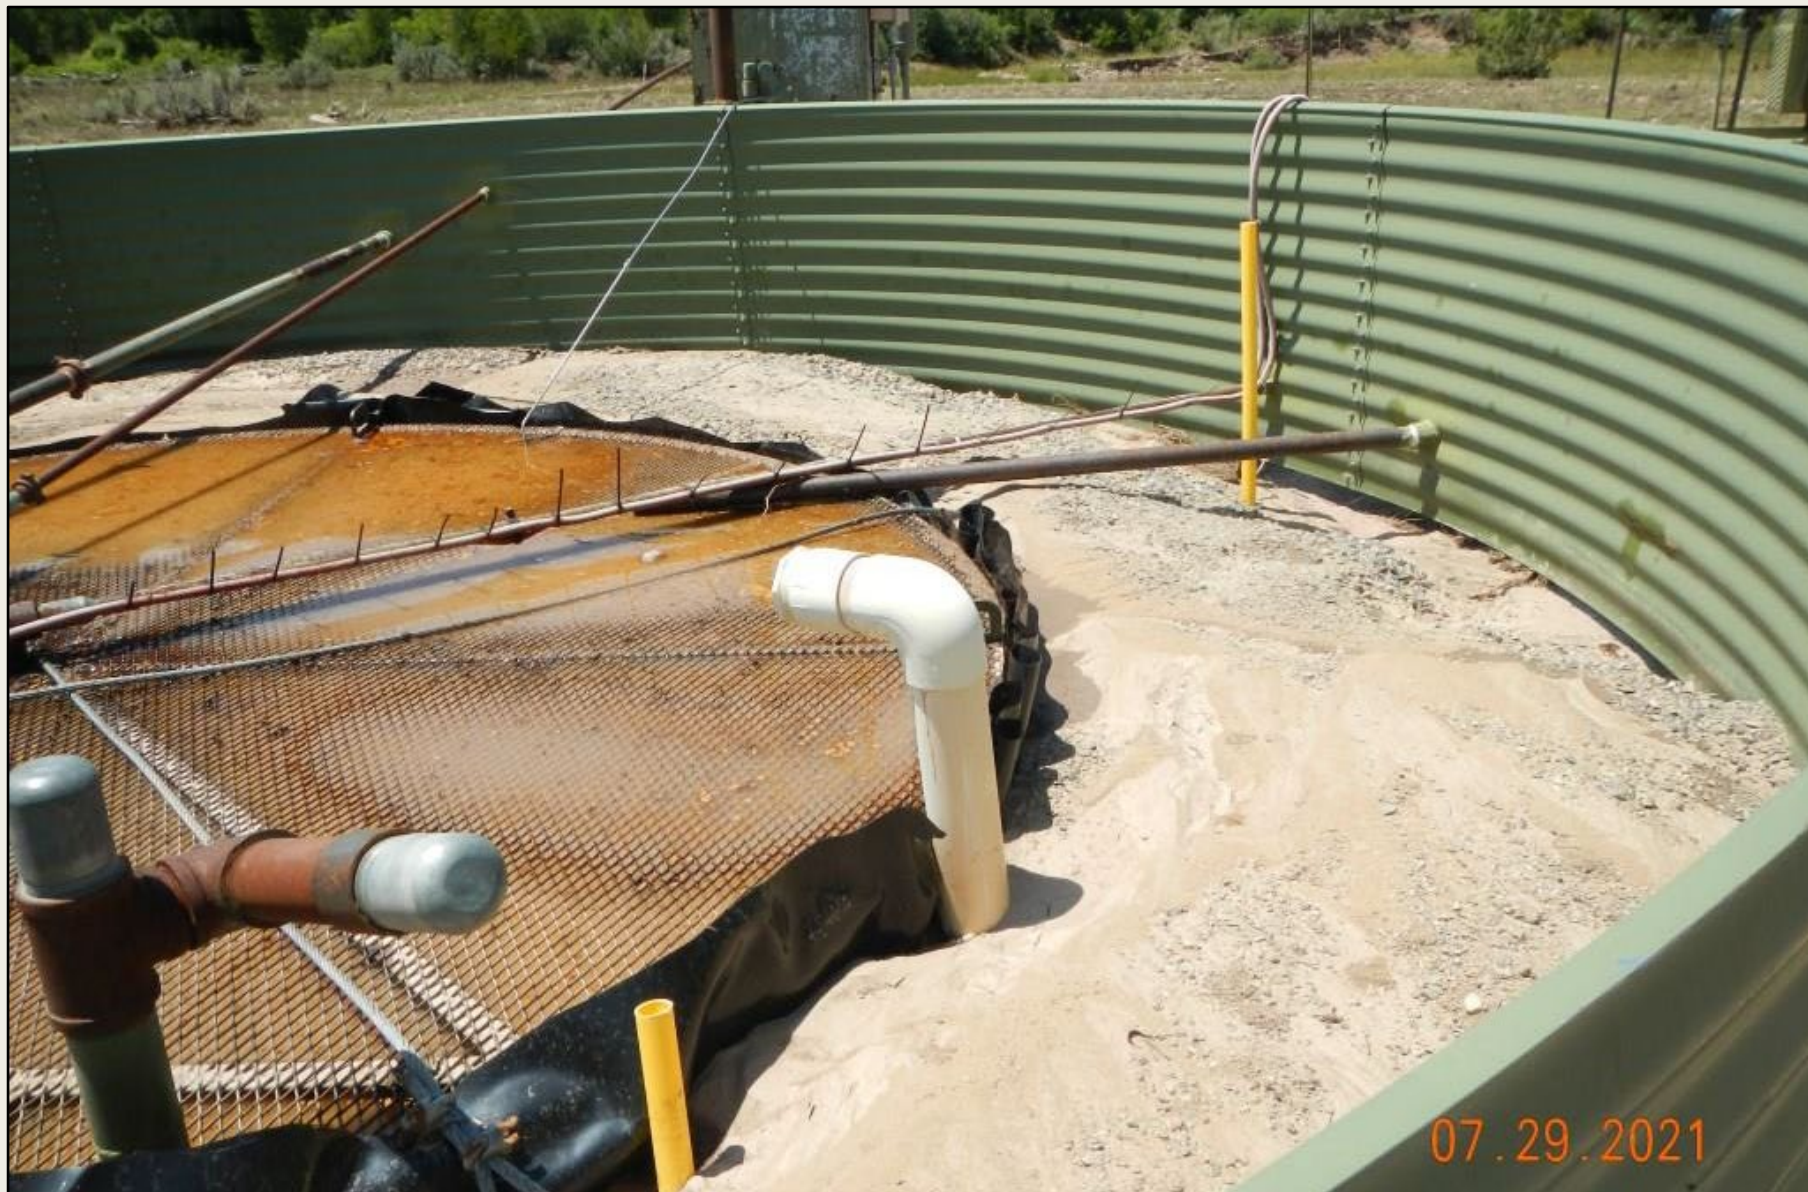
Photo 7. View of flow pattern from water flow due to compromised containment.

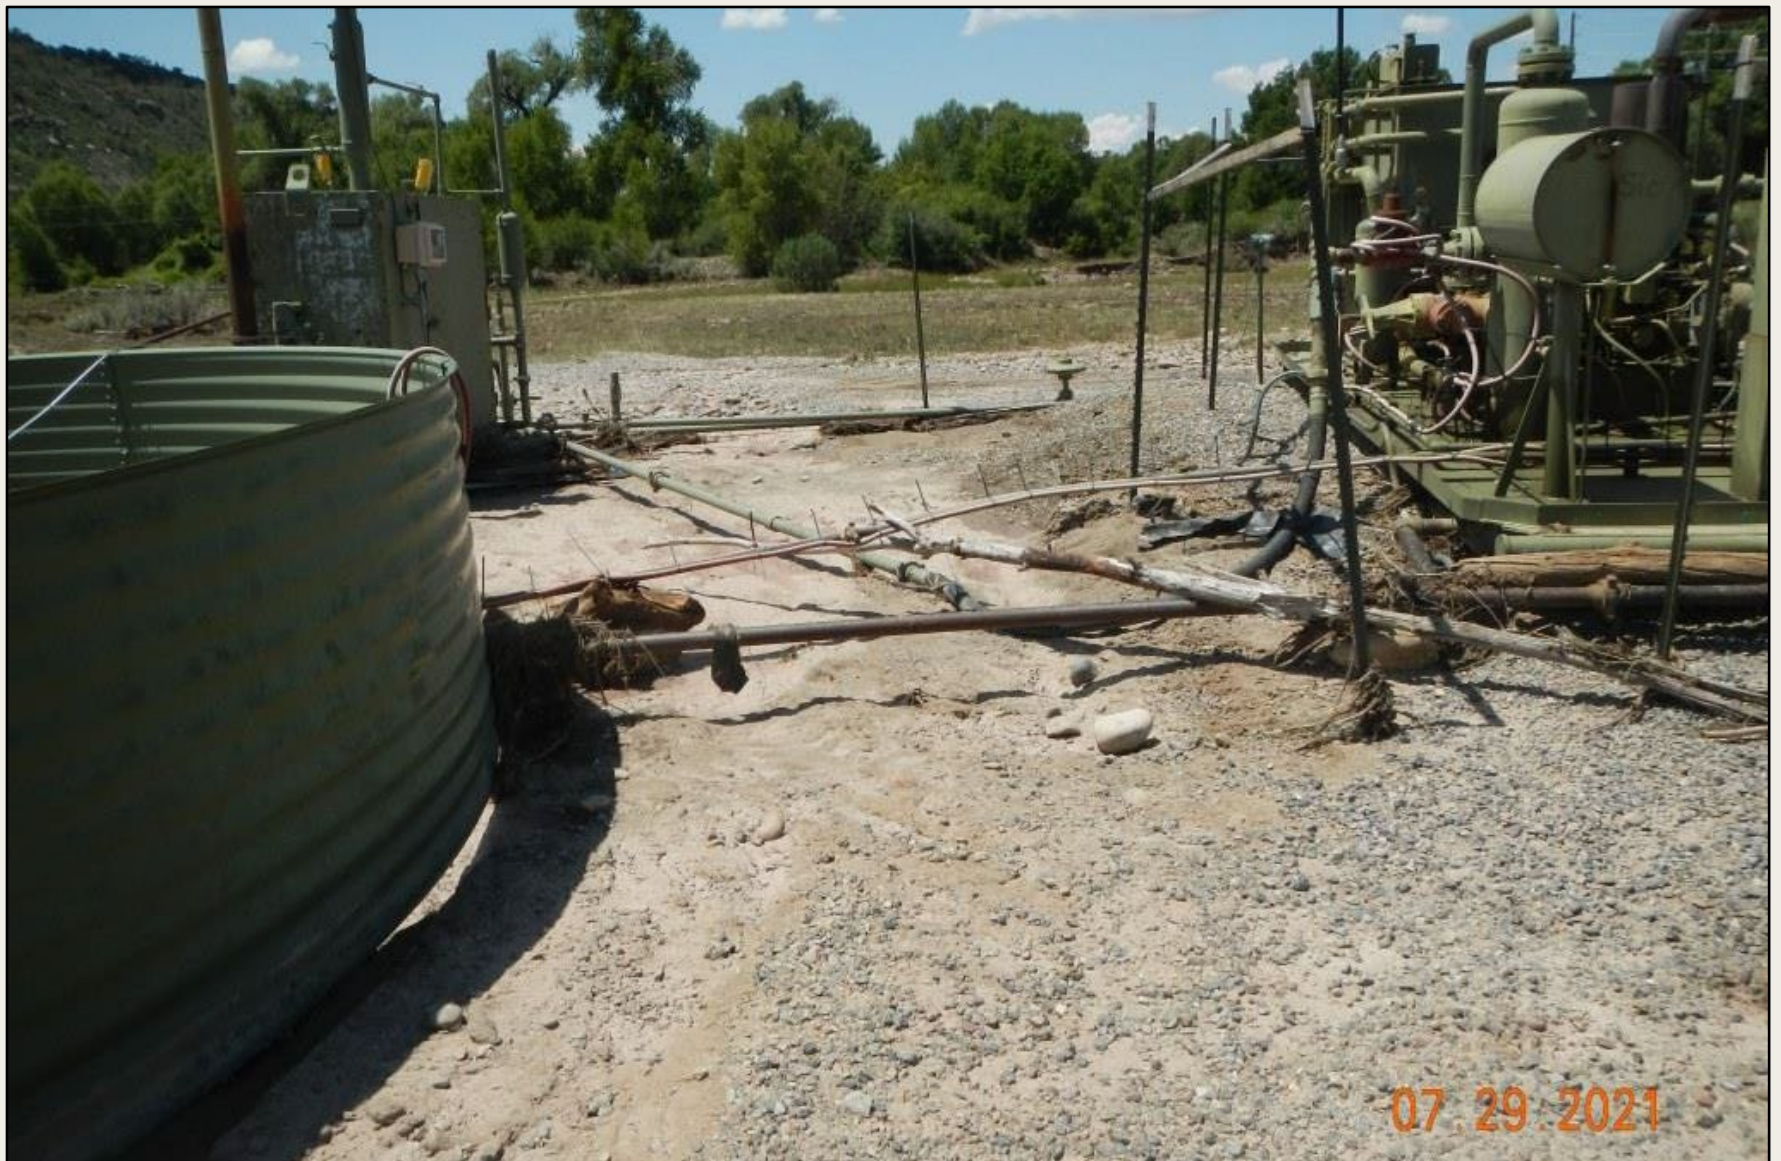
Photo 9. View of area with significant substrate loss exposing pipe and equipment infrastructure with large woody debris.

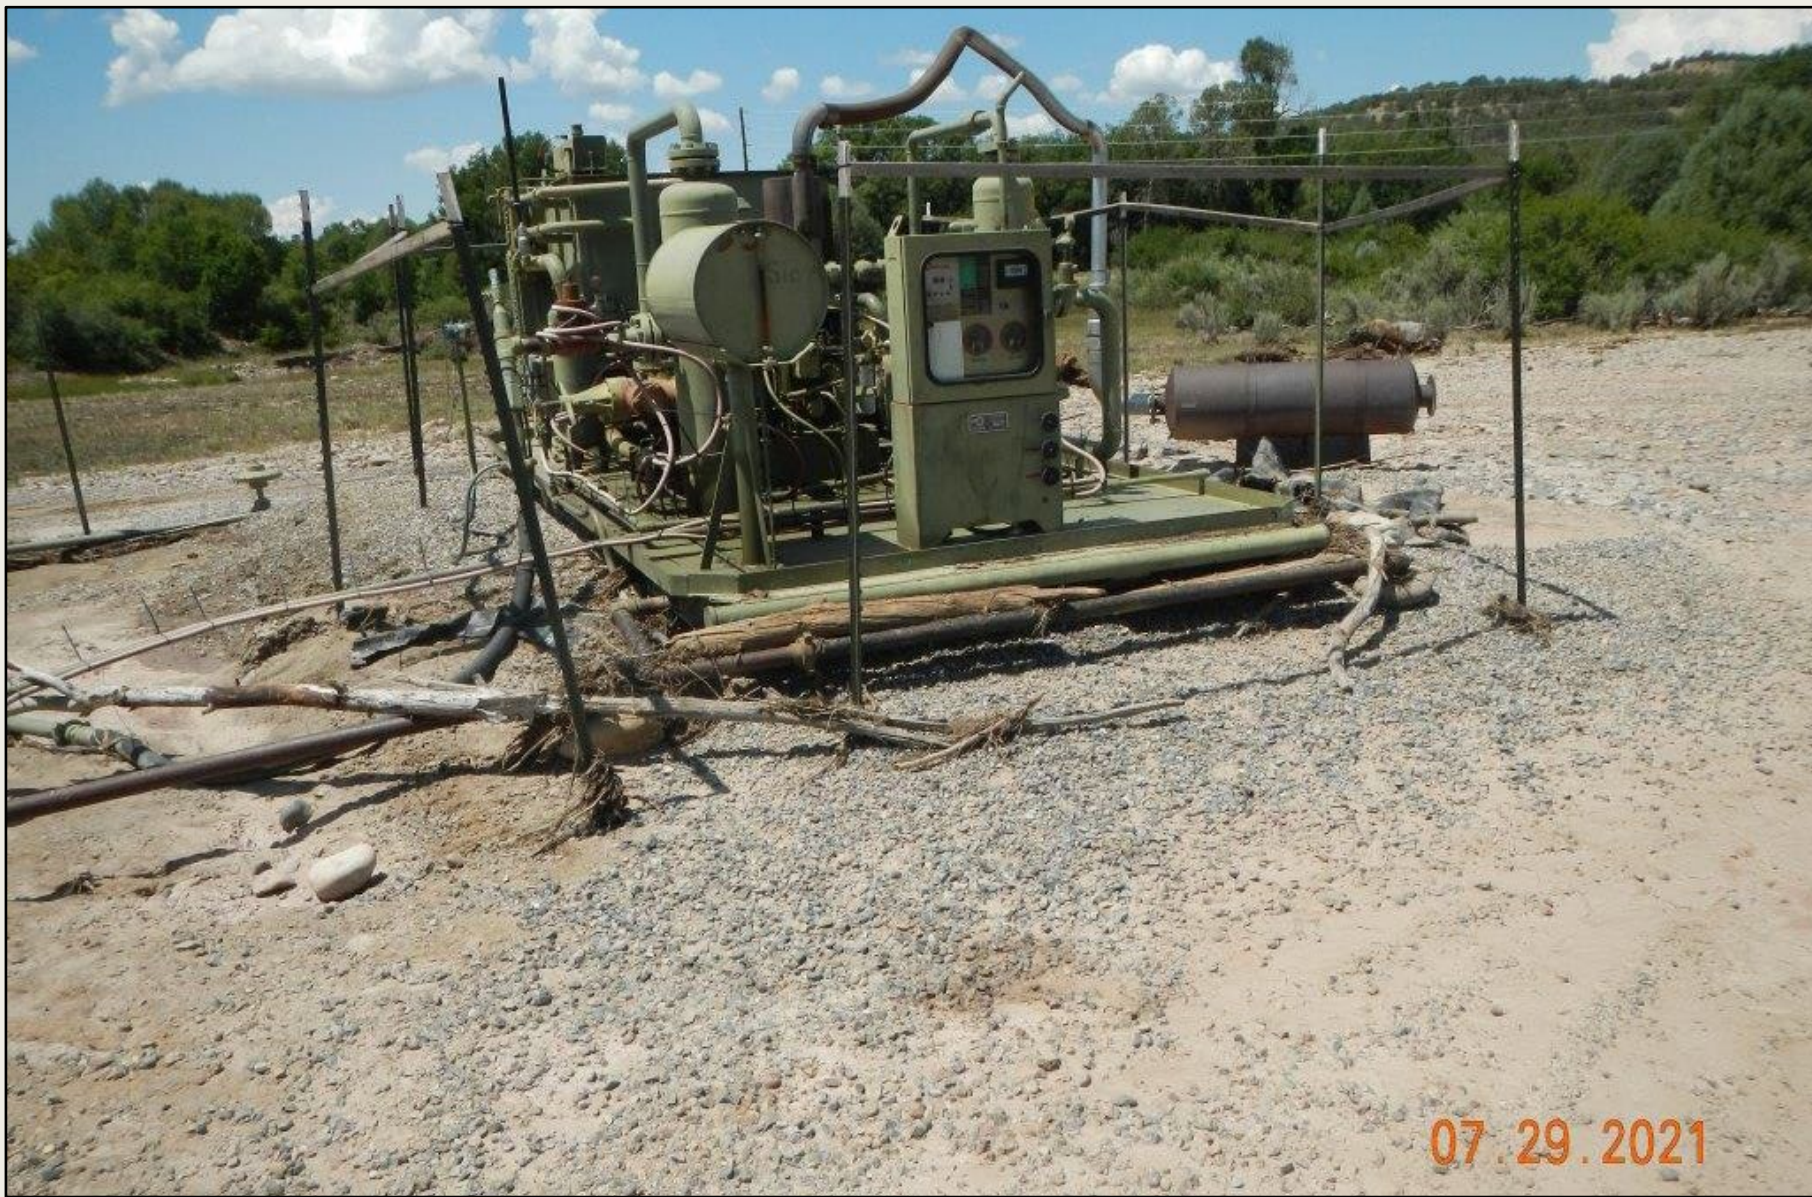
Photo 10. Another view of scoured surface and woody debris.

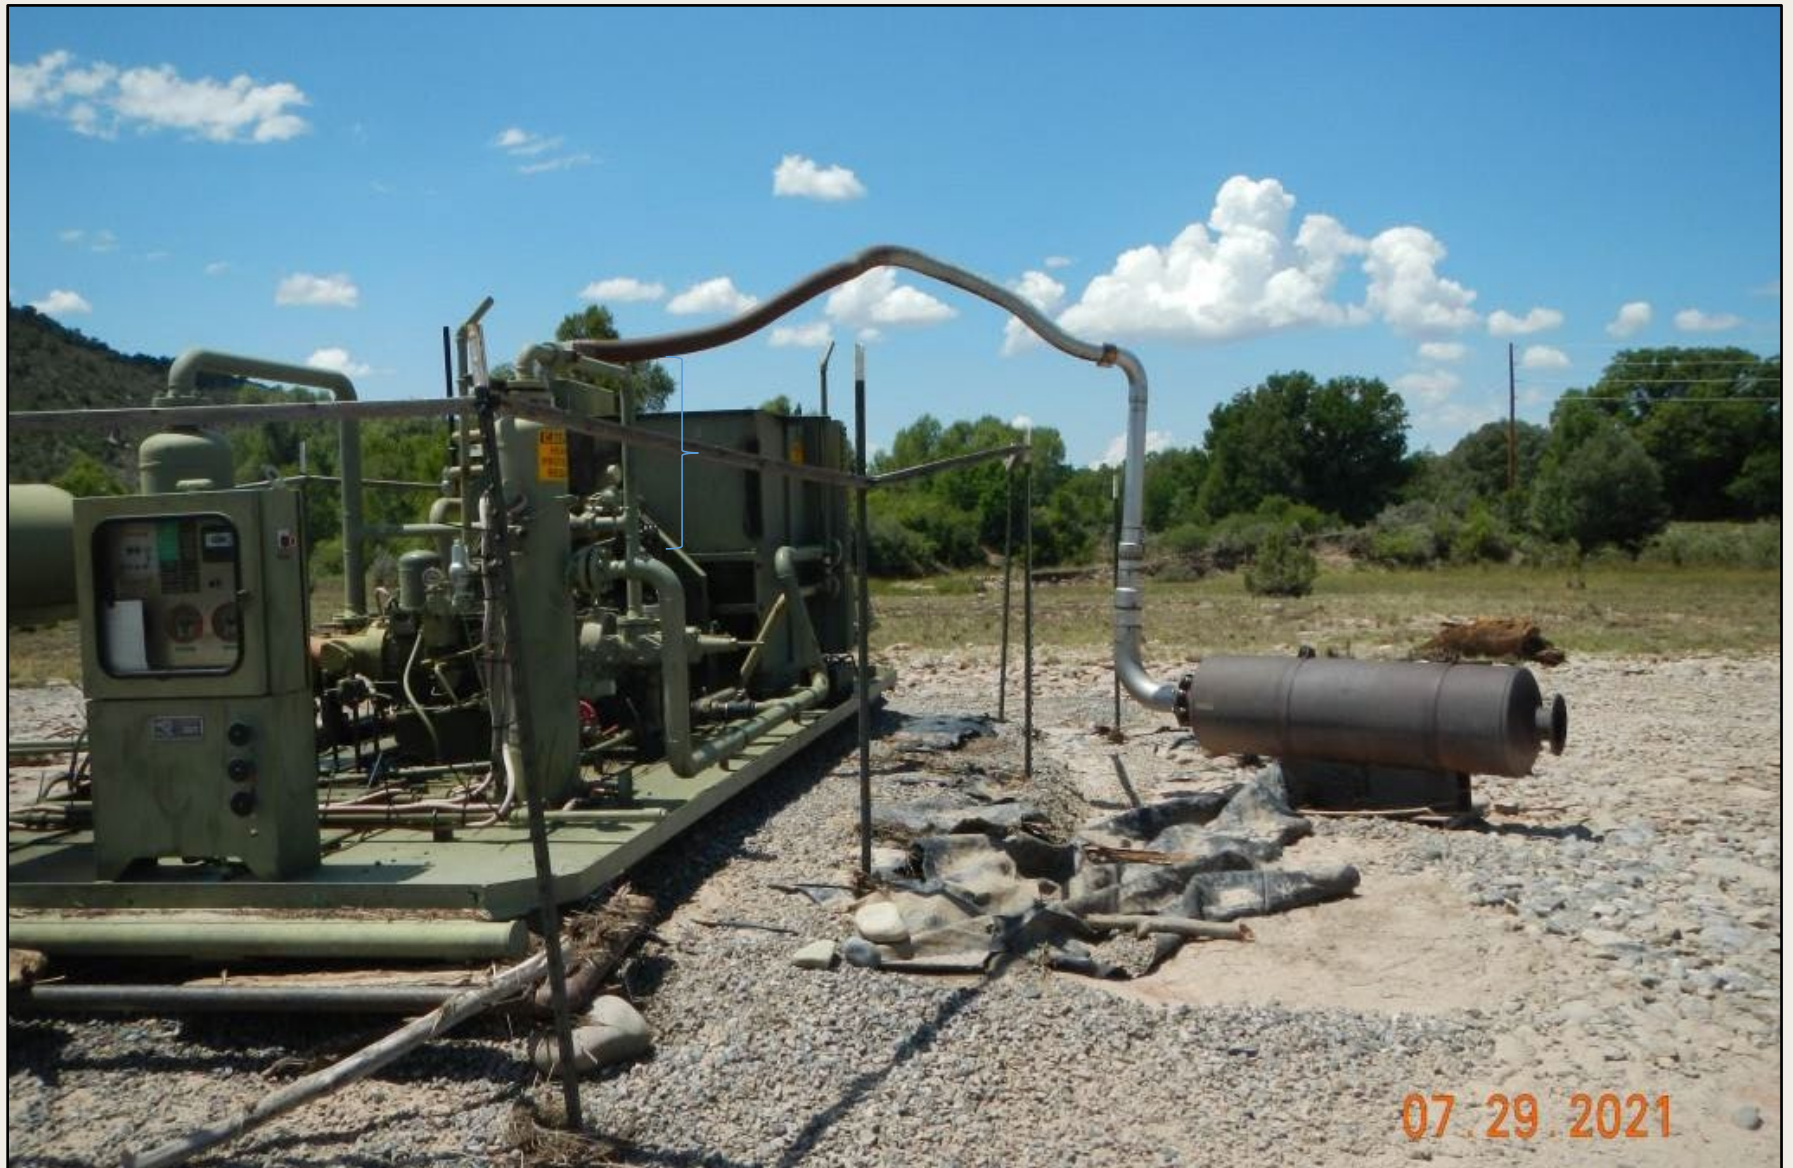
Photo 11. View of another area where materials are scoured away exposing liner. It appears that approximately 12-15 inches of material is washed away.
