Inspection Photos
Operator: Logos Operating
API: 067-05515
Date: 11/8/2021

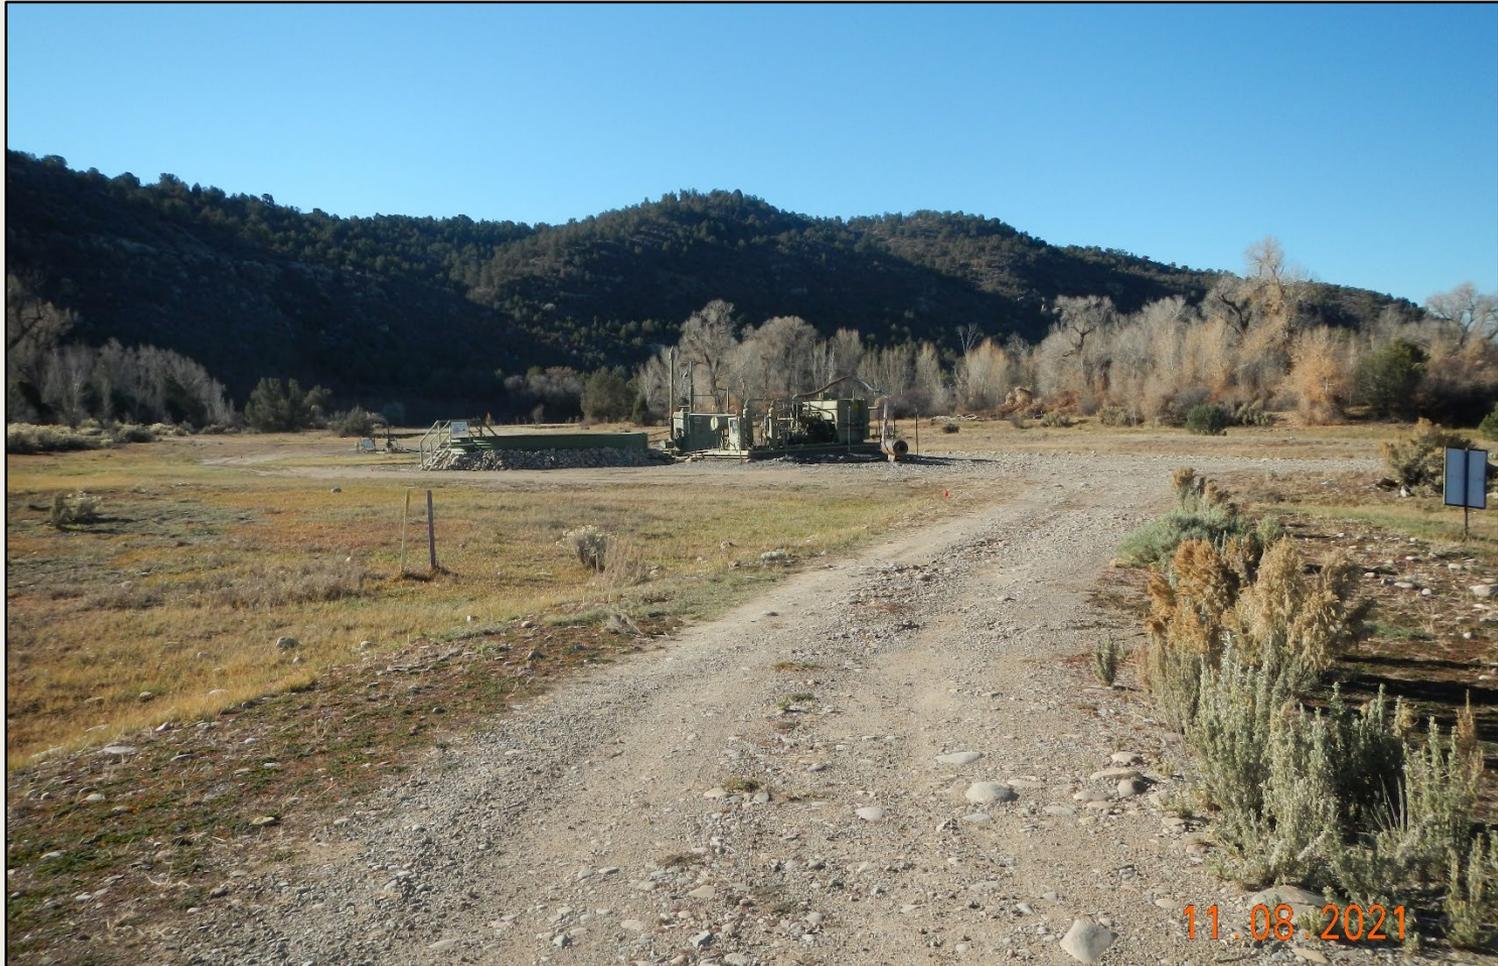
Photo 1. View of the project area from the well pad entrance facing center.

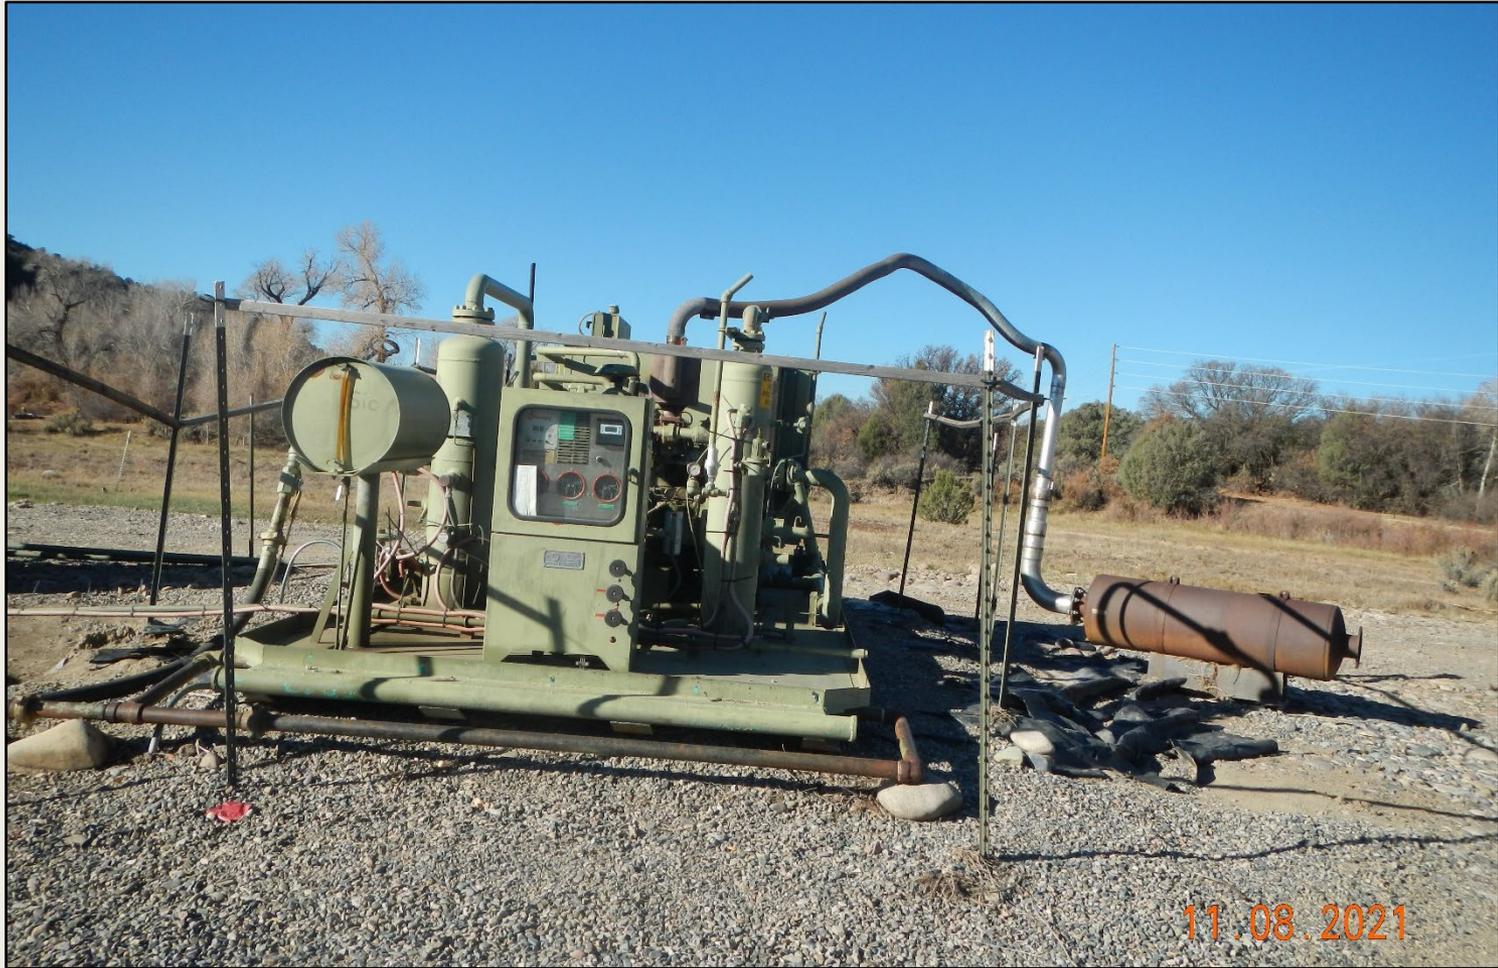
Photo 2. View of project facilities. Debris removed.

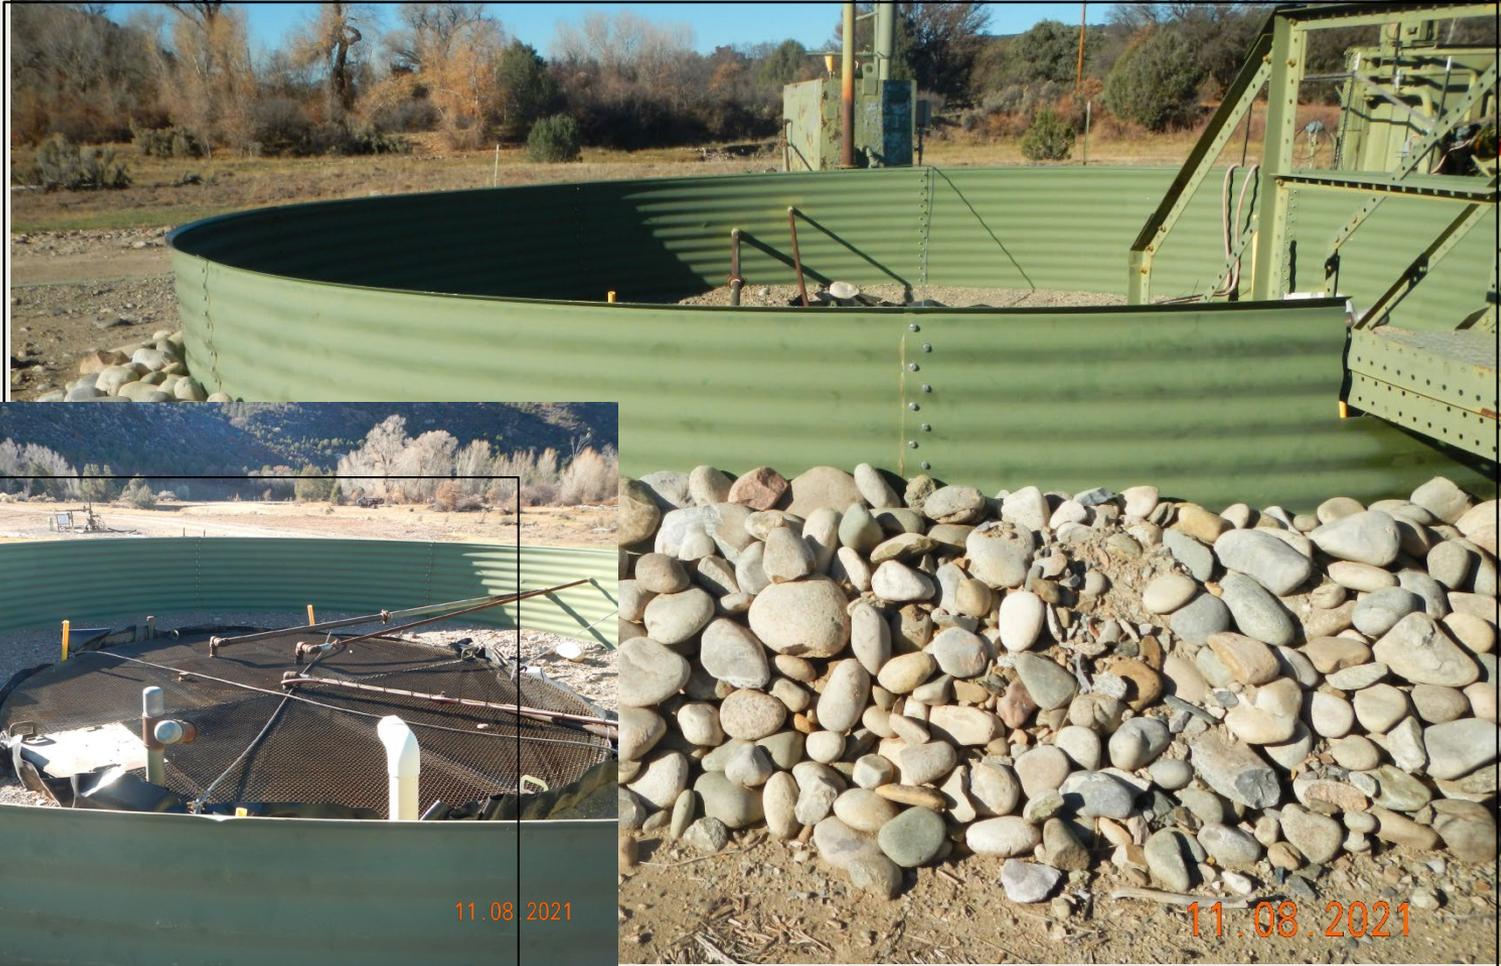
Photo 3. View of the partially buried vessel within the project area. Cobble placed around the base is not an adequate BMP. Vessel remains in place, approximately 6 inches above ground level (inset).

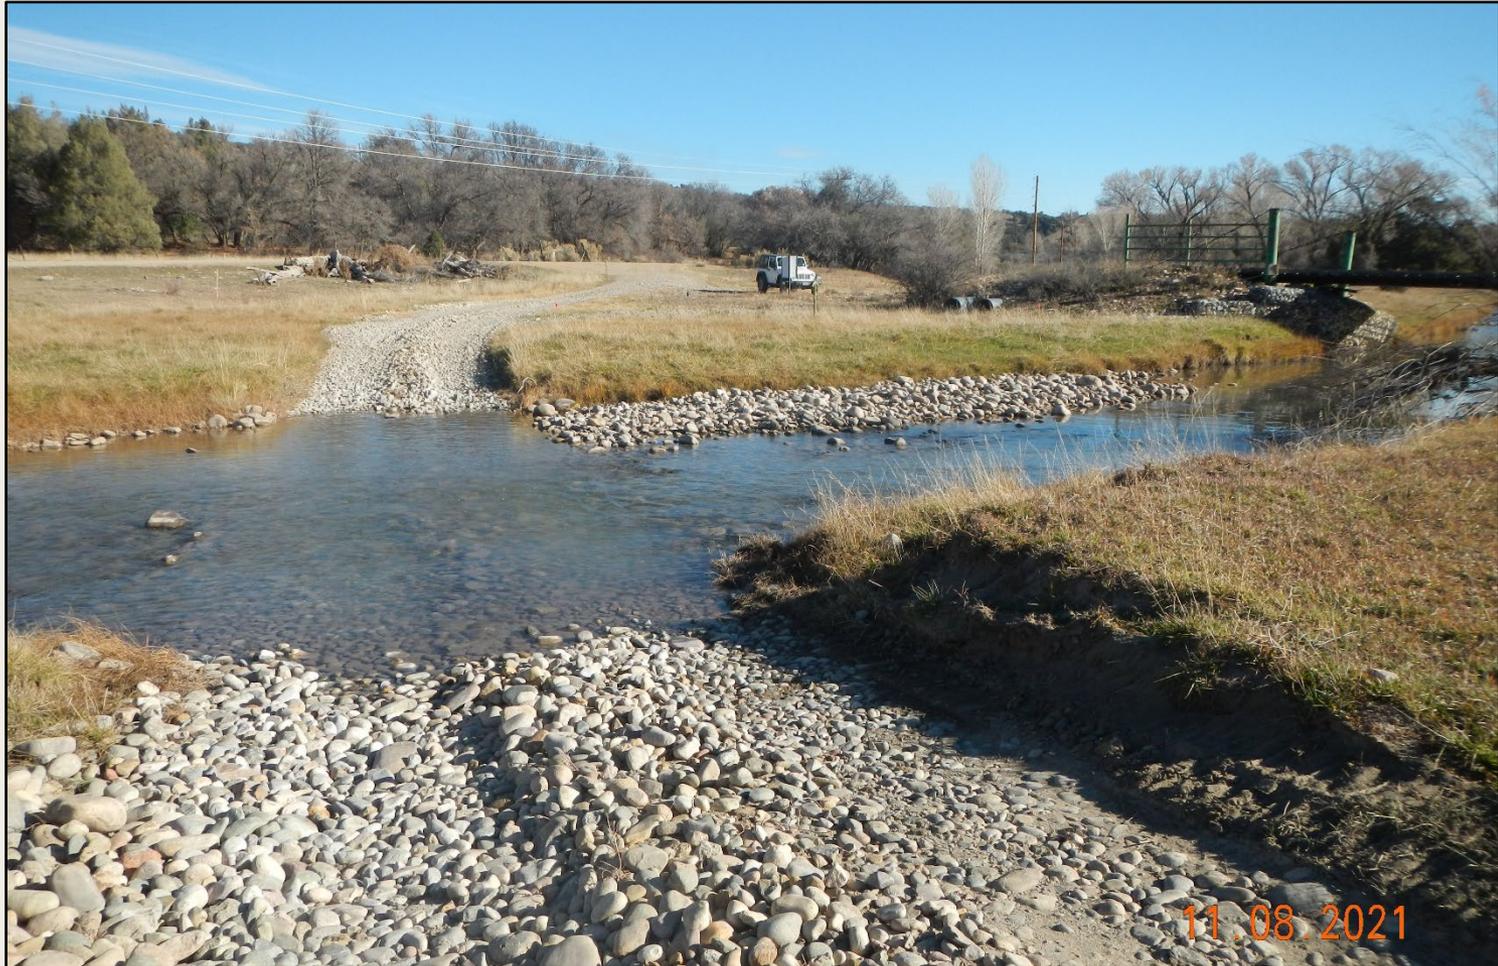
Photo 4. View of cobble placement within the low water crossing.

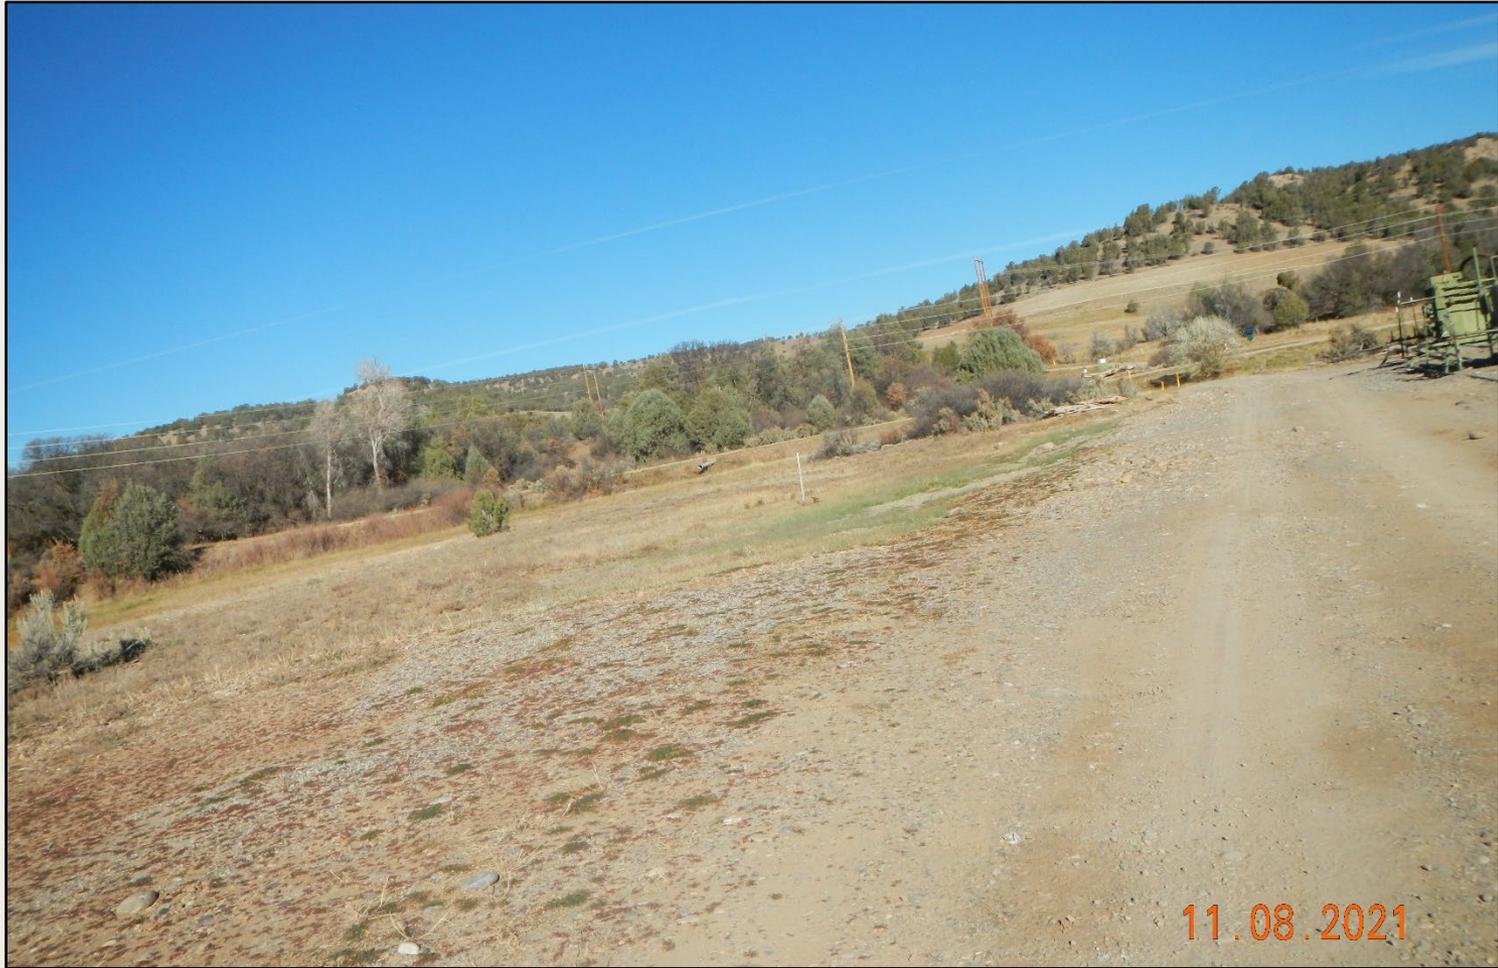
Photo 5. View of the western project area from the southwestern corner facing northward. Soils and vegetation are scoured here.

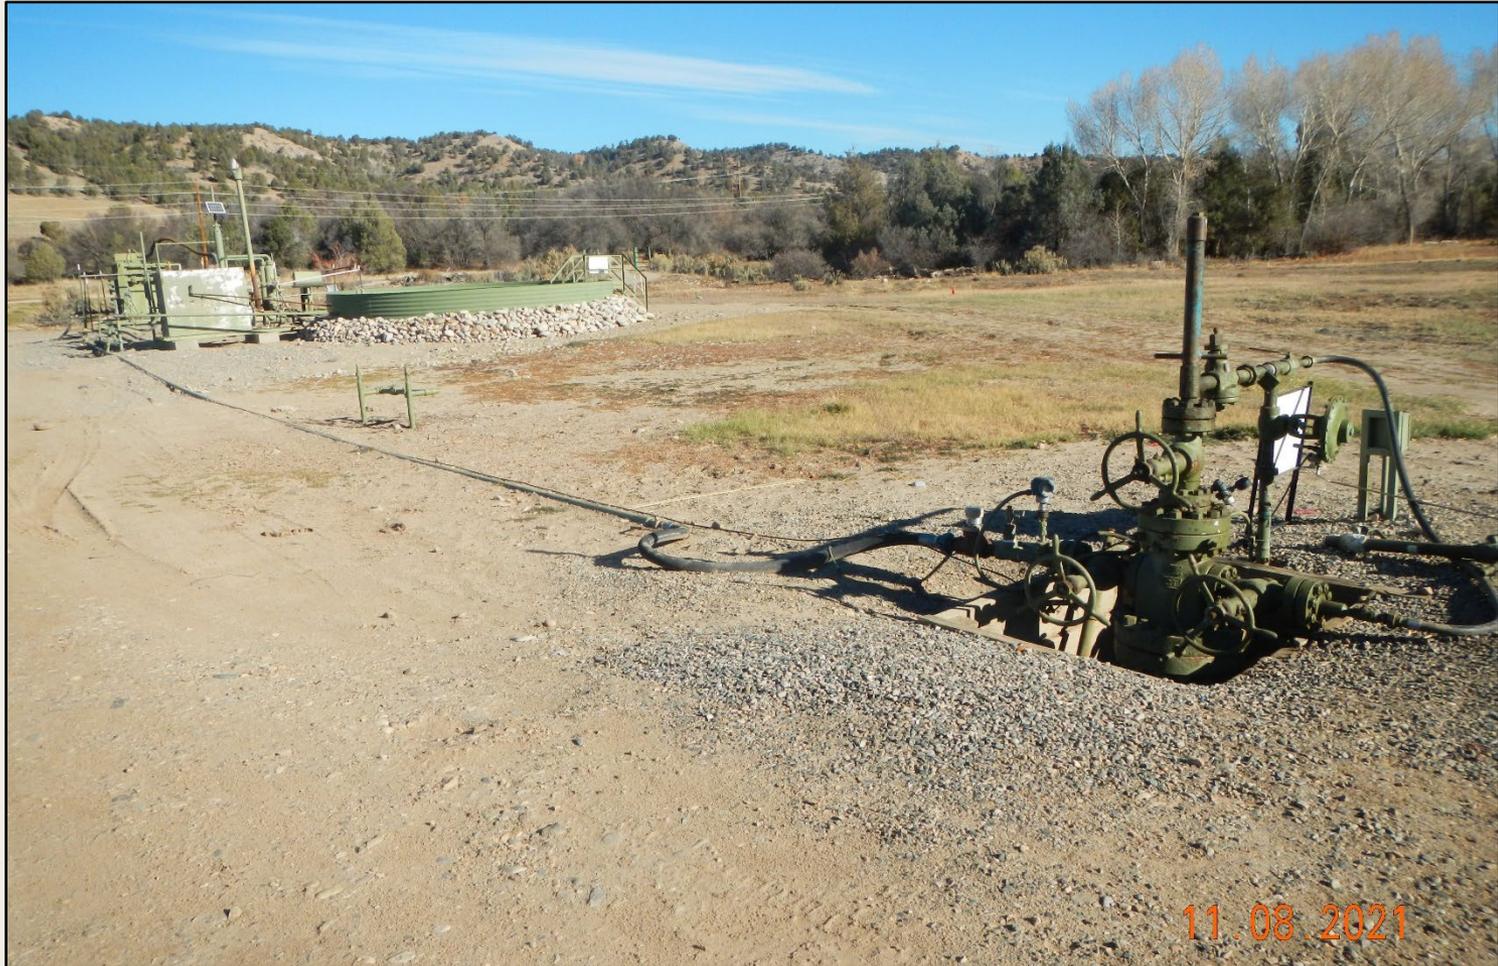
Photo 6. View of the wellhead and facilities, facing northward. Wood debris removed.

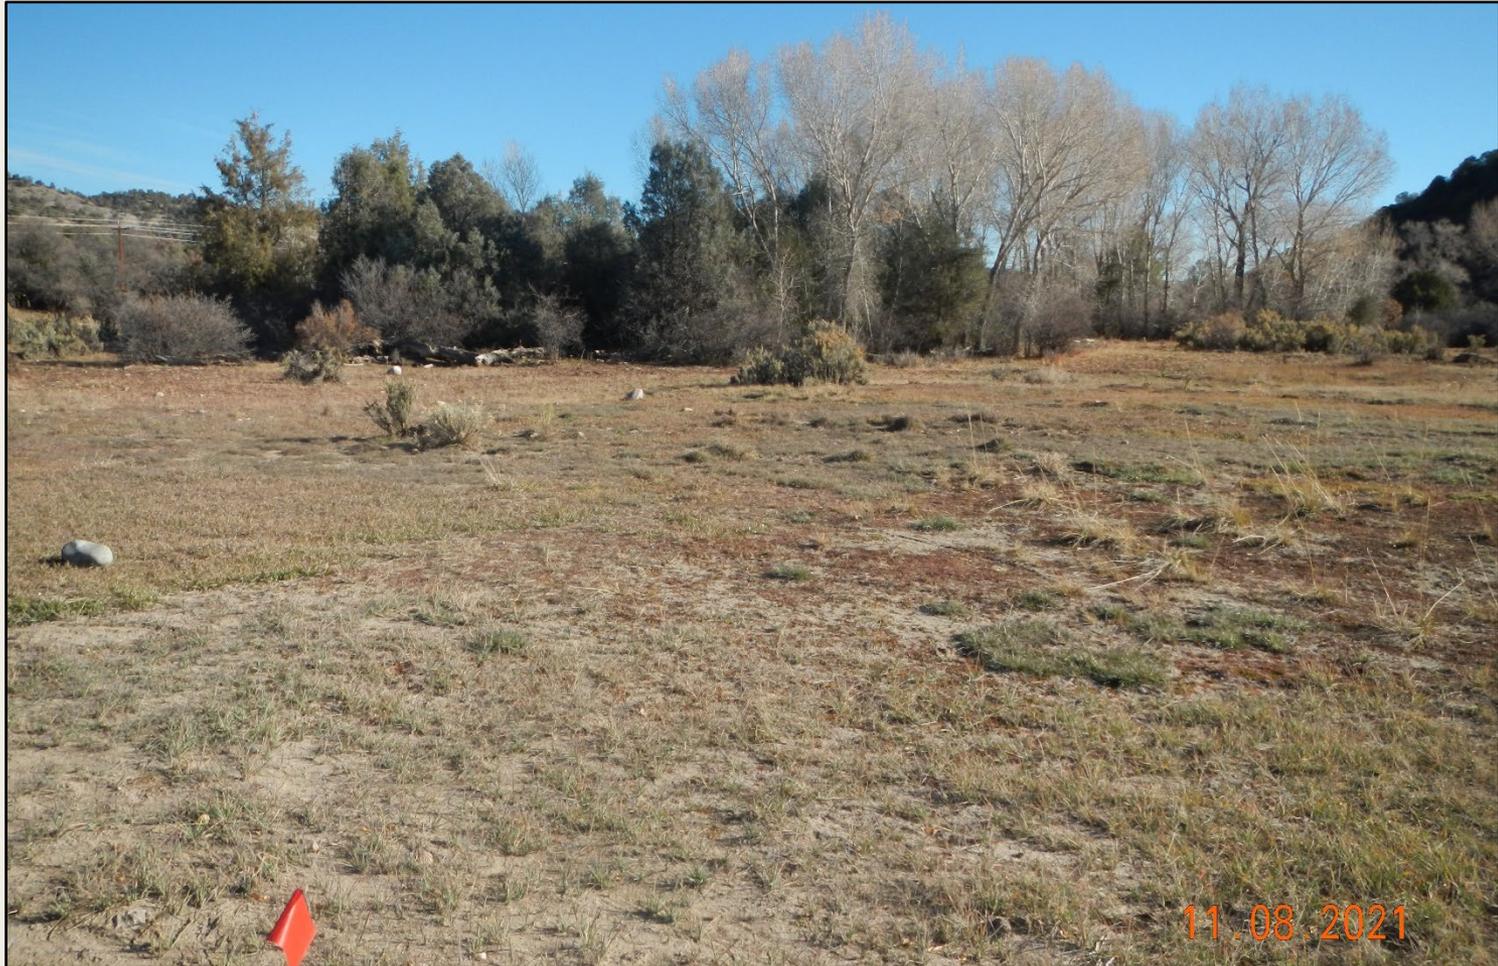
Photo 7. View of reference area comprised of open grass field with western wheatgrass, smooth brome, and scattered sagebrush.
