Inspection Photos
Operator: Logos/Simcoe
API: 067-08138 and 067-08731
Date: 7/29/2021

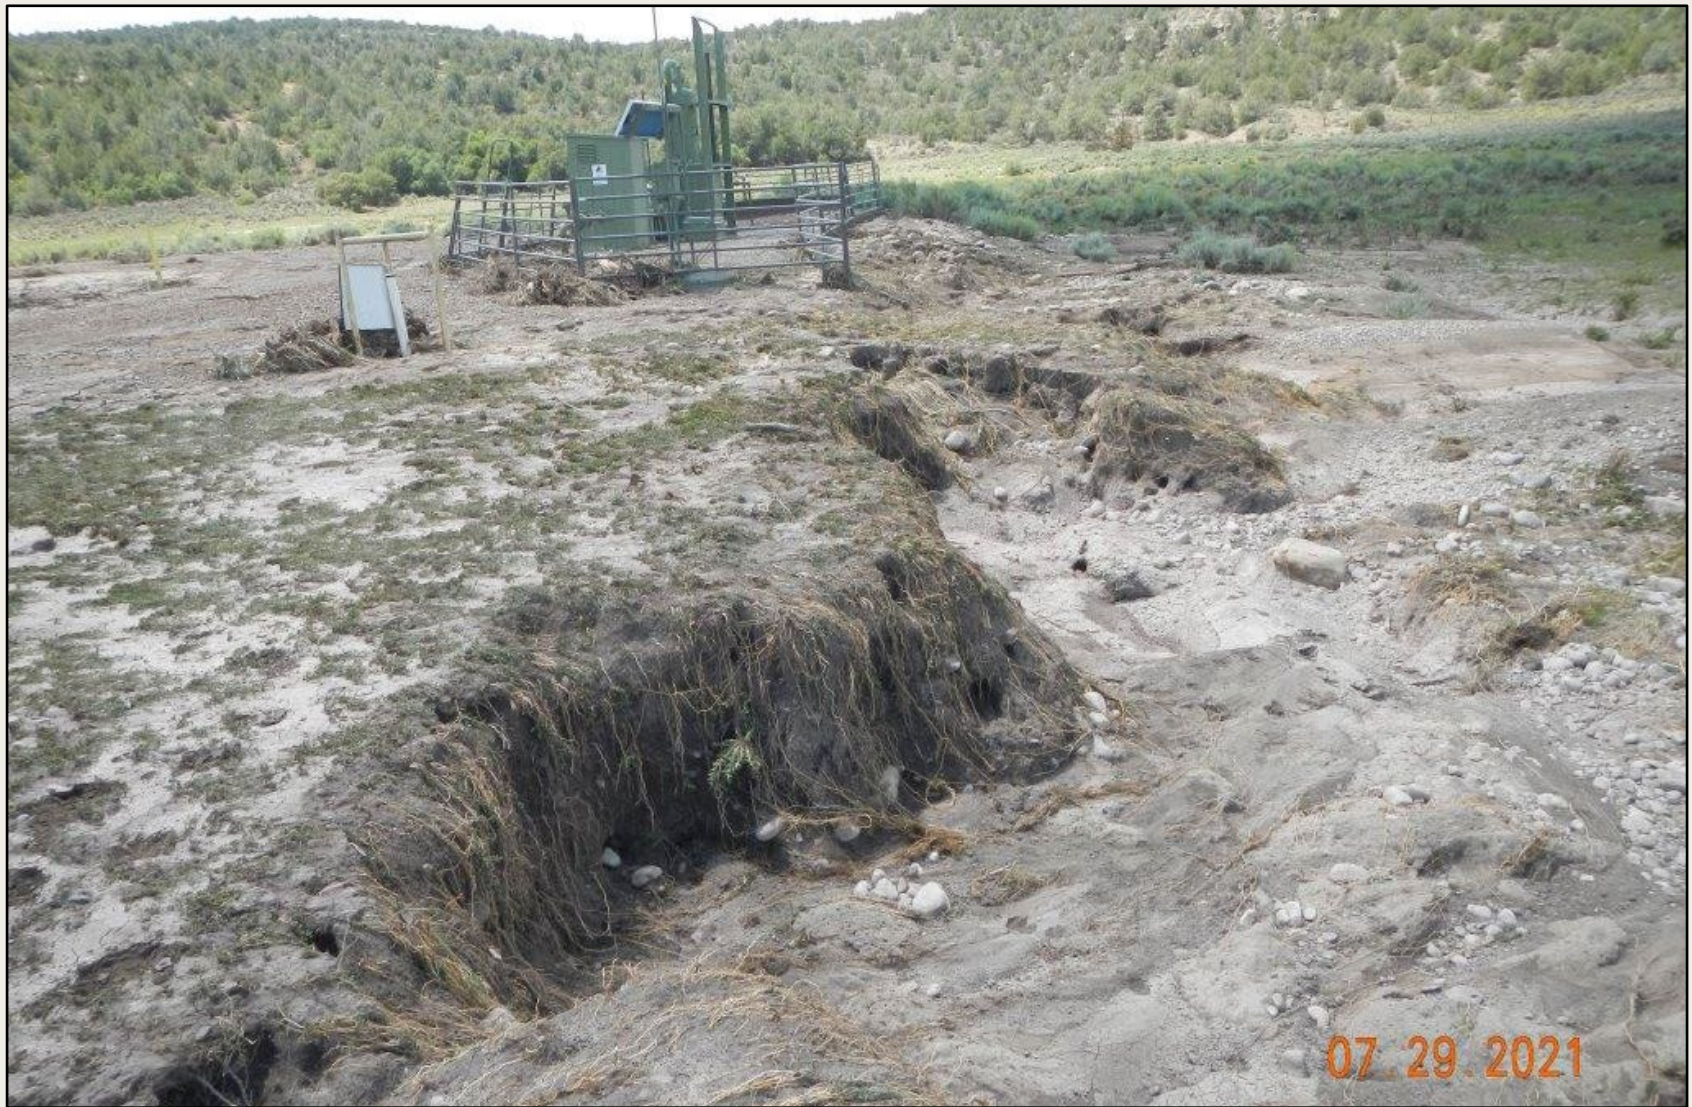
Photo 1. View of the location from the northwestern corner facing southward. Stormwater flows have washed well pad material off of well pad and deposited down-slope and downstream. Water flow is from right to left here.

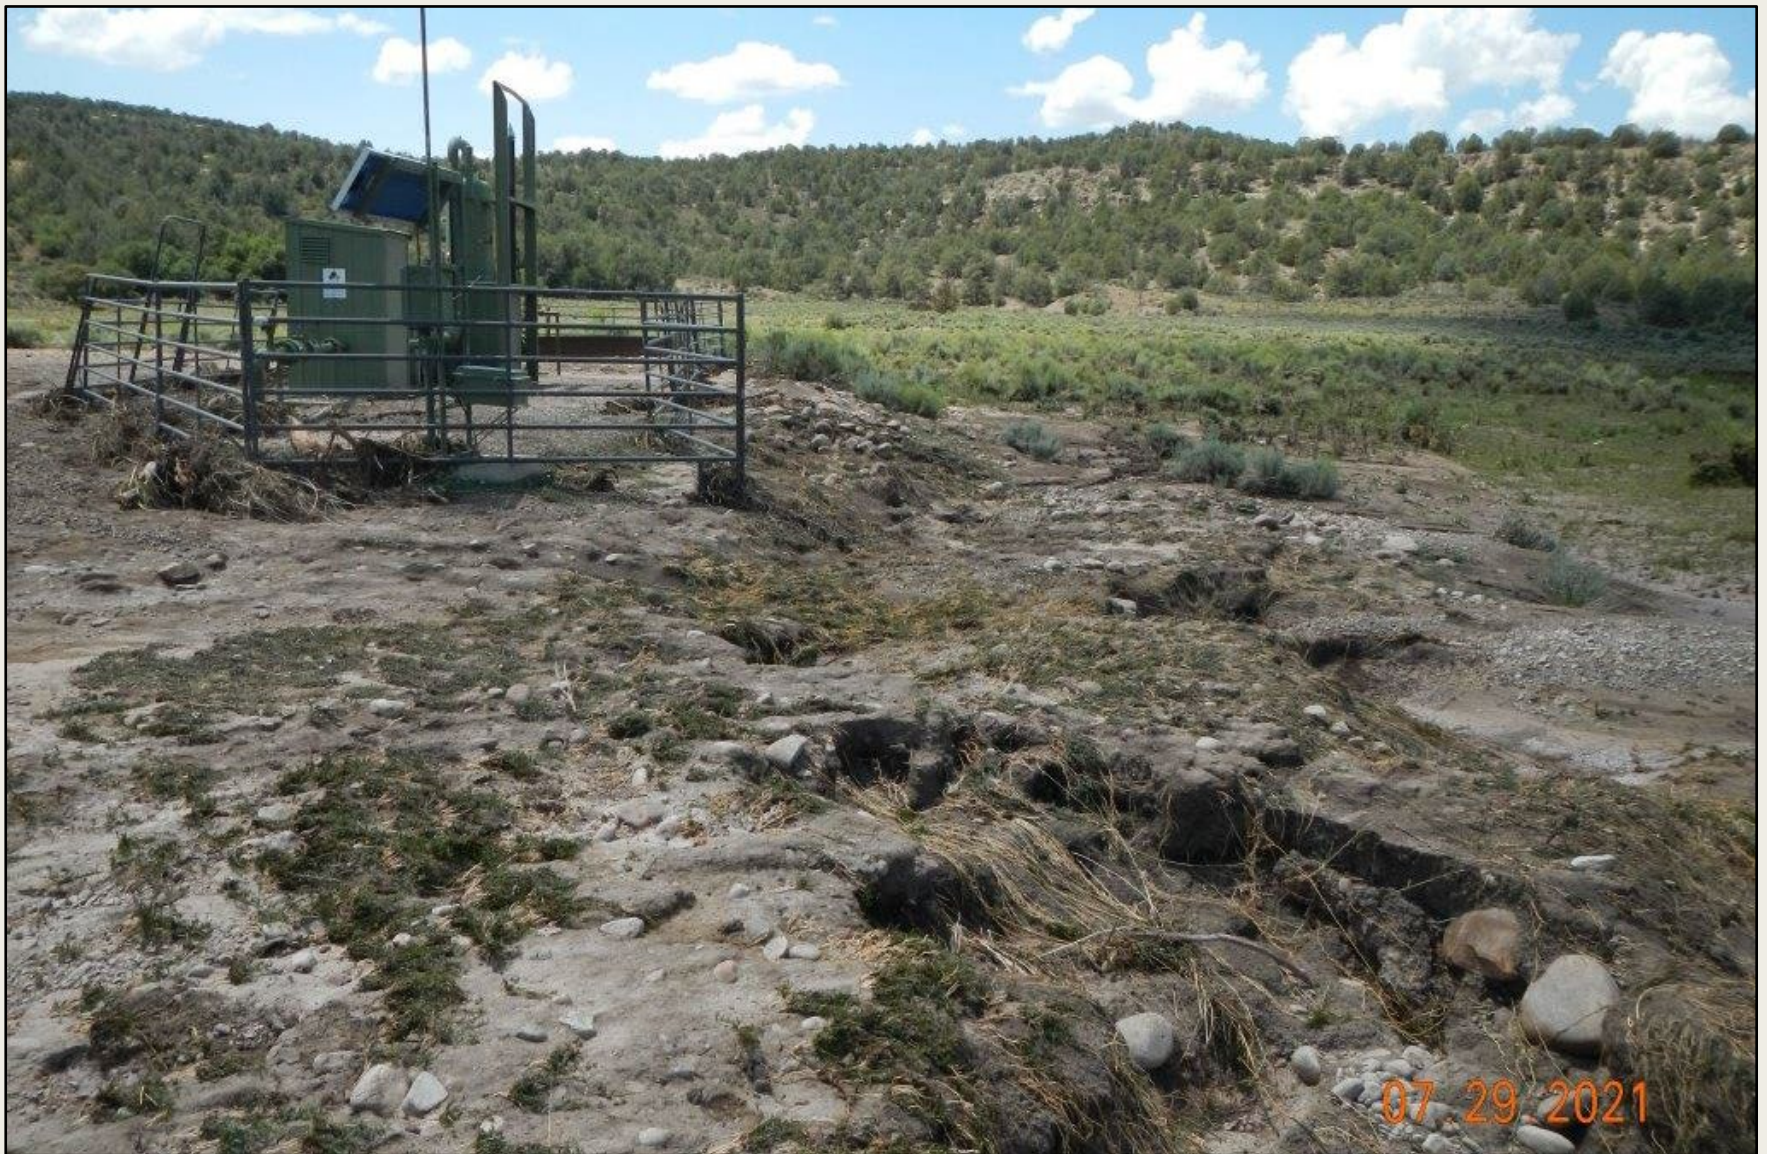
Photo 2. View of area where stormwater has washed away well pad material, and deposited wood and plant debris on project facilities.

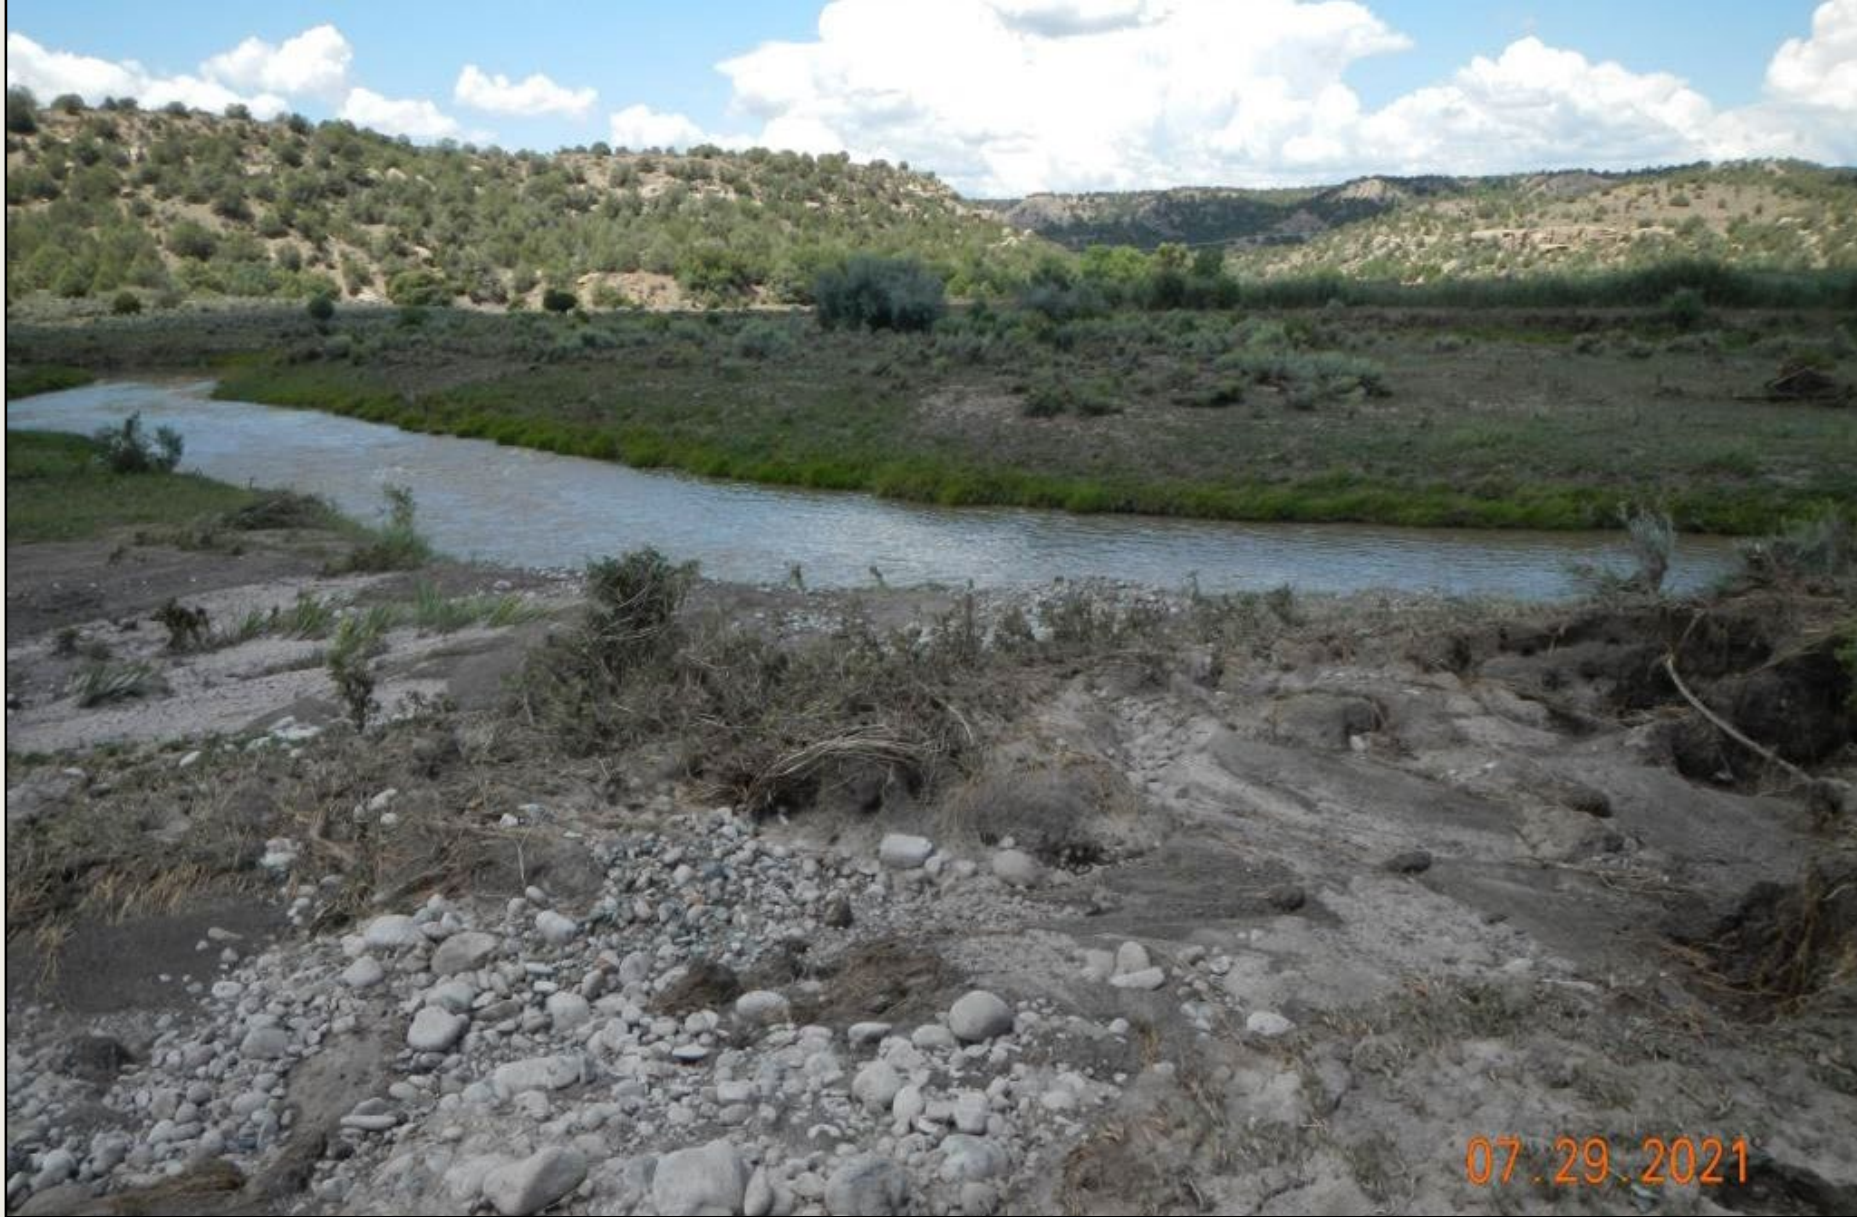
Photo 3. View of sediment, gravel, cobble well pad material washing downstream to the Florida River (facing downslope).

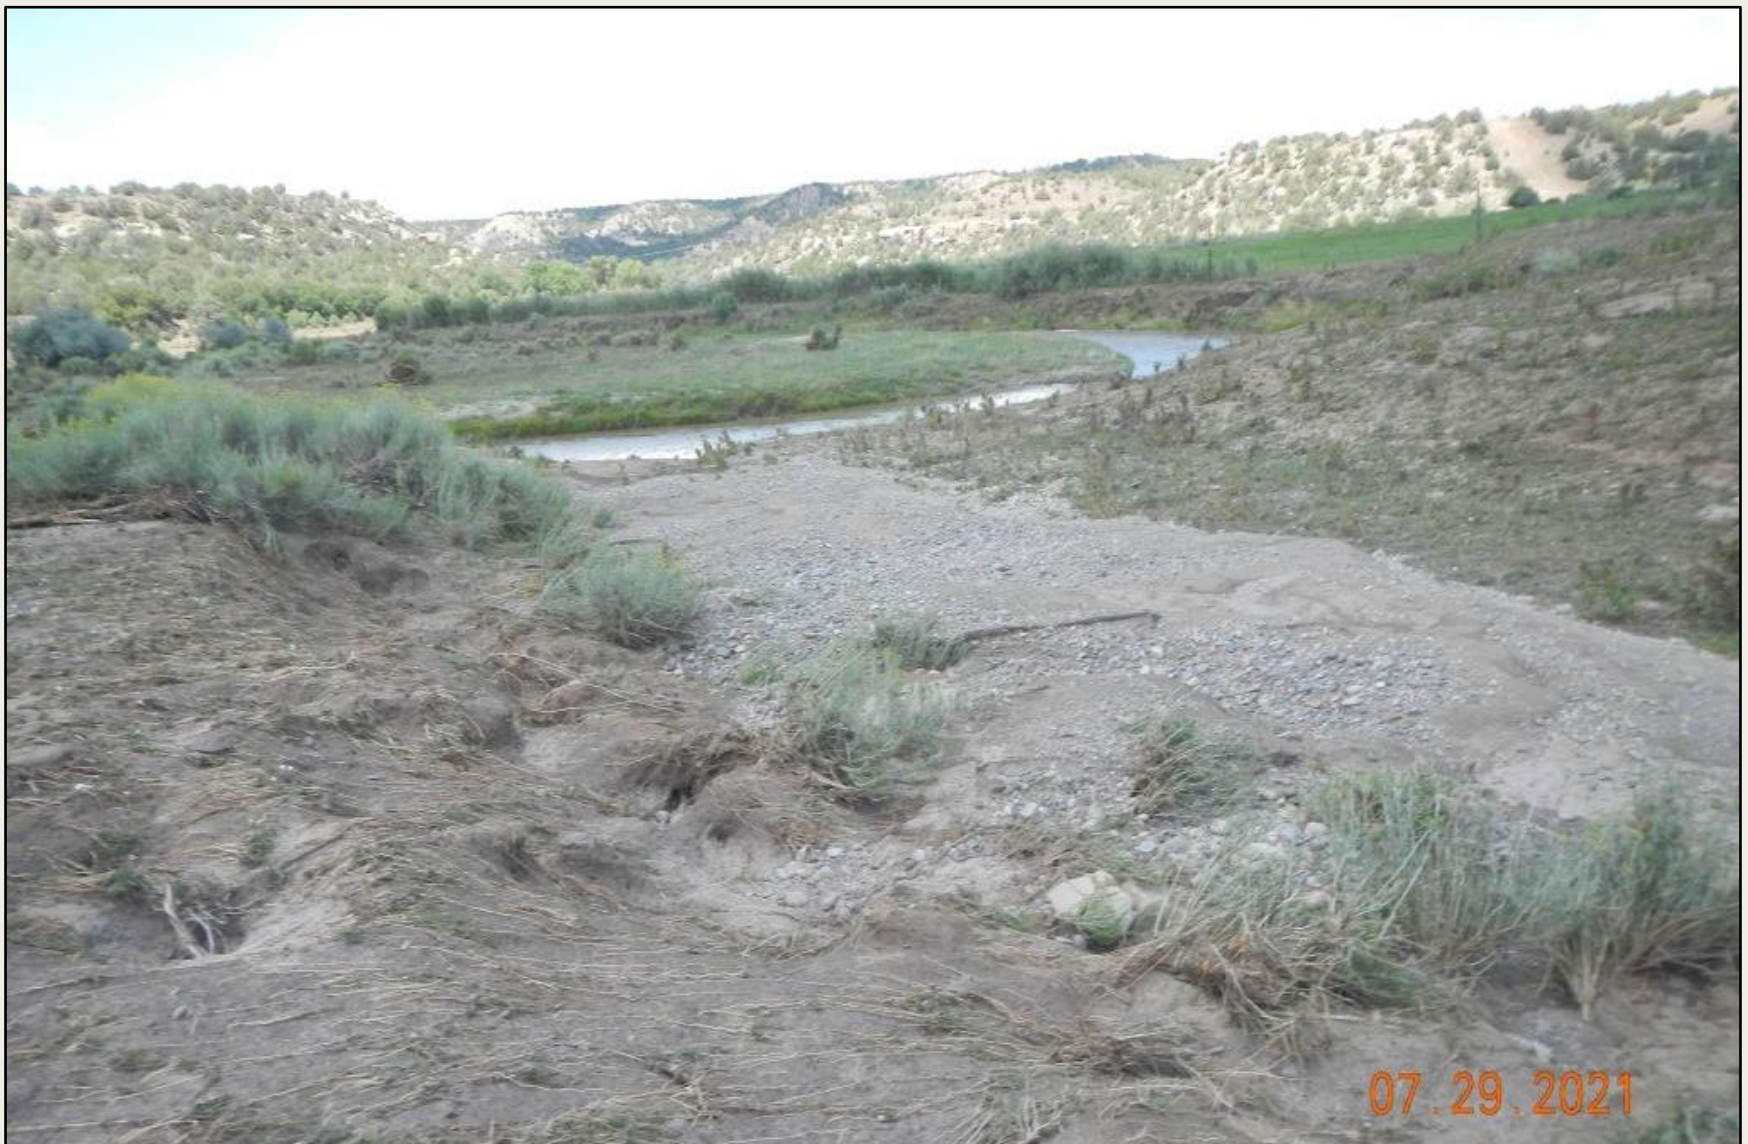
Photo 4. View of a large volume of well pad material discharging off of the project area into the river and along the banks of the river (facing downstream).

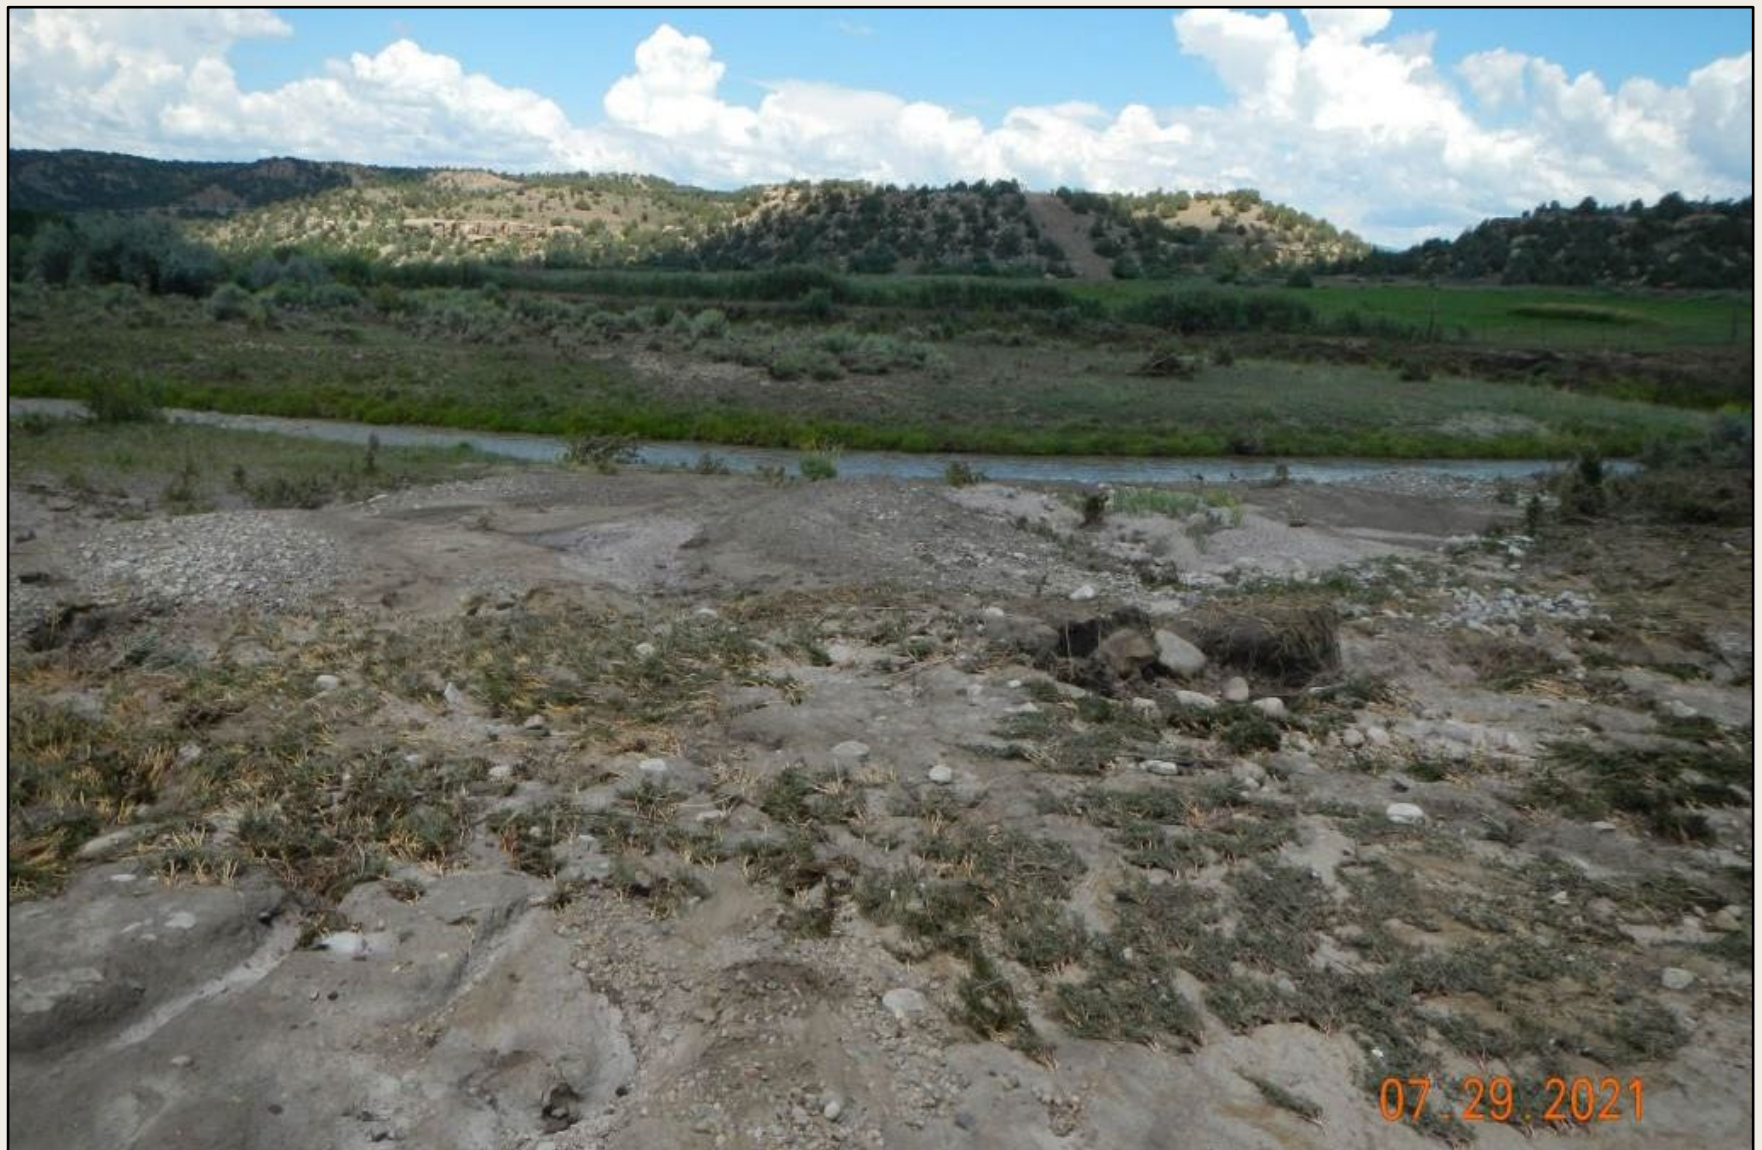
Photo 5. View of more material discharge from well pad along and into the Florida River (facing downslope).

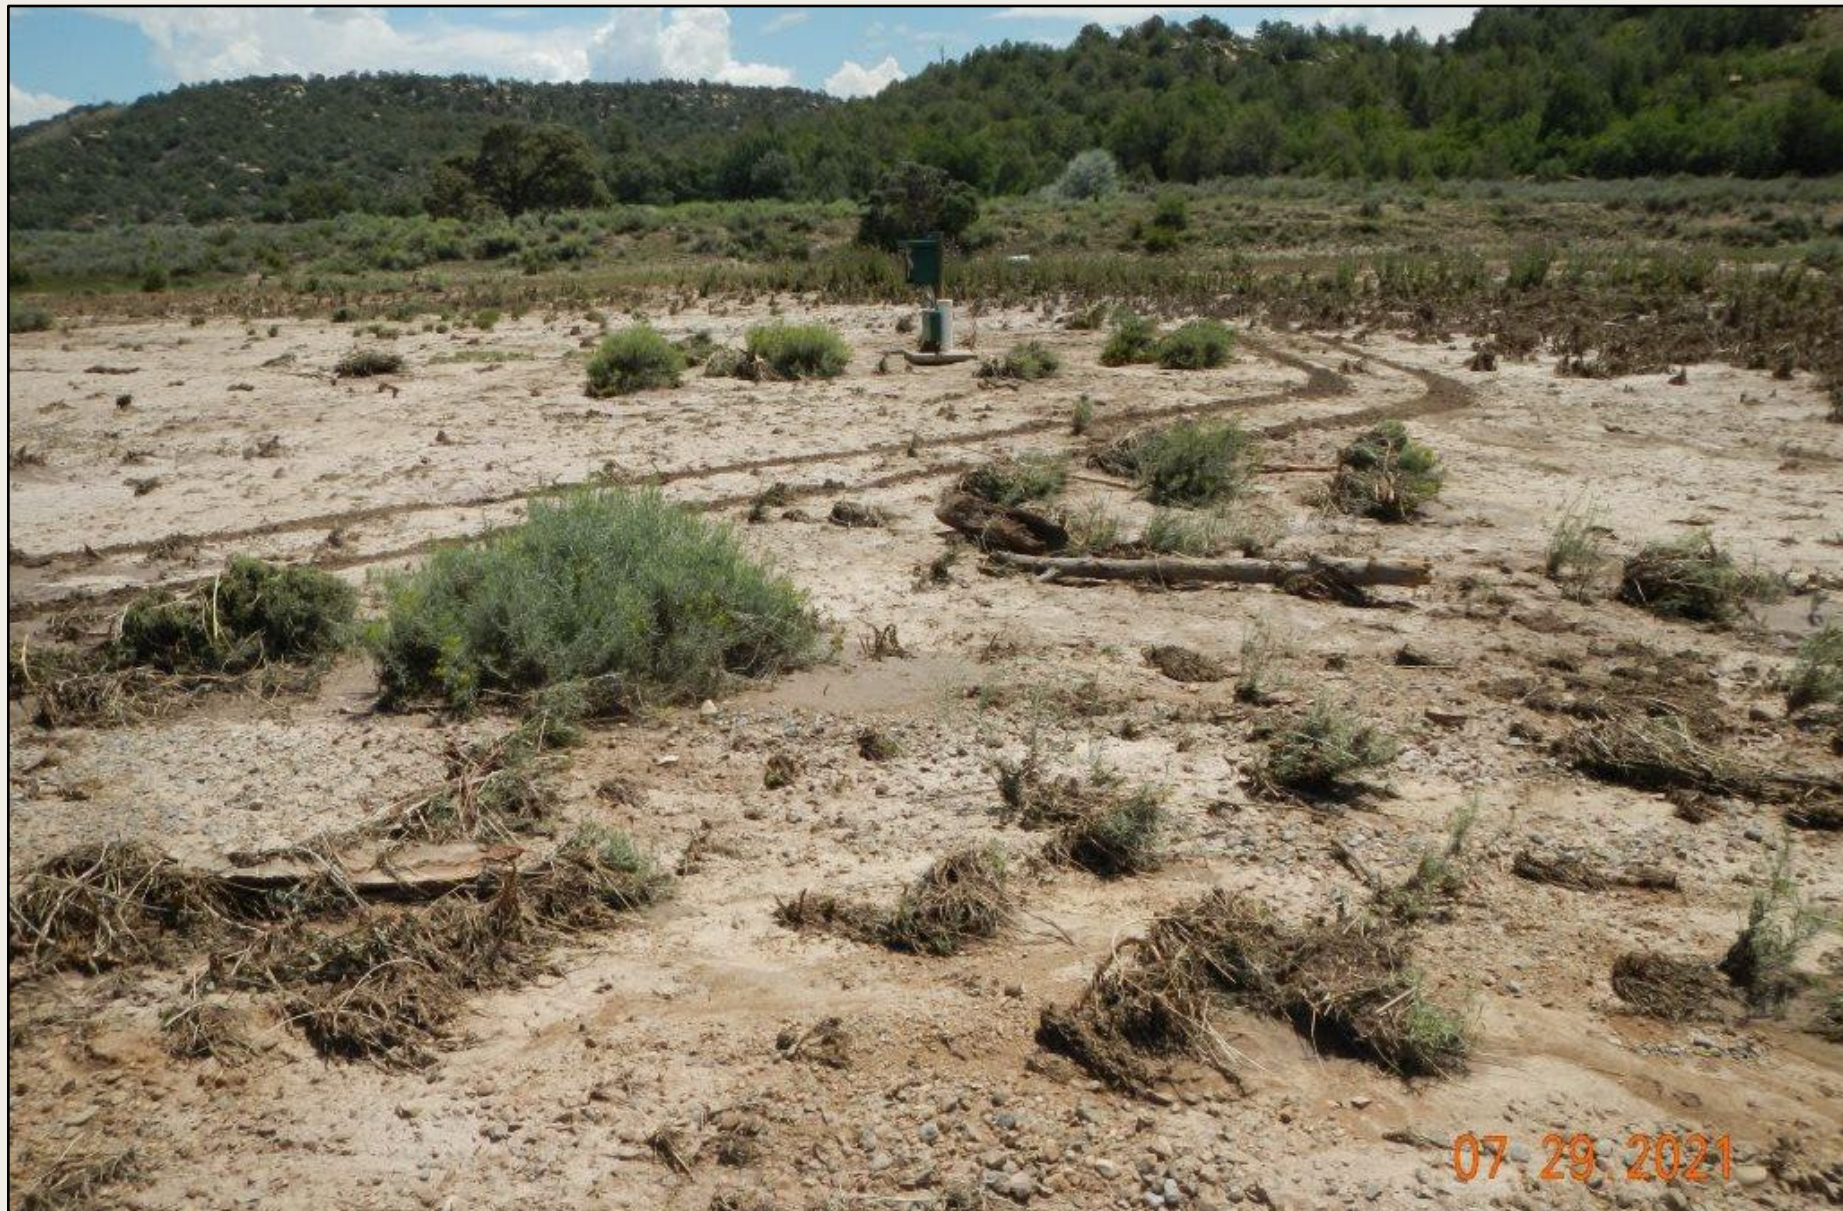
Photo 6. View of erosional scouring and debris deposited within the southeastern project area.

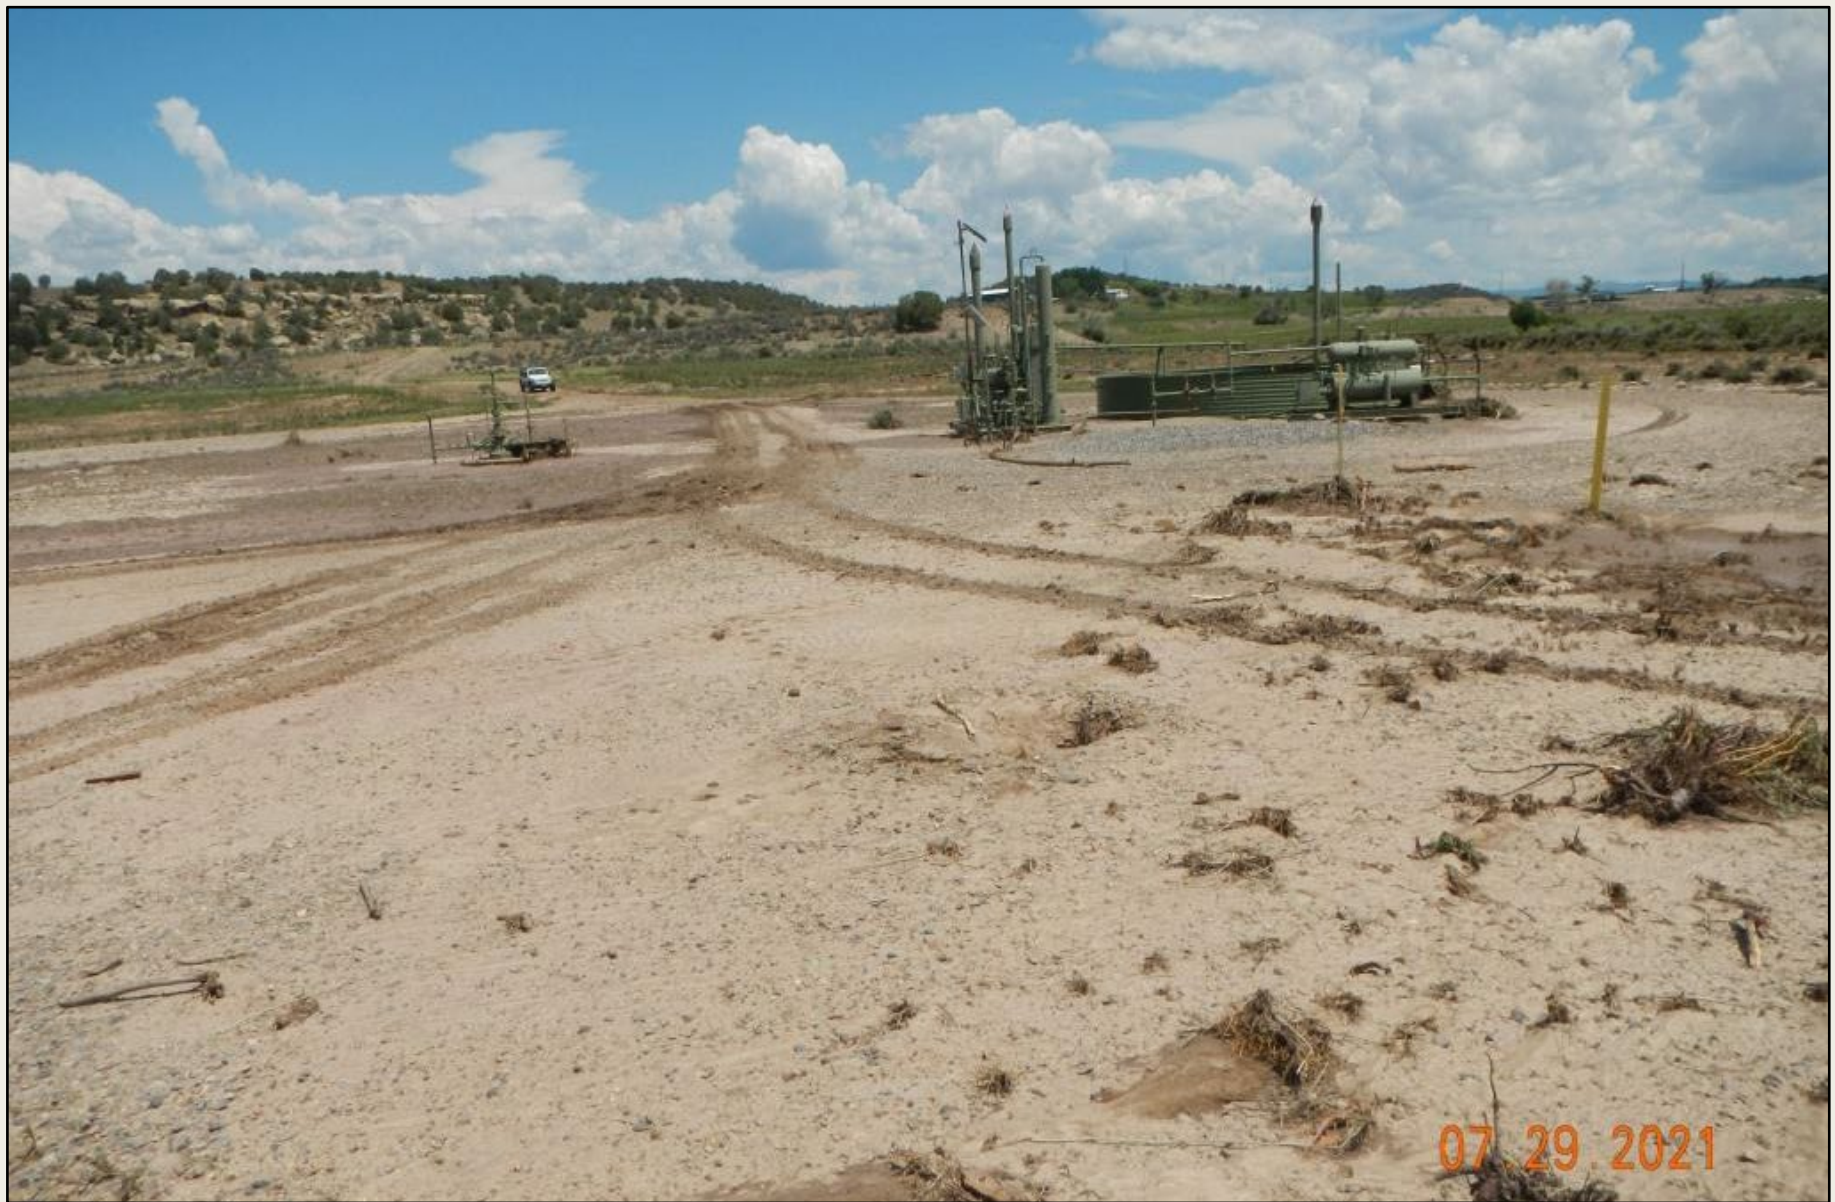
Photo 7. View of Logos well in the eastern project area from the southern edge facing center.

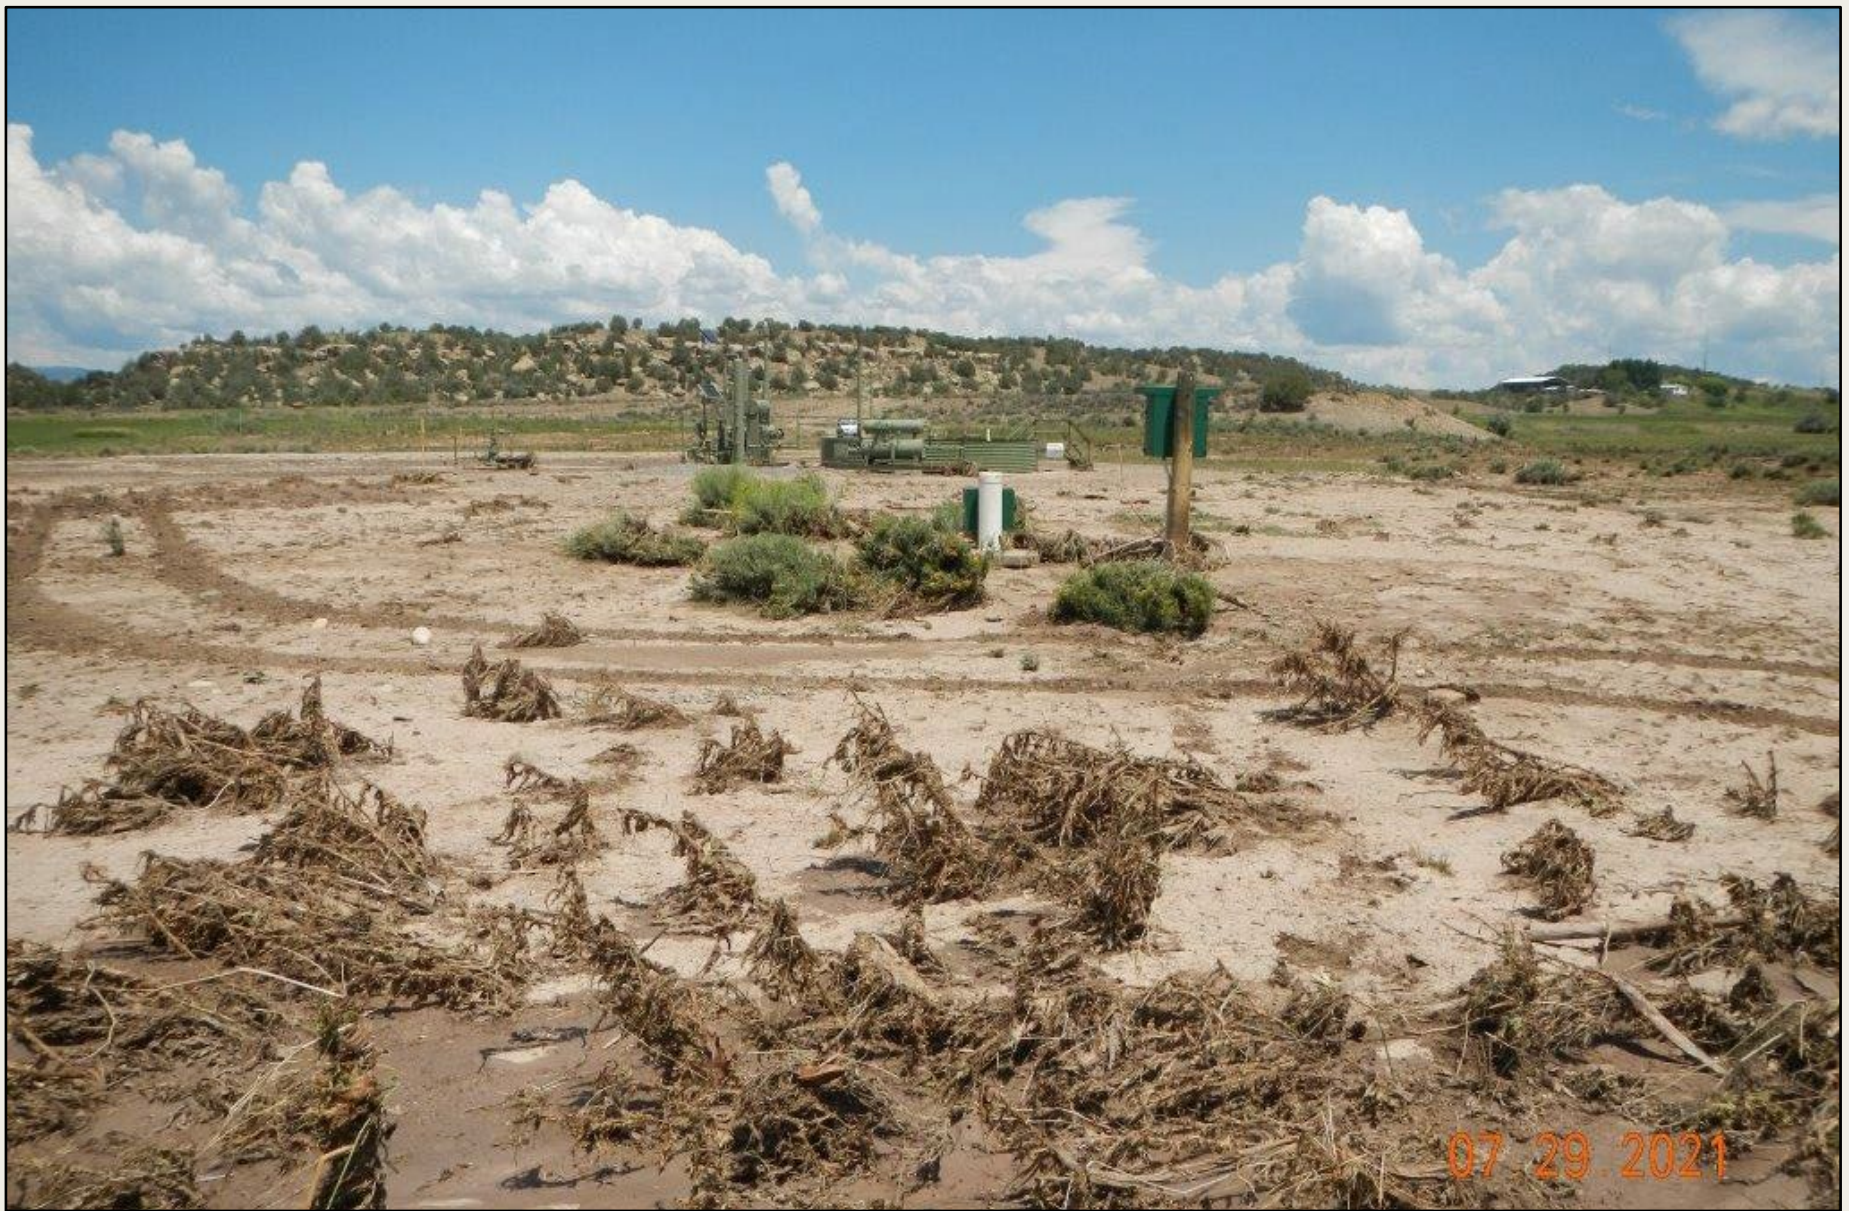
Photo 8. View of impacted vegetation and mud deposited on the well pad.

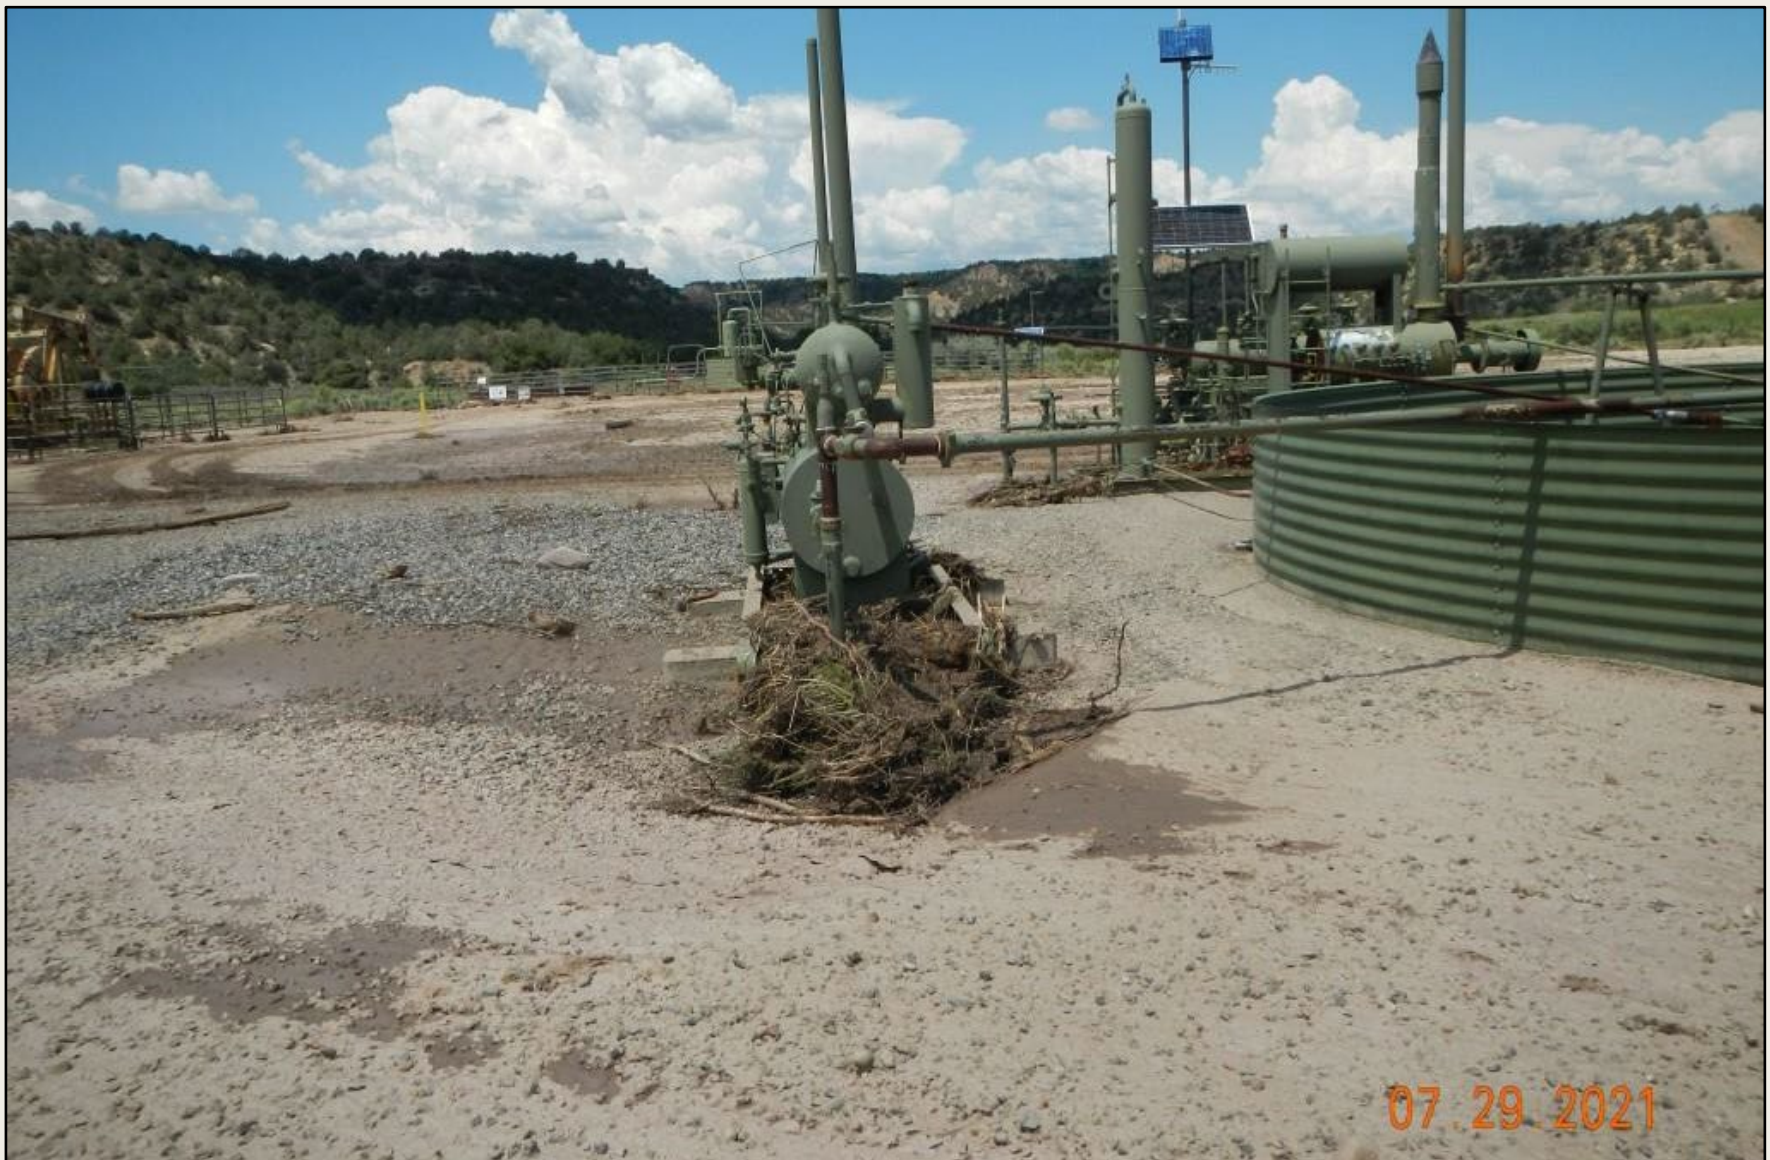
Photo 9. View of woody debris deposited around facilities.

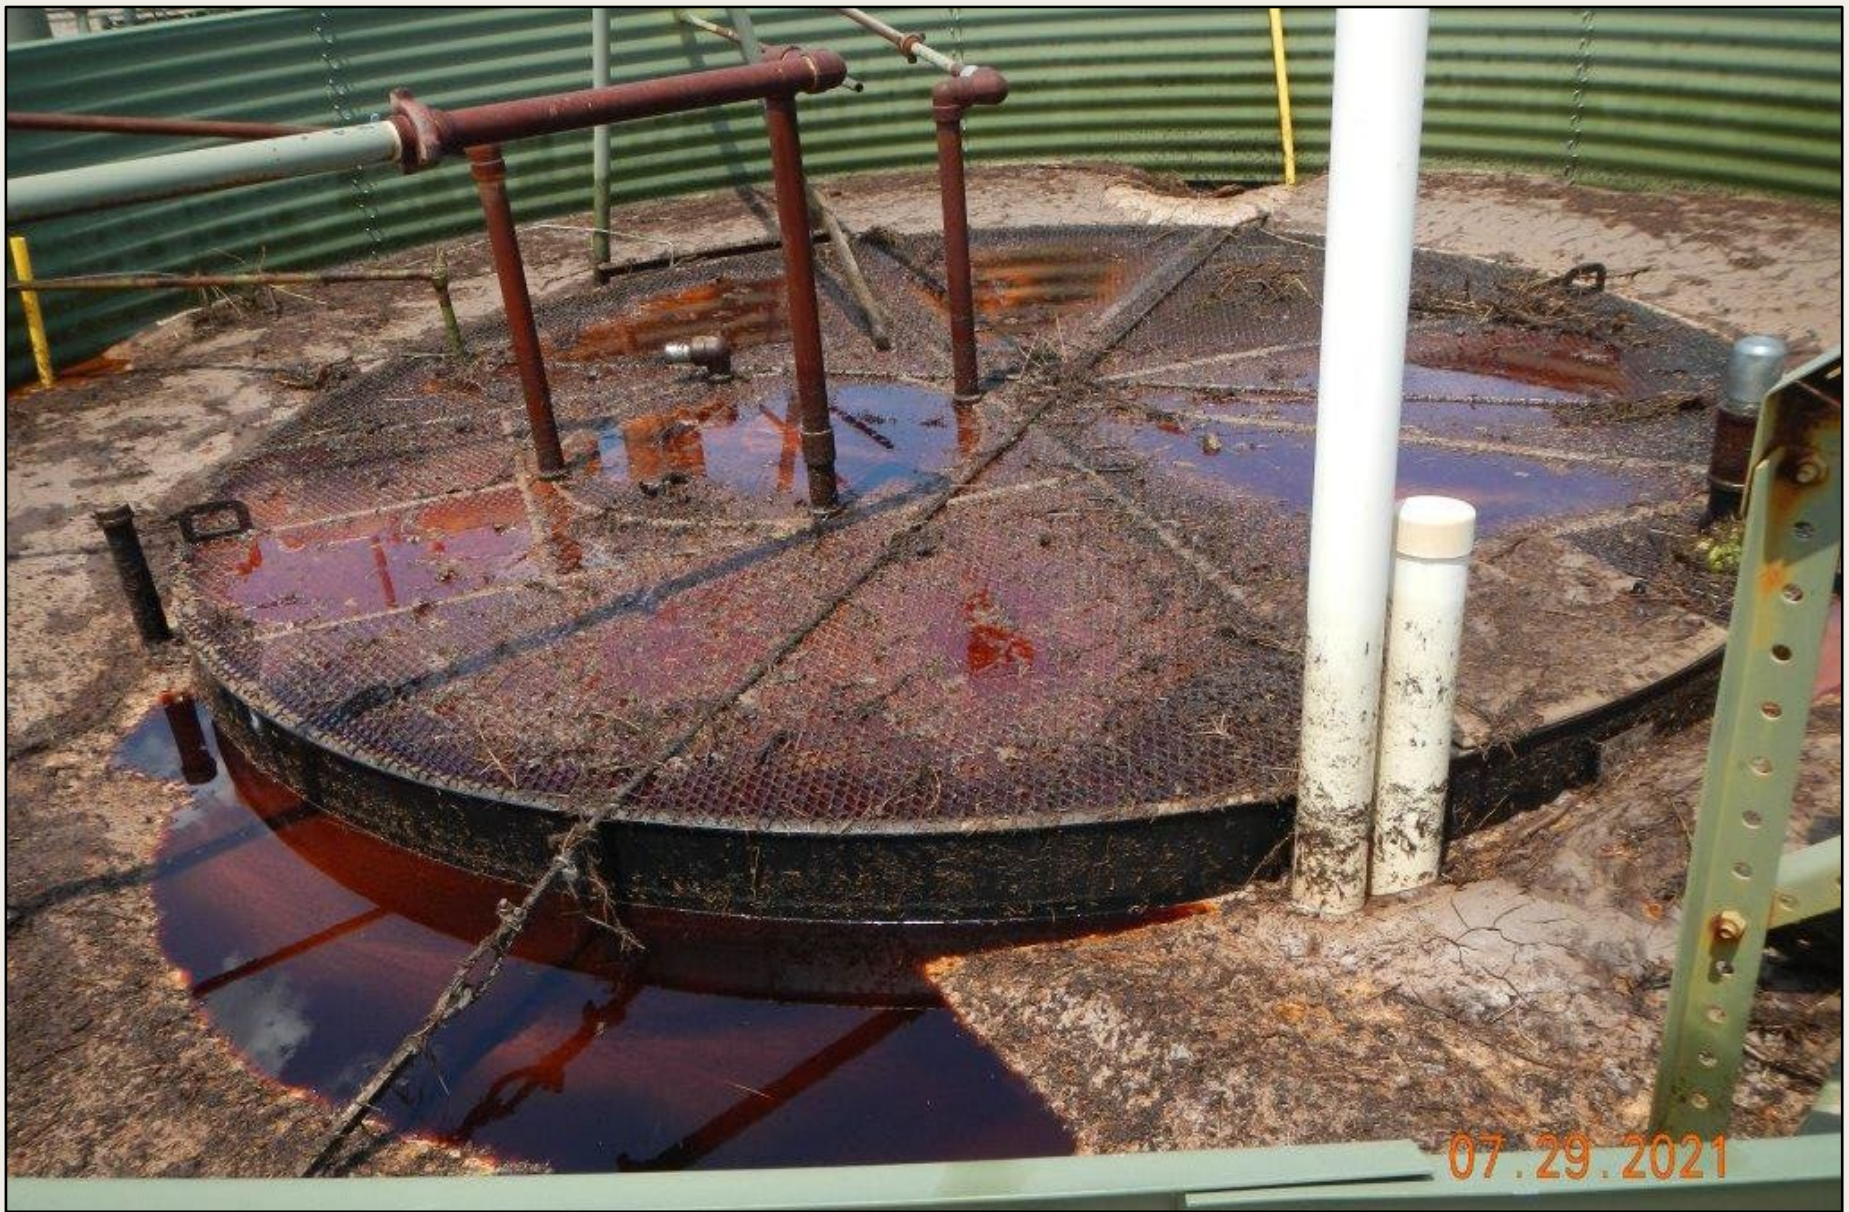
Photo 10. View of tank overflowing in eastern portion of the project area. Oily material pooled outside of tank. Wood debris deposited within and on top of tank.
