Inspection Photos
Operator: Logos/Simcoe
API: 067-08138 and 067-08731
Date: 7/29/2021

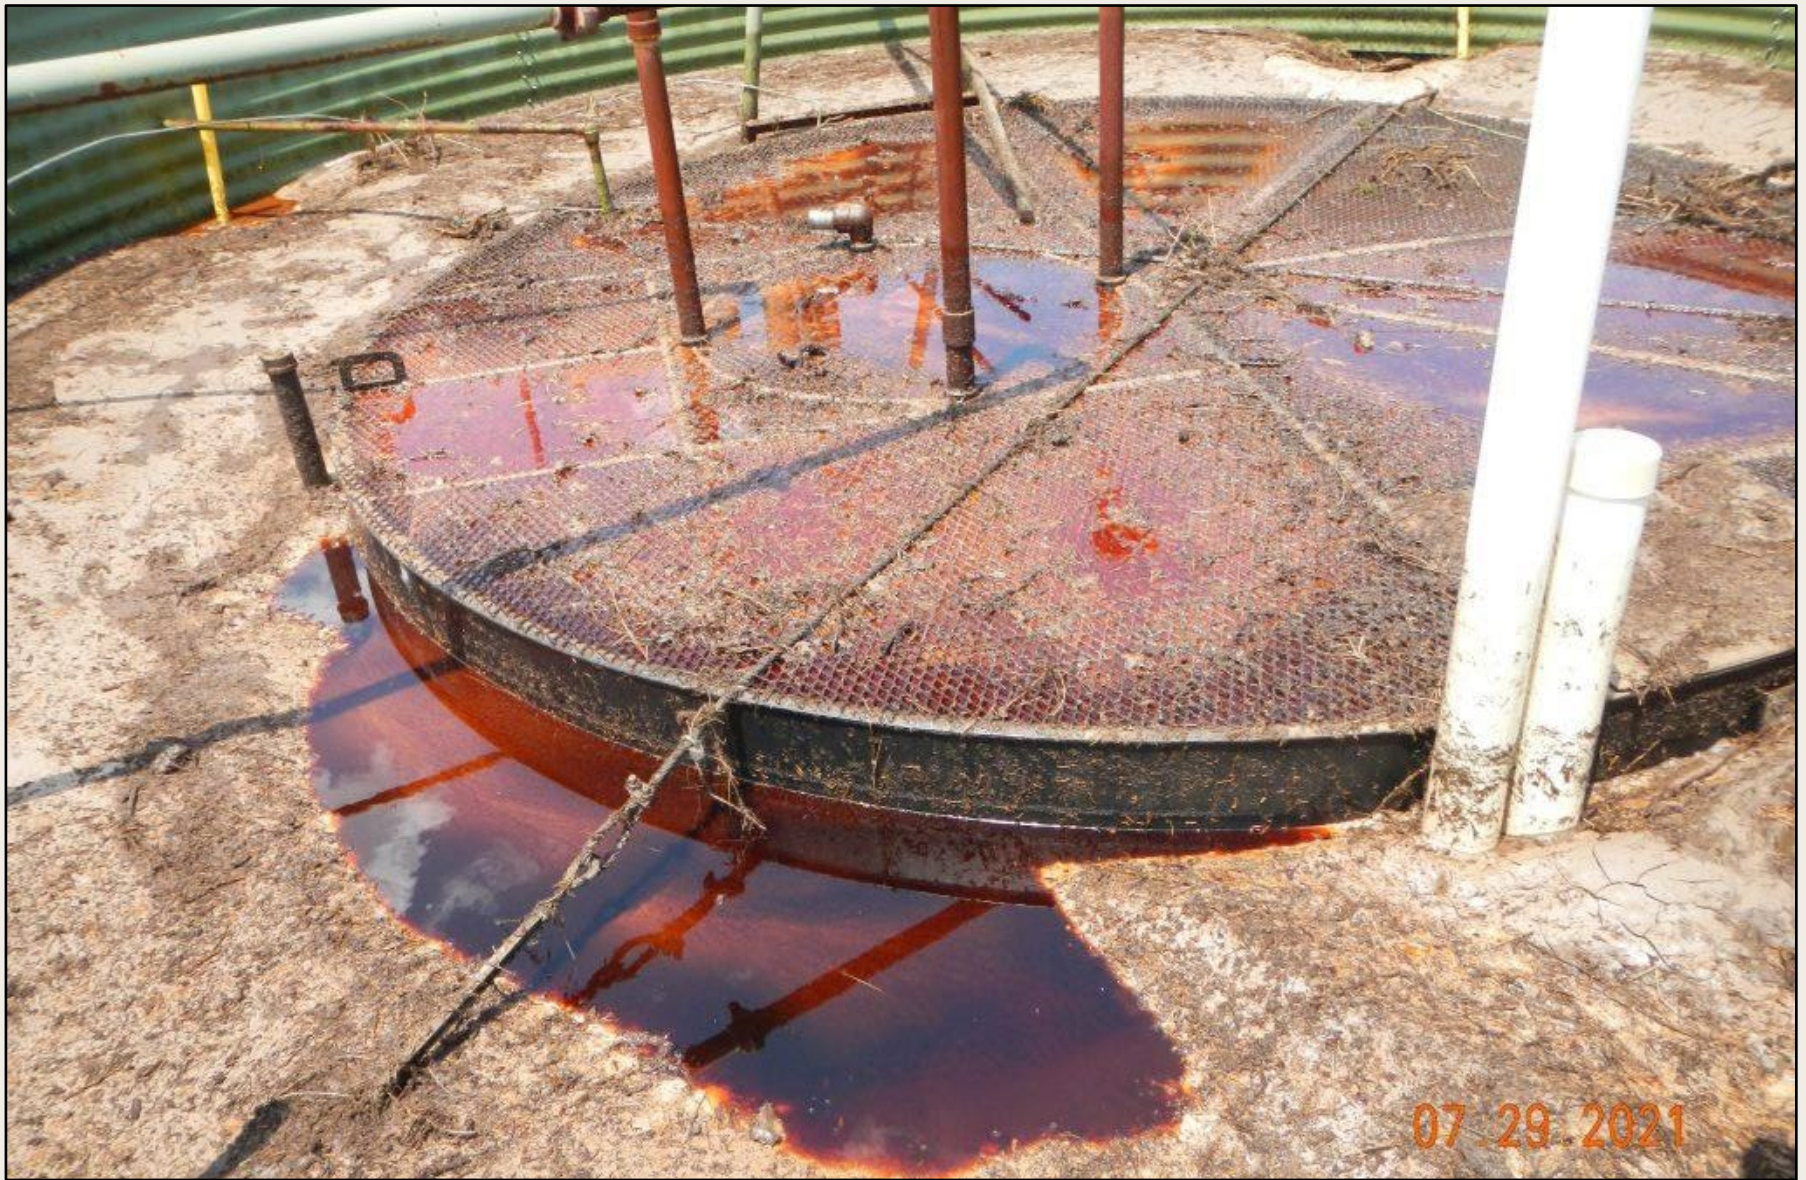
Photo 11. Another view of material released from overflowing tank.

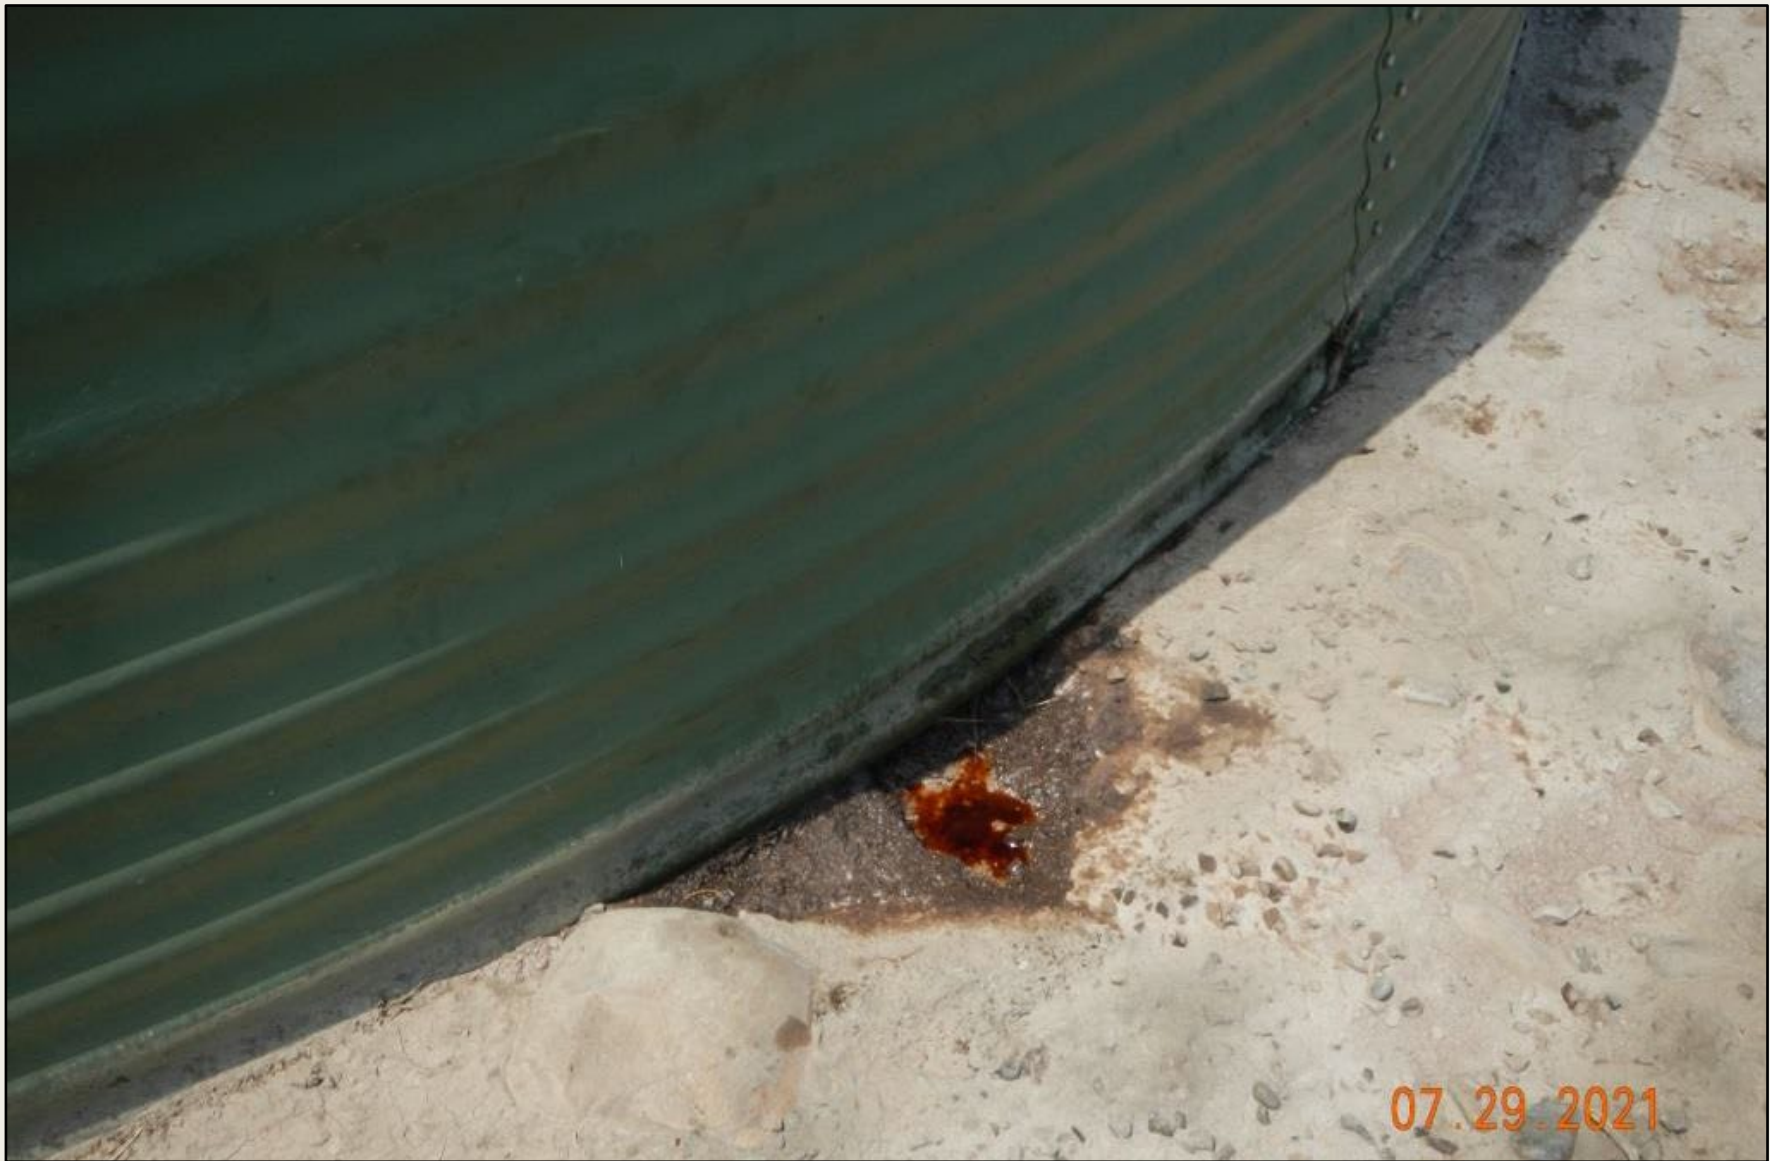
Photo 12. View of pooled material outside of tank containment.

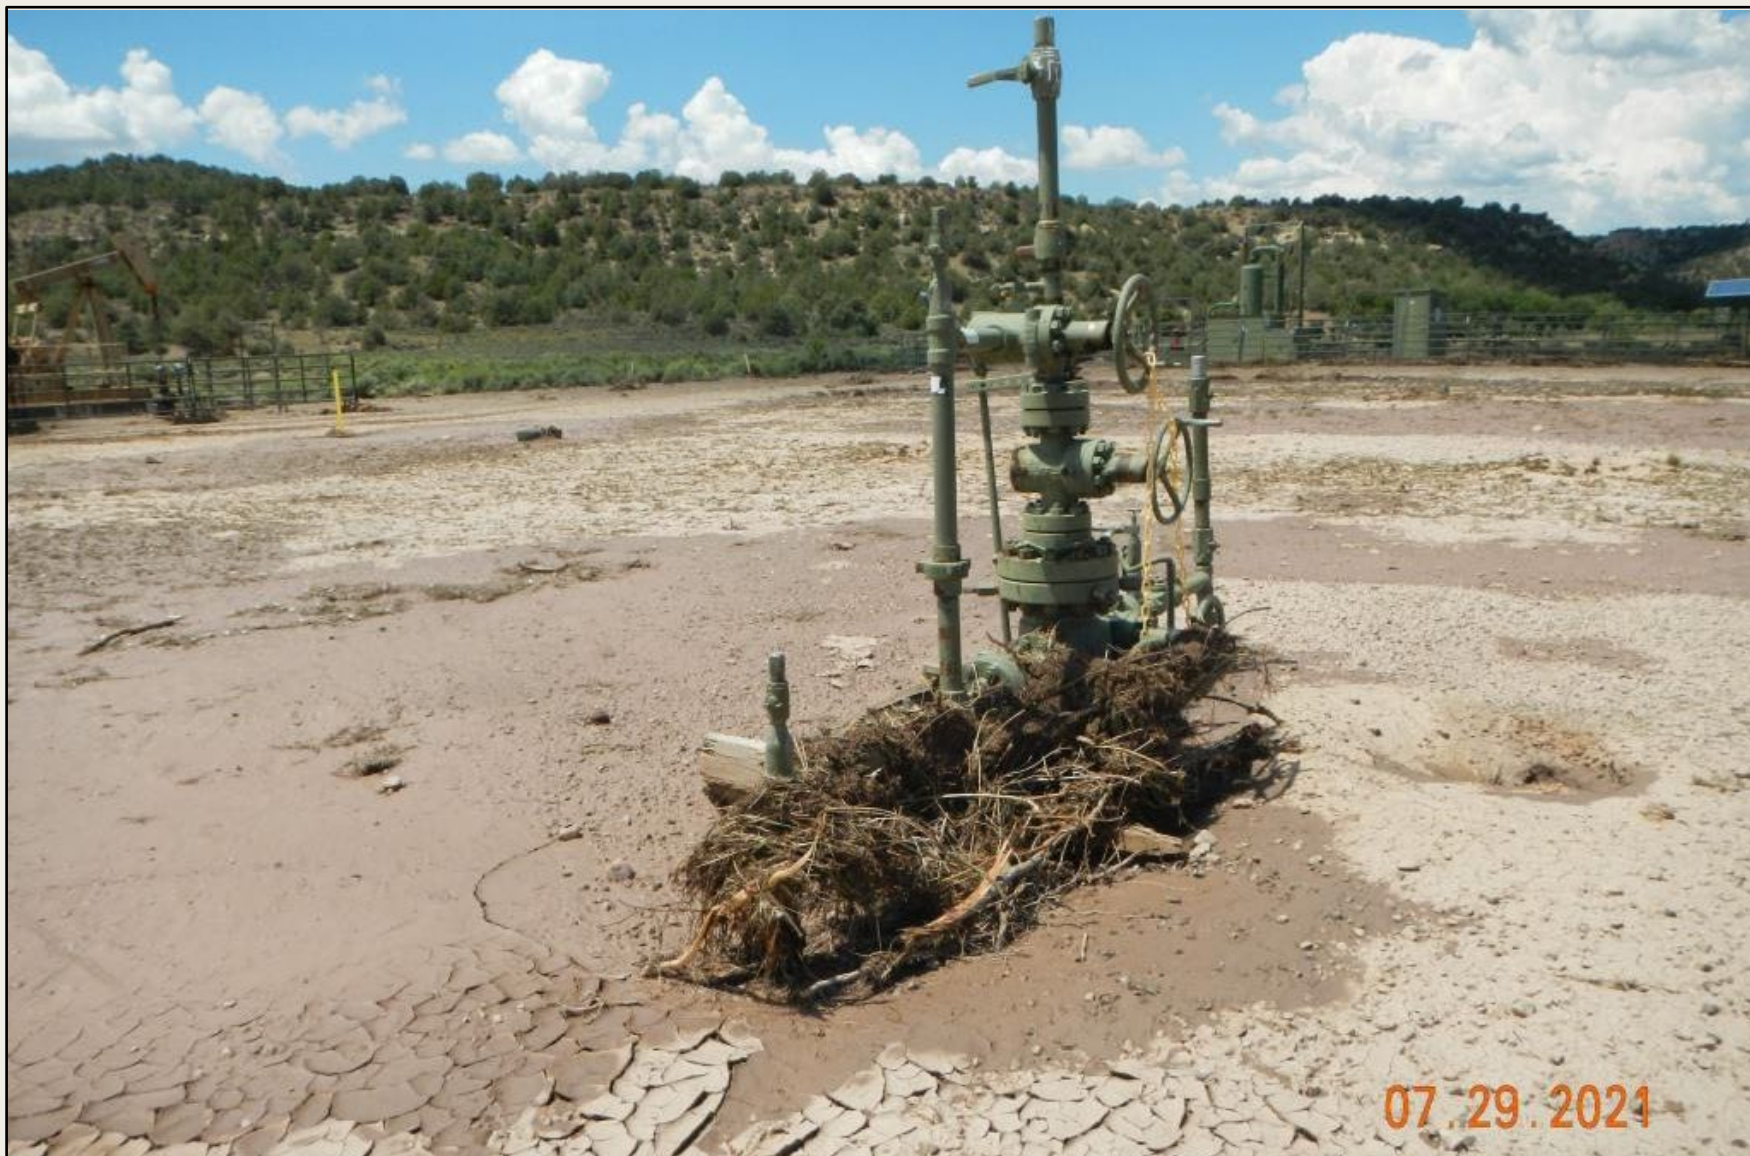
Photo 13. View of woody debris around wellhead.
