Caerus Piceance LLC
E13W
Location # 334900/334910

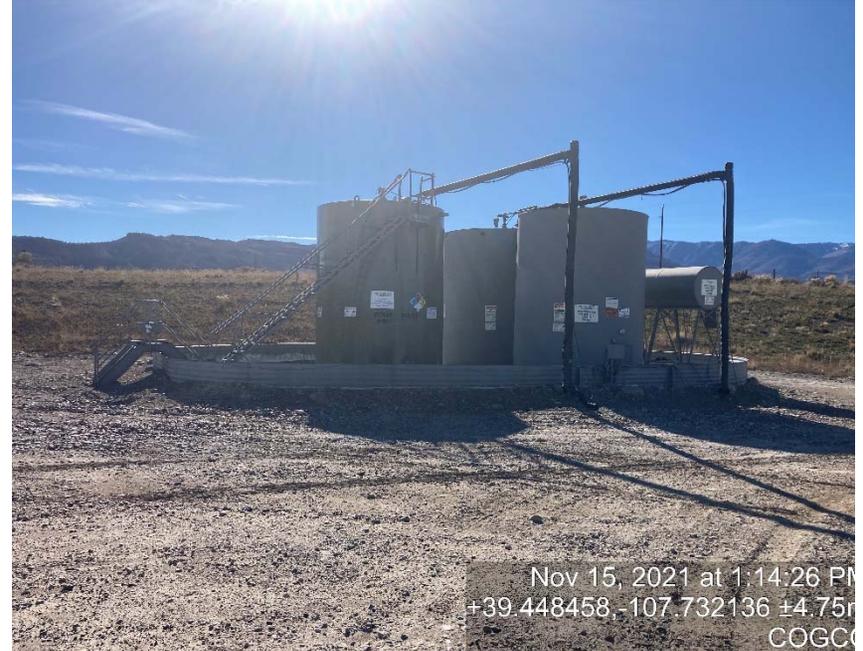
location/ lack of battery signage

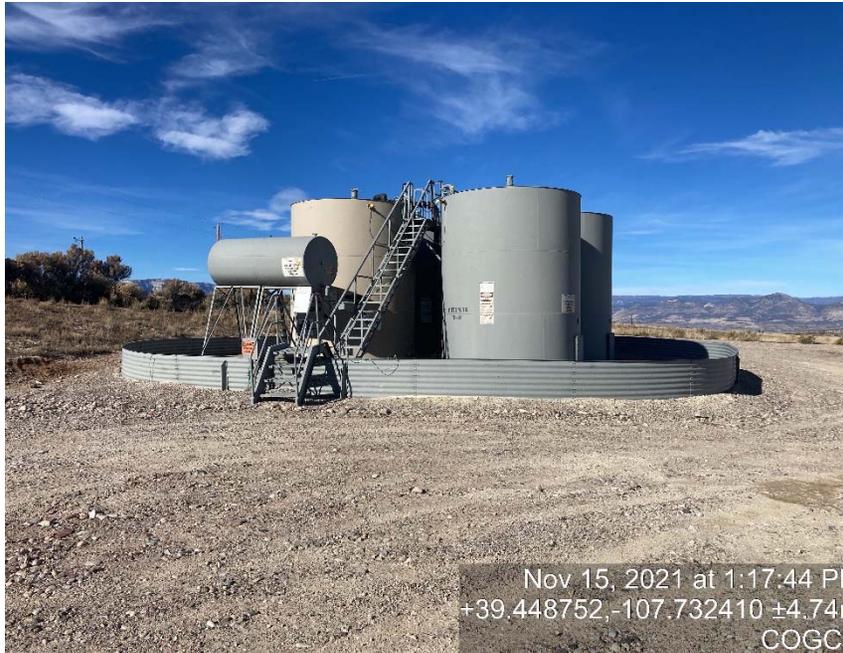
Location/ lack of battery signage

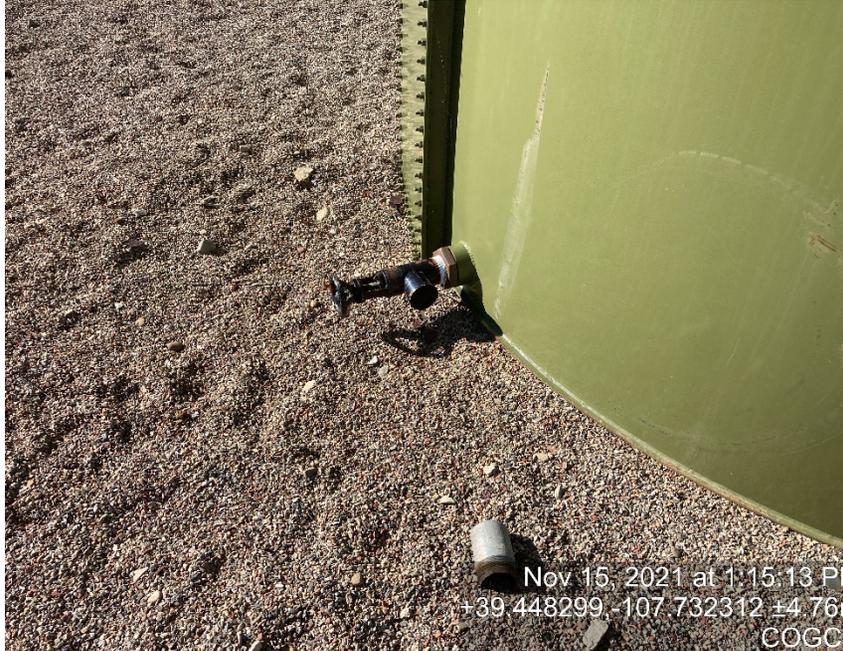
Load lines lacking bull plug

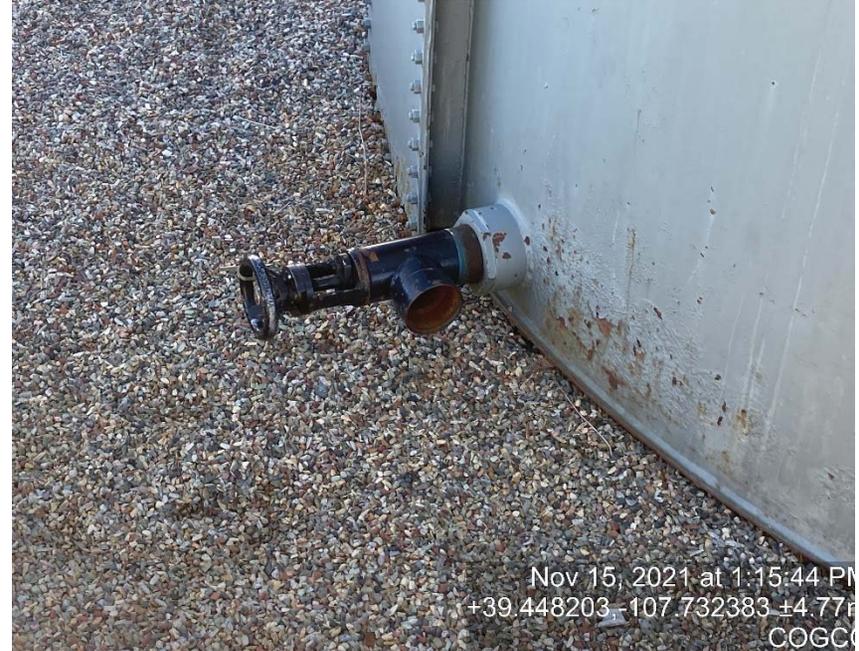
Load lines lacking bull plug

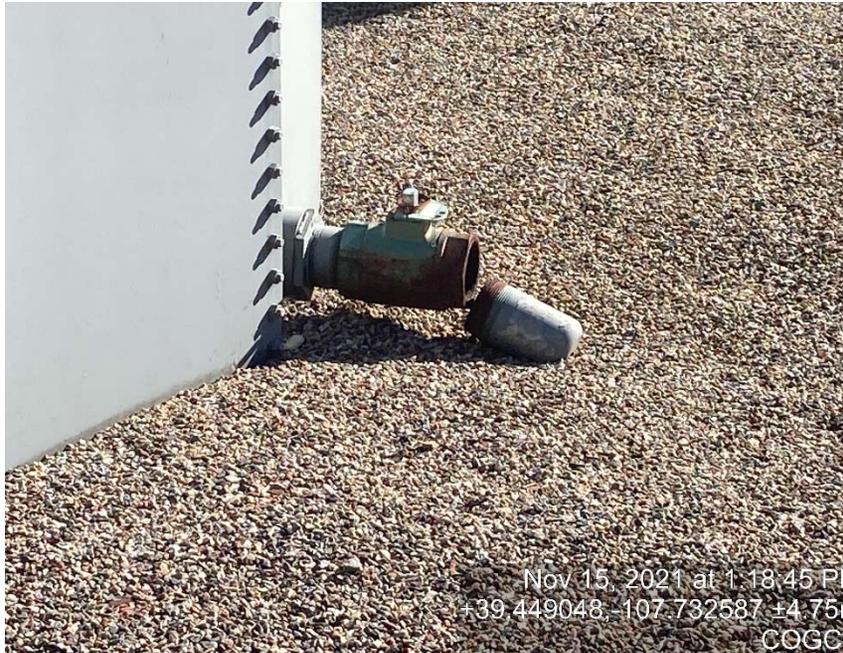
Load lines lacking bull plug

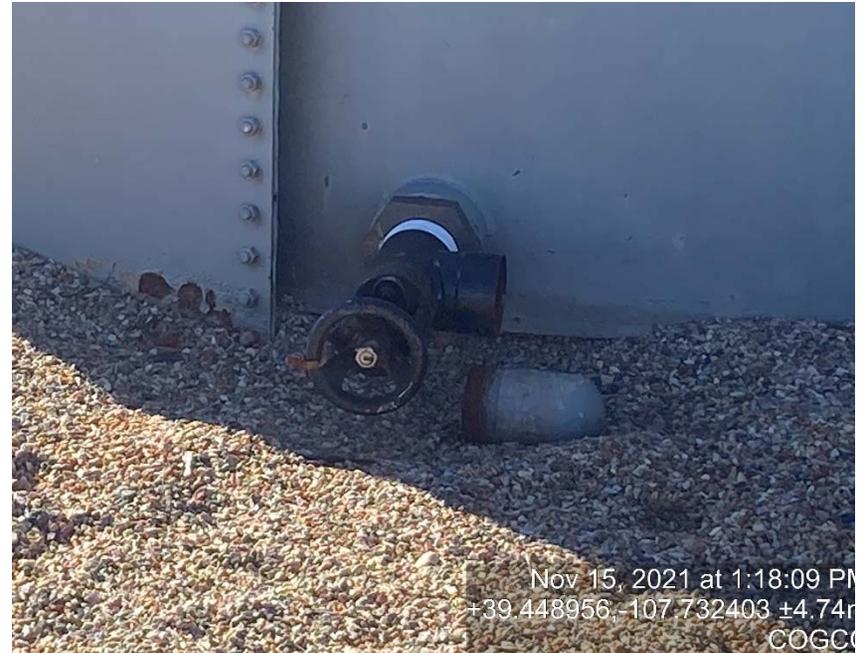
Load lines lacking bull plug

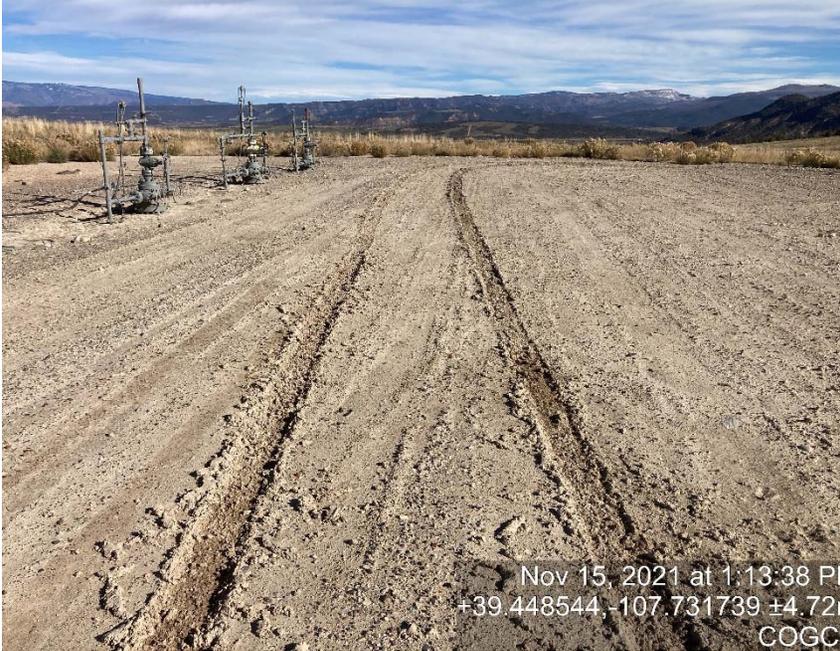
Lack of stabilization/compaction

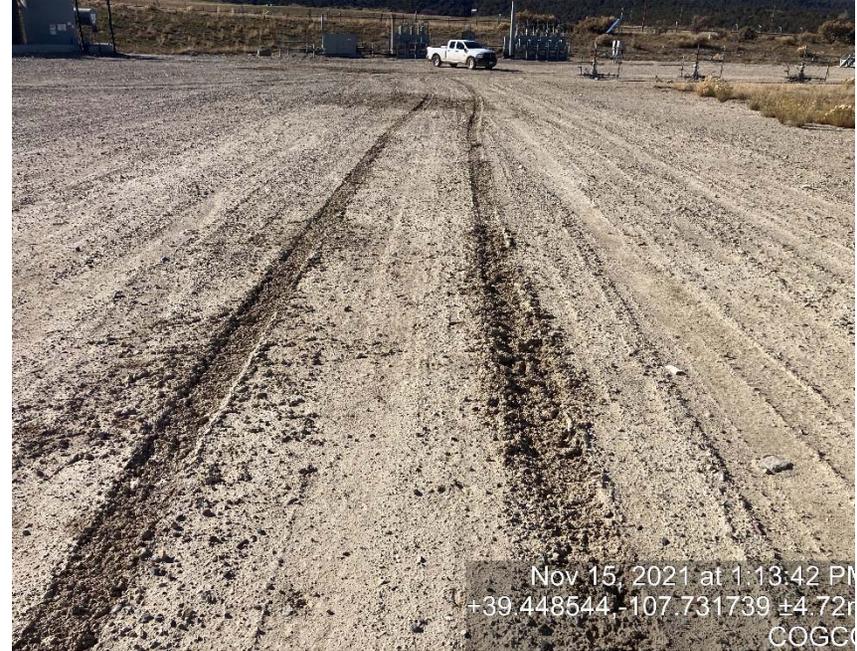
Lack of stabilization/compaction

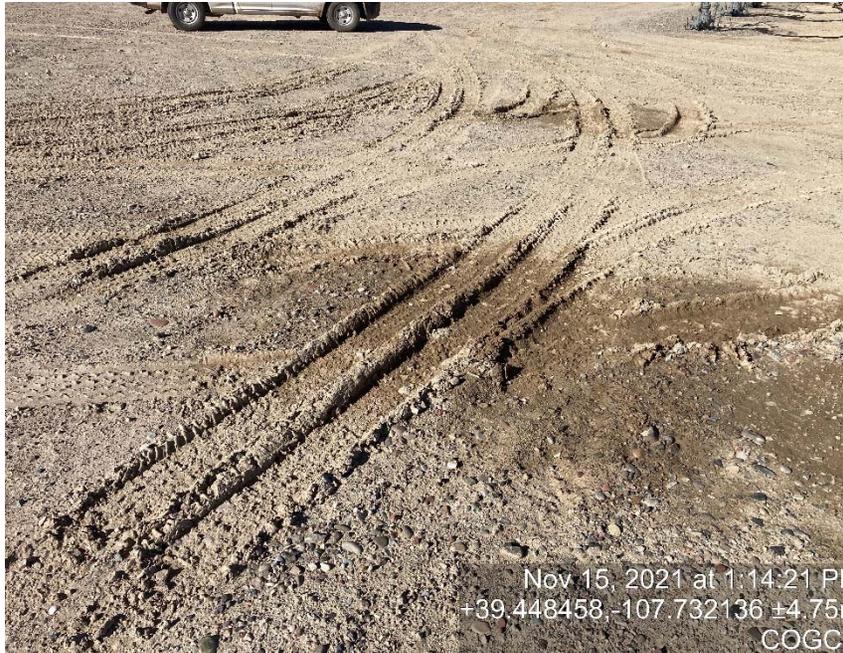
Lack of stabilization/compaction

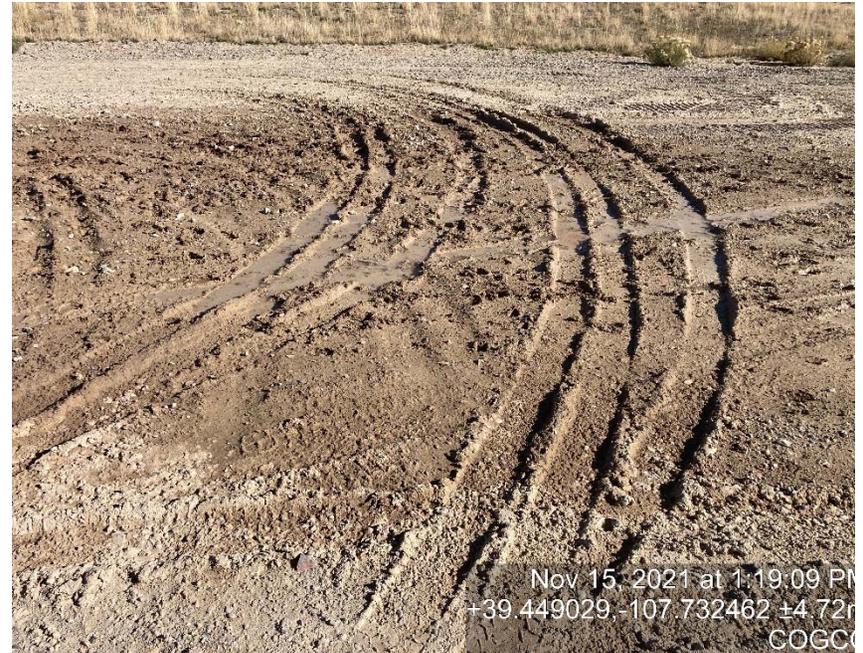
Lack of stabilization/compaction

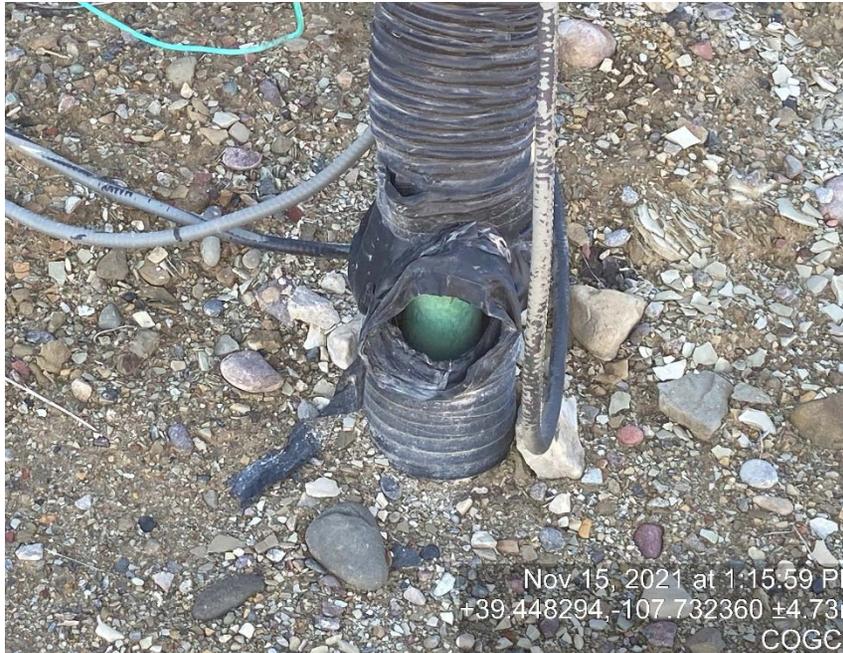
Open ended piping for thawing out dump lines on tanks with exhaust from trucks.

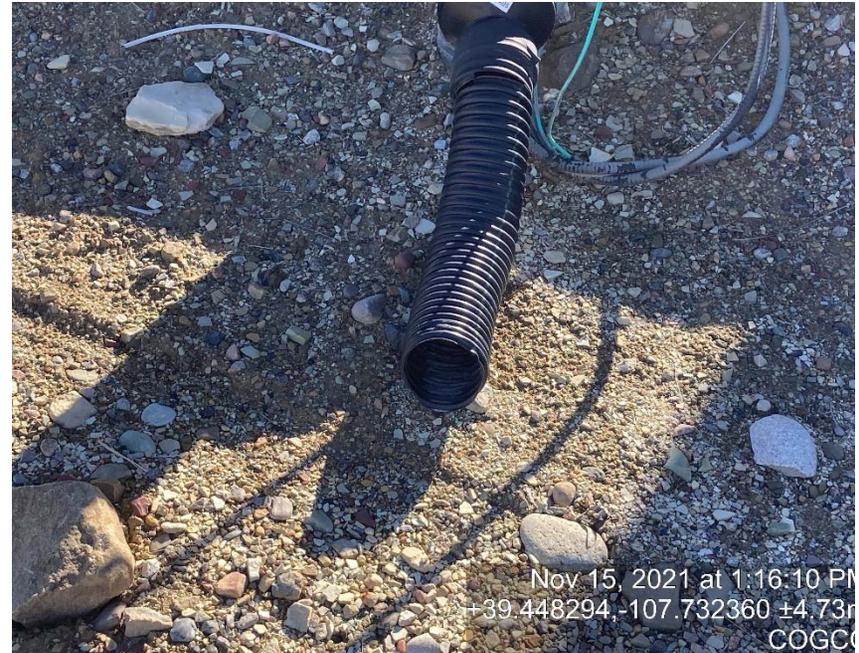
Open ended piping for thawing out dump lines on tanks with exhaust from trucks.

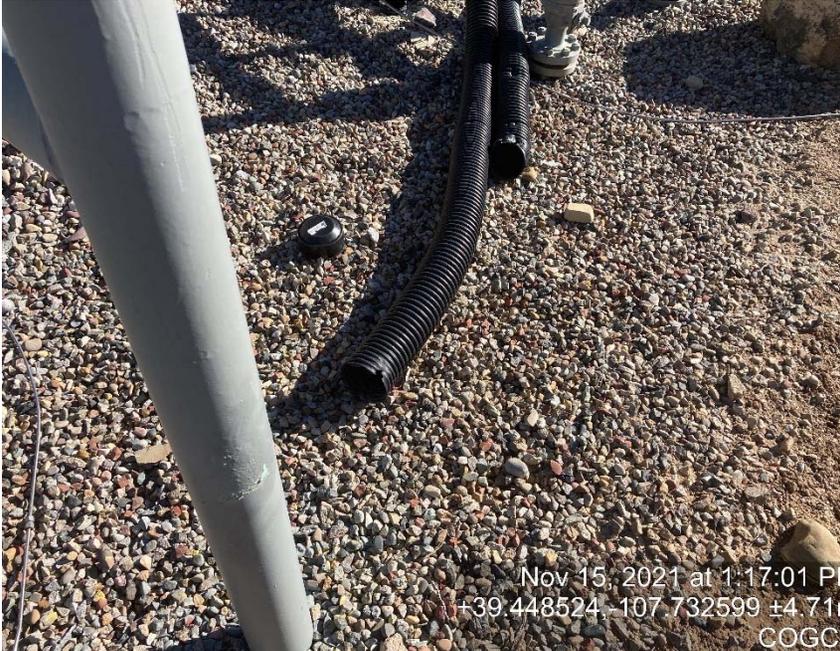
Open ended piping for thawing out dump lines on tanks with exhaust from trucks.

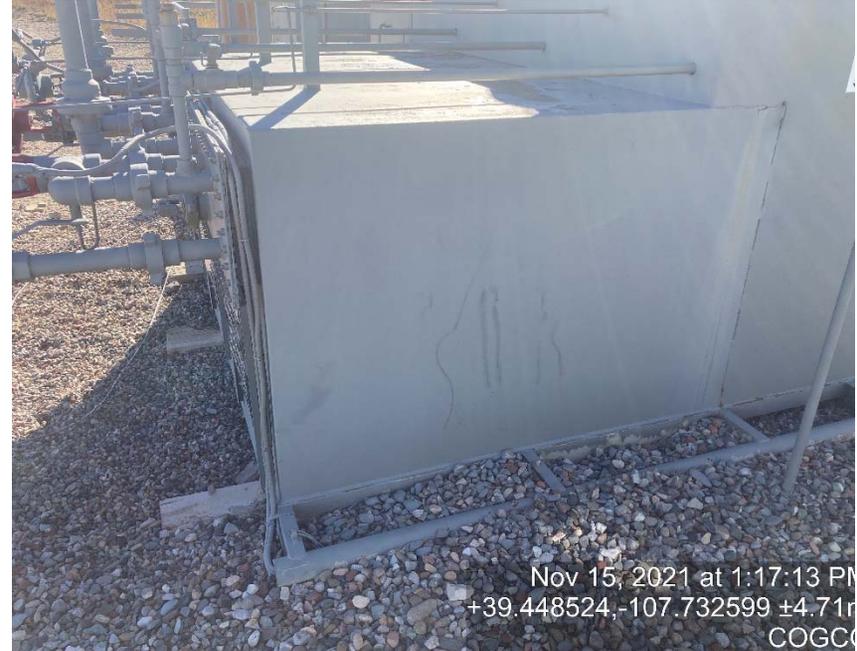
Glycol vessel lacking labeling
