Inspection Photos

Location Name: CAERUS PICEANCE LLC ENYEART-67S95W /16NWNW

Location ID: 334761

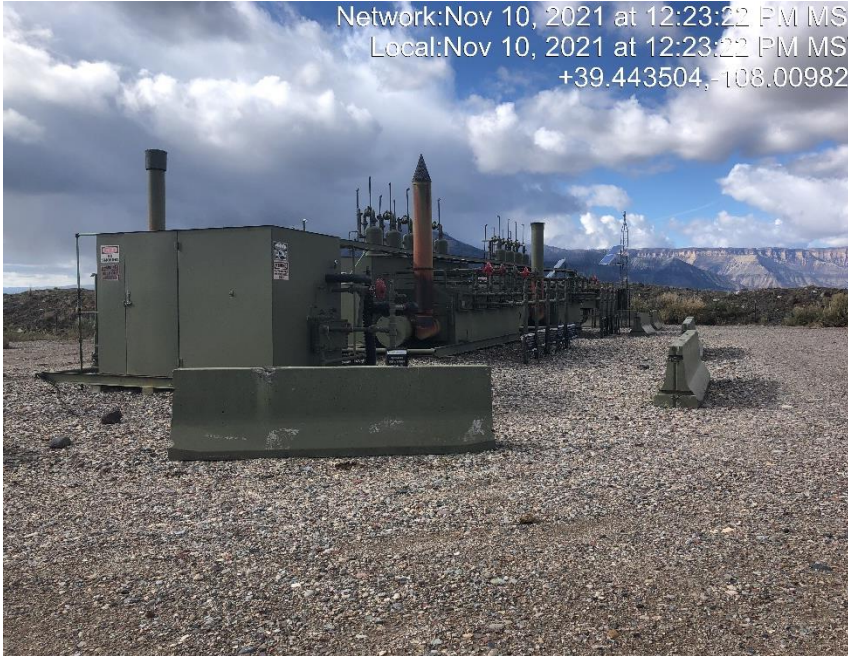
Photo #5179 from entrance to location.

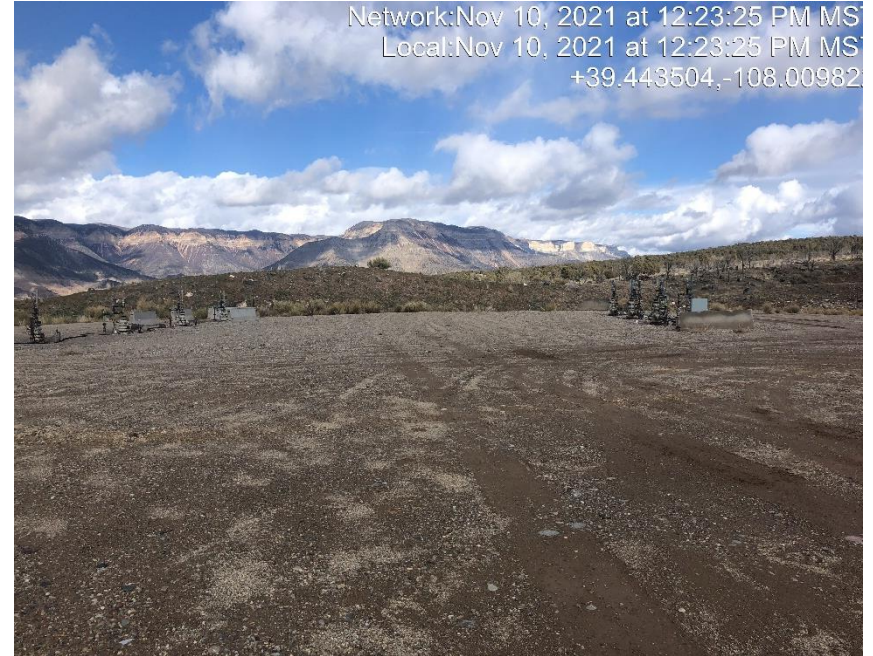
Photo #5180 from entrance to location.

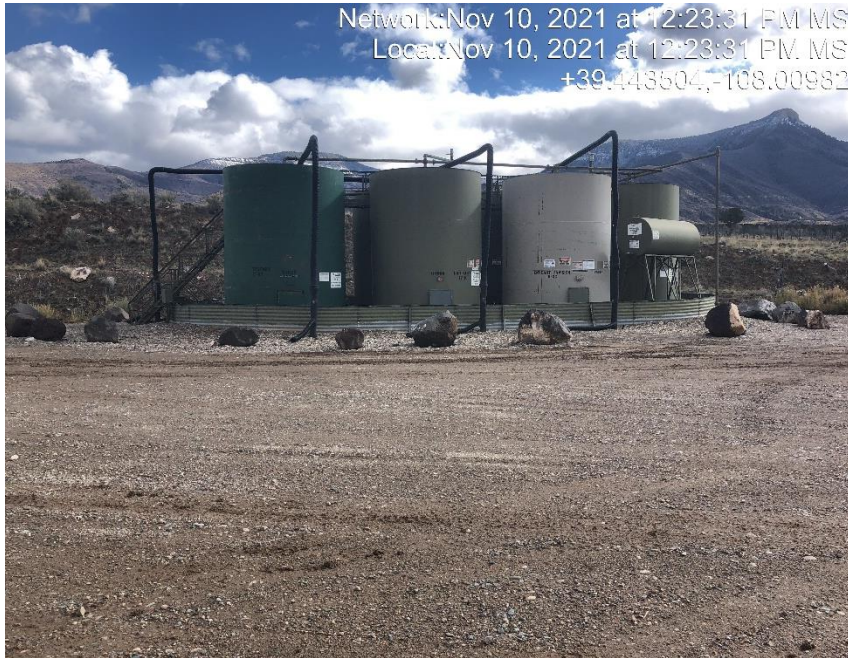
Photo #5181 from entrance to location.

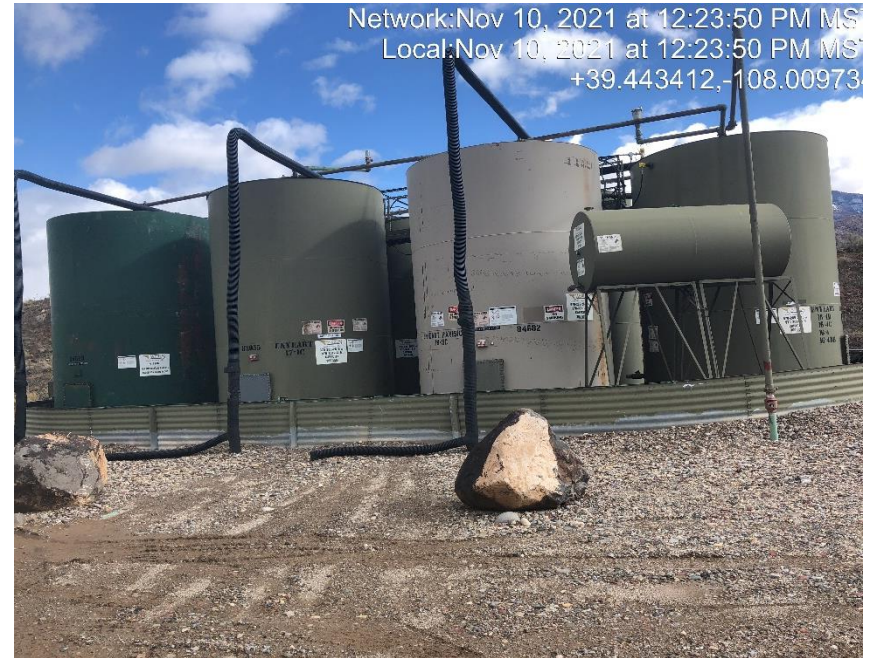
Photo #5182 No battery sign located at the tank battery.

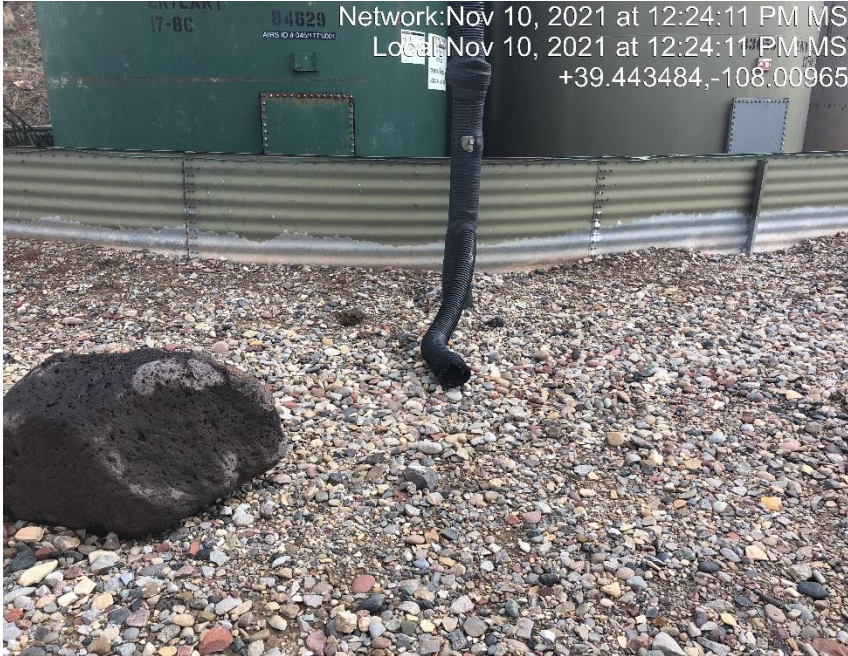
Photo #5183 Flowline heating insulation open ended and not capped.
