# Interim Reclamation Inspection

Operator: KERR MCGEE OIL & GAS ONSHORE LP #47120

Location ID: 331236

Inspection Photos  
Location Name: DEEPE /14N-27HZ  
Location ID: 331236

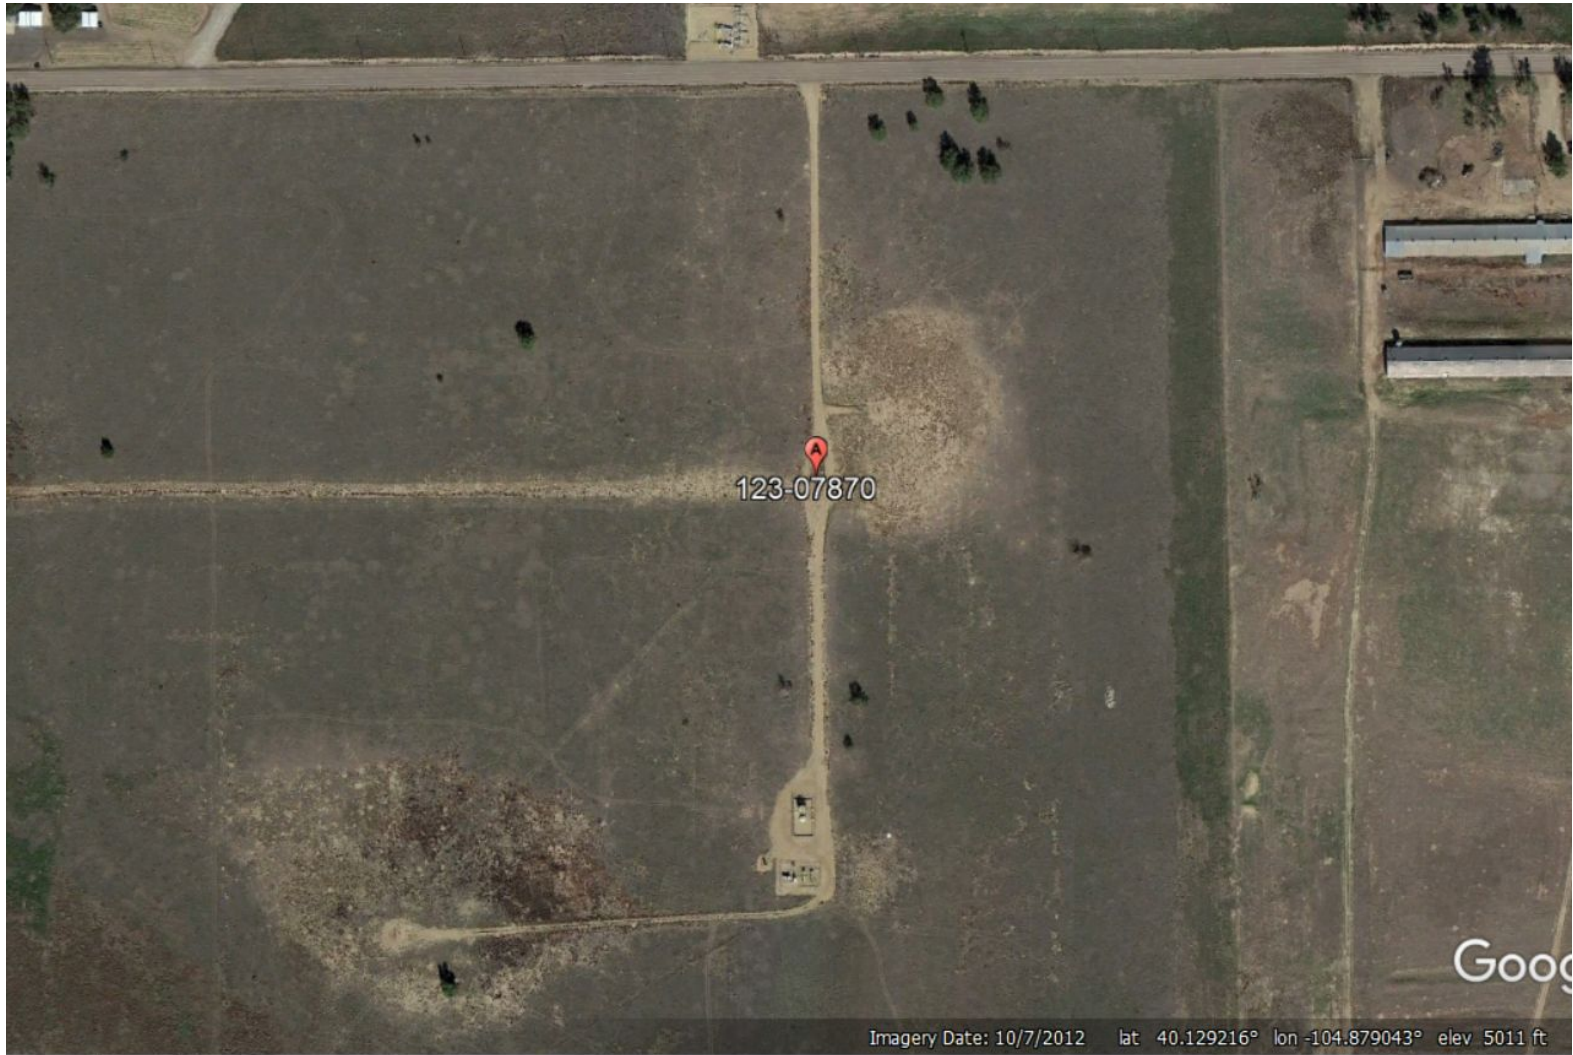
**Photo 1.** Google Earth aerial imagery taken 10/7/2012 prior to the Kerr McGee Deep locations. Photo illustrates the access road, which was planned to be used by Kerr McGee after their new locations were built.

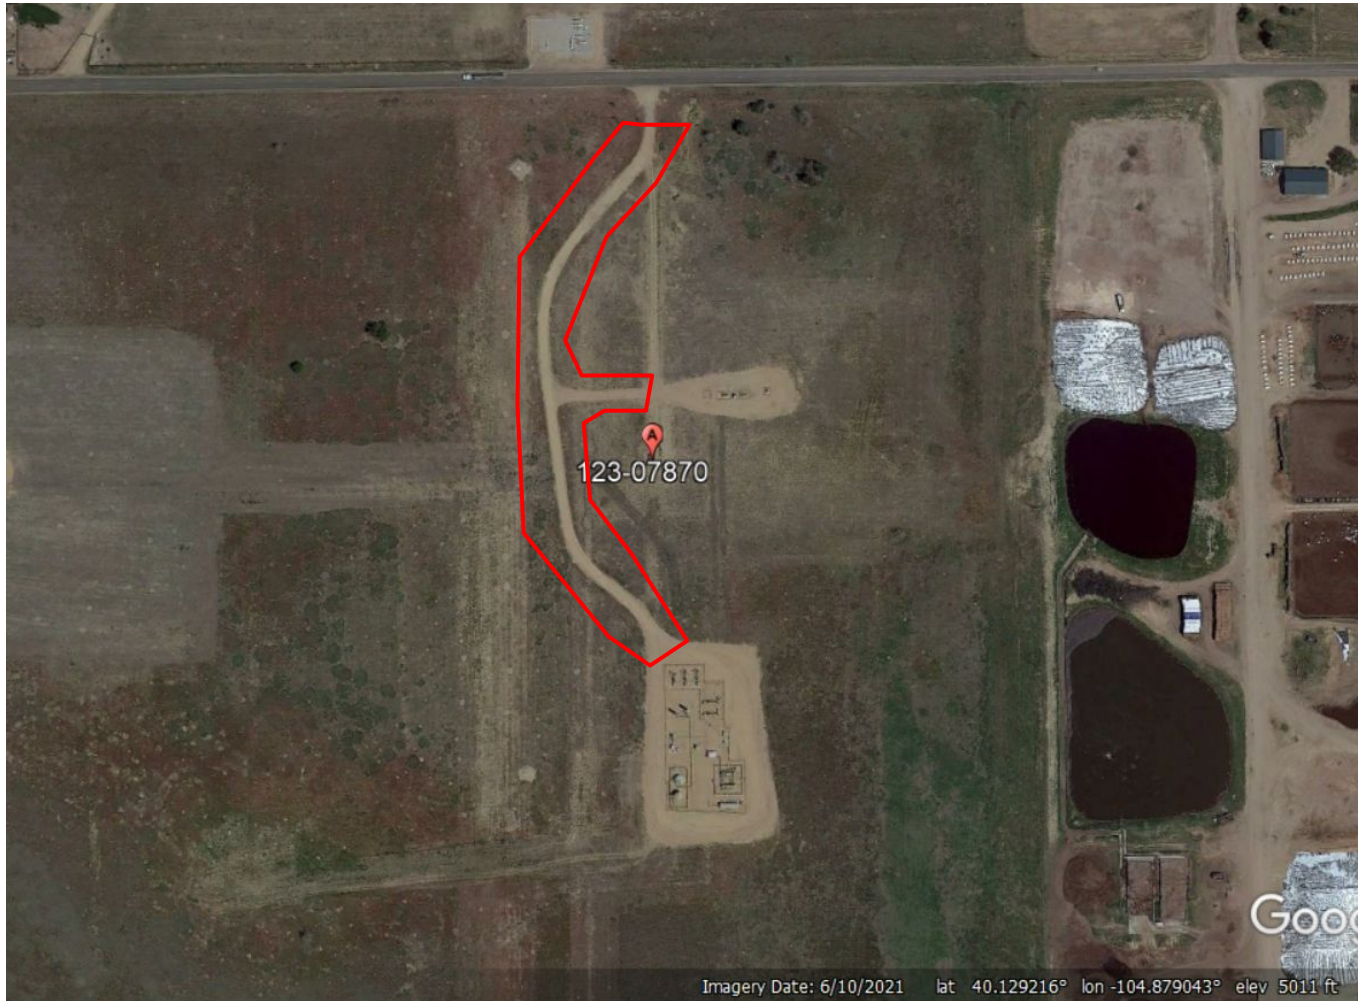
**Photo 2.** Google Earth aerial imagery taken 6/10/2021 after the Kerr McGee Deep locations were built. Photo illustrates a new access road built by Kerr McGee, which is not what was planned to be used. Kerr McGee was planning to use the previous access route illustrated in the previous photo.

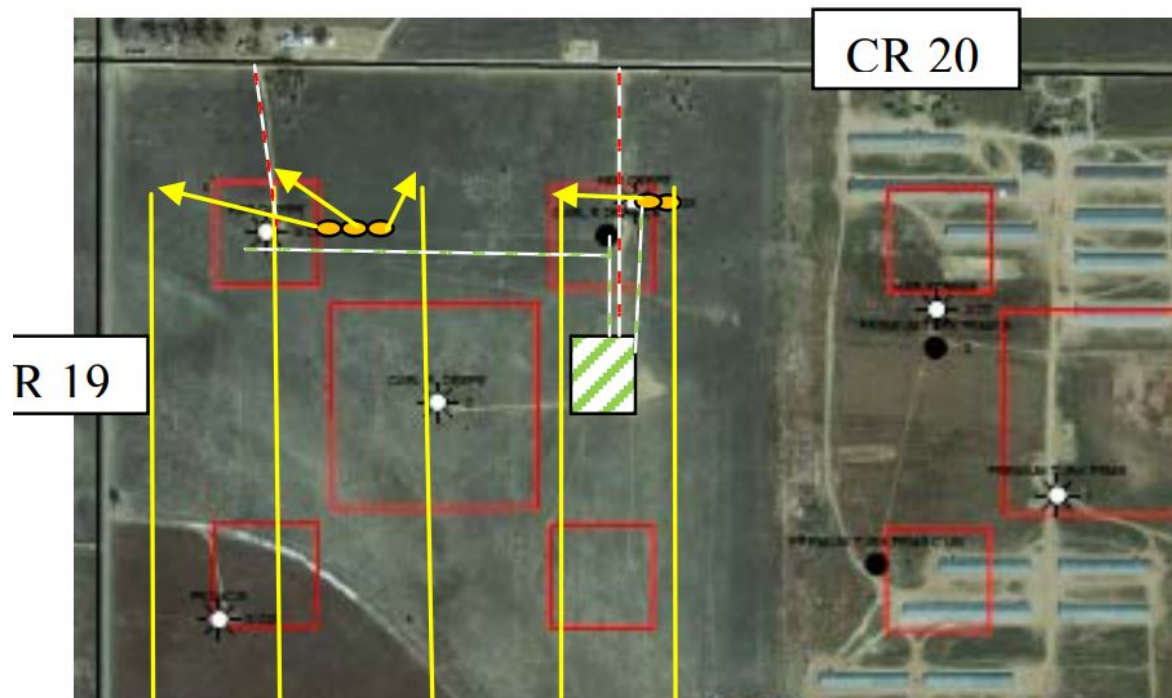
## ACCESS ROAD MAP

**Photo 3.** Kerr McGee aerial imagery of the planned and approved access road to be used. Kerr McGee built new access roads that were not approved.

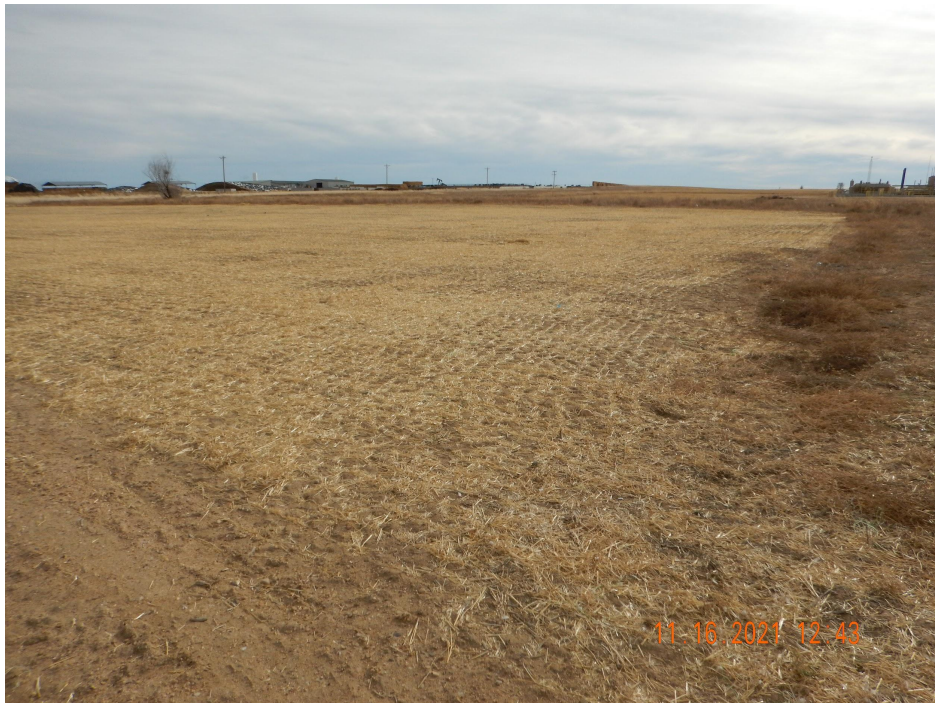
**Photo 5.** Photo taken from the well location, facing South. Photo illustrates interim reclamation has been performed with the evidence of straw crimped mulch stabilizing the seeded soil.

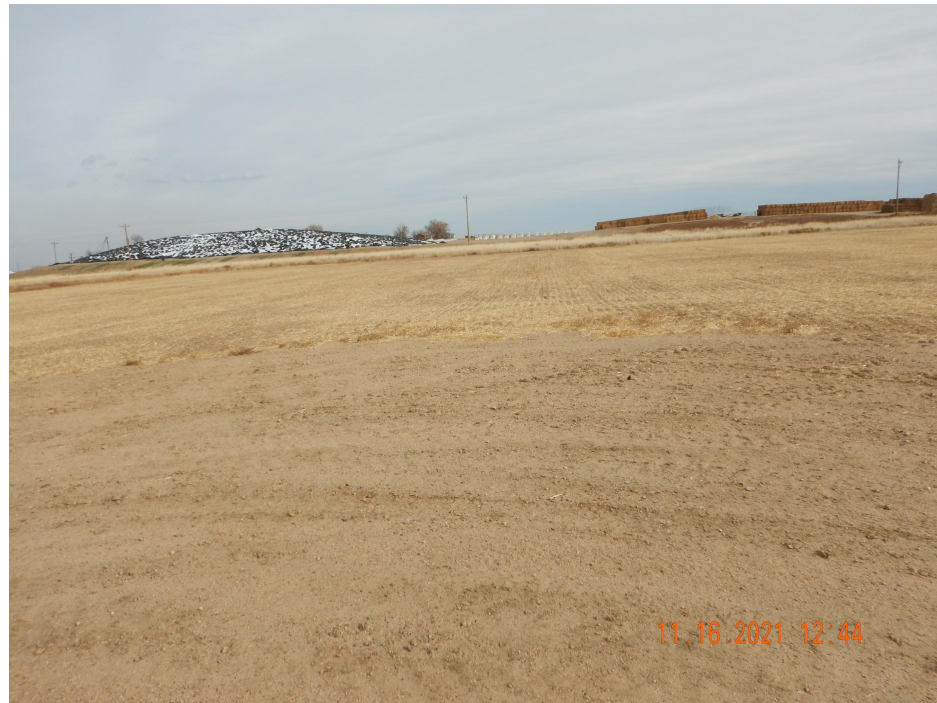
**Photo 6.** Photo taken from the well location, facing East. See comments under Photo 5.

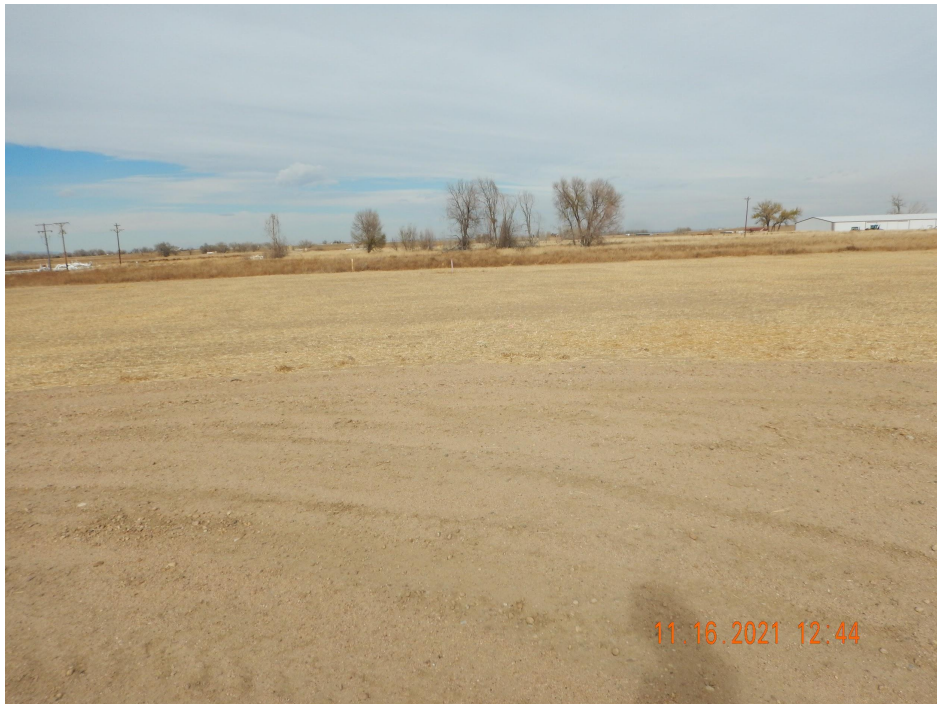
**Photo 7.** Photo taken from the well location, facing North. See comments under Photo 5.

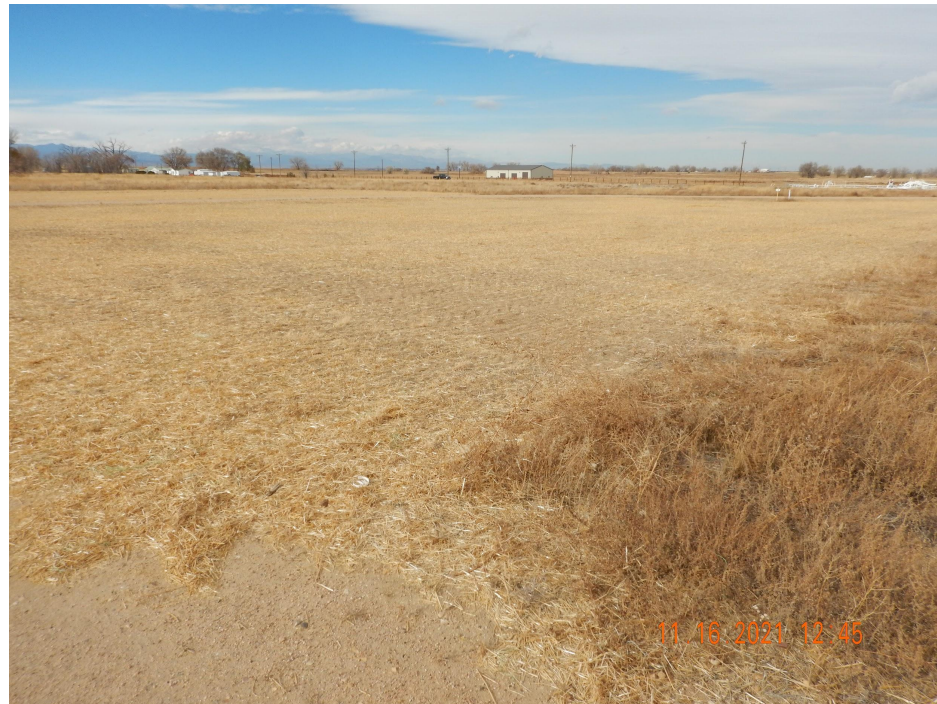
**Photo 8.** Photo taken from the well location, facing Northwest. See comments under Photo 5.
