Caerus Piceance LLC
I2W
Location # 334906

COLORADO
Oil & Gas Conservation
Commission
Department of Natural Resources

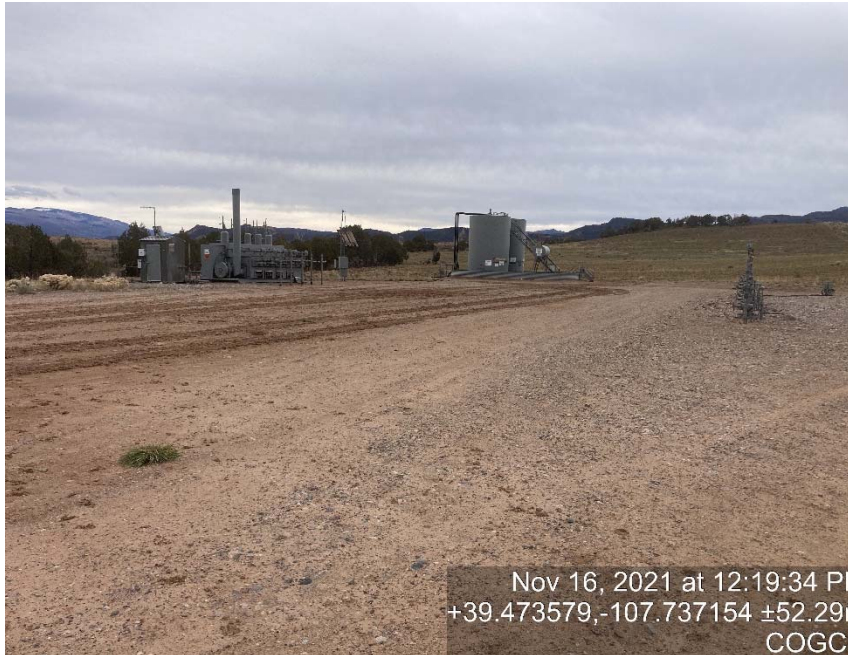
Location

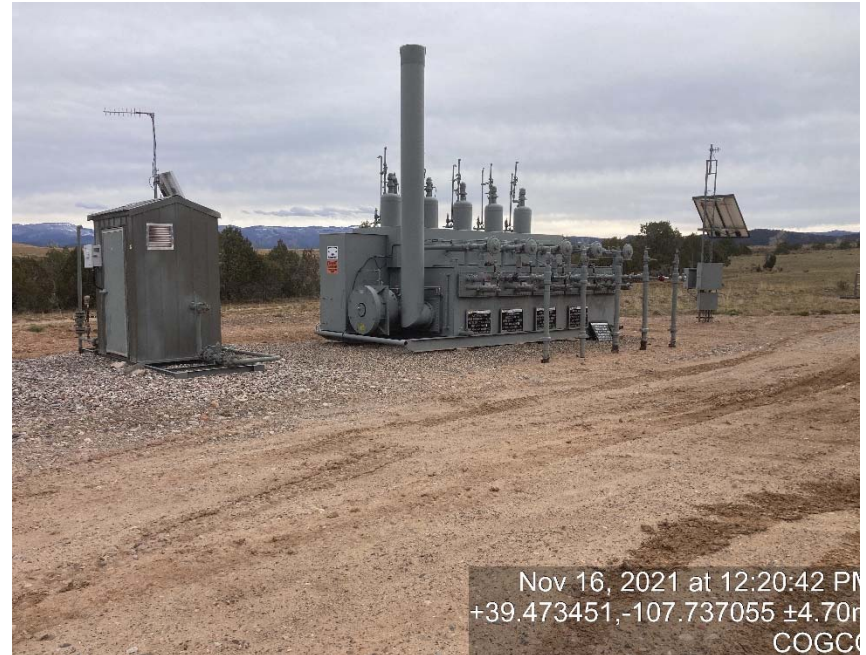
location

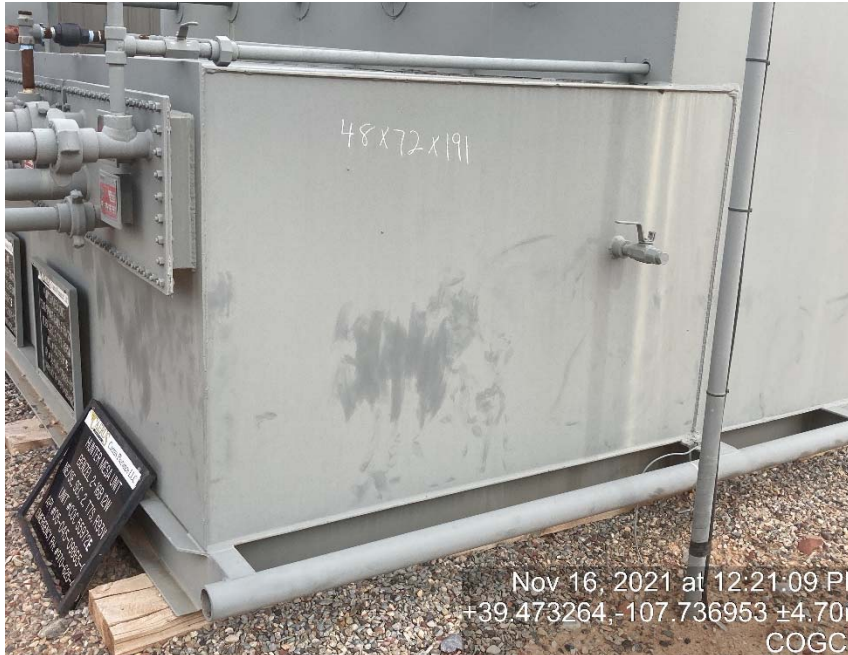
Glycol vessel lacking labeling/ dimensions

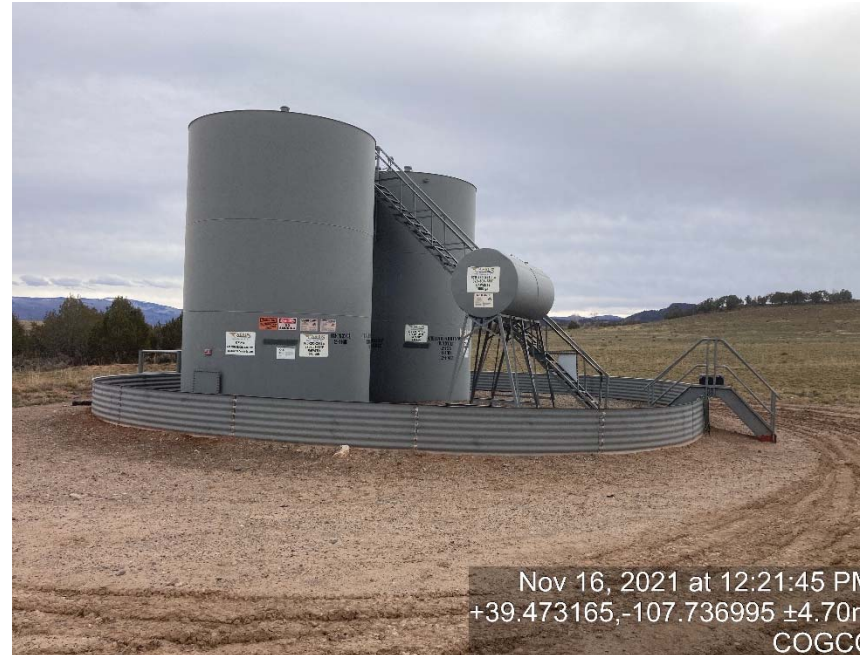
Location/ lack of battery signage

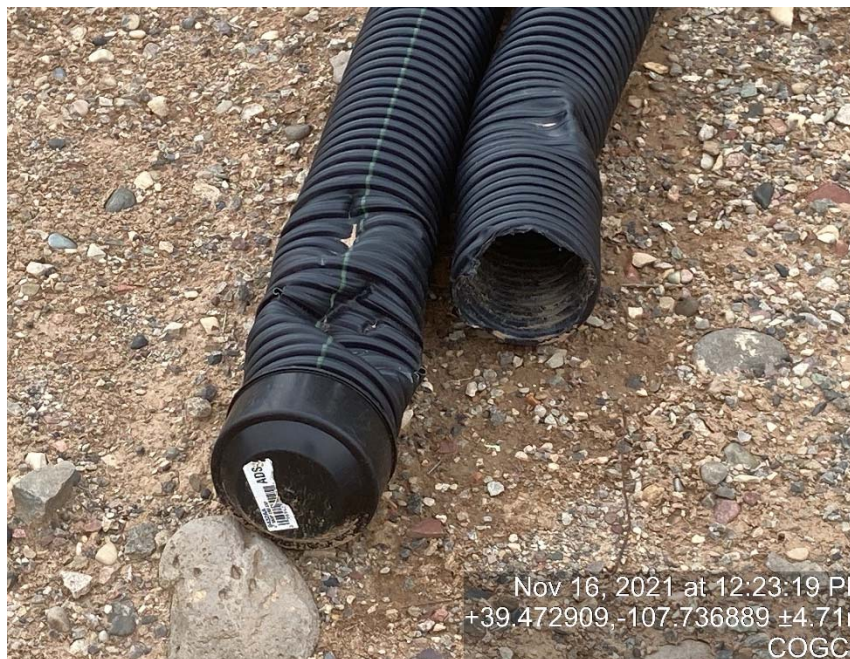
Open ended piping for thawing out dump lines on tanks with exhaust from trucks.

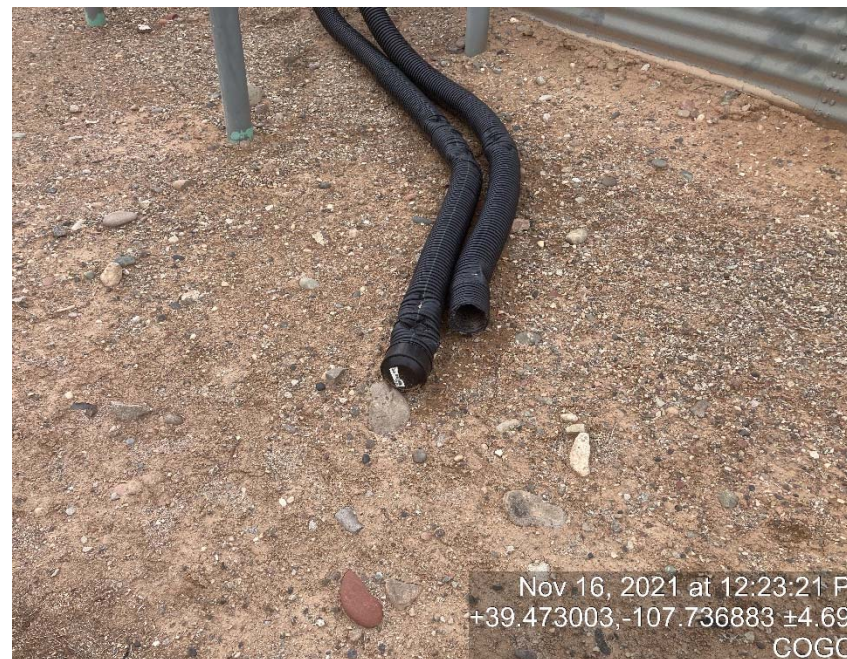
Open ended piping for thawing out dump lines on tanks with exhaust from trucks.

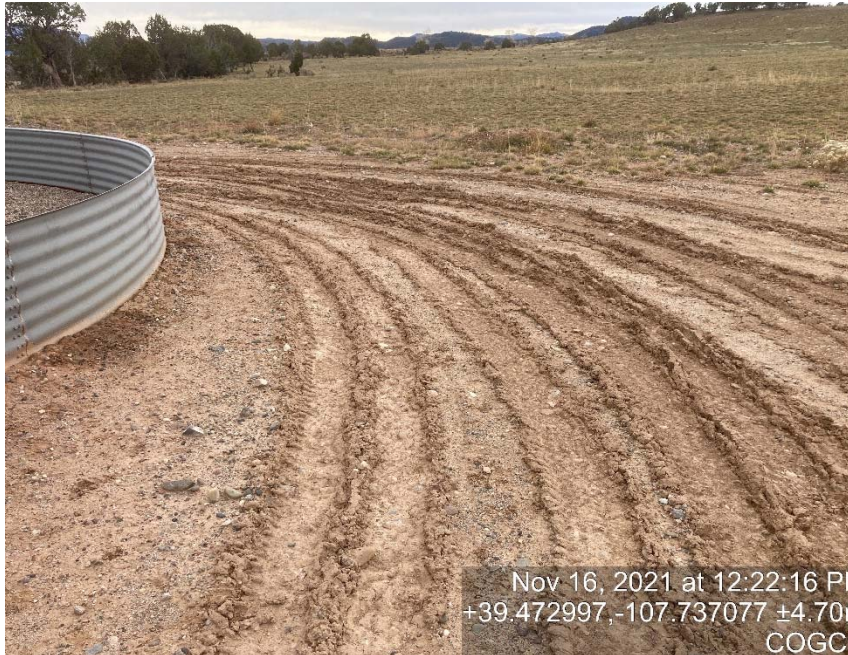
Lack of stabilization/ compaction

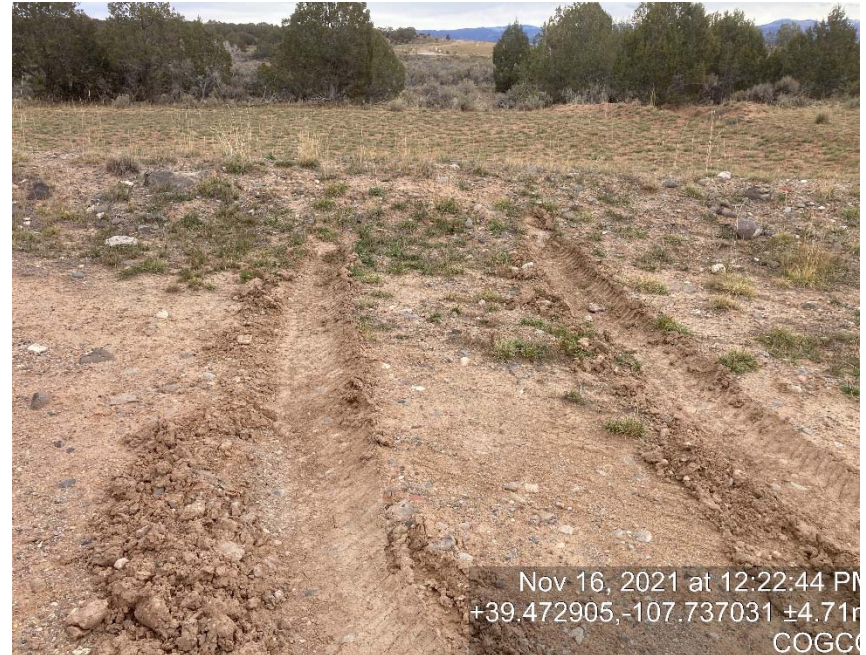
**Lack of stabilization/ compaction/ degradation of
berm**

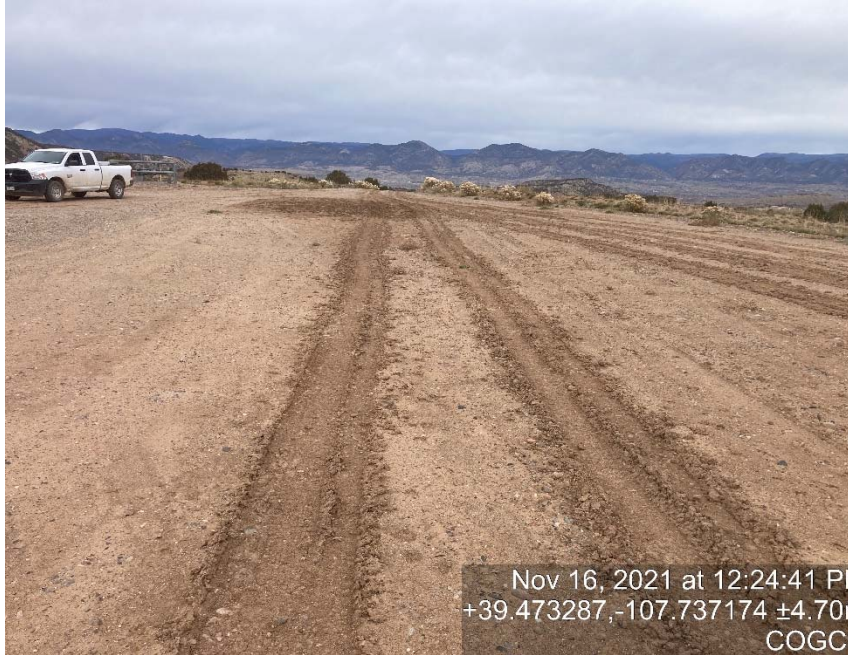
Lack of stabilization/compaction

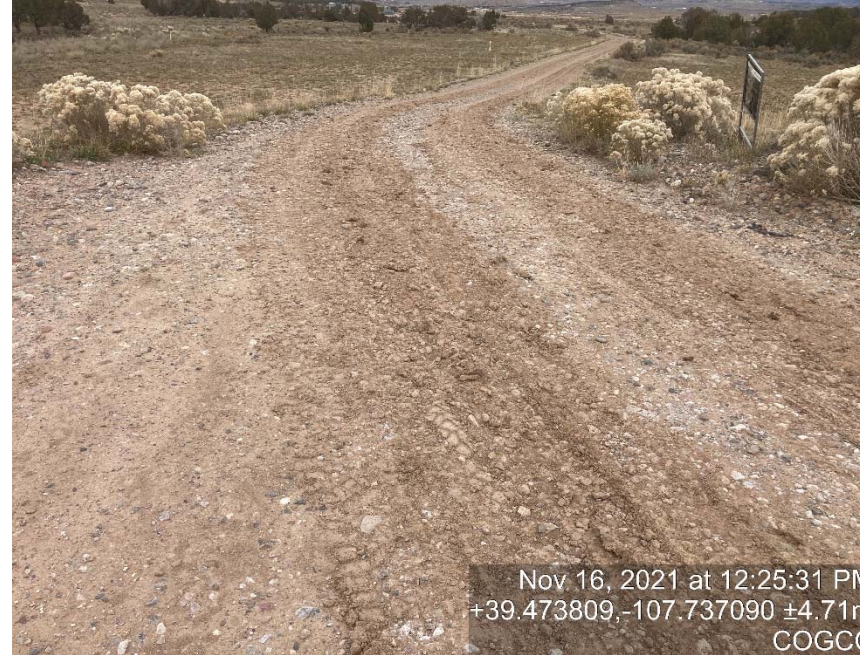
Lack of stabilization/compaction
