APACHE CANYON 12-14 API# 05-071-06128 – OGRIS OPERATING LLC - OGCC OPERATOR NUMBER 10758.

INSTALLATION DATE: SEPTEMBER 13, 2021. THE CORRECTIVE ACTIONS ARE COMPLETED TO IMPLEMENT AND MAINTAIN BMP'S PER FIELD INSPECTION REPORTS: DOCUMENT # 690200709, DOCUMENT # 690200848, DOCUMENT # 690201265, DOCUMENT # 690201545, DOCUMENT # 690201813.

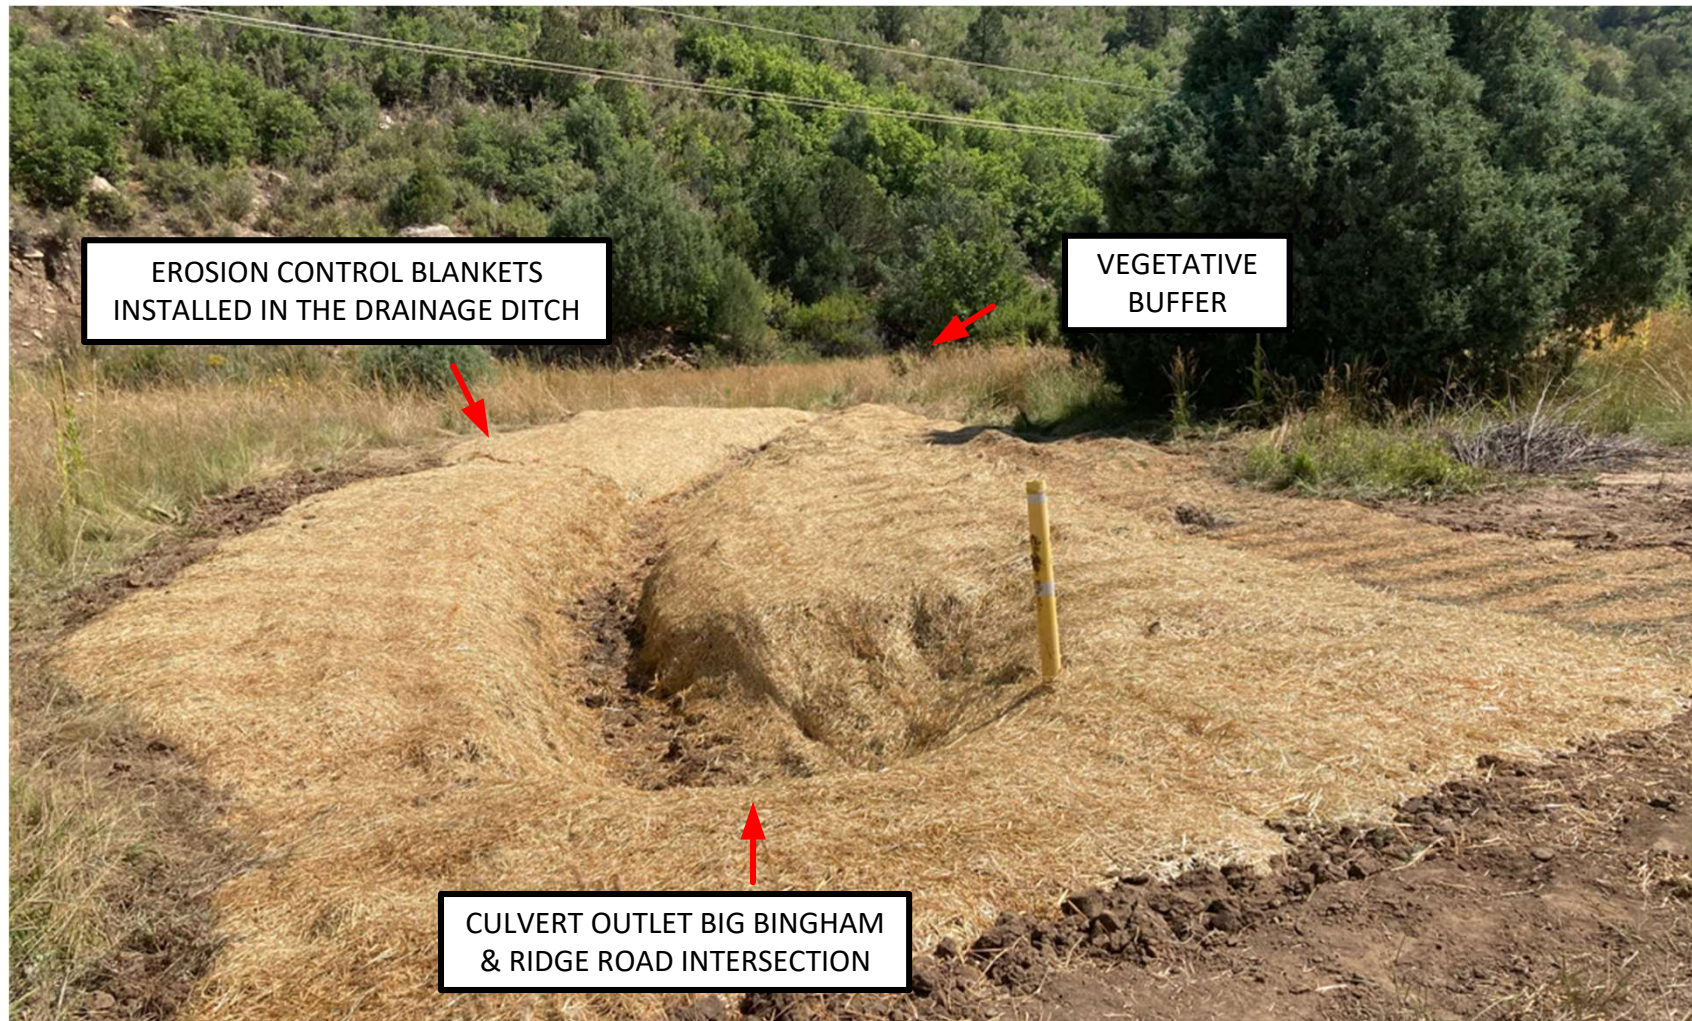
THE CULVERT OUTLET ON THE MAIN LEASE ROAD OF BIG BINGHAM CANYON AND THE RIDGE ROAD INTERSECTION WAS BELOW GRADE AND WOULD NOT DRAIN PROPERLY. POSITIVE DRAINAGE WAS ESTABLISHED FOR THE OUTLET. THE DISTURBED SOIL WAS SEEDED WITH AN APPROVED CPW SEED MIX TO ESTABLISH VEGETATION. EROSION CONTROL BLANKETS WERE INSTALLED FOR TEMPORARY SOIL STABILIZATION.

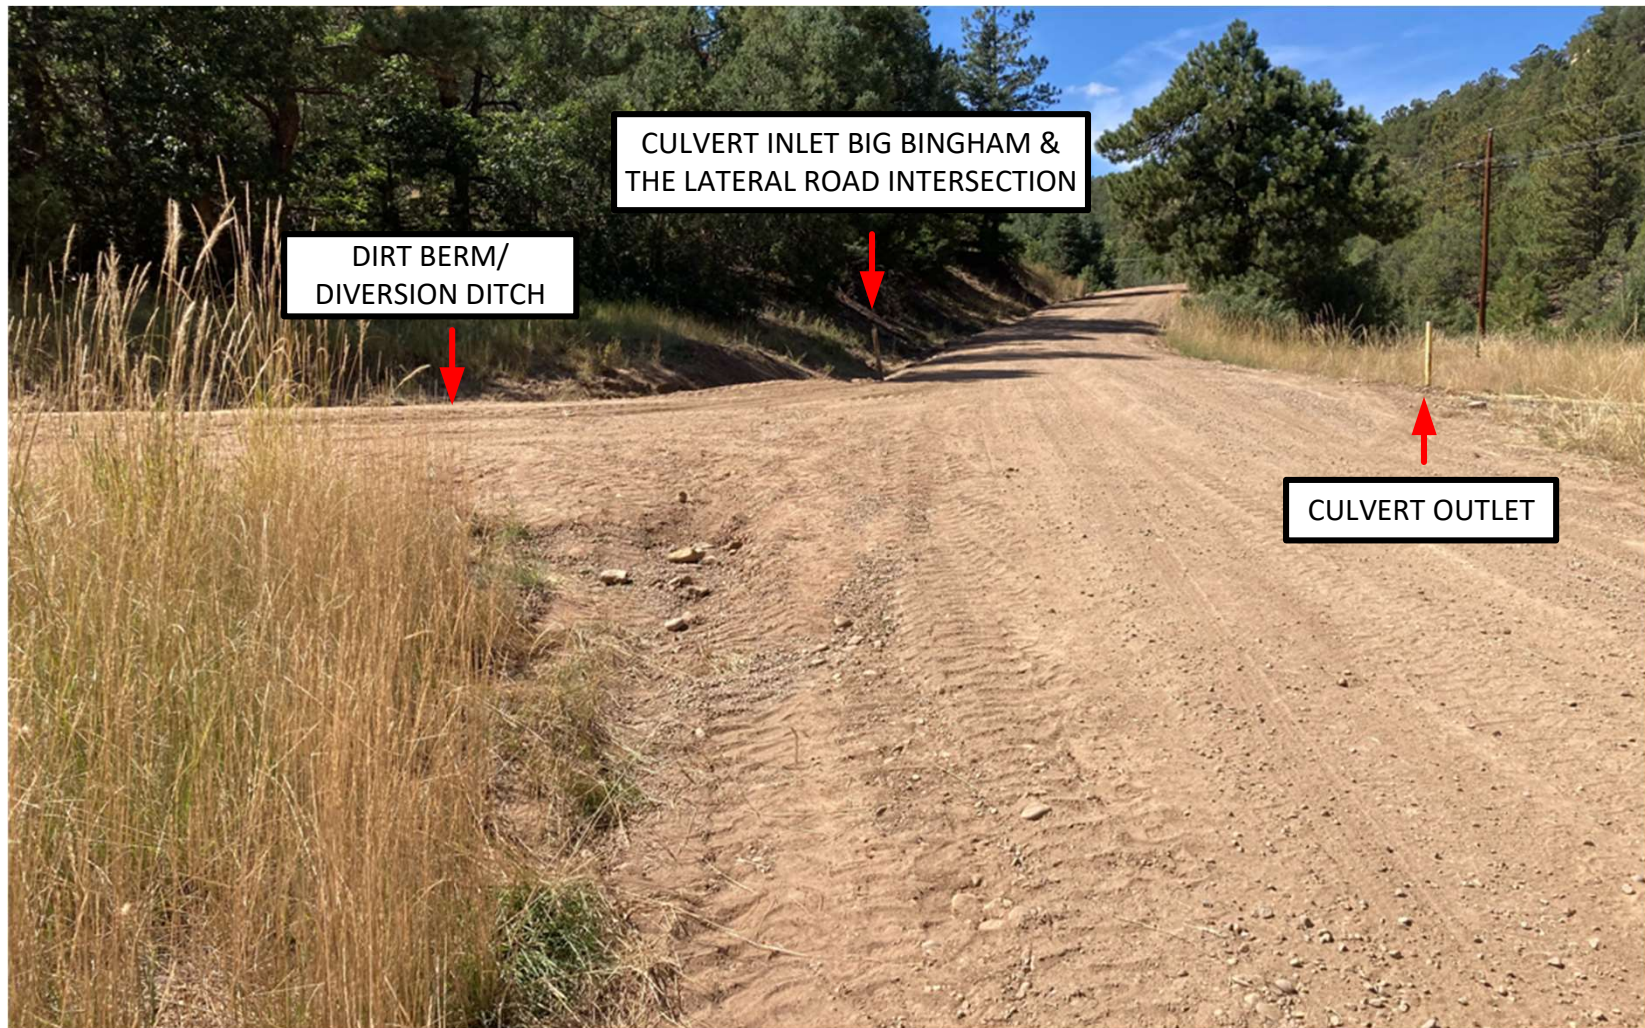
THE ROAD SURFACE WAS REGRADED TO CREATE SHEET FLOW AND ELIMINATE THE SURFACE EROSION. THE DIRT BERM/ DIVERSION DITCH WAS DOMINATED TO DIRECT RUN OFF FROM THE UPGRADIENT LATERAL ROAD TO THE CULVERT INLET ON THE MAIN ROAD. THE SEDIMENT ACCUMULATION WAS REMOVED FROM THE CULVERT INLET AND POSITIVE DRAINAGE WAS ESTABLISHED FOR THE CULVERT OUTLET.

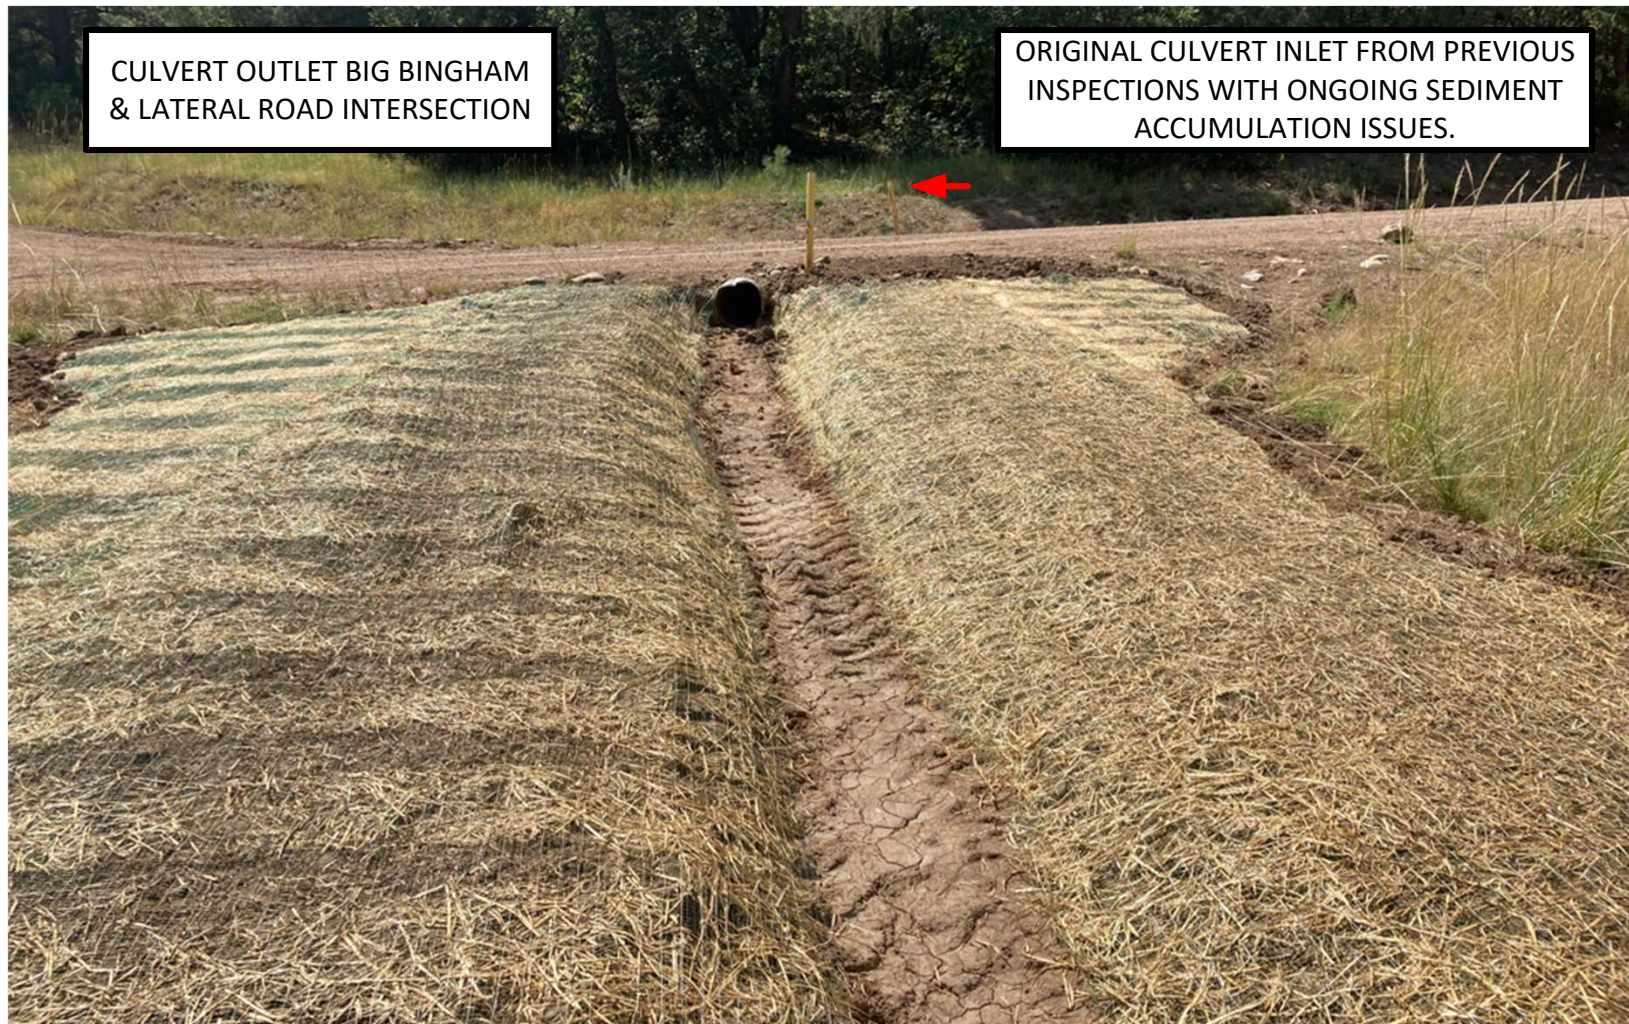
THE CULVERT OUTLET ON THE MAIN LEASE ROAD WAS BELOW GRADE AND WOULD NOT DRAIN PROPERLY. DRAINAGE WAS ESTABLISHED FOR THE OUTLET AND THE DISTURBED SOIL WAS SEEDED USING THE CPW APPROVED SEED MIX TO PROMOTE THE ESTABLISHMENT OF VEGETATION. EROSION CONTROL BLANKETS WERE INSTALLED FOR TEMPORARY SOIL STABILIZATION.

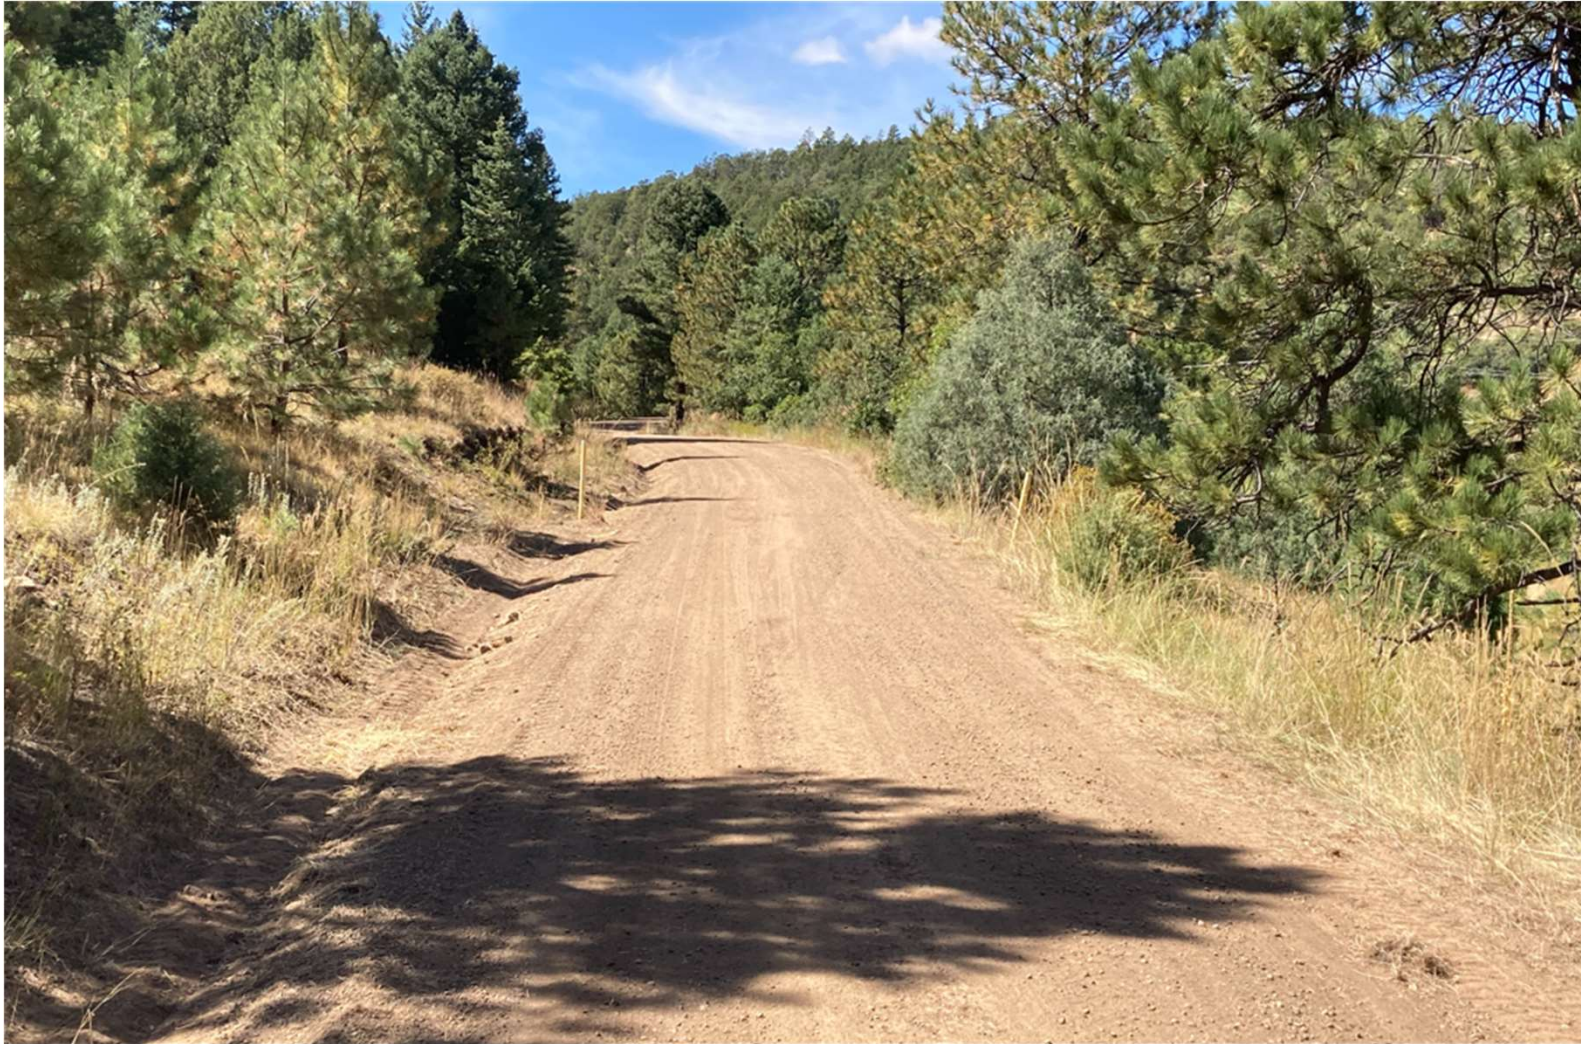
THE ROAD SURFACE WAS CROWNED TO CREATE SHEET FLOW AND ELIMINATE THE TIRE RUTS. ADDITIONAL ROAD
BASE/GRAVEL WAS INSTALLED TO THE ROADWAY SURFACE TO PROVIDE ADDED STABILIZATION.

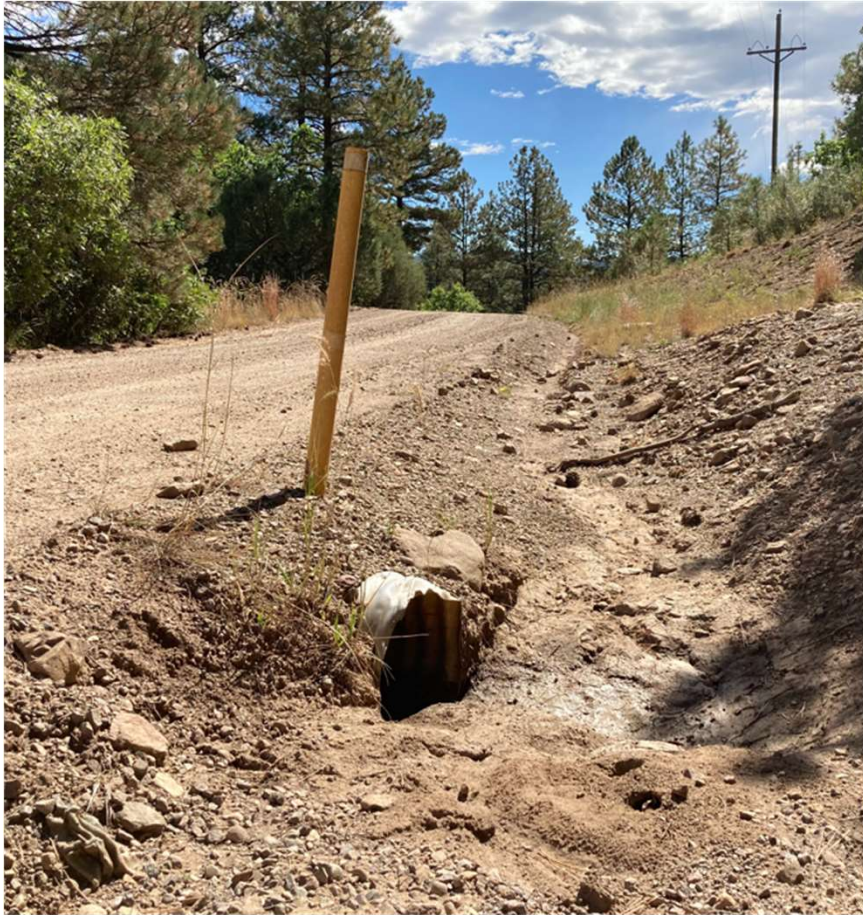
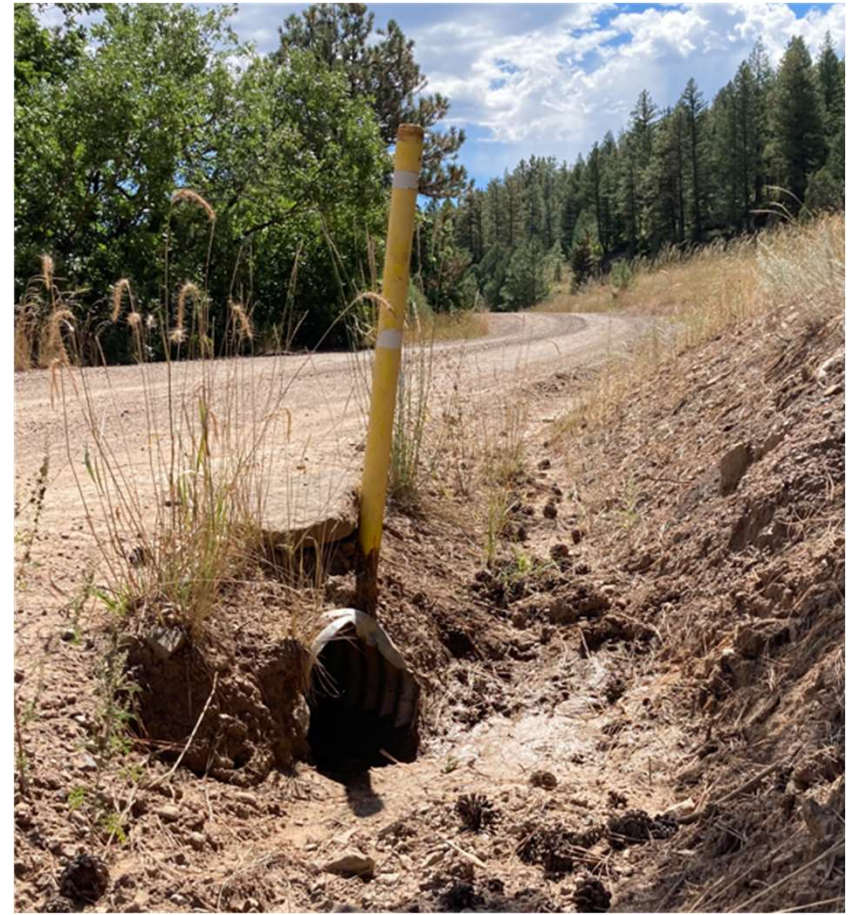
THE SEDIMENT ACCUMULATION IN THE CULVERT INLETS ALONG BIG BINGHAM CANYON WERE REMOVED.

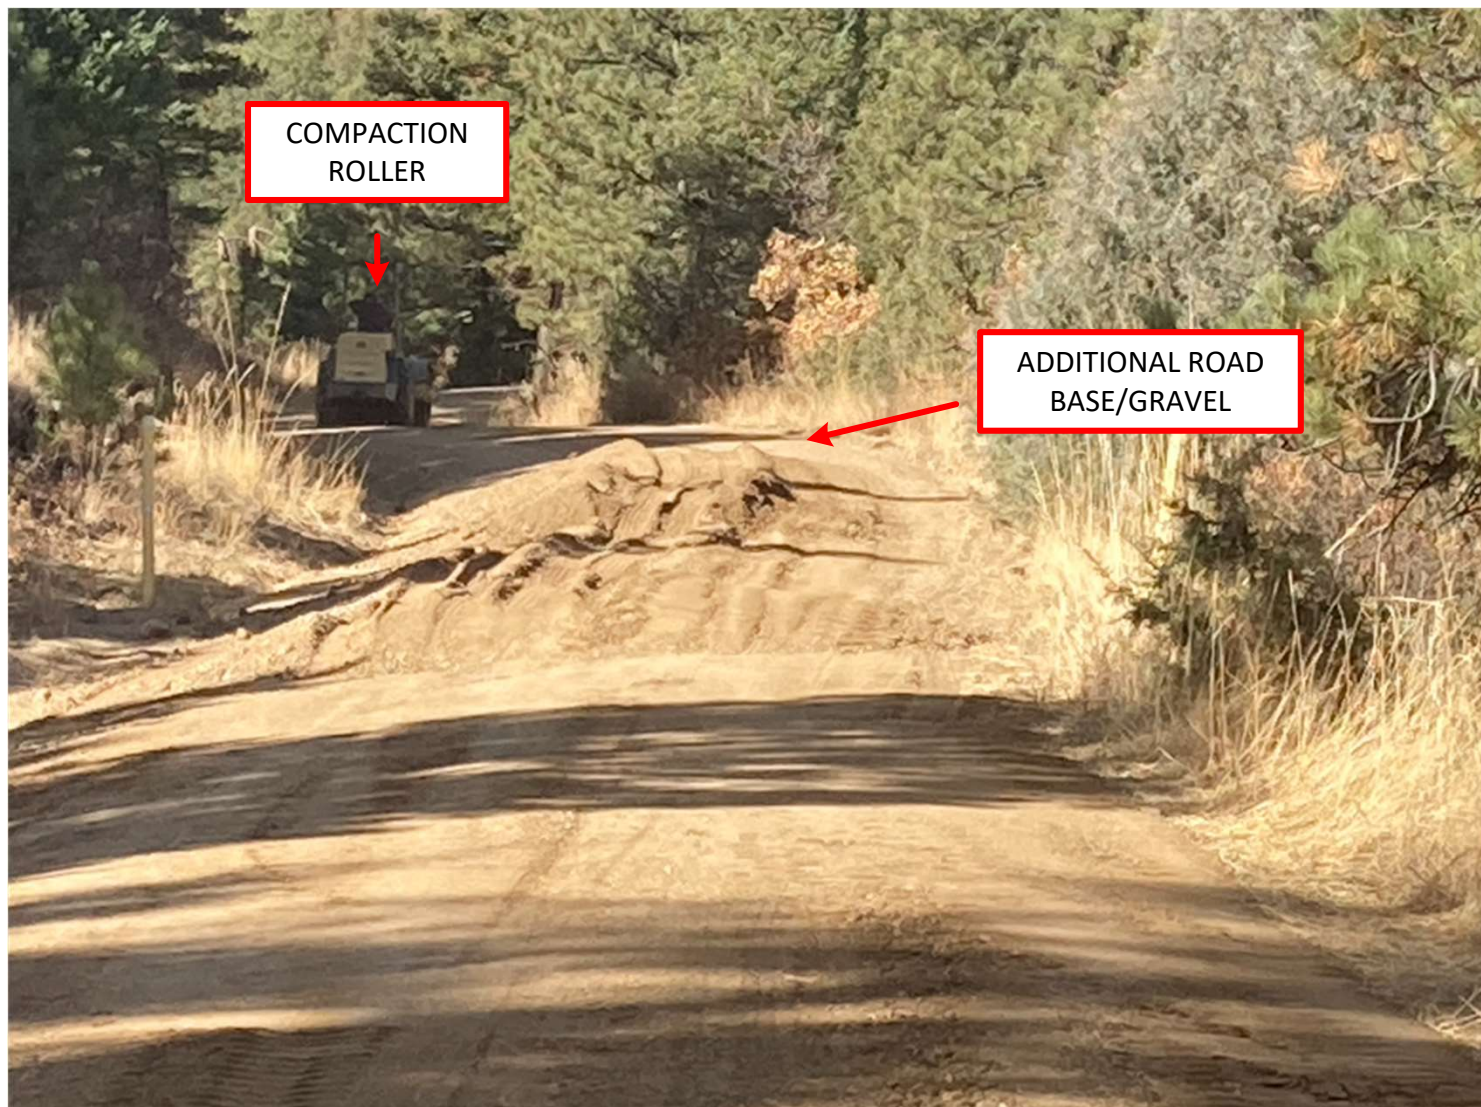
THE ROAD SURFACE WAS CROWNED TO CREATE SHEET FLOW AND ELIMINATE THE TIRE RUTS. ADDITIONAL ROAD BASE/GRAVEL WAS INSTALLED TO THE ROADWAY SURFACE TO PROVIDE STABILIZATION. A COMPACTION ROLLER WAS USED DURING THE INSTALLATION TO COMPACTED THE ROAD BASE.

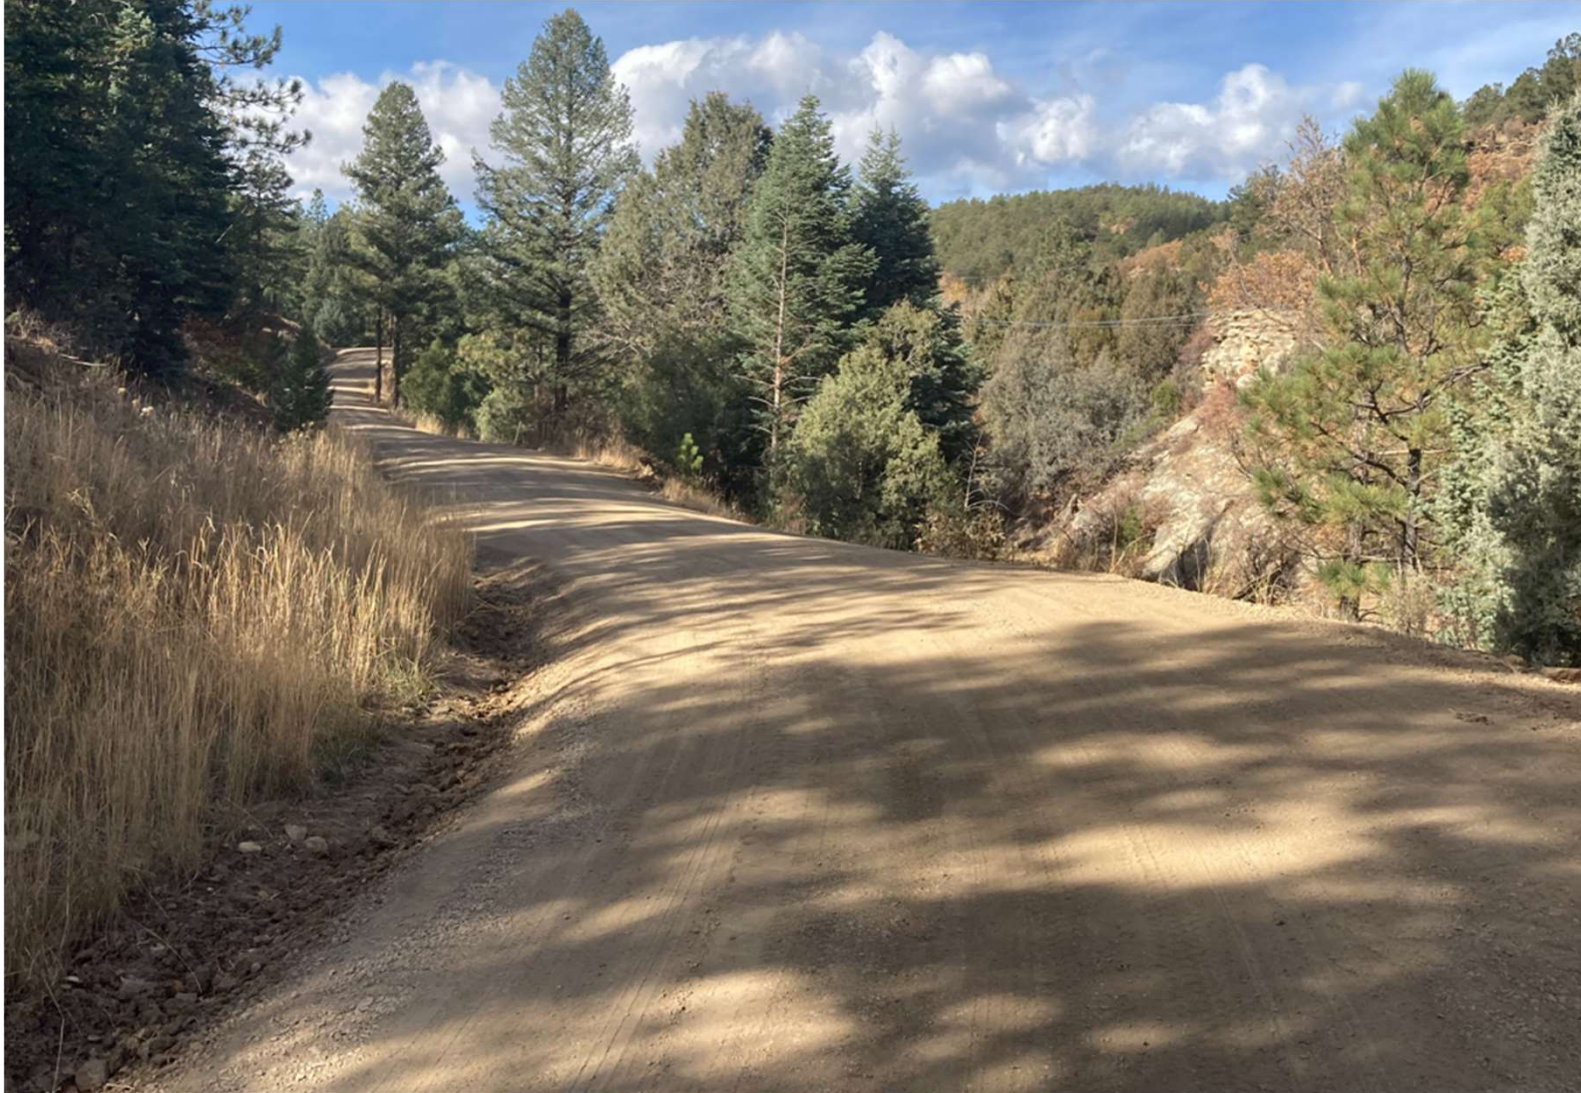
THE ROAD SURFACE WAS CROWNED TO CREATE SHEET FLOW AND ELIMINATE THE TIRE RUTS. ADDITIONAL ROAD BASE/
GRAVEL WAS INSTALLED TO THE ROADWAY SURFACE TO PROVIDE ADDED STABILIZATION. A COMPACTION ROLLER WAS
USED DURING THE INSTALLATION TO COMPACTED THE ROAD BASE.

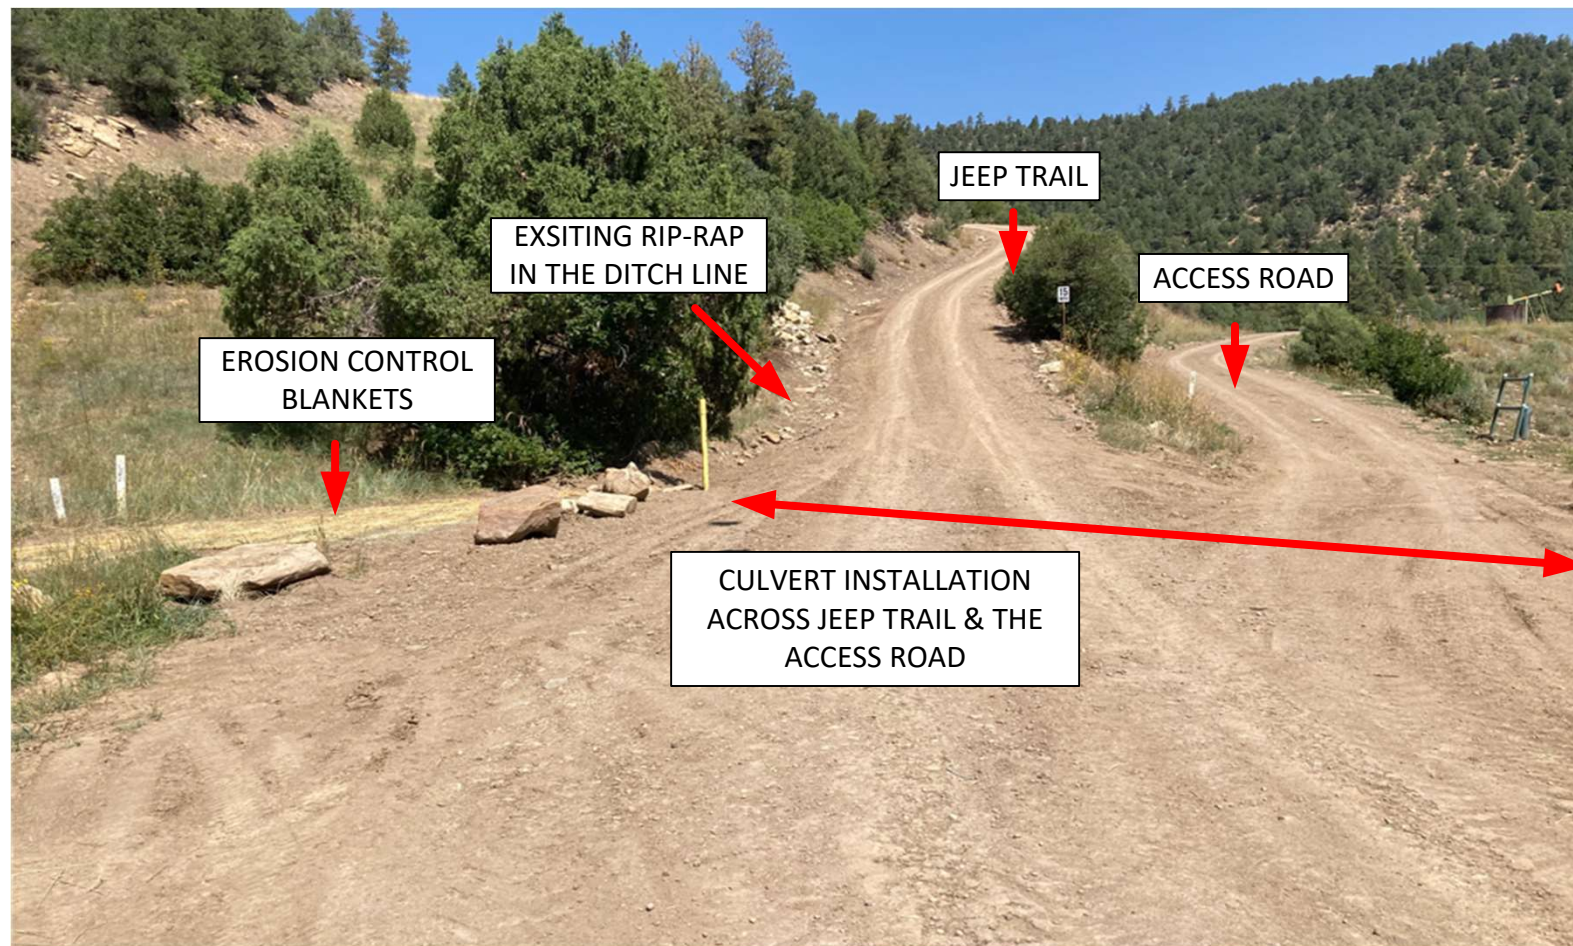
A CULVERT WAS INSTALLED AT THE BOTTOM OF JEEP TRAIL AND CROSSED THE ACCESS ROAD TO APACHE CANYON 12-16. THE FACE OF THE BELL HOLE ON THE CULVERT INLET WAS ARMORED TO ABSORB ENERGY AND PREVENT SCOURING. THE EXISTING WATER CALL OUT WAS RECLAIMED AND THE DISTURBED SOIL WAS SEEDED WITH AN APPROVED CPW SEED MIX. EROSION CONTROL BLANKETS WERE INSTALLED IN THIS AREA FOR TEMPORARY SOIL STABILIZATION. THE EXISTING RIP-RAP IN THE DITCH LINE PROVIDES SOIL STABILIZATION AND EROSION CONTROL. A GABION BASKET WAS INSTALLED ON THE NEW CULVERT OUTLET FOR SEDIMENT CONTROL.

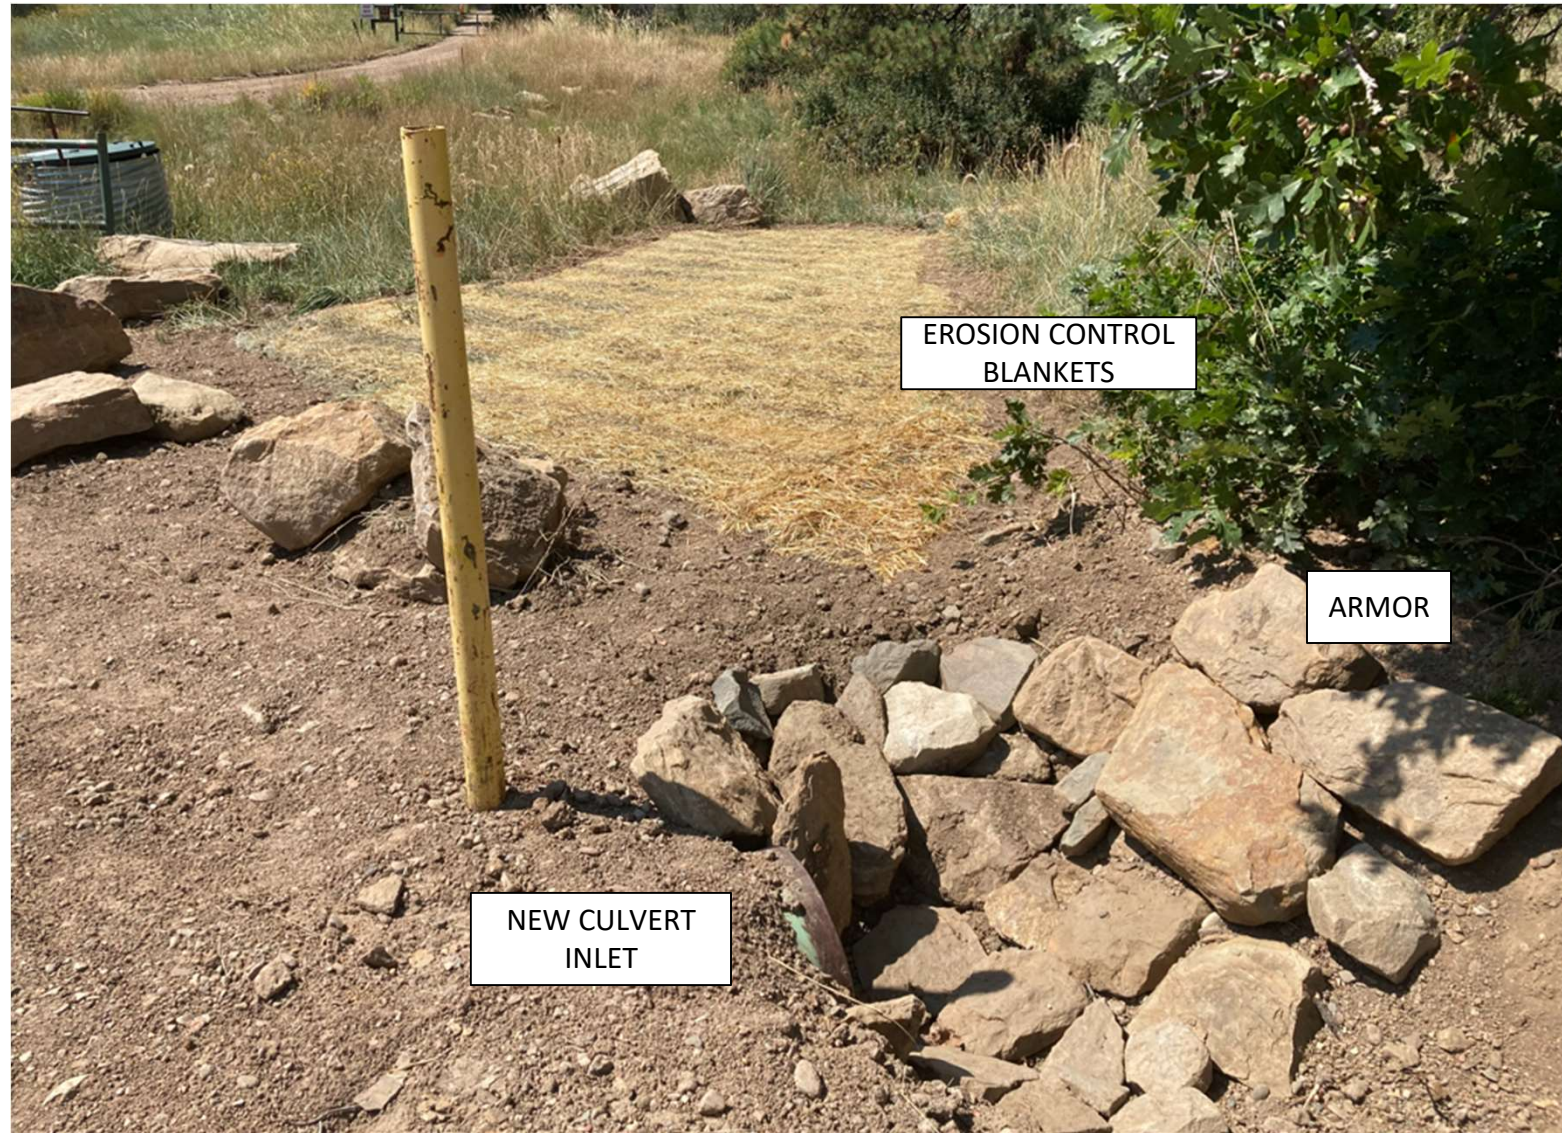
THE CULVERT INLET AT THE BOTTOM OF JEEP TRAIL WAS ARMORED TO ABSORB ENERGY. THE WATER CALL OUT ON THE WEST SIDE OF JEEP TRAIL WAS REMOVED AND RECLAIMED. THE SEDIMENT ACCUMULATION THAT WAS PRESENT, WAS REMOVED. RUN OFF IS NOW DIRECTED TO THE EAST SIDE OF JEEP TRAIL FOR IMPROVED SEDIMENT CONTROL.

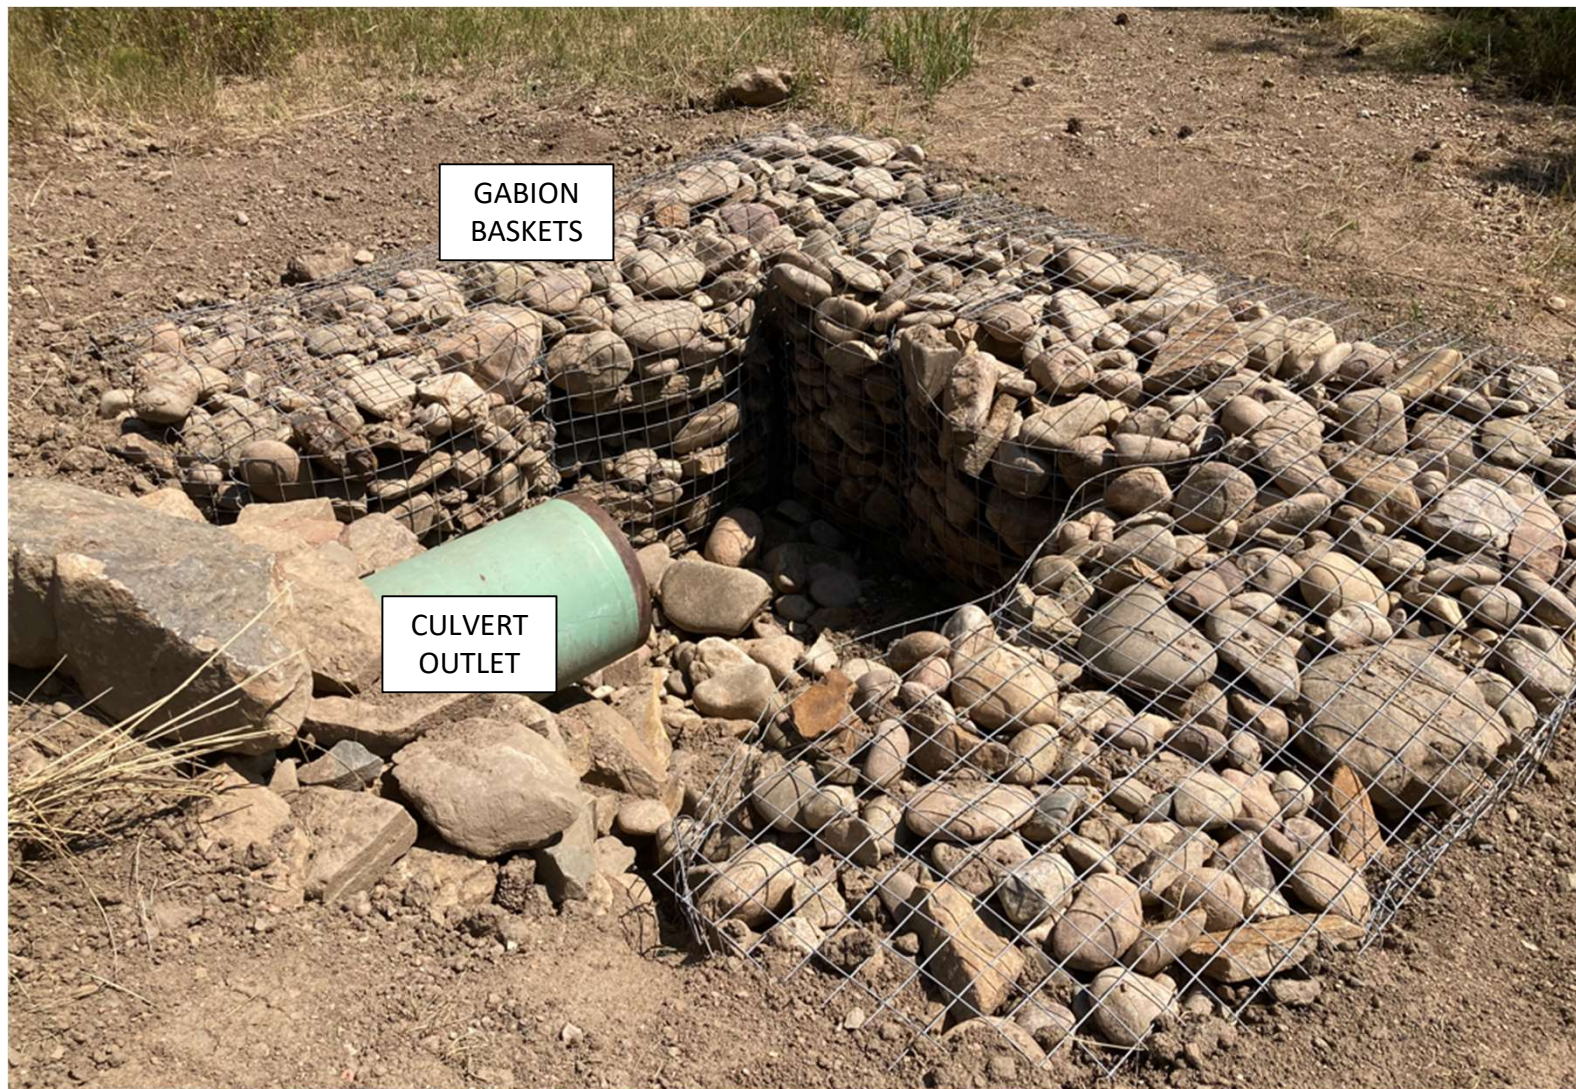
GABION BASKETS WERE INSTALLED ON THE NEW CULVERT OUTLET AT THE BOTTOM OF JEEP TRAIL. STORMWATER IS DIVERTED TO THE BASKETS WHERE RUN OFF HAS TIME FOR THE SEDIMENT TO DROP OUT AND FILTER THROUGH THE ROCK. THIS PROVIDES PERIMETER SEDIMENT CONTROL FROM THE JEEP TRAIL LEASE ROAD.

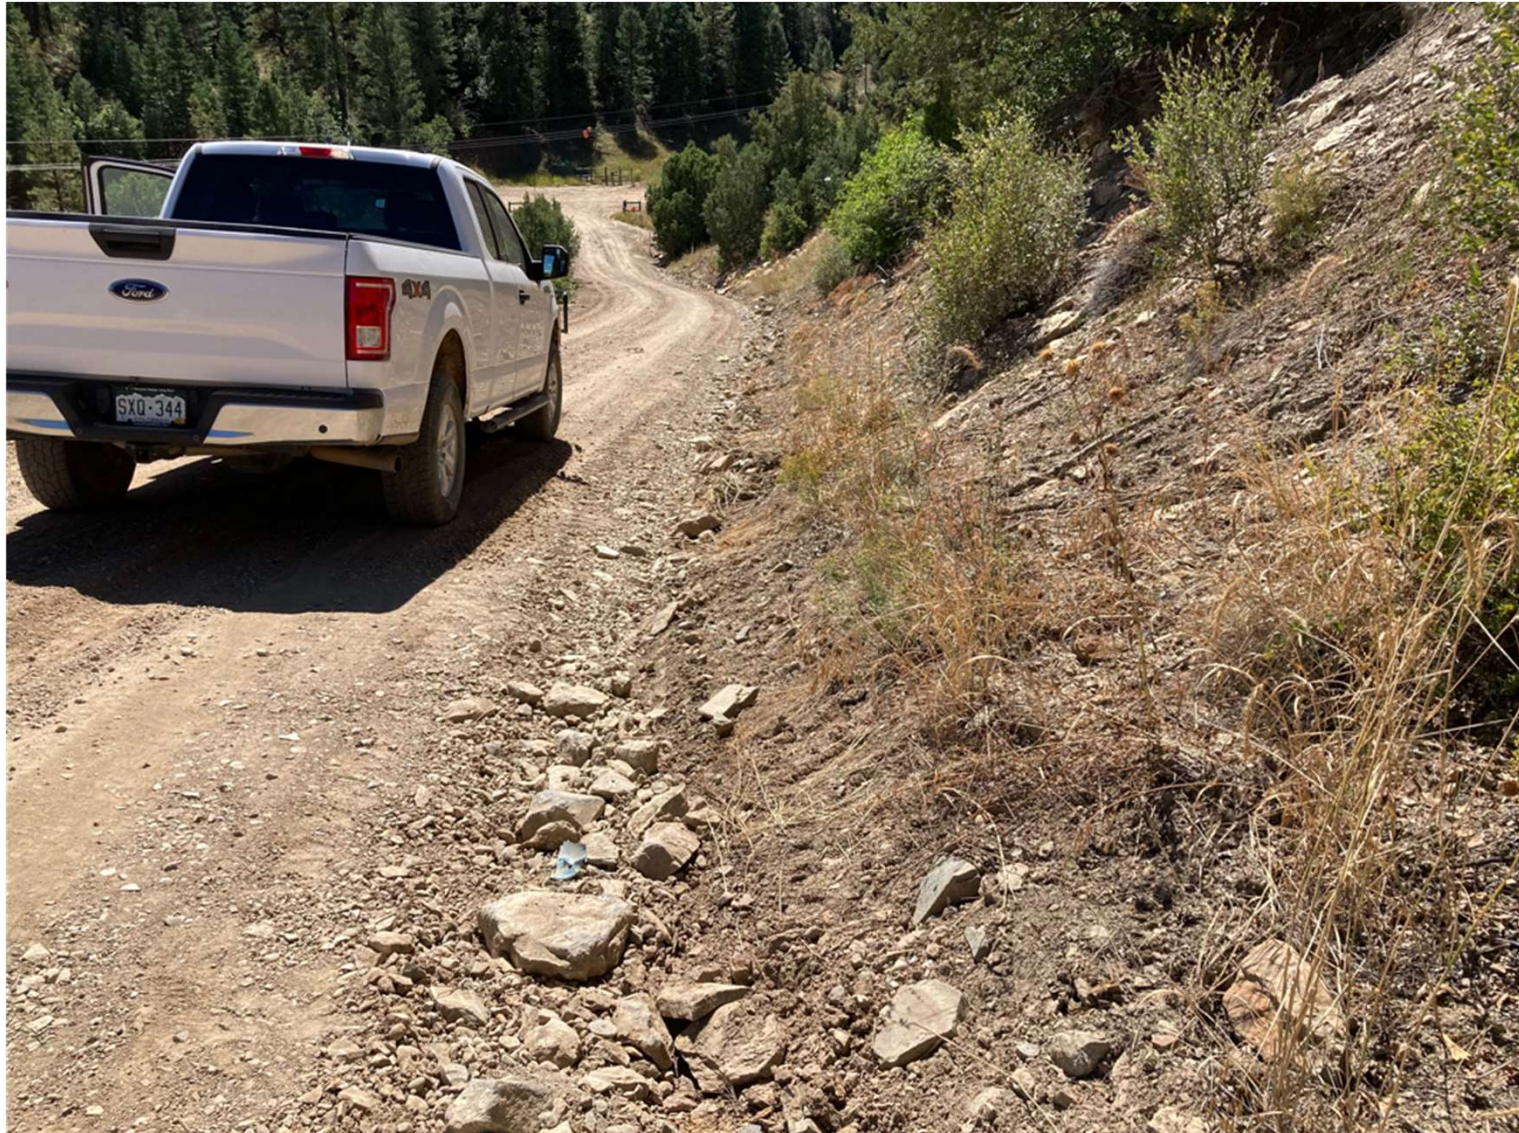
THE EXISTING RIP RAP IN THE BAR DITCH PROVIDES SOIL STABILIZATION AND EROSION CONTROL IN THE BAR DITCH.

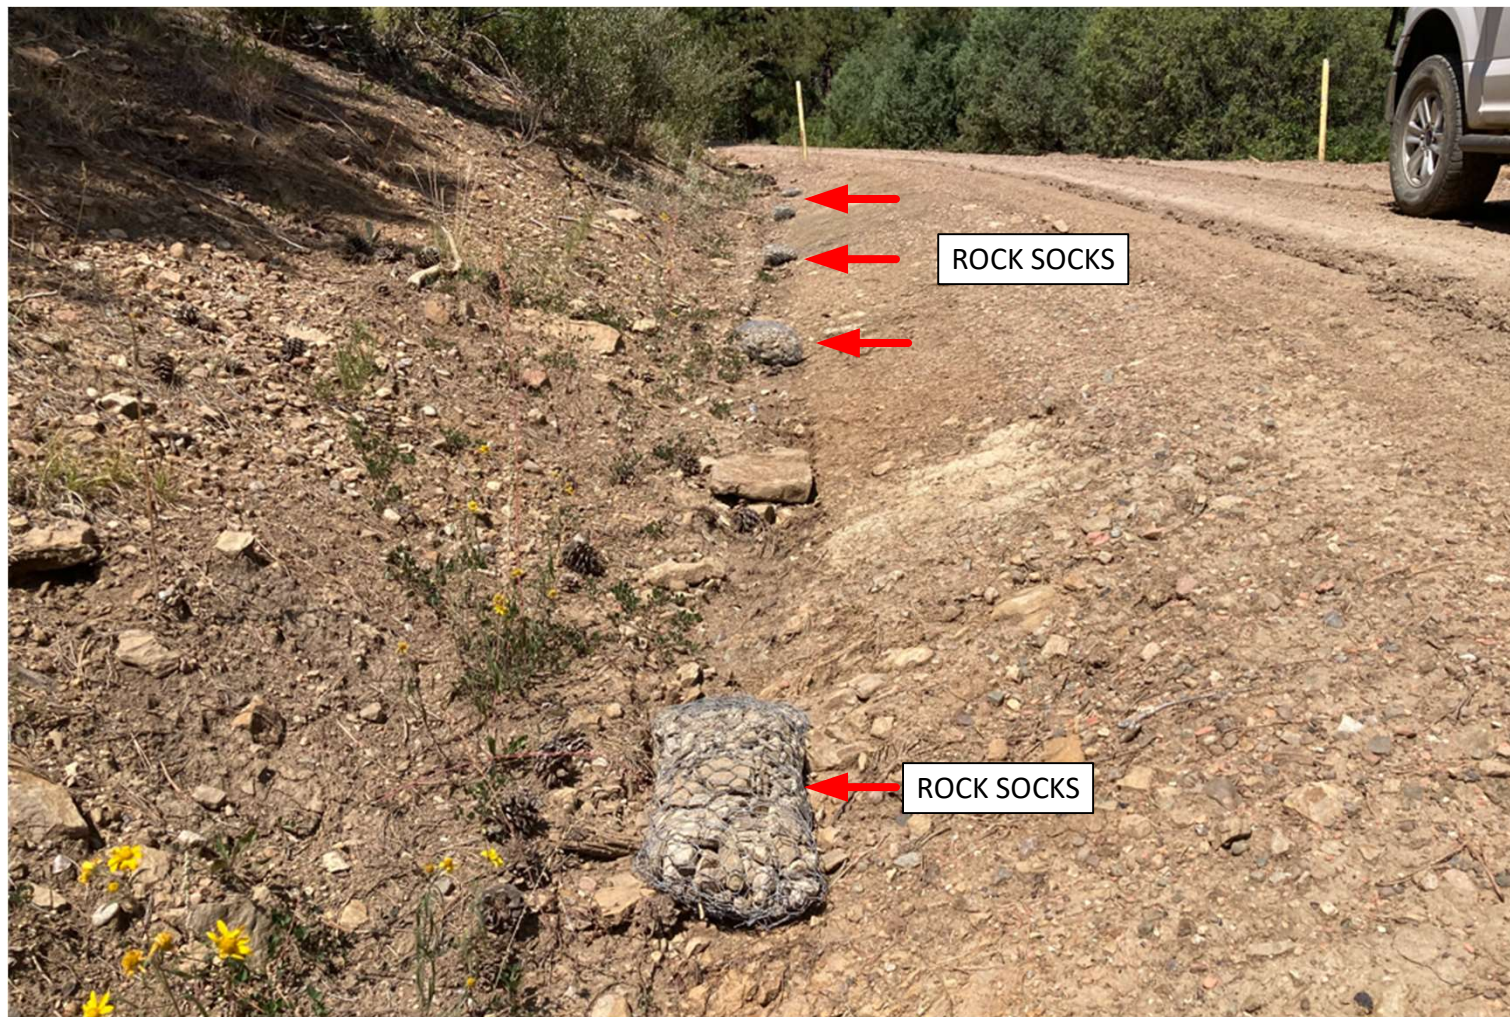
ROCK SOCKS WERE PLACED IN THE BAR DITCH TO FILTER STORMWATER FLOWING IN THE DITCH LINE. THIS PORTION OF THE LEASE ROAD IS NARROW. WHEN TRAFFIC IS ENCOUNTERED TRAVELING UP THE TRAIL, VEHICLES TRAVELING DOWN THE TRAIL WILL PULL OVER INTO THE BAR DITCH FOR SAFE PASSAGE. ROCK CHECK DAMS (SUGGEST BY FIELD INSPECTOR) WOULD BE DAMAGED EACH TIME THIS OCCURS. THE ROCK SOCKS ARE CONTAINED GRAVEL WRAPED IN WIRE THAT CAN REMAIN AN EFFECTIVE SEDIMENT CONTROL WHEN TRAVELED ON.

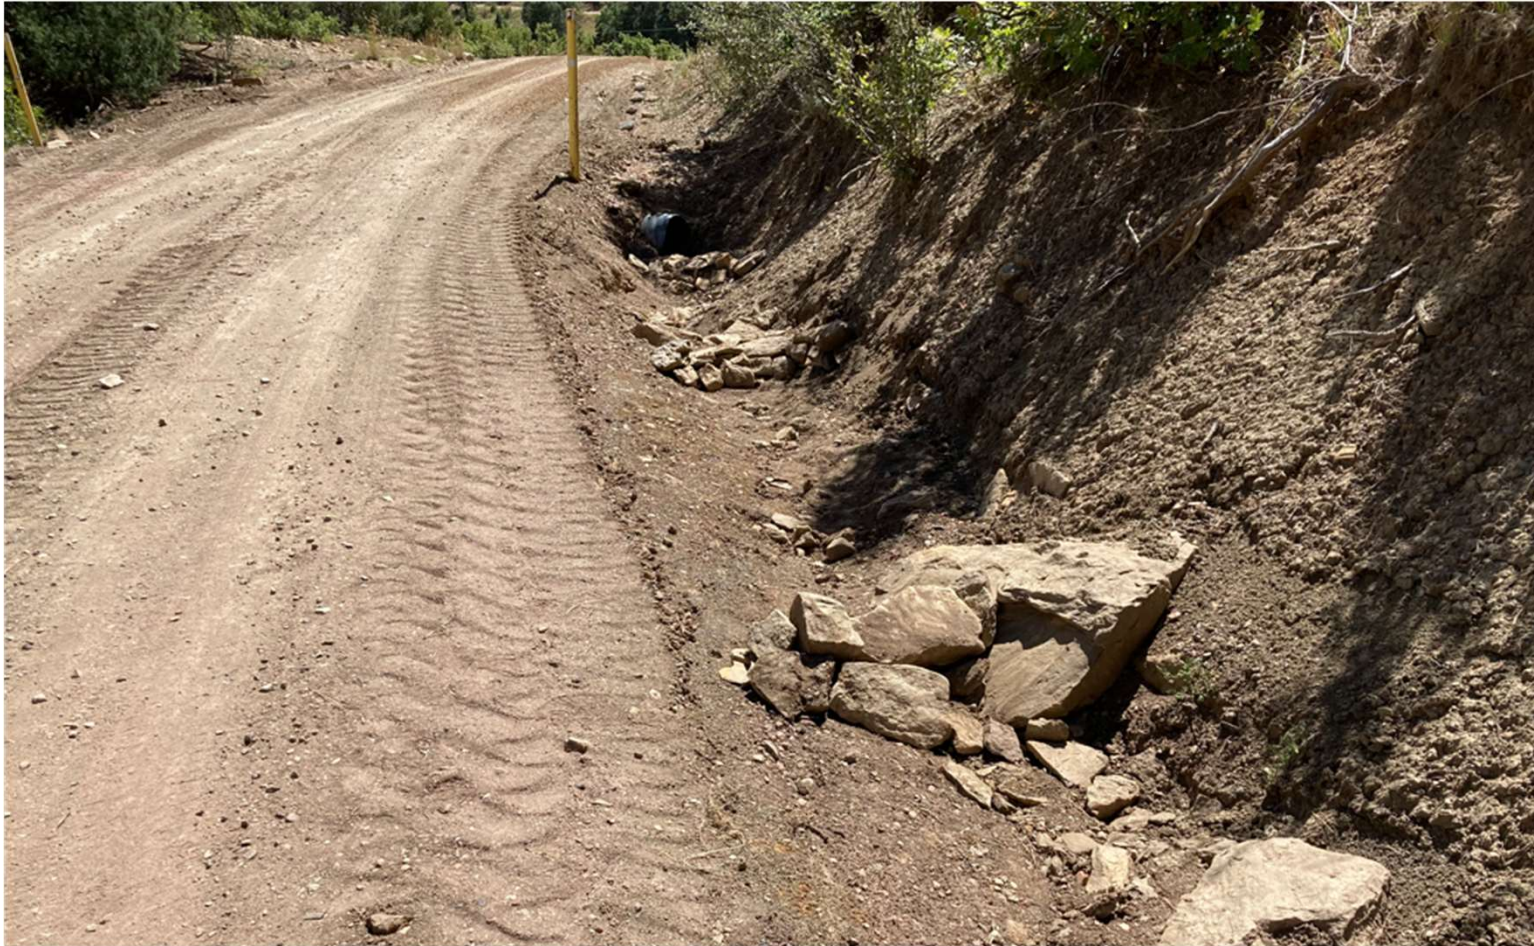
ROCK CHECK DAMS WERE PLACED IN THE BAR DITCH UP GRADIENT OF THE CULVERT INLET TO ABSORB ENERGY AND PROVIDE SEDIMENT FILTRATION FROM RUN OFF. THE ROAD SURFACE WAS CROWNED TO CREATE SHEET FLOW AND ELIMINATE THE TIRE RUTS. ADDITIONAL ROAD BASE WAS INSTALLED TO THE ROAD SURFACE TO PROVIDE ADDED STABILIZATION.
