APACHE CANYON 12-14 API# 05-071-06128 – OGRIS OPERATING LLC - OGCC OPERATOR NUMBER 10758.

INSTALLATION DATE: SEPTEMBER 13, 2021. THE CORRECTIVE ACTIONS ARE COMPLETED TO IMPLEMENT AND MAINTAIN BMP'S PER FIELD INSPECTION REPORTS: DOCUMENT # 690200709, DOCUMENT # 690200848, DOCUMENT # 690201265, DOCUMENT # 690201545, DOCUMENT # 690201813.

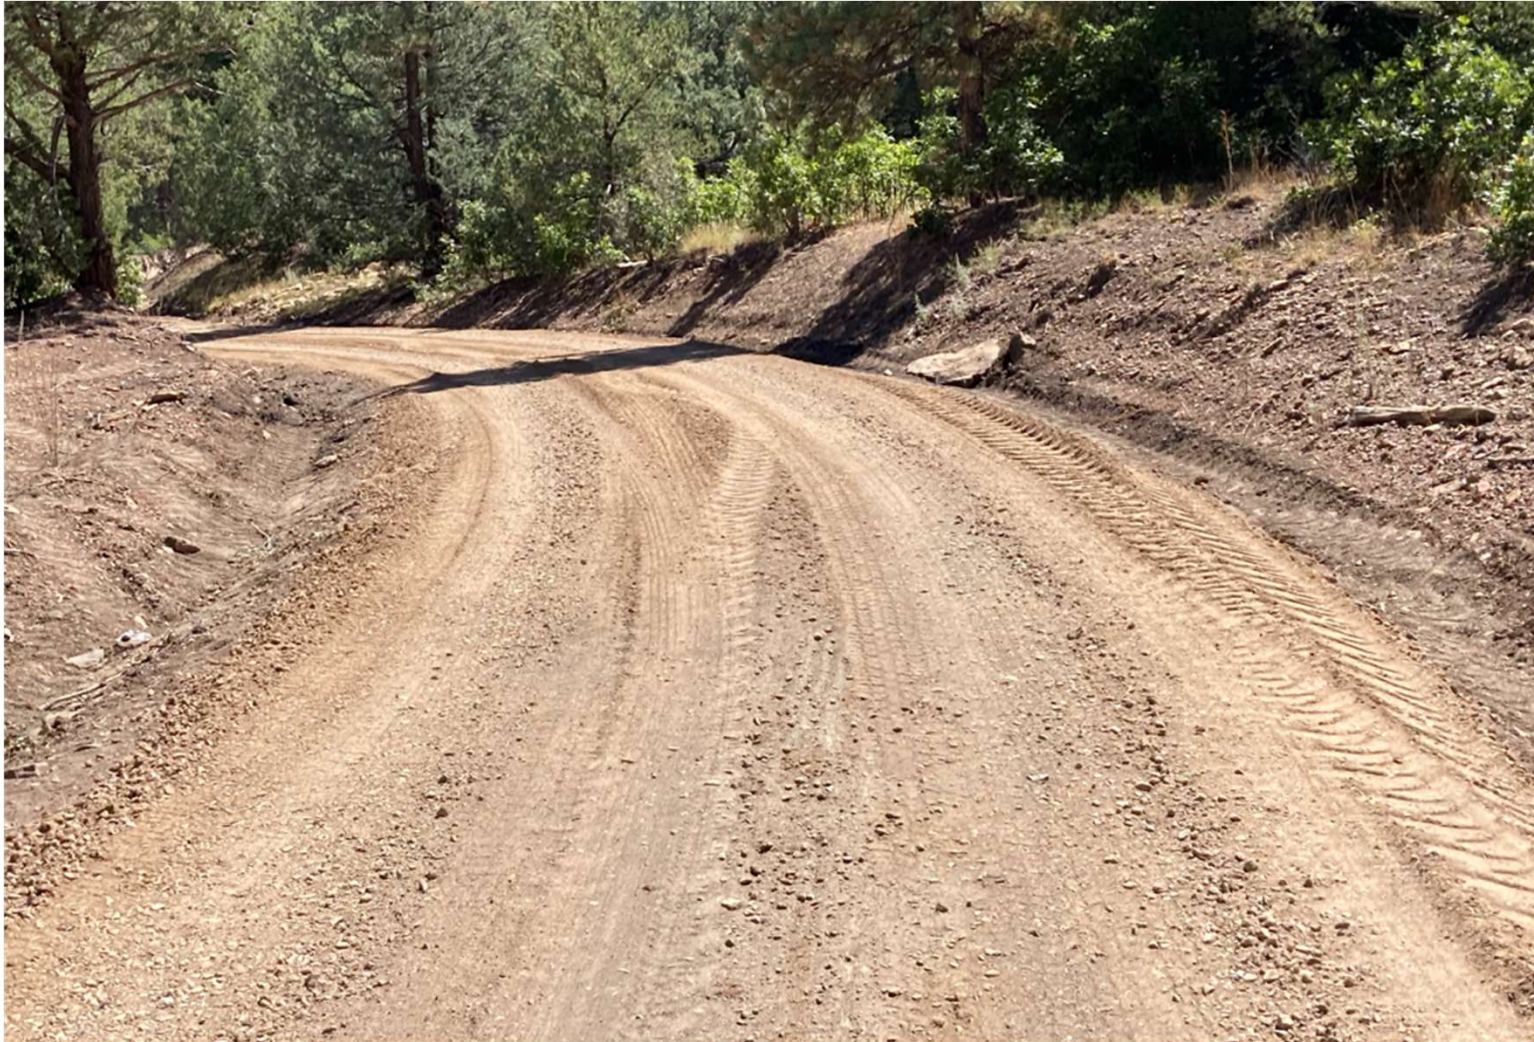
THE ROAD SURFACE WAS CROWNED TO CREATE SHEET FLOW AND ELIMINATE THE TIRE RUTS. ADDITIONAL ROAD
BASE/GRAVEL WAS INSTALLED TO THE ROADWAY SURFACE TO PROVIDE ADDED STABILIZATION.

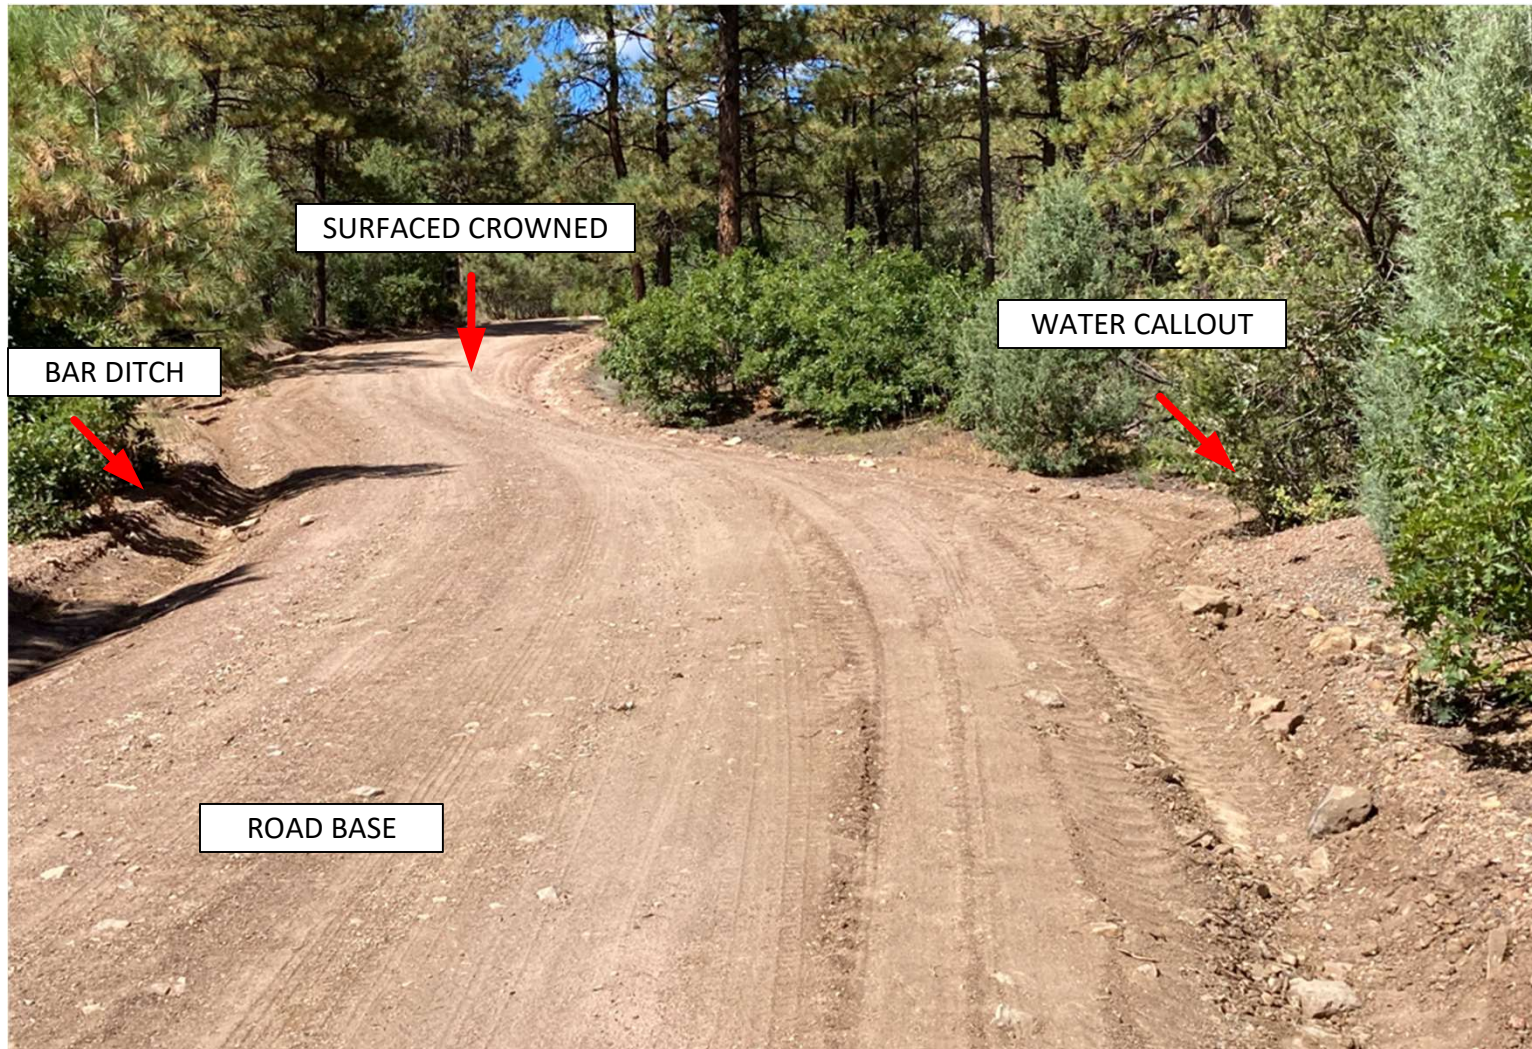
WATER CALLOUTS WERE INSTALLED TO MOVE STORMWATER AWAY FROM THE LEASE ROAD. THE ROAD SURFACE WAS CROWNED TO CREATE SHEET FLOW AND ELIMINATE THE TIRE RUTS. ADDITIONAL ROAD BASE/GRAVEL WAS INSTALLED TO THE ROADWAY SURFACE TO PROVIDE ADDED STABILIZATION.

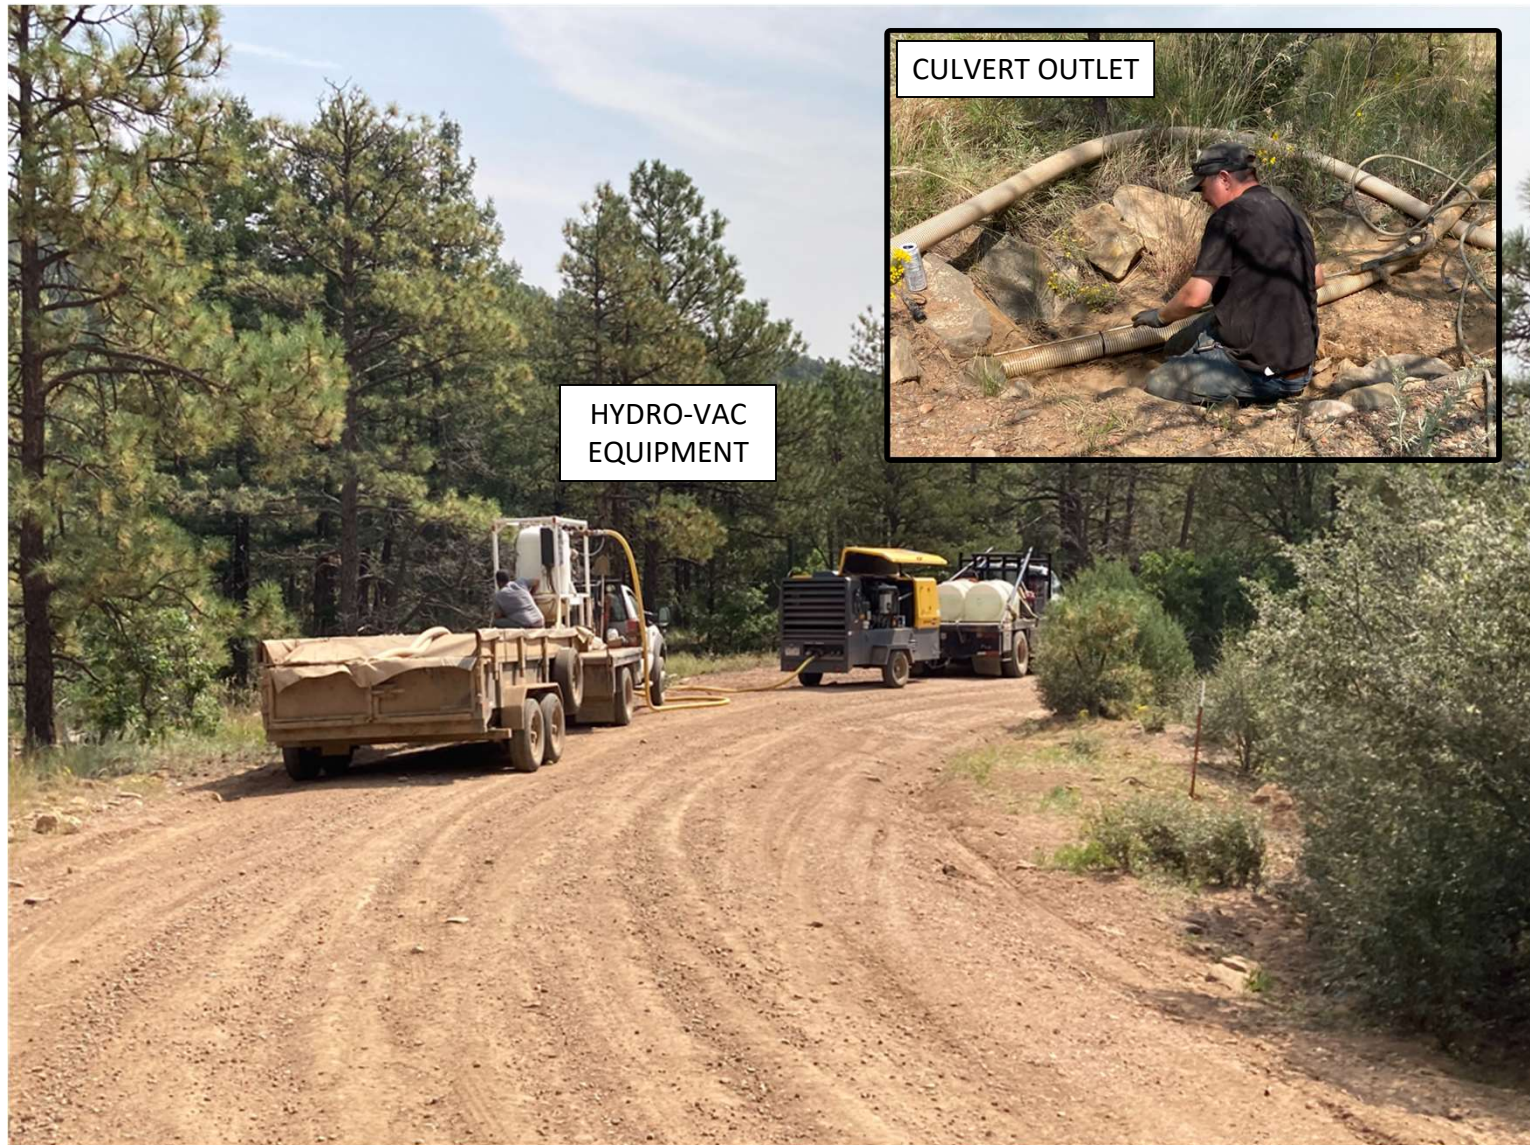
SEDIMENT WAS REMOVED FROM CULVERTS ALONG JEEP TRAIL TO MAINTAIN FLOW.

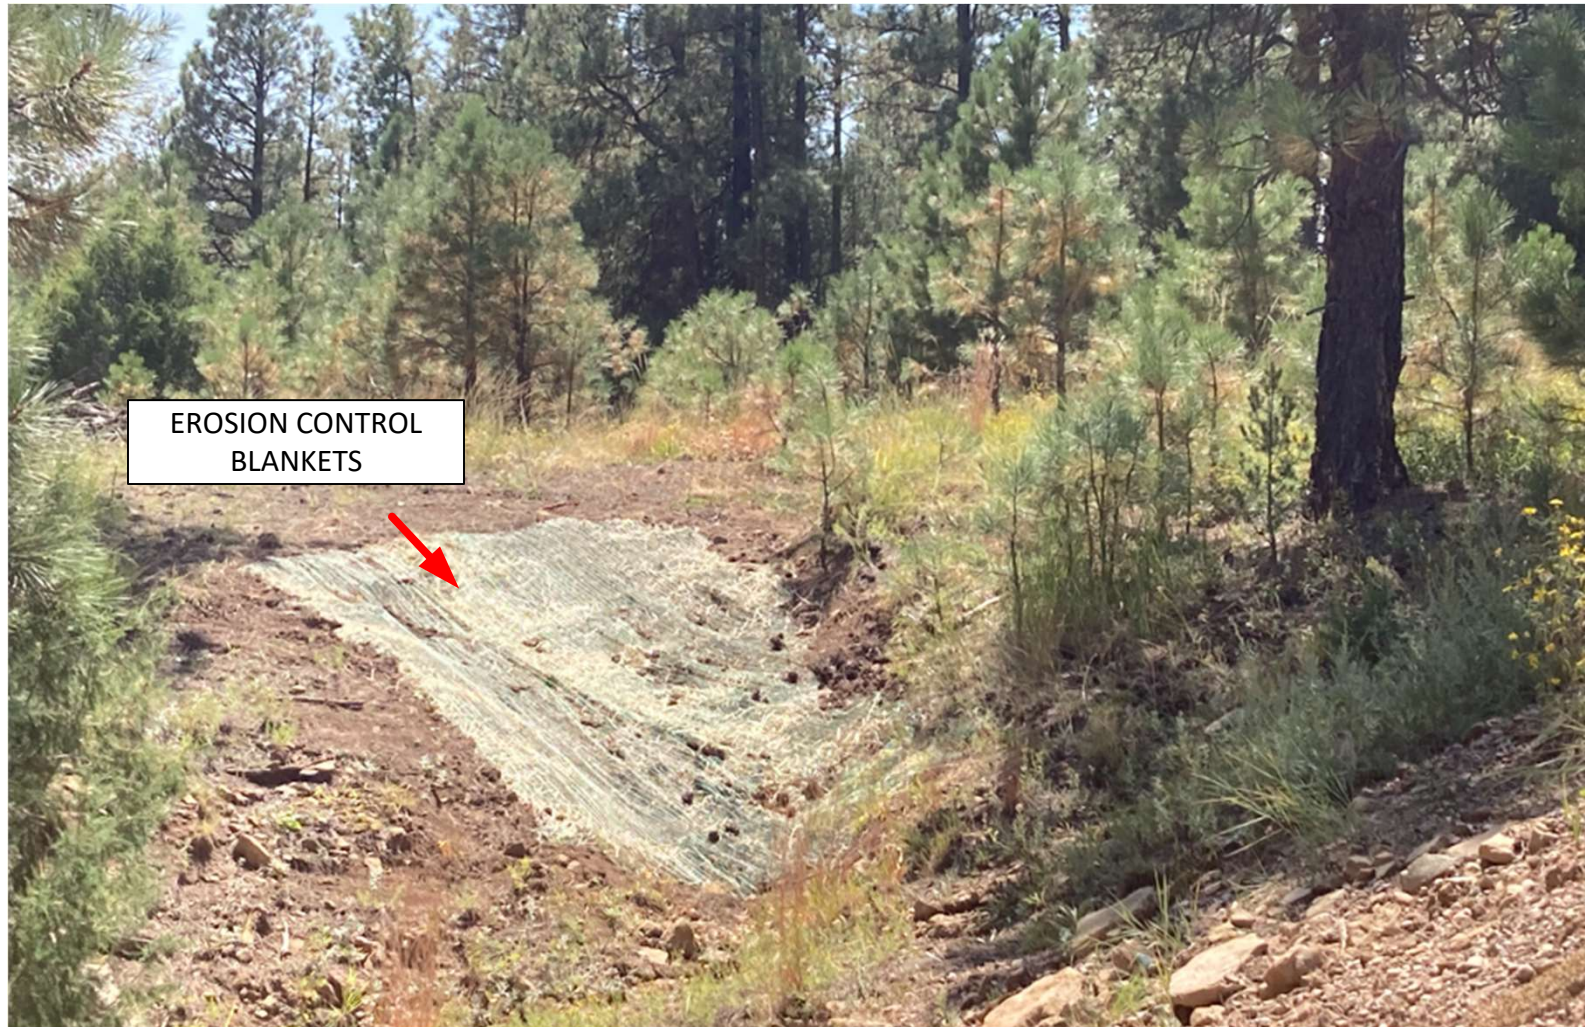
RUN OFF WAS RE-DIRECTED AWAY FROM THIS AREA. THE EROSION RILL WAS BACKFILLED. THE DISTURBED SOIL WAS SEEDED BY HAND BROADCAST WITH AN APPROVED CPW SEED MIX TO ESTABLISH VEGETATION. EROSION CONTROL BLANKETS WERE INSTALLED FOR SOIL STABILIZATION AND EROSION CONTROL.

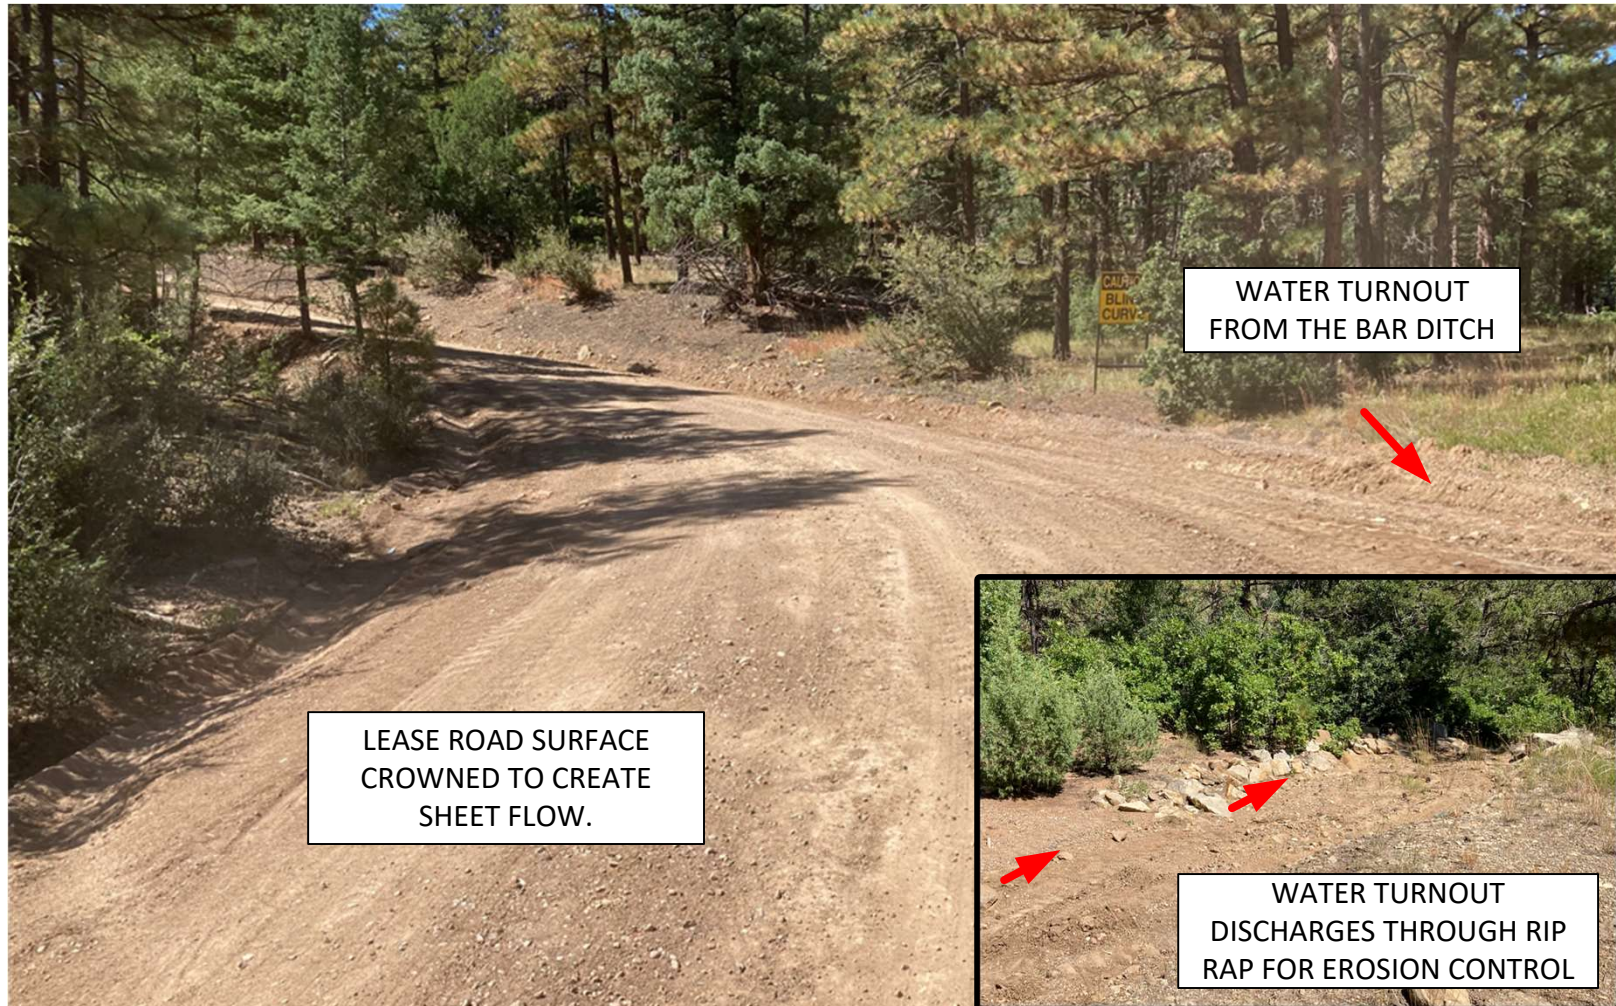
THE BLUE PIPE FRAGMENTS WERE PICKED UP AND DISPOSED OF. THE EXISTING WATER CALLOUT WAS DOMINATED TO PROVIDE POSITIVE FLOW OF STORMWATER OFF OF THE LEASE ROAD. THE FLOW FROM THE WATER TURNOUT INTERCEPTS RIP RAP FOR EROSION CONTROL DURING DISCHARGE. THE ROAD SURFACE WAS CROWNED TO CREATE SHEET FLOW AND ELIMINATE THE TIRE RUTS. ADDITIONAL ROAD BASE/GRAVEL WAS INSTALLED TO THE ROADWAY SURFACE TO PROVIDE ADDED STABILIZATION.

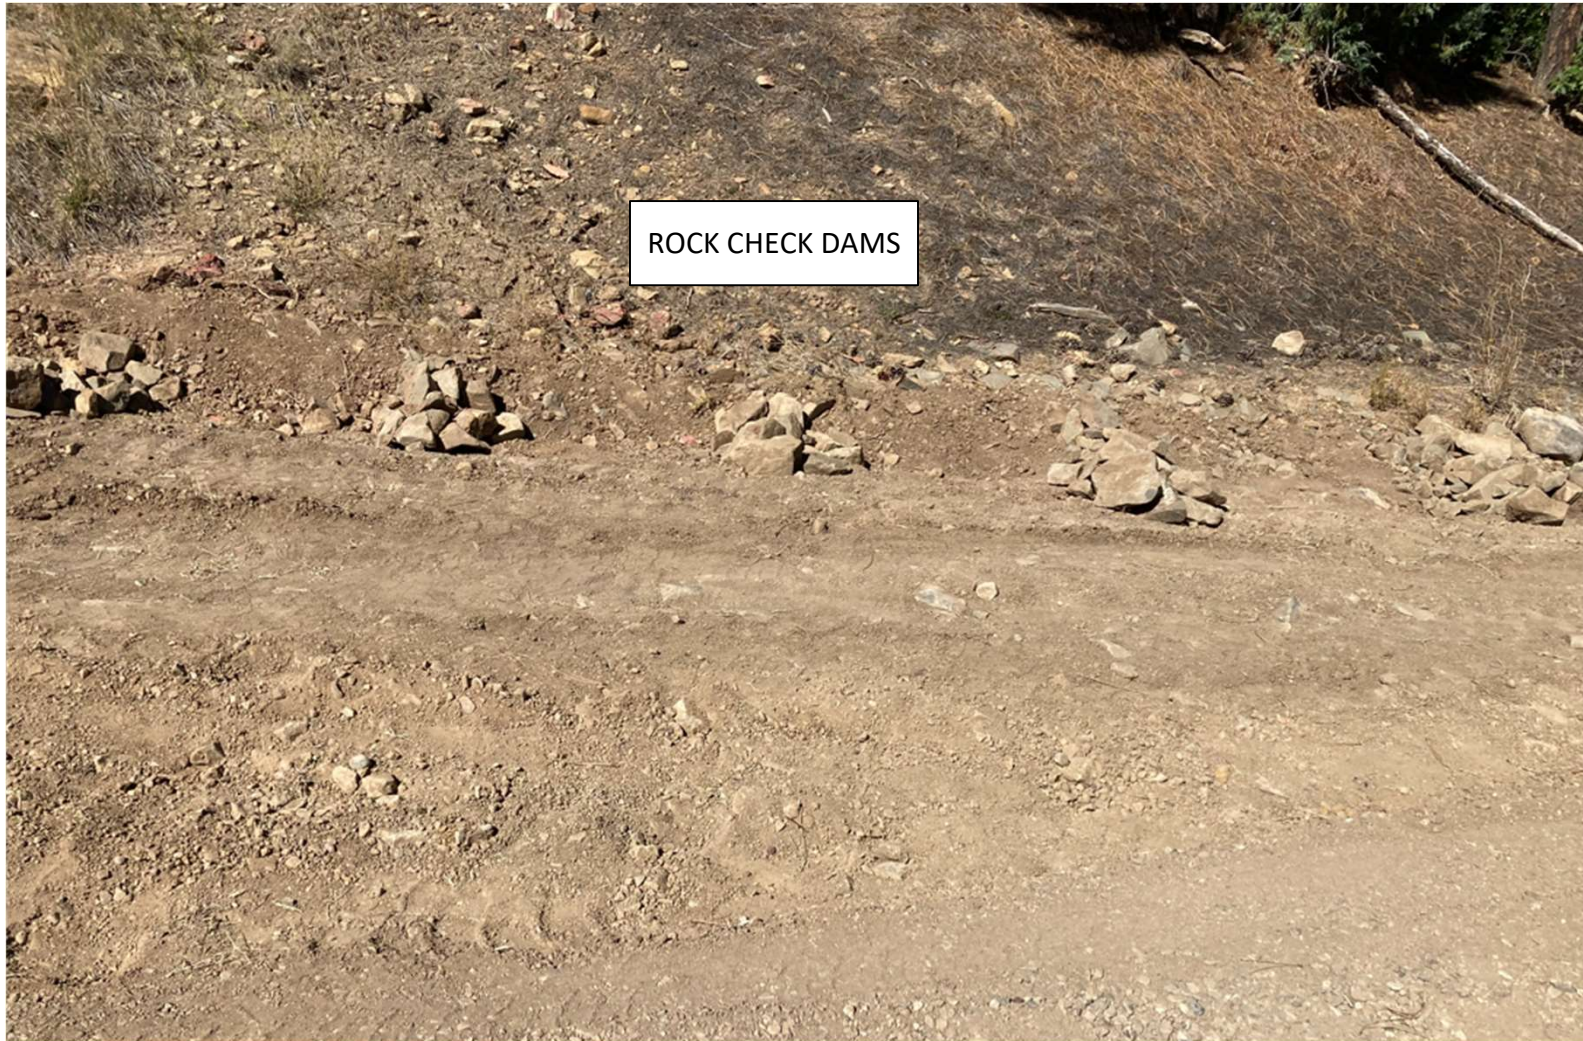
ROCK CHECKS DAMS WERE PLACED IN THE BAR DITCH TO DISSIPATE ENERGY AND PROVIDE SEDIMENT FILTRATION DURING RUN OFF EVENTS.
