# Inspection Photos

11/19/2021

Operator: TEP ROCKY MOUNTAIN LLC #96850

Location ID: 335538

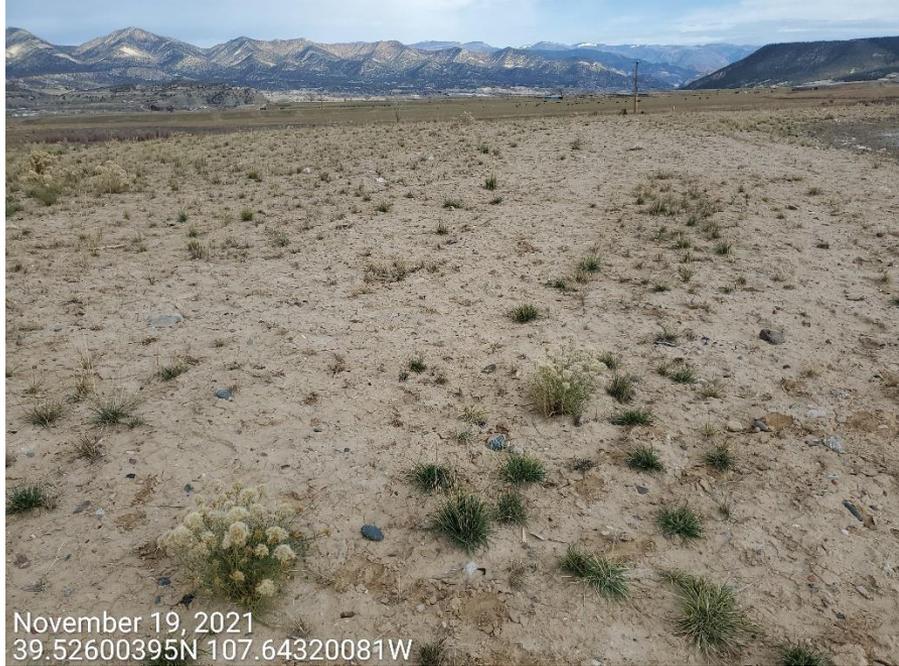
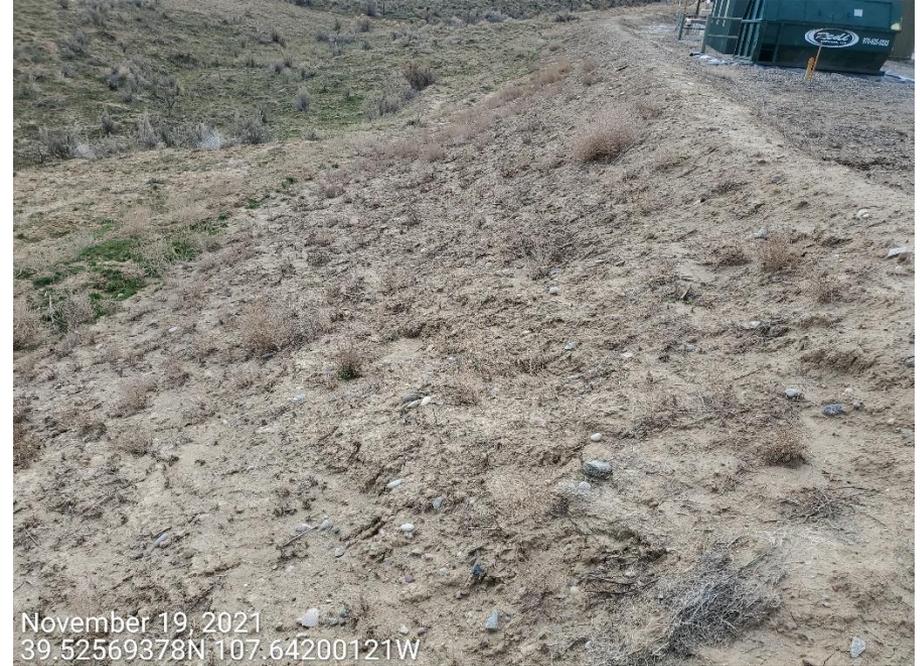
**Photo 1:** Photos provide examples of interim areas on the Location that are not progressing towards 1003 uniform revegetative standards.

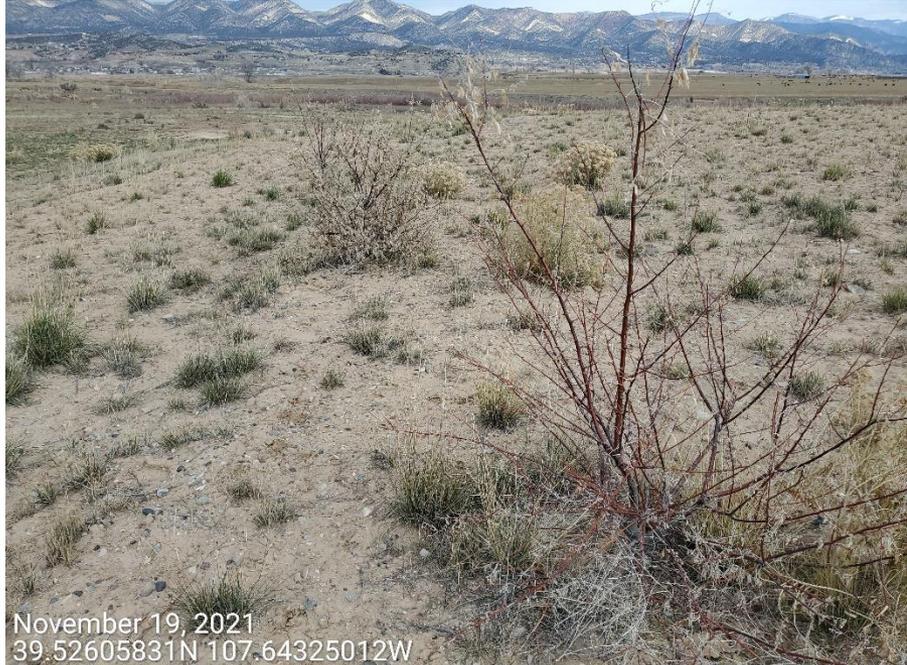
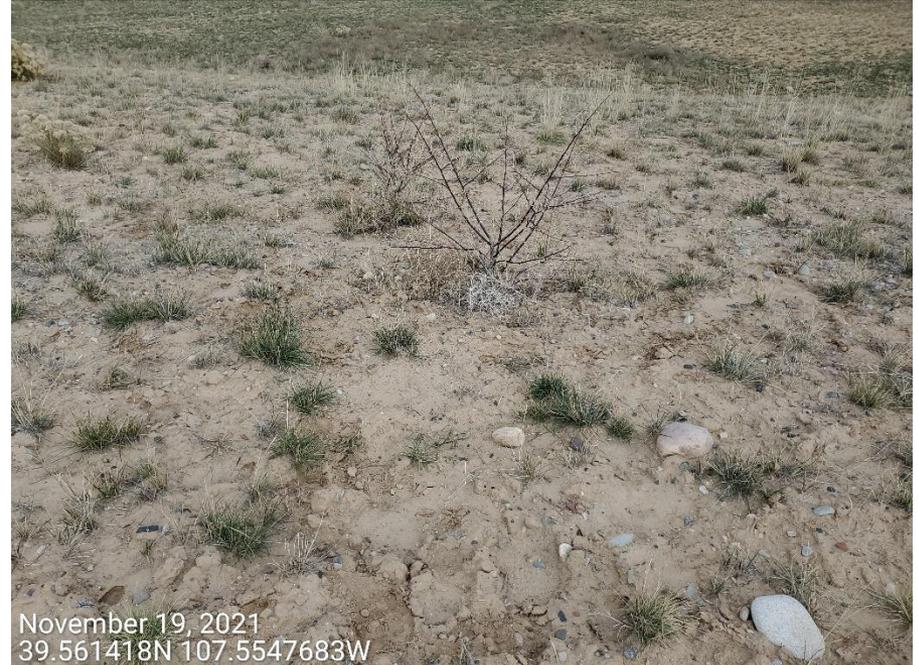
**Photo 2:** Photos provide examples of Noxious weeds (Russian olive) observed established on the western/northern interim areas of the Location.

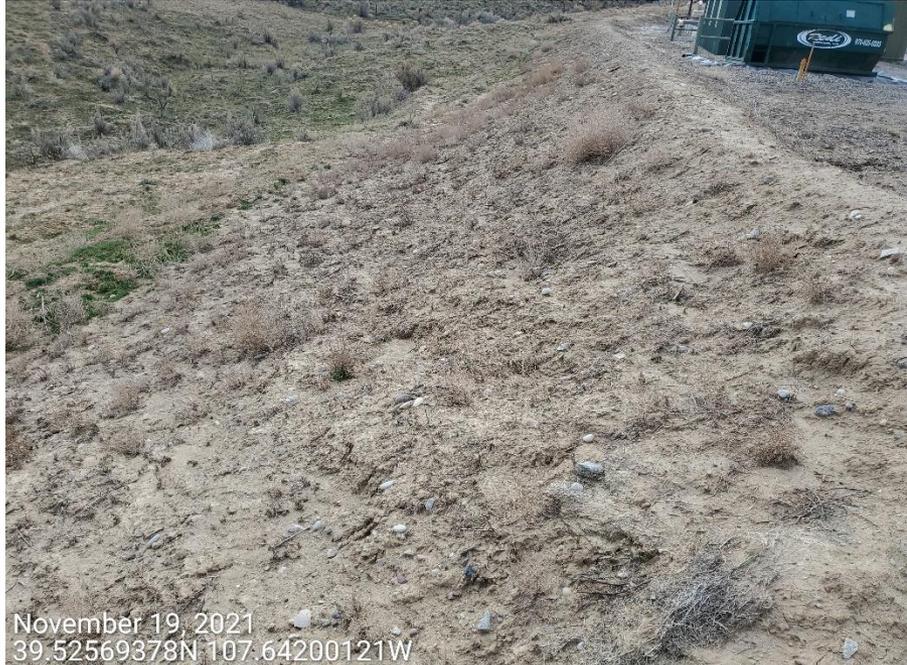
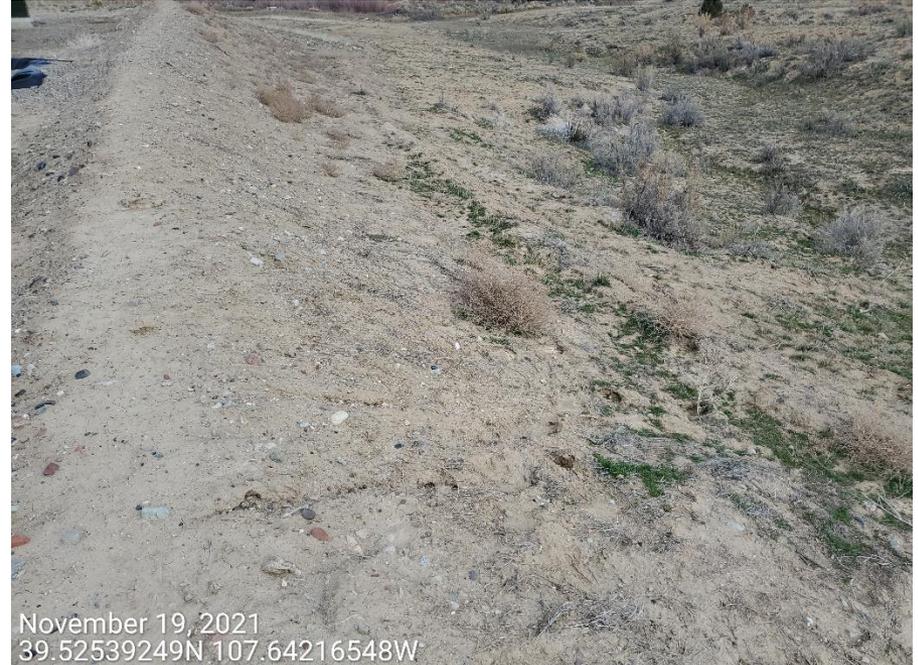
**Photo 3:** Photos taken from the slopes on the east end of the Location; control measures to protect/stabilize slopes missing or insufficient; erosion degradation evident. Areas are bare and exposed; desirable vegetative plant establishment not progressing towards 1003 standards.

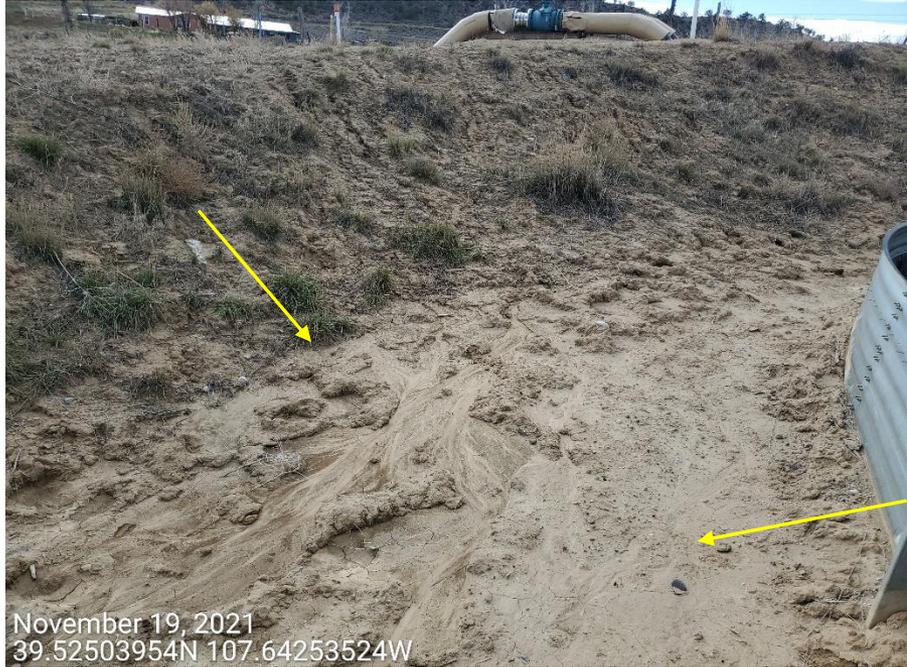
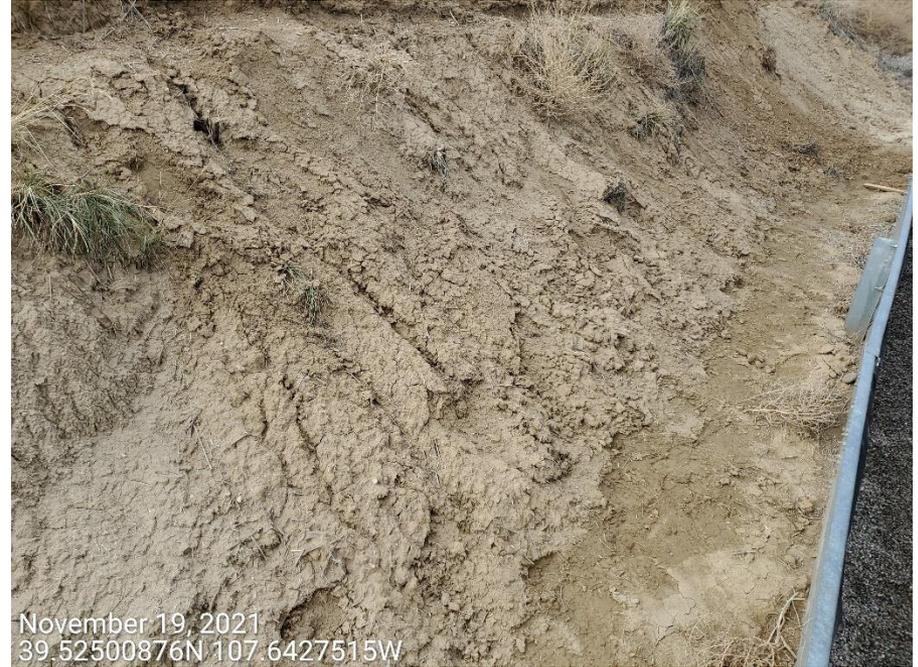
**Photo 4:** Photos provide examples of the cut slopes on the Location; control measures to protect and stabilize the cut slopes remains missing or insufficient per good engineering practices; erosion degradation evident. Note: yellow arrow indicating sediment deposition due to erosion at cut slopes.

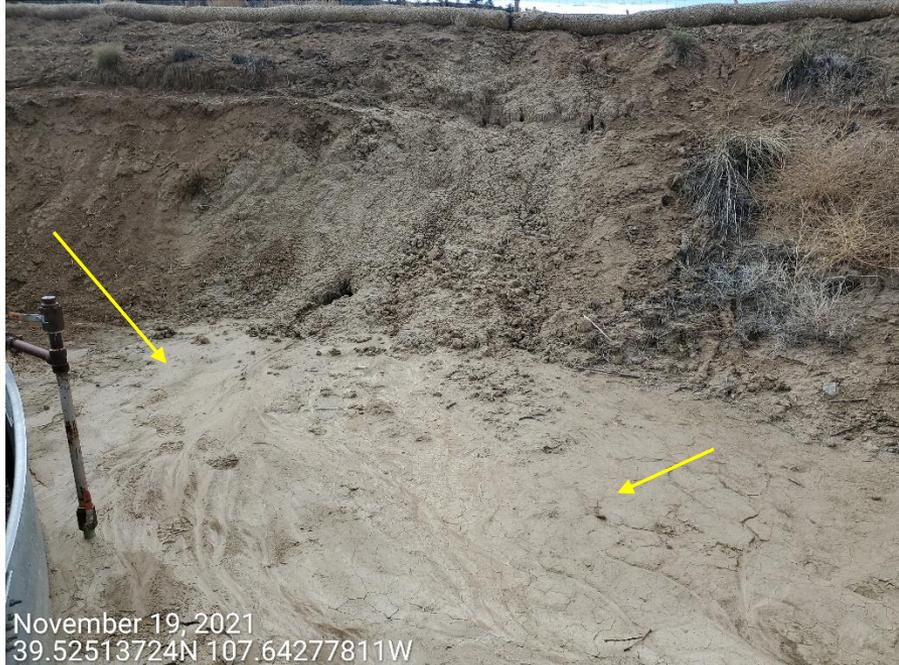
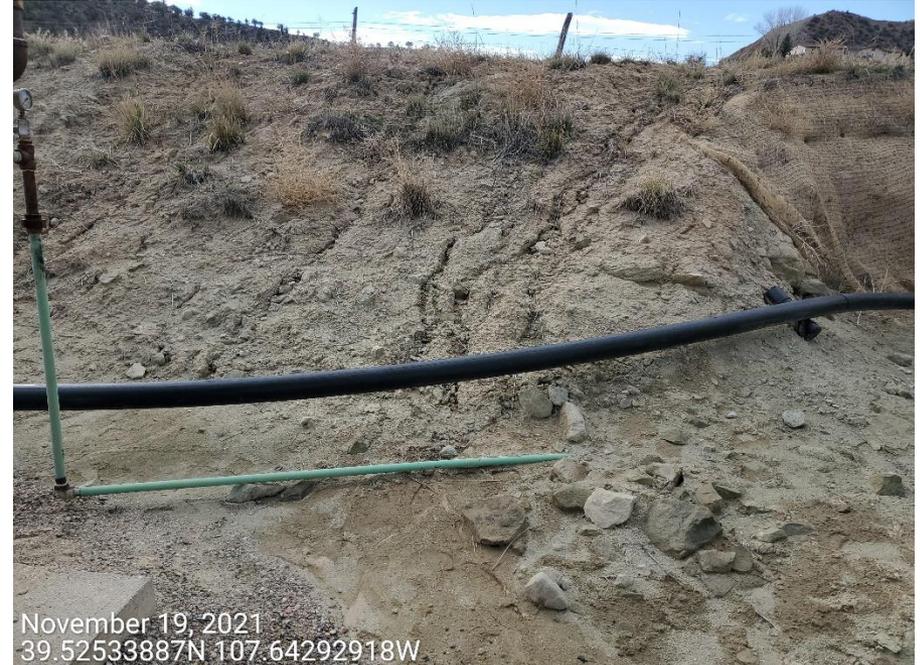
**Photo 5:** Photos provide examples of the cut slopes on the Location; control measures to protect and stabilize the cut slopes remains missing or insufficient per good engineering practices; erosion degradation evident. Note: yellow arrow indicating sediment deposition due to erosion at cut slopes.

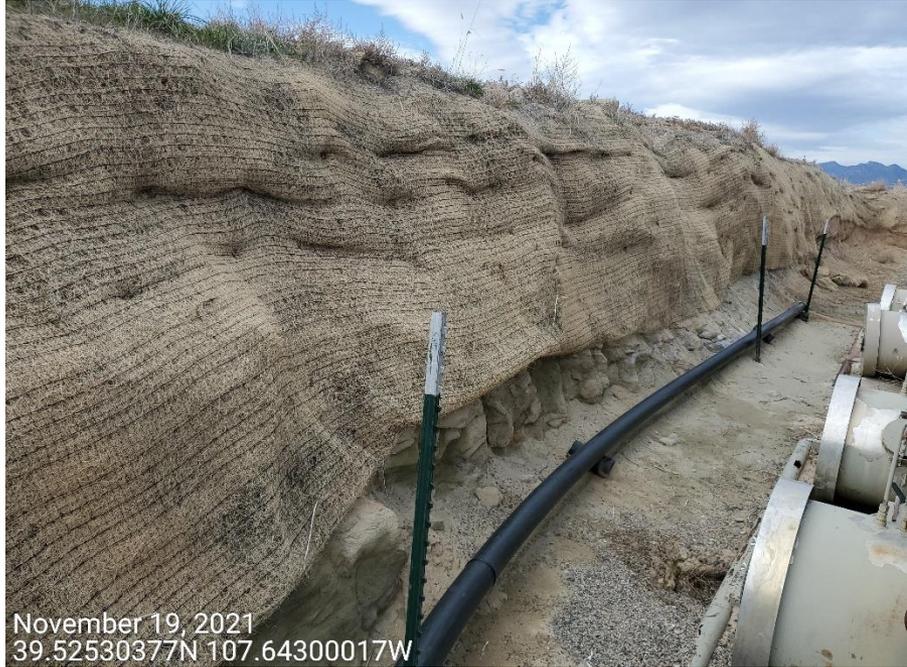
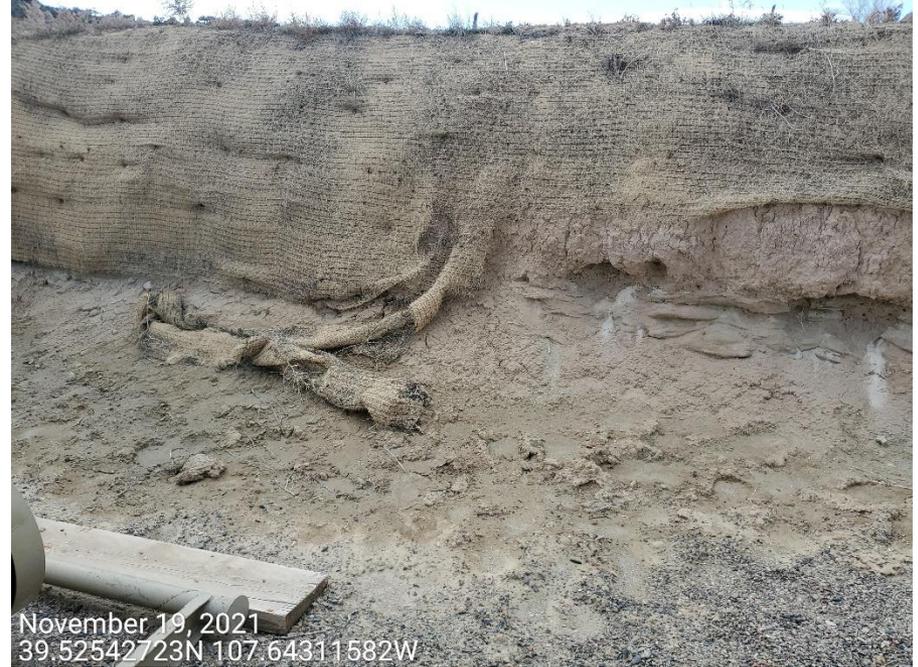
**Photo 6:** Photo shows erosion blankets at cut slopes behind separator equipment. Photo right shows sections of the BMP that has not been maintained in proper functioning condition.

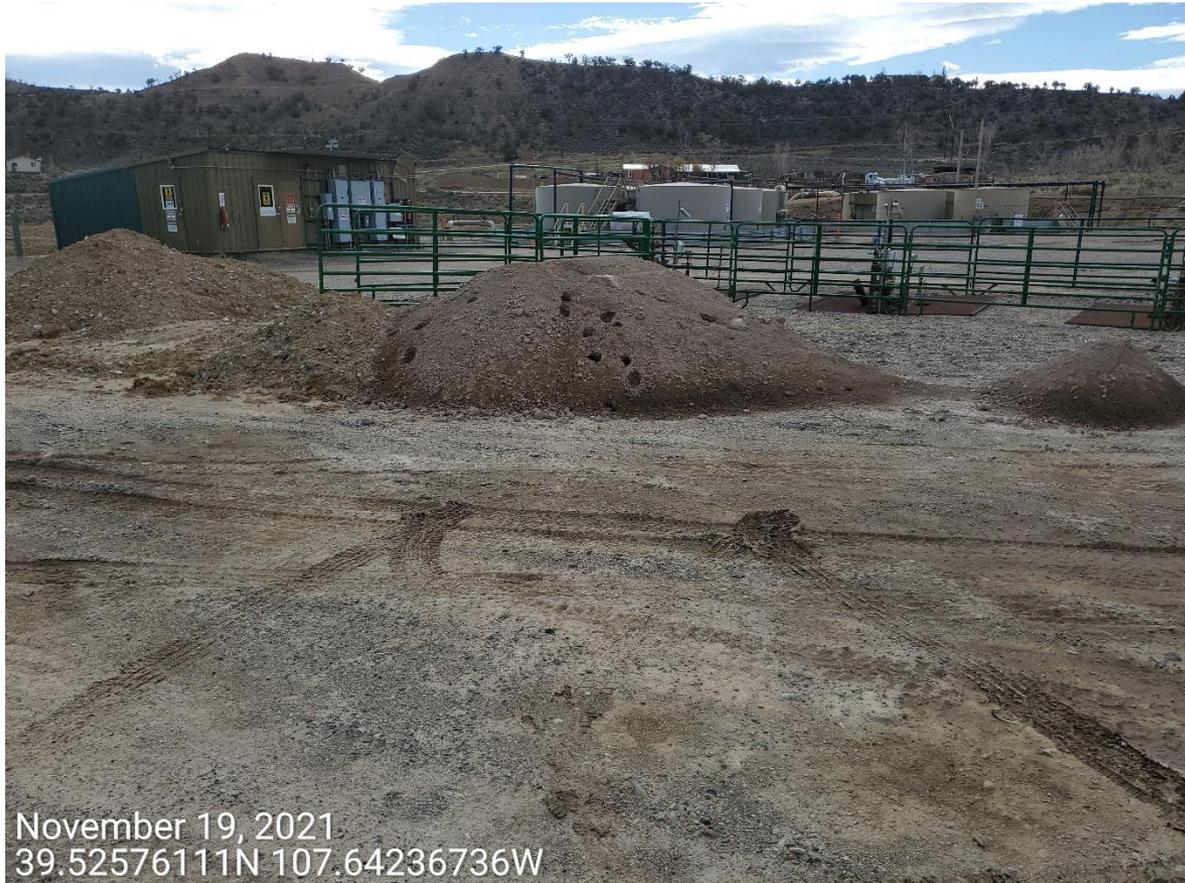
**Photo 7:** Photo shows stockpiled soils stored on the Location. Control measures to mitigate sediment transport from the soil stockpiles are missing or insufficient.

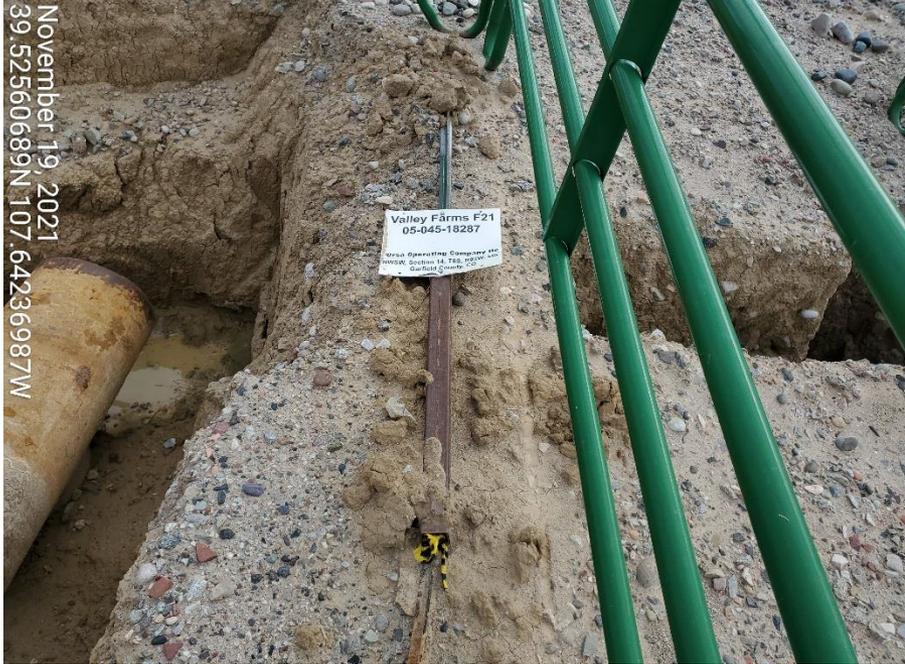
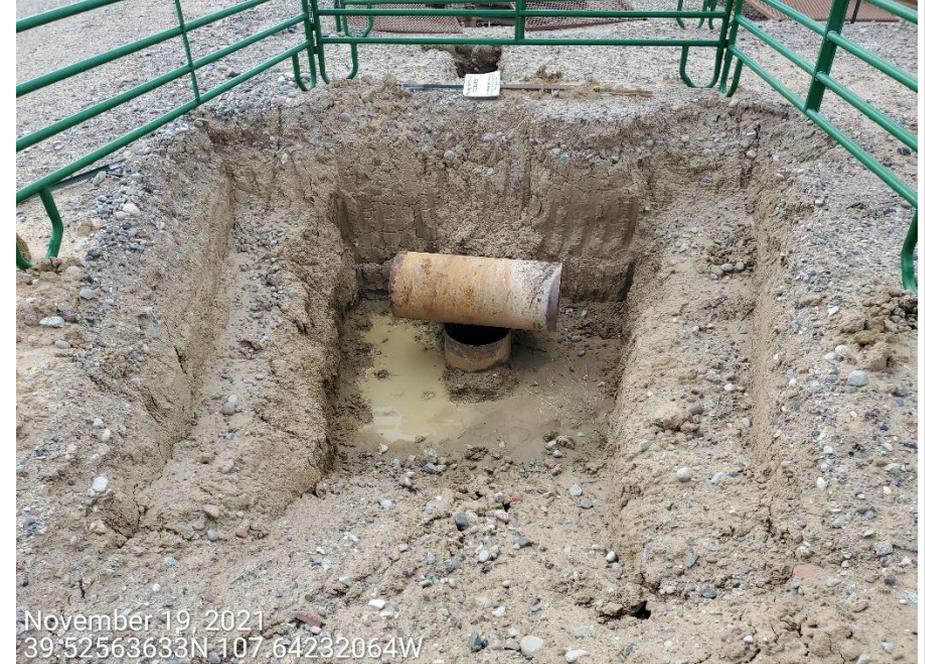
**Photo 8:** Photo of well API 045-18287 conductor setting; well has not been drilled; Form 2 permit expired 7/24/2020; no Form 4 to abandon well has been submitted; conductor setting requires plugging.

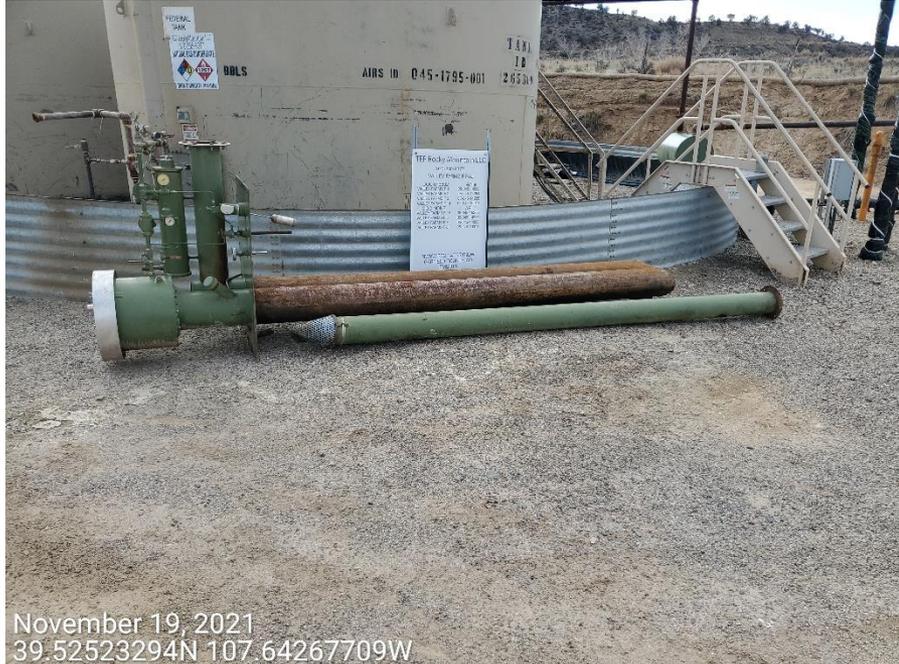
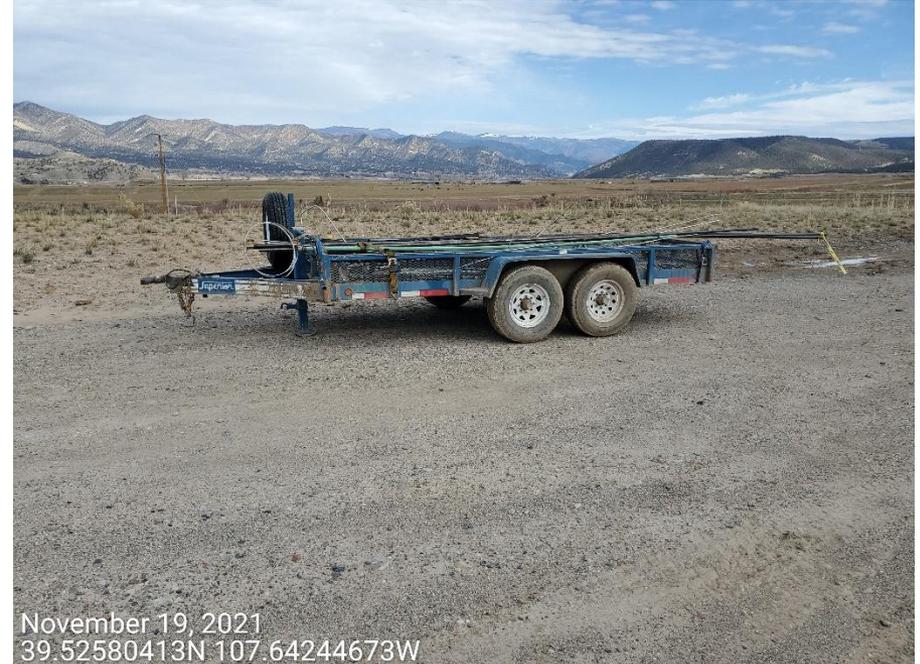
**Photo 9:** Photos show unused equipment, or equipment not necessary for production stored on the Location.
