Inspection Photos
Operator: Simcoe
API: 067-09958
Date: 11/30/2021

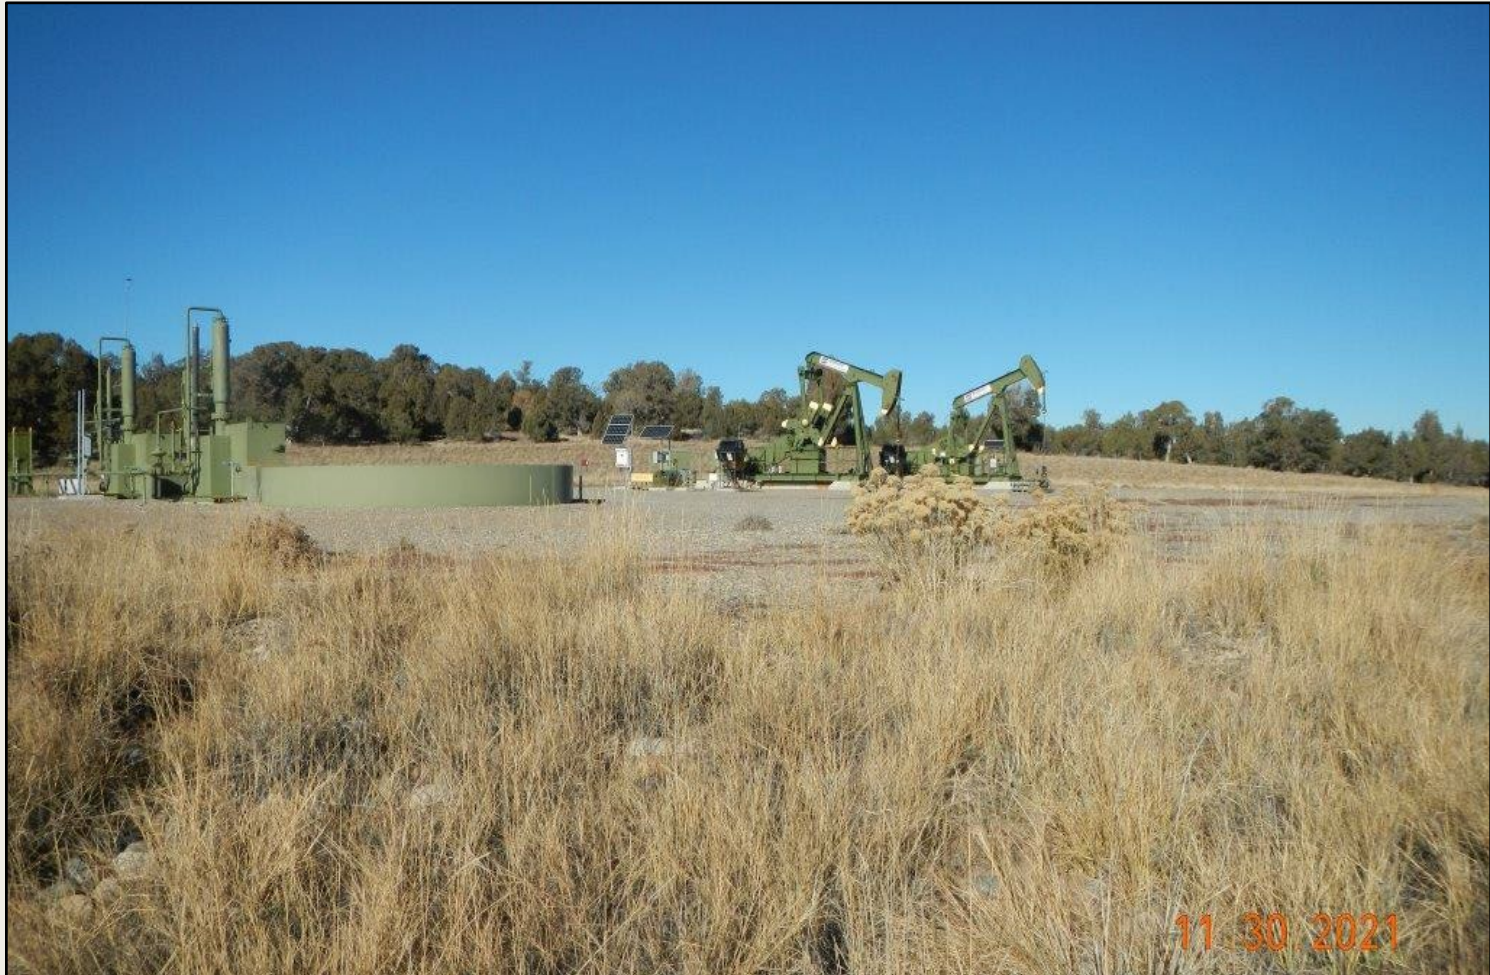
Photo 1. View of the project area from the southeastern corner facing center.

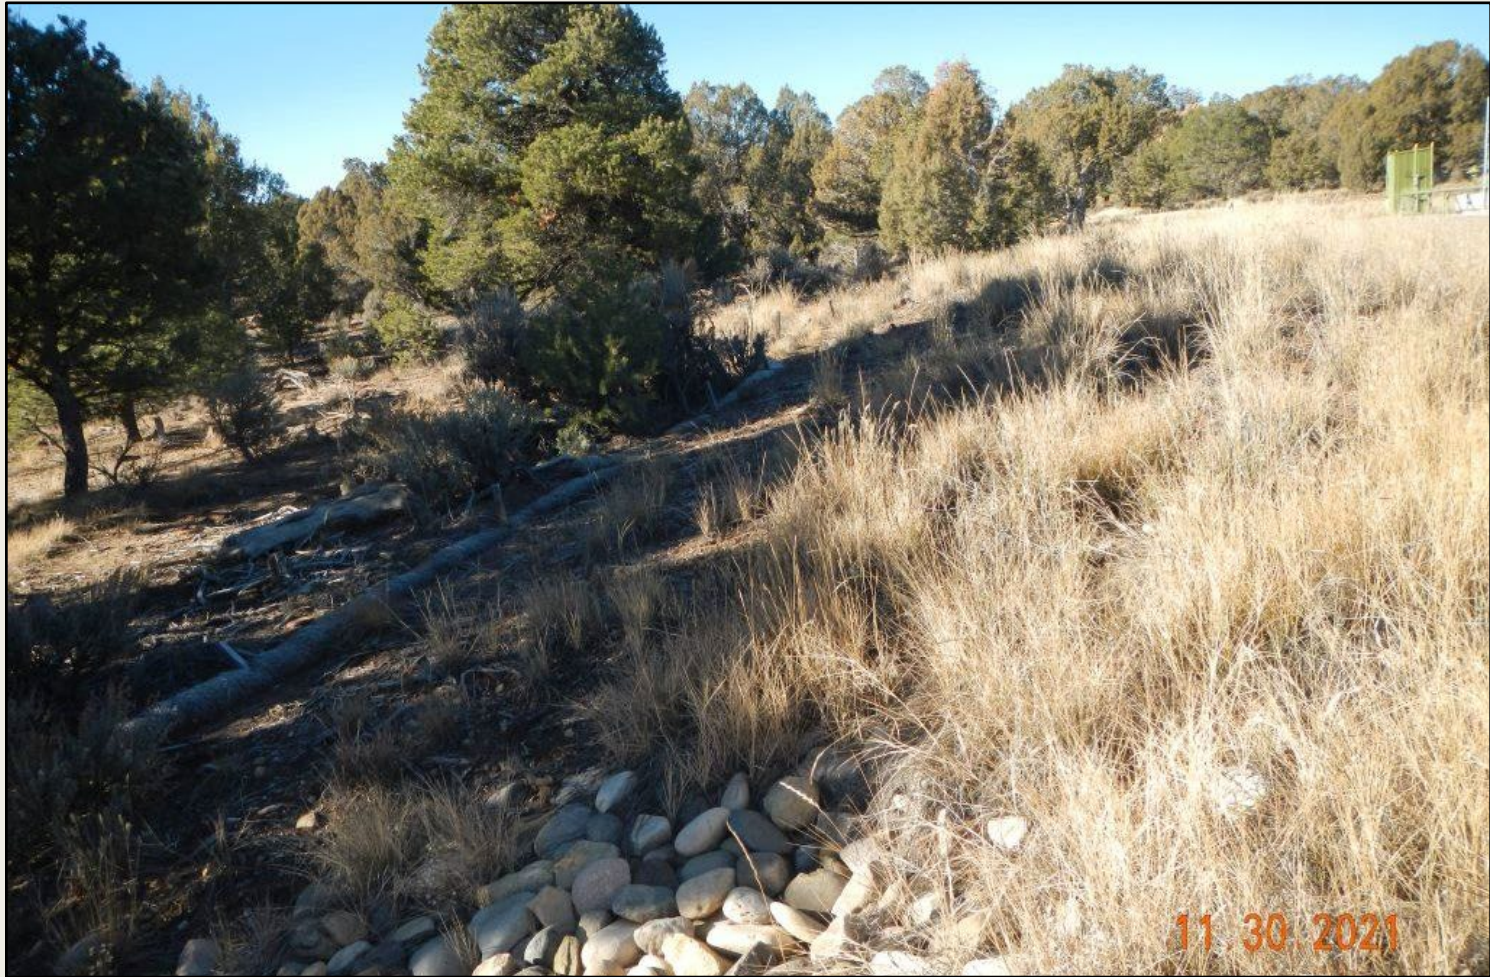
Photo 2. View of the southern fill slope, from the southeastern corner facing westward. Revegetation is progressing with western wheatgrass, crested wheatgrass, smooth brome, and sand dropseed.

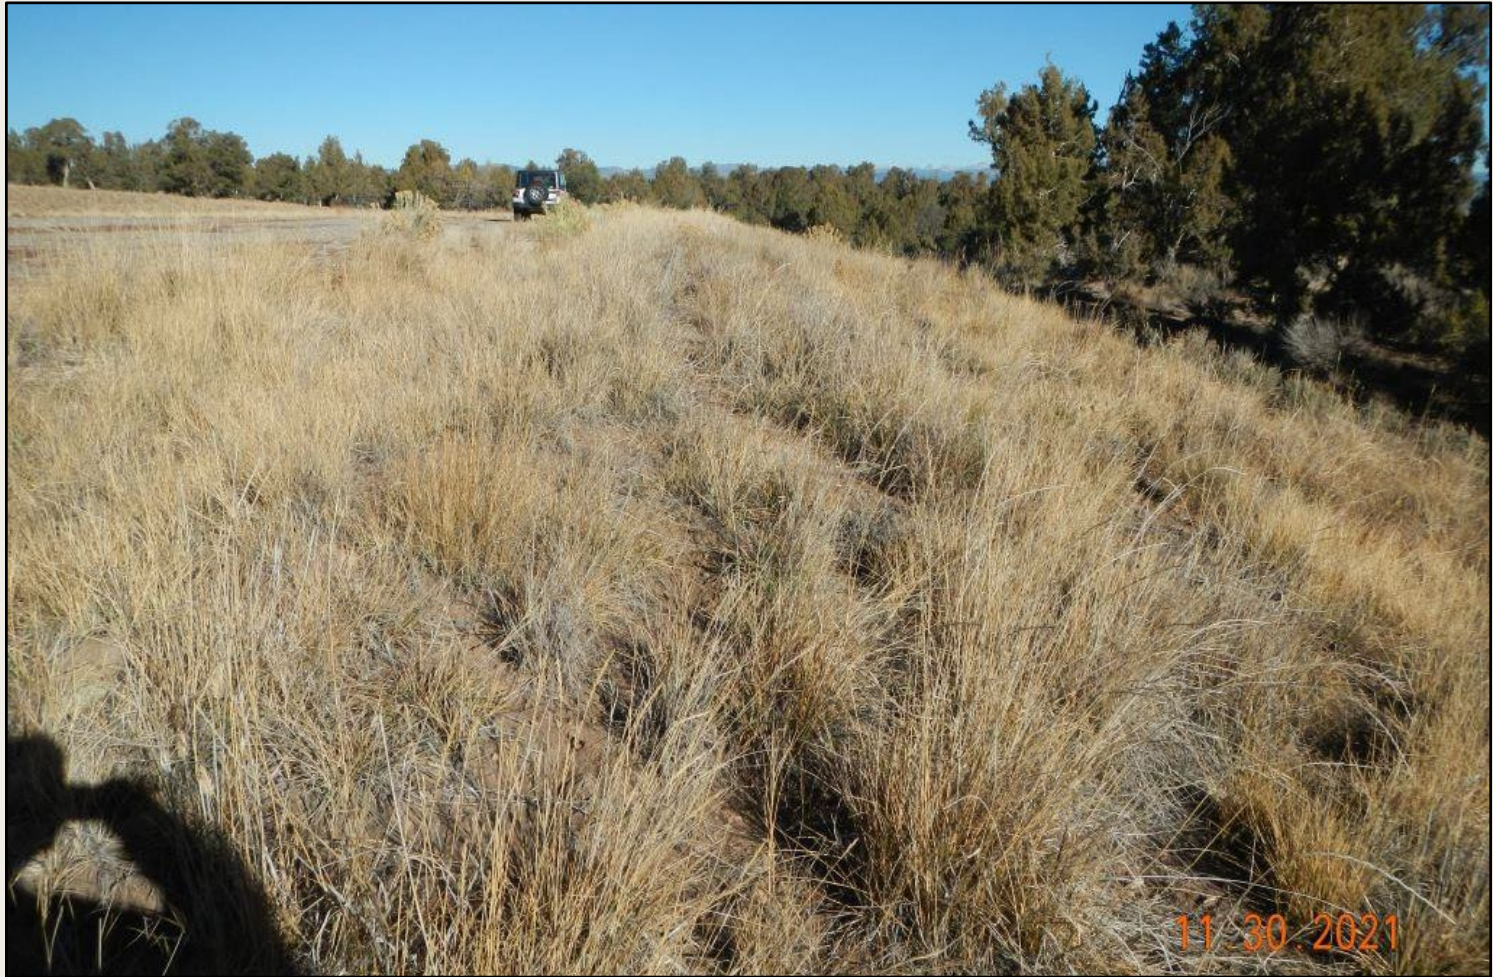
Photo 5. View of the eastern project area from the southeastern corner facing northward.

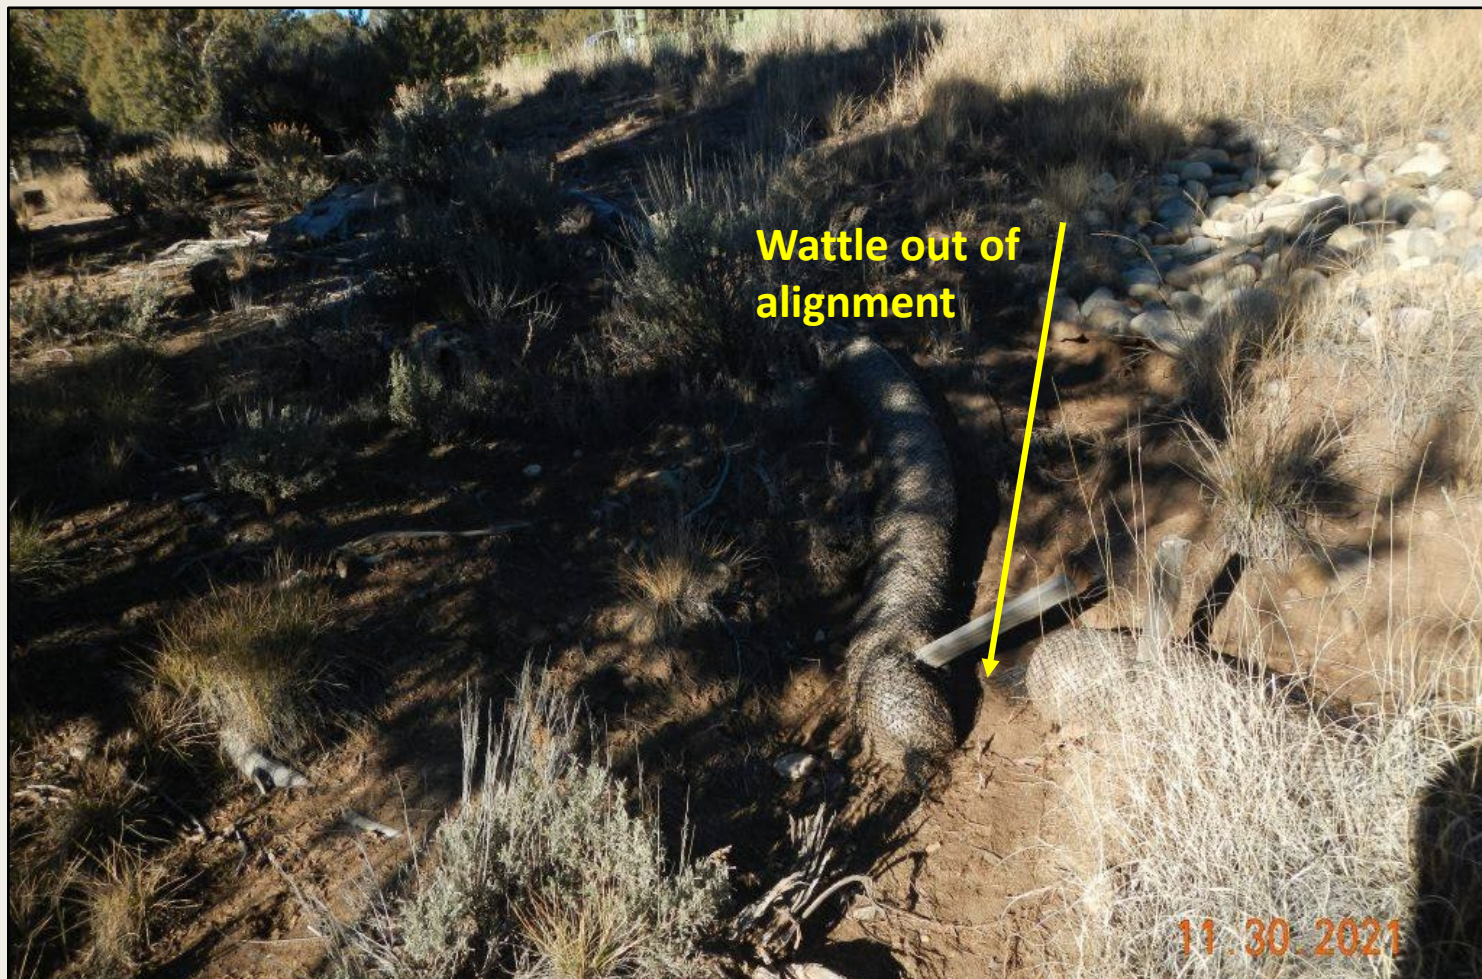
Photo 5. View of area within the southeastern project area, where wattle is out of alignment and erosion is occurring down-slope.

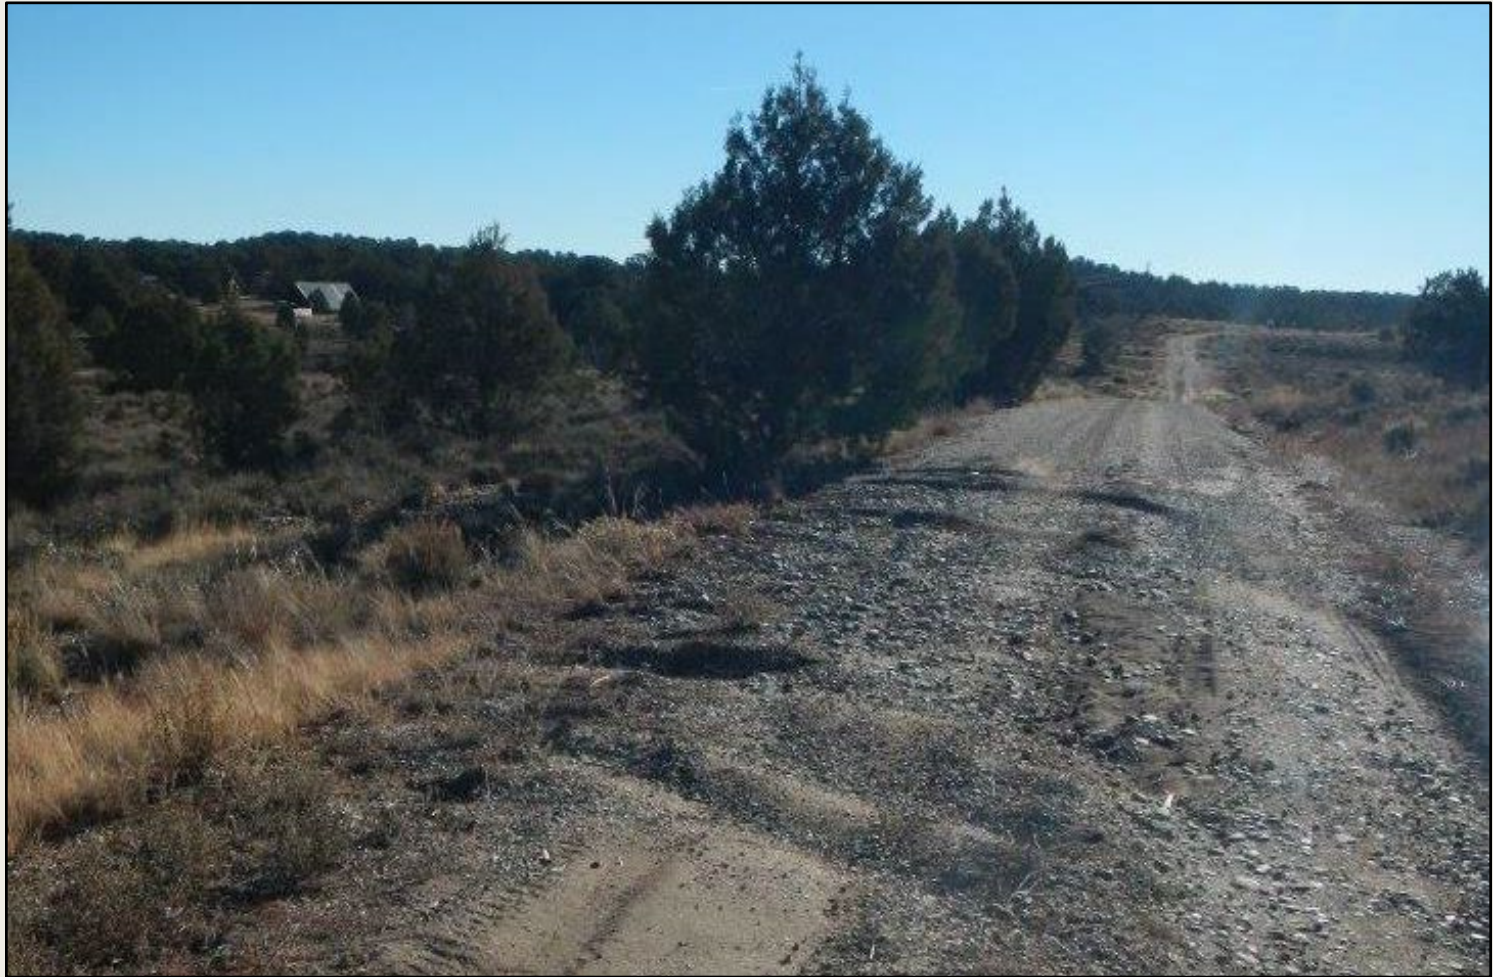
Photo 5. View of erosional scouring and erosion on the access road where stormwater flows are improperly diverted. Approximately 4-6 inches deep of material is eroded off of the road and down-slope.

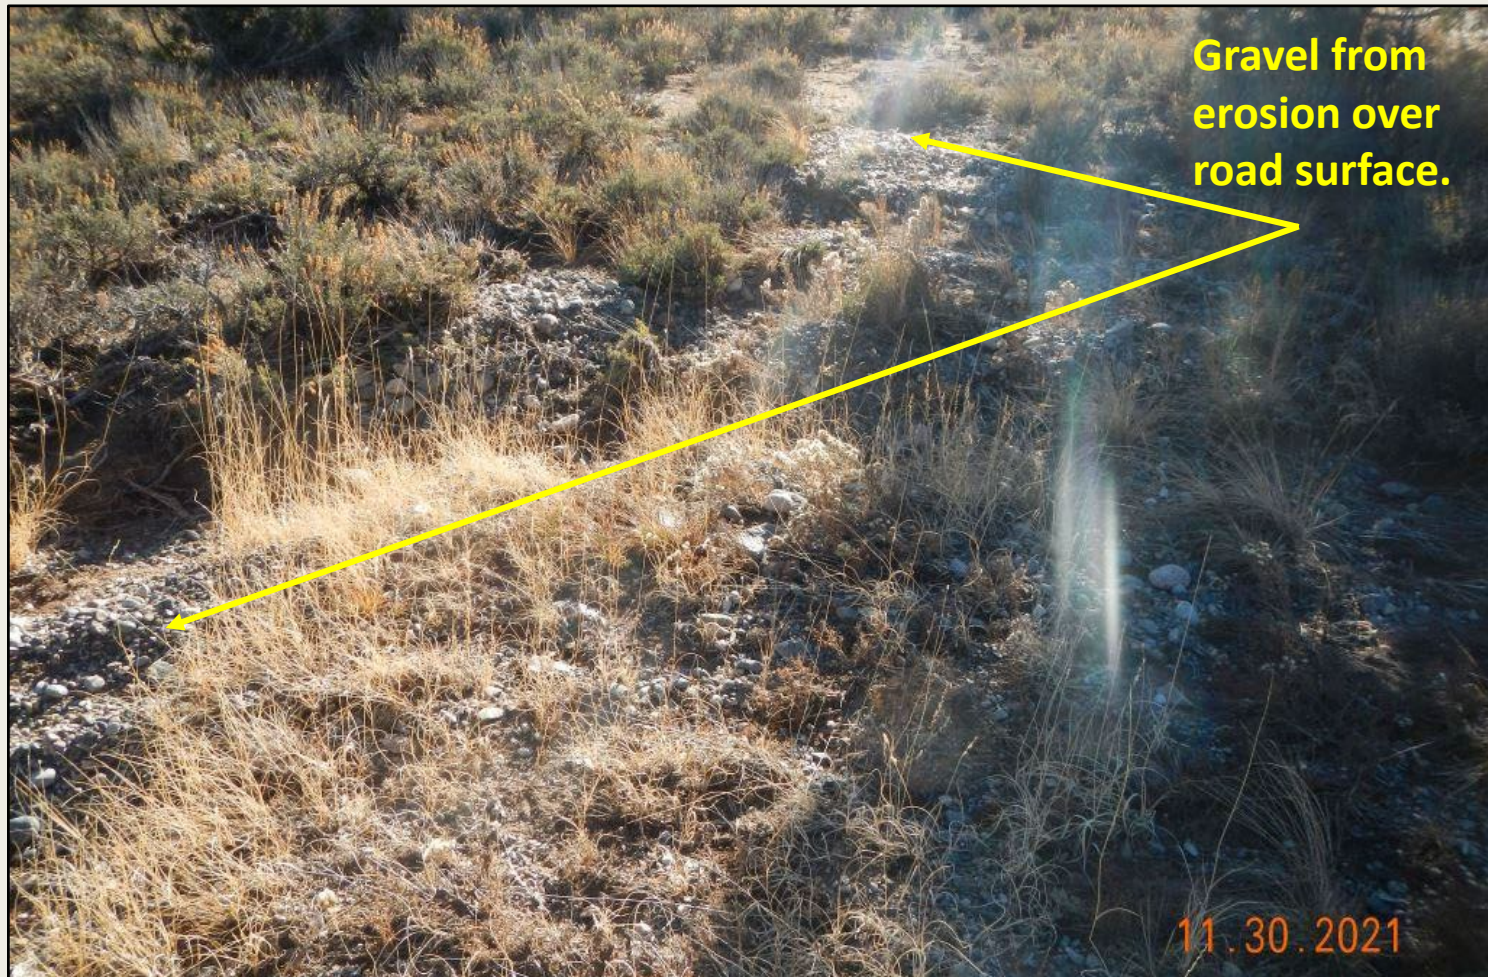
Photo 6. View of area down-slope of erosion on road observed in Photo 5. Stormwater flows have resulted in erosion and gravel deposition.

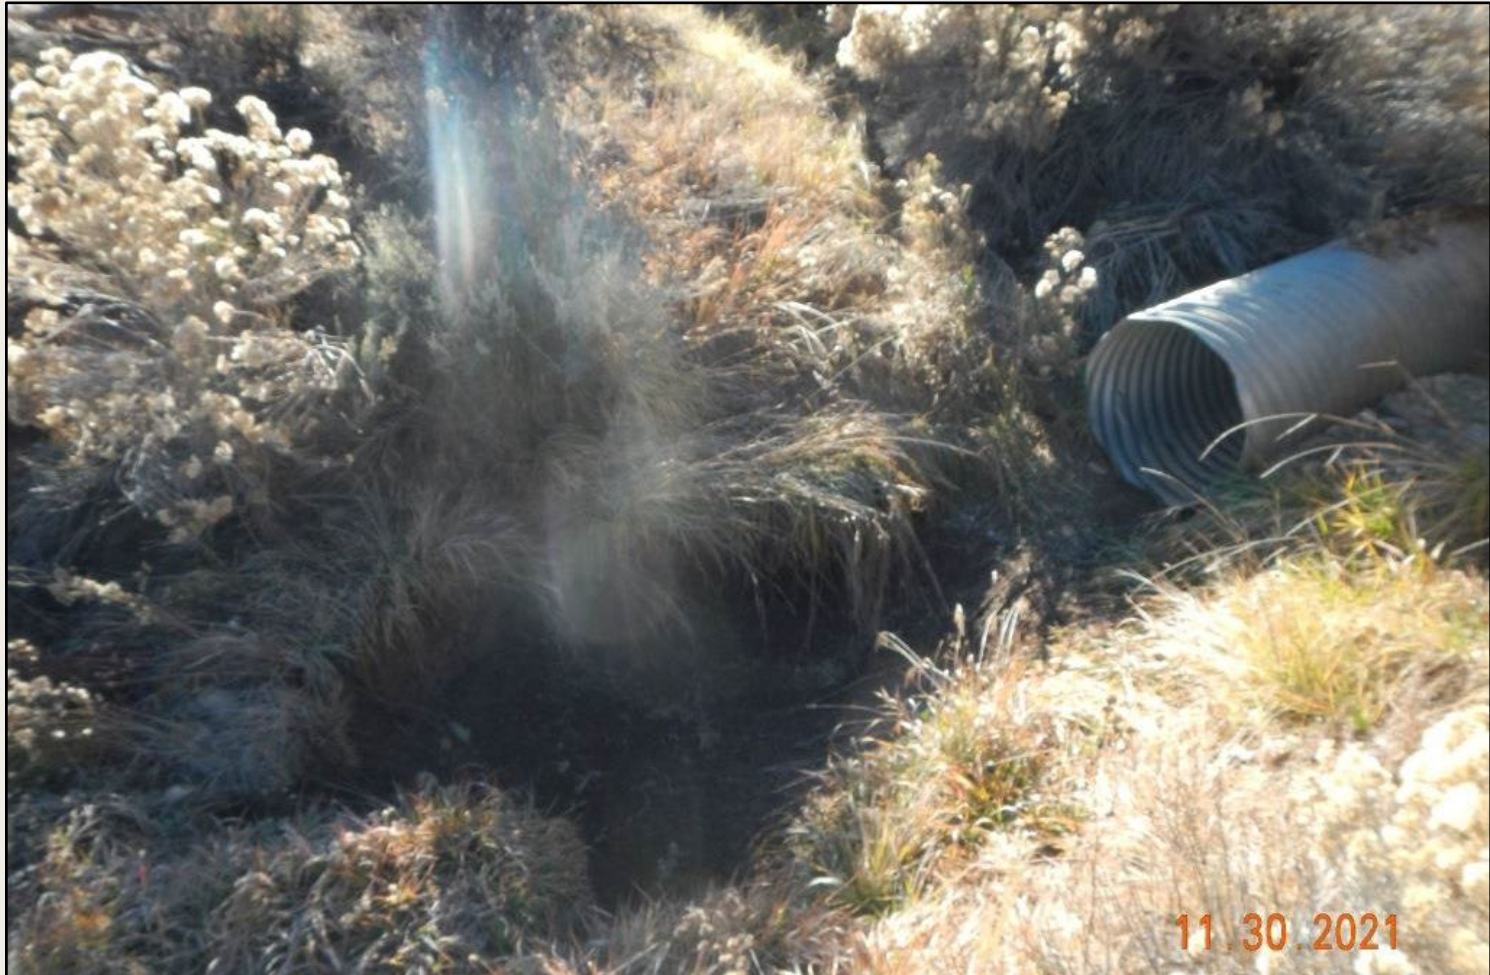
Photo 7. View of erosion occurring at culvert outlet along access road, approximately 3 feet deep, where concentrated stormwater flows out of culvert and eroding soil and vegetation. Erosion observed around culvert indicates that it is not stabilized.

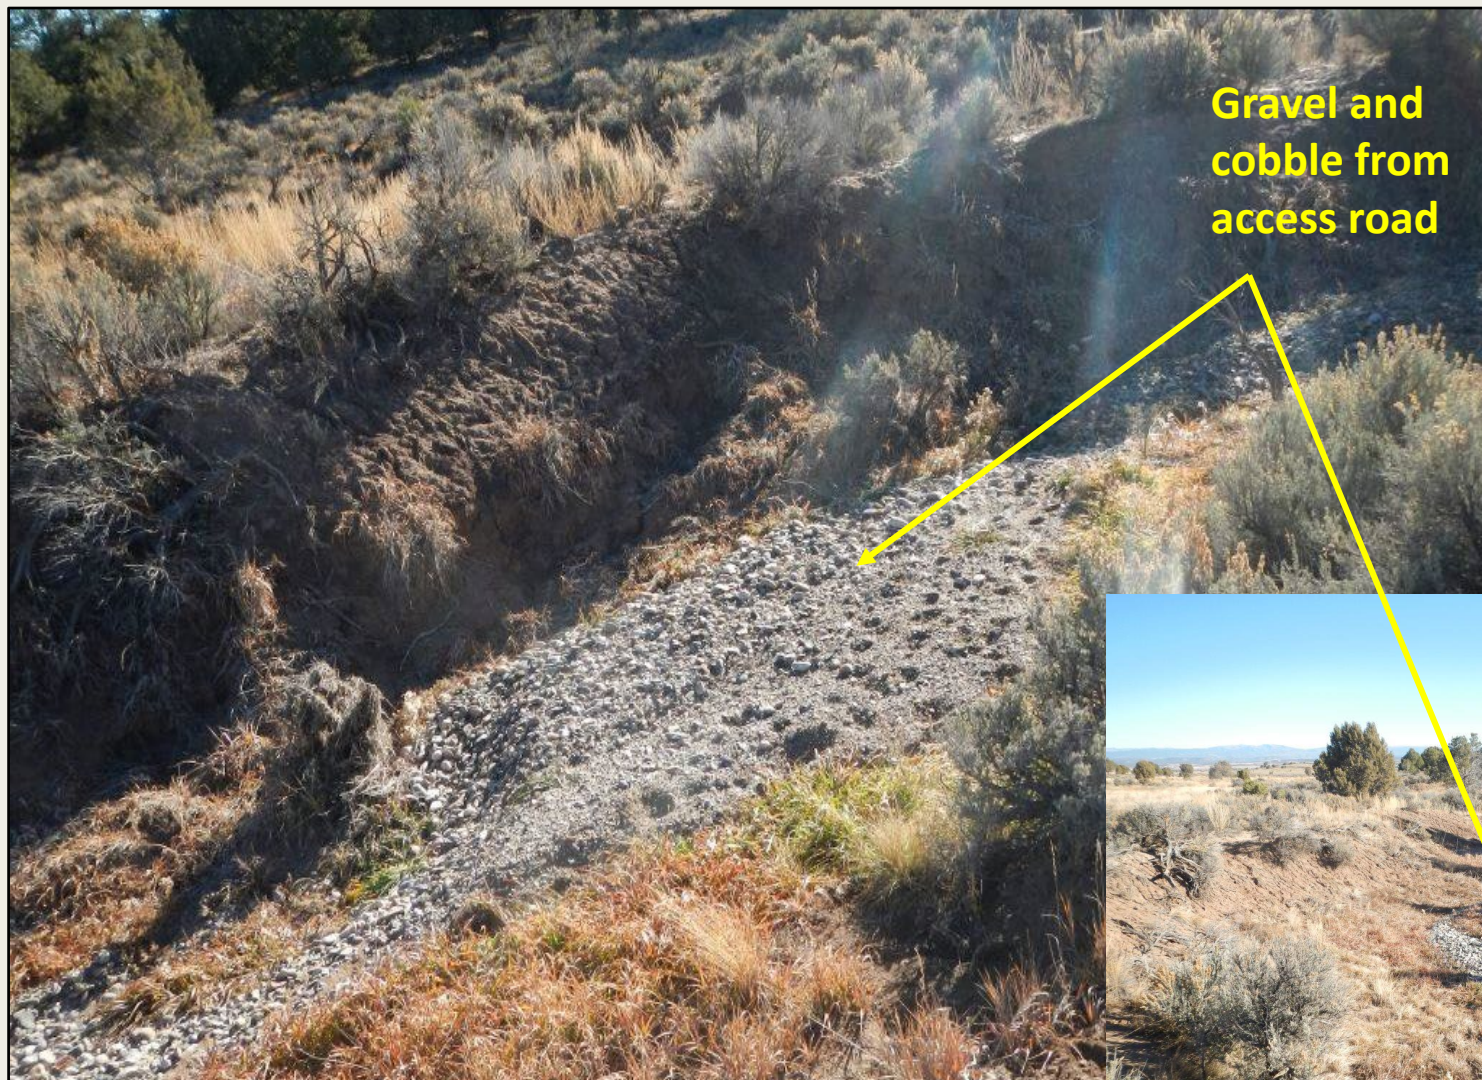
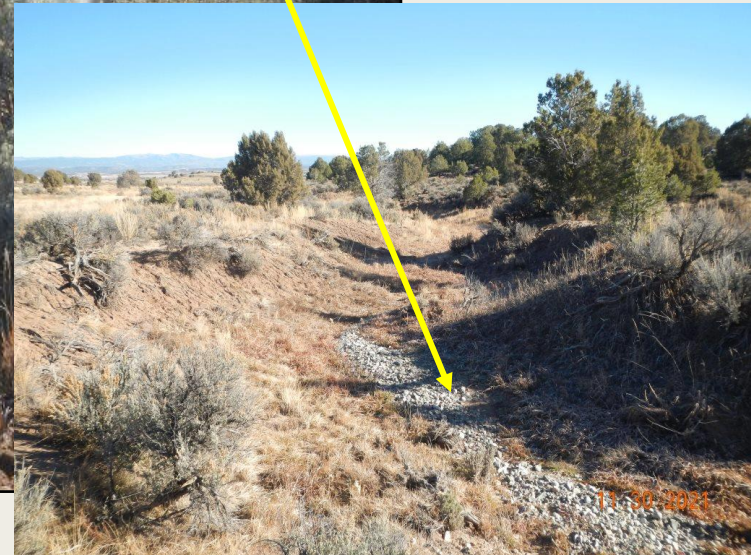
Gravel and
cobble from
access road

Photo 8. View of area approx. 50 ft down-slope of culvert outlet, where significant volumes (approx. 75ft long, 4-6 ft wide, and 4-6 inches deep) observed within the streambed.

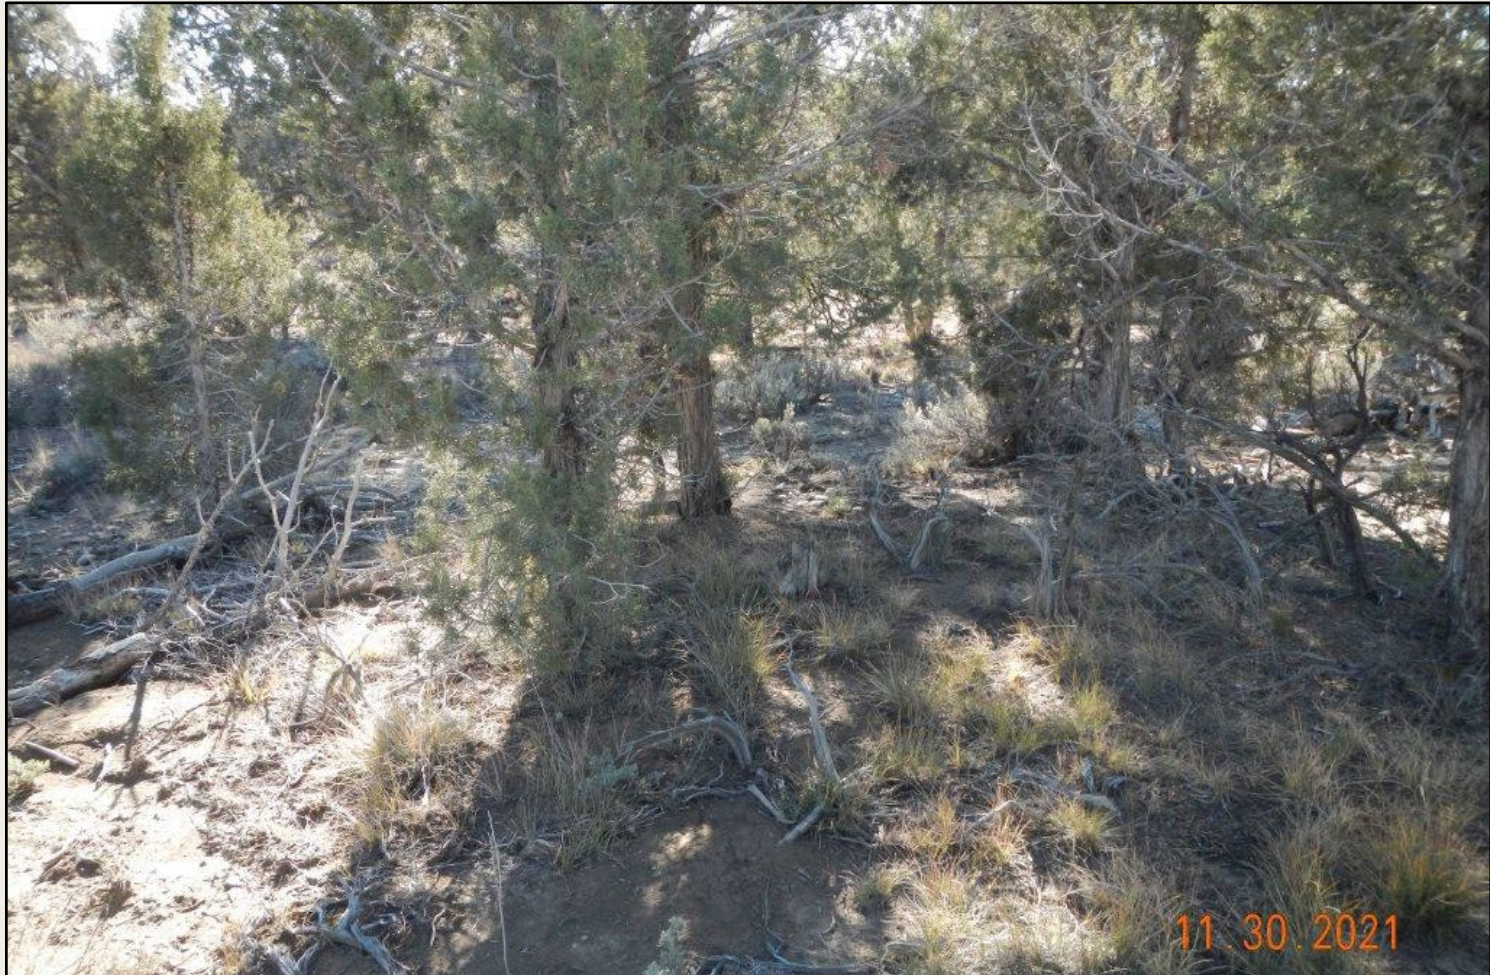
Photo 9. View of reference area comprised of pinyon and juniper woodland with understory of western wheatgrass, Indian ricegrass, black sage, prickly pear, and purple threeawn.
