TEP
RMV 16-35
Location # 323890

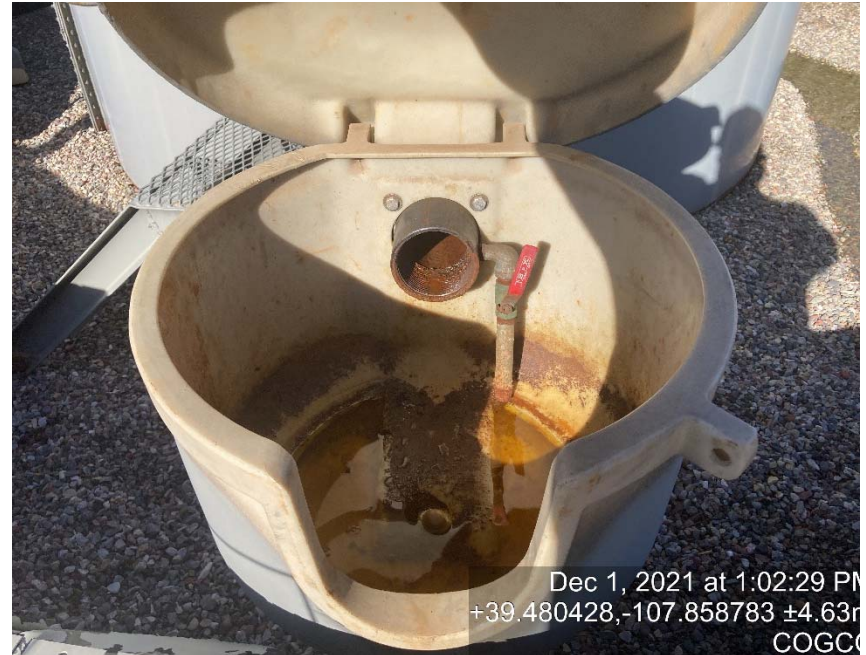
Load lines missing bull plugs/caps

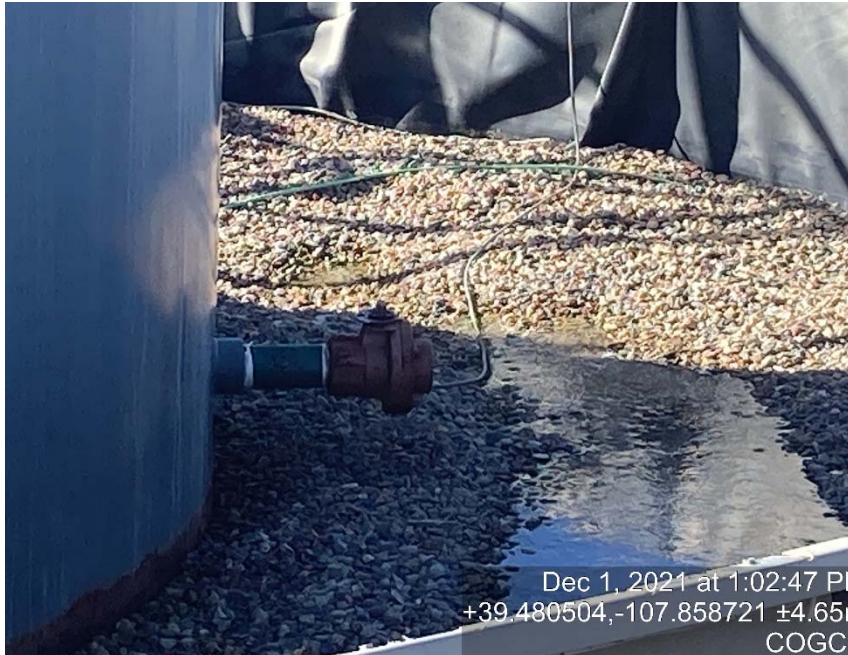
Load lines missing bull plugs/caps

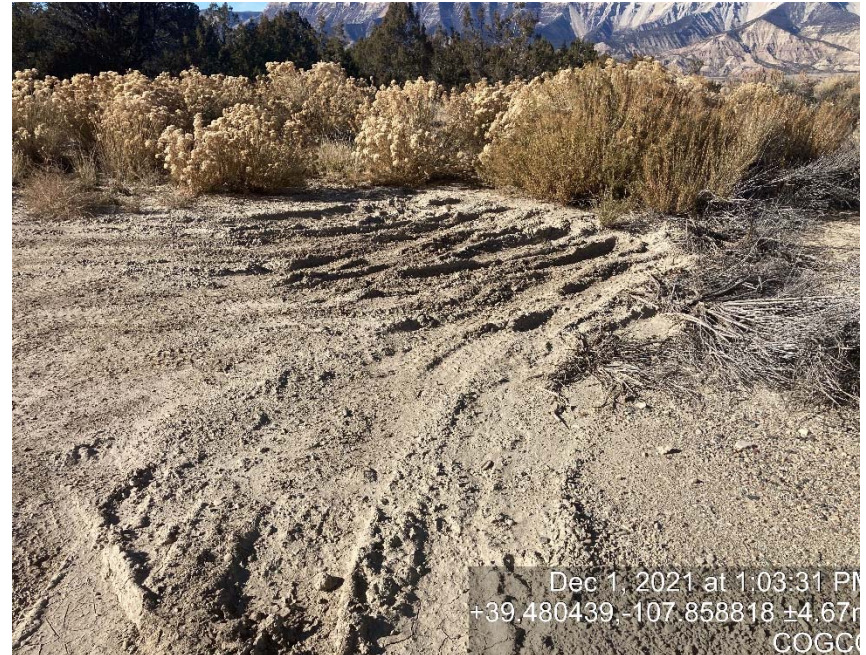
Location lack of stabilization/compaction

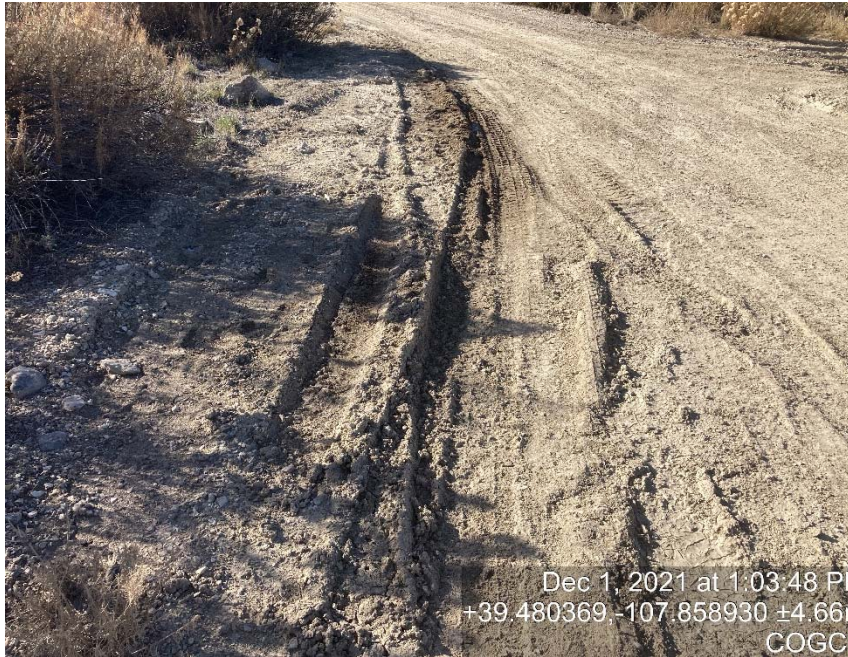
Location lack of stabilization/compaction

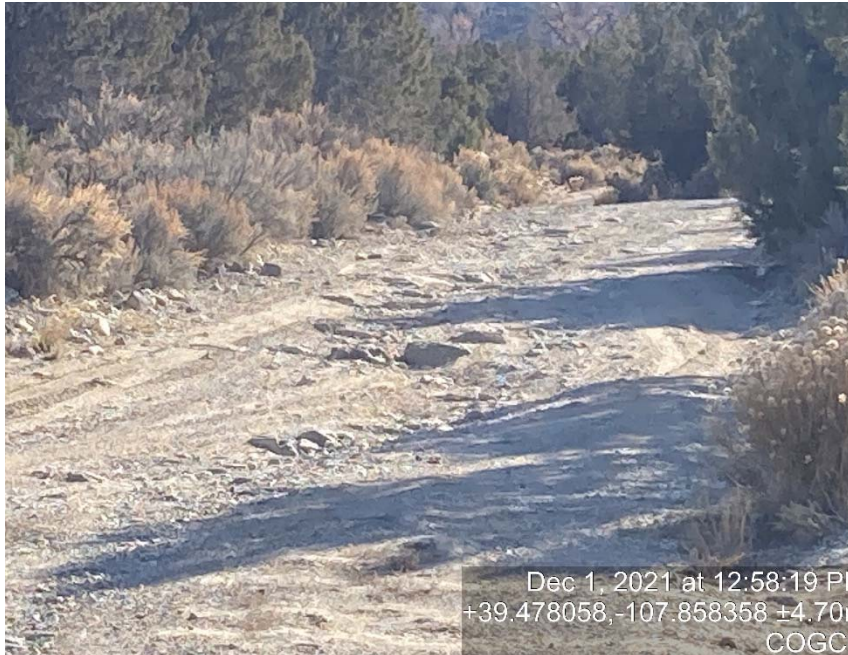
Access road lacking maintenance

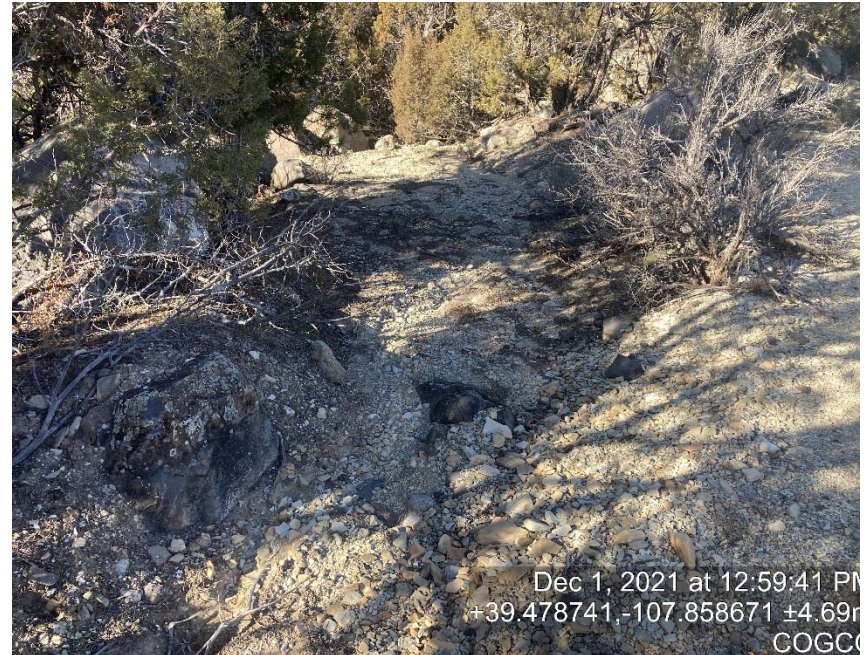
Sediment migration from access road
