Grand Mesa Operating CO, Nana Unit 1-16

073-06769

Inspection #688311687

Routine Field Inspection

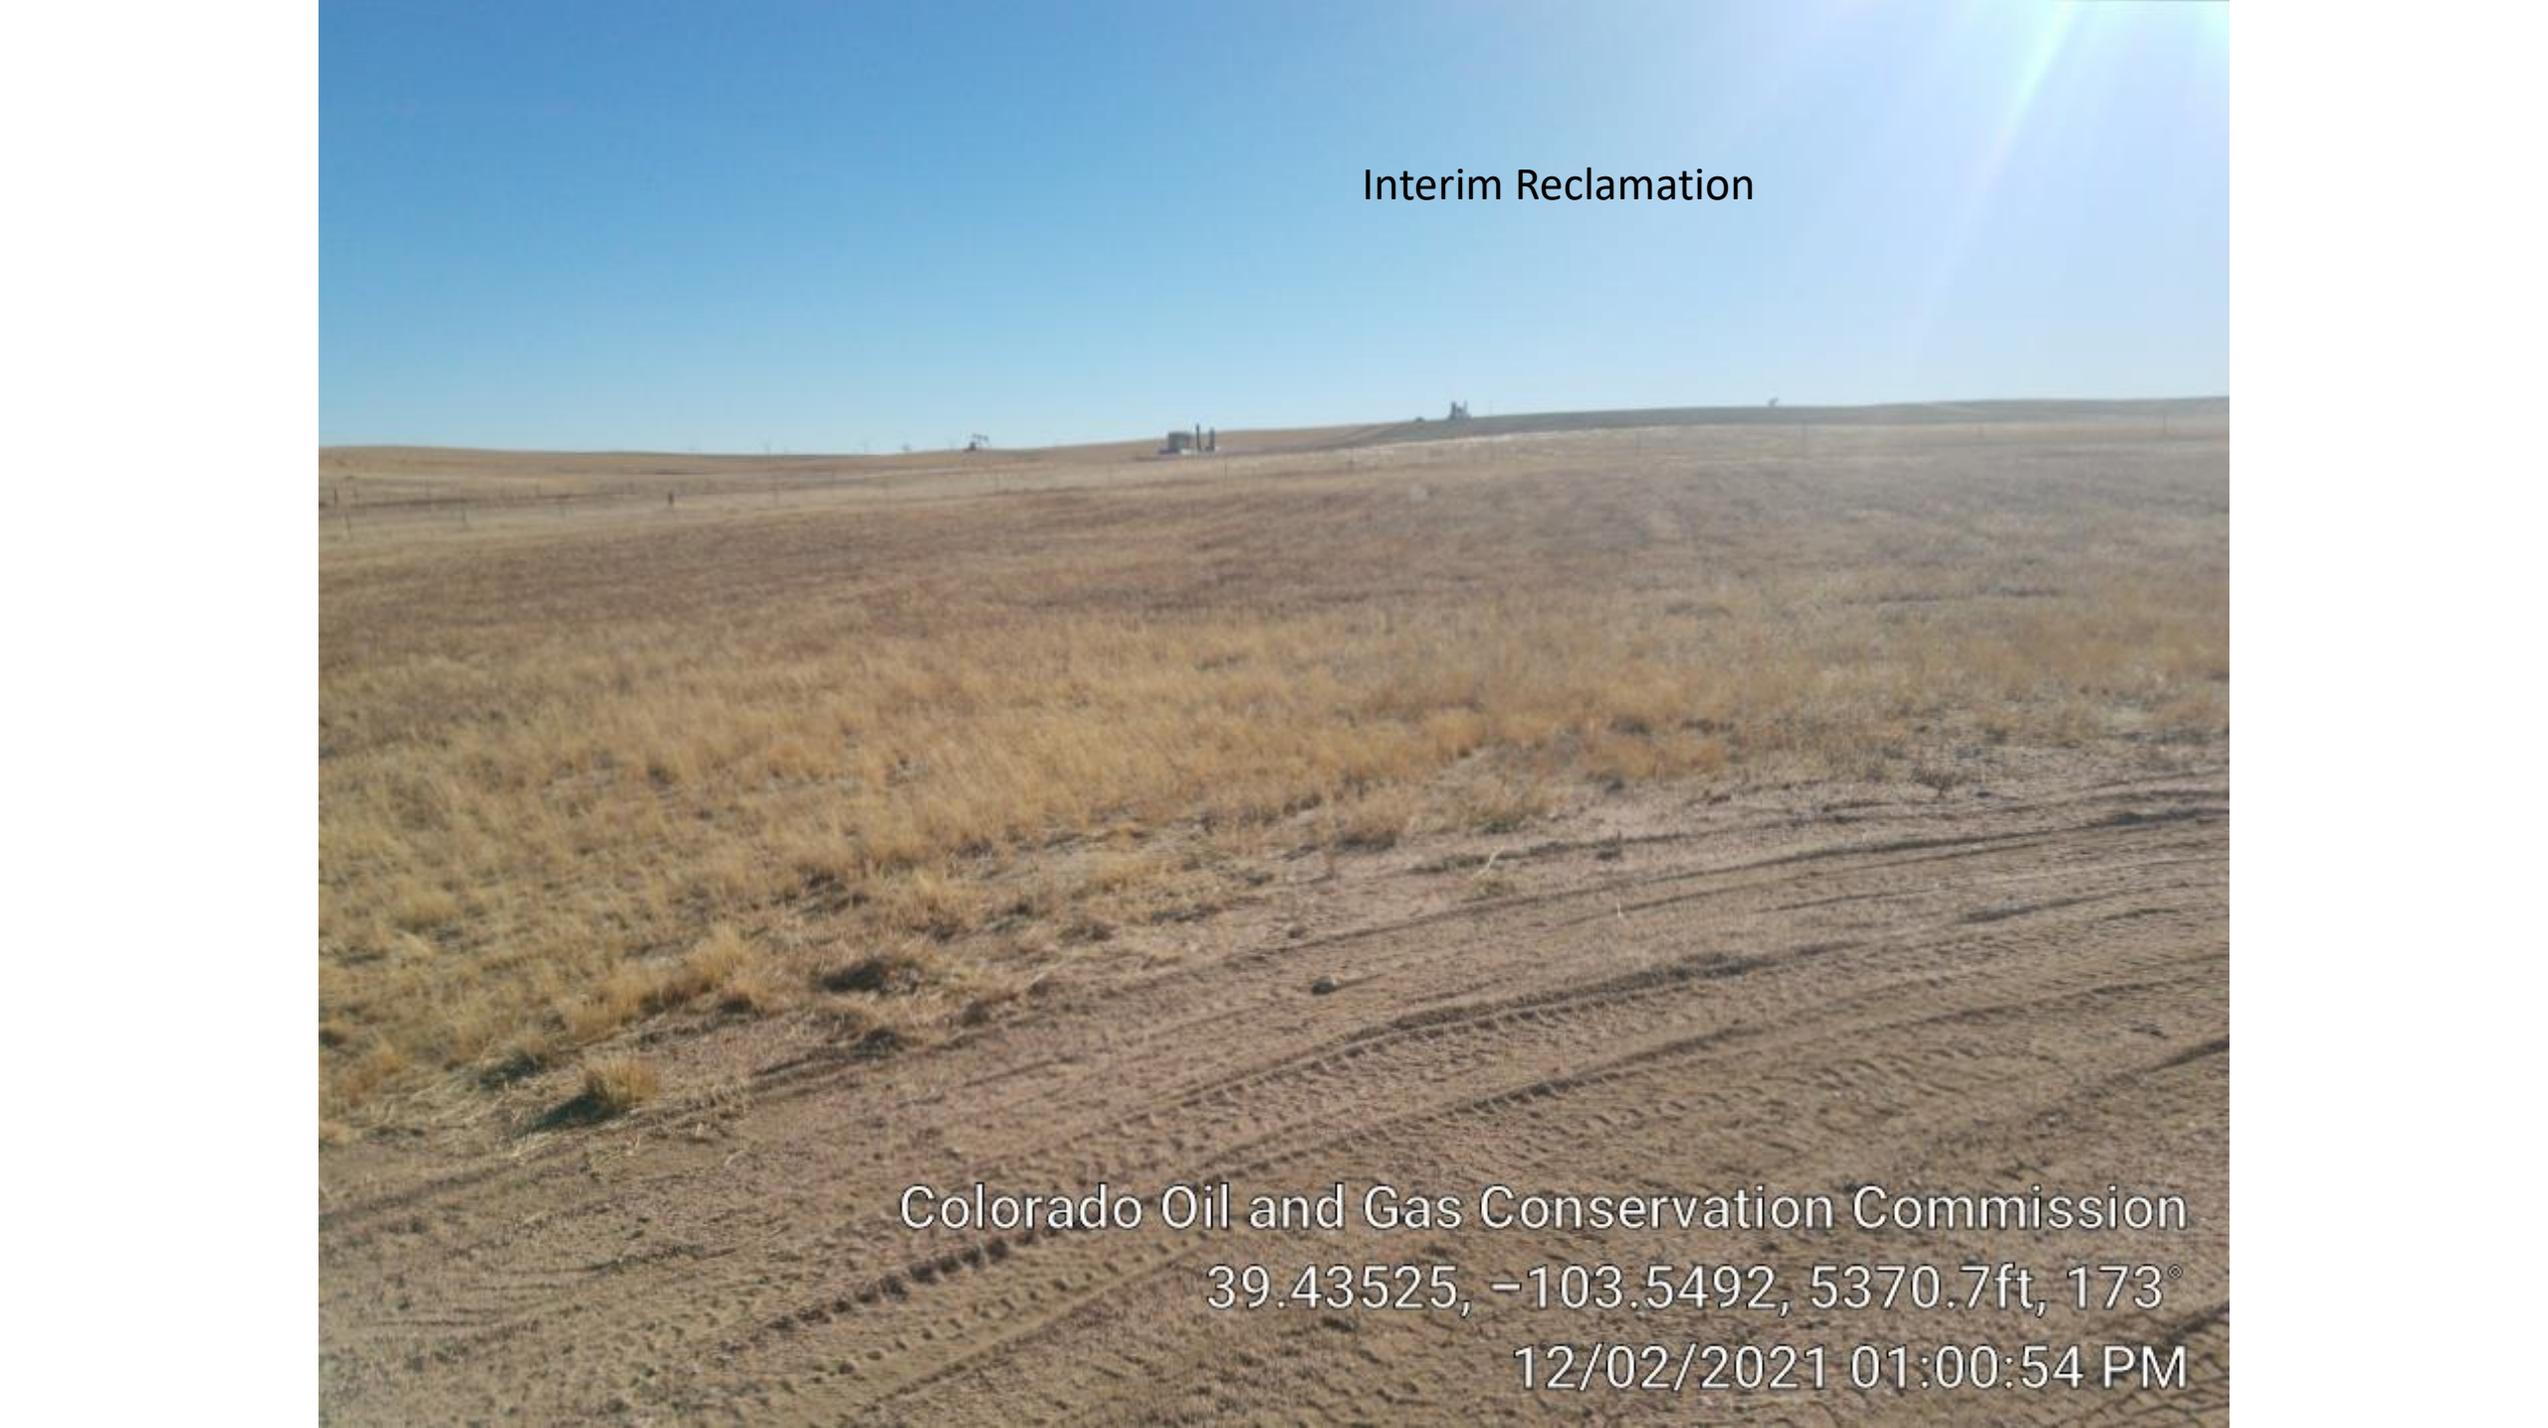
Interim Reclamation

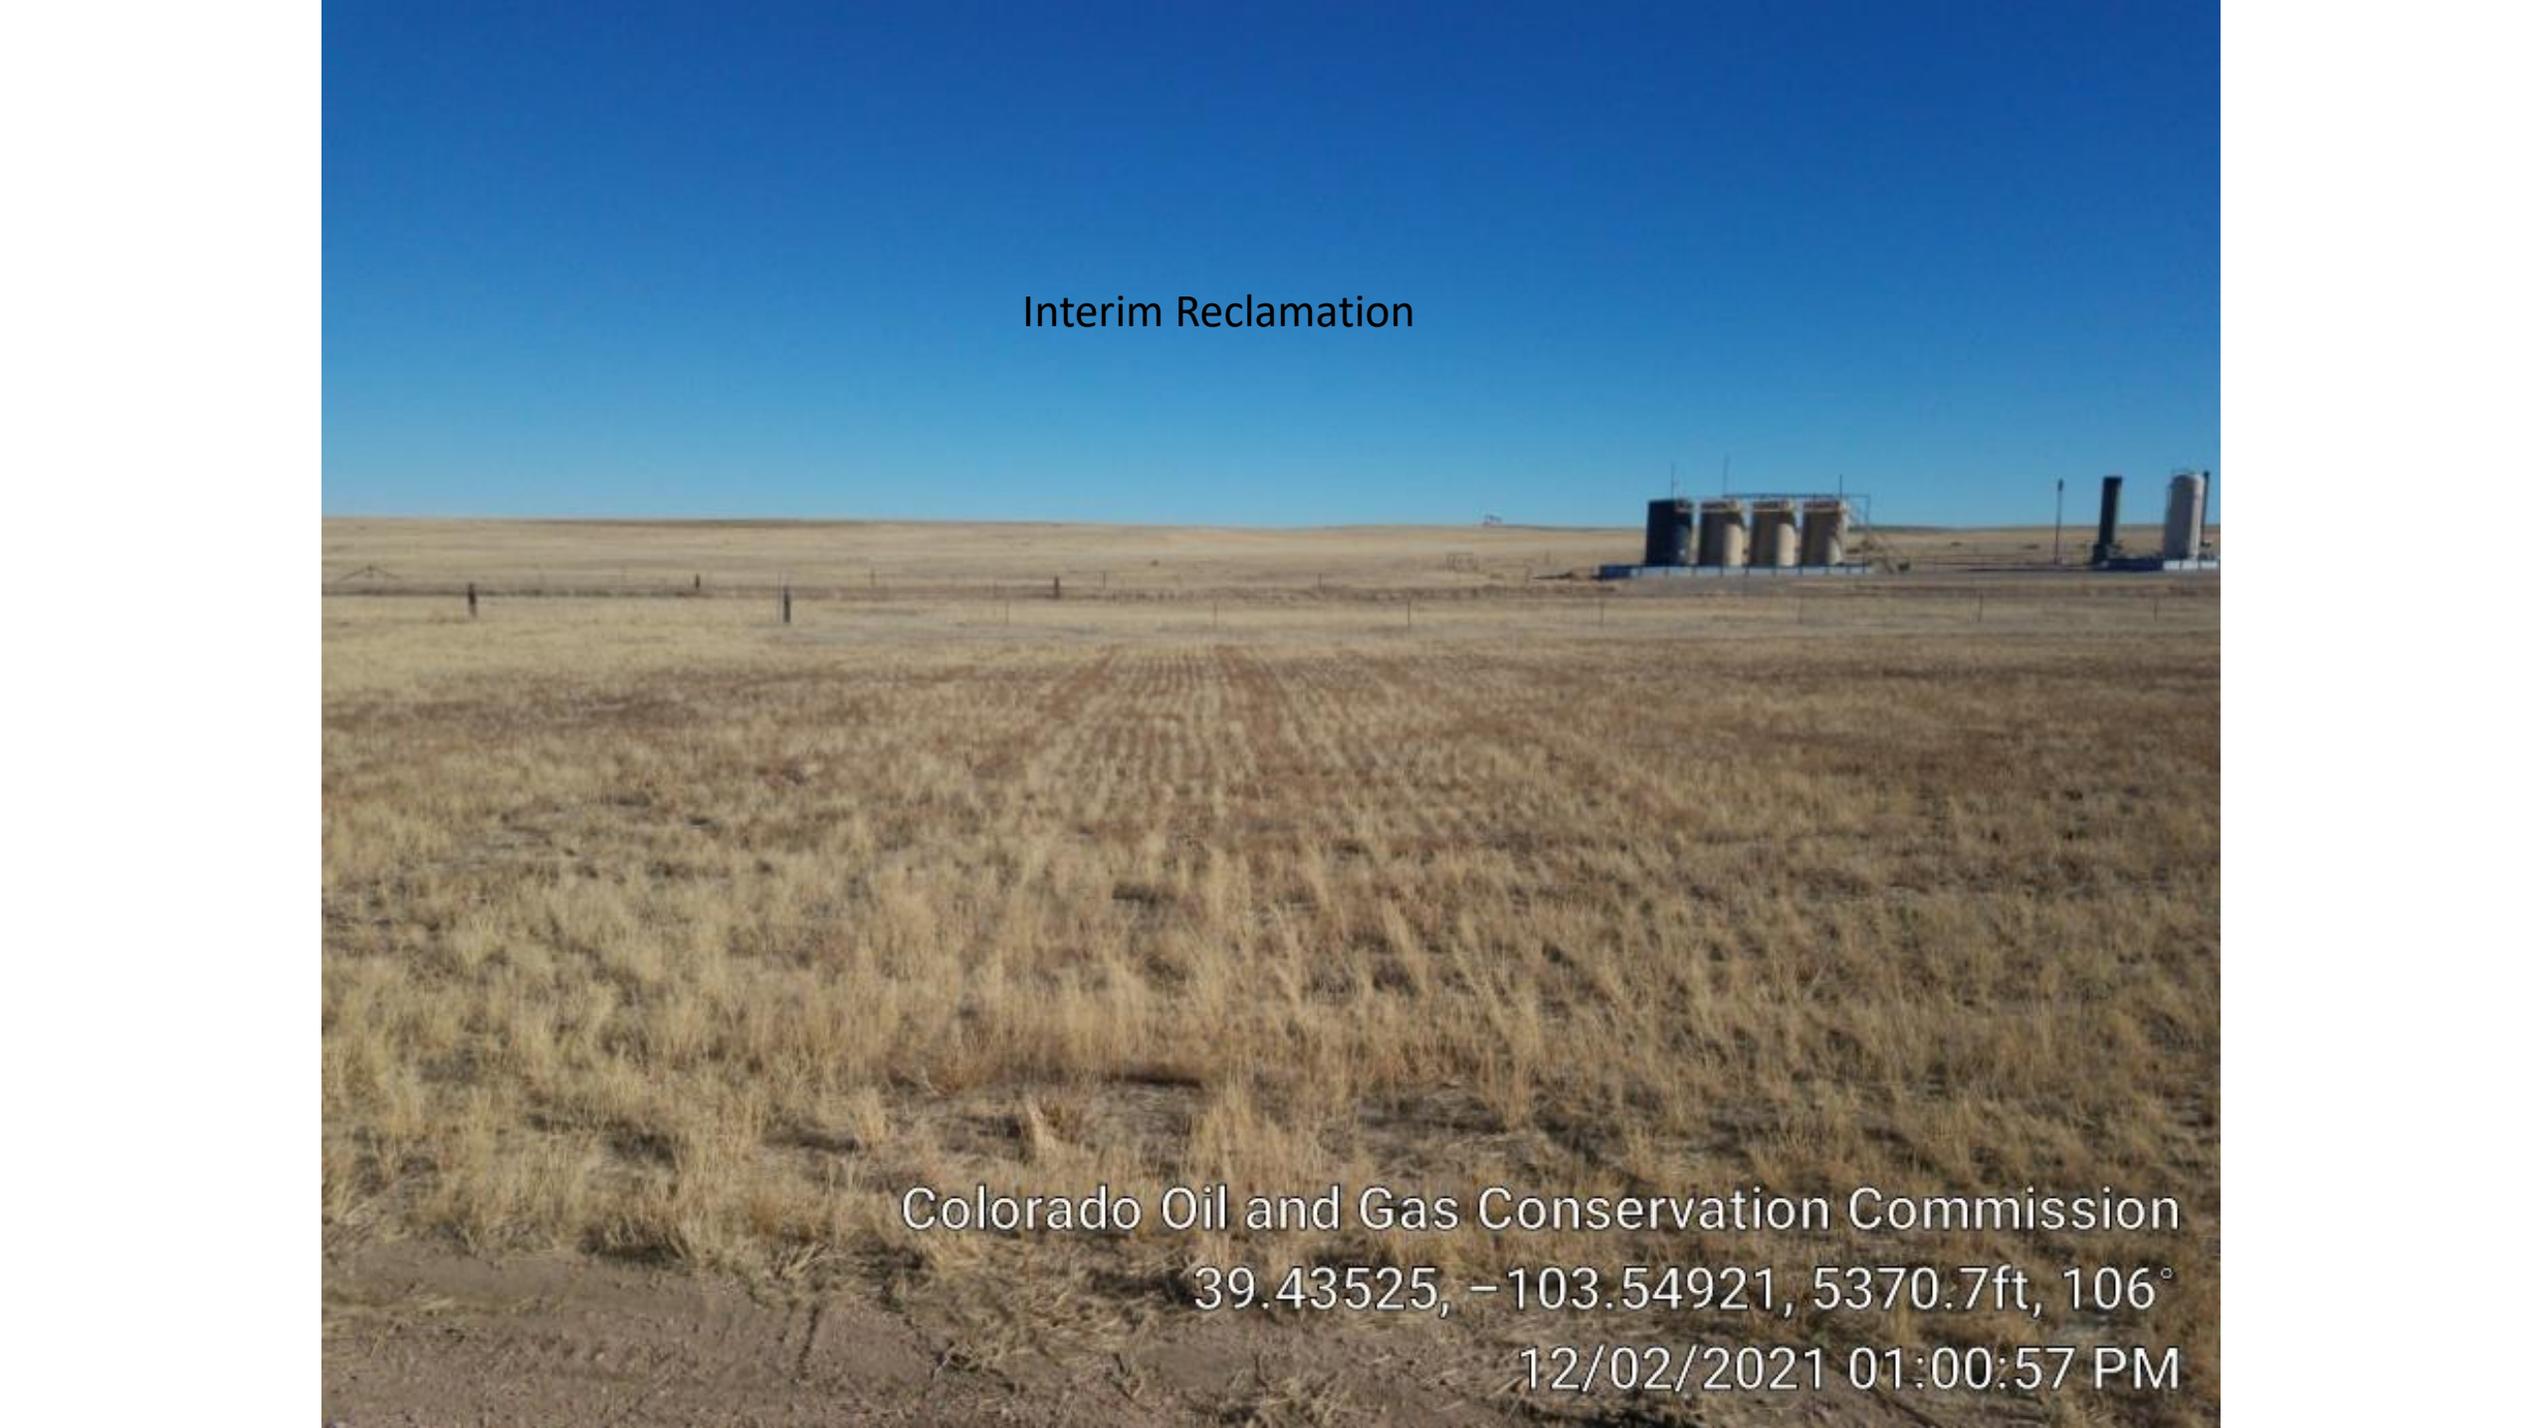
Interim Reclamation

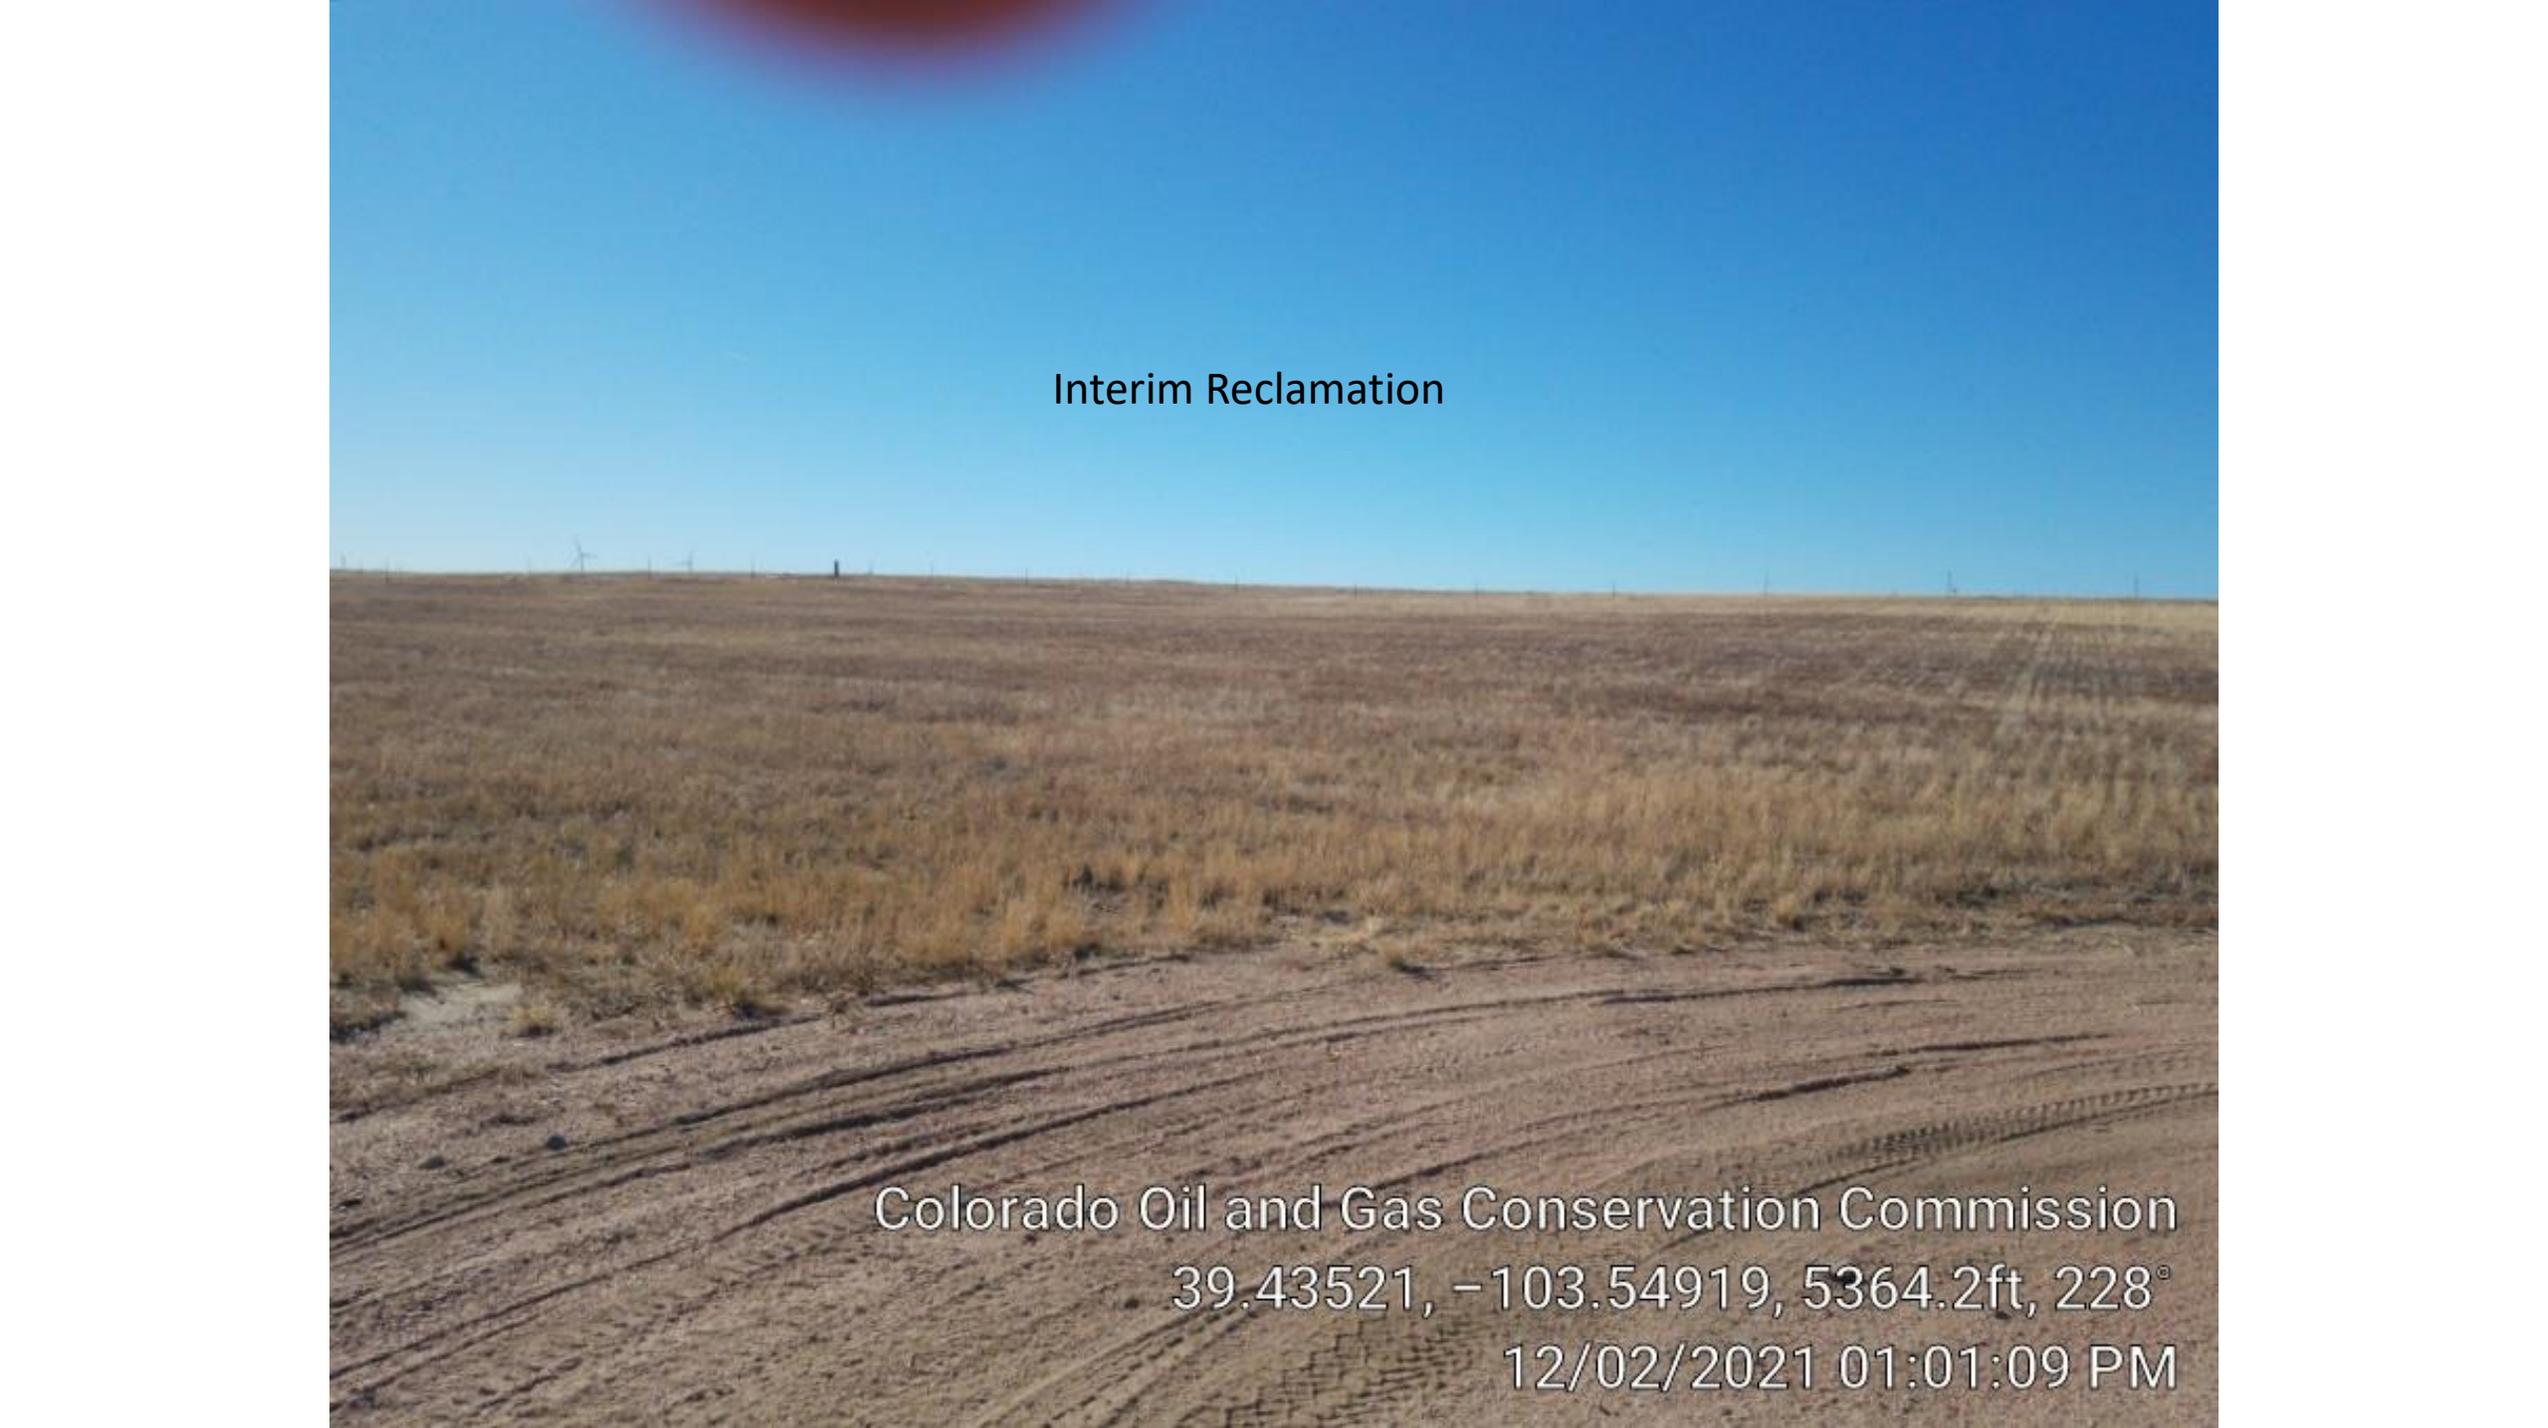
Interim Reclamation

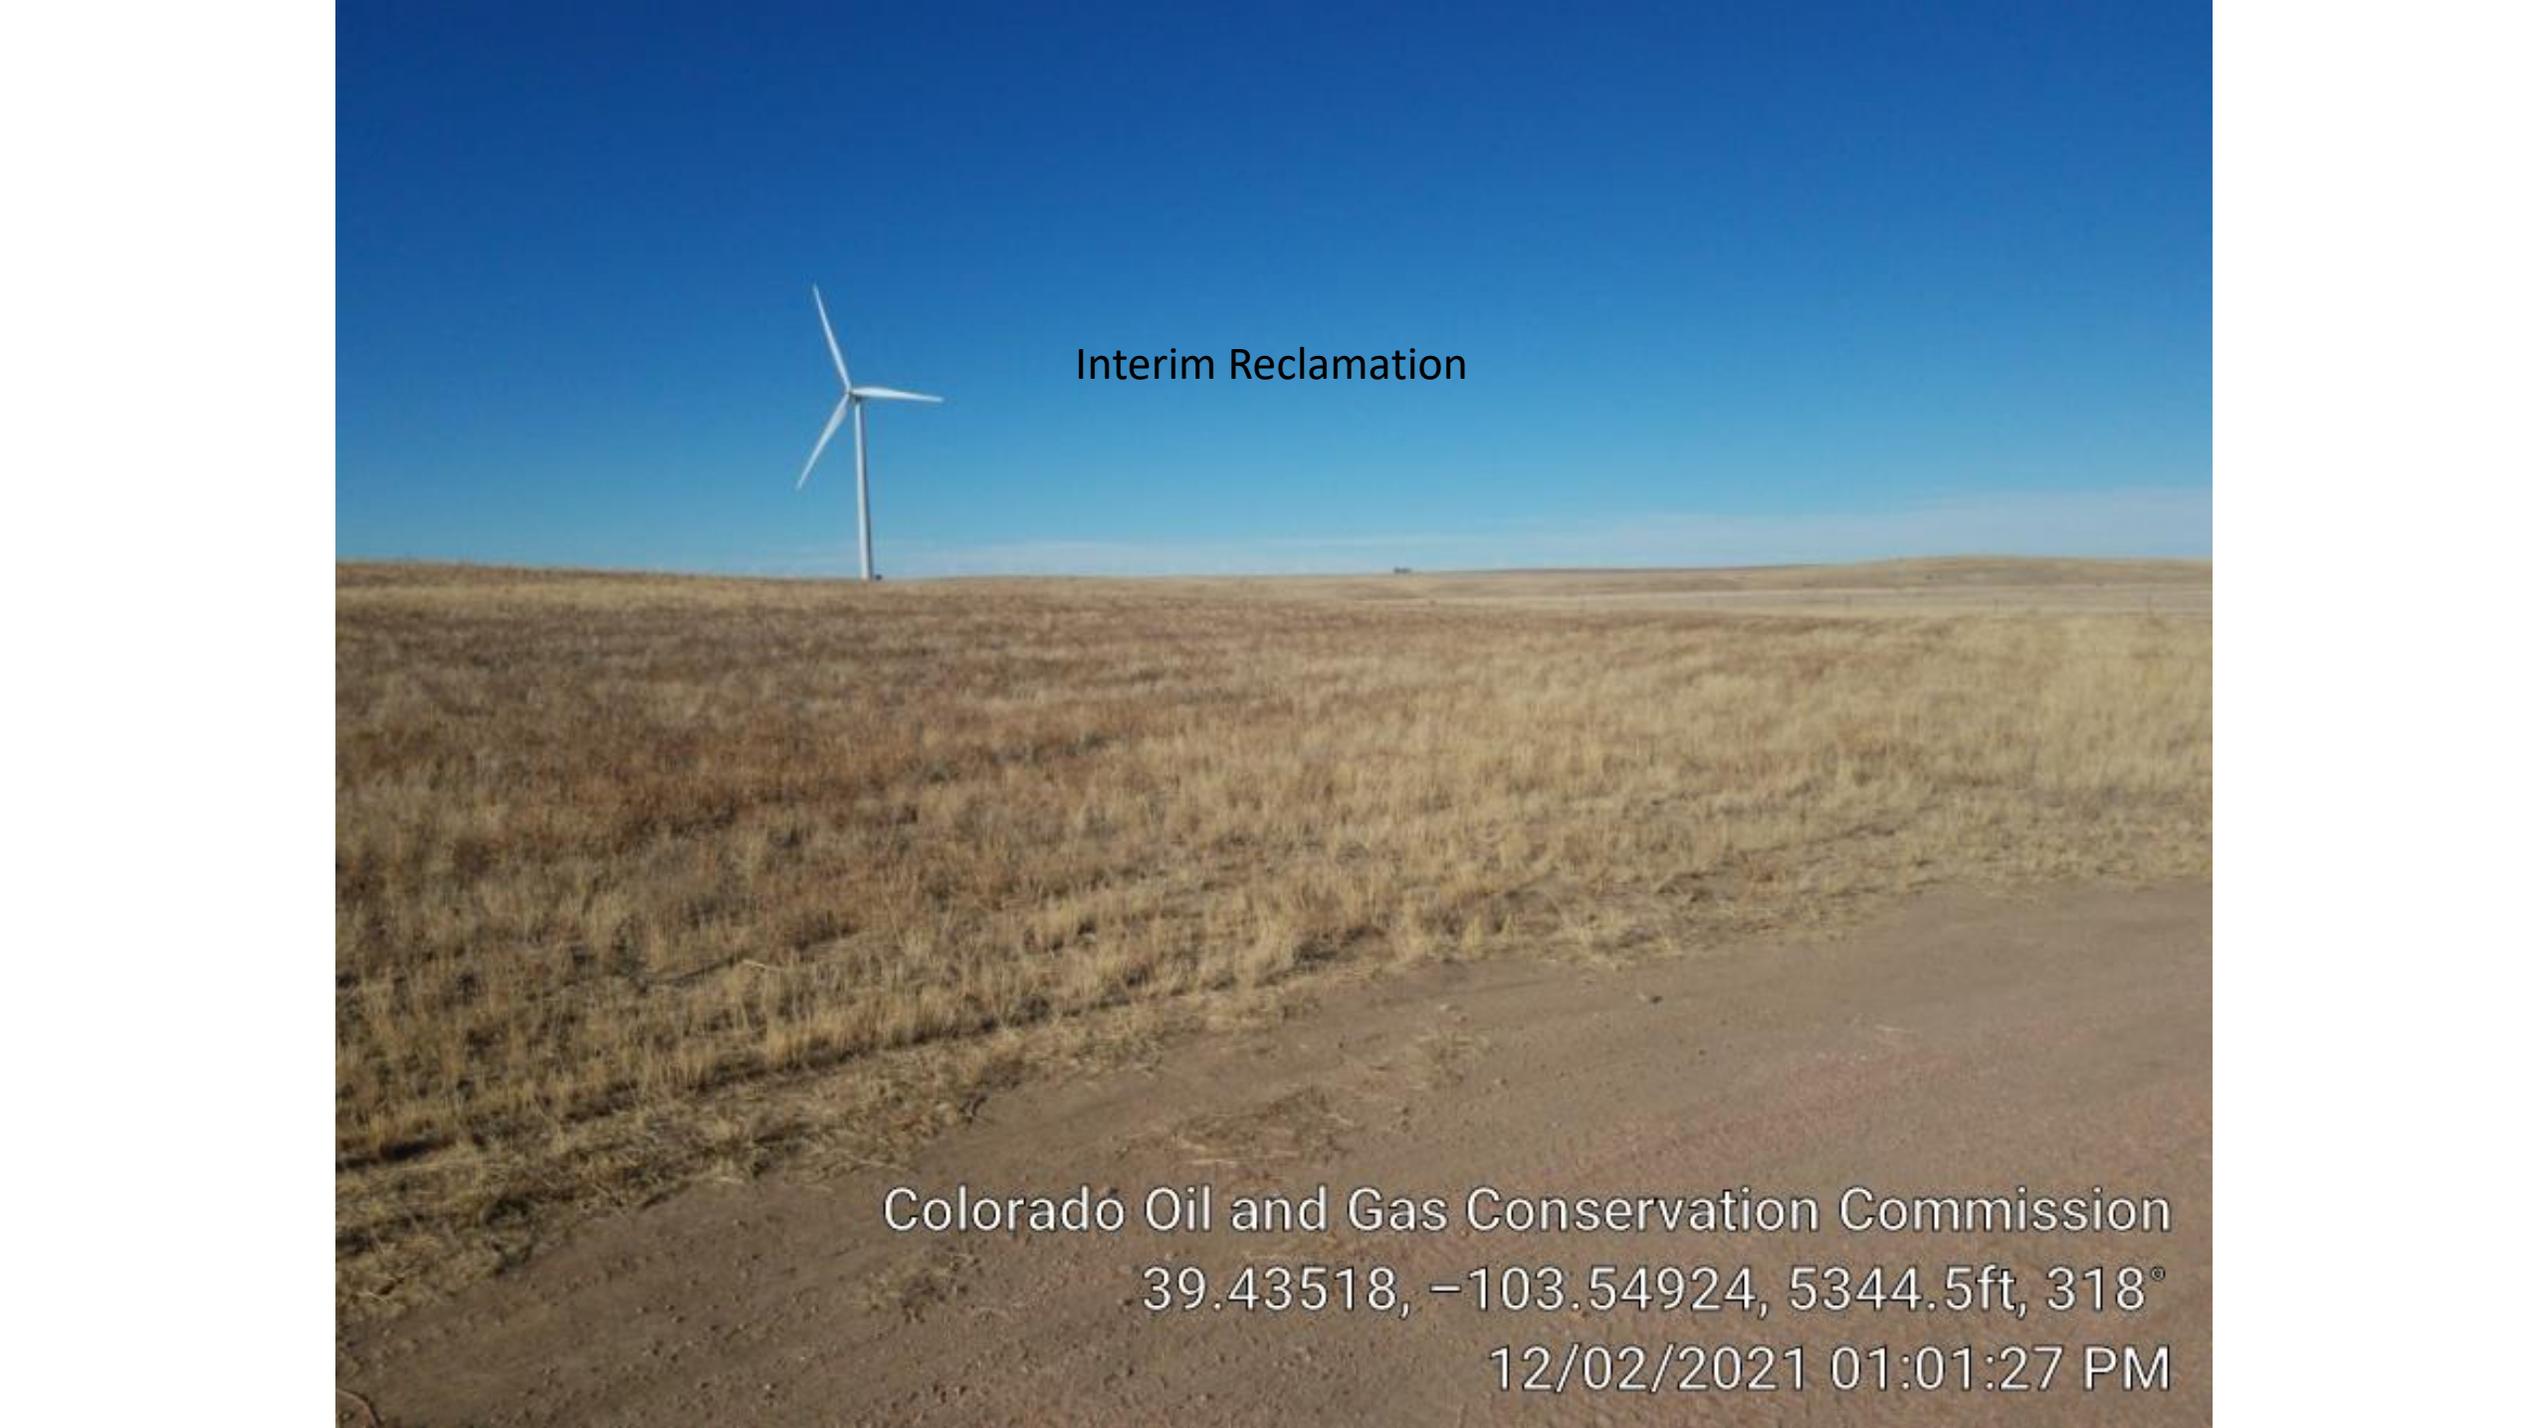
Interim Reclamation

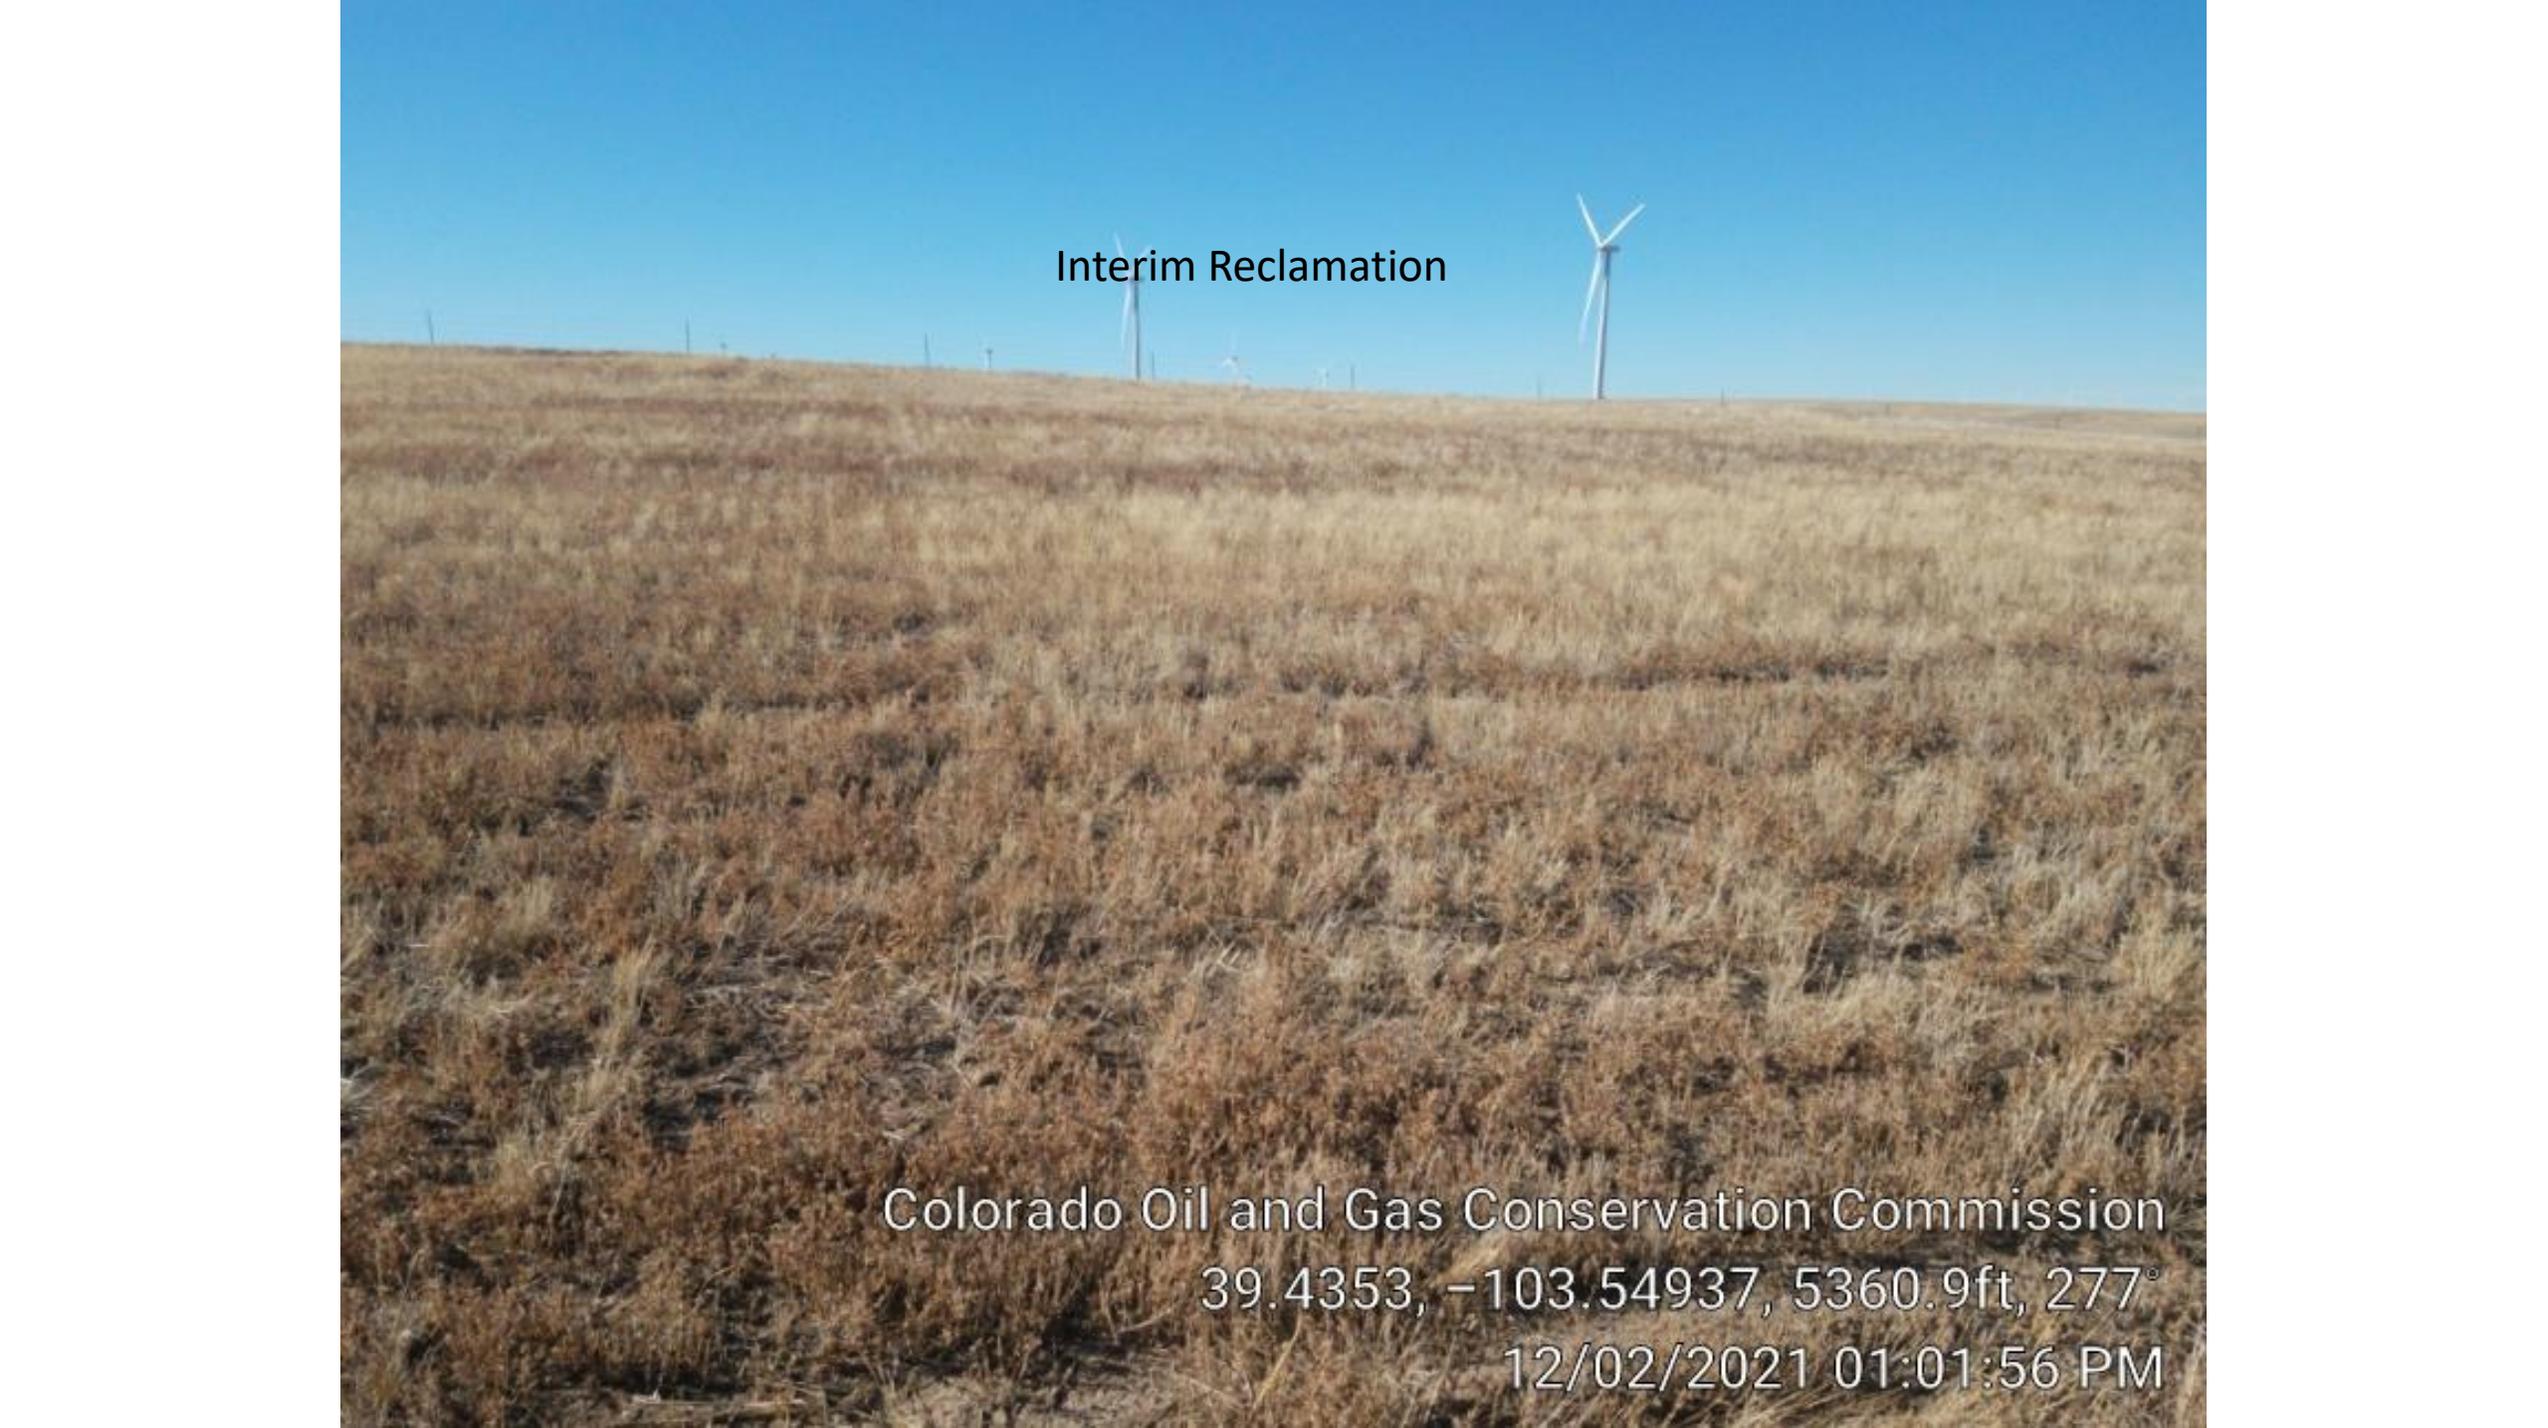
Interim Reclamation

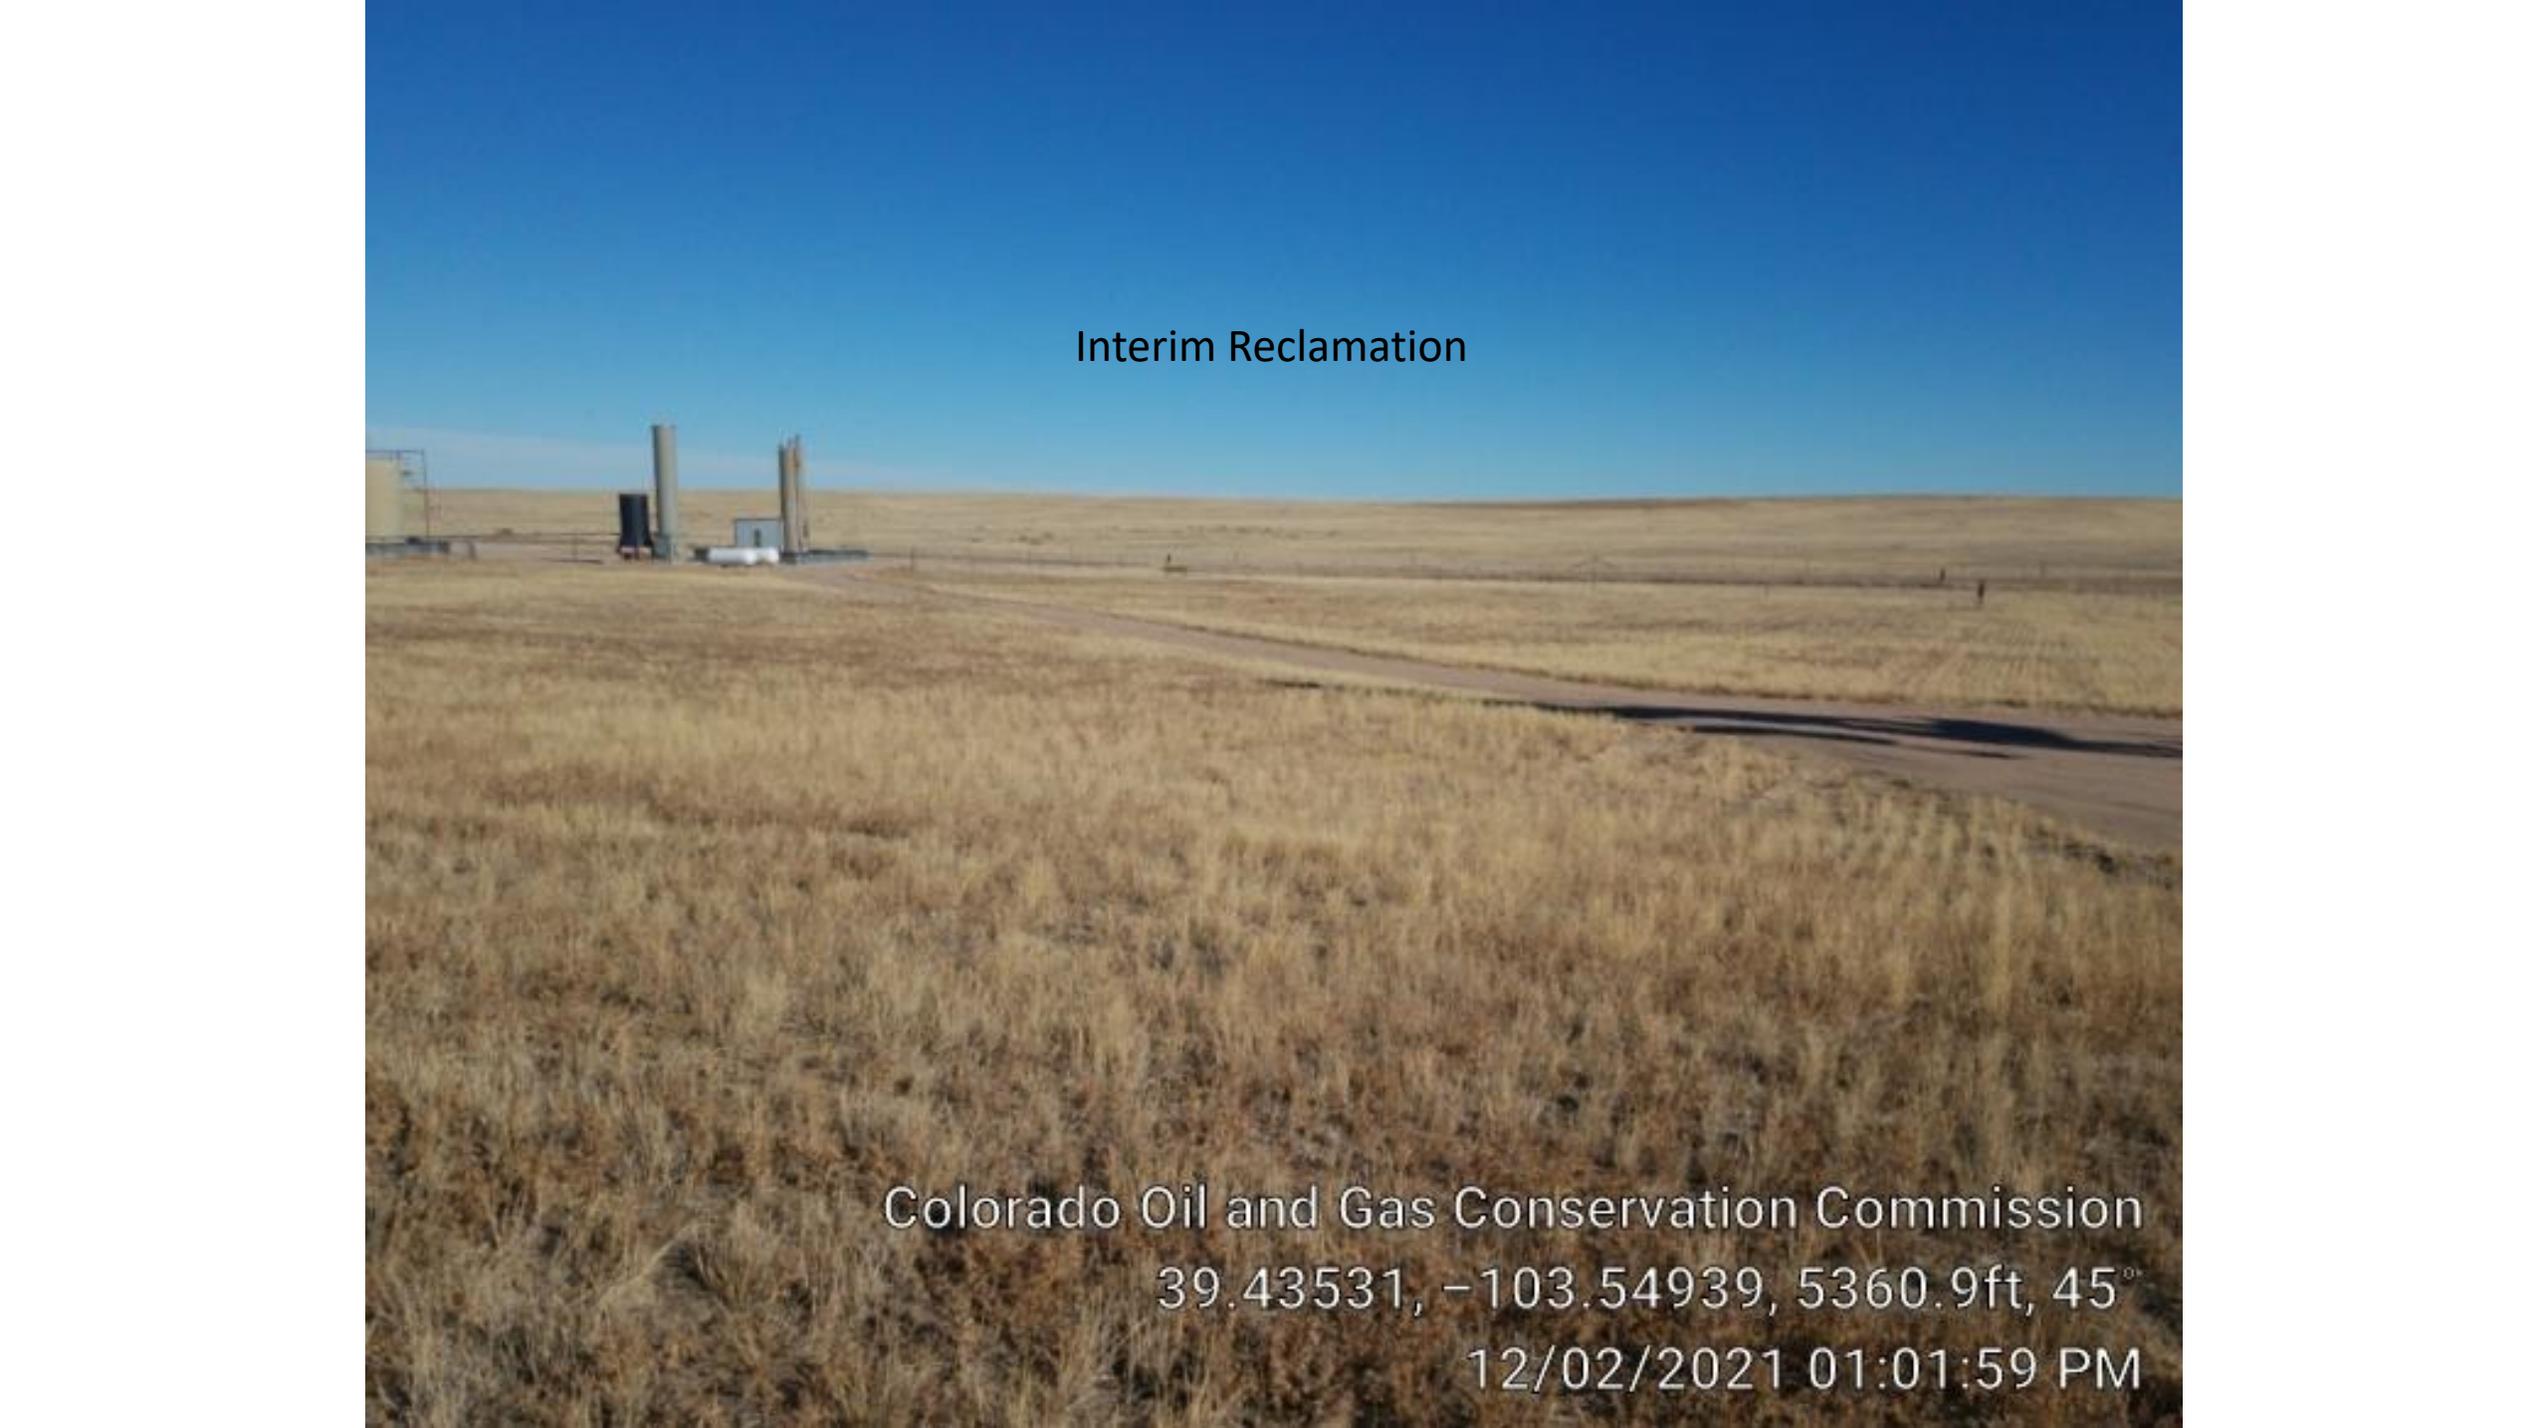
Interim Reclamation
