Grand Mesa Operating CO, Nana Unit 1-16

073-06769

Inspection #688311687

Routine Field Inspection

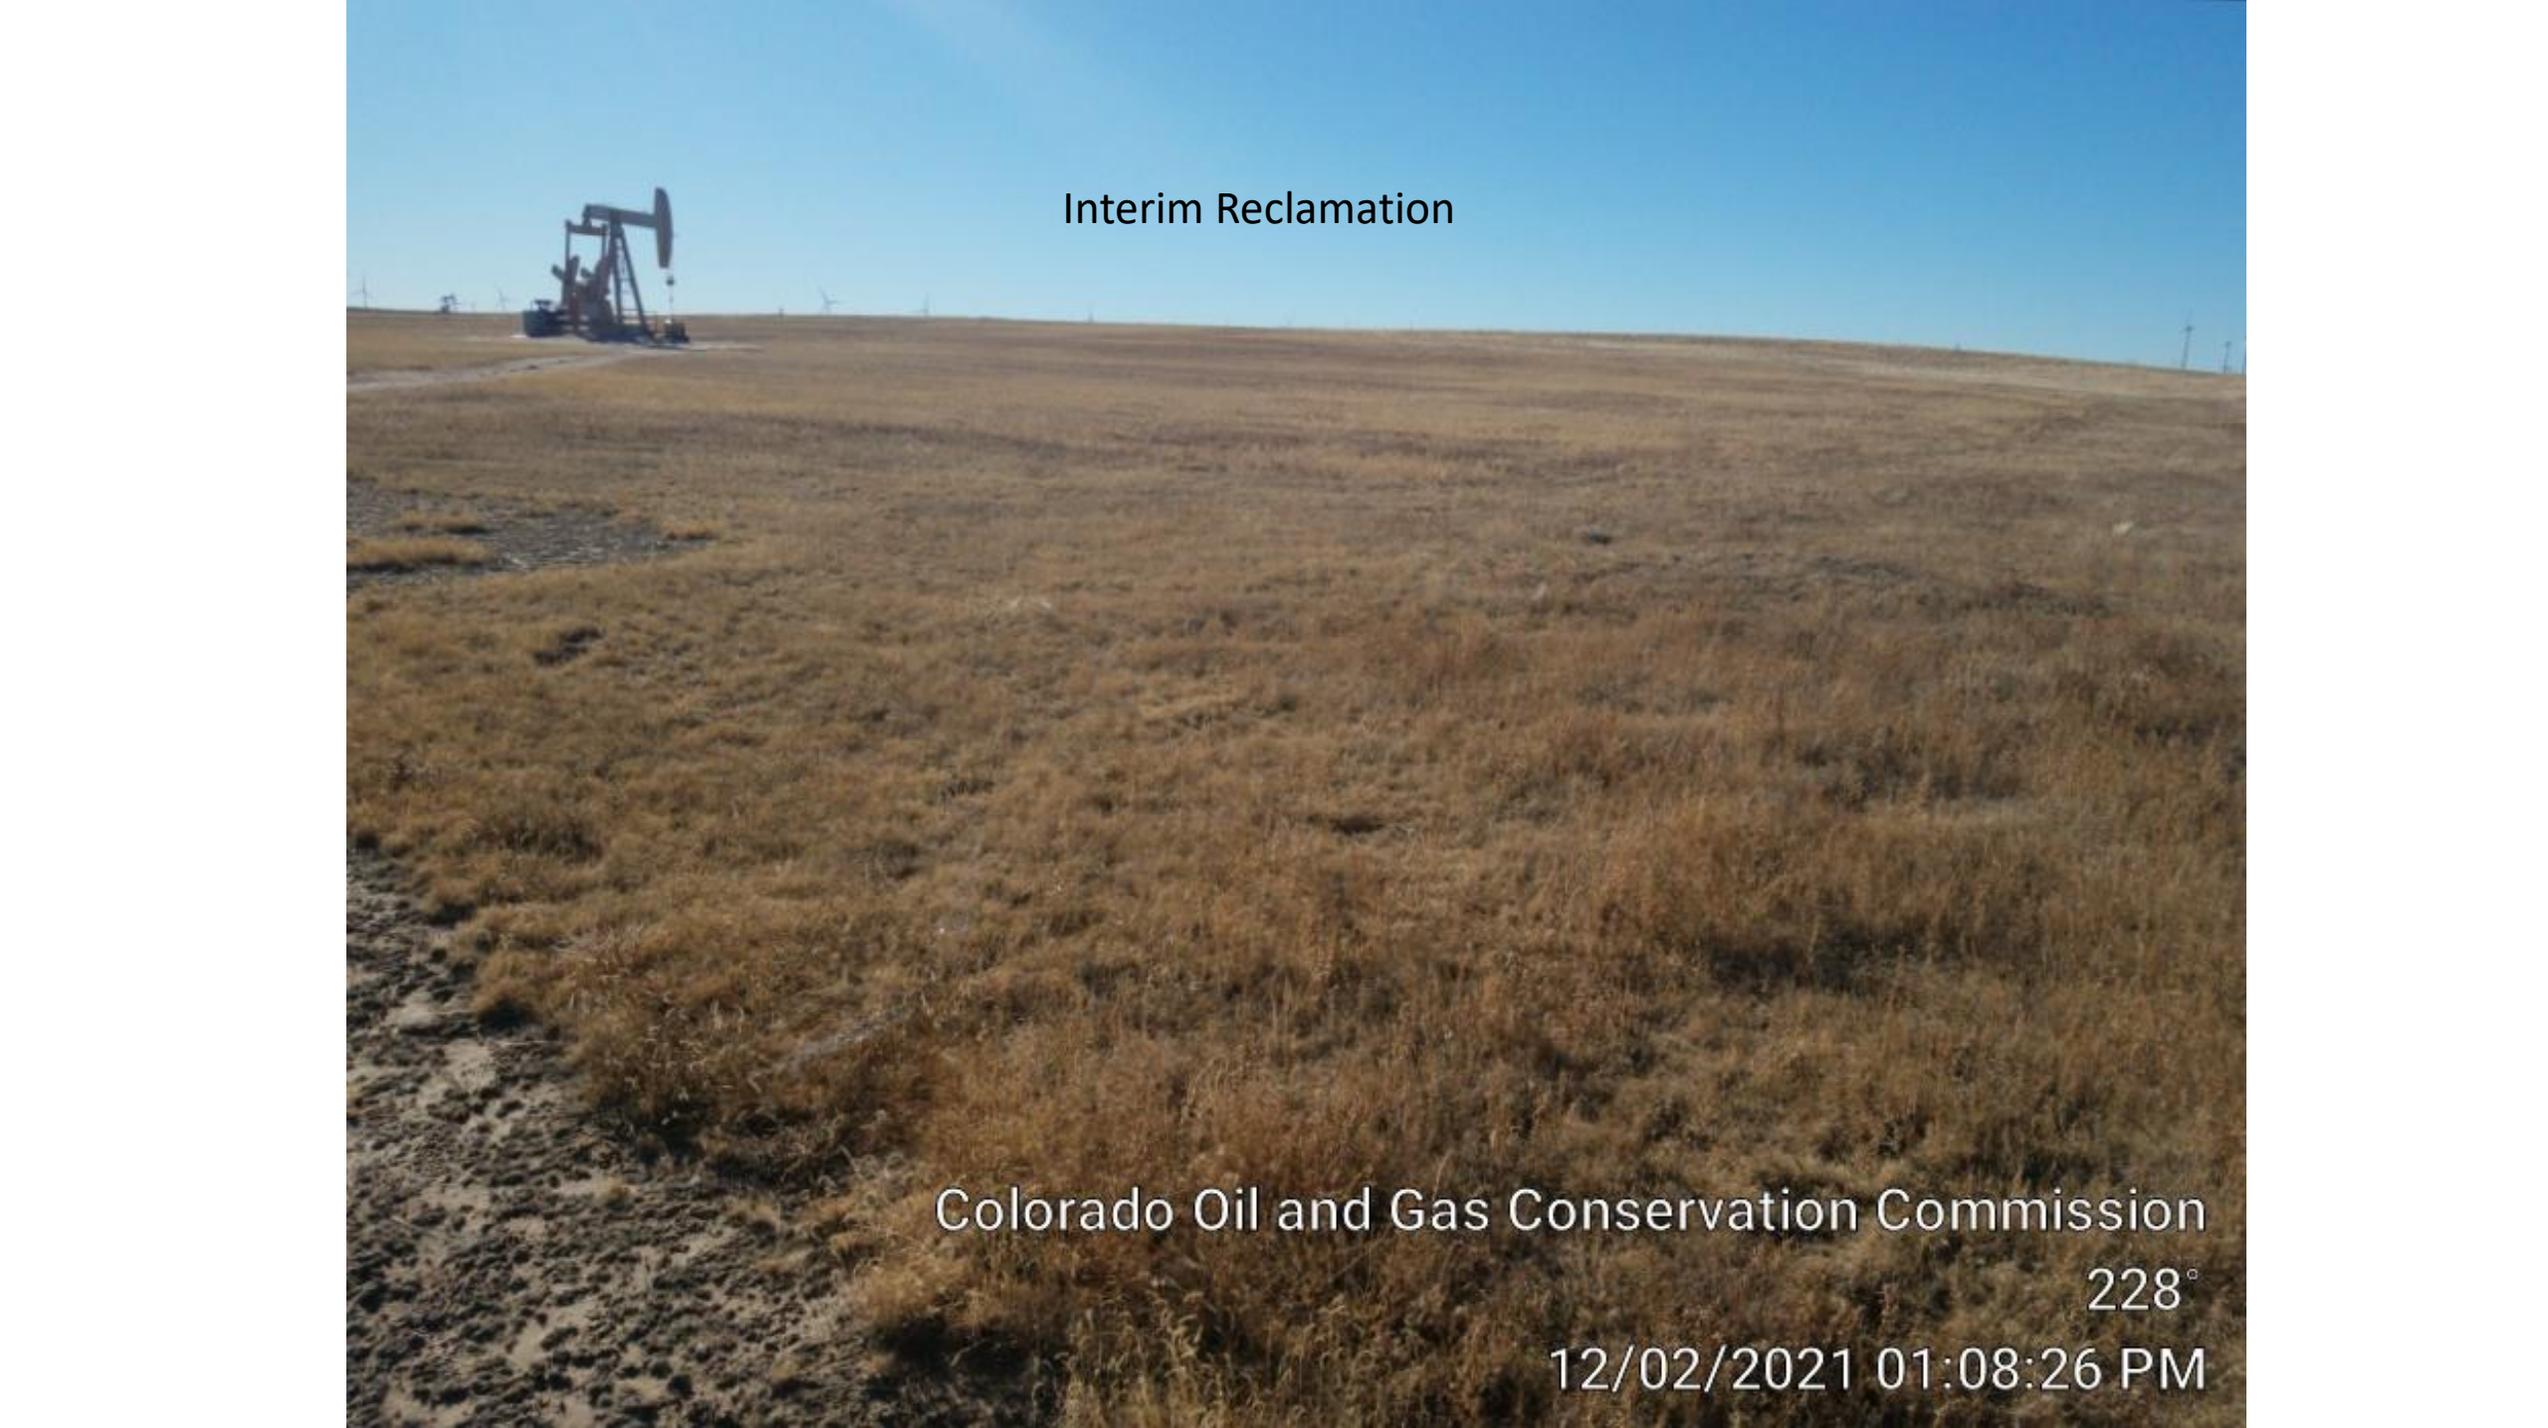
Interim Reclamation

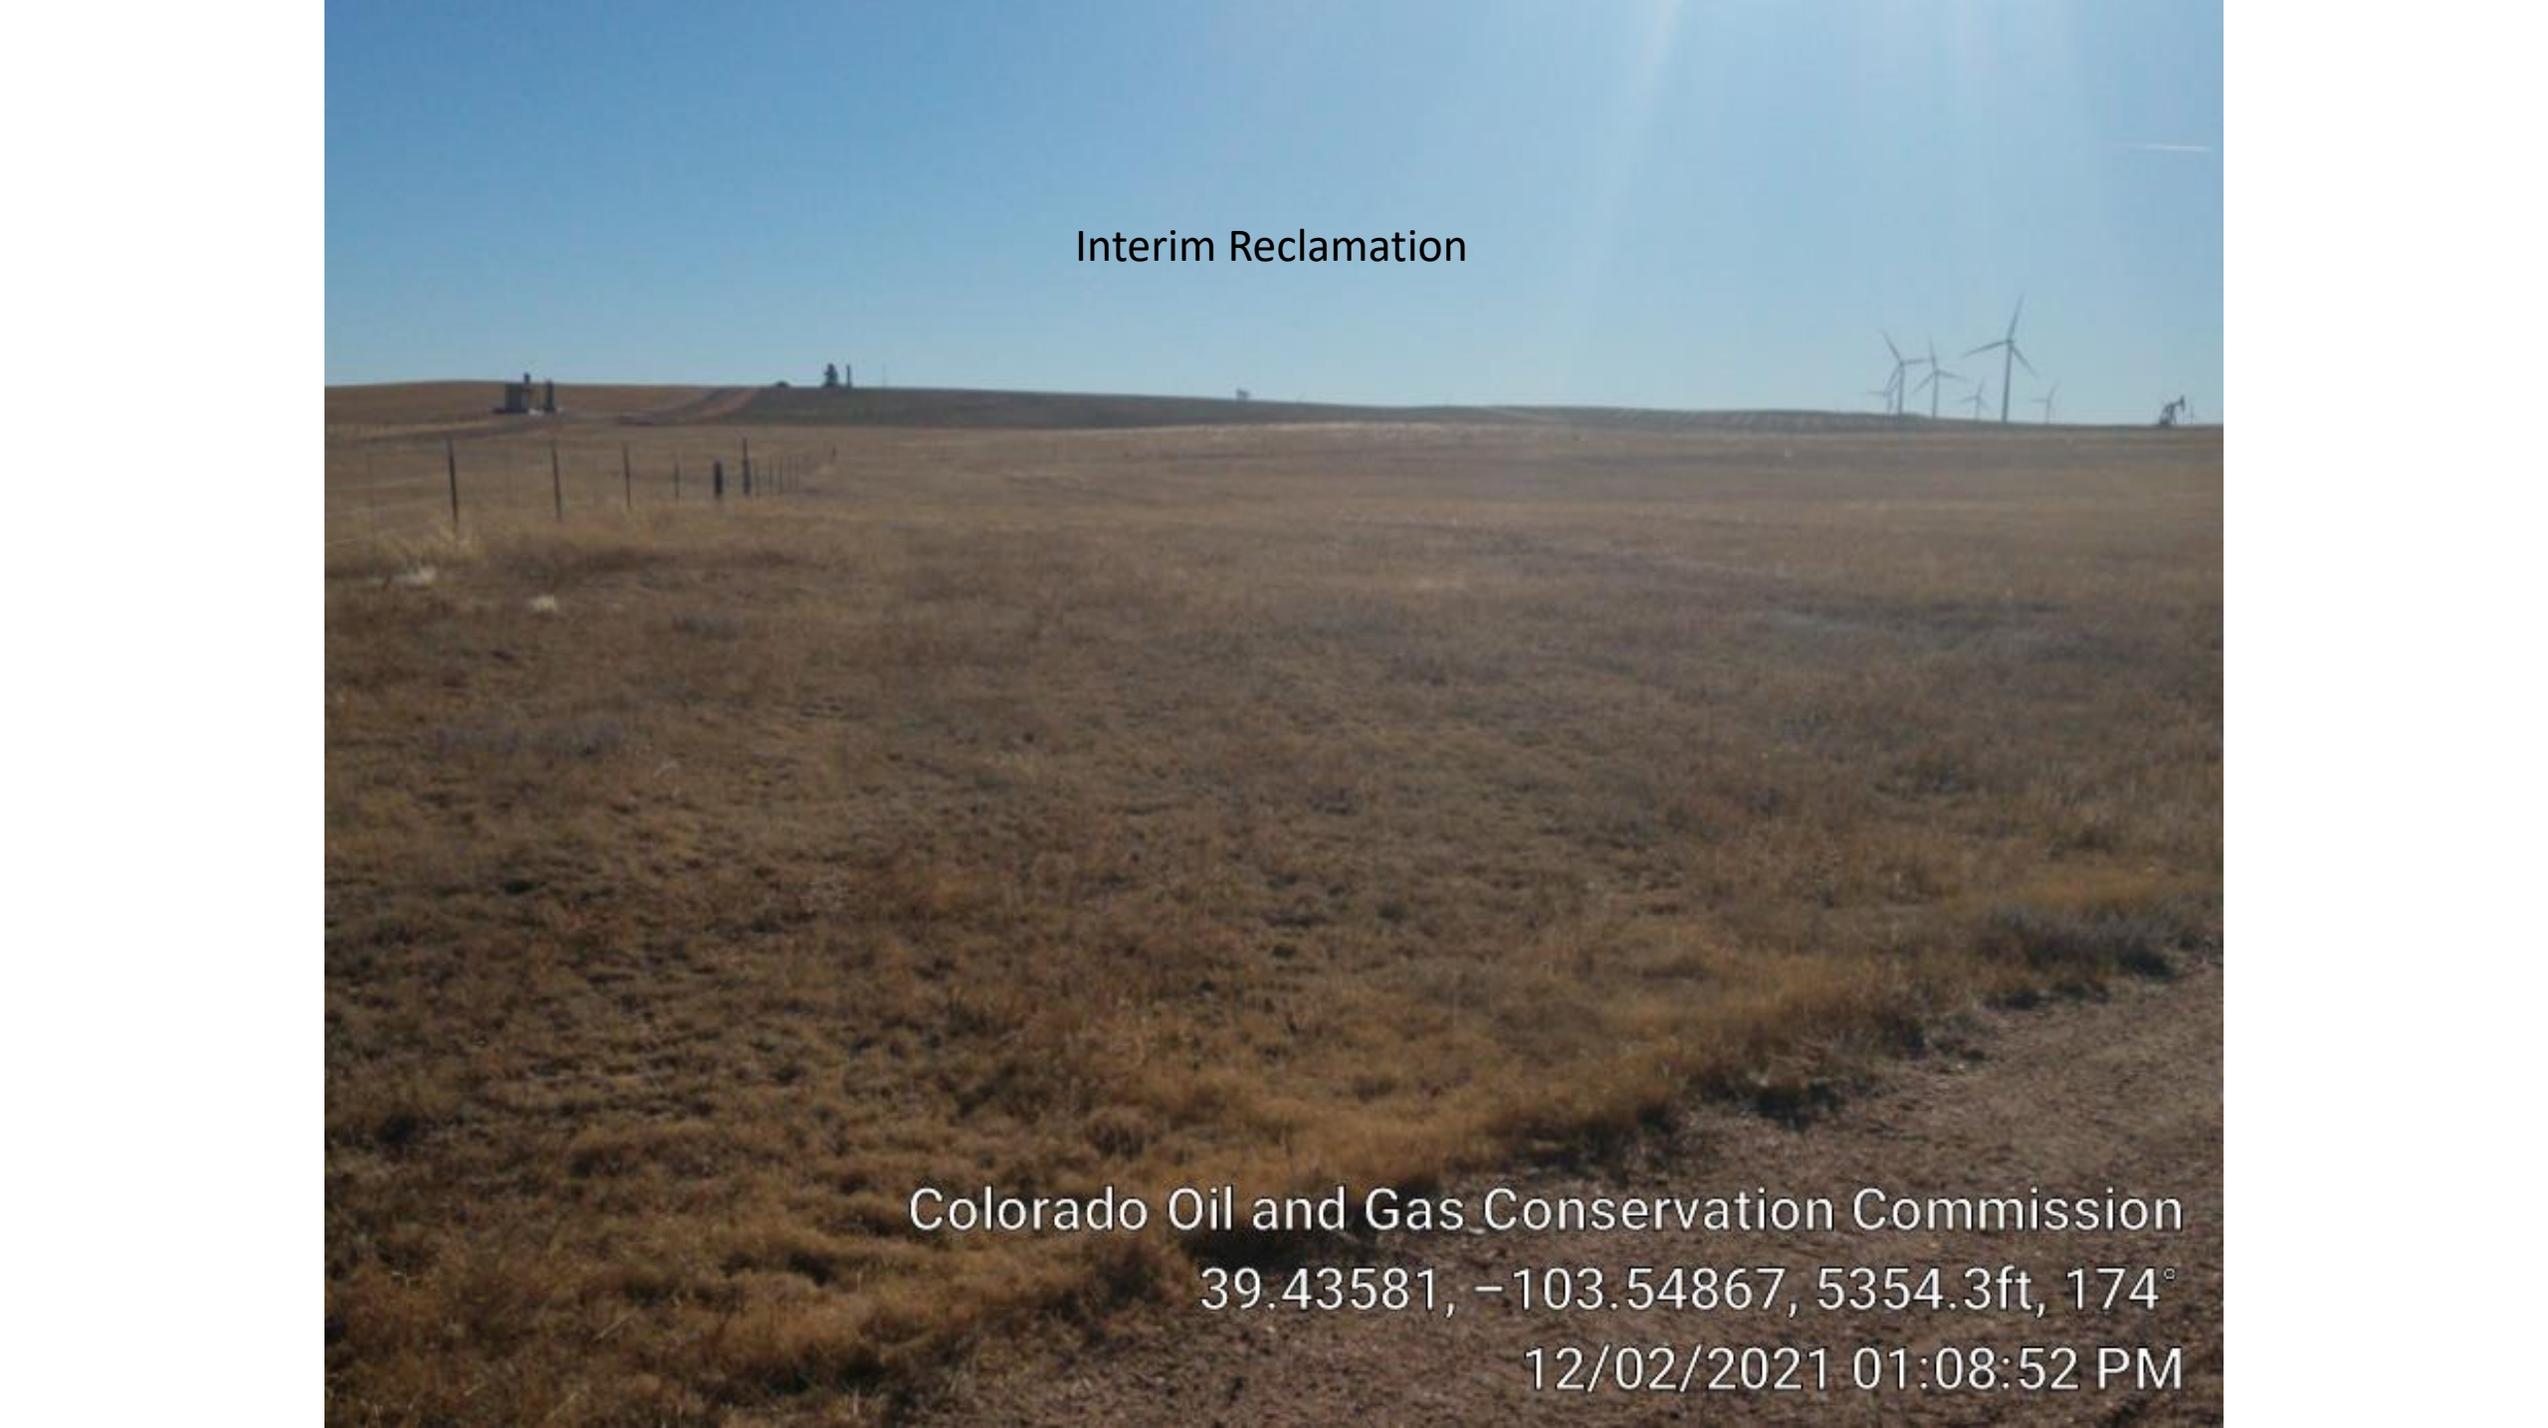
Interim Reclamation

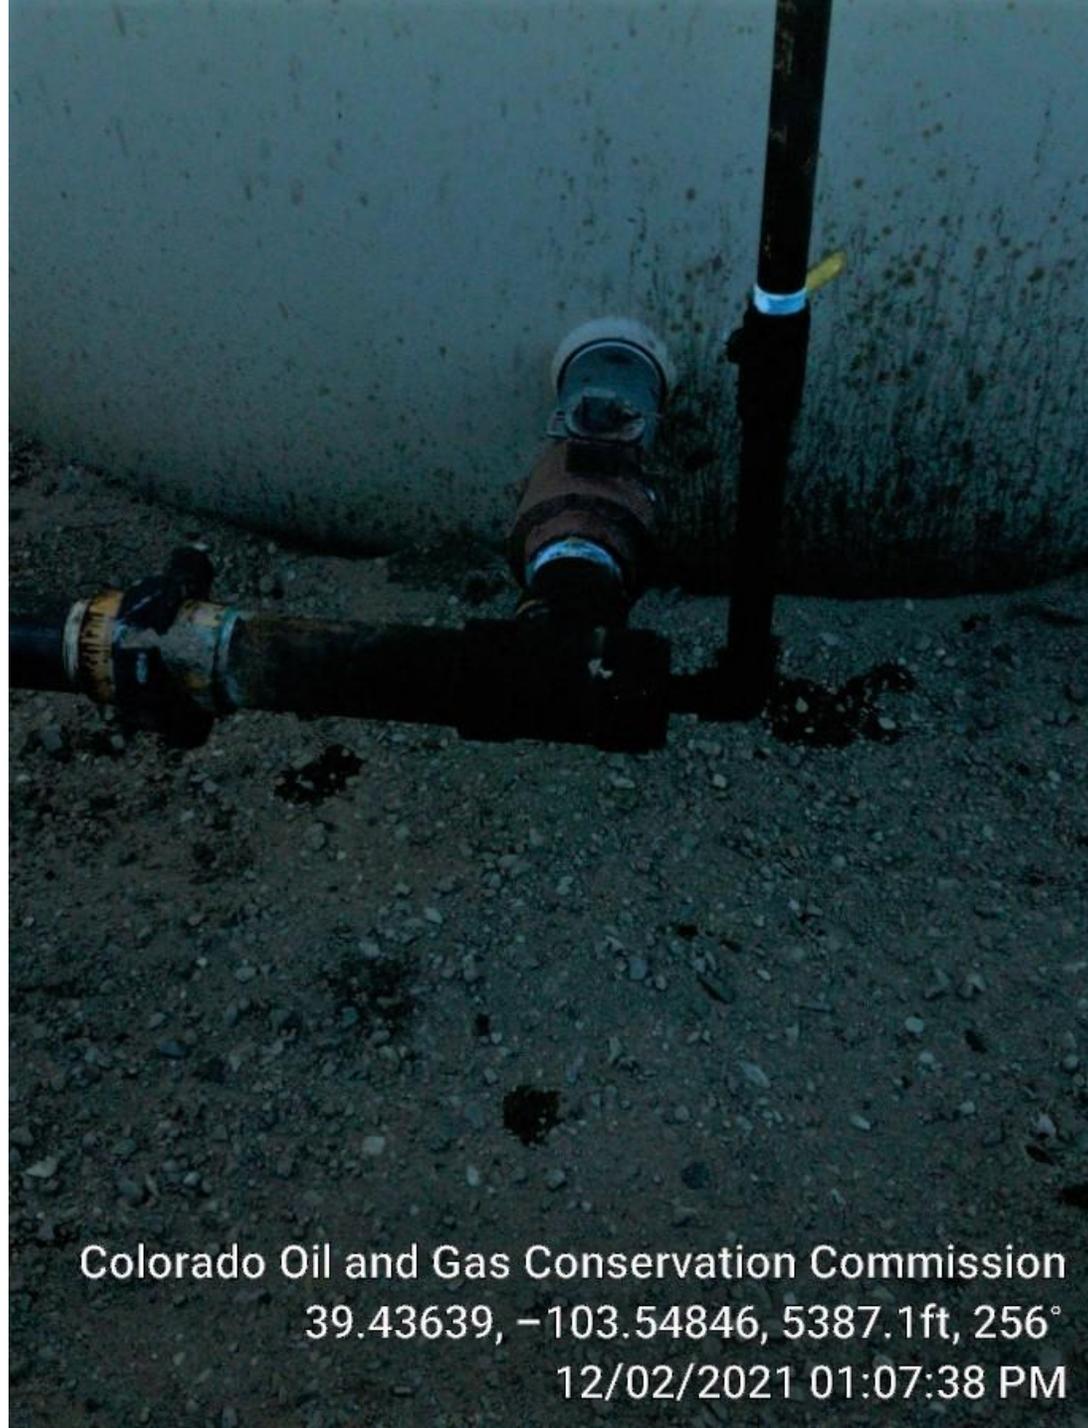
Mechanical conditions at  
tank valve.
