Grand Mesa Operating CO, Dado 2-21  
073-06770

Inspection #688311692

12/2/2021

Routine Field Inspection

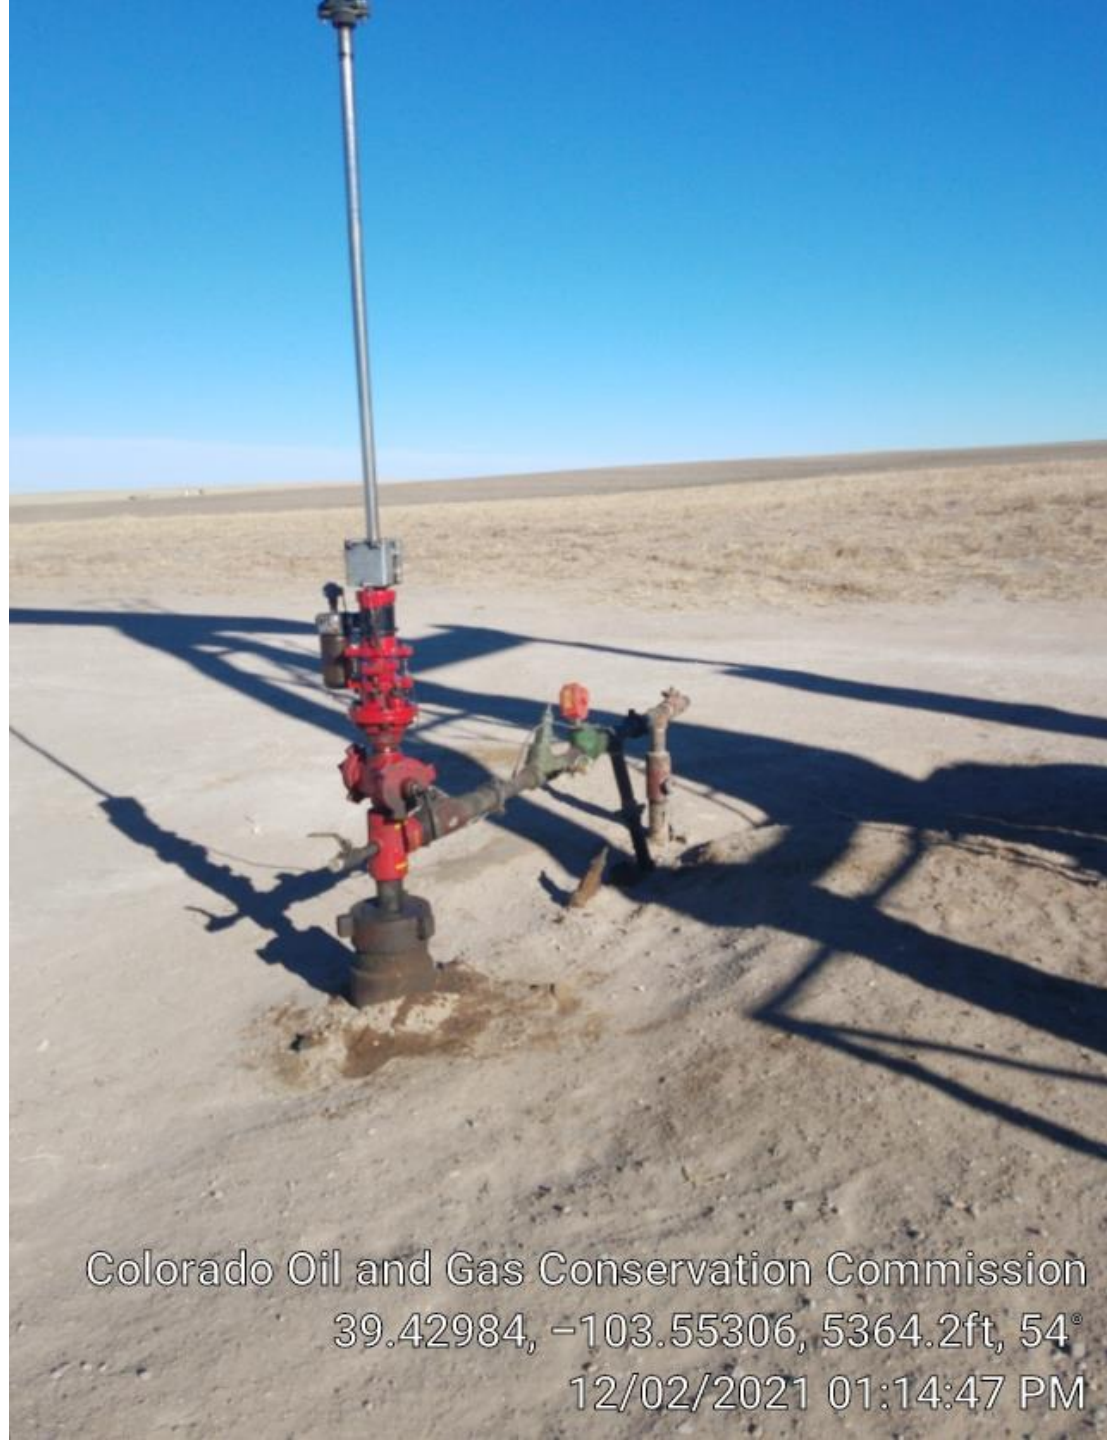
Stuffing box leak.
