Inspection Photos
Location Name: Rea 18U-03 #2
API: 05-067-08701

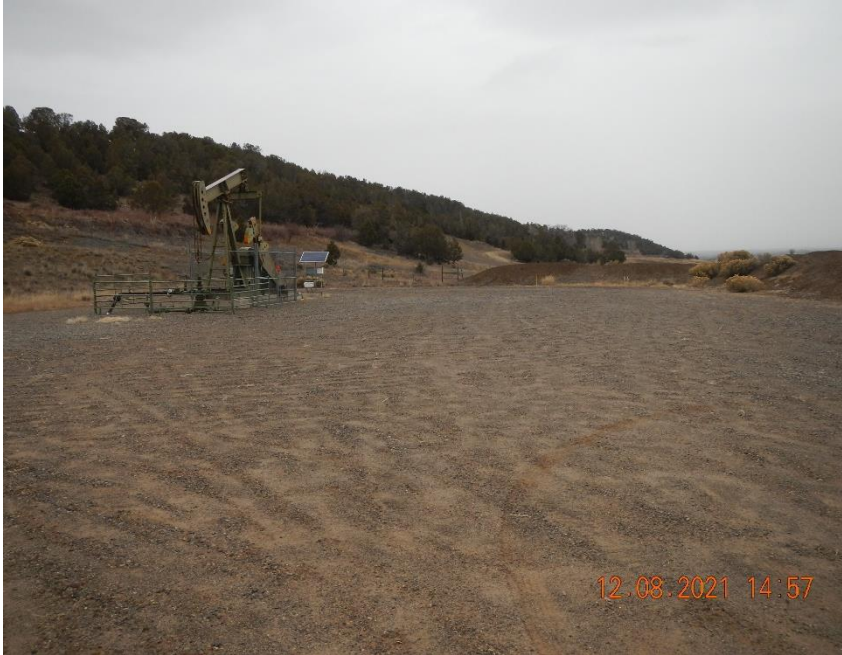
Rea 18U-03 #2 location photo.

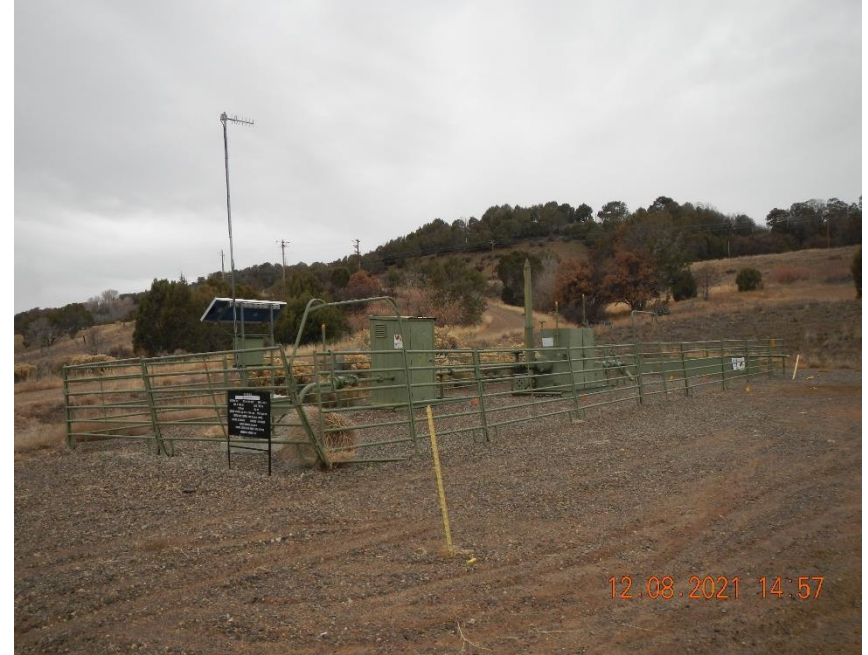
Rea 18U-03 #2 production equipment.

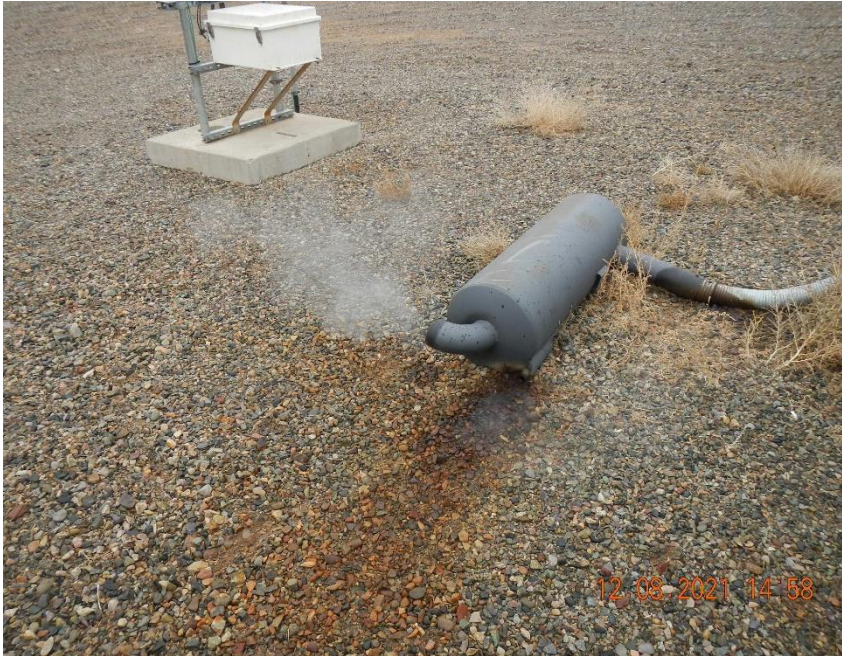
Stained gravel near prime mover exhaust.

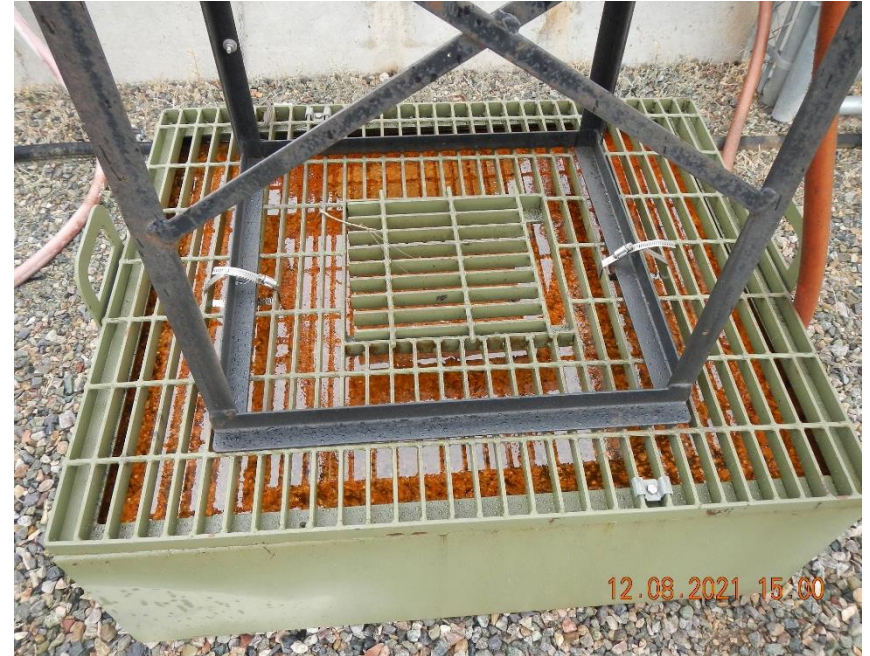
Secondary containment for lube oil container is almost full.
