Inspection Photos

12/07/2021

Operator: TEP ROCKY MOUNTAIN LLC #96850

Location ID: 452011

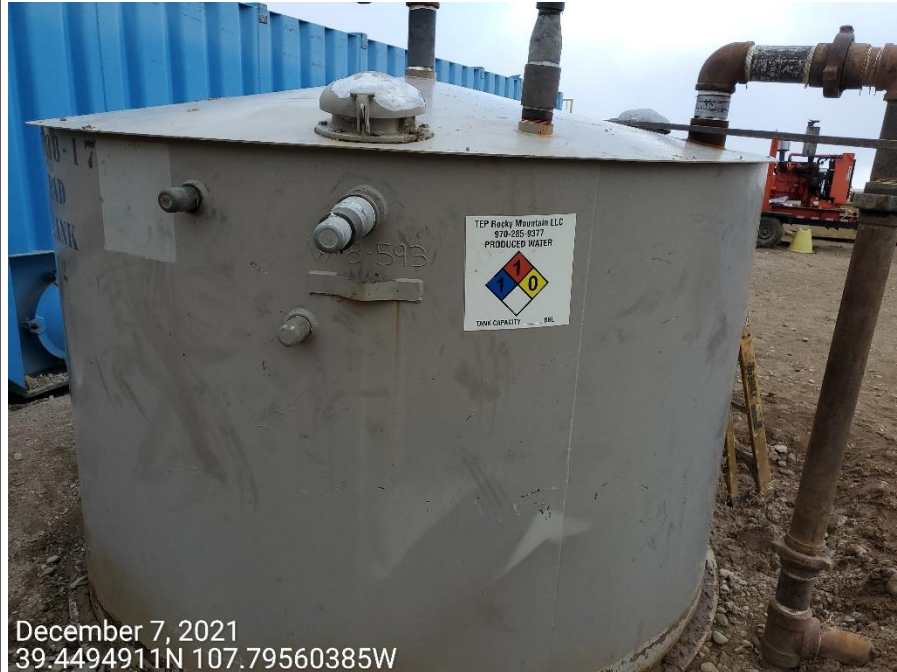
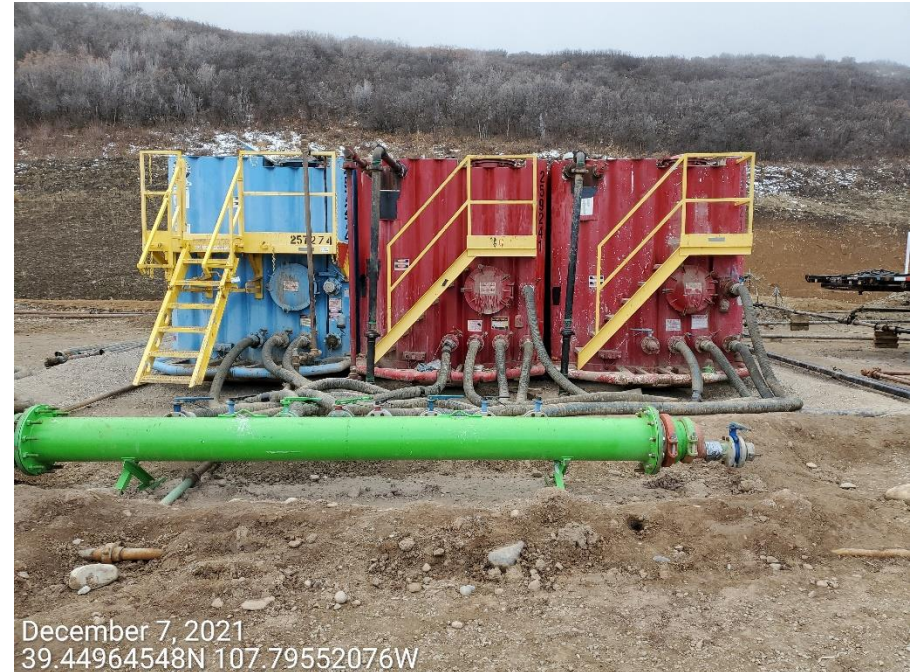
Photo 1: Photo of tanks with missing labelling information; tank of photo left missing capacity information. Labelling information on tanks in photo right not easily visible; unclear if tanks have required label information.

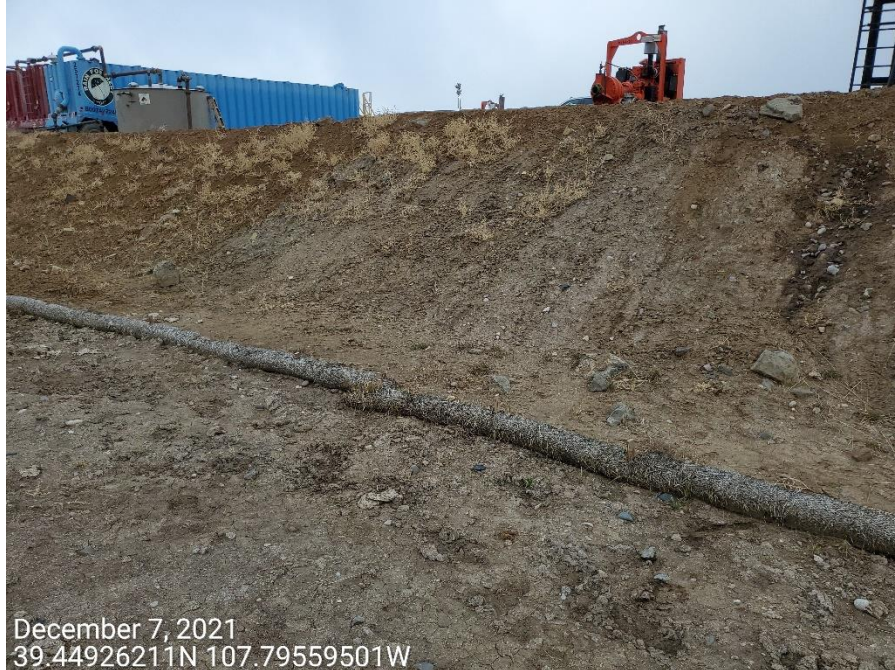
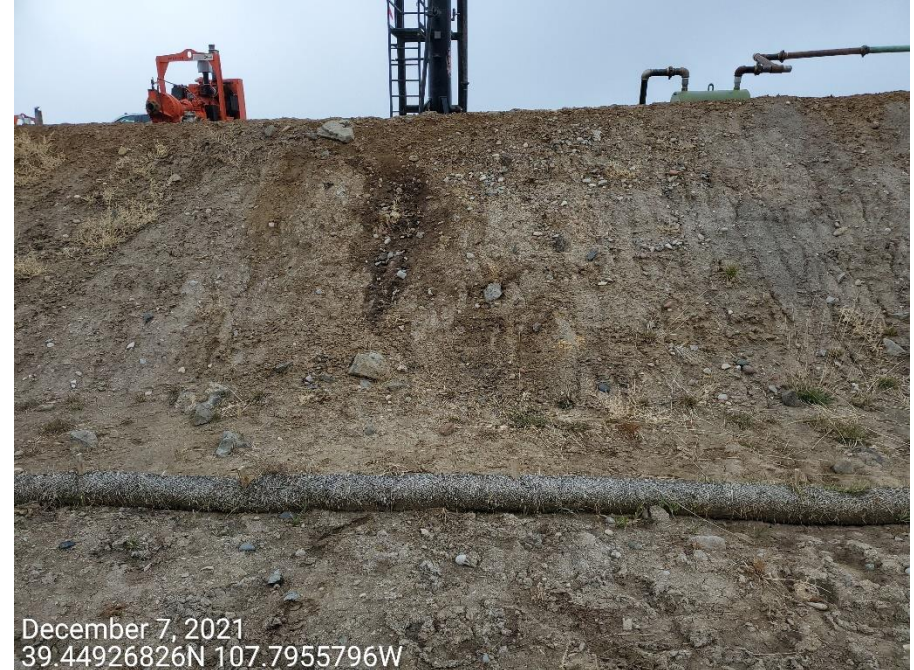
Photo 2: Photos taken from the southeast end of the Location, facing north. Photos show grey discolored/impacted soils observed on the fill slopes, and flat areas where the pit previously existed. Unclear what the observed materials are.

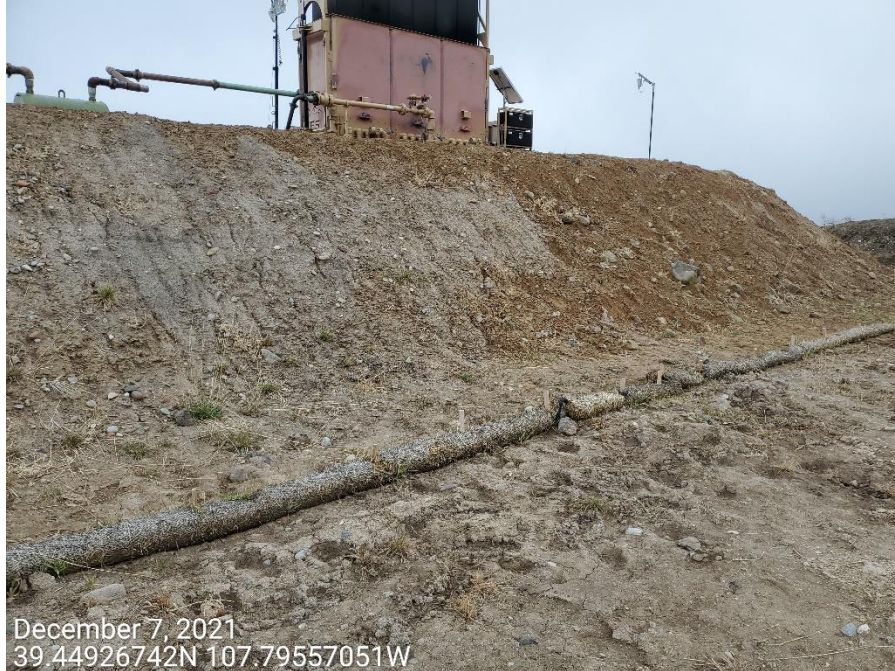
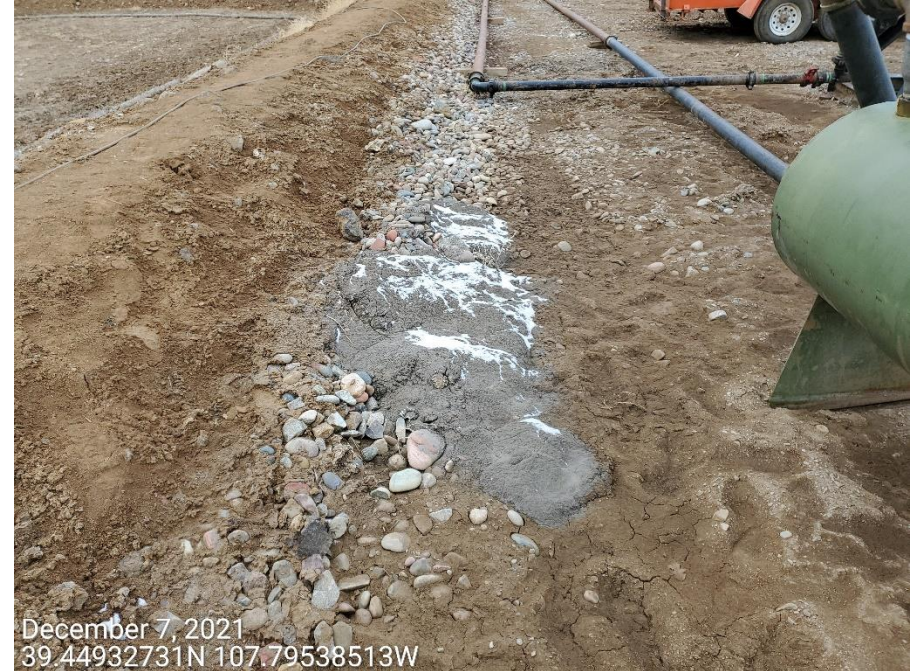
Photo 3: Photos taken from the southeast end of the Location. Photos show grey discolored/impacted soils observed on the fill slopes, and flat areas where the pit previously existed. Photo right shows a pile of grey material (possibly drilling mud) observed on the perimeter of the pad above the slopes in photo 2. Unclear what the observed materials are.

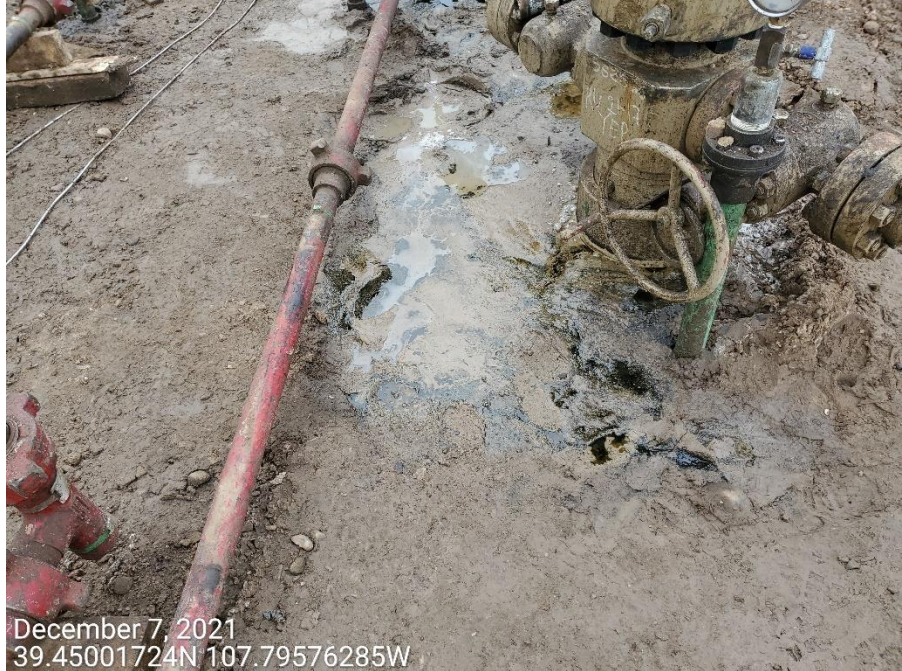
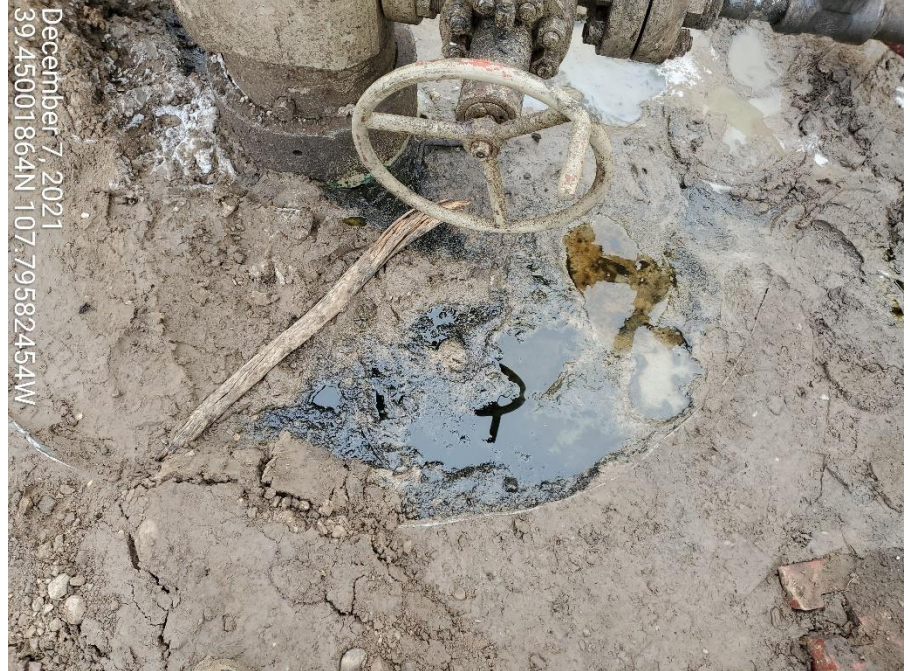
Photo 4: Photos examples showing impacted/stained materials observed around the wells.

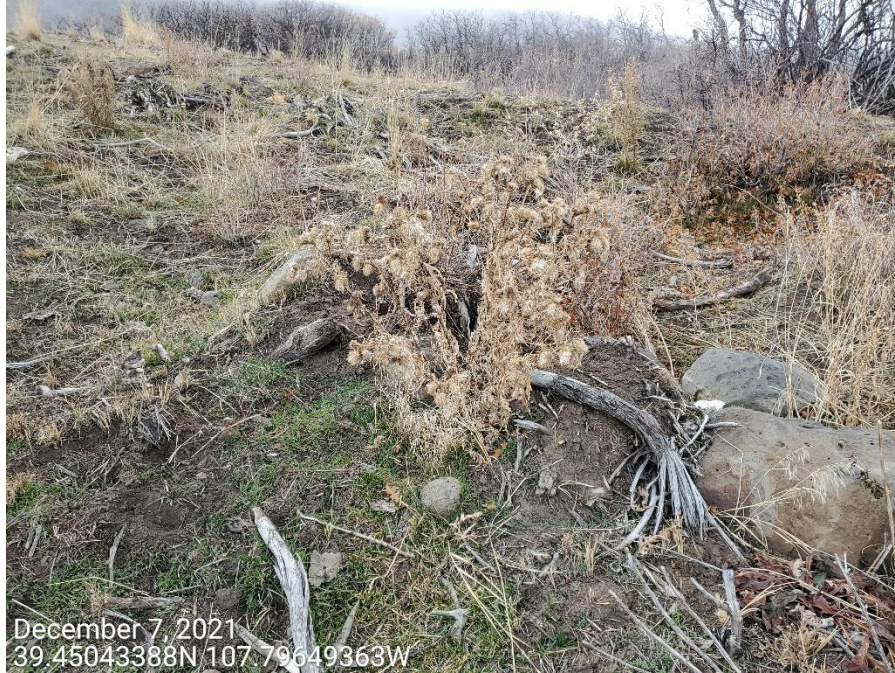
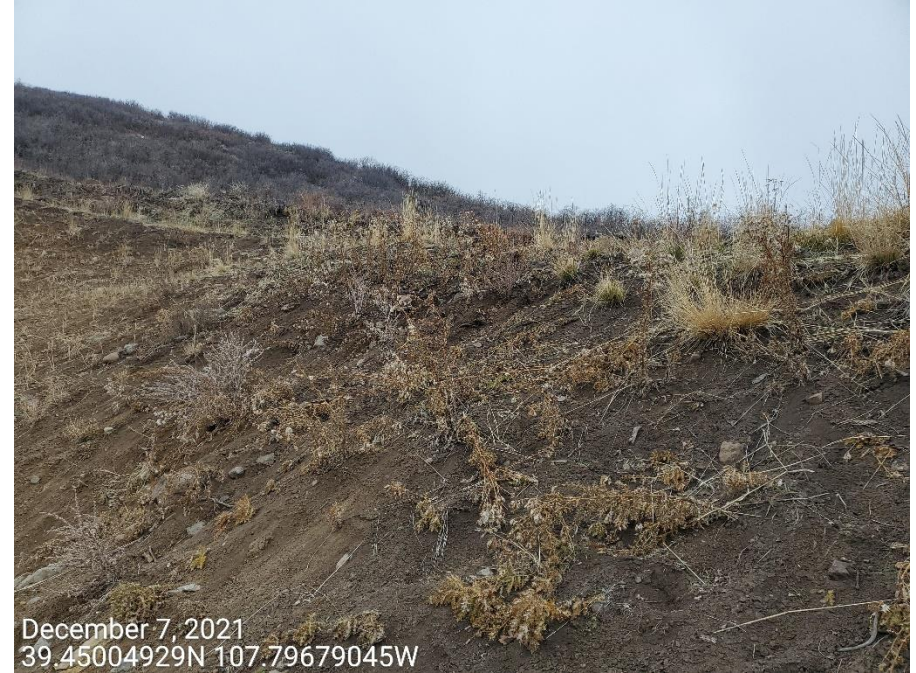
Photo 5: Photos examples of undesirable (noxious) plant species observed remaining on the topsoil stockpiles and Location. Examples of noxious weeds observed on the Location include Canada thistle, Plumeless thistle, Bull thistle, Houndsetongue, Common Mullein, etc... Weed debris, including seed material attached to the remaining plants, have not been removed.

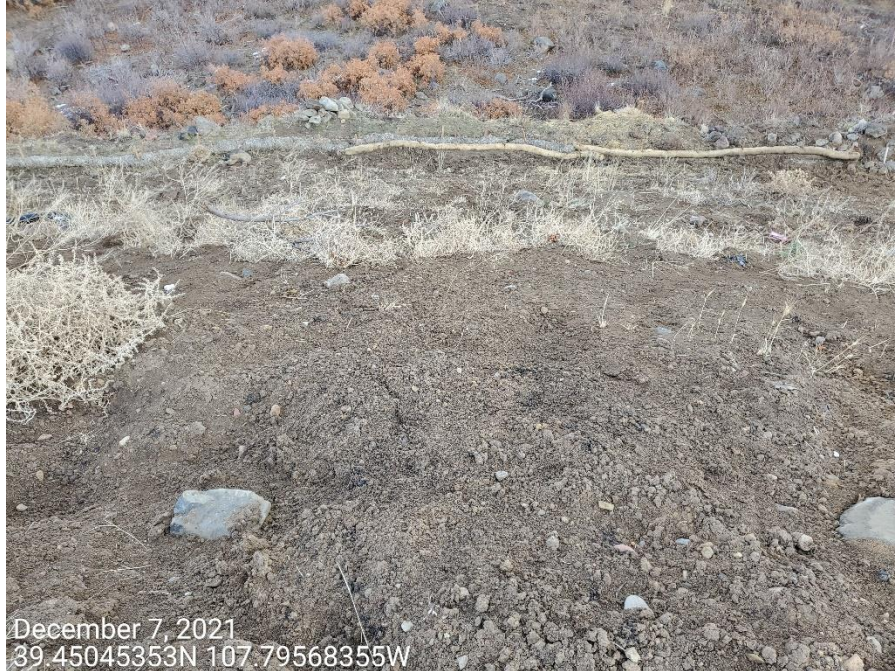
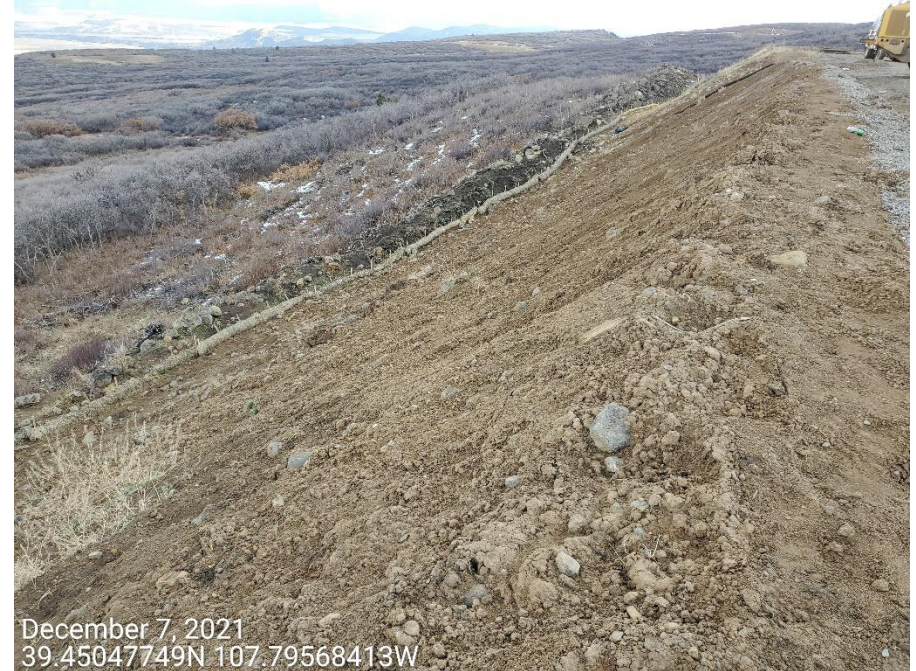
Photo 6: Photos examples showing control measures to protect and stabilize the fill slopes of the Location remain missing or insufficient; degradation has persisted.

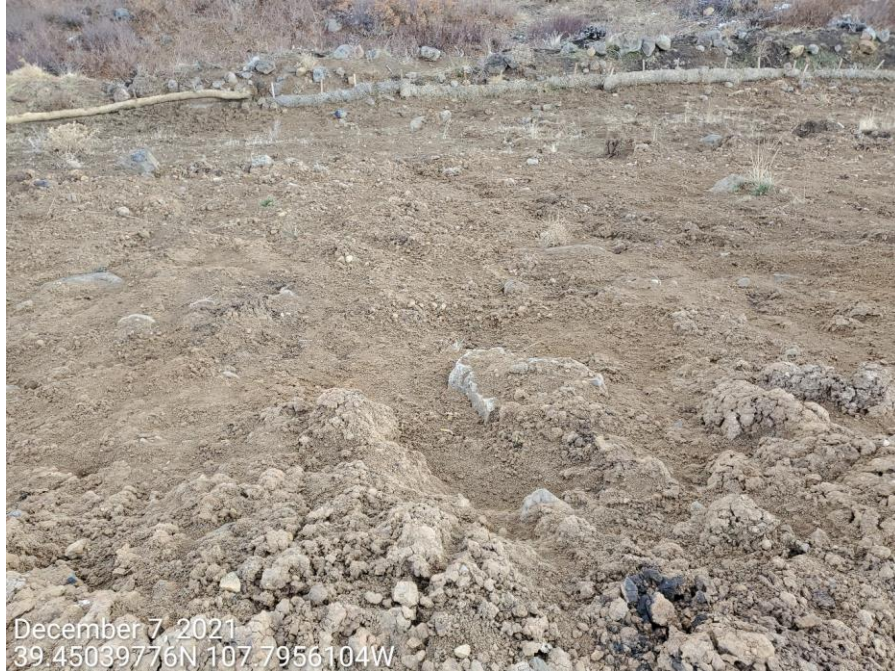
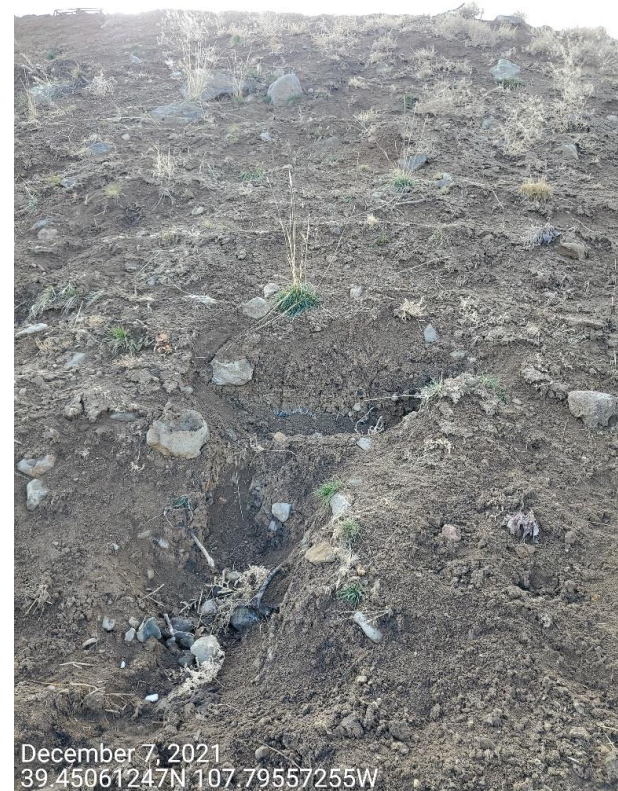
Photo 7: Photos examples showing control measures to protect and stabilize the fill slopes of the Location remain missing or insufficient; degradation has persisted.

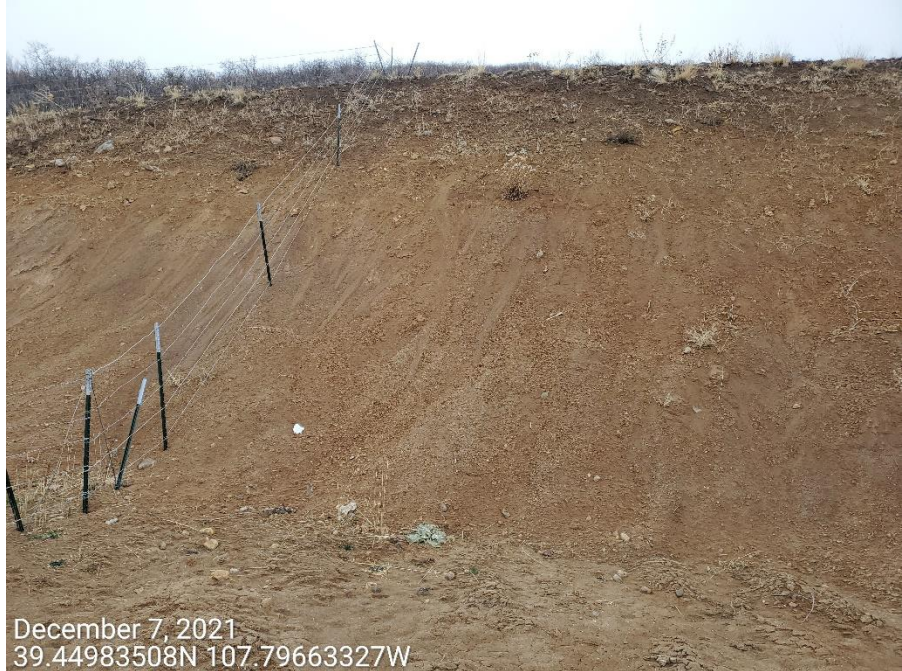
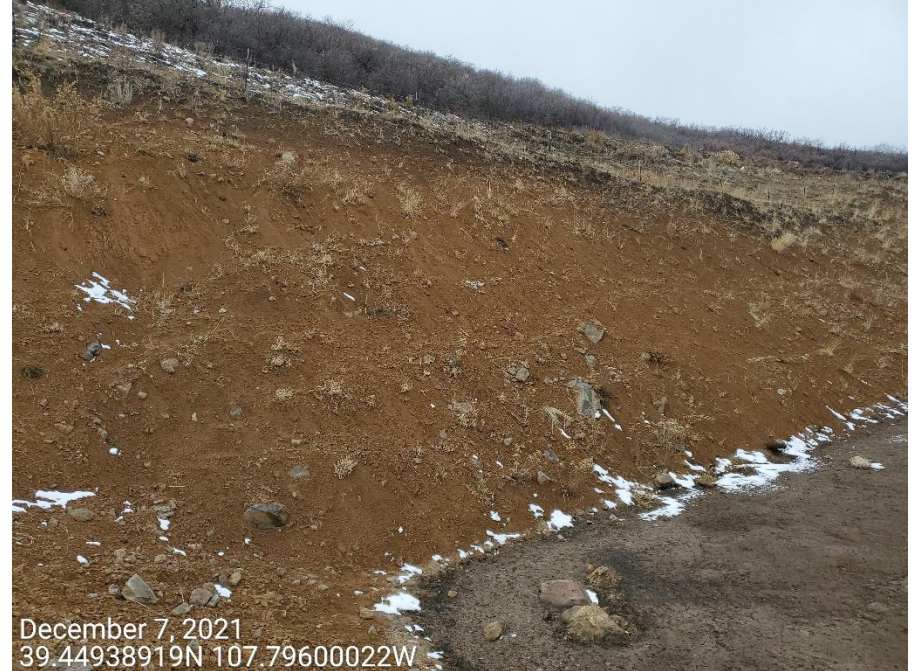
Photo 8: Photos examples showing control measures to protect and stabilize the cut slopes of the Location remain missing or insufficient; degradation has persisted.

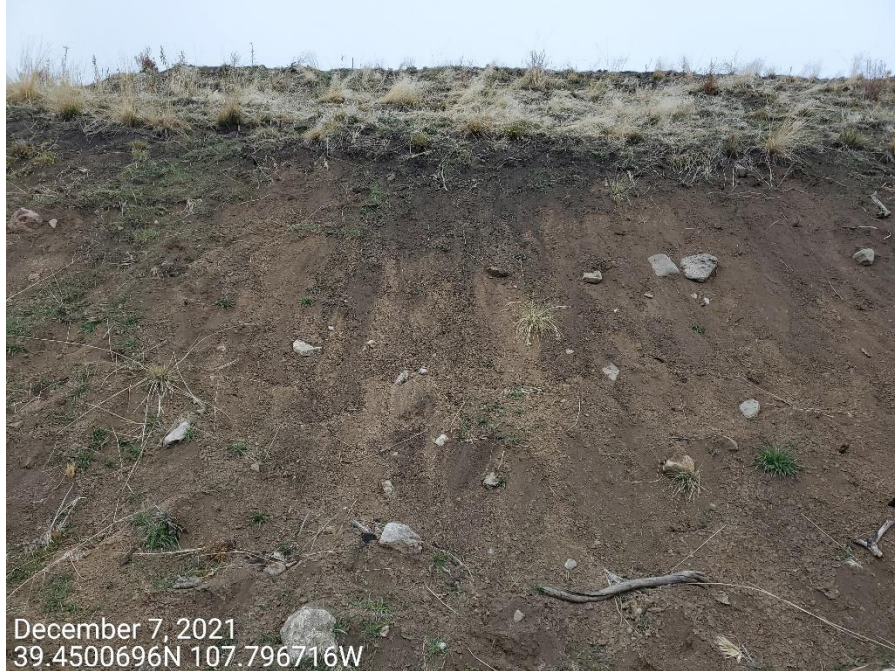
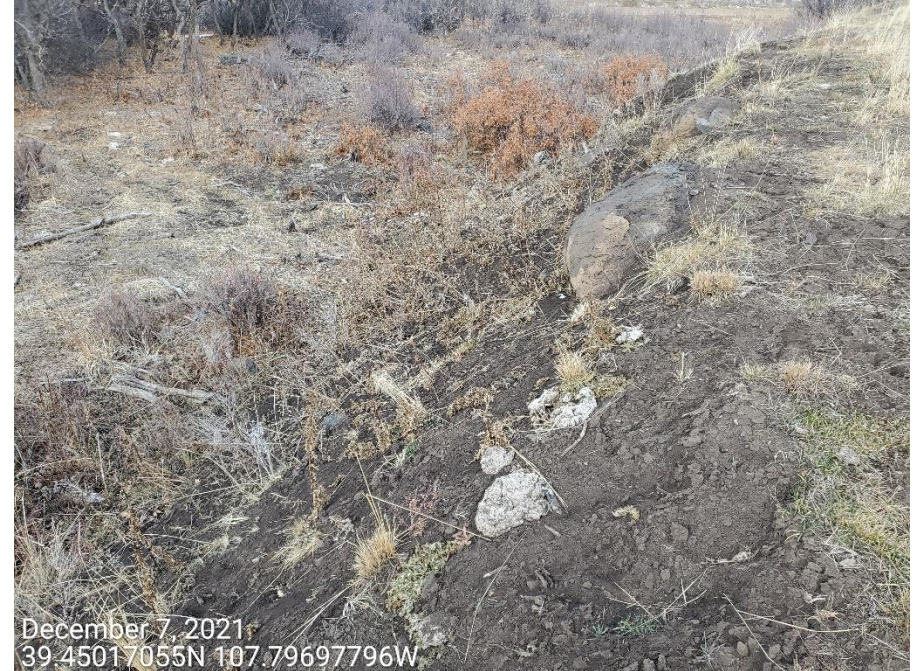
Photo 9: Photo left example showing control measures to protect and stabilize the cut slopes of the Location remain missing or insufficient; degradation has persisted. Photo also show erosion from the topsoil stockpile above the cut slope (photo left), has resulted in topsoil sediment transport and mixing with subsoil on the cut slopes. Photo right example showing control measures to stabilize and protect the topsoil stockpiles remain missing or insufficient.

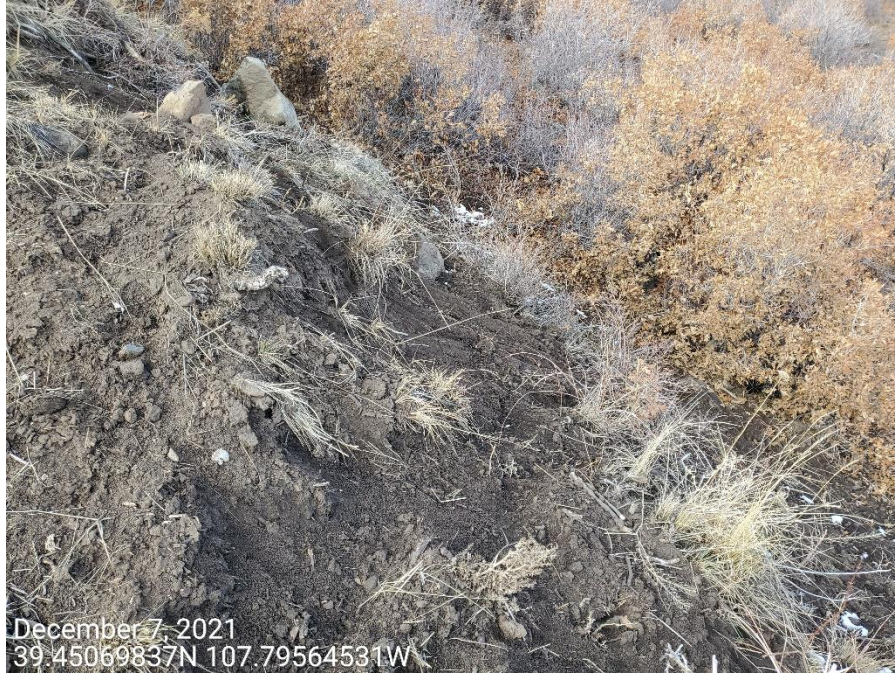
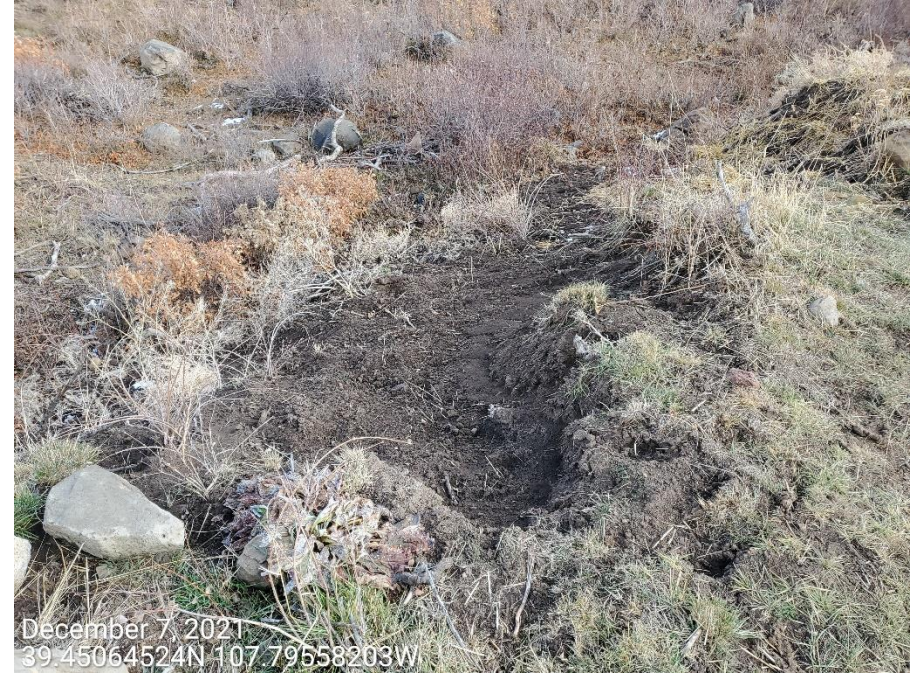
Photo 10: Photos examples showing control measures to protect and stabilize the topsoil stockpiles on the Location remain missing or insufficient.

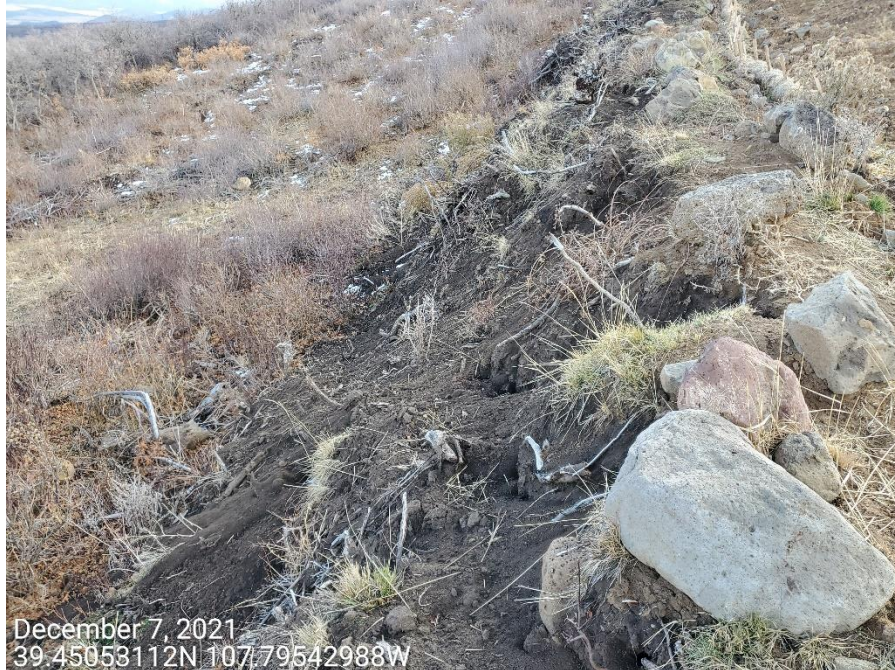
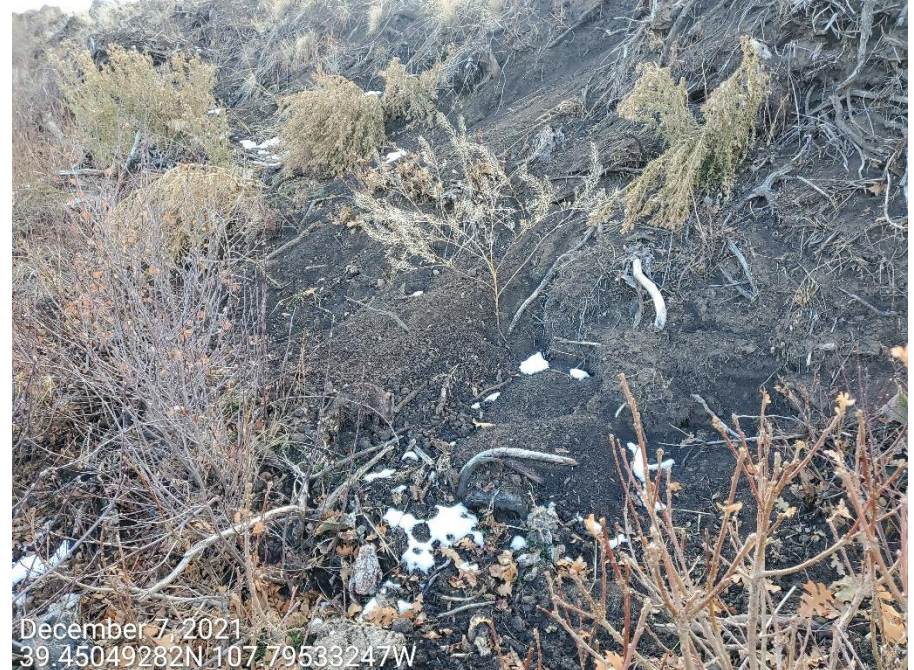
Photo 11: Photos examples showing control measures to protect and stabilize the topsoil stockpiles on the Location remain missing or insufficient.

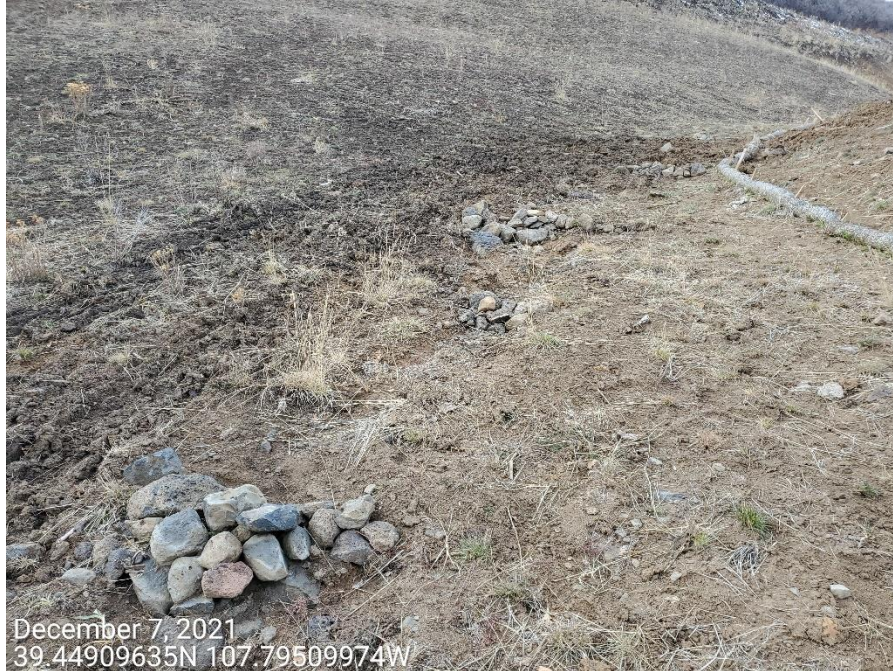
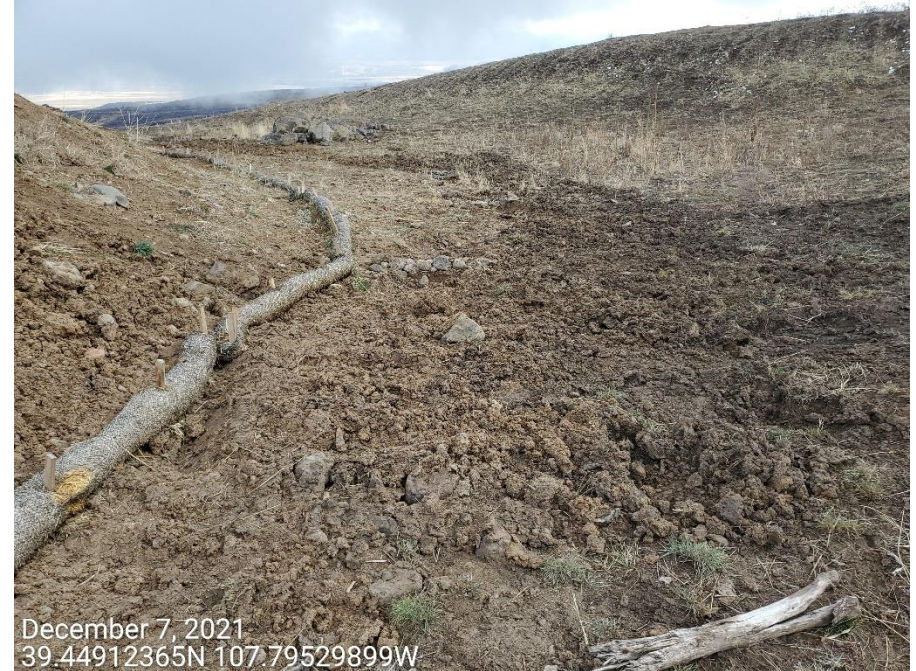
Photo 12: Photos taken from the east end of the Location. Photos examples showing perimeter stormwater control measures to manage runoff per good engineering practices remain missing or insufficient. Operator has placed rock material within eroded areas in lieu of installing properly engineered stormwater controls to manage runoff into the sediment trap; rock material inadequate to properly manage runoff or prevent further degradation.

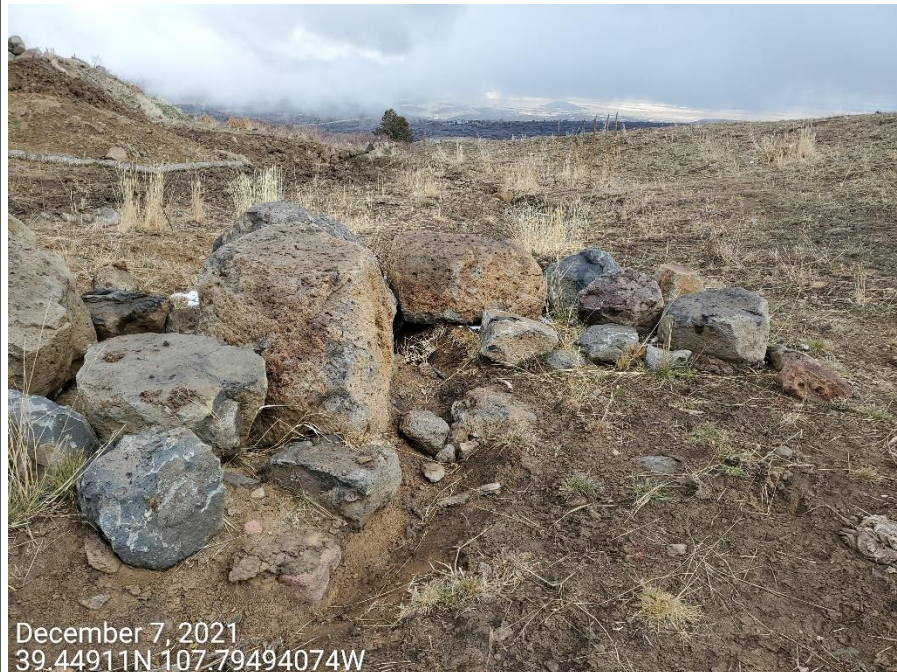
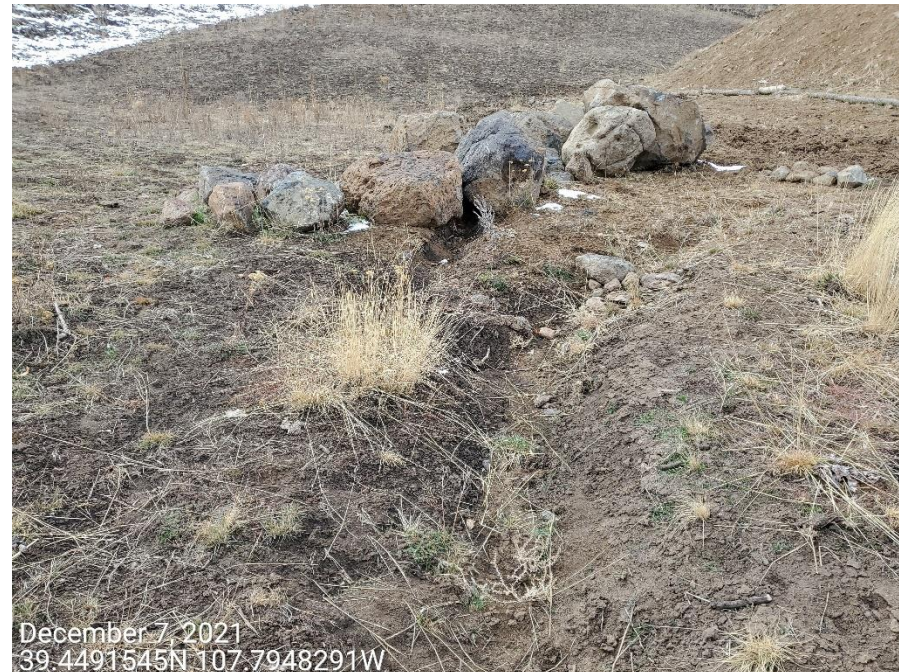
Photo 13: Photos taken from the east end of the Location. Photos examples showing perimeter stormwater control measures to manage runoff per good engineering practices remain missing or insufficient. Photo shows stormwater runoff has resulted in a small gully; Operator has constructed a sediment trap at the end of the gully erosion. Stormwater controls to manage runoff have not been constructed in accordance with good engineering practices. Note; rock material observed in photos was not placed into erosion channel like the rock material in photo 12; rocks likely existed prior to the gully, with erosion occurring beneath the rocks during stormwater events.

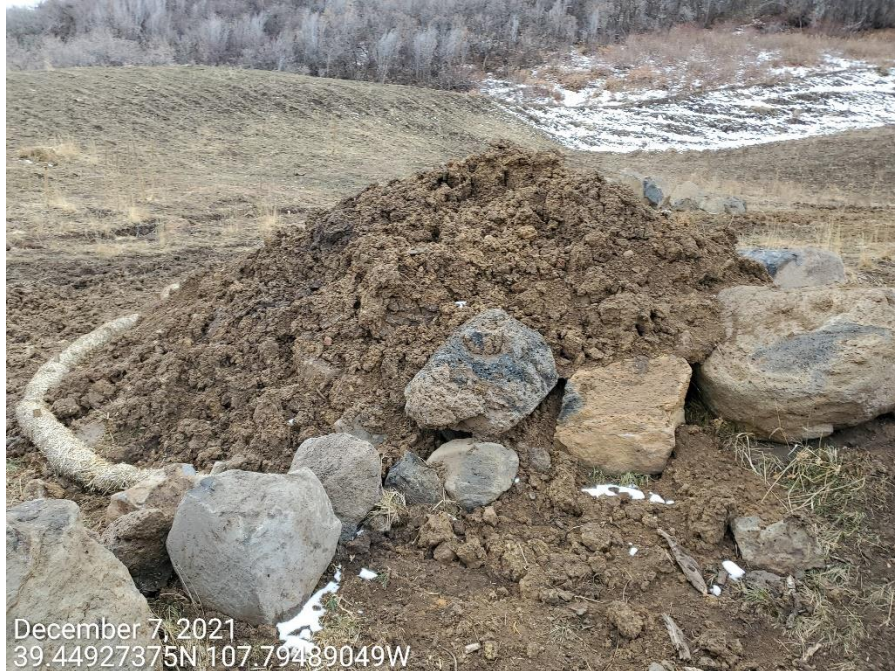
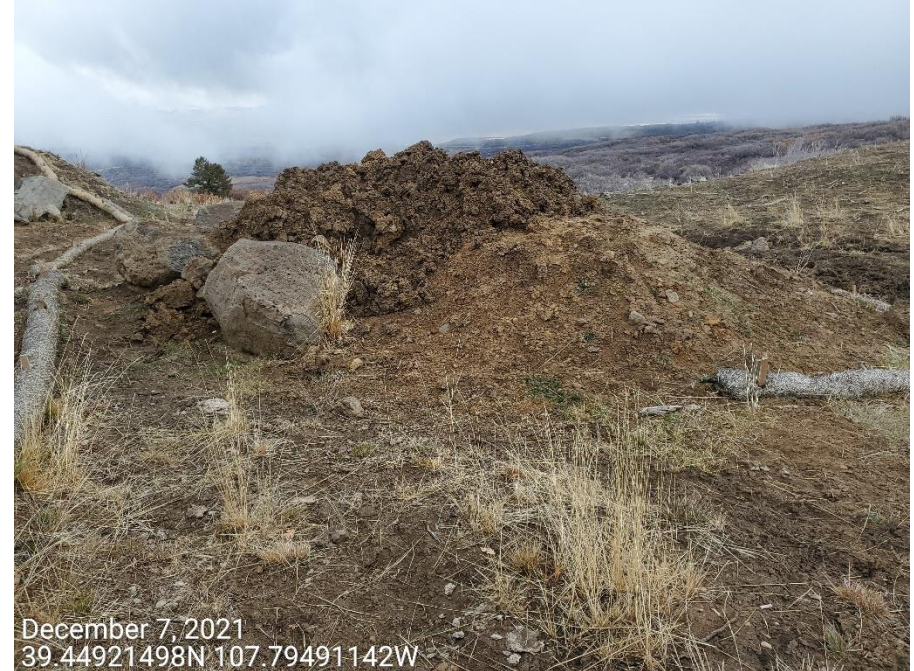
Photo 14: Photo taken from the east end of the Location. Photo shows control measures to mitigate sediment transport at the stockpiled soils is inadequate.

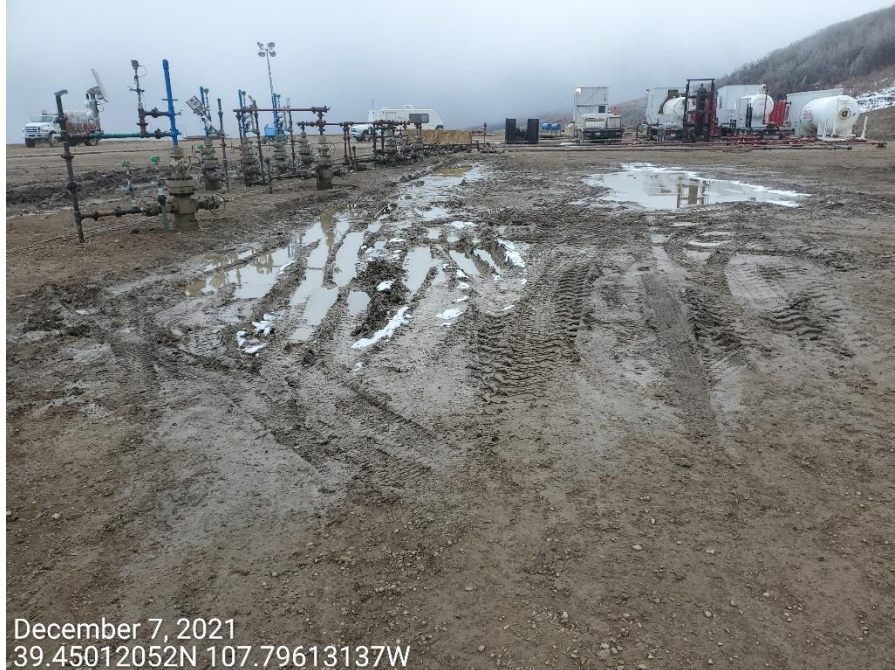
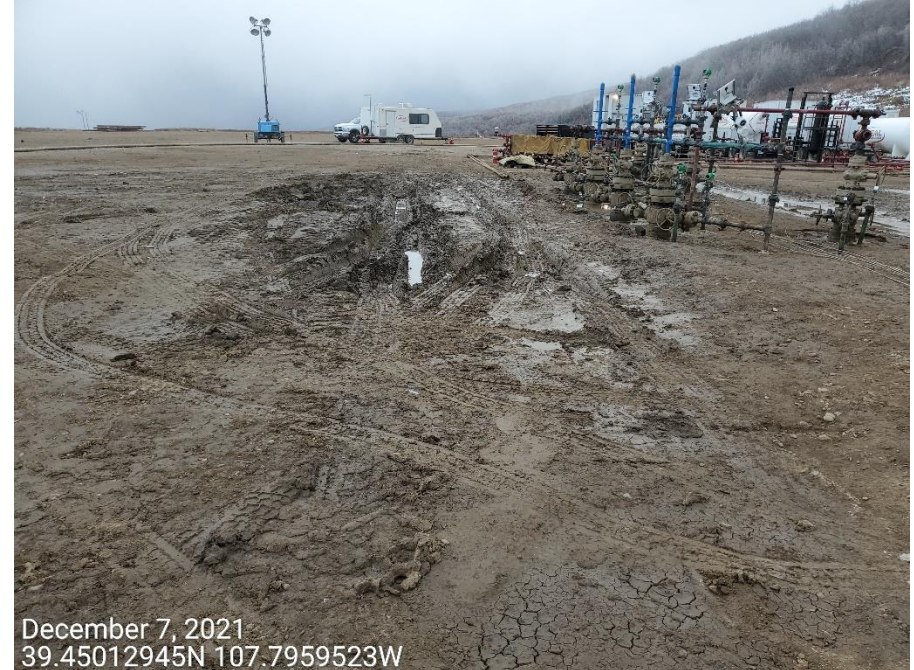
Photo 15: Photos show control measures to stabilize the production areas, and mitigate tracking and sediment transport are missing or insufficient.

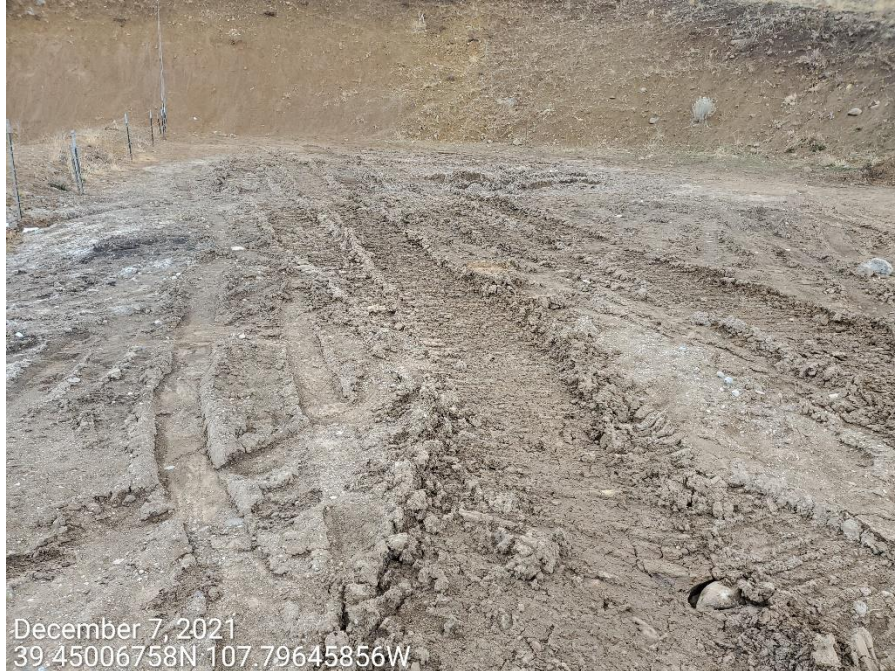
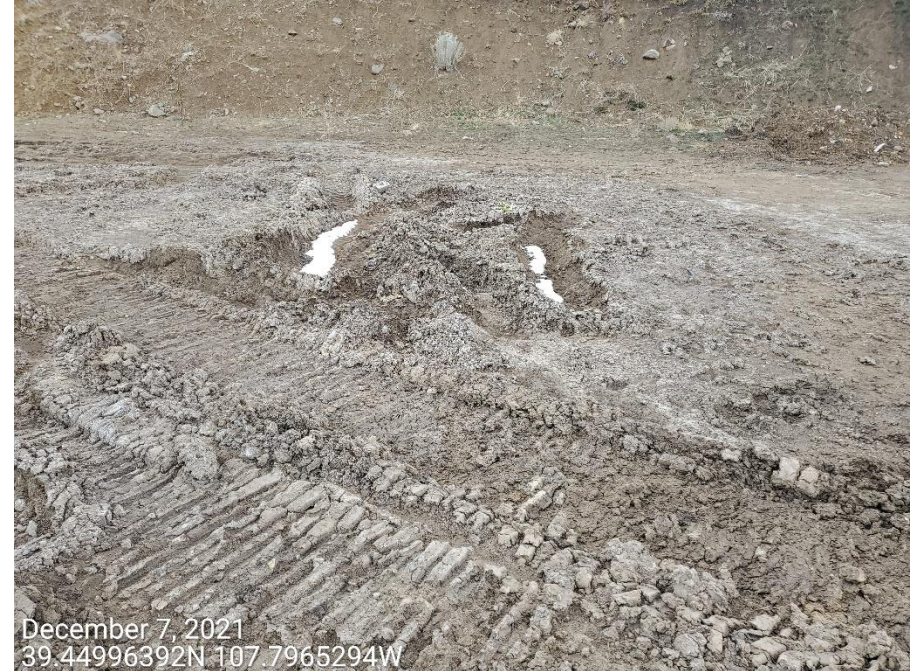
Photo 16: Photos show control measures to stabilize the production areas, and mitigate tracking and sediment transport are missing or insufficient.

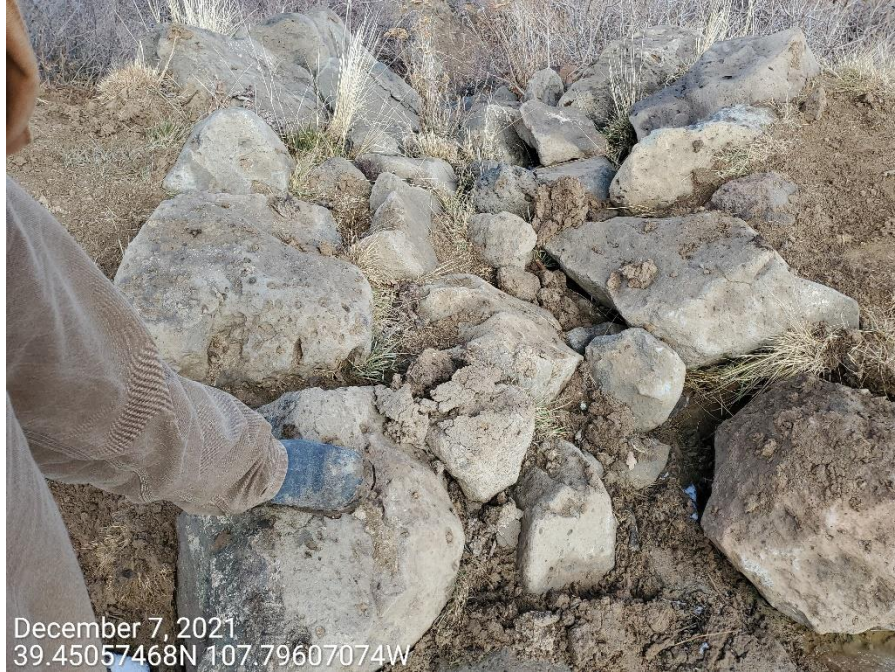
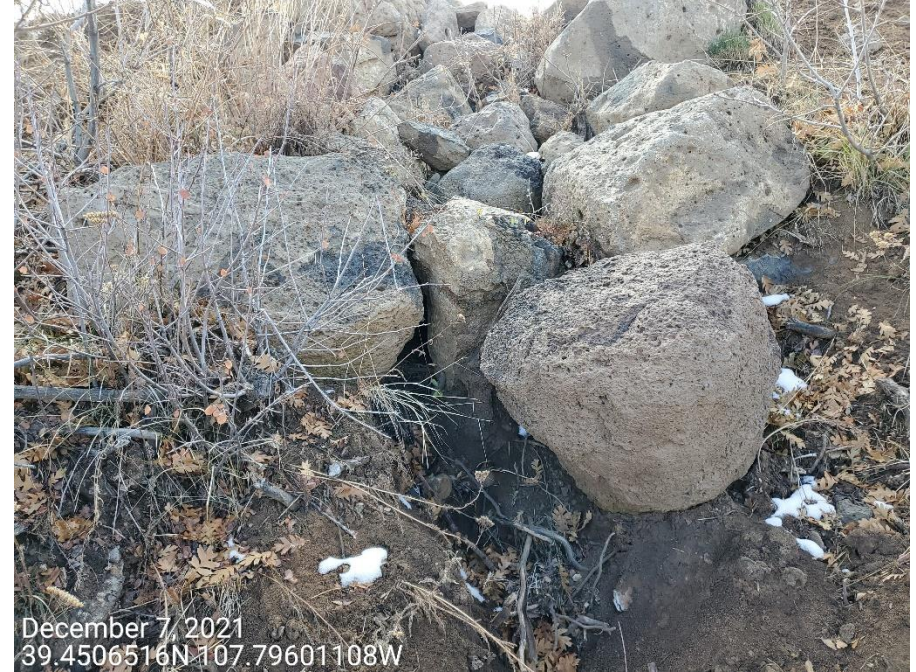
Photo 17: Photos taken from the sediment trap at the Location entrance (west end of the Location). Trap has not been installed in accordance with good engineering practices; control missing appropriate inlet/outlet protection in accordance with good engineering practices; geotextile lining not observed; erosion degradation under/around rip-rap material evident.
