Inspection Photos  
Operator: Morningstar  
API: 007-06211  
Date: 12/13/2021

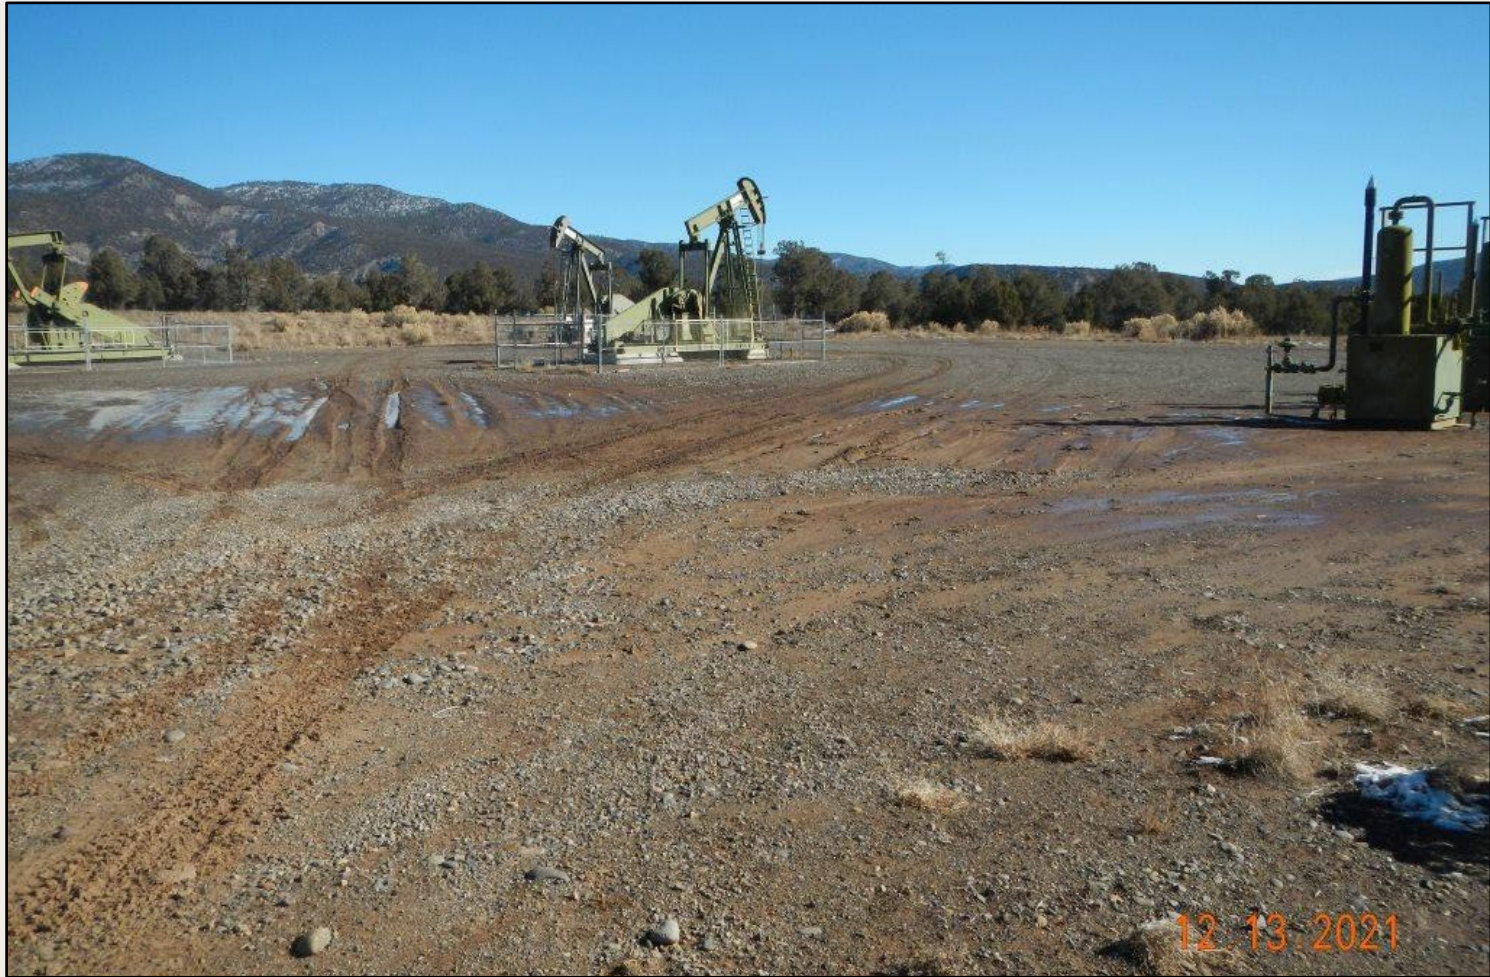
Photo 1. View of the project area from the northwestern corner facing center.

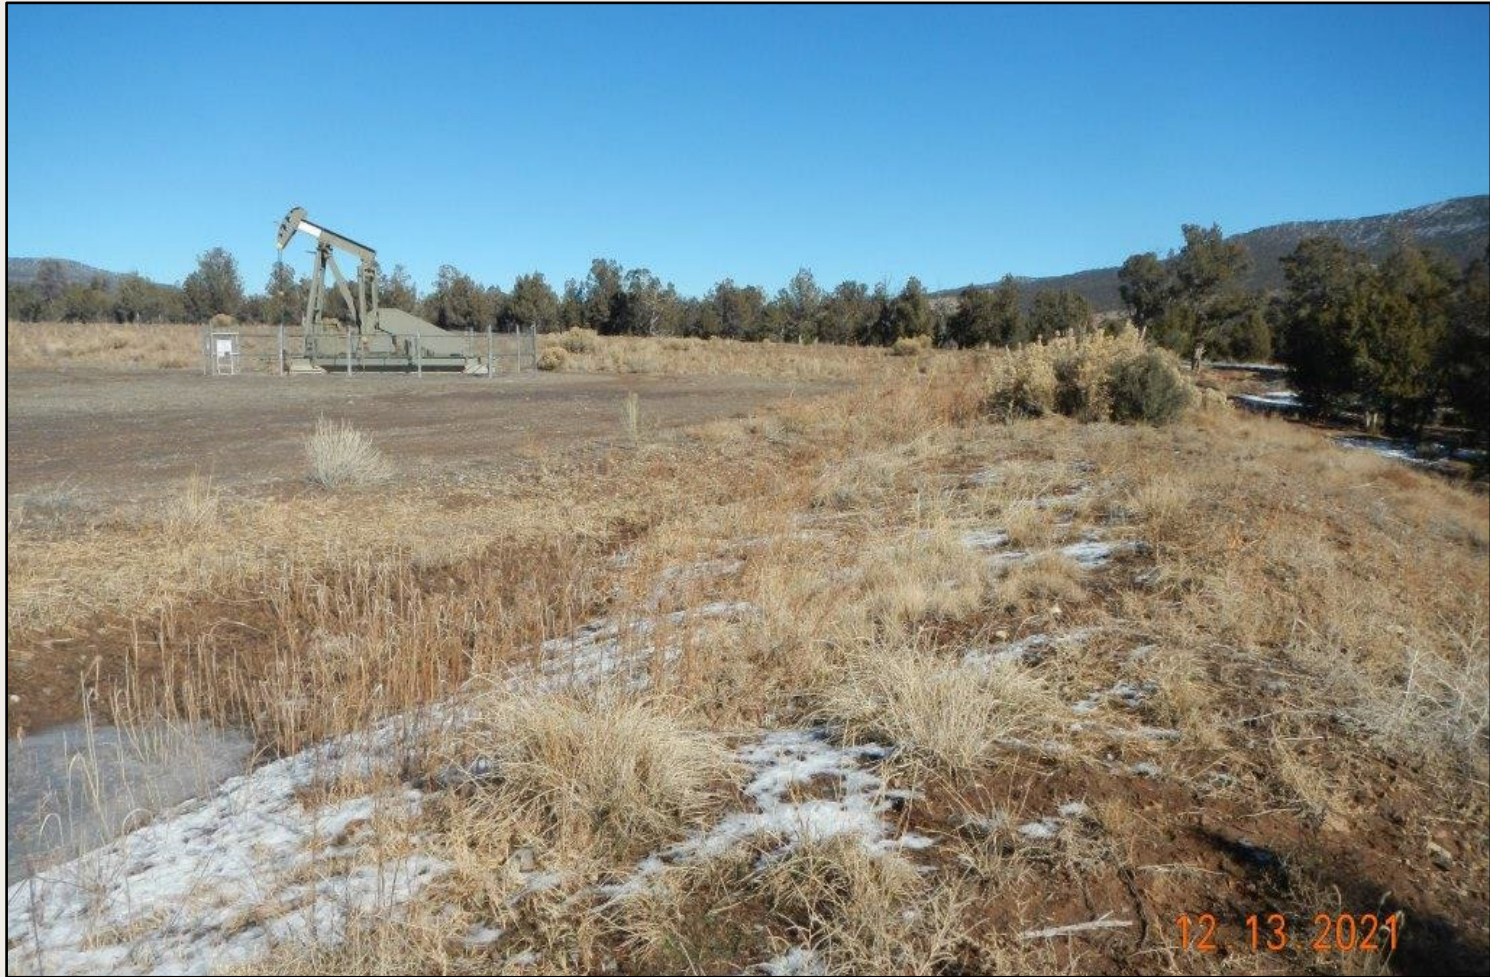
Photo 2. View of the southern project area from the southwestern corner facing eastward. Revegetation is progressing with Indian ricegrass, crested wheatgrass, western wheatgrass, and rubber rabbitbrush. Pinyon and juniper trees growing along the edges of the project area.

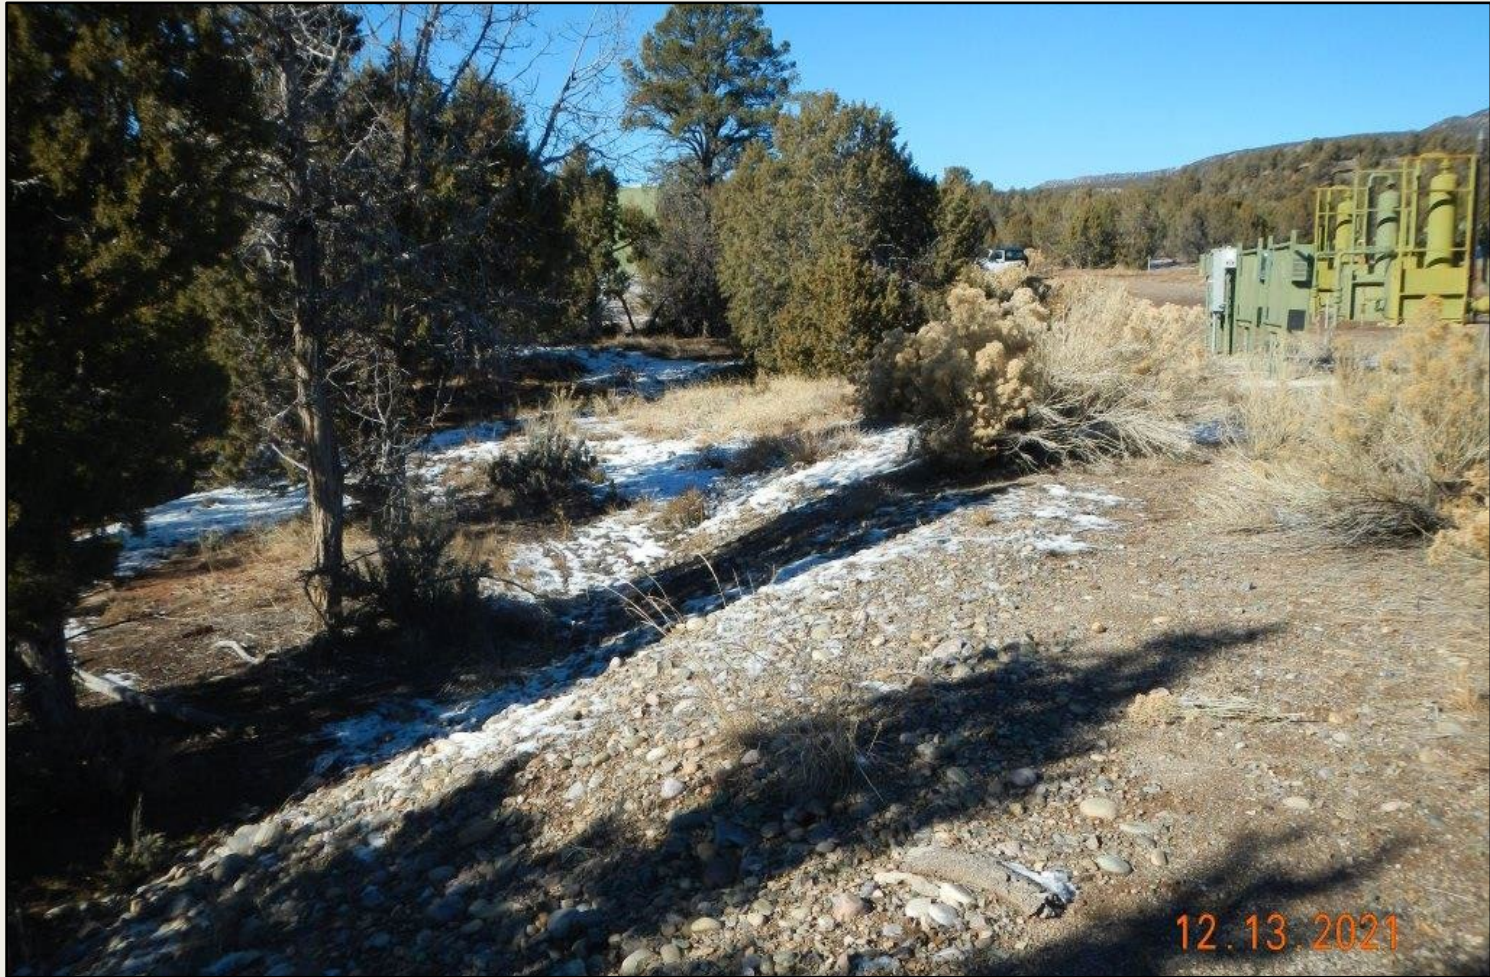
Photo 3. View of the western project area from the southwestern corner facing northward.

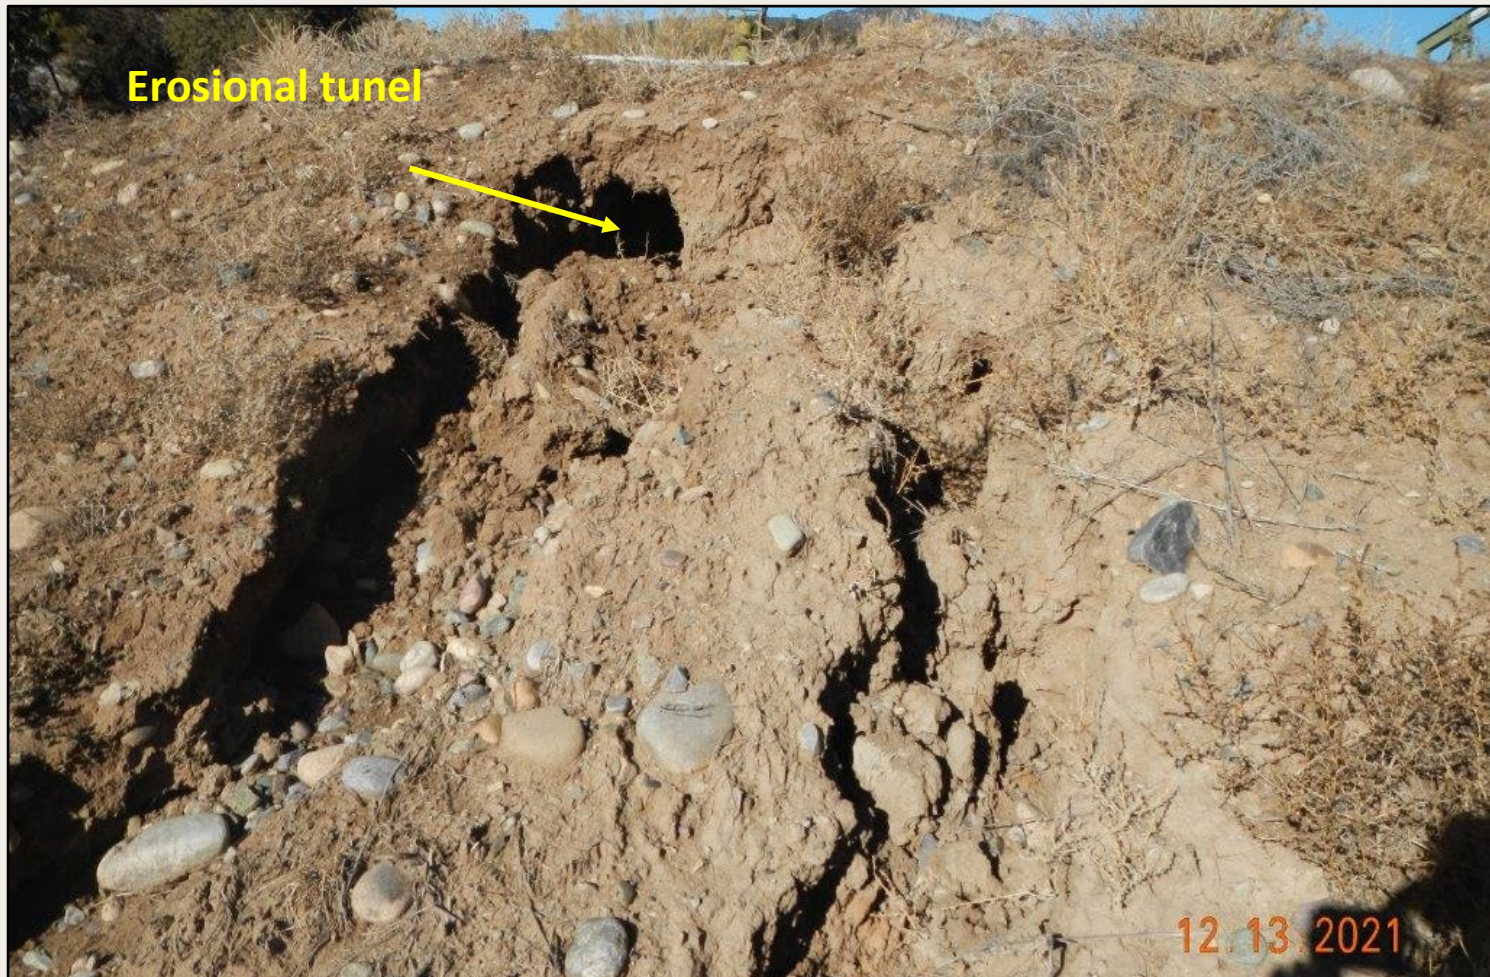
Photo 4. View of erosional tunnel (approx. 1ft diameter) and channels (approx. 12in deep and 2-3ft wide), forming within the southwestern project area (facing up-slope).

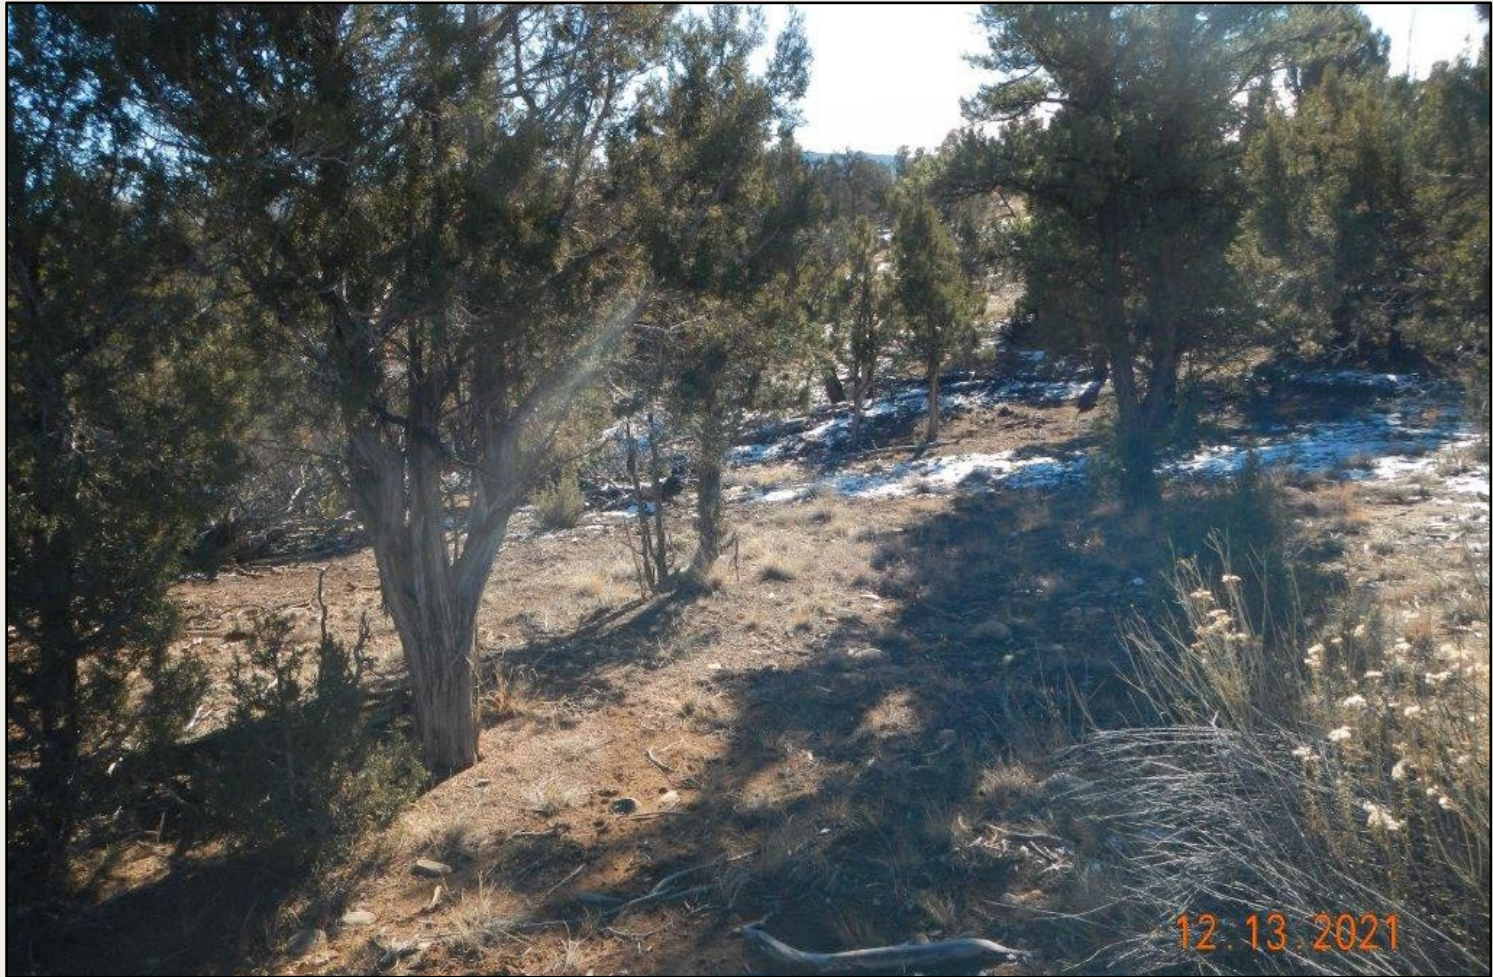
Photo 5. View of reference area comprised of pinyon and juniper woodland with understory of sagebrush, Indian ricegrass, blue grama, James galleta, and cholla.
