Inspection Photos

API: 043-06142

Operator: JAVERNICK OIL

Inspection Date: 12/14/2021

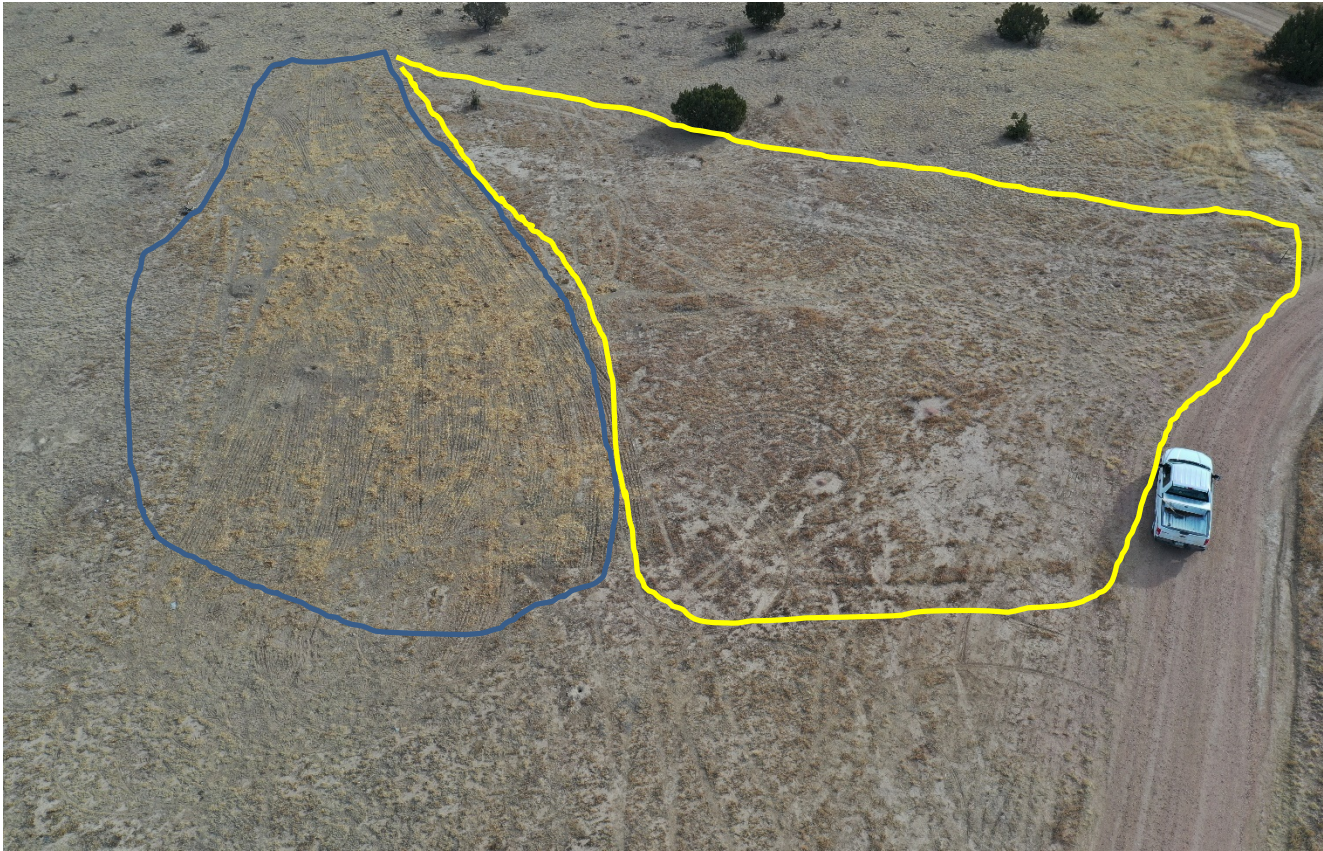
Photo 1. Drone aerial photo facing southeast toward the abandoned well site. The area circled in blue was seeded and straw mulched. The remaining location circled in yellow was not reclaimed.

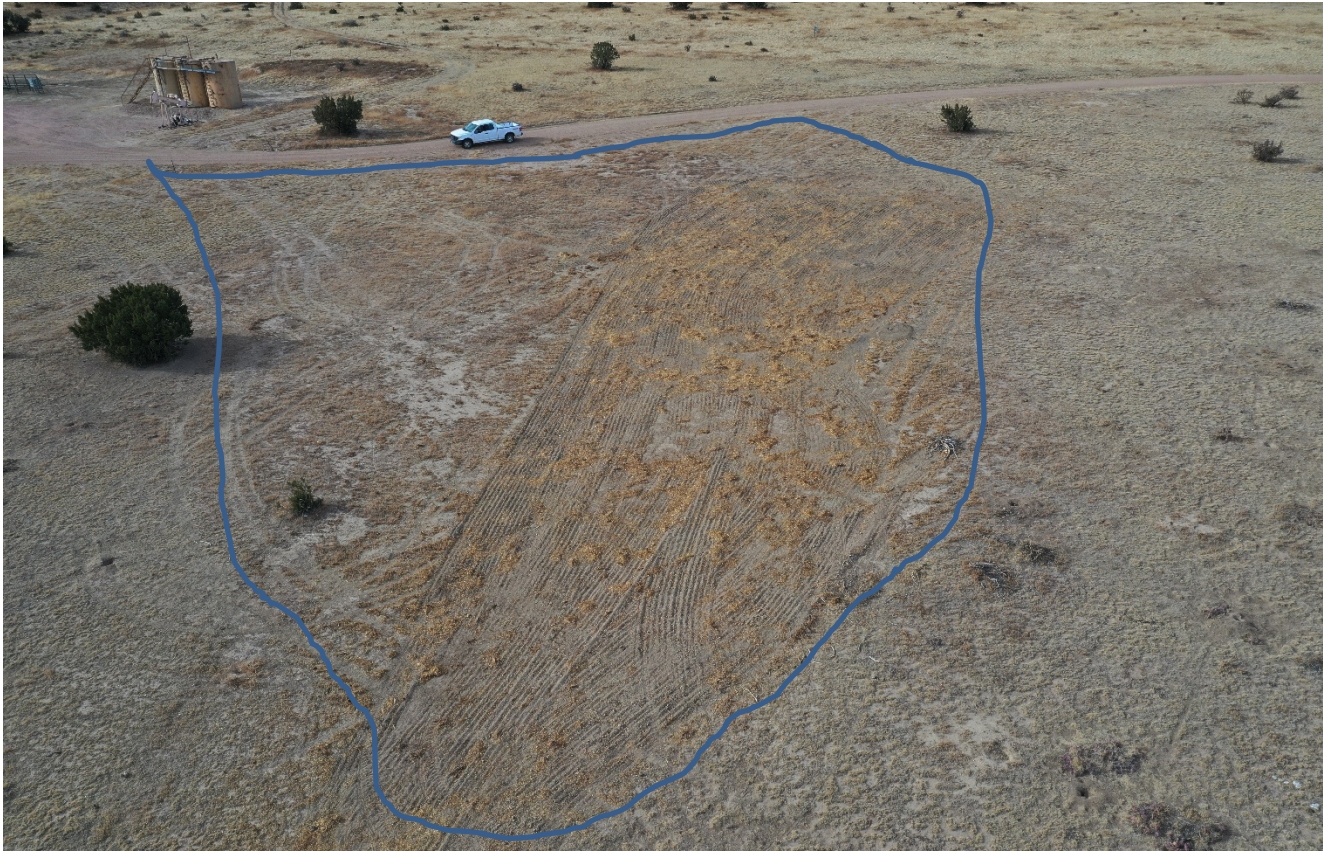
Photo 2. Drone aerial photo facing west. The approximate disturbance area of the location is circled and only a portion of the location was reclaimed.

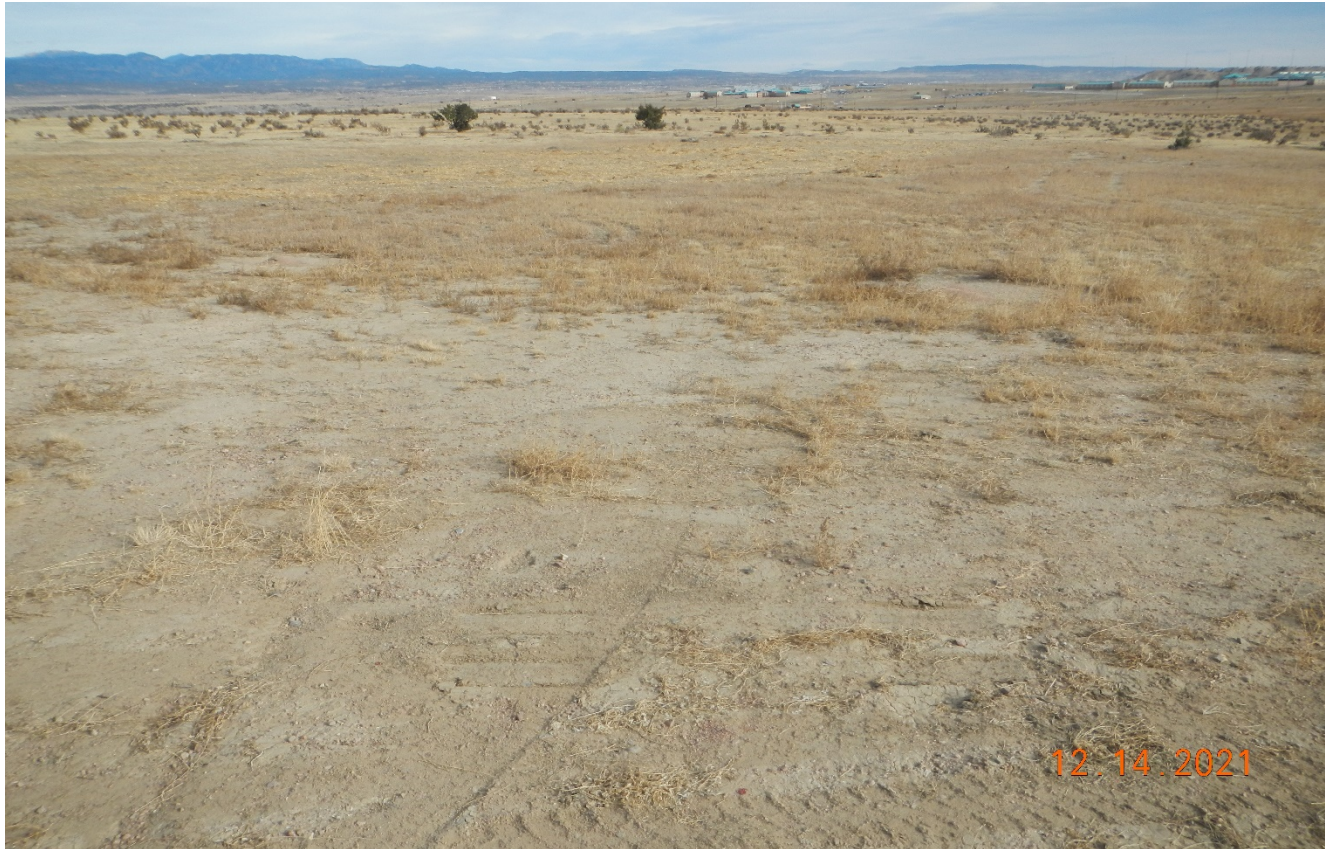
Photo 3. Facing northeast toward the location. The trailer has been removed and soils are bare where the ytrailer was parked shown in the photo.

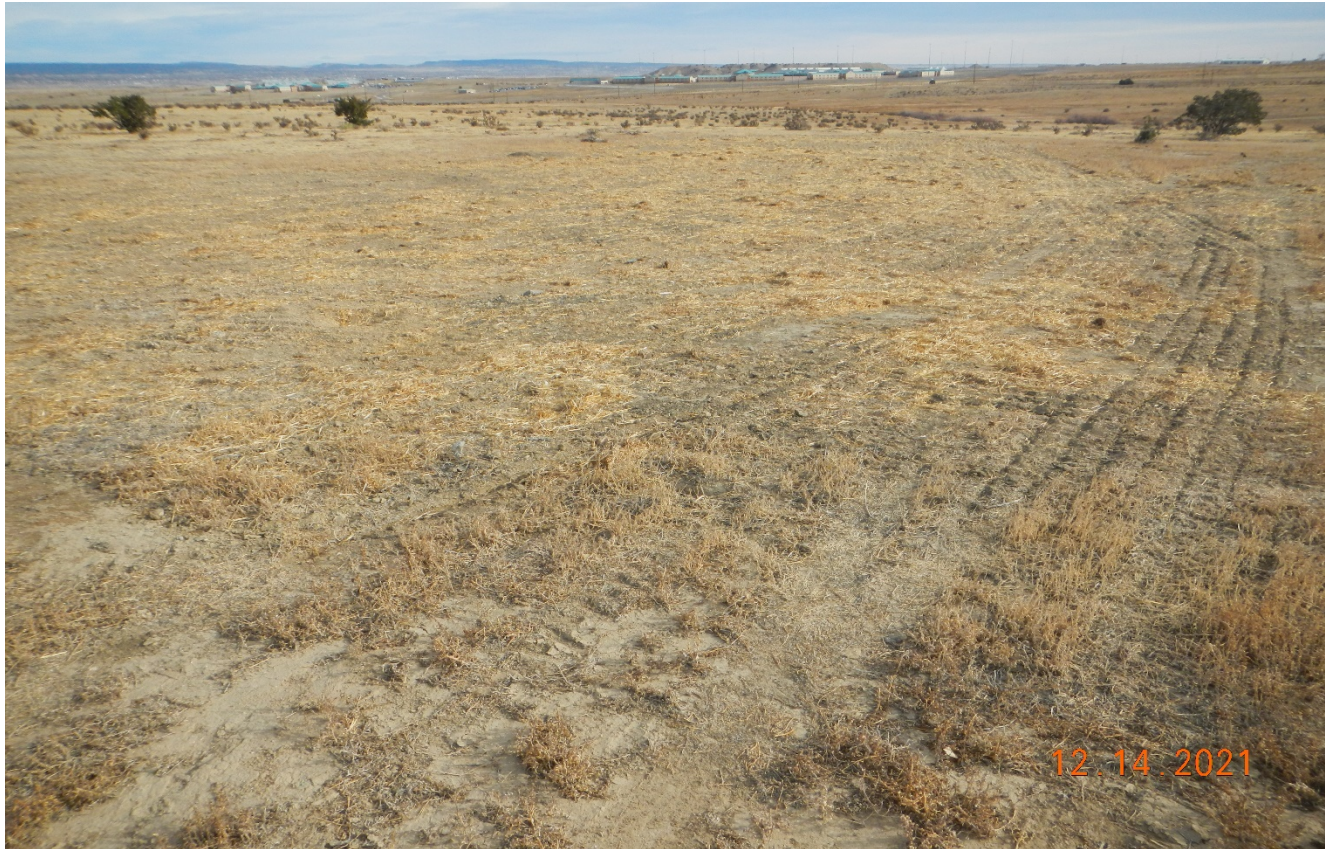
Photo 4. Facing northeast. The northern portion of the location was seeded and straw mulch. It is unknown if certified weed free straw was used.

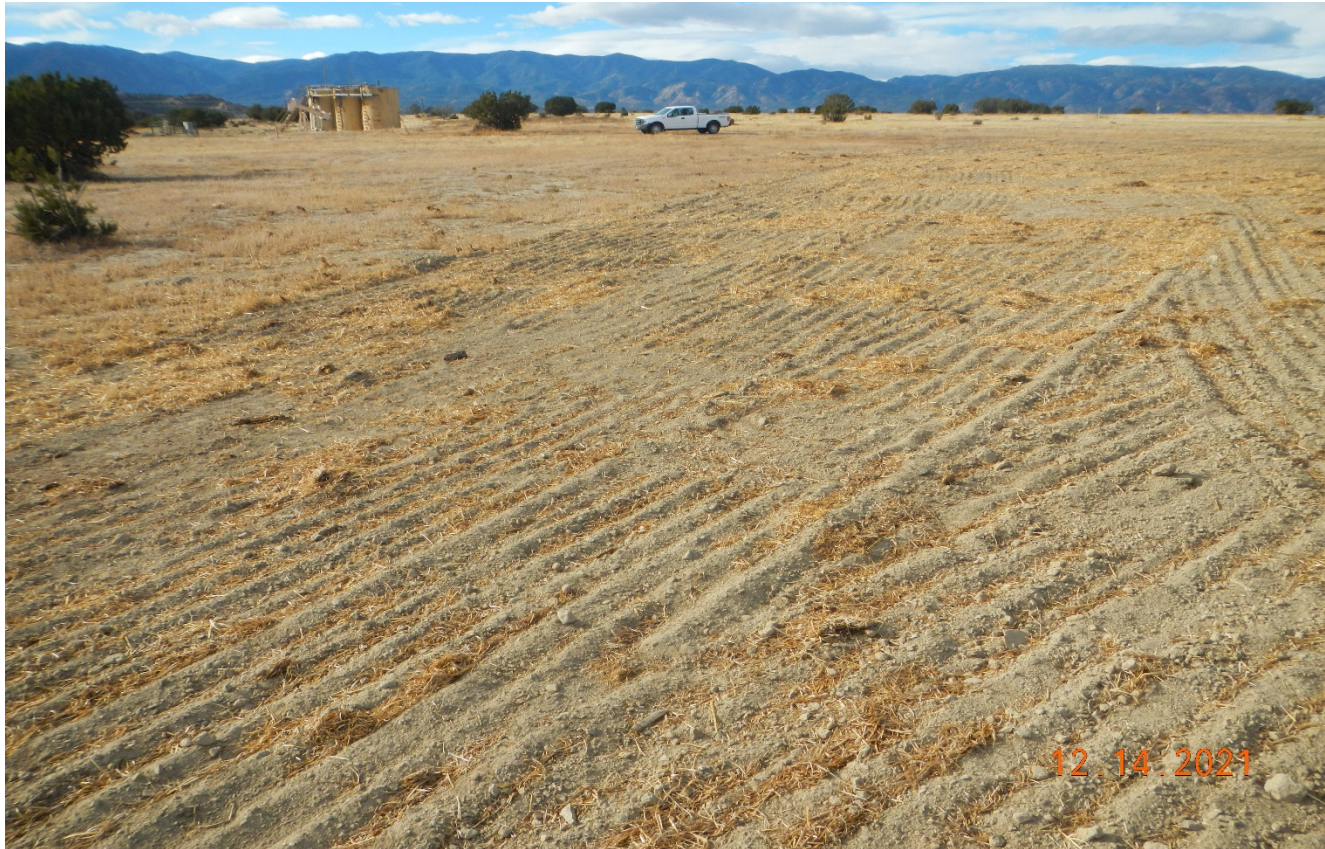
Photo 5. Facing west at the location. The soils are lightly mulched and the mulch was not crimped into the soil which may blow away.

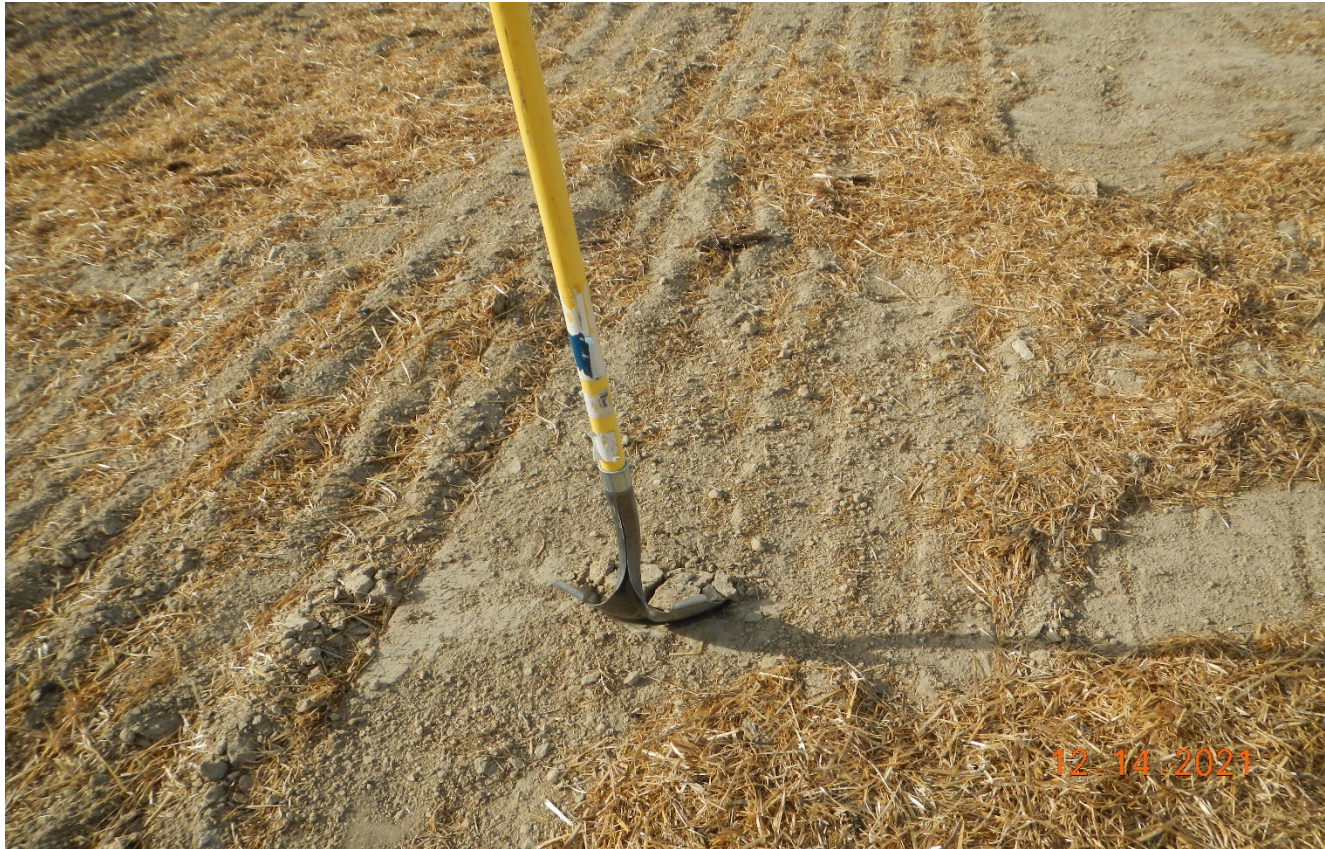
Photo 6. The shovel was placed into the soil to test for compaction. Soils seemed compacted down past 4 inches into the soil. Proper soil decompaction requires cross ripping to at least 18 inches.

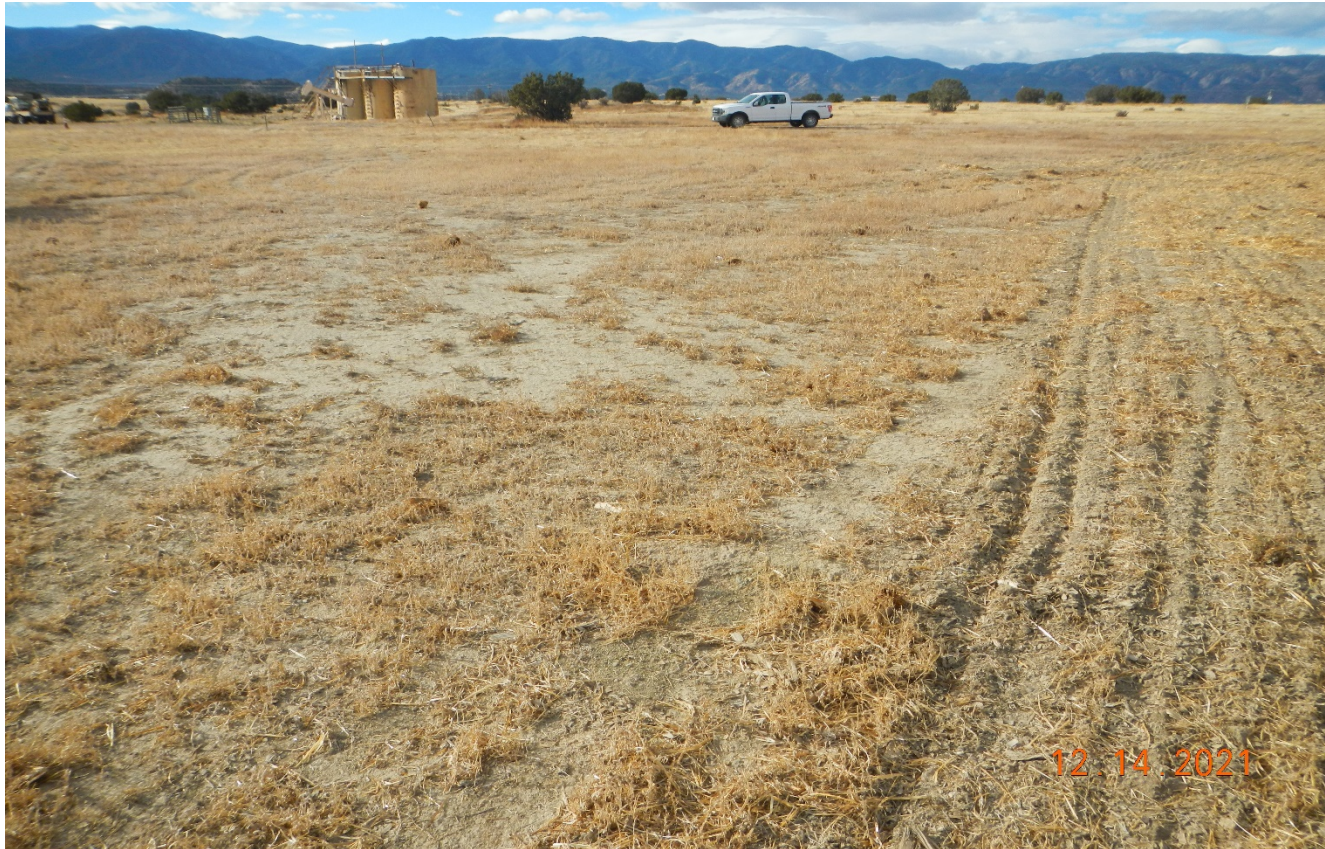
Photo 7. Facing west at the location. The southern portion of the location was not reclaimed and consists of undesirable weeds.

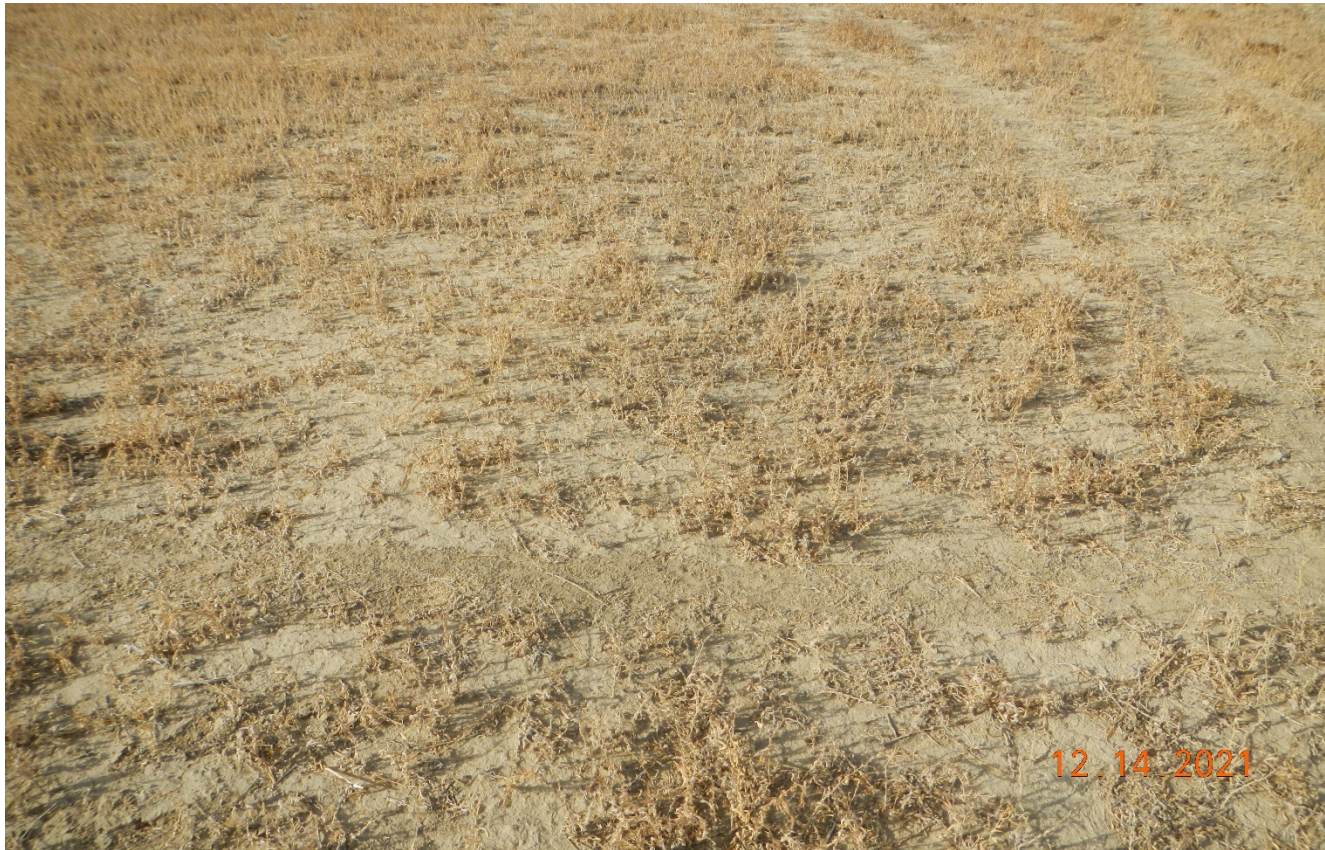
Photo 8. View of groundcover showing undesirable weeds (*Kochia* sp.).

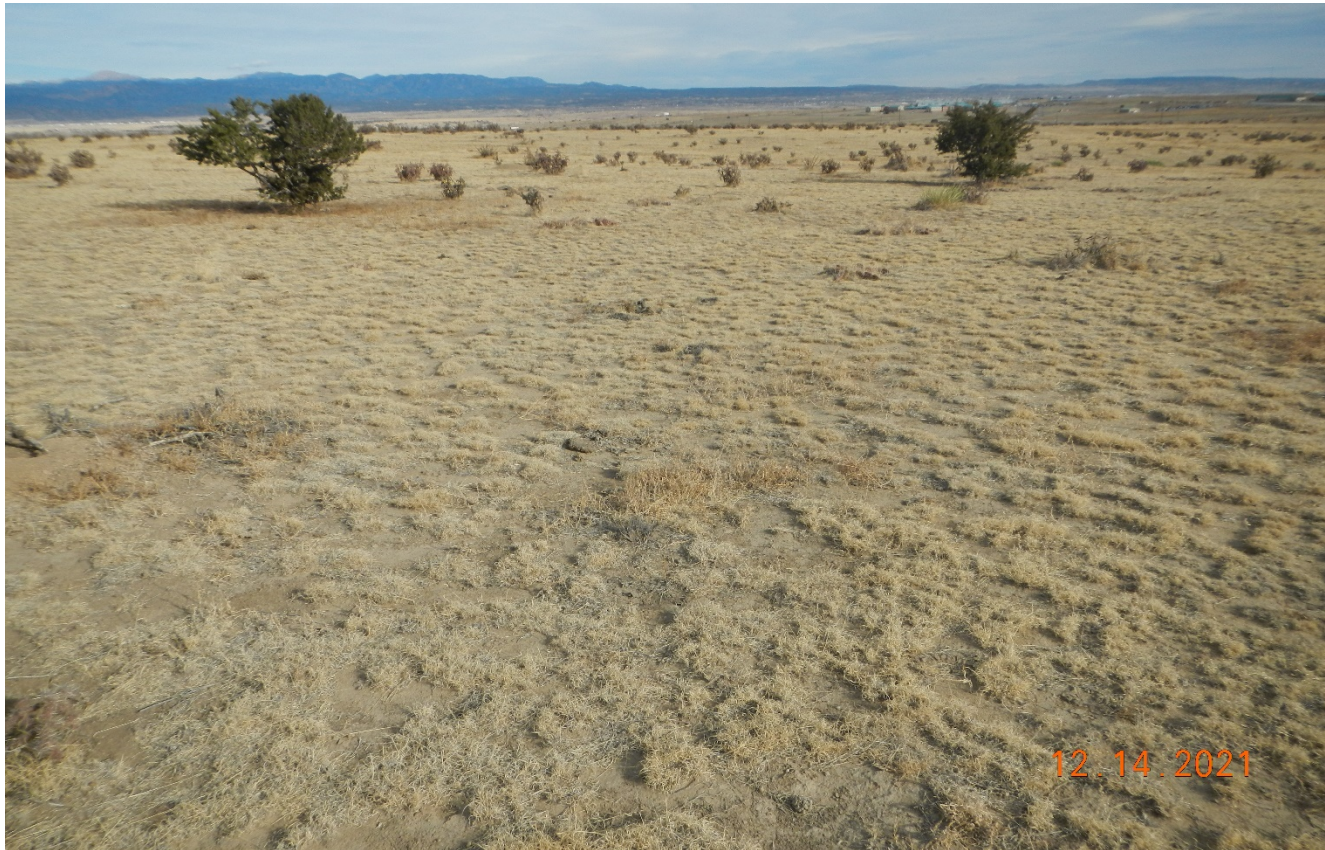
Photo 9. Facing north toward the surrounding undisturbed reference area which consists of Blue grama prairie with little to no undesirable weeds.
