Inspection Photos

API: 043-40000

Operator: JAVERNICK OIL

Inspection Date: 12/14/2021

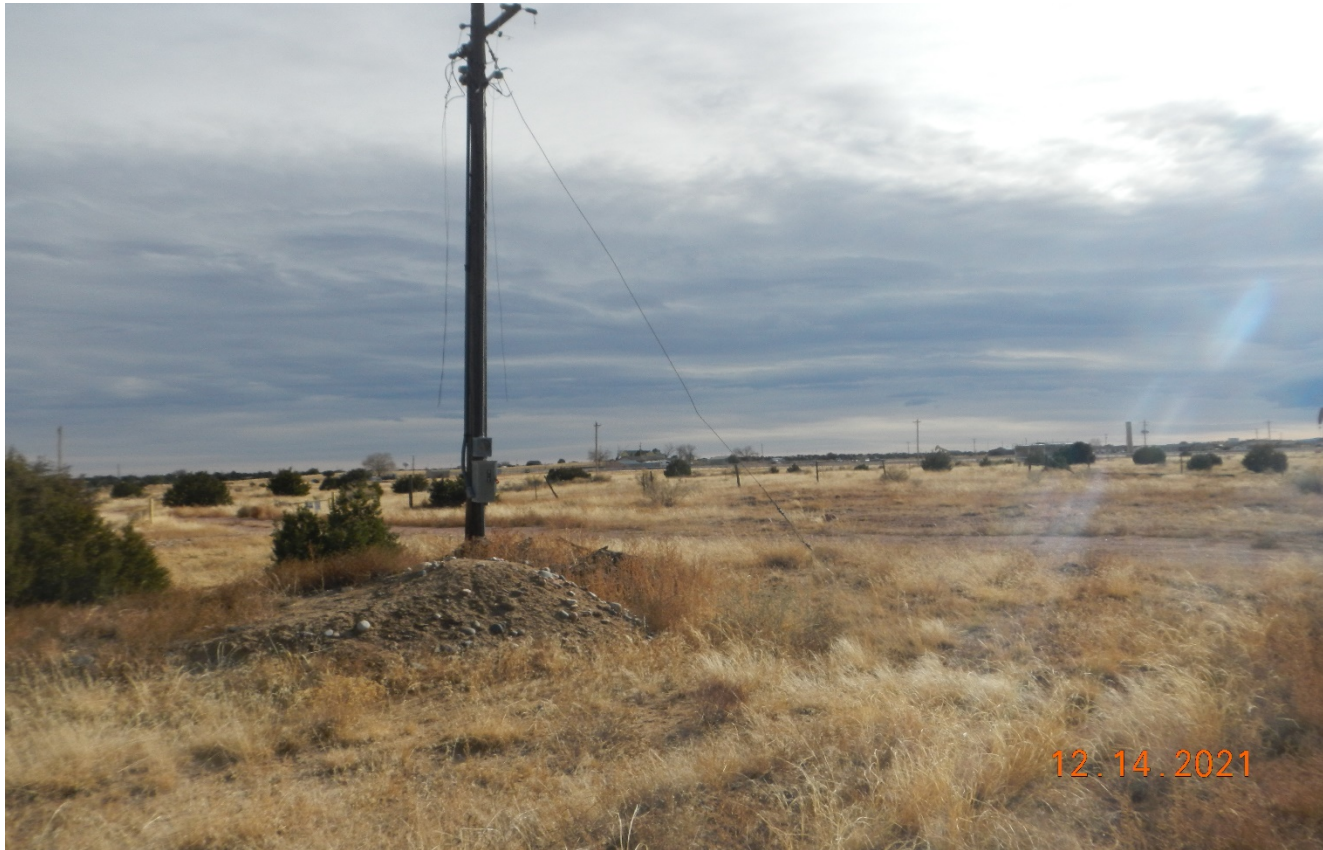
Photo 1. Facing east at the abandoned well site. There is an abandoned powerpole that remains which needs to be removed.

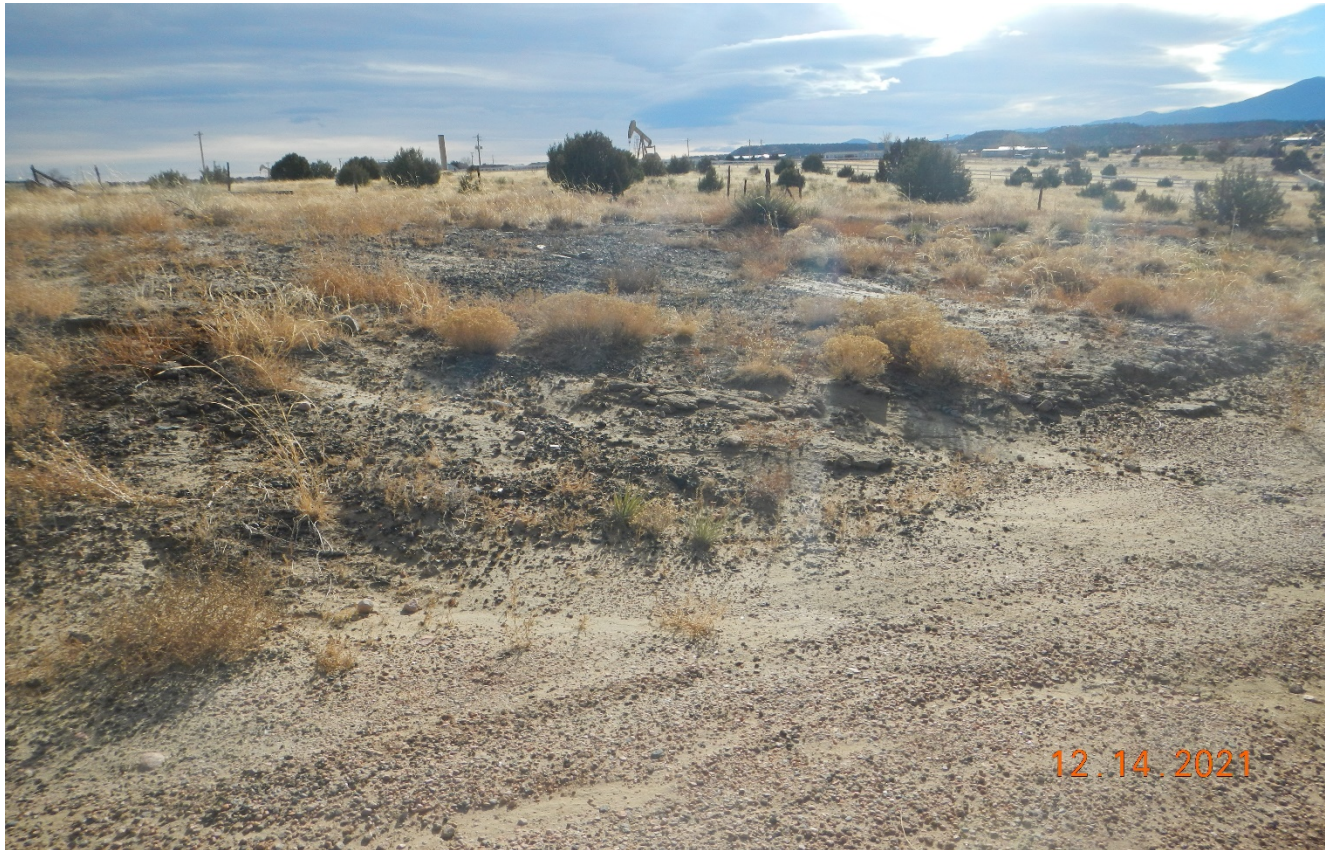
Photo 2. Facing south toward the location. There is gravelly soils that remain and the location is not reclaimed.

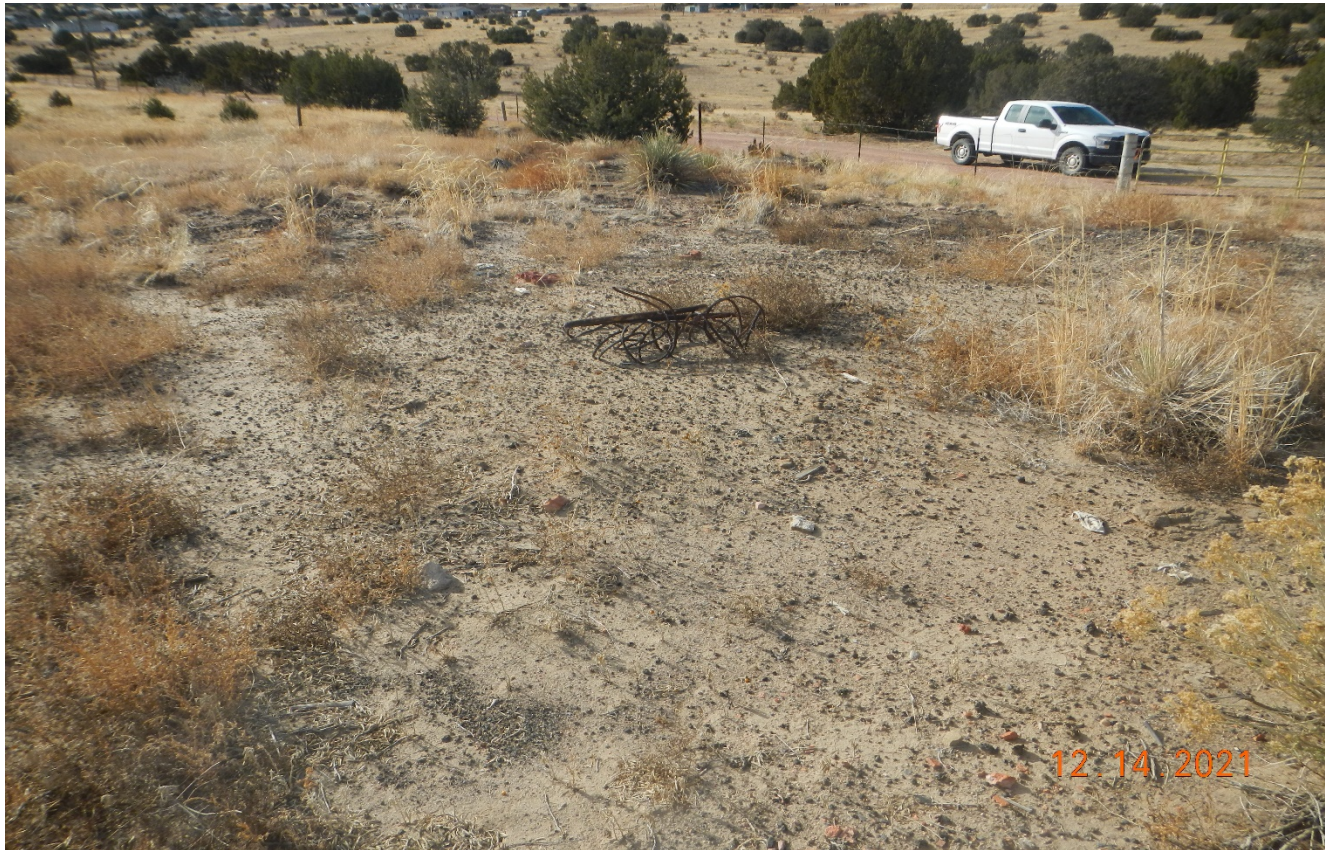
Photo 3. There is cable and various debris that remains.

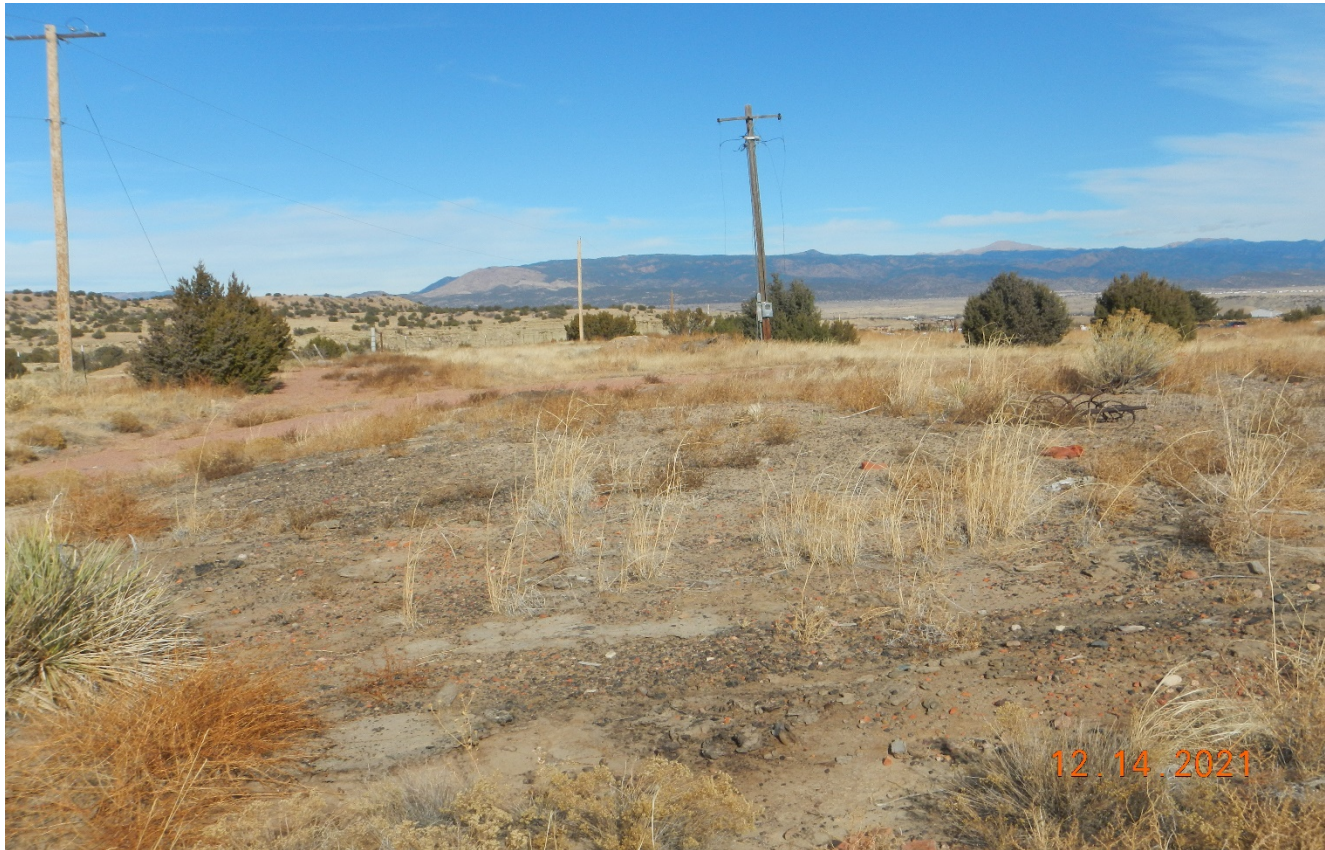
Photo 3. Facing north toward the location. There is gravelly soils that remain and the location is not reclaimed.

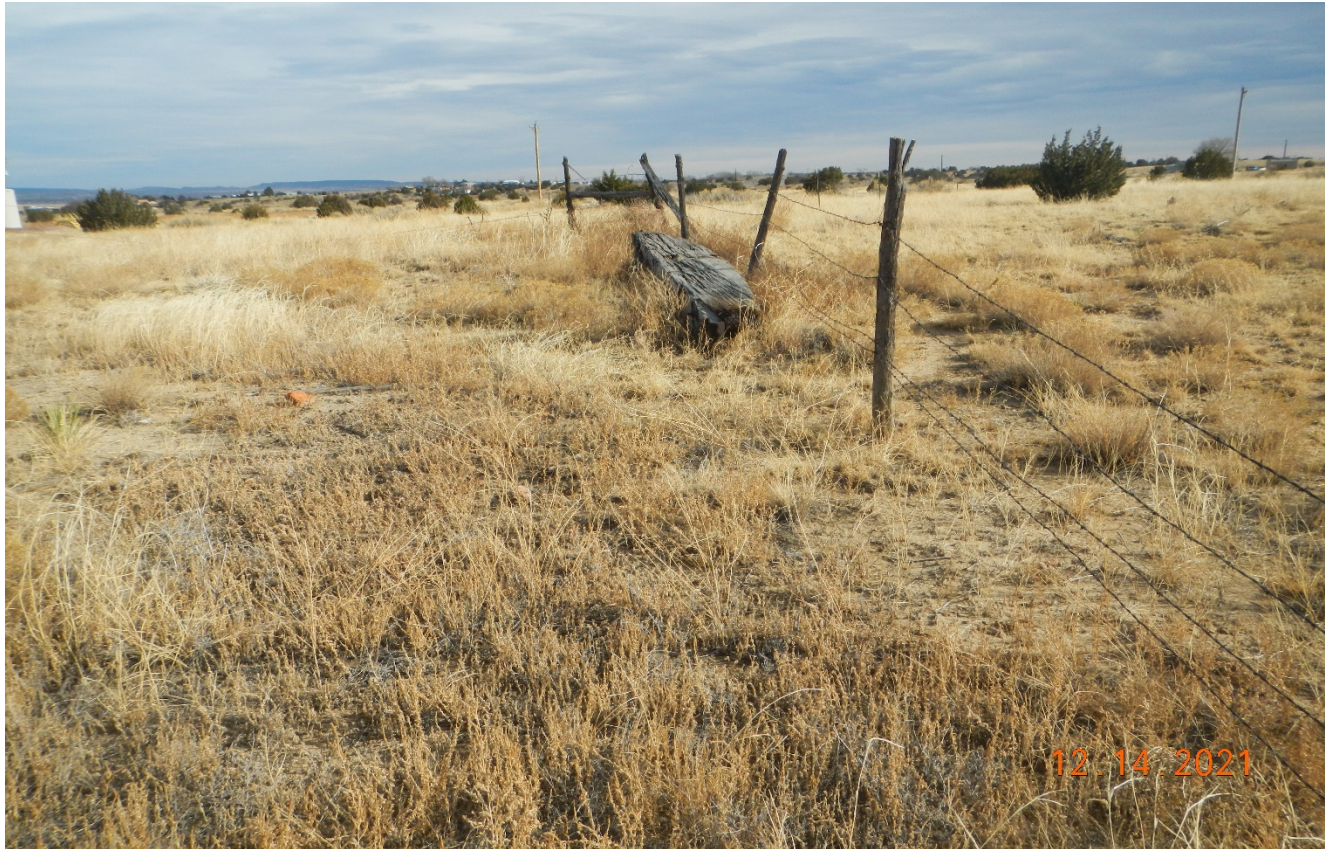
Photo 5. There is a bridge timber used for the pumpjack base that needs to be removed.

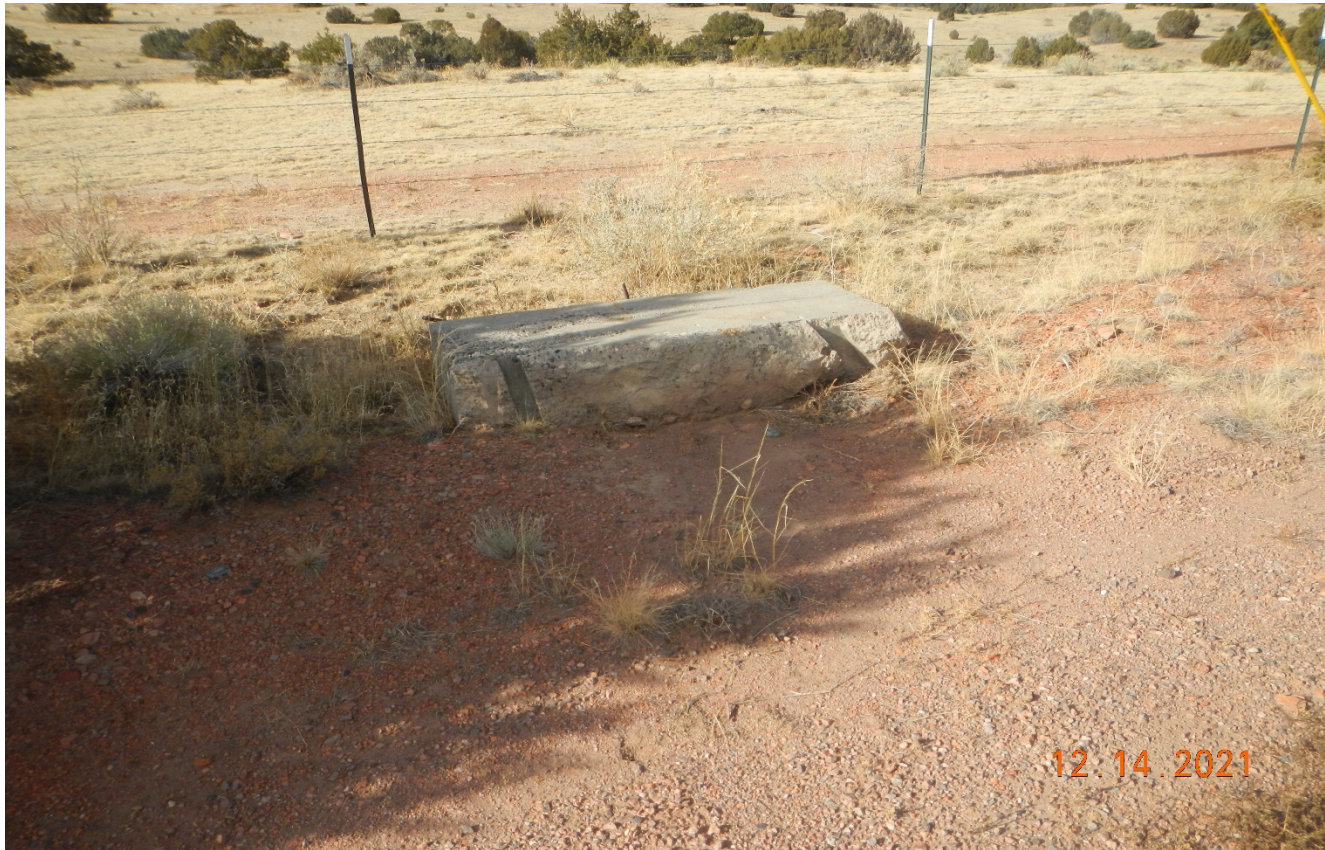
Photo 6. There are cement blocks that remain.
