Inspection Photos
location 430051
Inspection Date: 12/15/21
All Photos taken by Kris Neidel

COLORADO
Oil & Gas Conservation
Commission
Department of Natural Resources

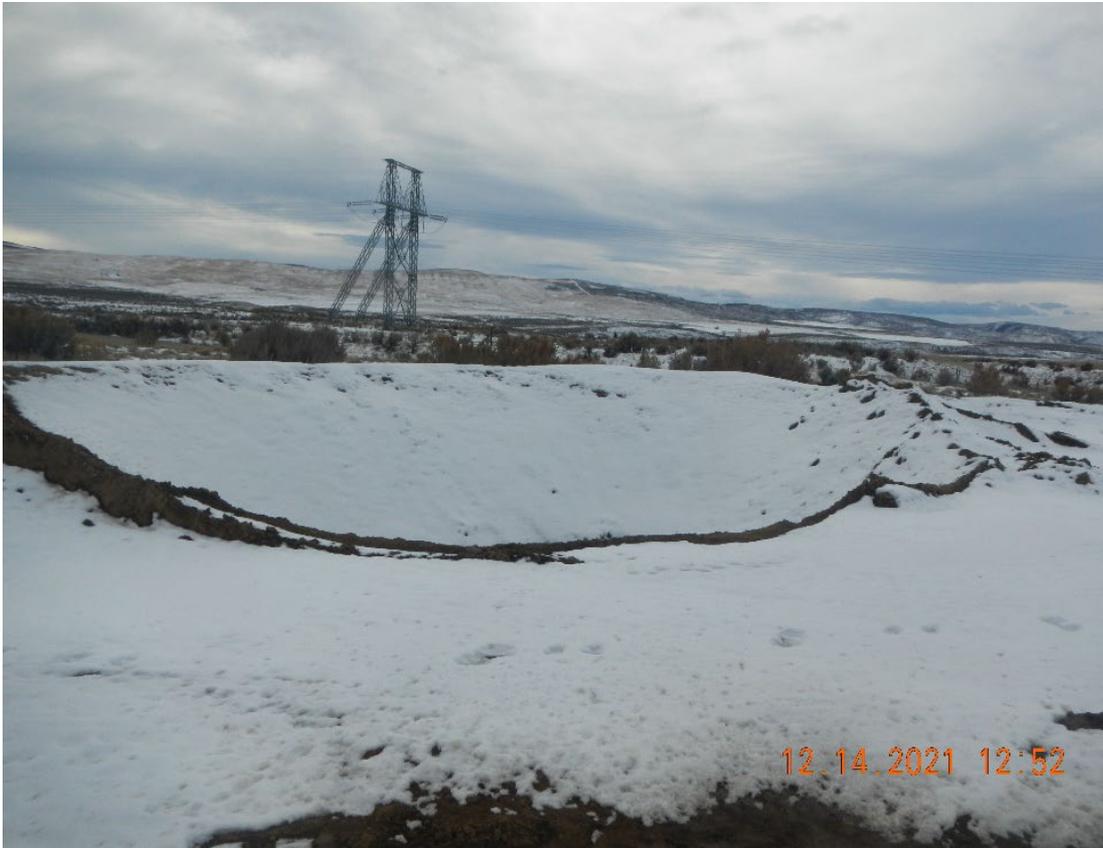
Photo #1 looking south from entry to pad at flare pit.

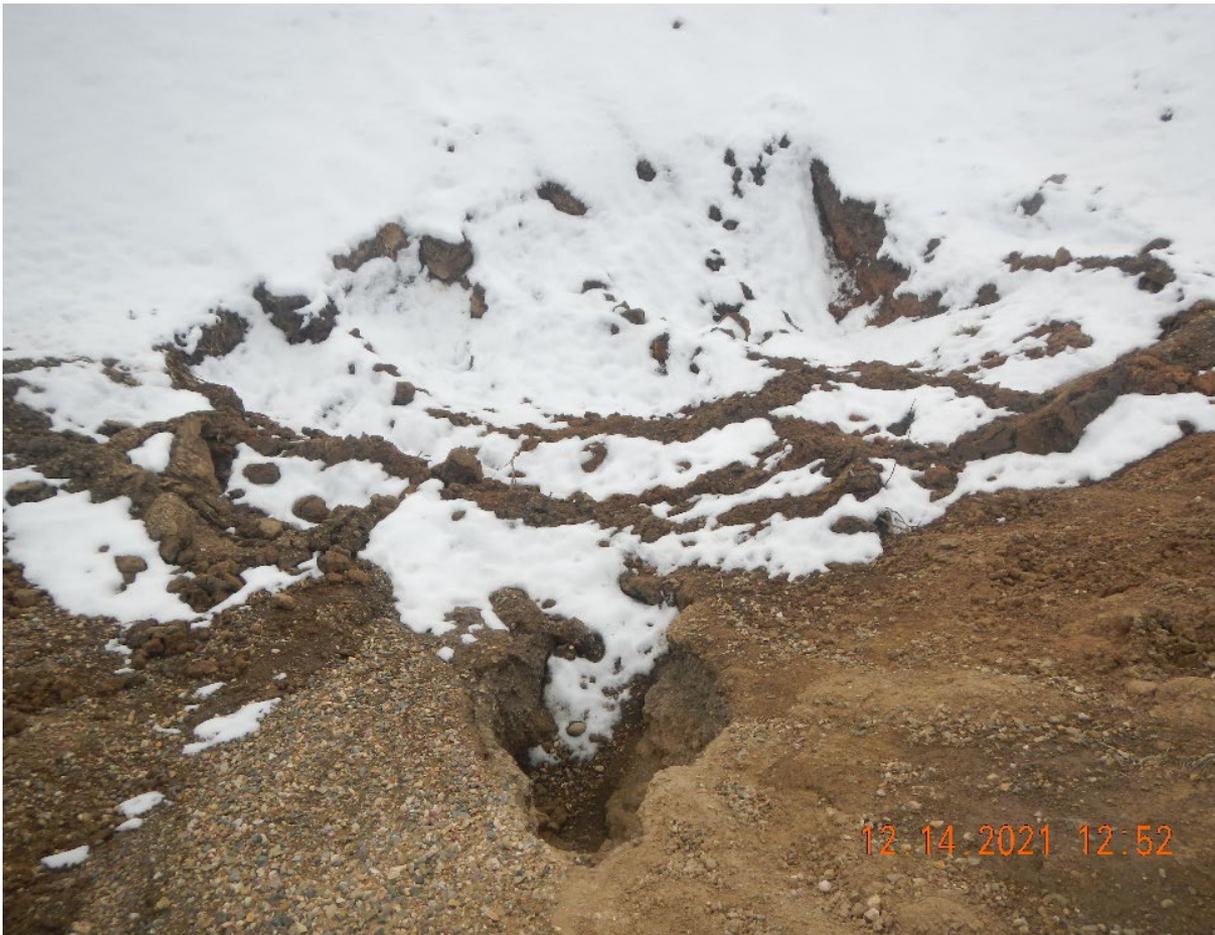
Photo #2 Close up of bottom of flare pit. It appeared that some soil was removed with an excavator bucket. No equipment from operations was observed in the pit (no flare, no flowline, etc)

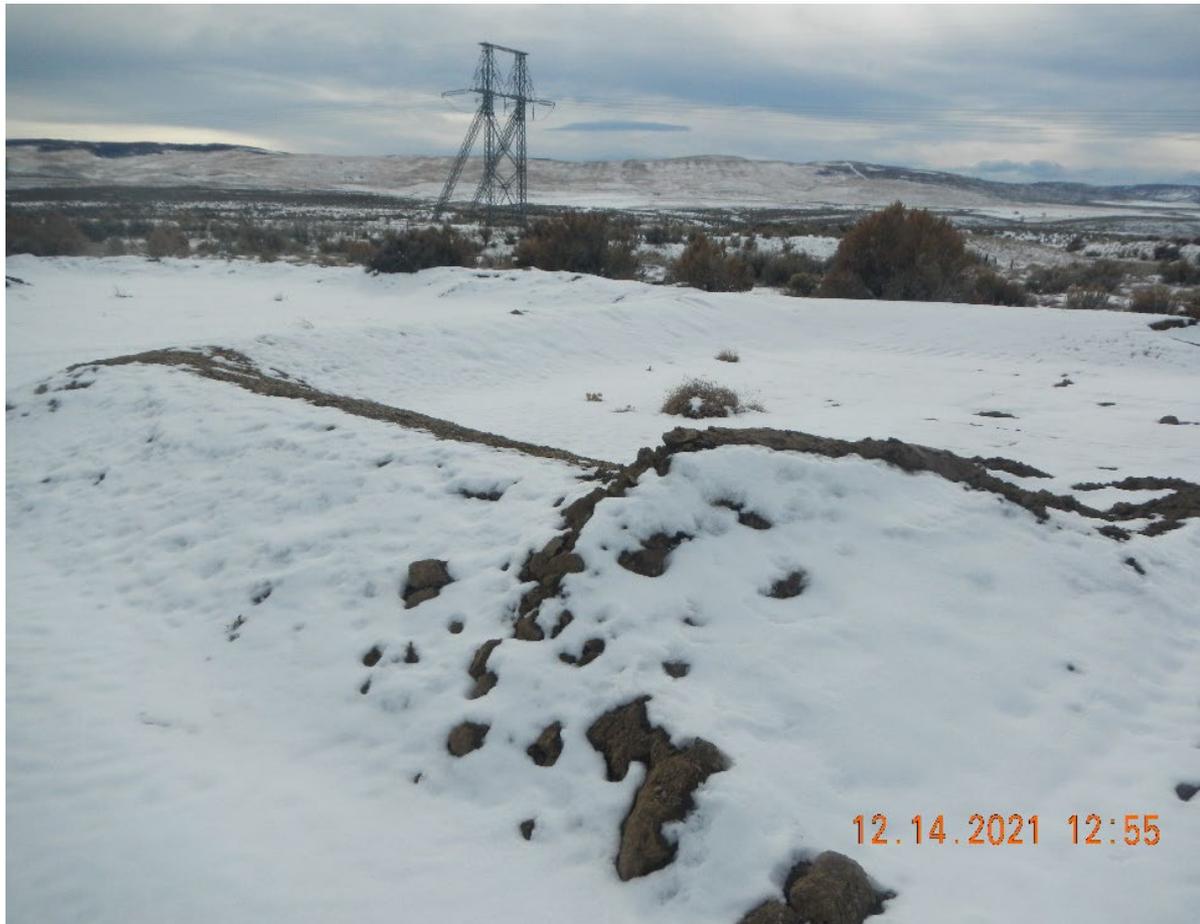
Photo #3 area where separator was, the berm was pushed over on the northwest side.

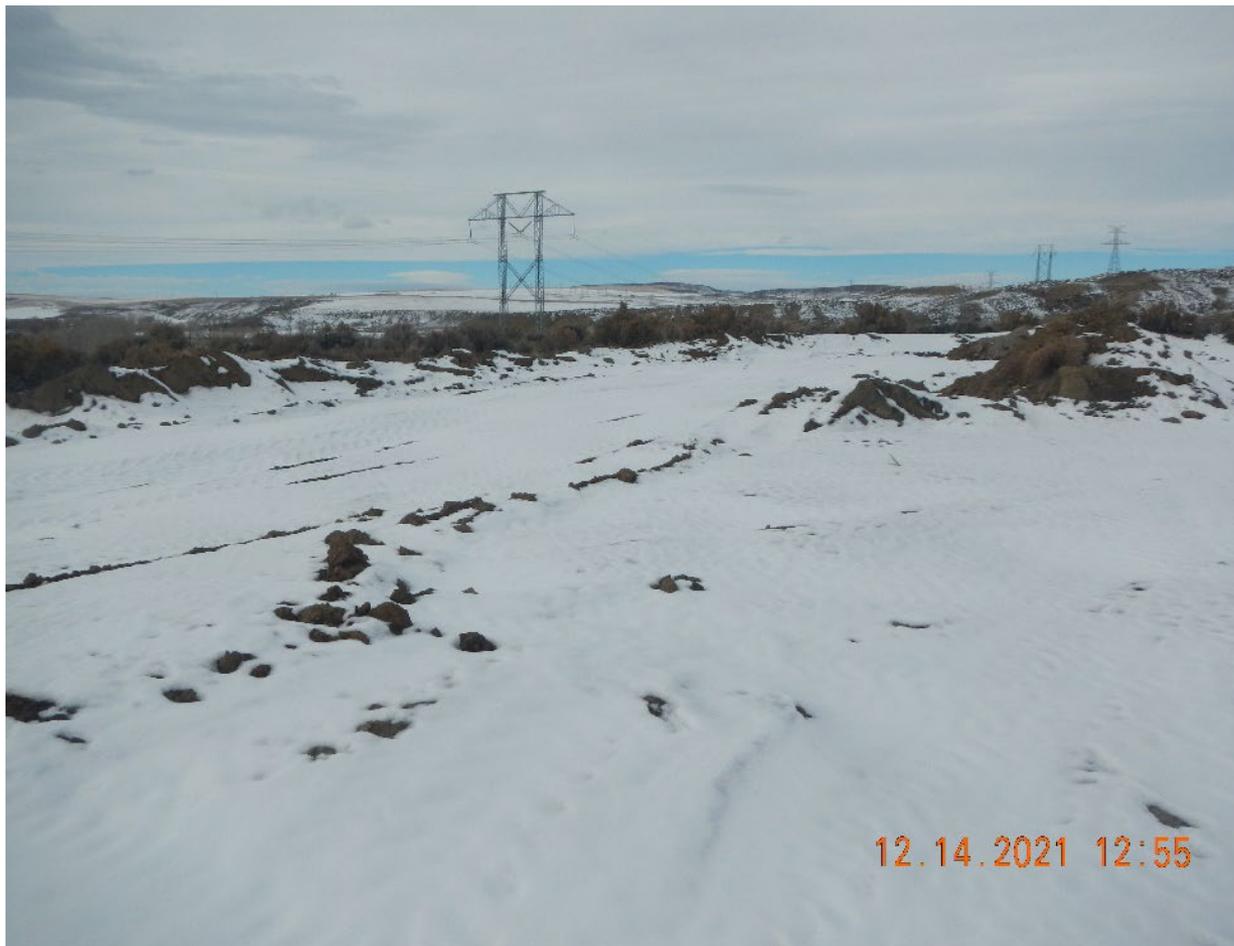
Photo #4 looking mostly south at area of old tank battery, the far right of photo was north end of secondary containment.

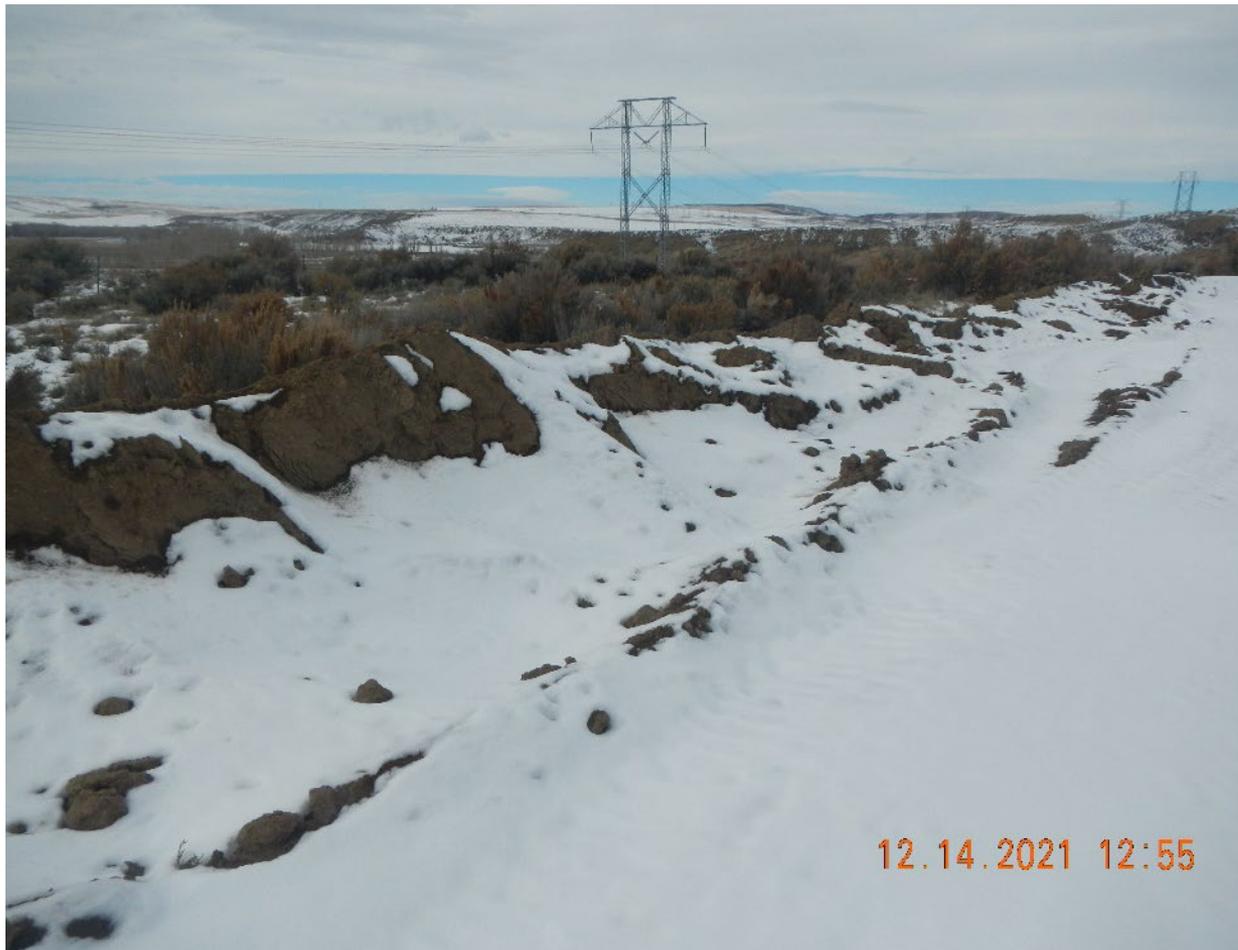
Photo #5 piled up soil on south west edge of location. It was not obvious where the soil was from or what it was for.

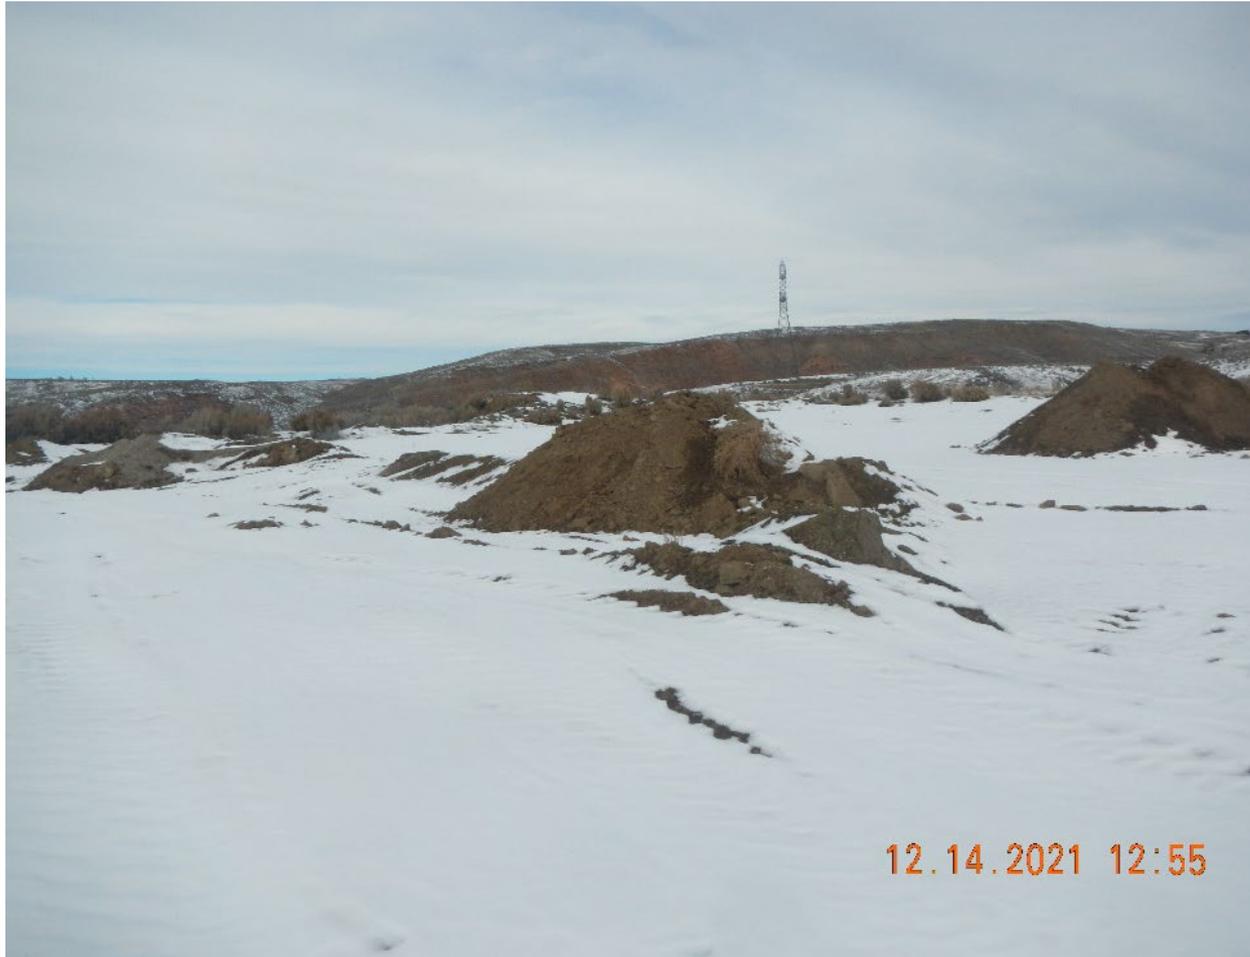
Photo #6 looking north standing near the old tank battery, at two piles of soil.

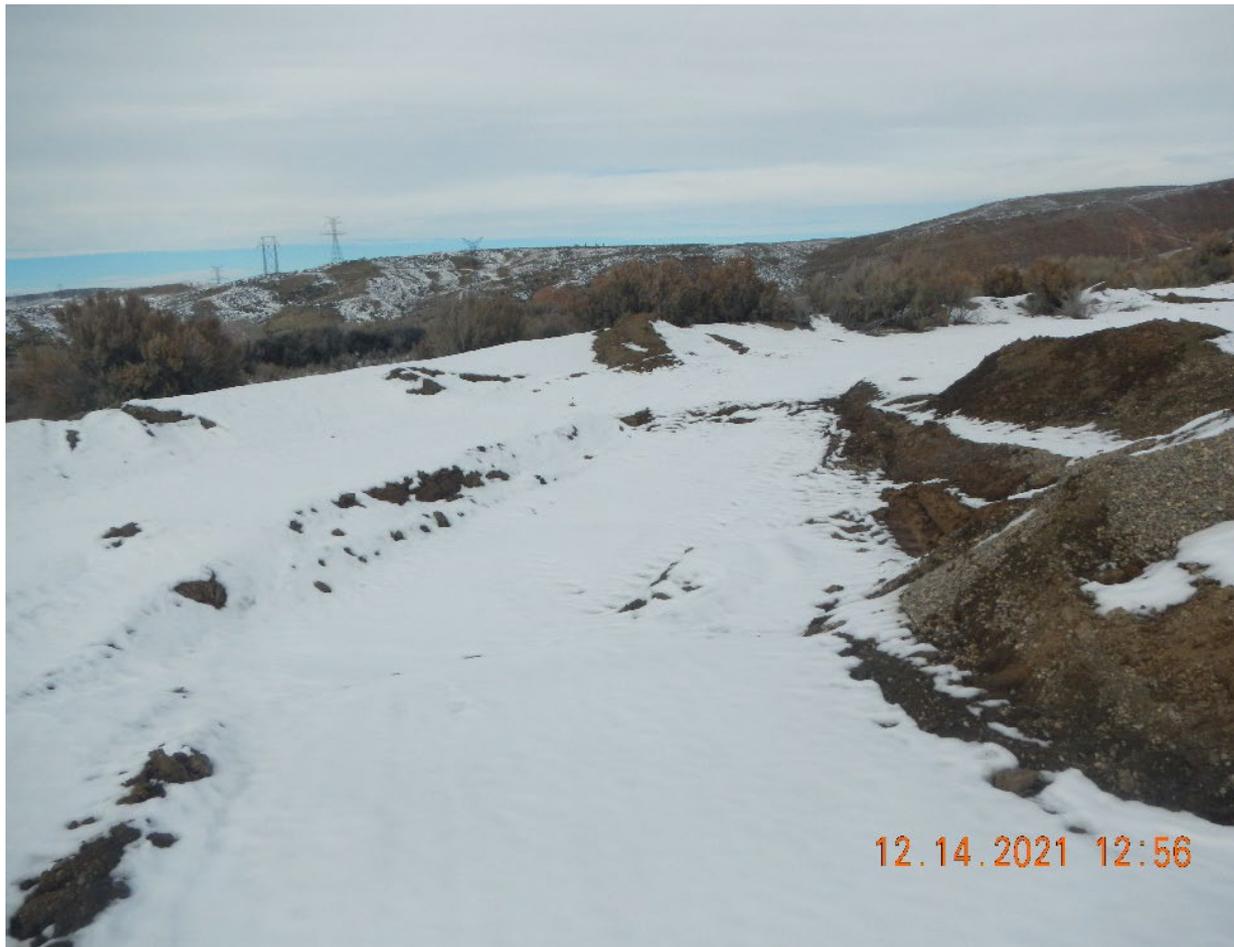
Photo #7 north end of tankbattery, tire tracks were observable (heavy equipment)

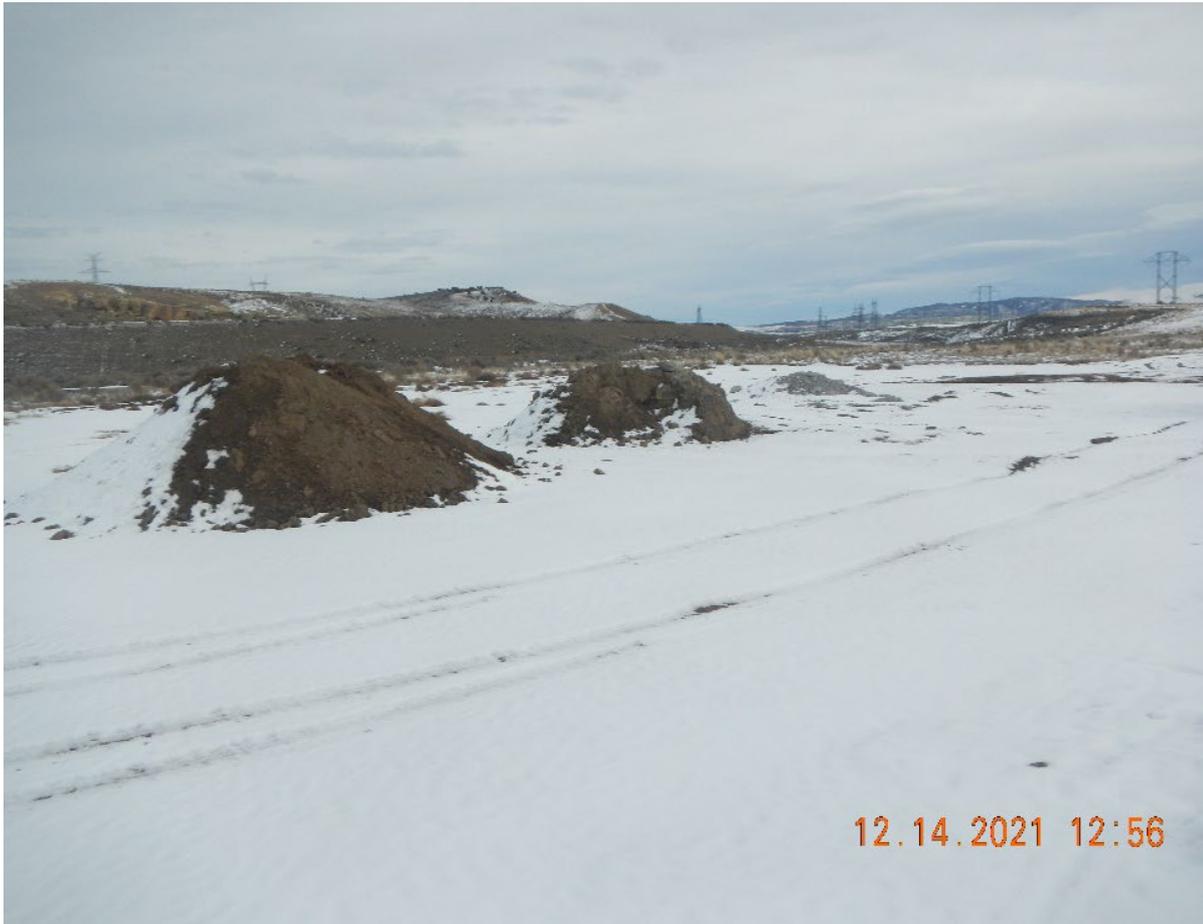
Photo # looking northeast, the dark soil in snow on right is where the wellhead was.

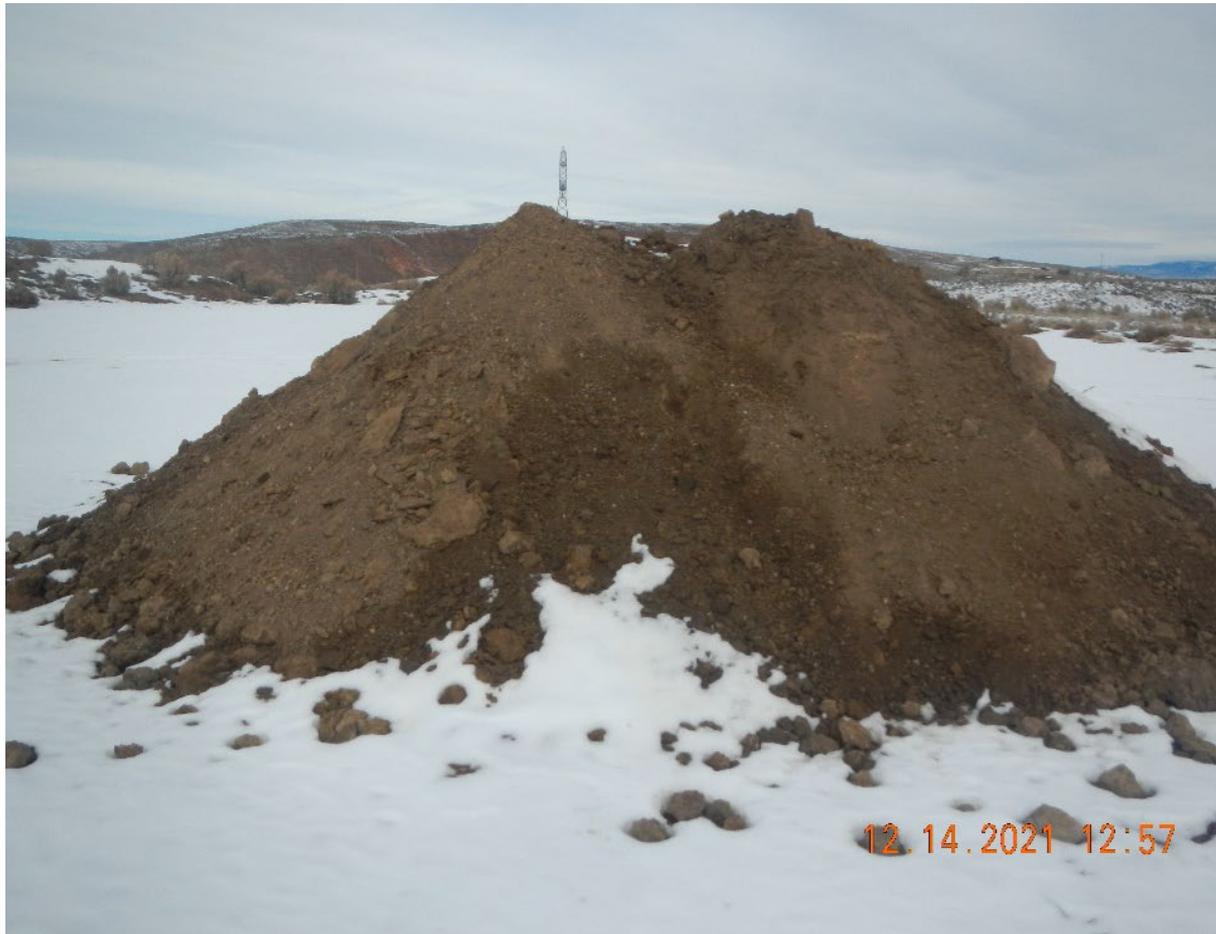
Photo #9 close-up of the north most pile of soil.

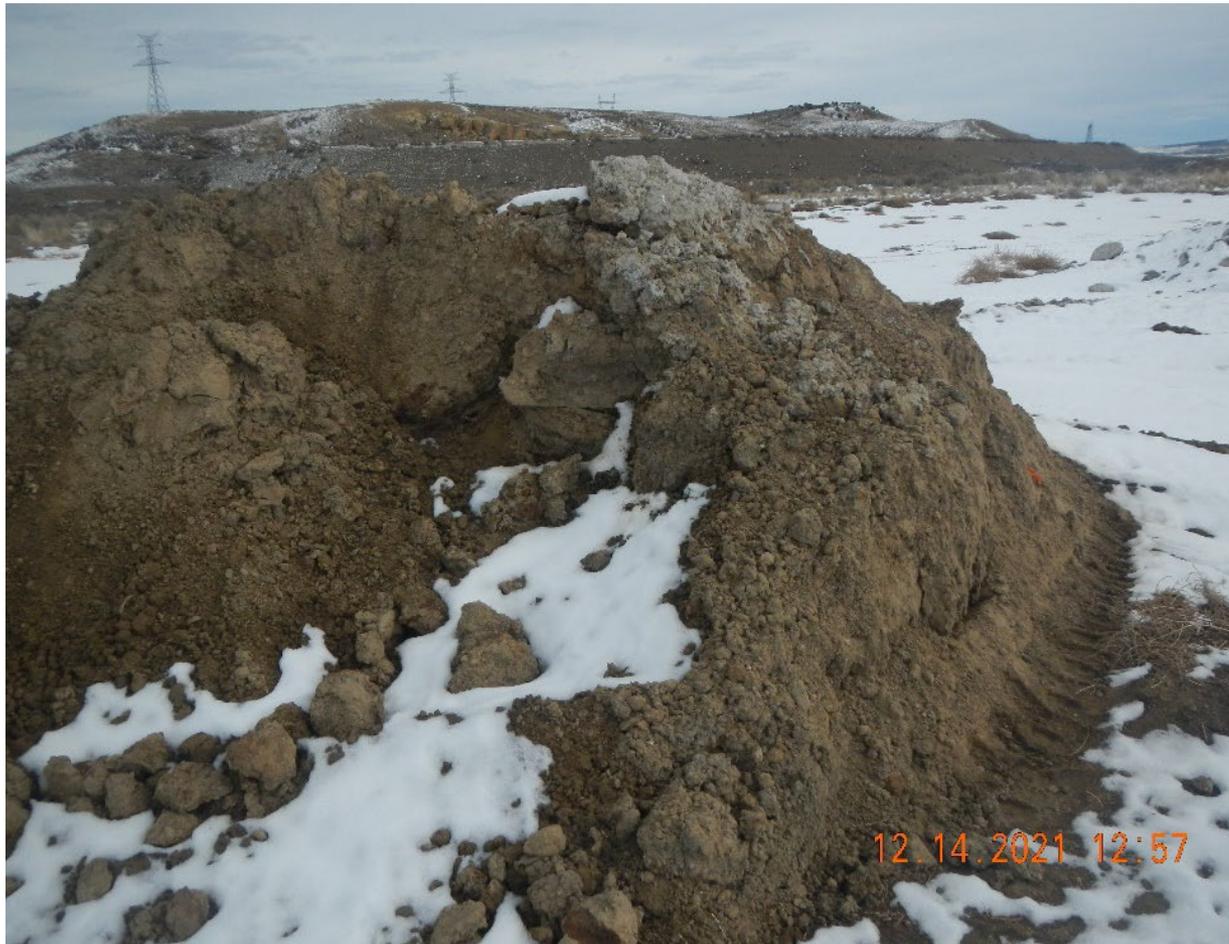
Photo #10 middle pile of soil, this pile appeared to have cement.

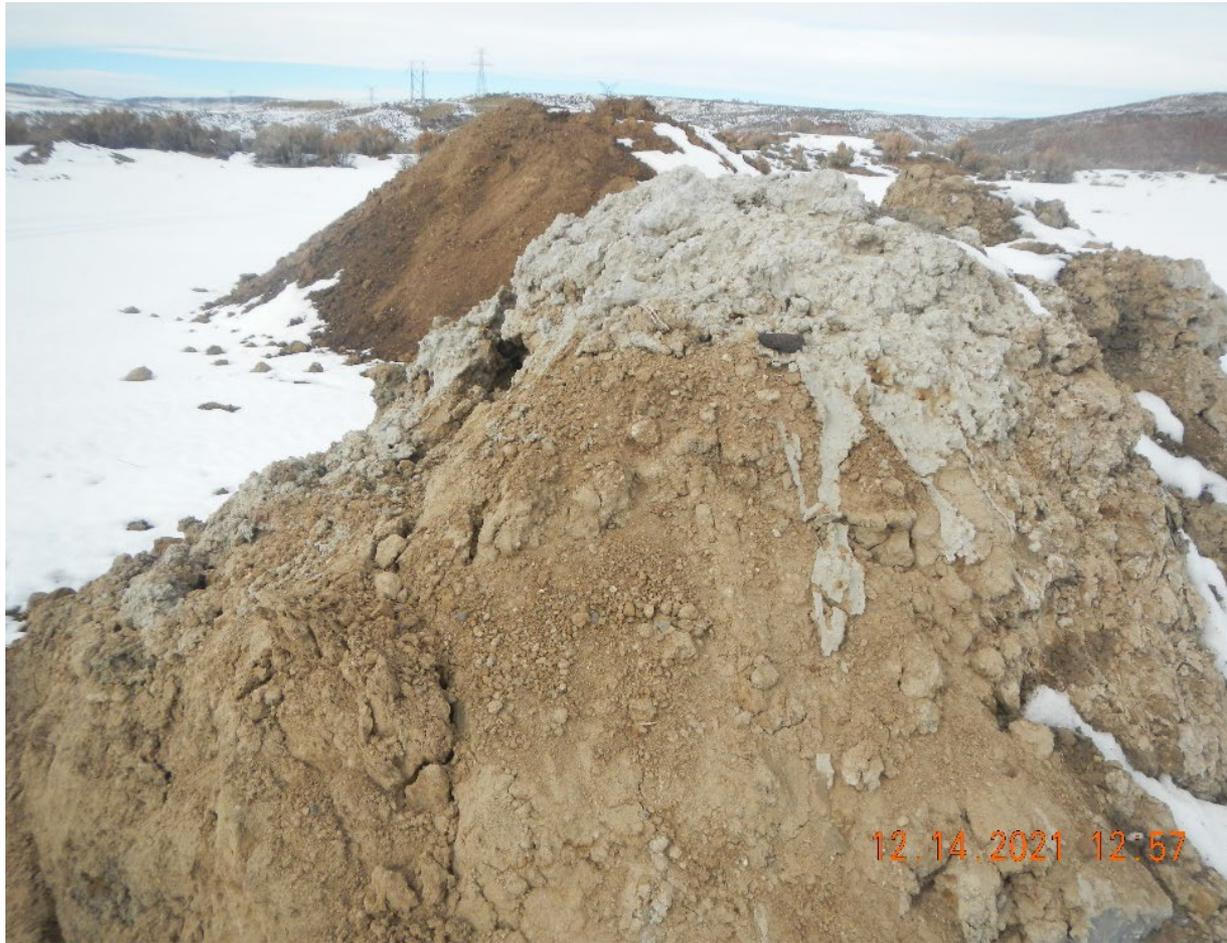
Photo #11 soil and cement.

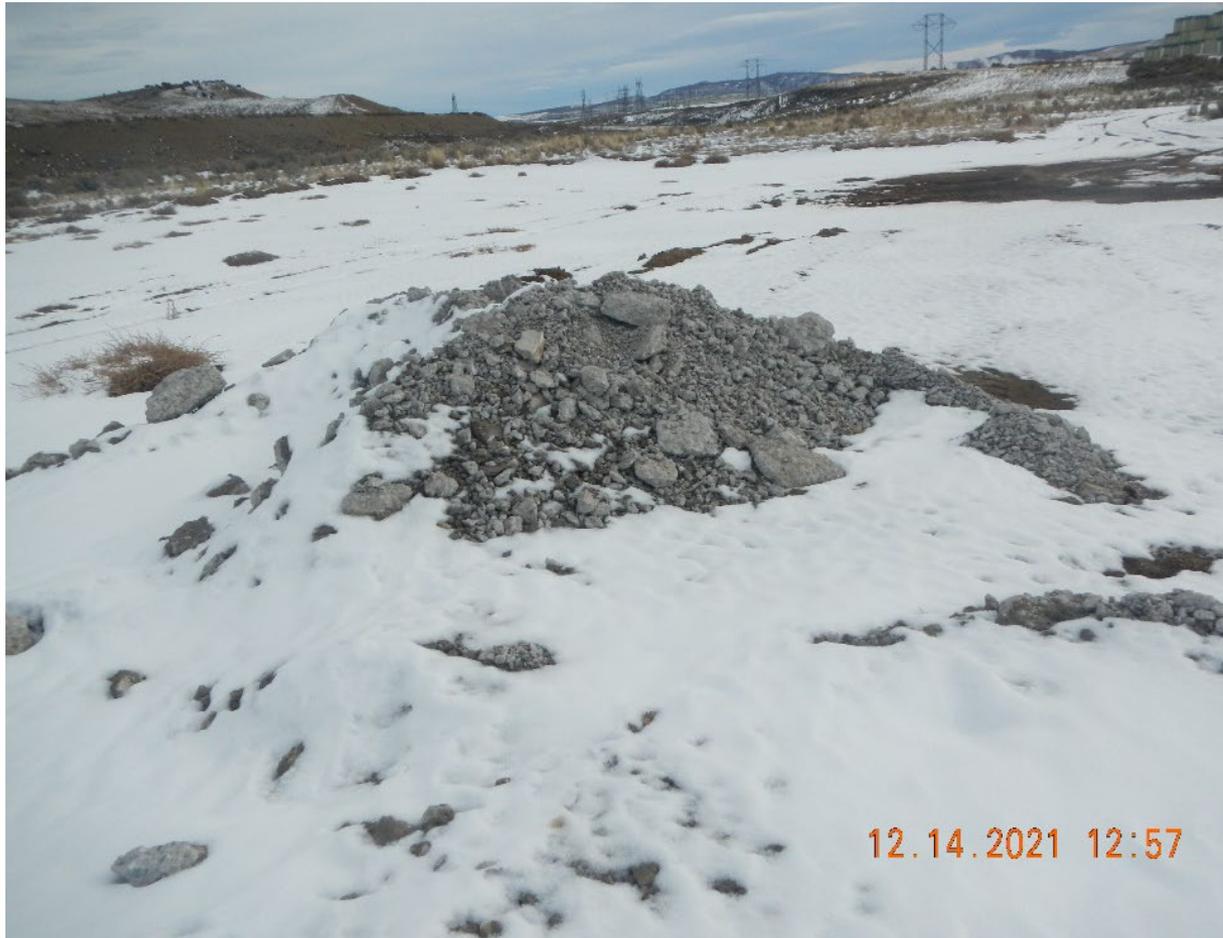
Photo #12 pile of cement. This pile can not be incorporated in any backfill

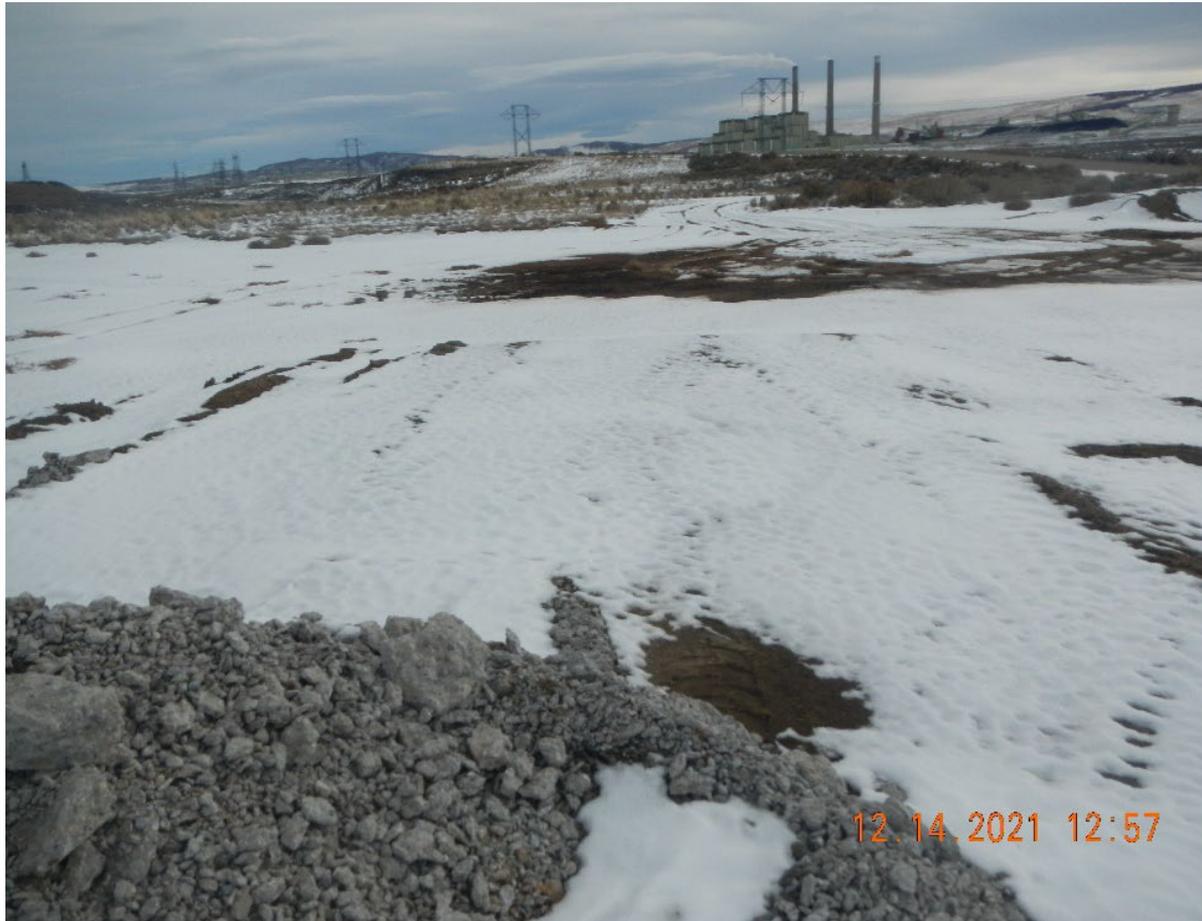
Photo #13 dark are in back 1/3 of photo is area of PA well and pumping unit.
