Inspection Photos

Location Name: TEP ROCKY MOUNTAIN LLC FEDERAL-66S95W /28SWSW

Location ID: 335446

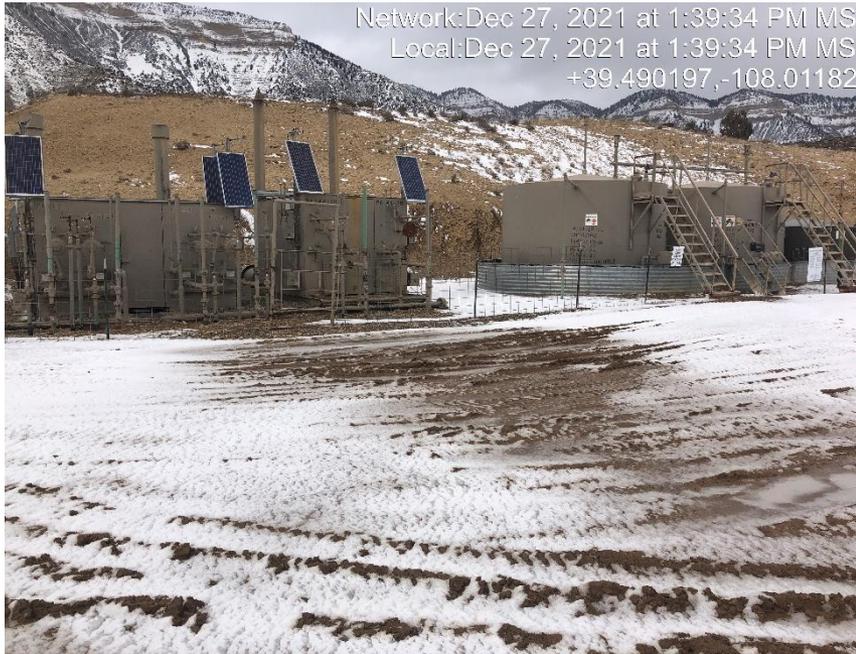
Photo #5518 from entrance to location.

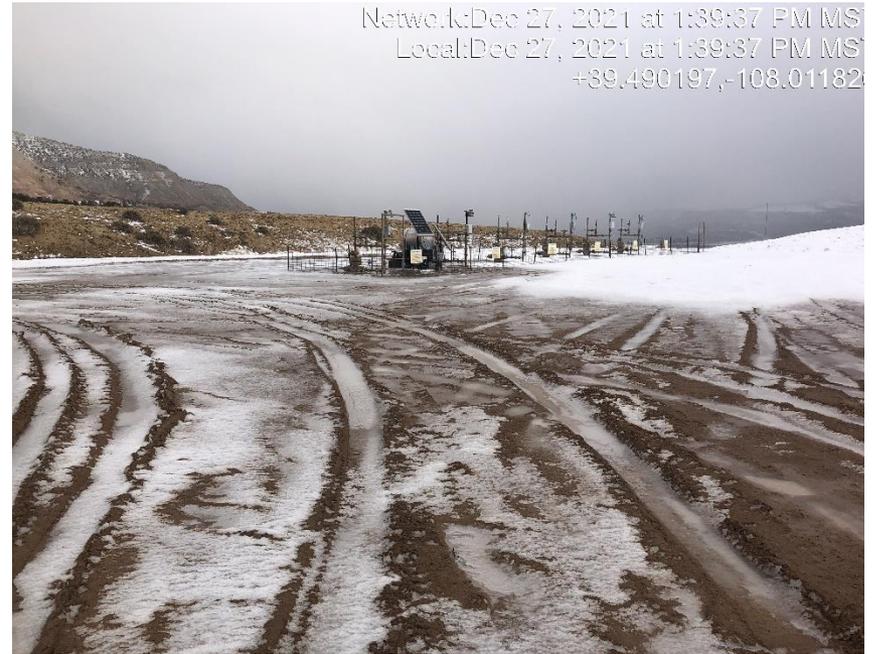
Photo #5519 from entrance to location.

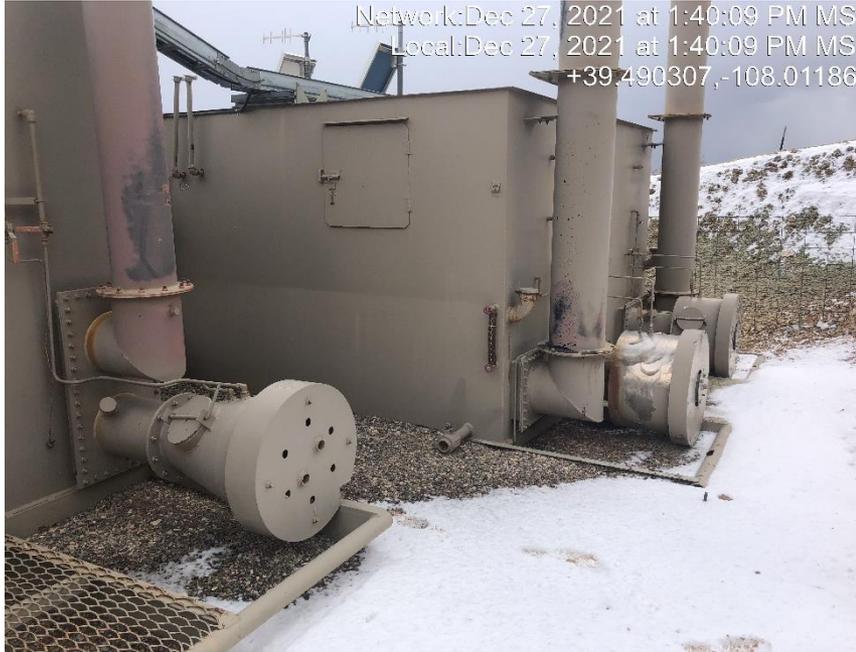
Photo #5520 Storage tank not labeled.

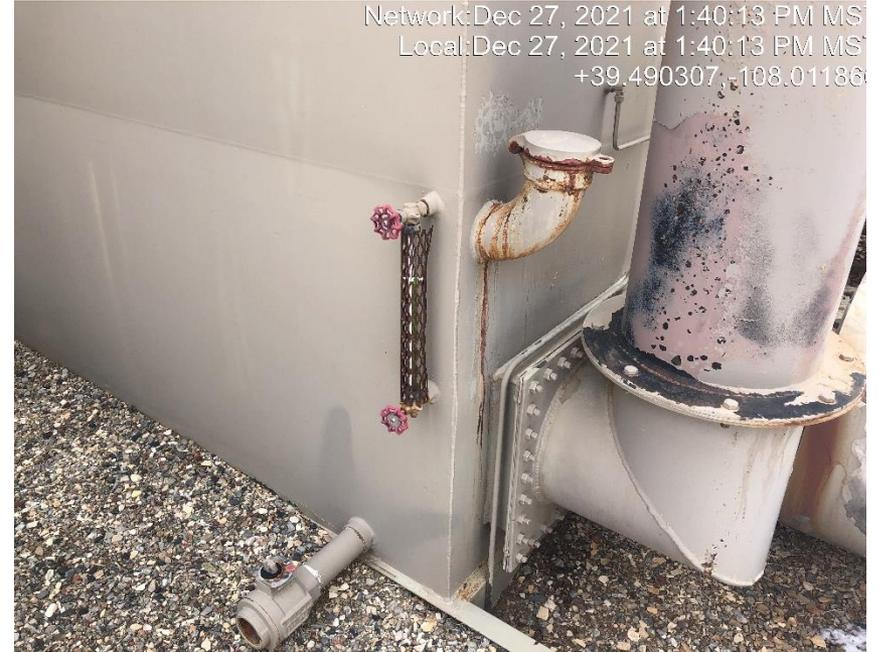
Photo #5521 Sight glass indicates the storage tank is full of an unknown fluid.

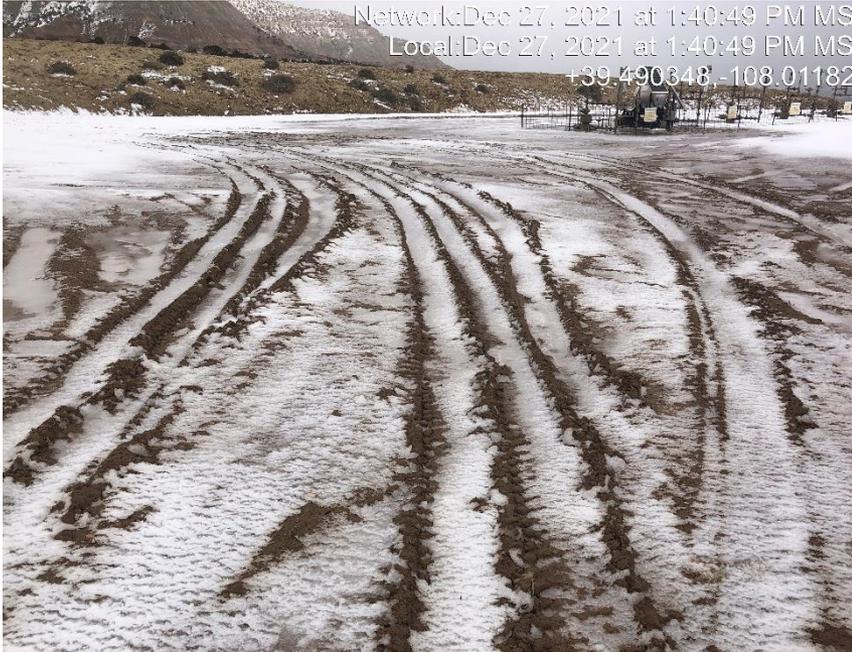
Photo #5522 Location lacks stabilization.

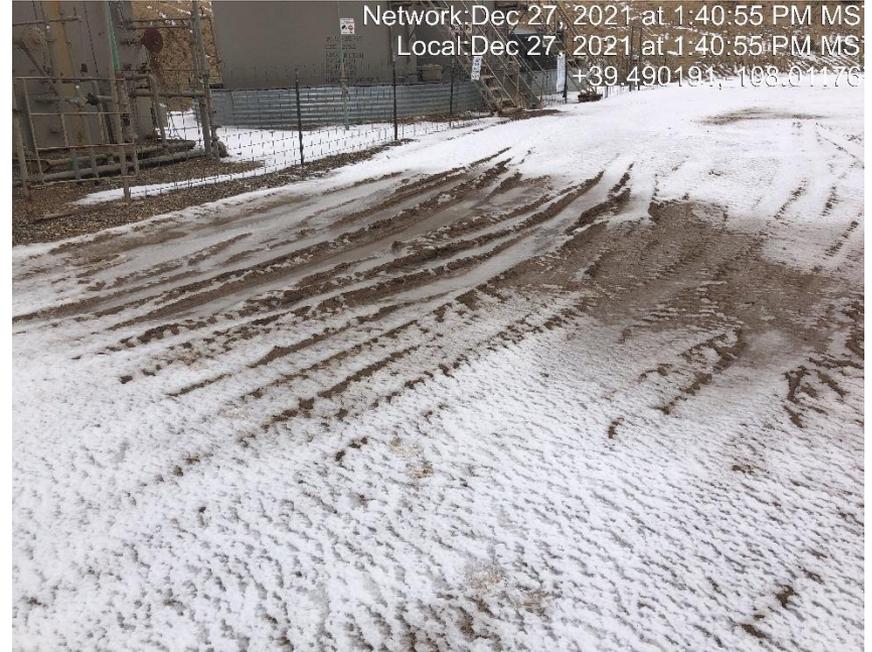
Photo #5523 Location lacks stabilization.

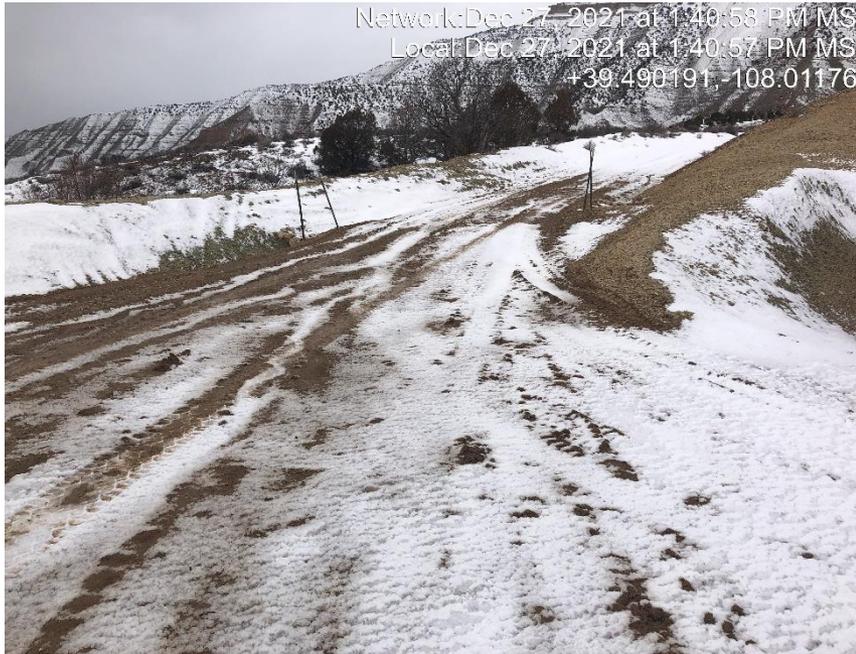
Photo #5524 Insufficient tracking BMP at entrance to location.
