Inspection Photos
Operator: Arkoma
API: 067-08793
Date: 12/22/2021

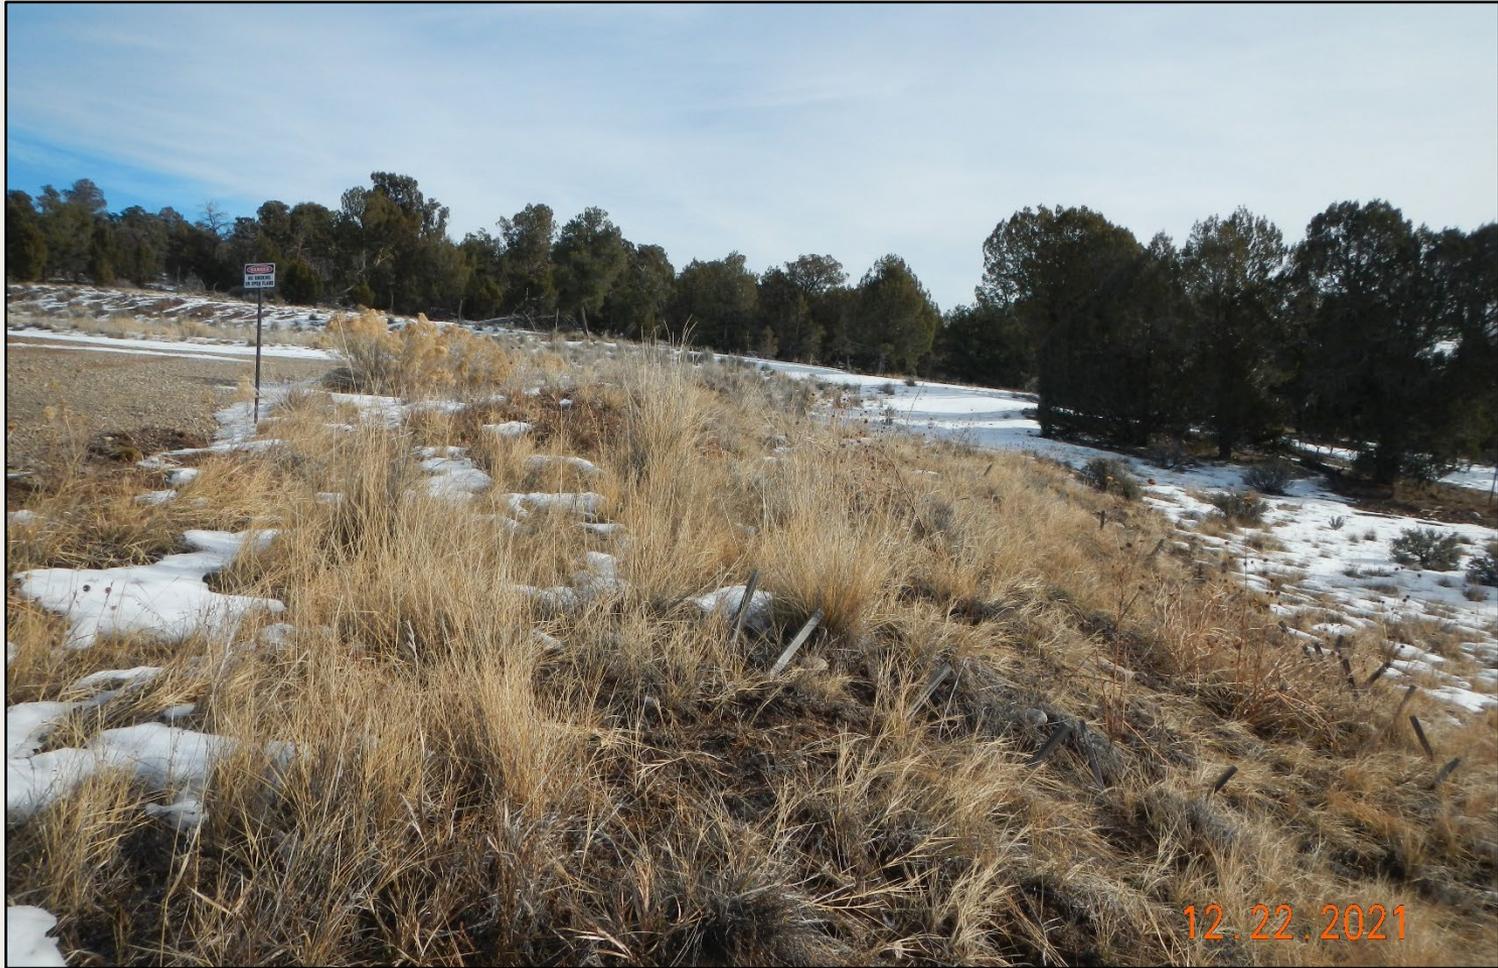
Photo 1. View of the southern project area from the southwestern corner facing center. Revegetation is progressing with western wheatgrass, smooth brome, and intermediate wheatgrass. Revegetation at final reclamation needs to be representative of the surrounding reference area.

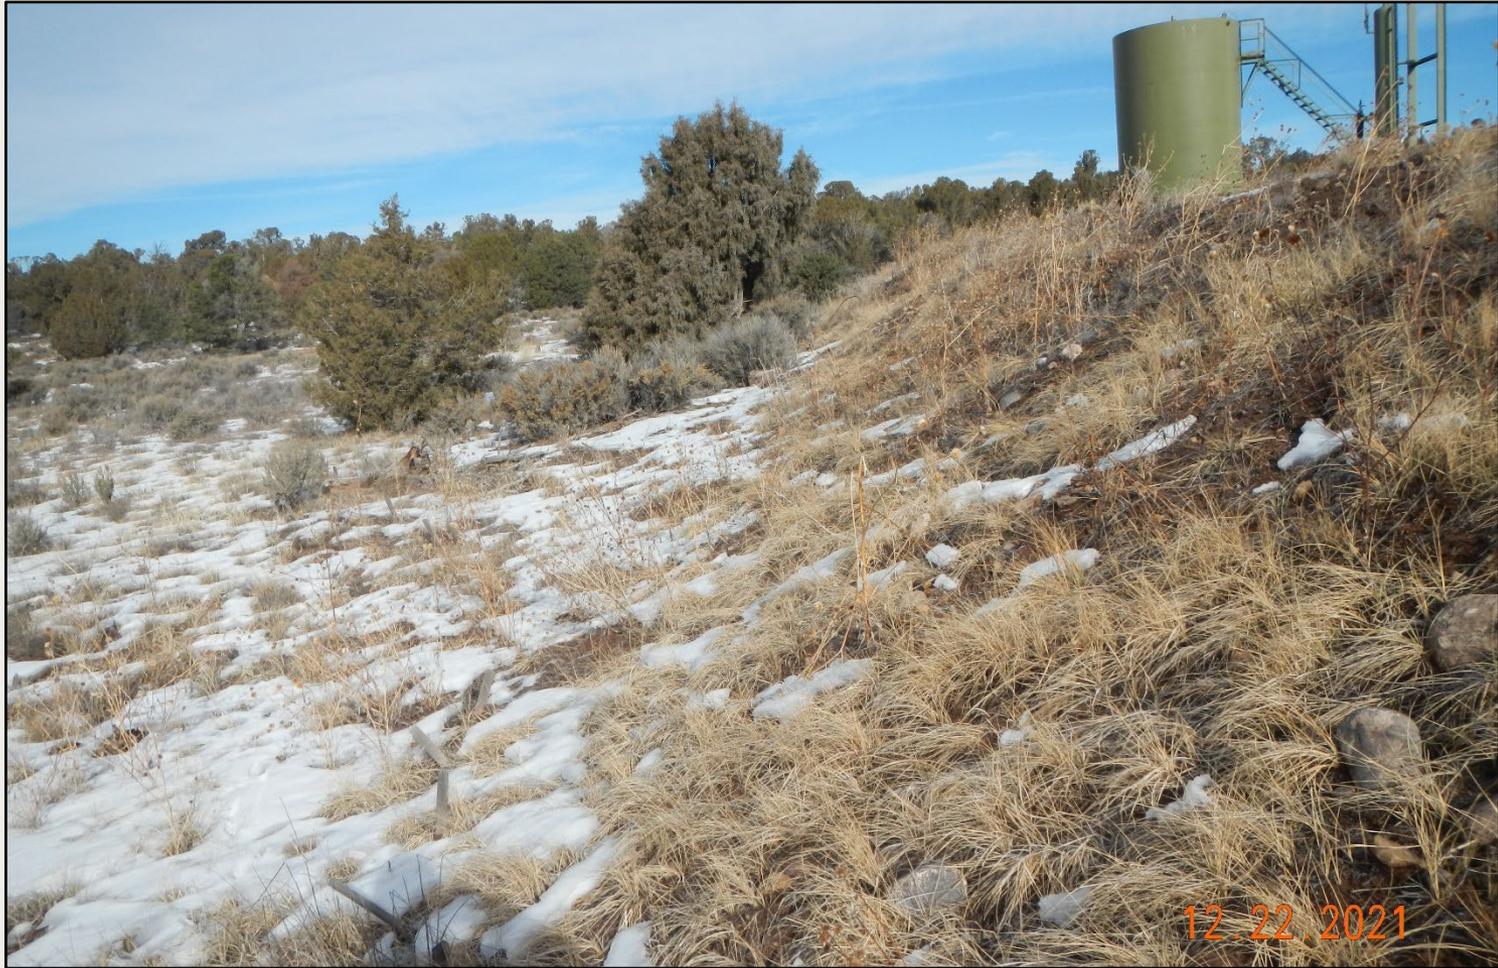
Photo 2. View of the western fill slope from the southwestern corner facing northward.

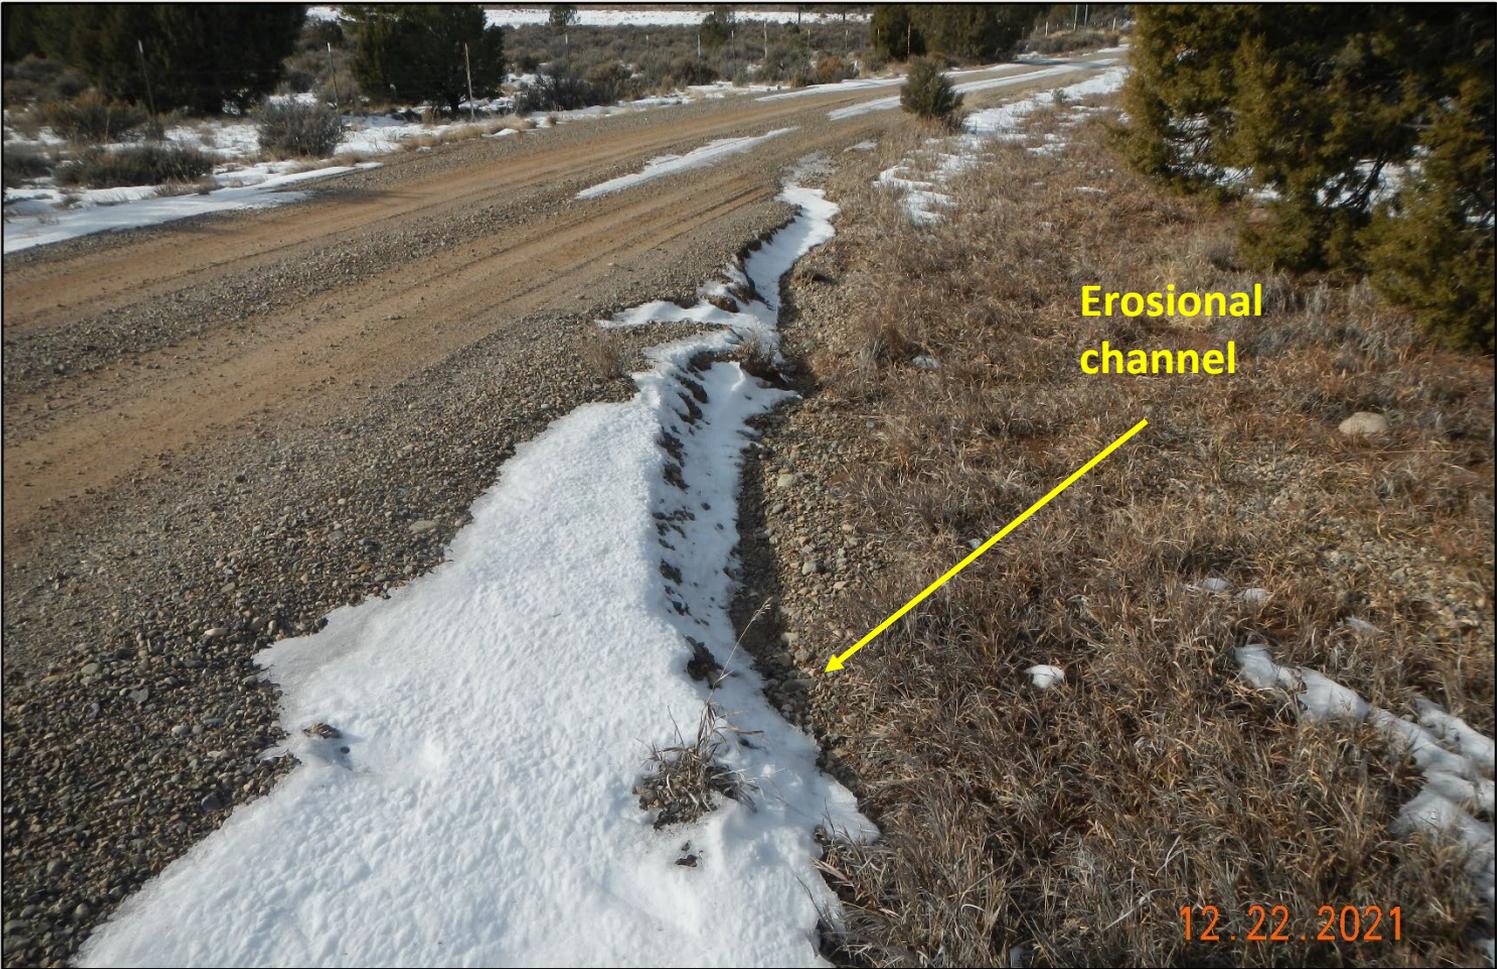
Photo 3. View of erosional channel approximately 12-15 inches wide and deep, flowing off of the well pad and down/across the access road.

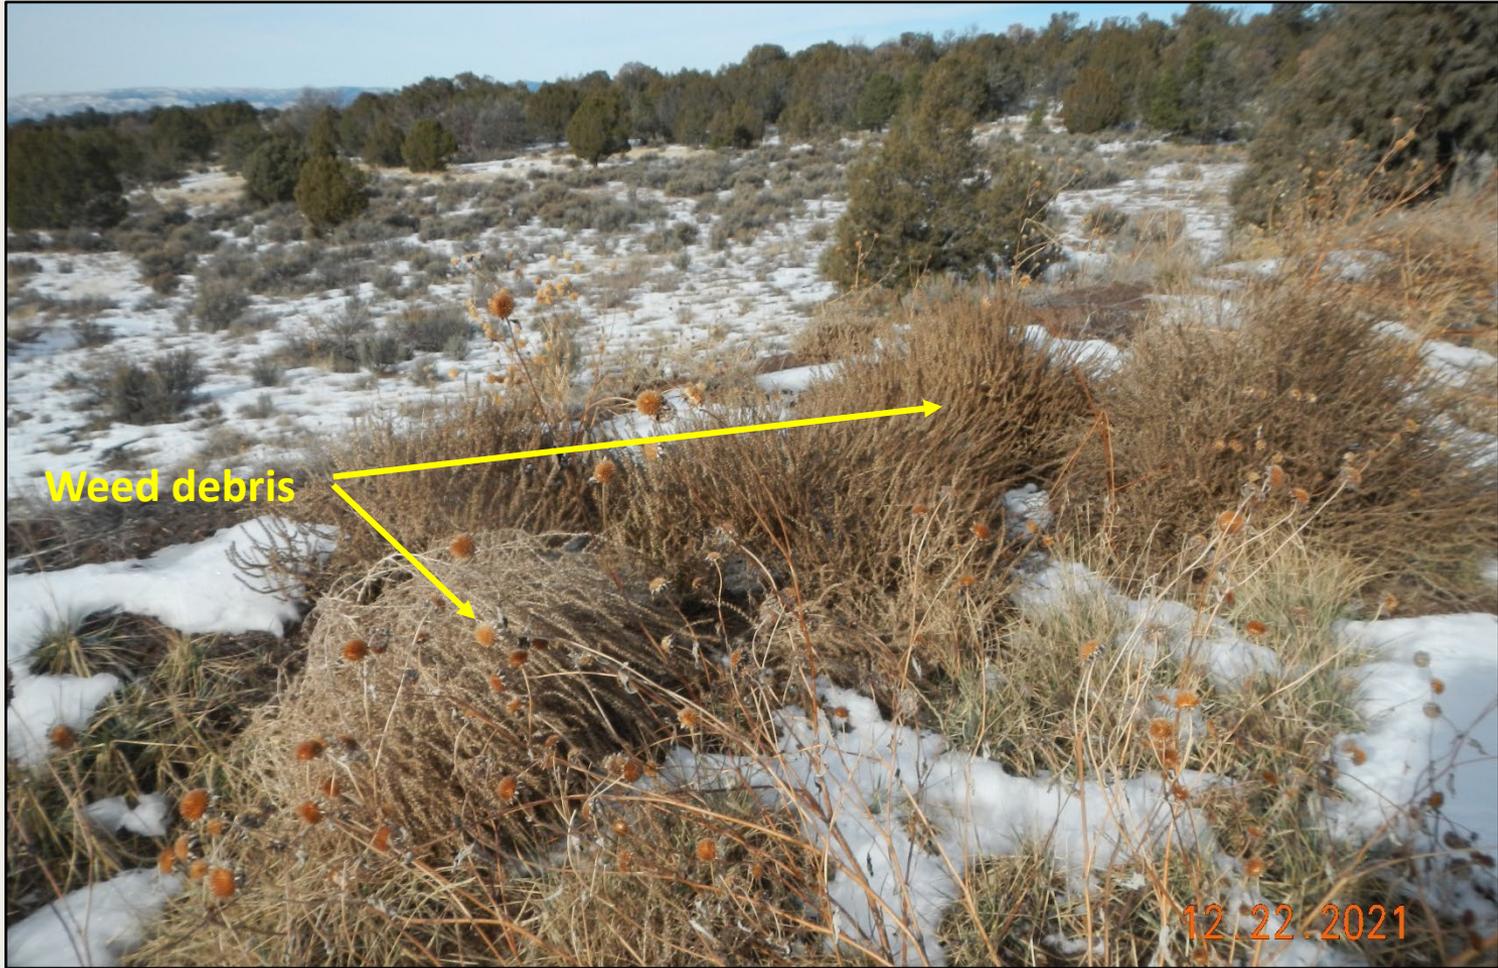
Photo 4. View of Russian thistle debris observed within the project area, near the well pad entrance, needs to be removed.

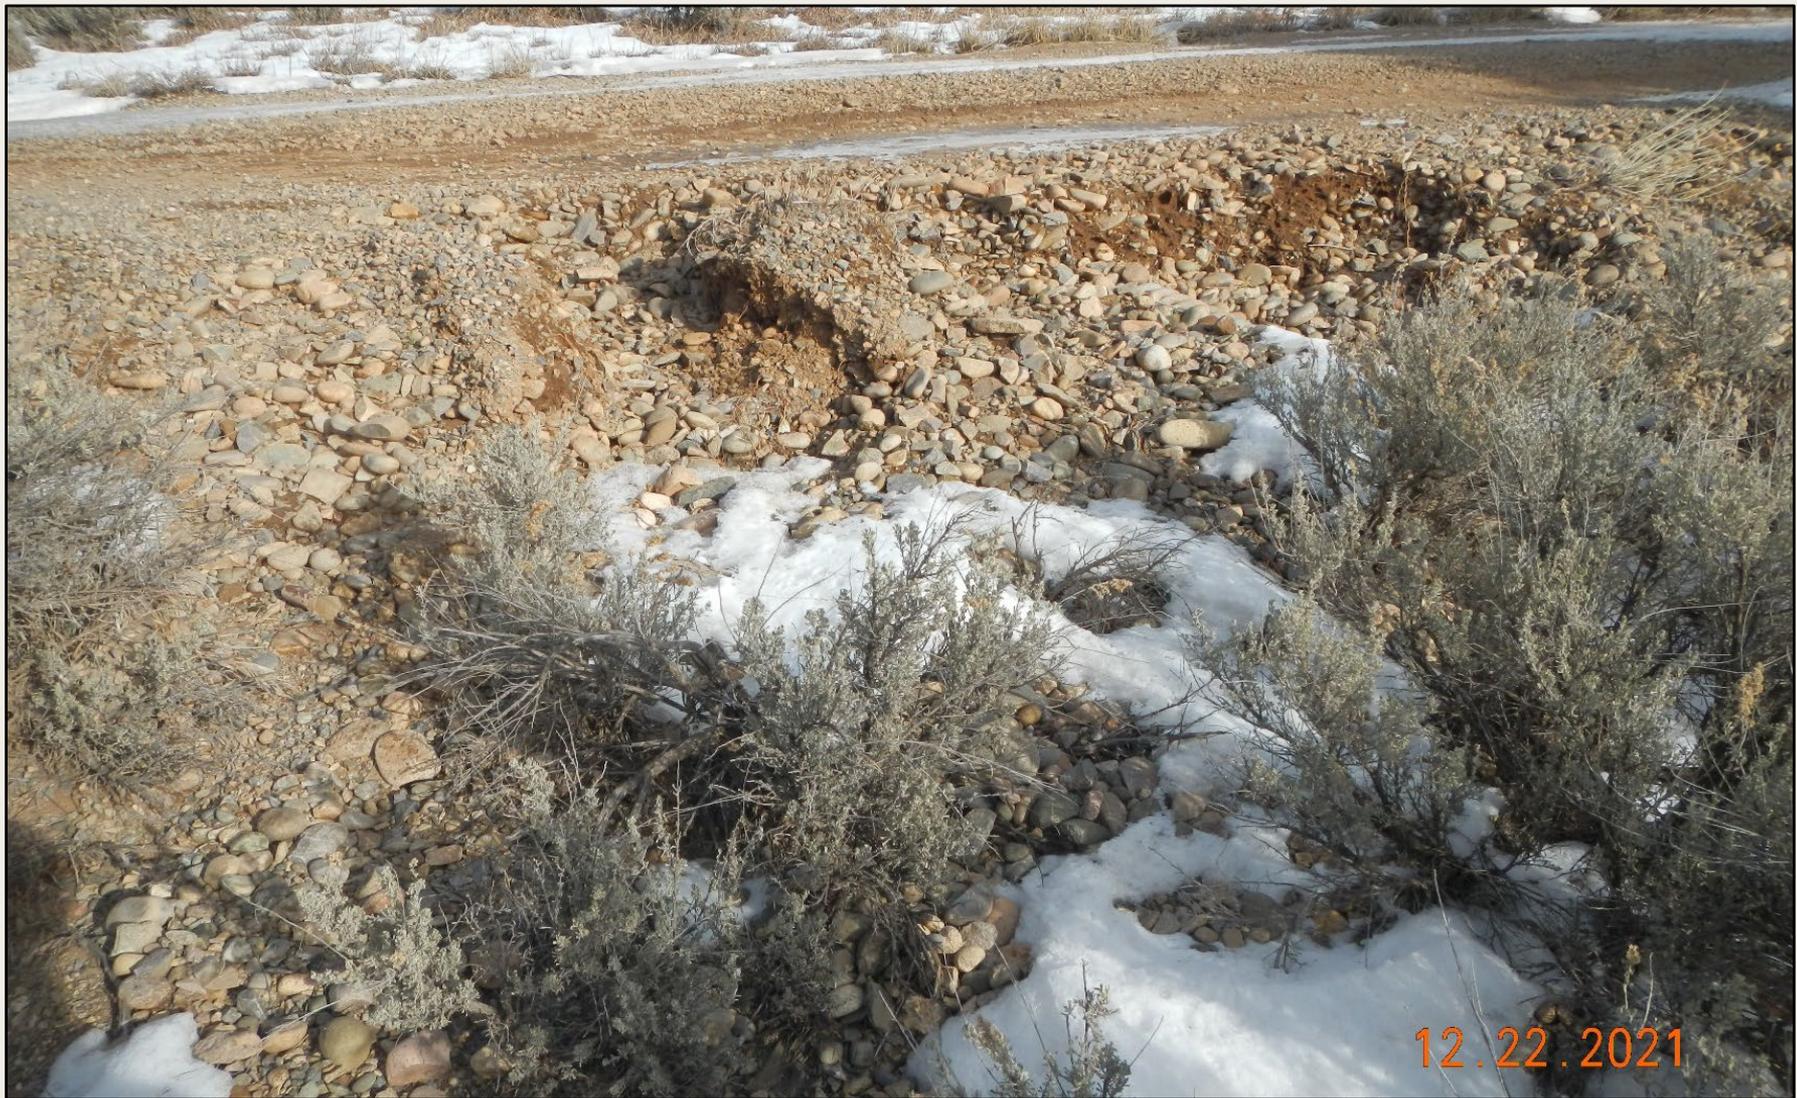
Photo 5. View of area along access road (approx. 10 -15 feet long) where stormwater flows over the access road and is eroding the edges of the road. Cobble and gravel from the road observed washed down-slope. Drainage and road need stabilization here.

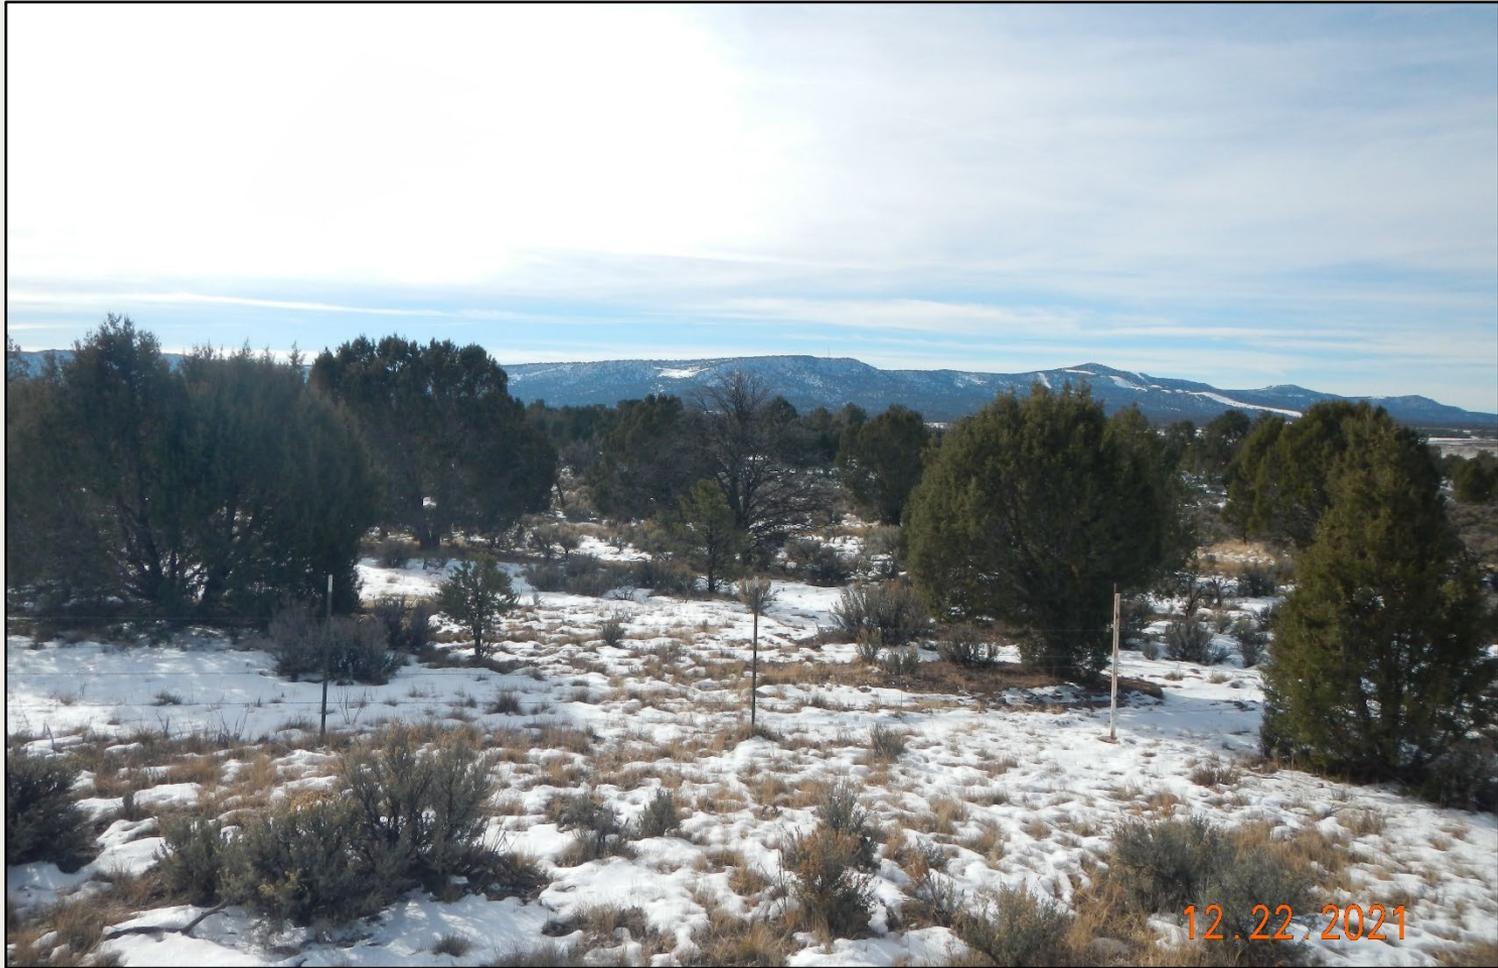
Photo 6. View of the reference area comprised of pinyon and juniper woodland with sagebrush, James galleta, purple threeawn, and Indian ricegrass.
