Inspection Photos
Operator: Simcoe
API: 067-07621
Date: 1/11/2022

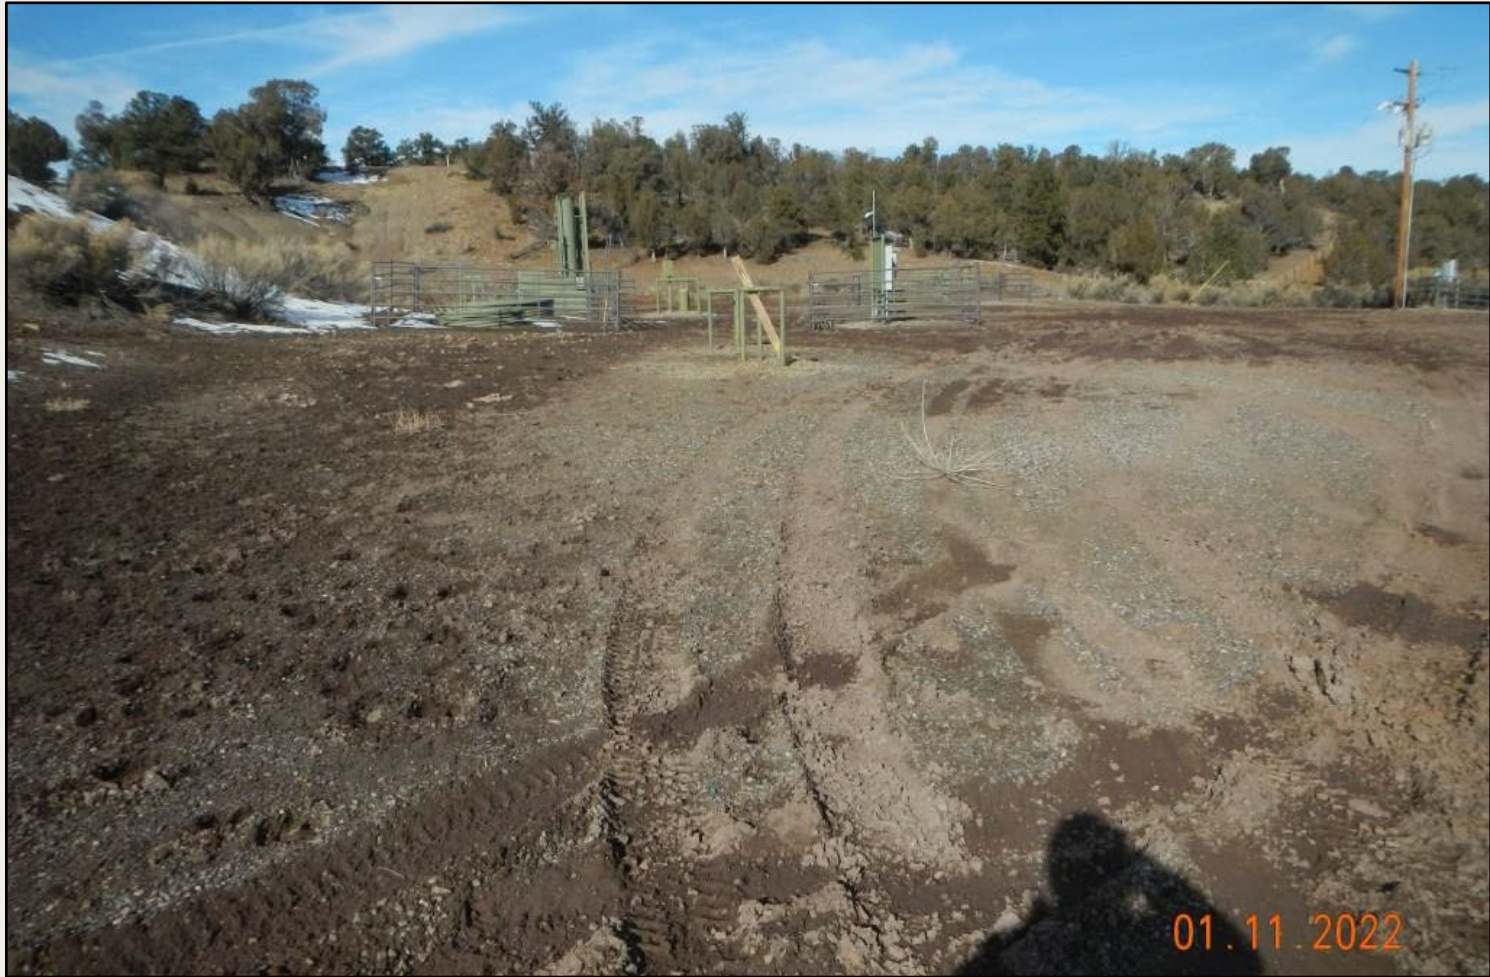
Photo 1. View of project area from the southwestern corner facing center.

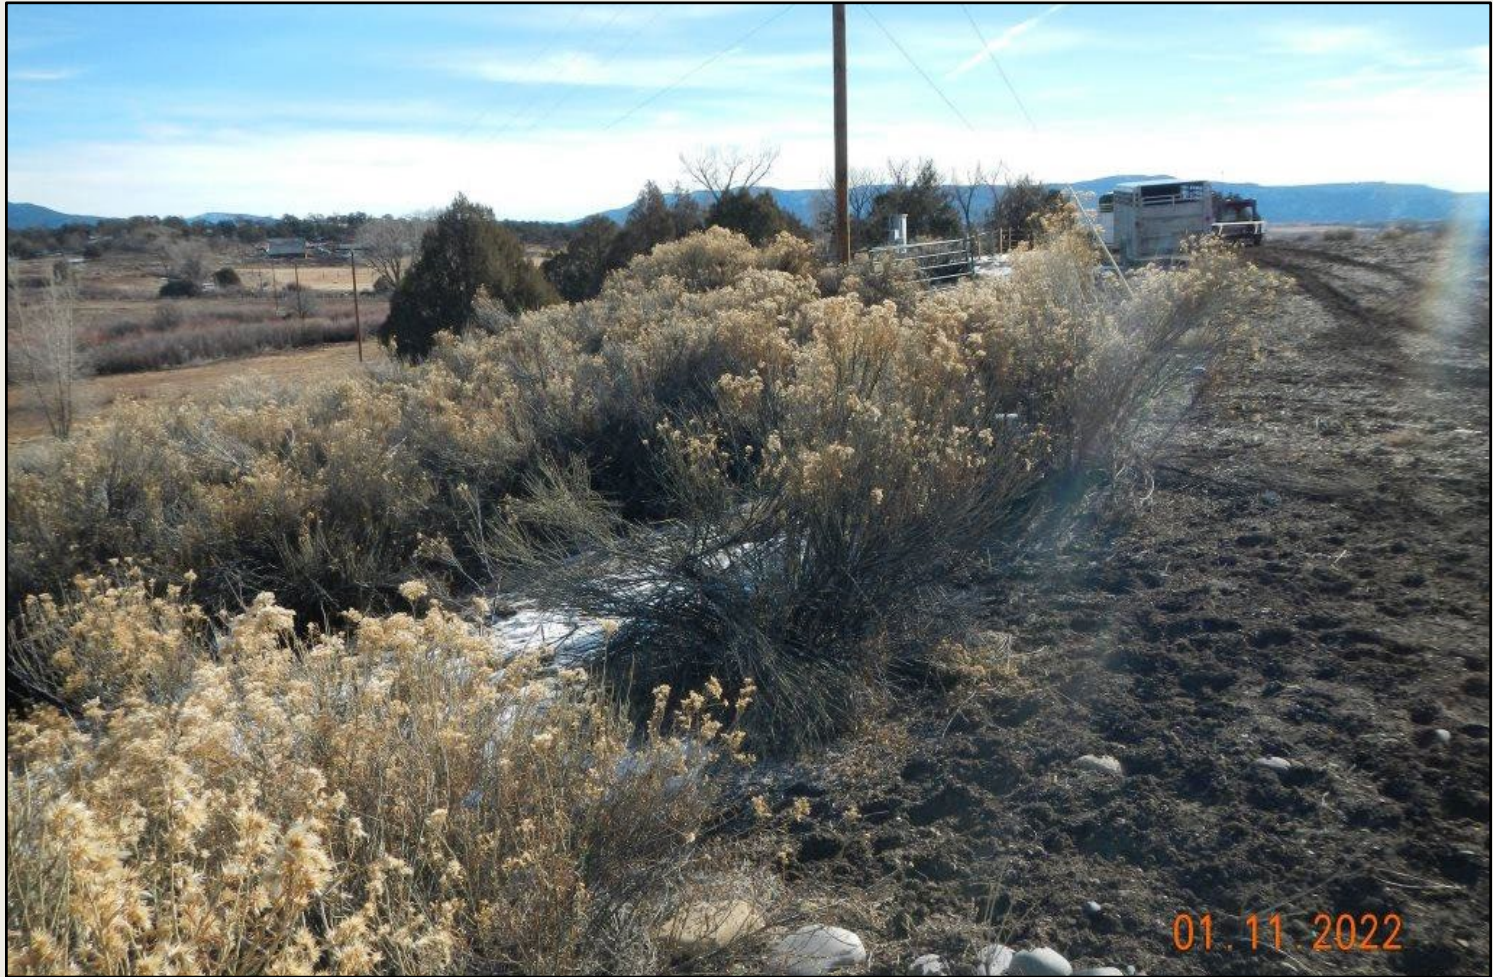
Photo 2. View of the northern fill slope from the northwestern corner facing eastward. Revegetation is progressing here with rubber rabbitbrush, crested wheatgrass, and smooth brome.

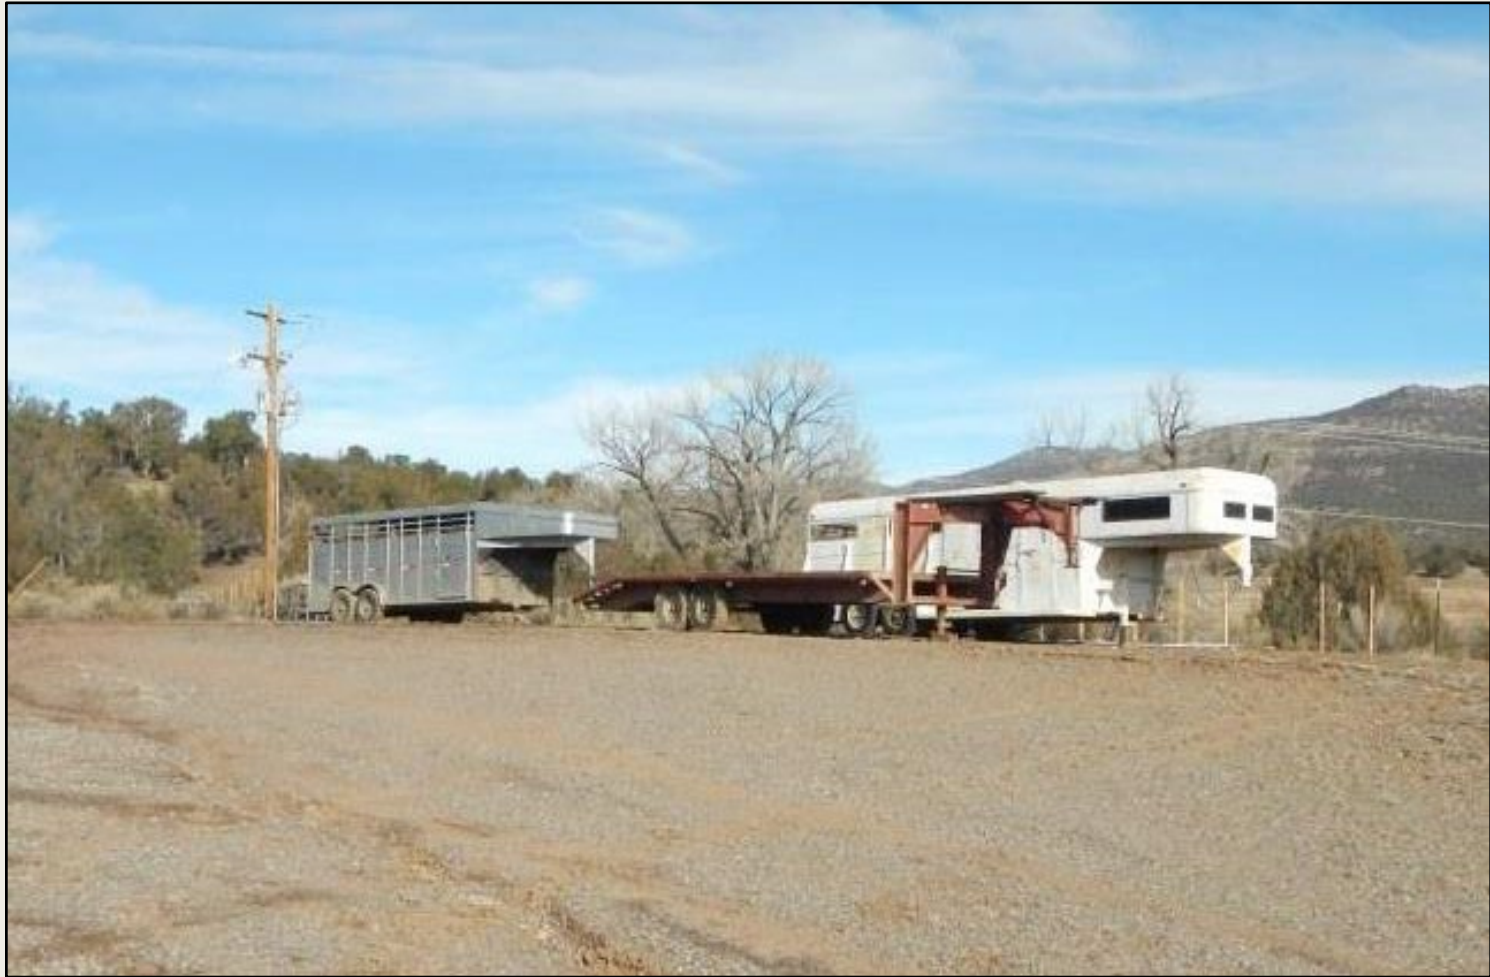
Photo 3. View of trailers stored on the northern portion of the well pad. This portion of the well pad is not in use for production operations and needs interim reclamation.

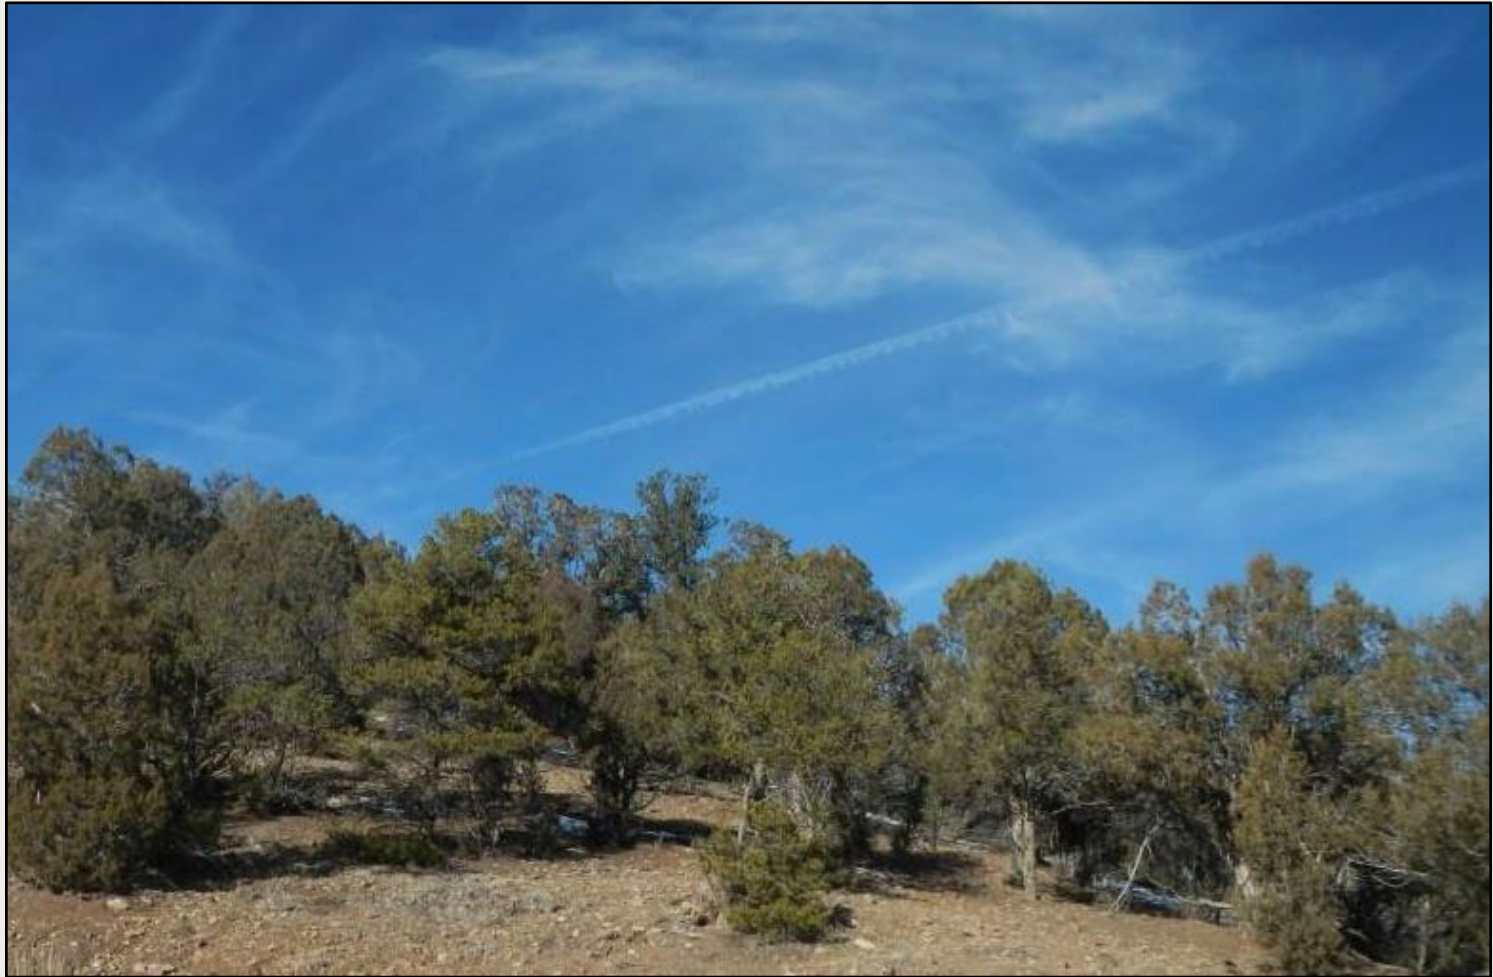
Photo 4. View of reference area, comprised of pinyon and juniper woodland with prickly pear, squirrel tail, blue grama, and sagebrush in the understory.
