Inspection Photos
Operator: Simcoe
API: 067-07862
Date: 1/24/2022

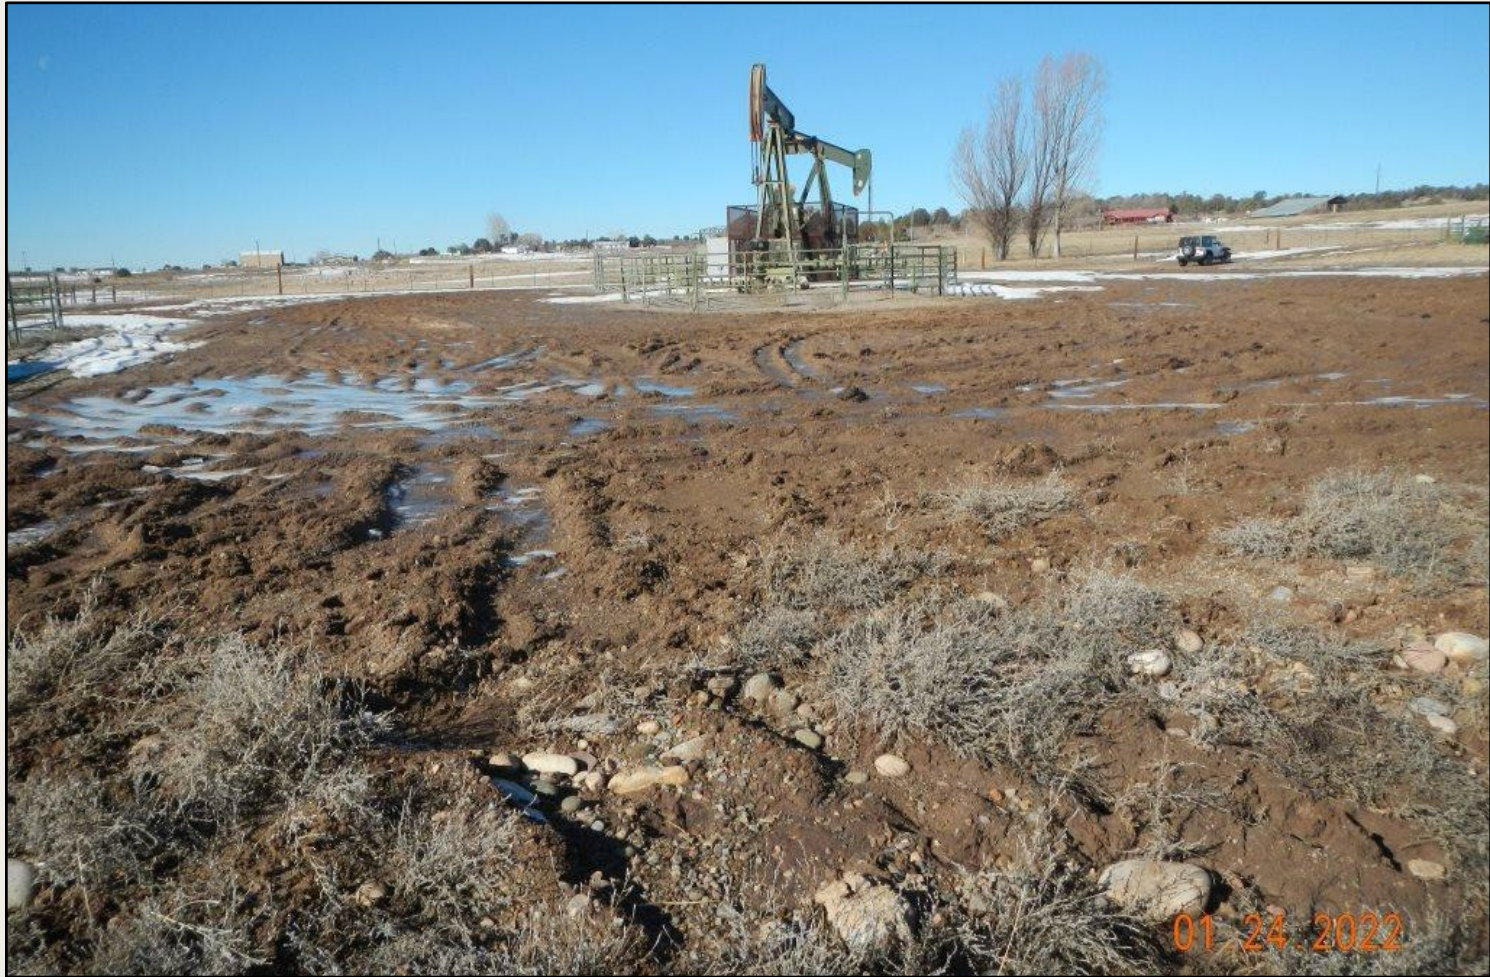
Photo 1. View of project area from the southeastern corner facing center.

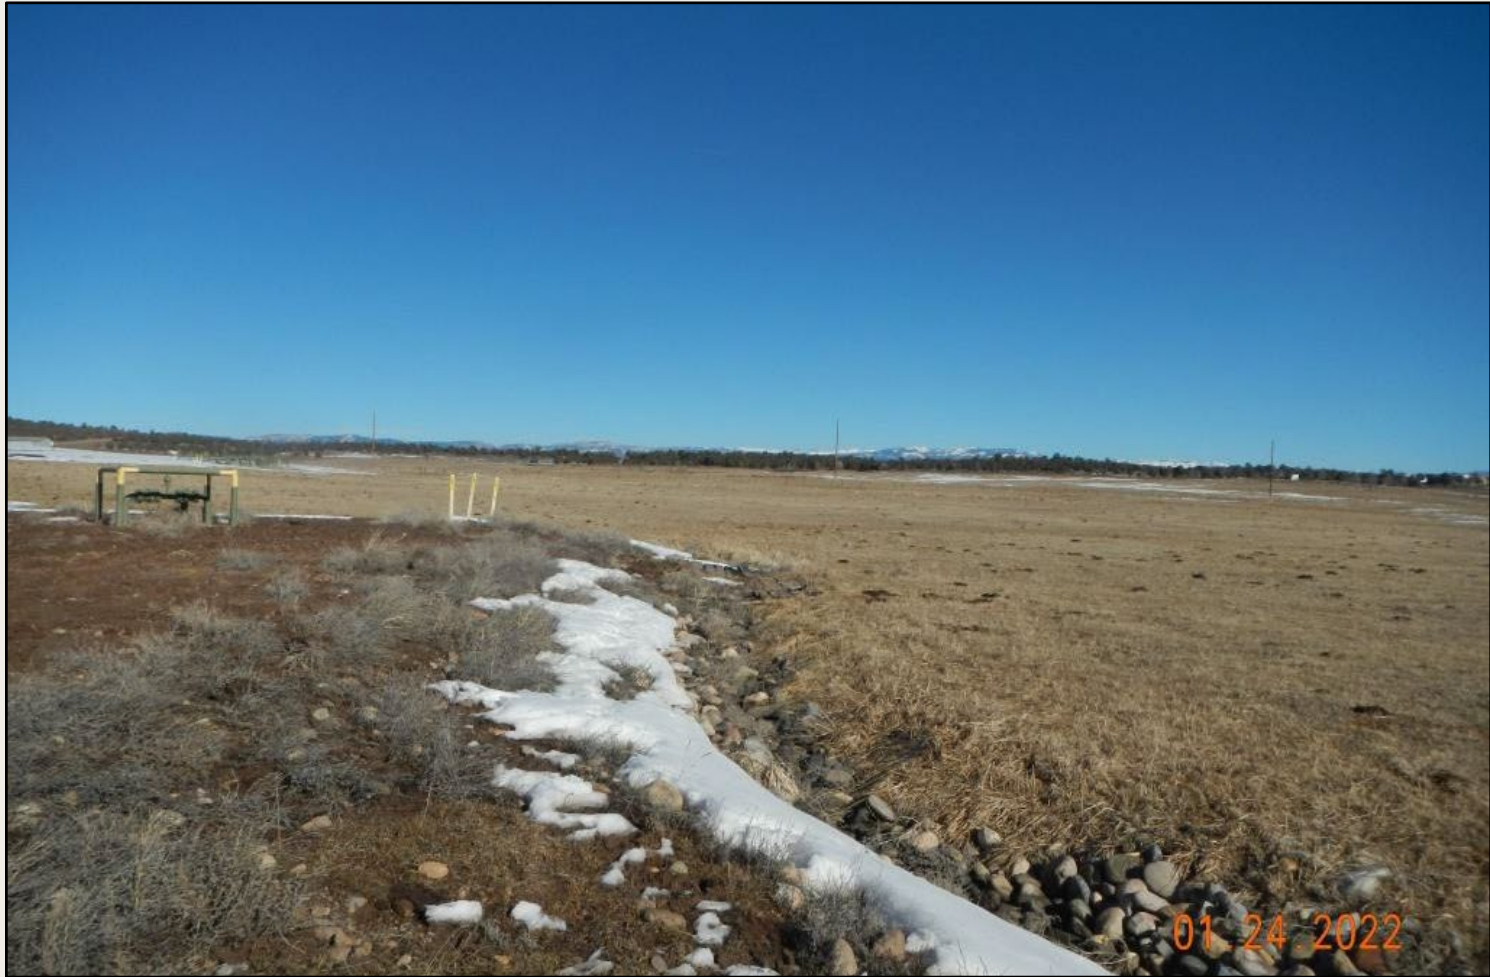
Photo 2. View of the eastern project area from the southeastern project area facing northward. Revegetation is progressing with irrigated grasses such as tall fescue and timothy.

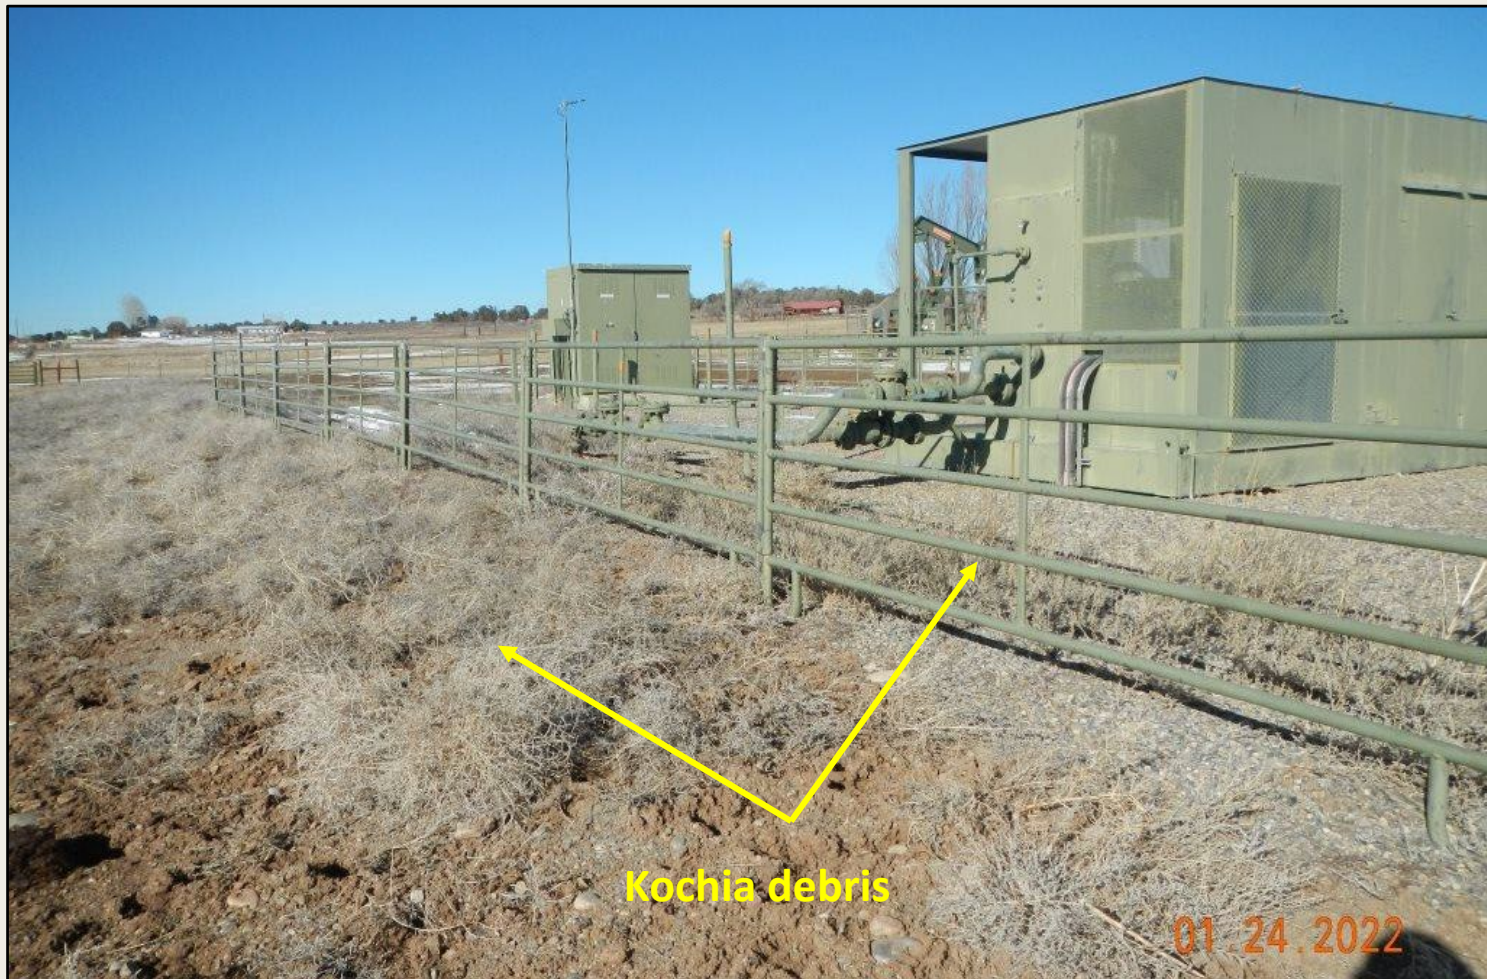
Photo 3. View of the weedy kochia debris observed on the well pad and in the reclamation area.

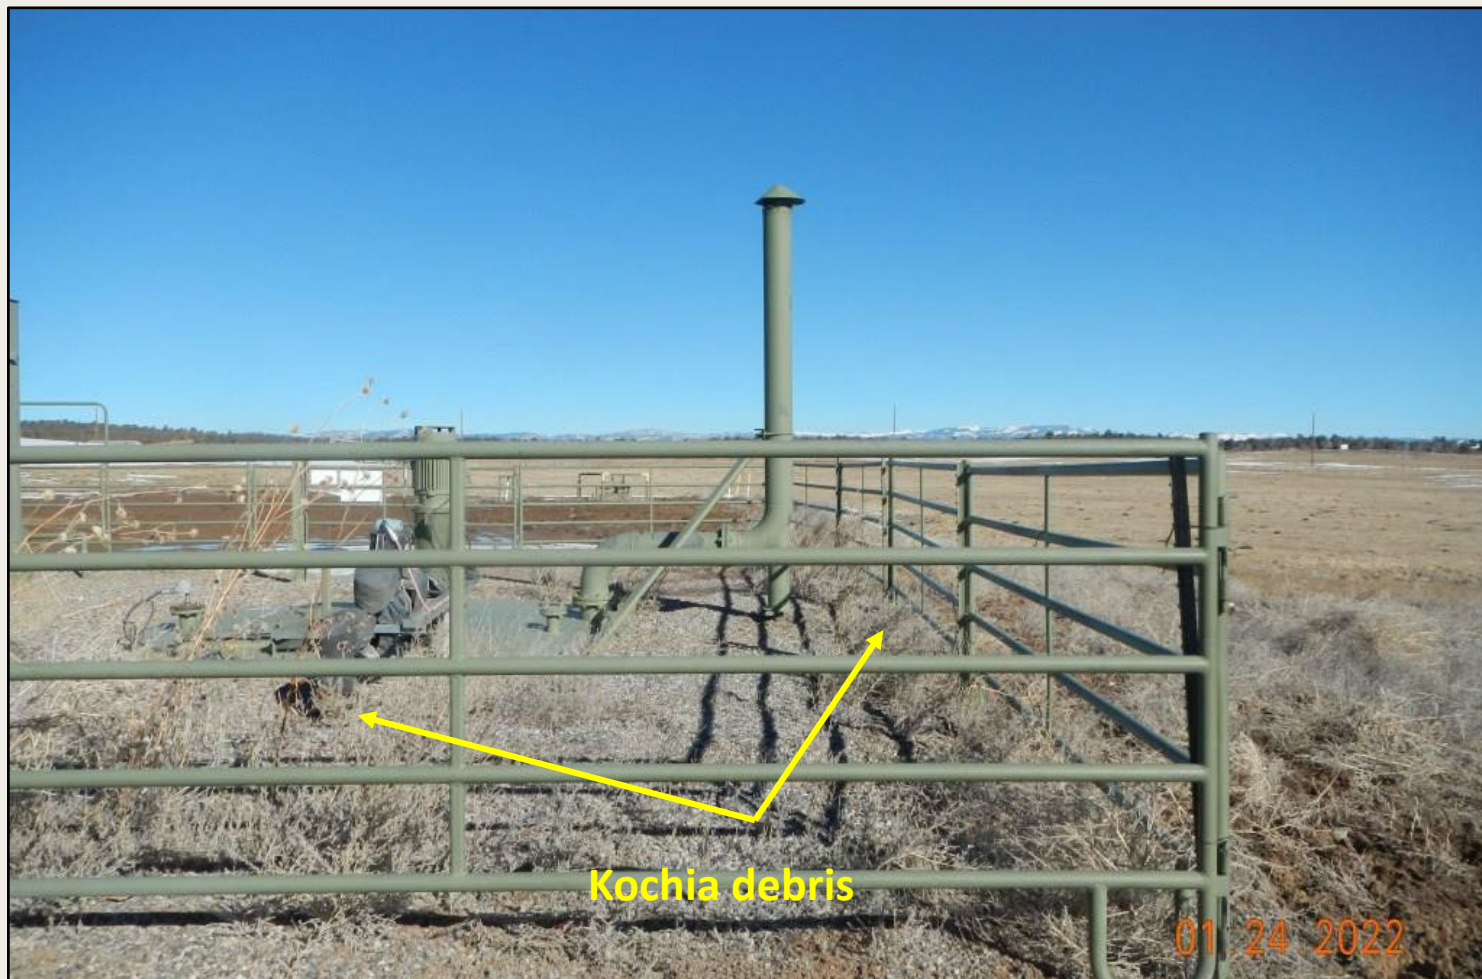
Photo 4. View of more kochia debris observed around fired equipment and within the outer edges of the working area.

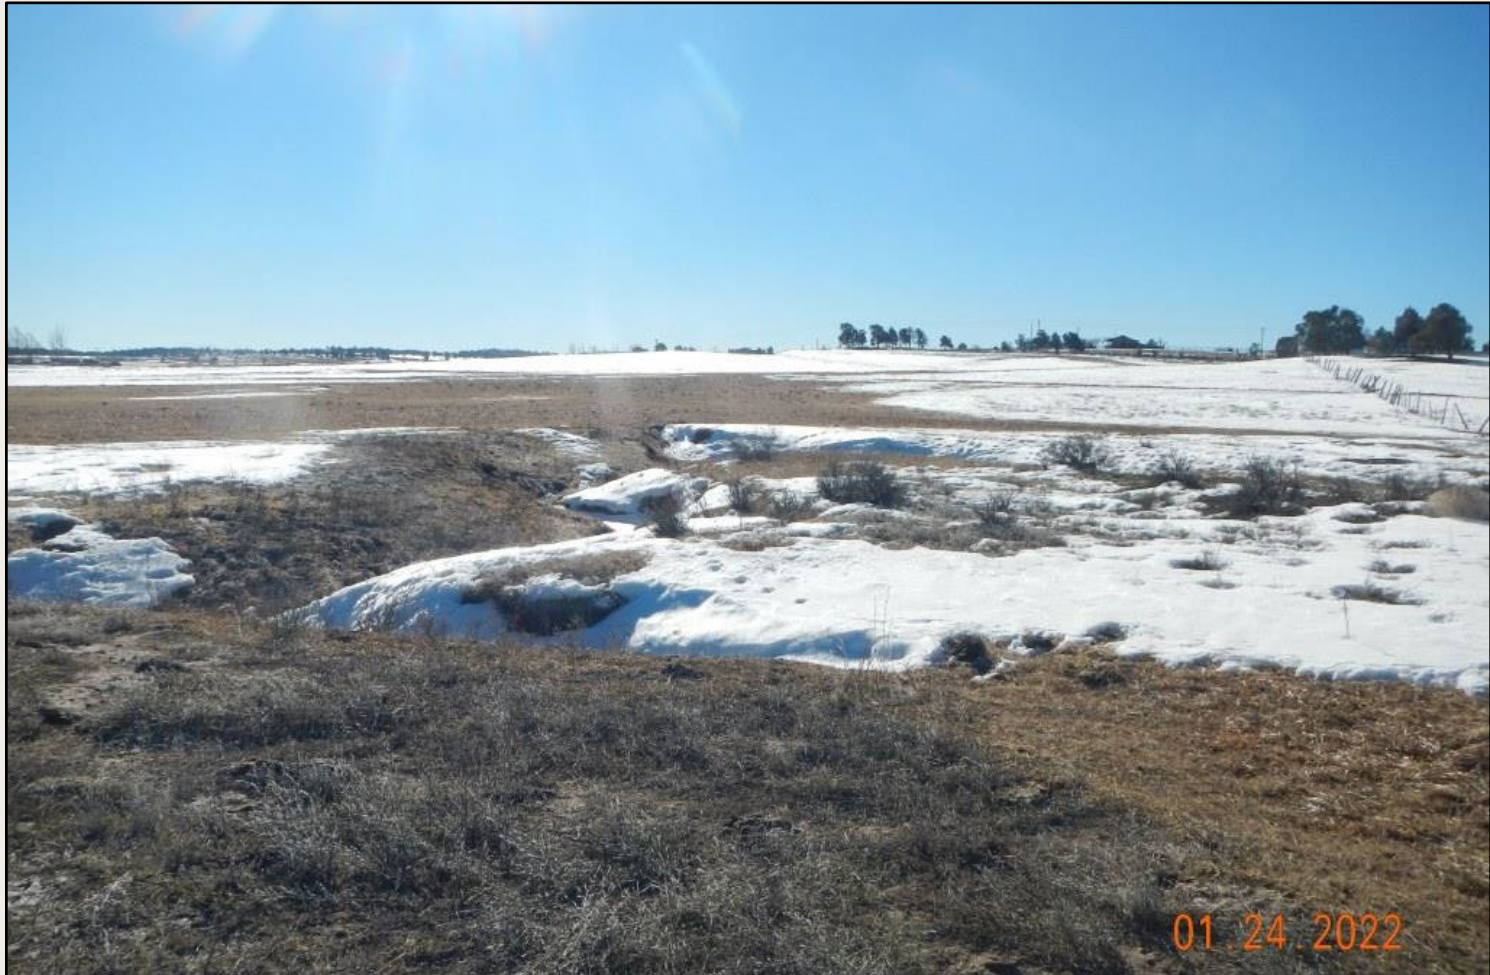
Photo 5. View of reference area vegetation comprised of grasses such as irrigated grass field, with timothy, tall fescue, and meadow brome.
