Inspection Photos
Operator: Simcoe
API: 067-07722
Date: 1/27/2022

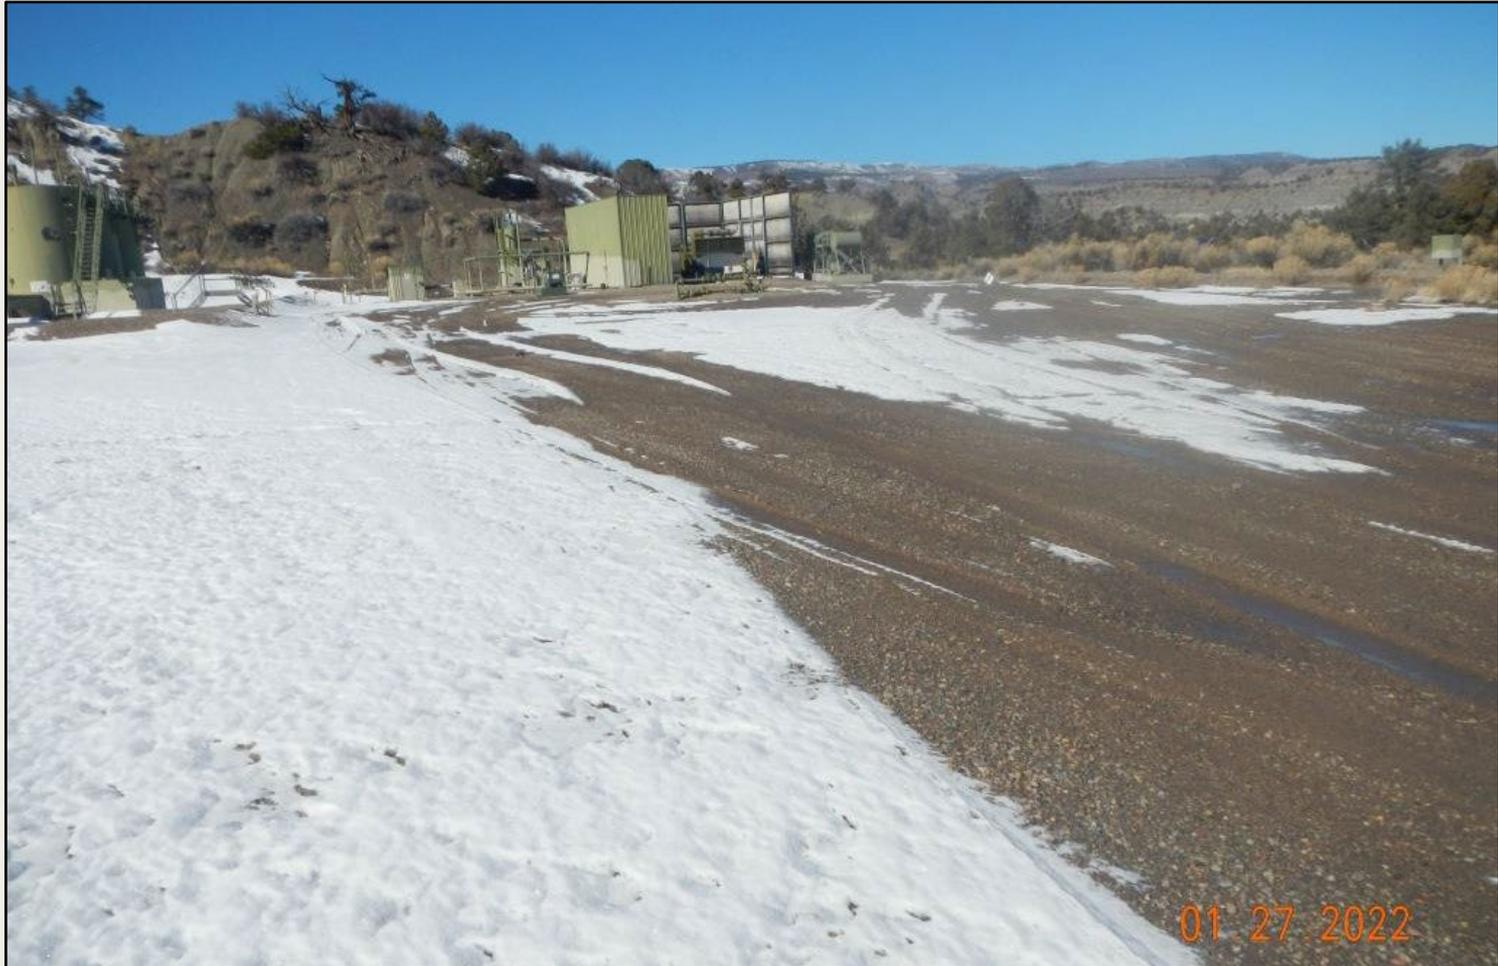
Photo 1. View of project area from the well pad entrance facing center.

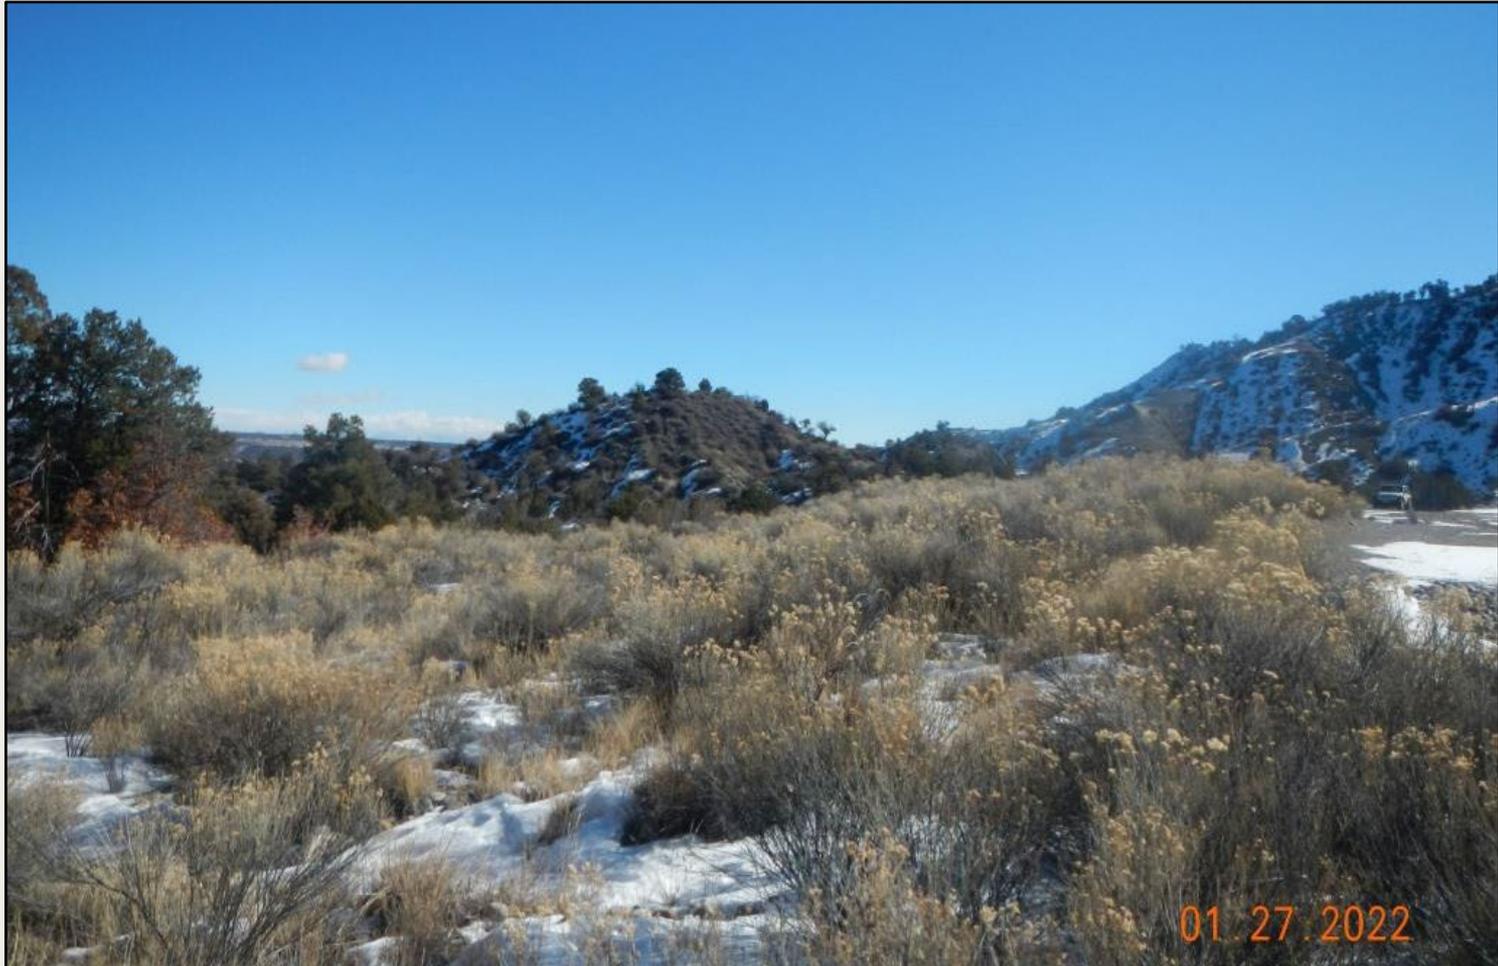
Photo 2. View of the northern fill slope from the northwestern corner facing eastward. Revegetation appears to be progressing although partially snow covered, with western wheatgrass, rubber rabbitbrush, and sand dropseed.

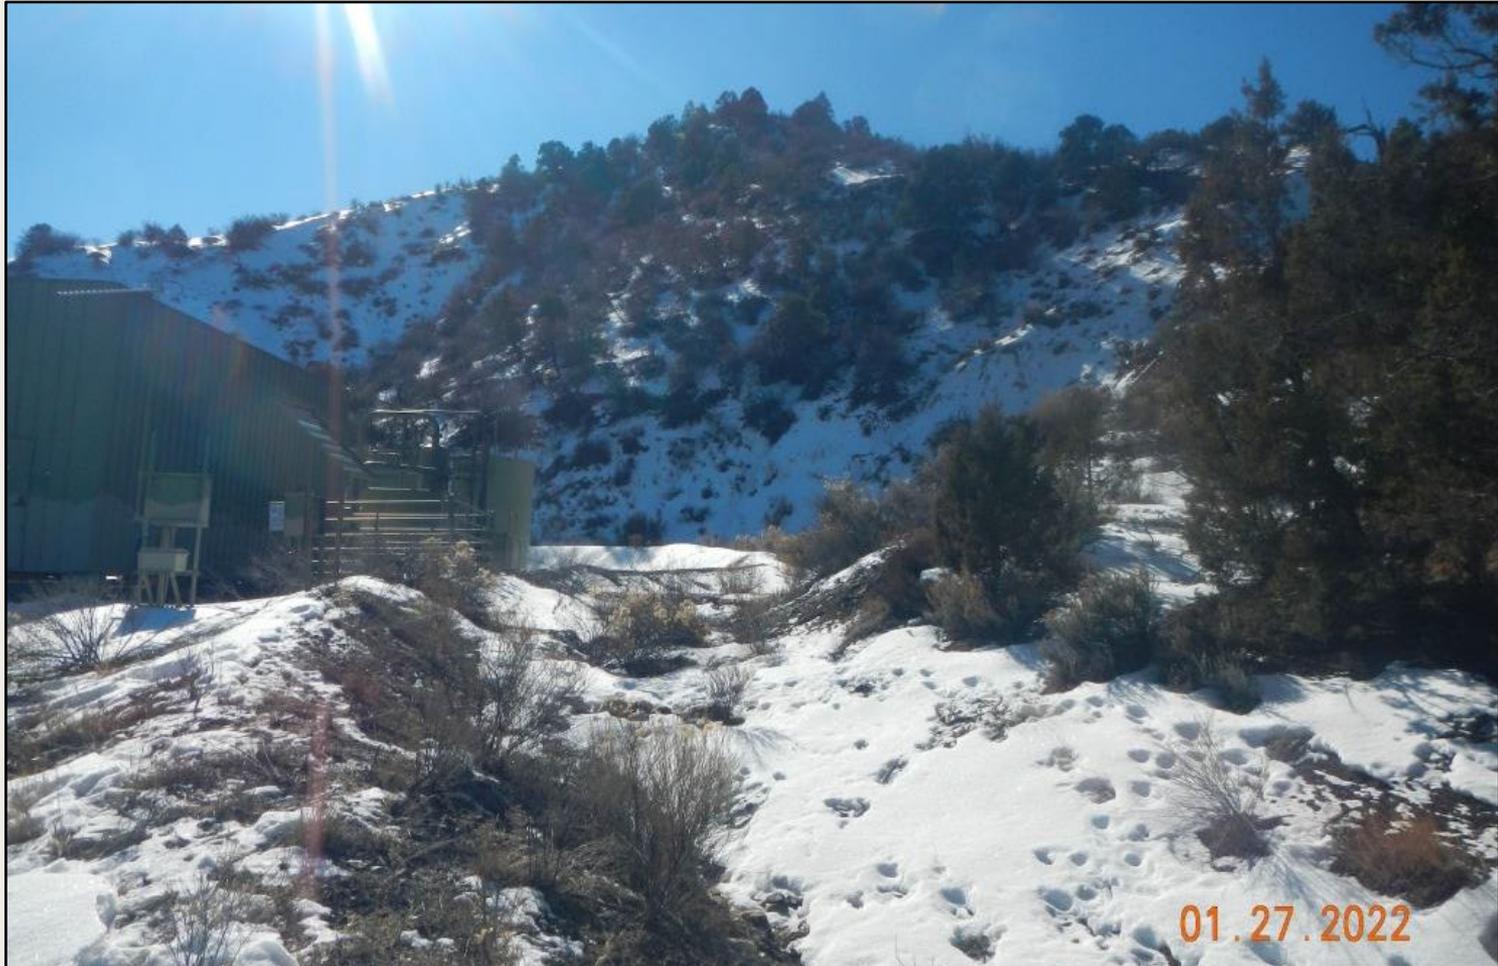
Photo 3. View of the western project area from the northwestern corner facing southward. Stormwater diversion here, needs to be assessed during snow melt, and BMPs applied where needed.

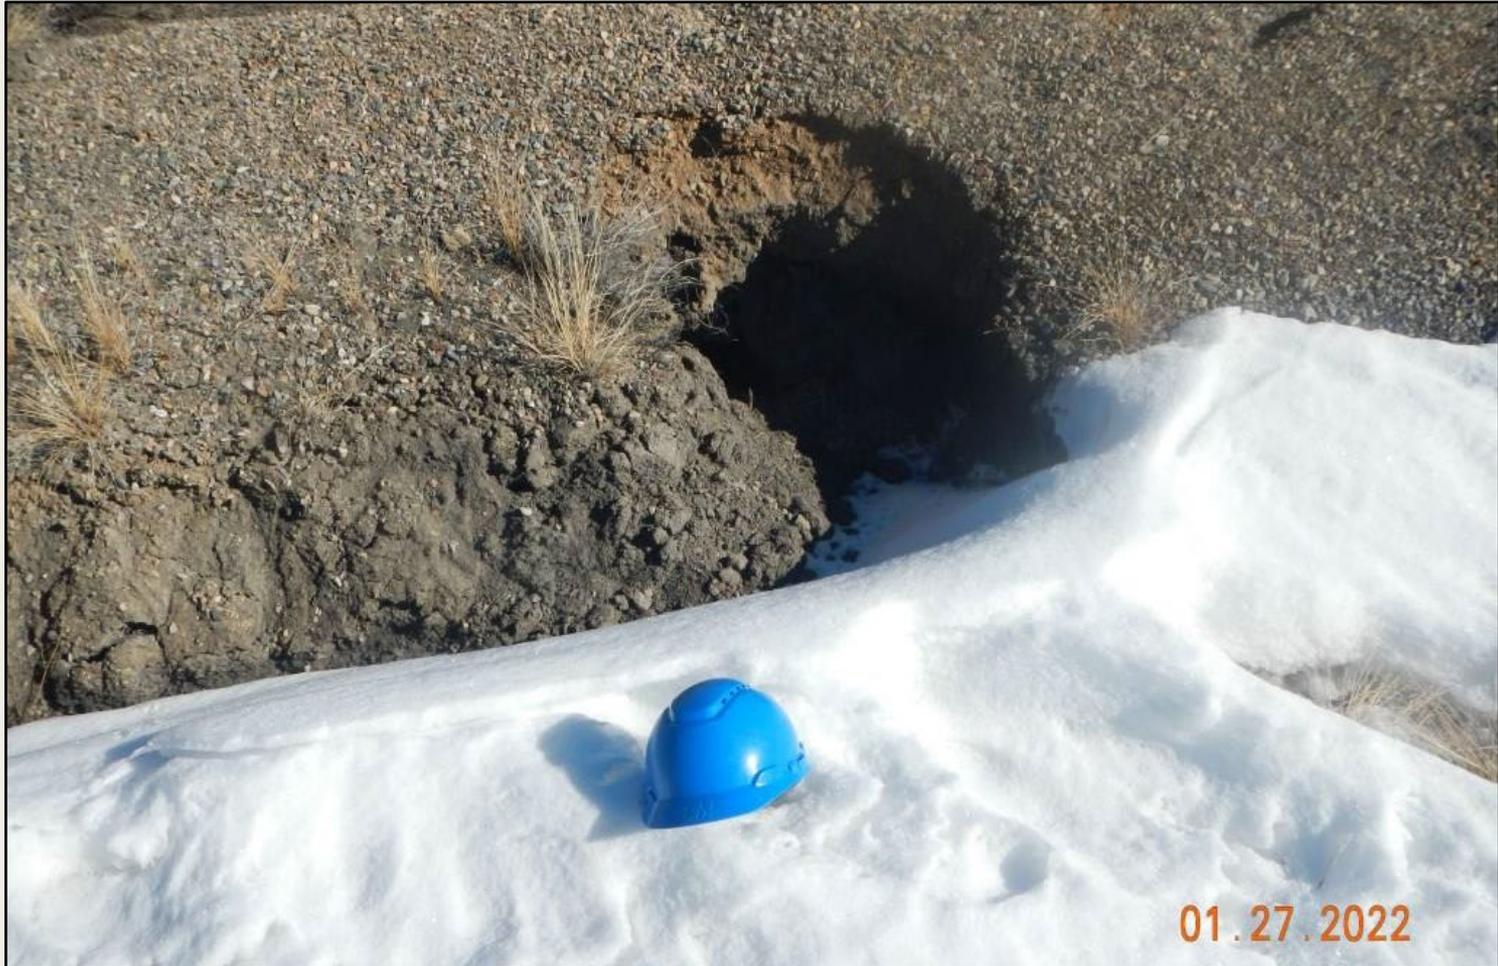
Photo 4. View of erosional tunneling within the northern fill slope where concentrated stormwater tunnels through well pad berms. Hard hat in place for scale.

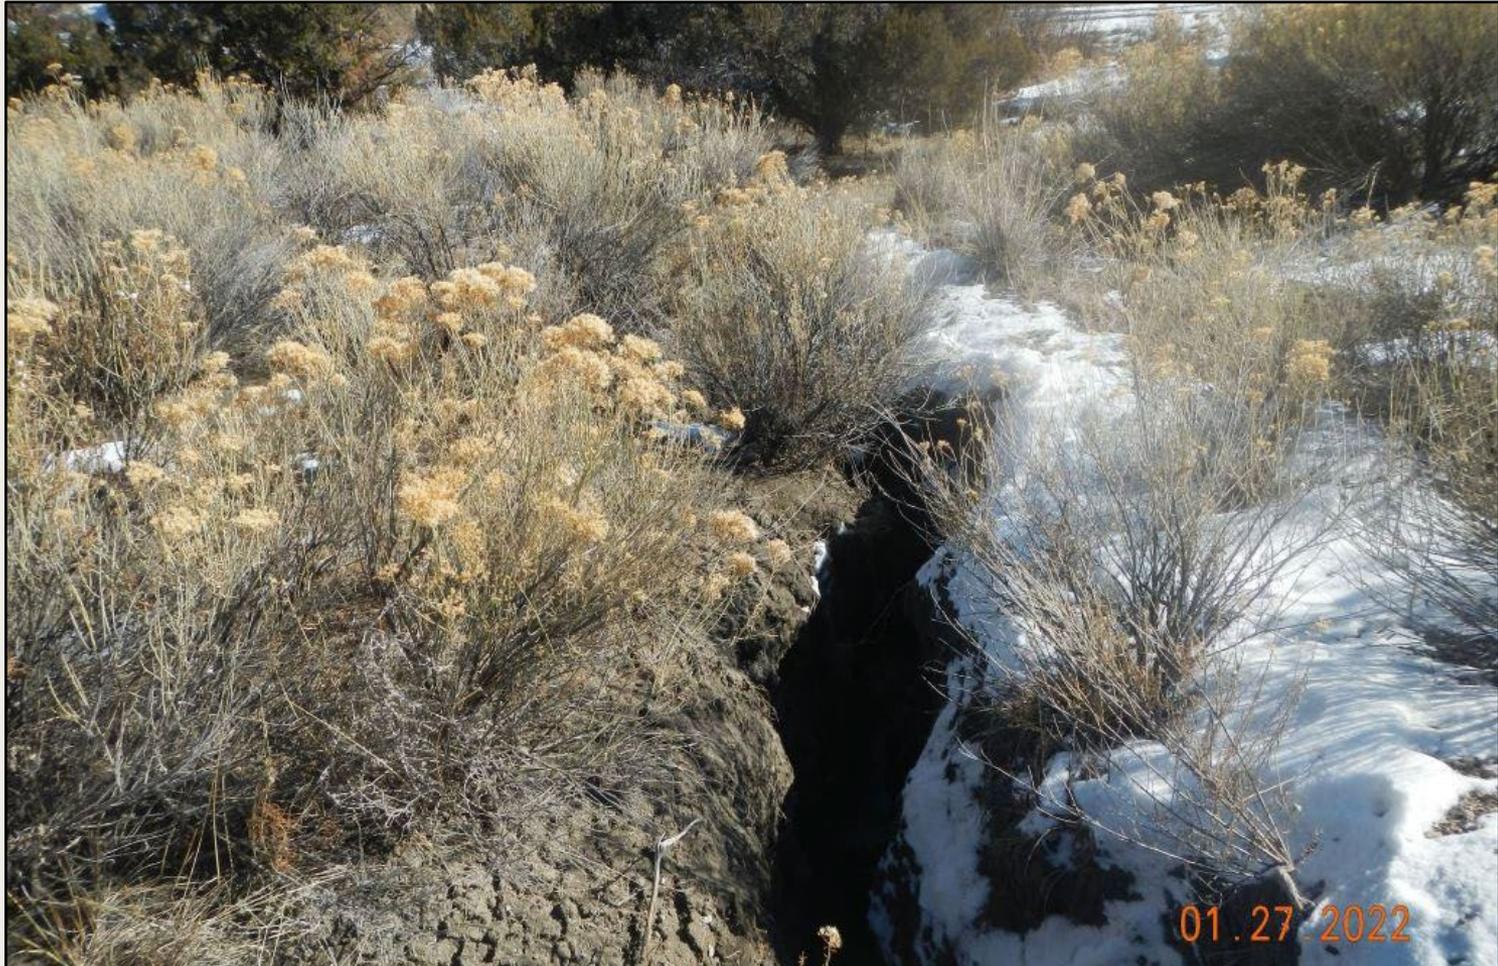
Photo 5. View of erosional channel, downstream from photo 4, approximately 2 feet wide and 5-6 feet deep, needs stabilization.

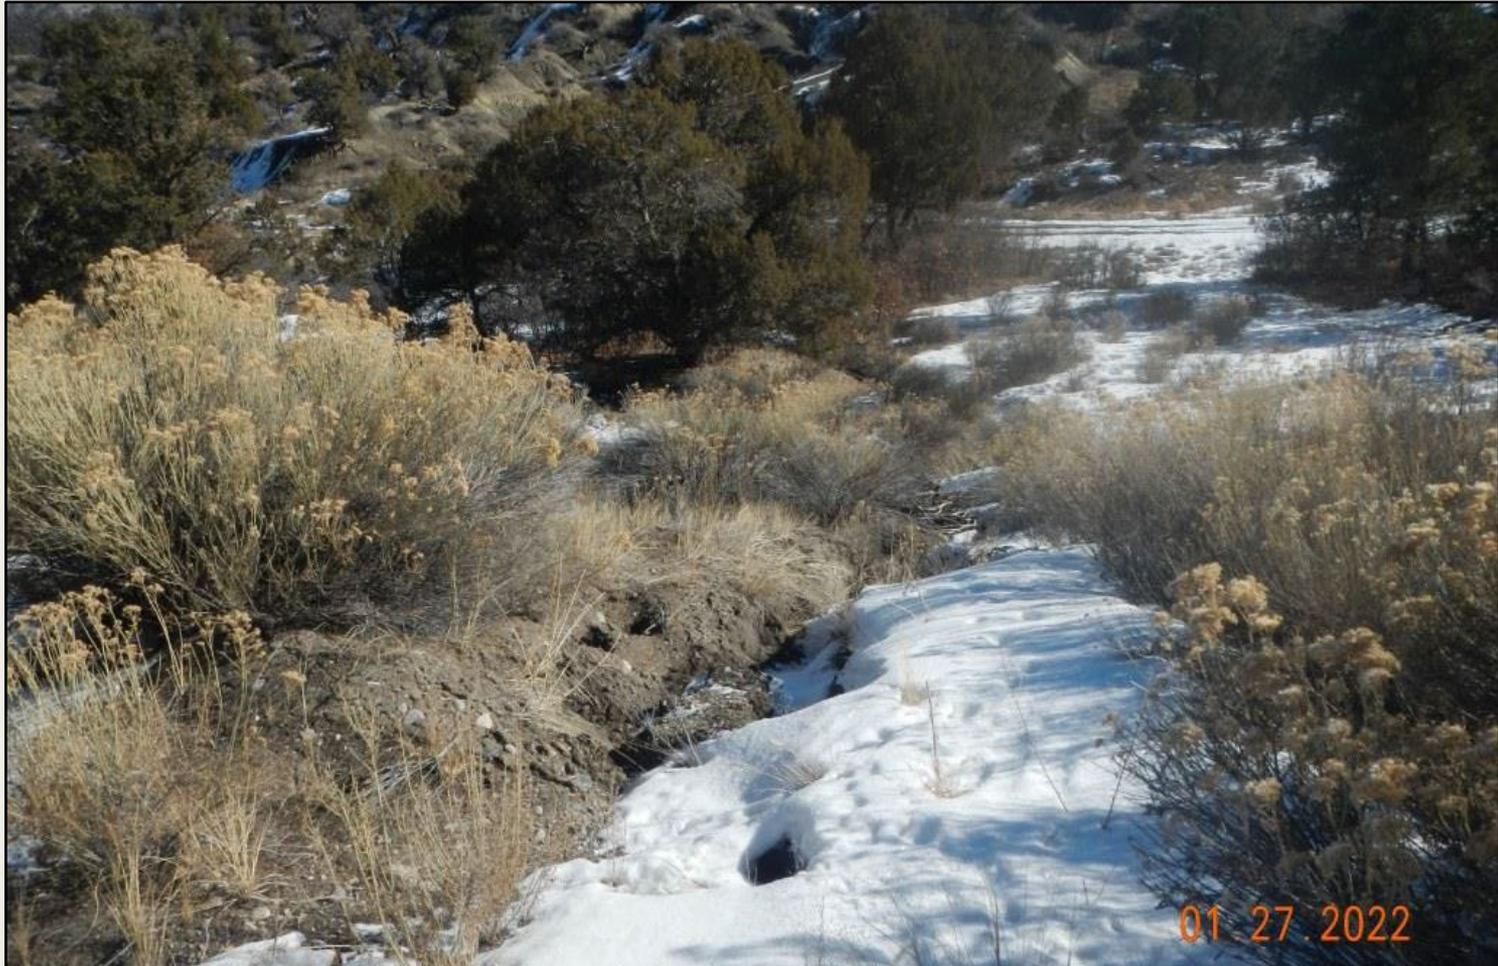
Photo 6. View of erosional channel, approx, 3ft wide and 4ft deep, observed downslope from another erosional tunnel in the northern project area. .

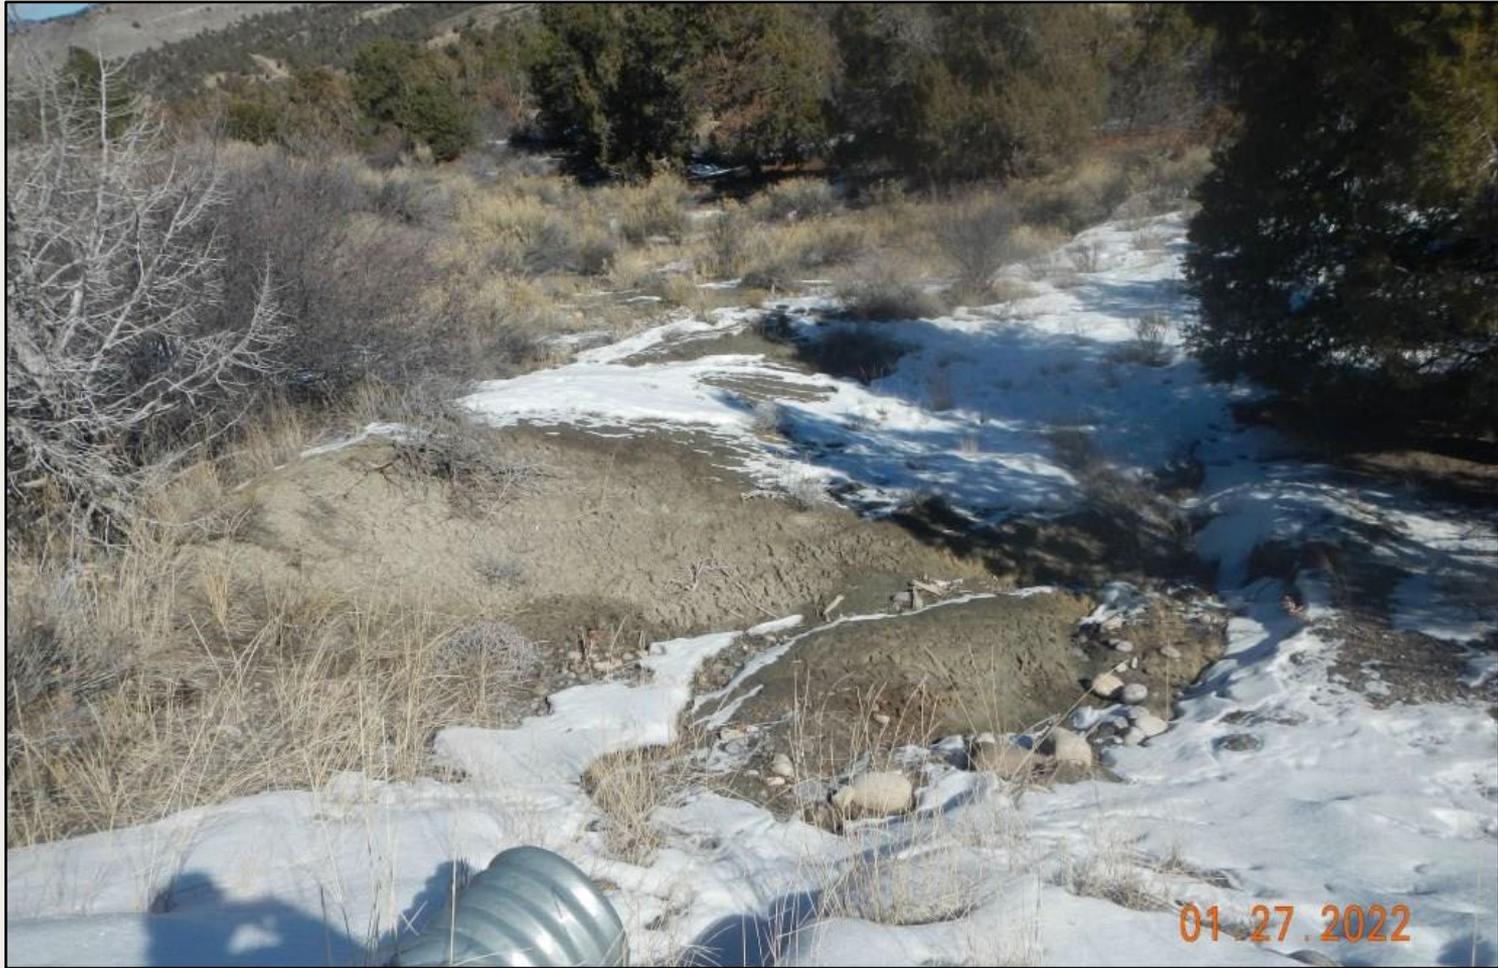
Photo 7. View of area downslope from culvert outlet near well pad entrance where multiple erosional channels are eroding the slope without adequate stabilization.
