Inspection Photos
Operator: Logos
API: 067-05601
Date: 1/27/2022

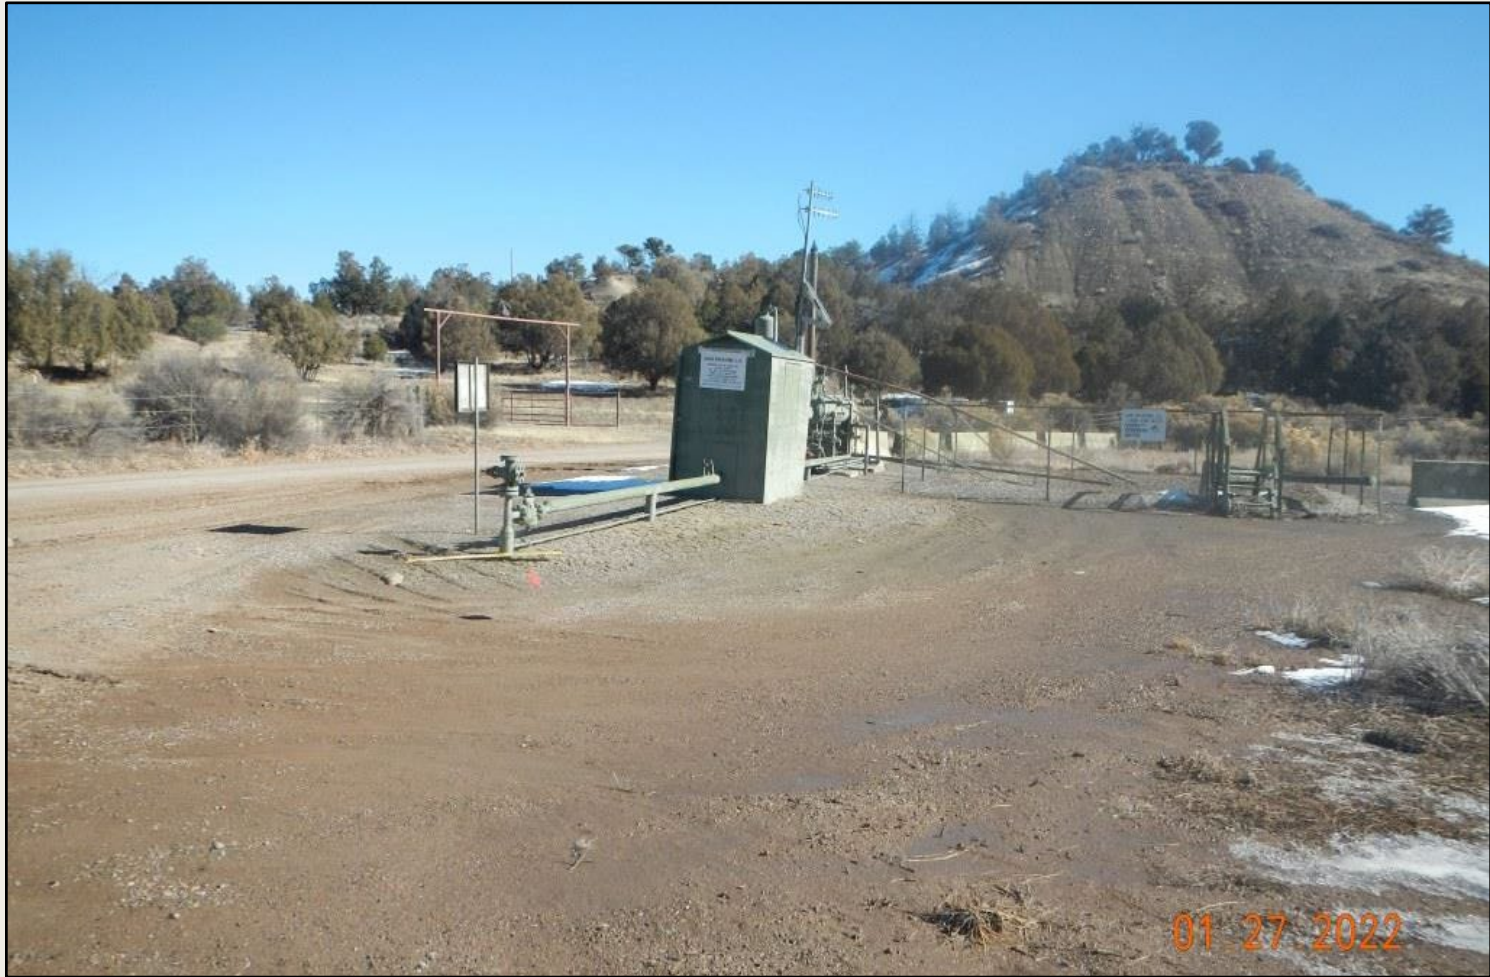
Photo 1. View of project area from the southwestern corner facing center.

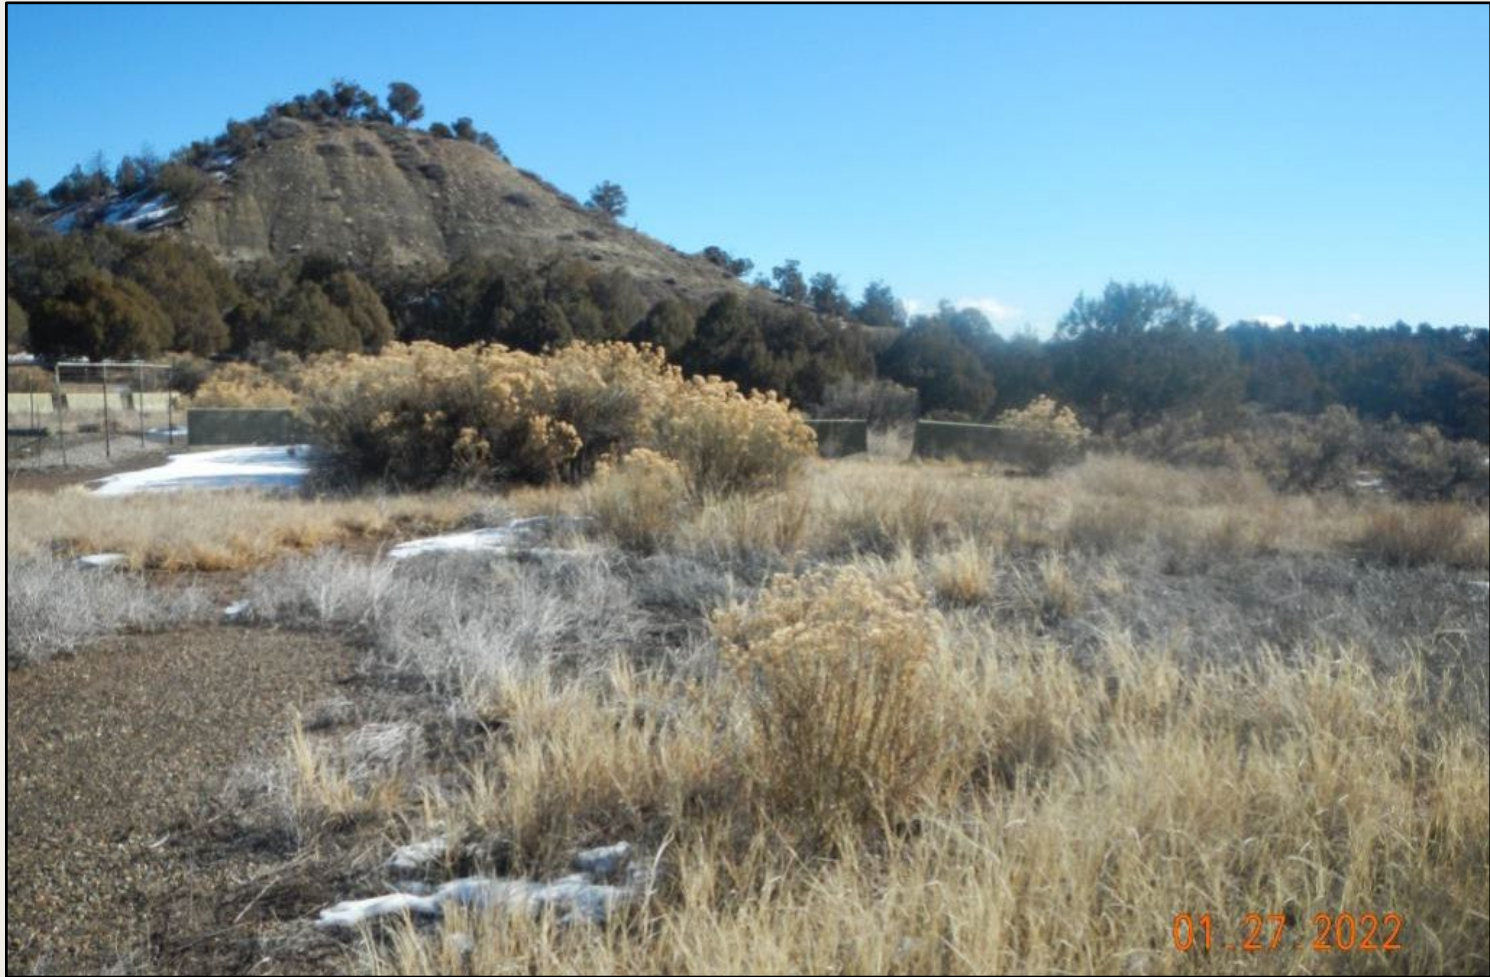
Photo 2. View of the southern project area from the the southwestern corner facing eastward. Revegetation appears to be progressing with sand dropseed, western wheatgrass, and smooth brome.

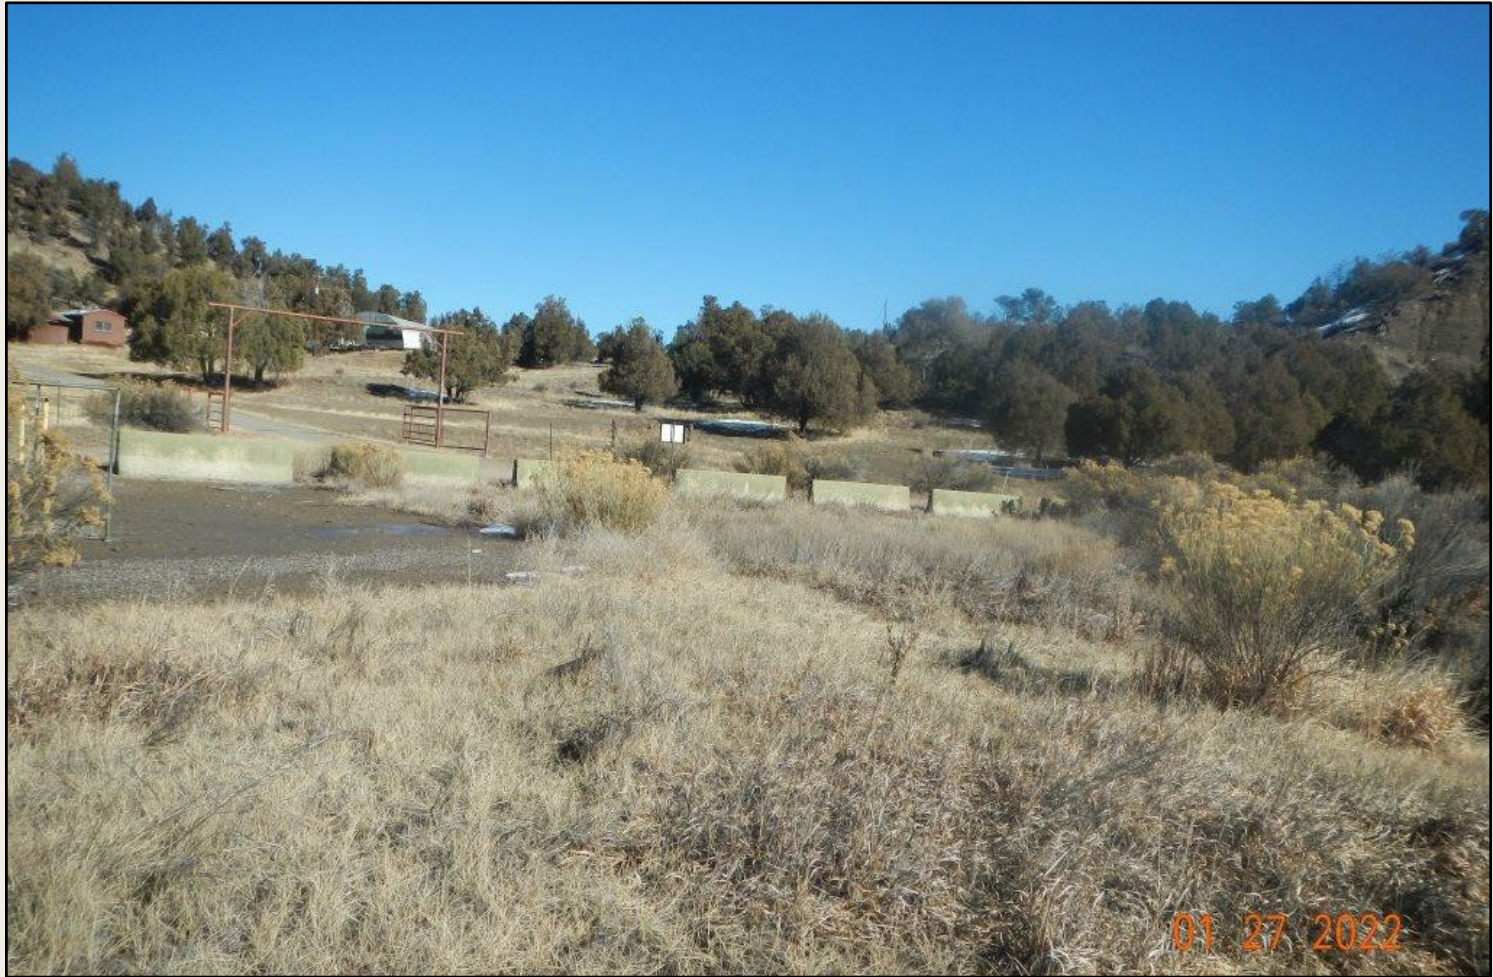
Photo 3. View of the western project area from the southern corner facing northeastward.

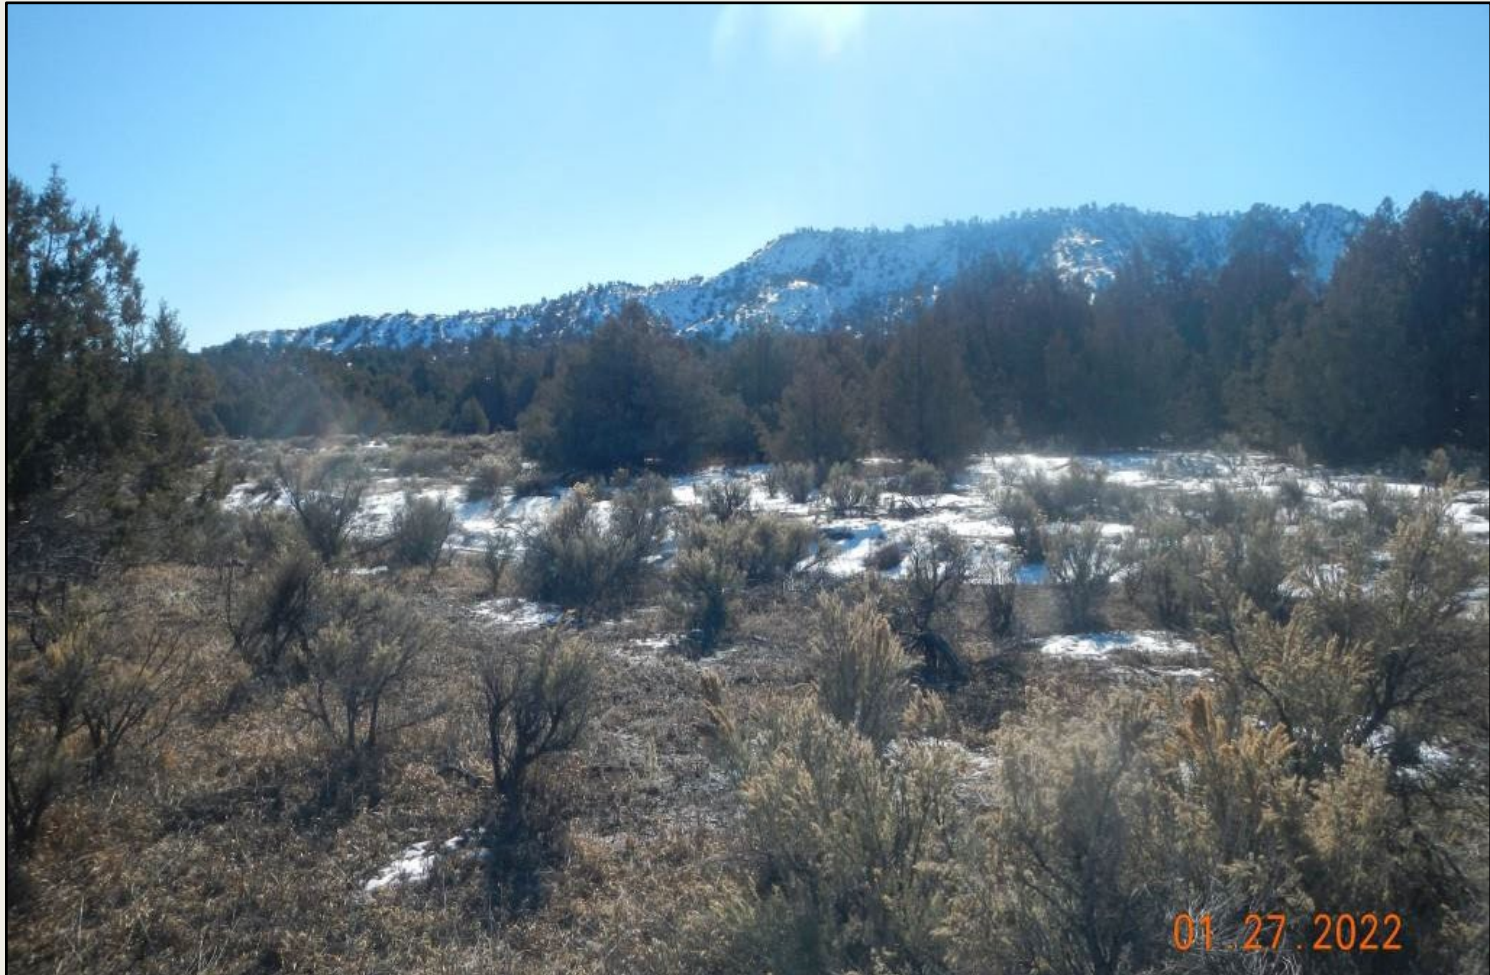
Photo 4. View of reference area comprised of pinyon and juniper mixed with big sagebrush, saltbush, smooth brome, and Indian ricegrass.
