Inspection Photos
Operator: Simcoe
API: 067-07471
Date: 1/27/2022

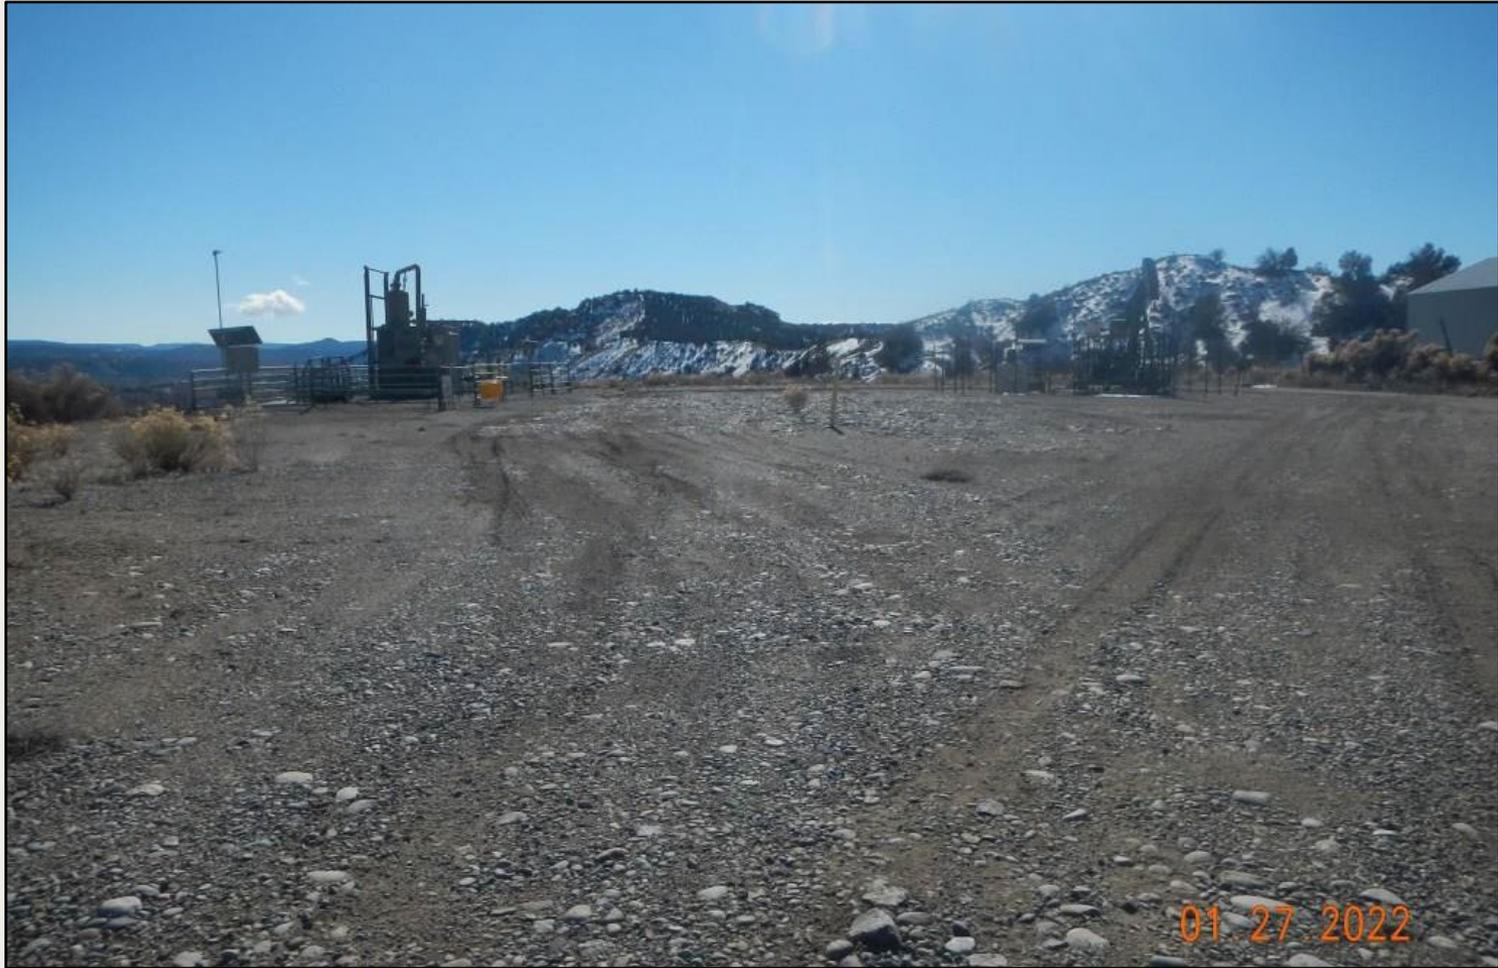
Photo 1. View of project area from the well pad entrance facing center.

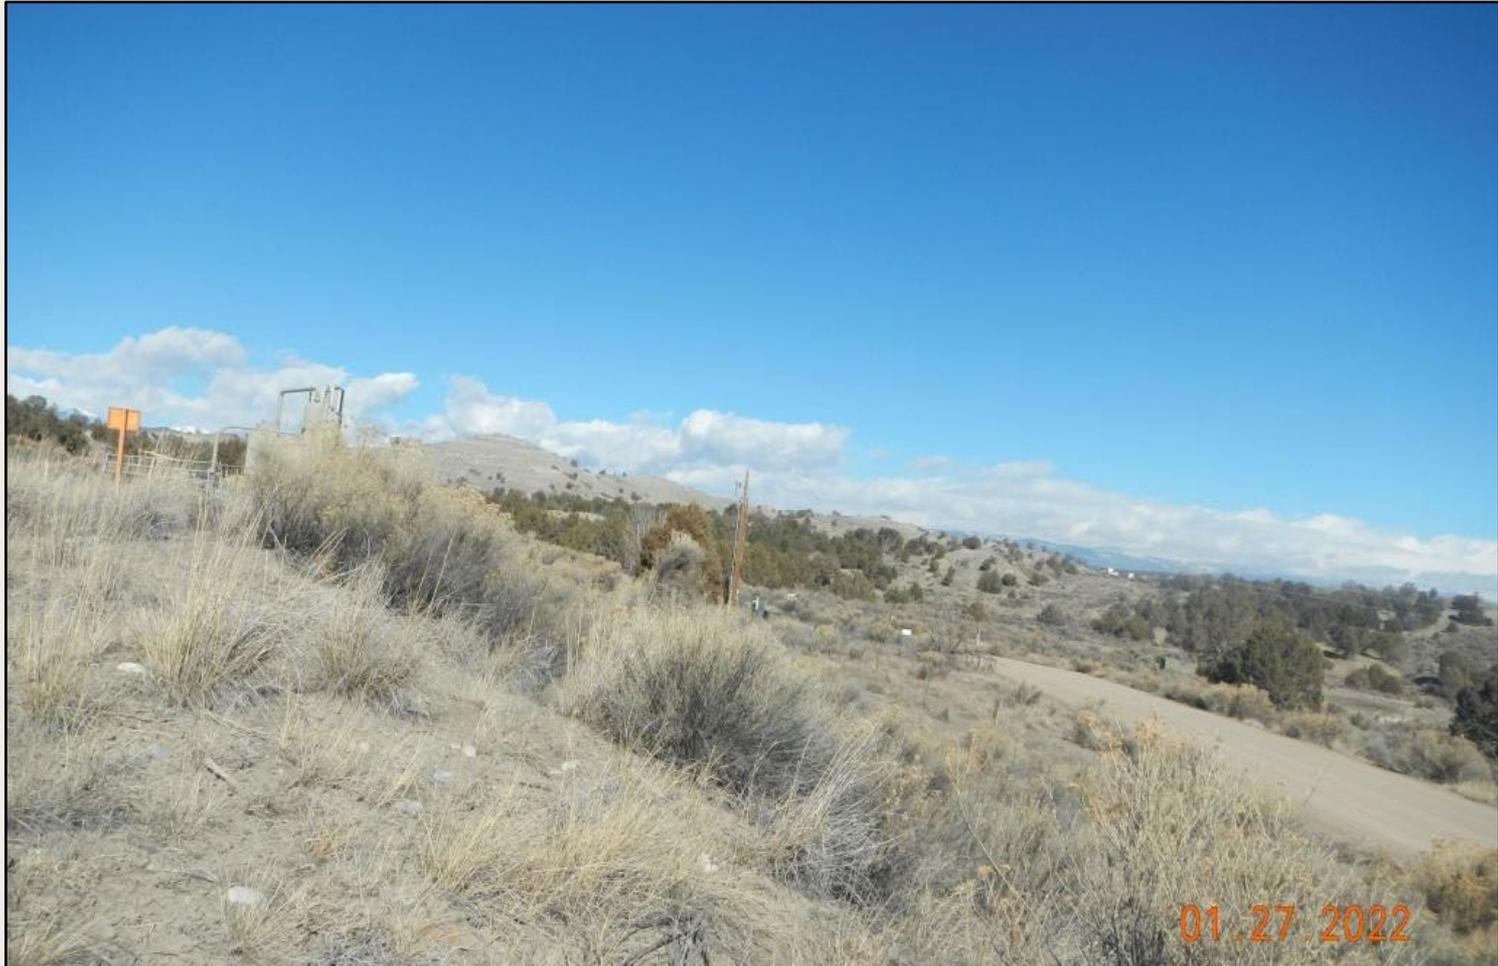
Photo 2. View of the eastern project area from the southeastern corner facing northward. Revegetation is progressing with western wheatgrass, Indian ricegrass, and rubber rabbitbrush.

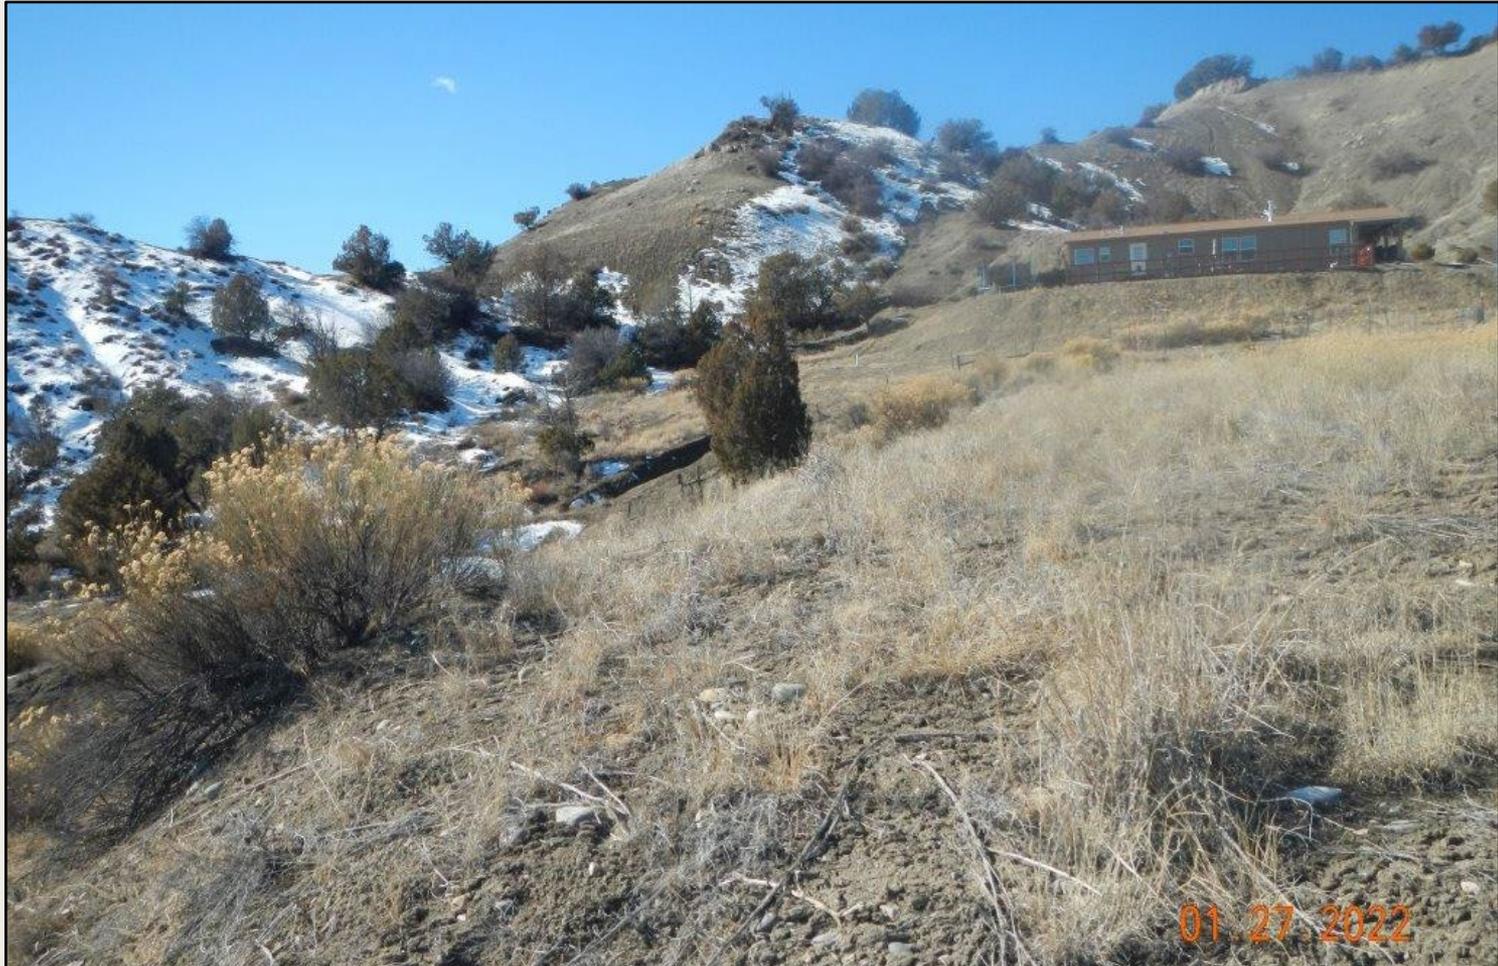
Photo 3. View of southern project area from the southeastern corner facing westward.

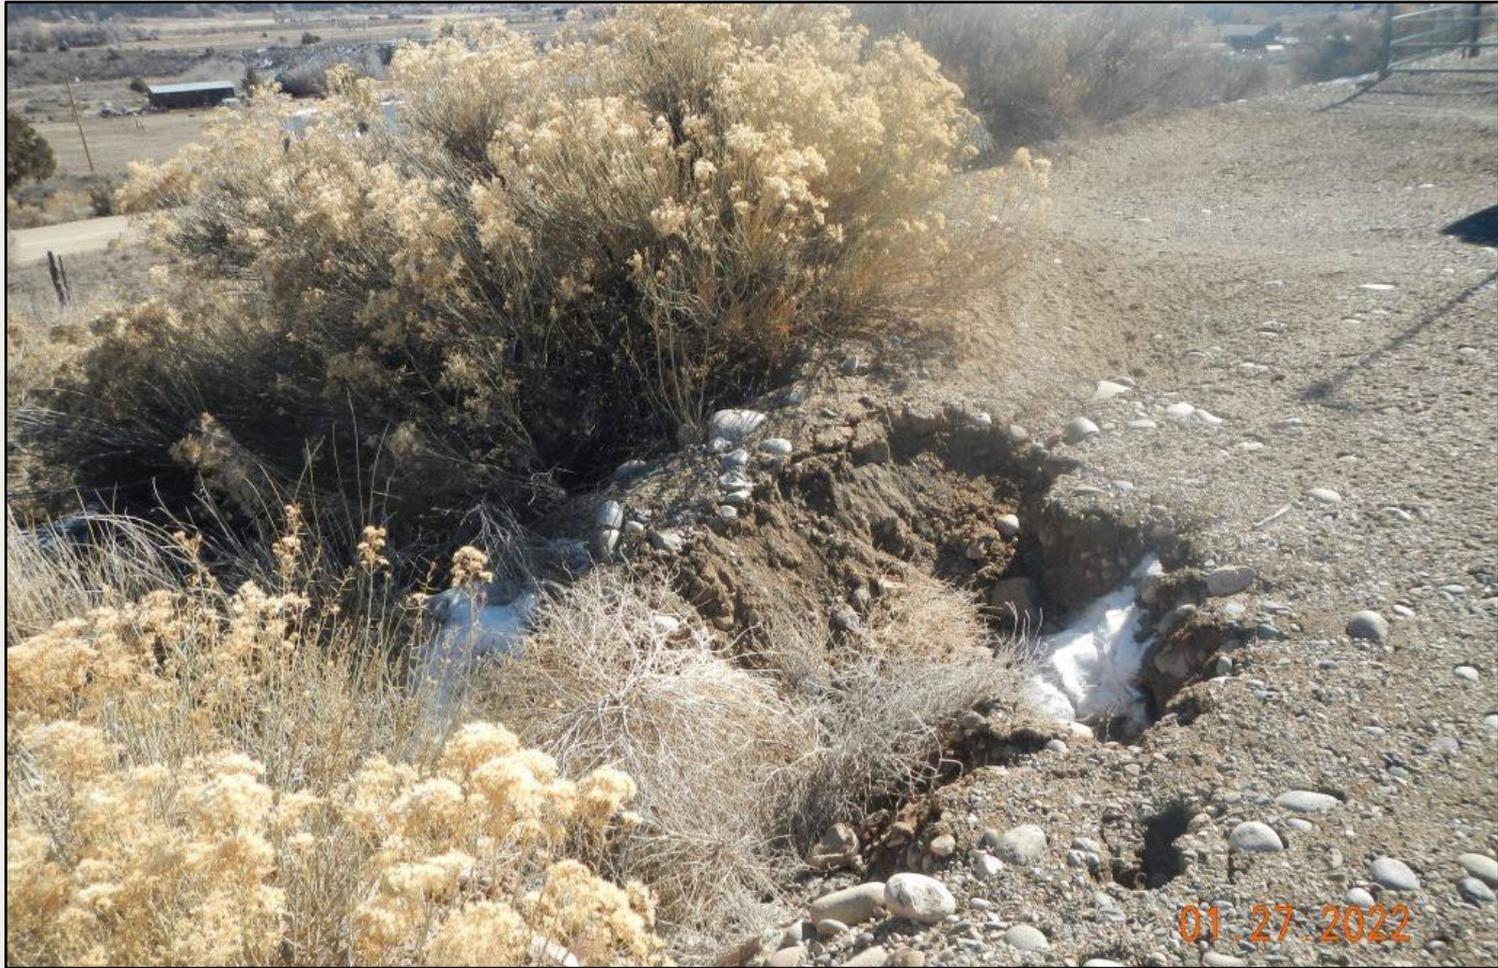
Photo 4. View of erosional tunneling occurring where concentrated stormwater flows off of the northeastern corner of the well pad around and below a cobble BMP that is not functioning properly.
