Inspection Photos

Location Name: TEP ROCKY MOUNTAIN LLC PA-66S95W /32NWSE

Location ID: 335103

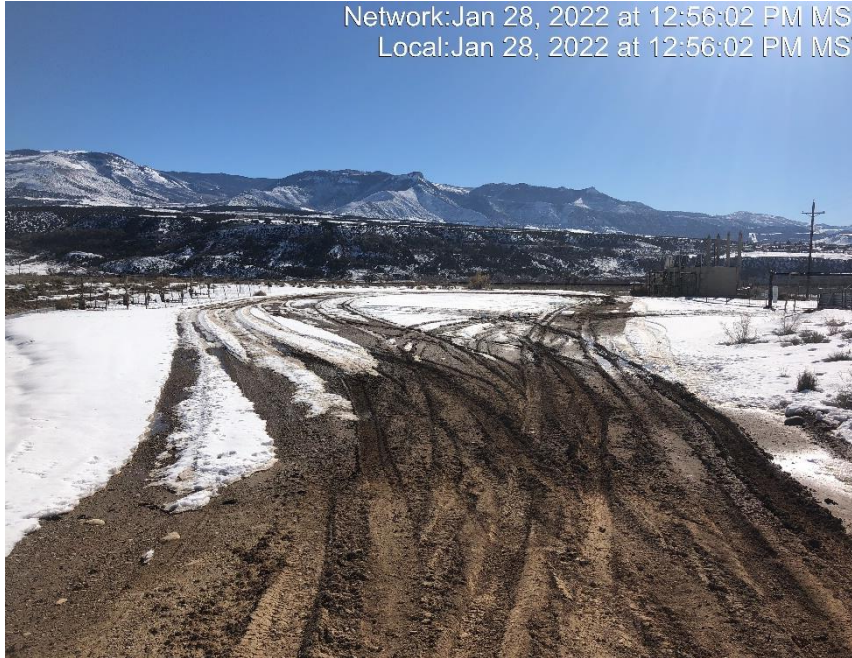
Photo #5818 from entrance to location.

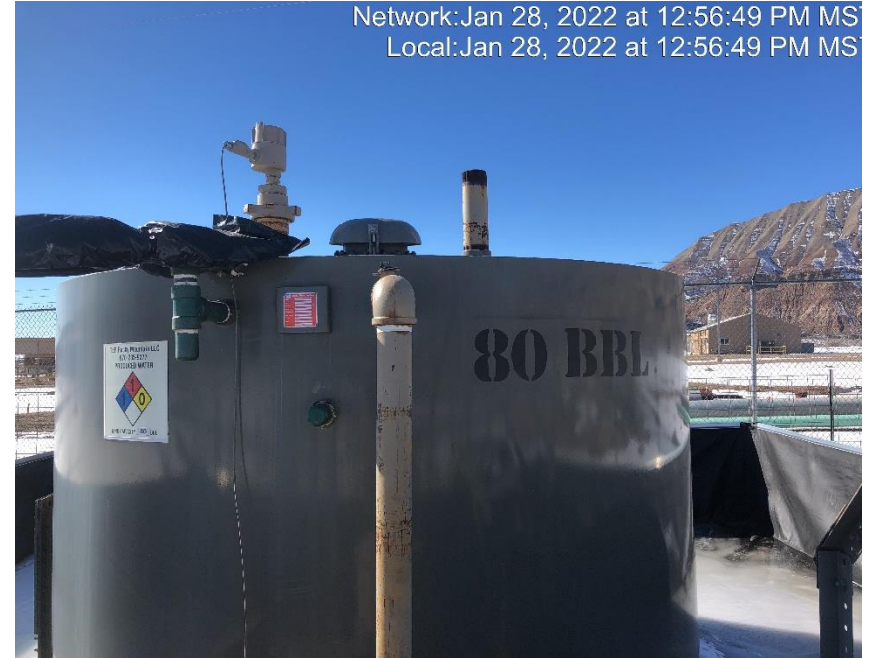
Photo #5819 Vent pipe on tank open ended.

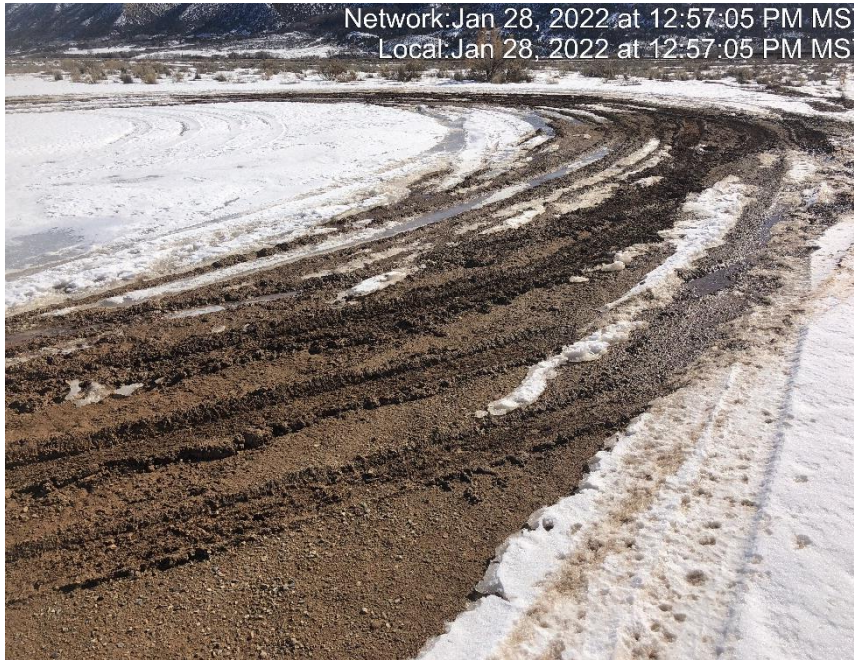
Photo #5820 Location lacks stabilization.

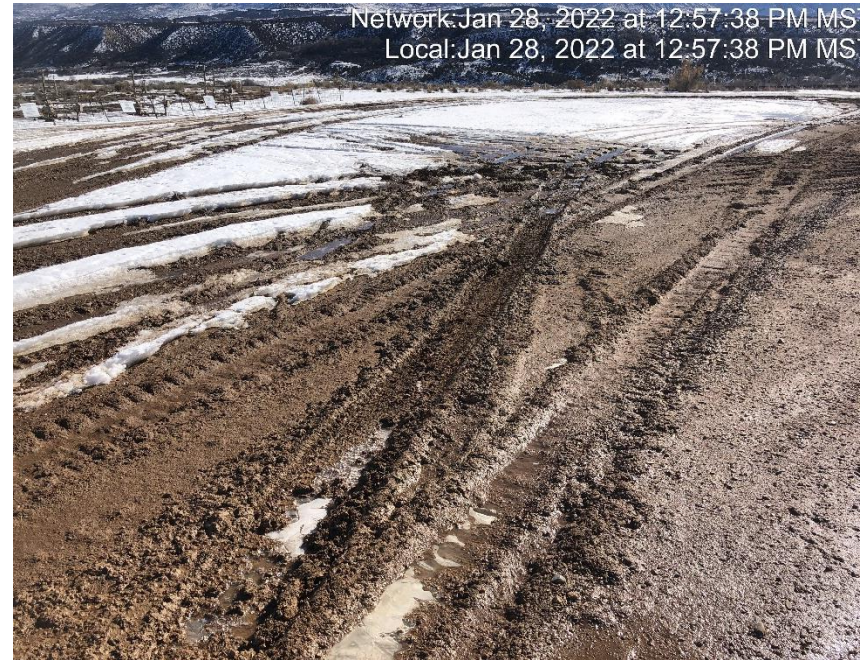
Photo #5821 Location lacks stabilization.

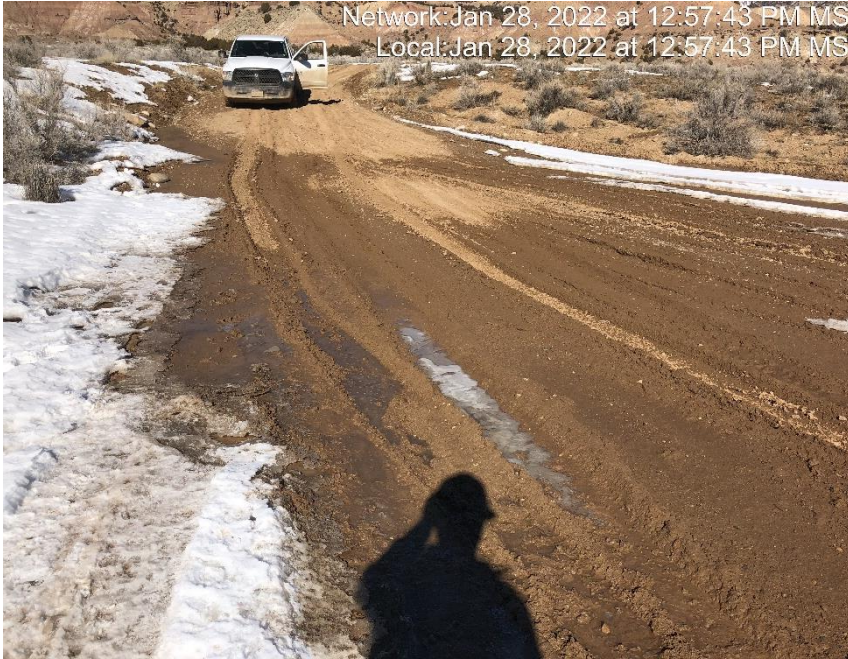
Photo #5822 Insufficient tracking BMP located at the entrance to location.
