Inspection Photos

API: 009-06341

Operator: SCHREIDER & COMPANY

Inspection Date: 2/1/2021

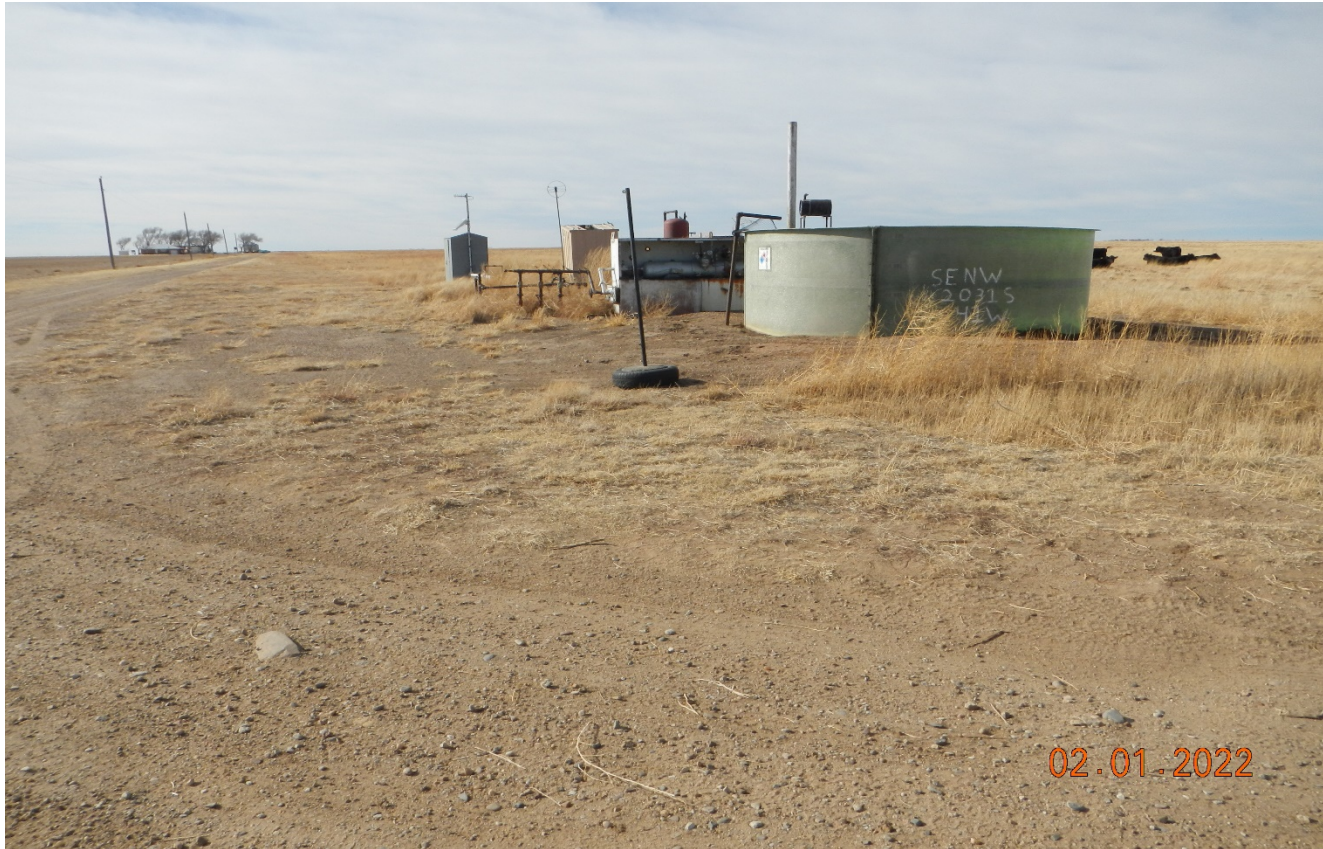
Photo 1. Facing toward the associated facility along CR 55.5 approximately 900' southeast of the Hume 1-20 abandoned well site. All equipment at the associated facility needs to be removed and disturbance reclaimed.

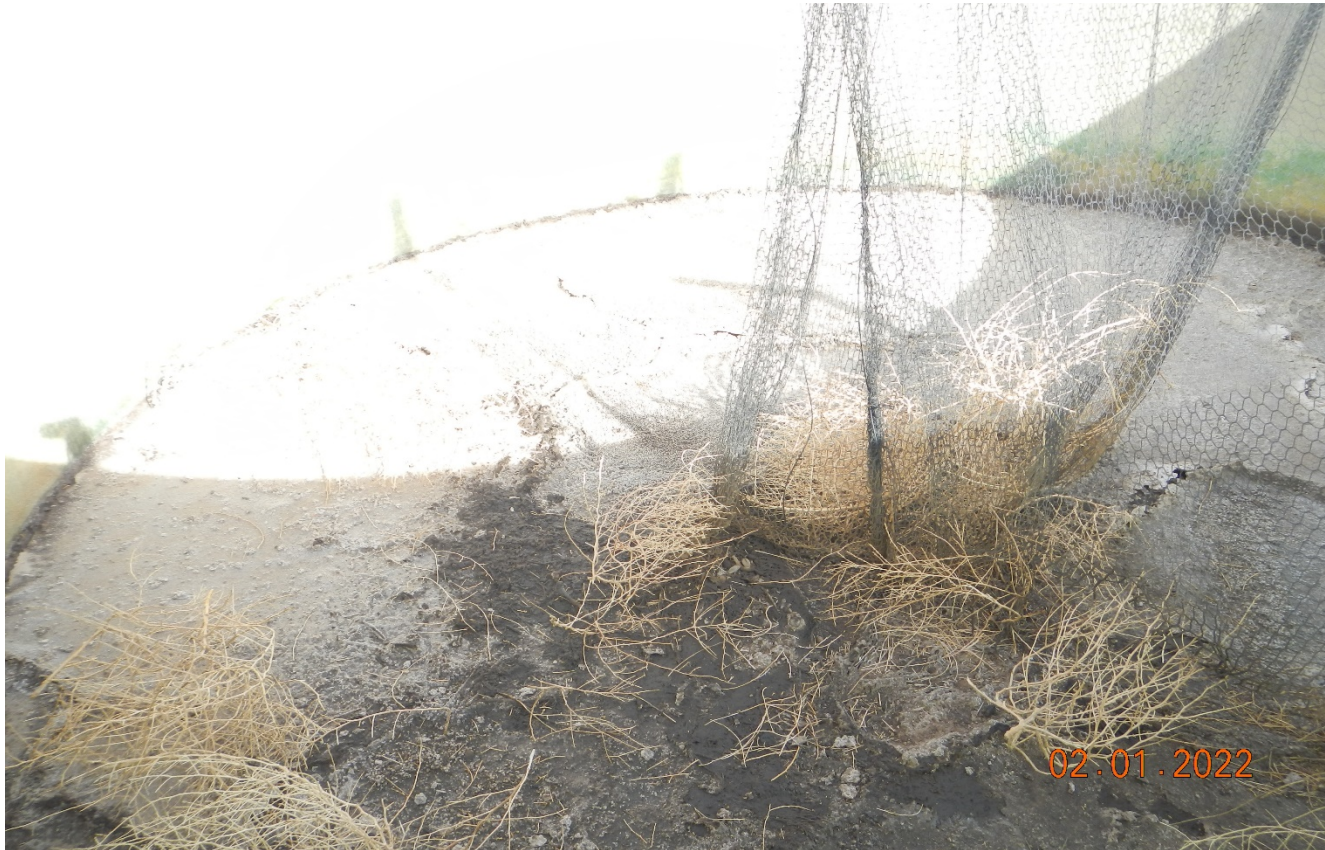
Photo 2. There is a solidified substance in the tank and the netting is not maintained.

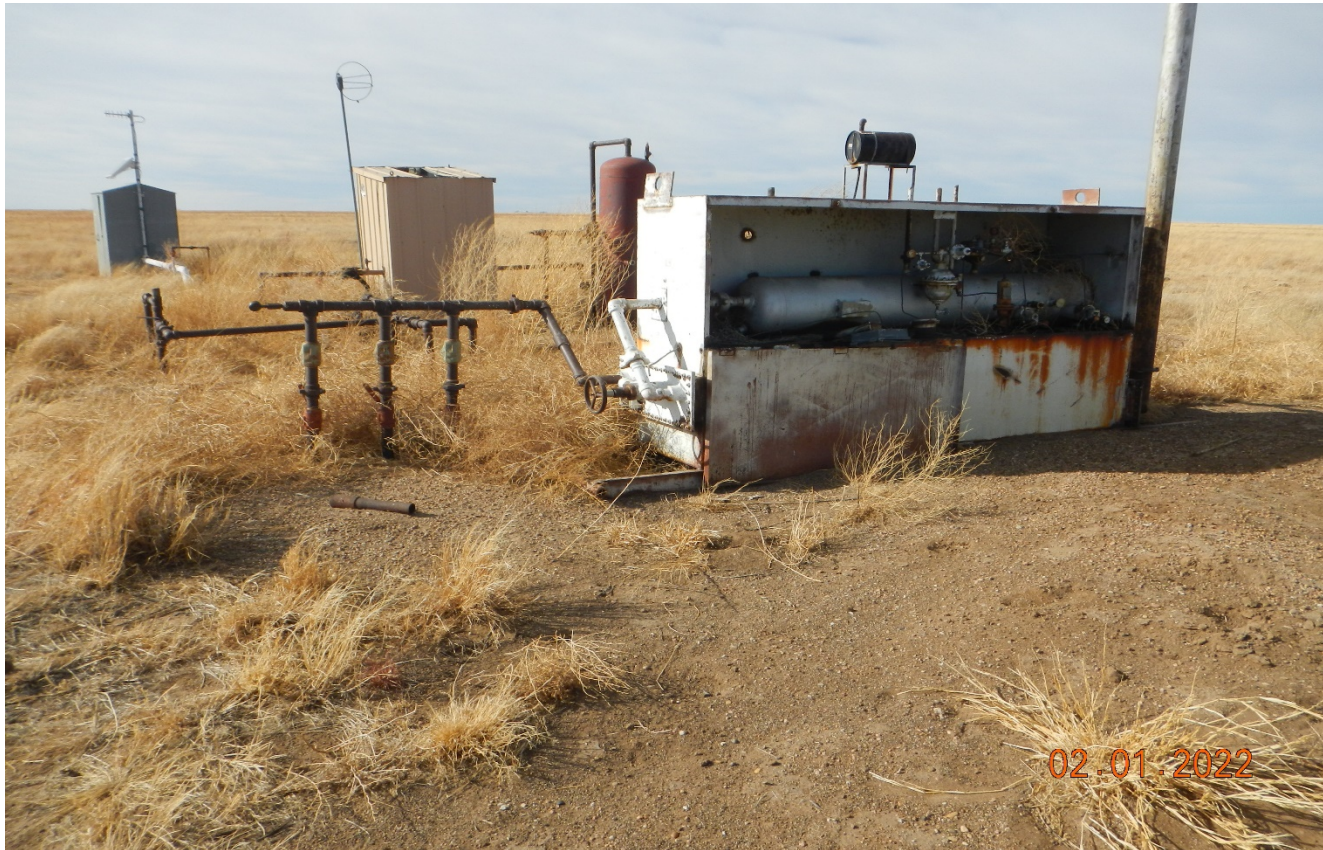
Photo 3. All equipment needs to be removed.

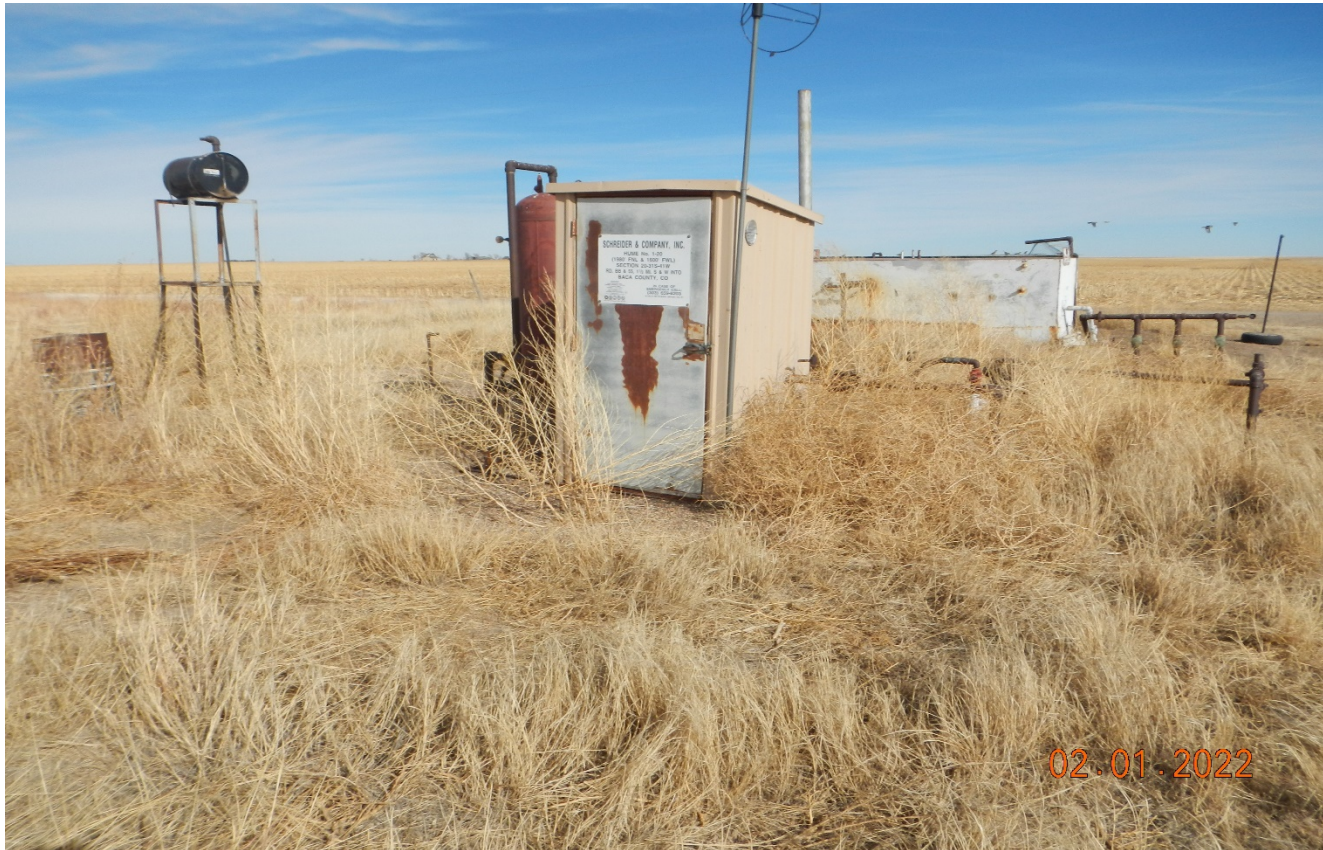
Photo 4. Sign posted at the facility is listed as the Hume 1-20 which the well was plugged and abandoned in 2005. All equipment should've been removed within 3 months of abandonment.

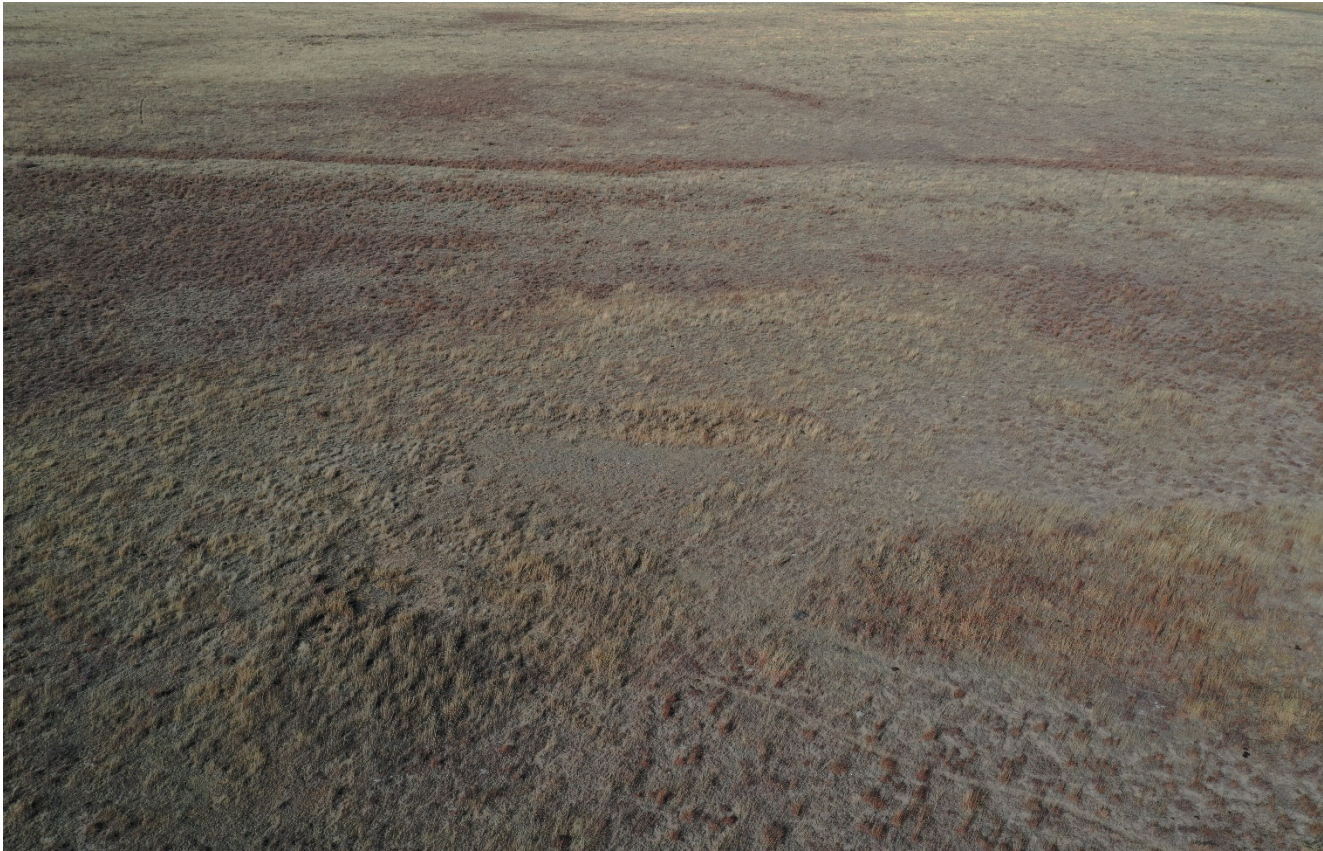
Photo 5. Drone image facing north at the plugged and abandoned wellsite. All equipment has been removed at the well site and the vegetation has re-established.

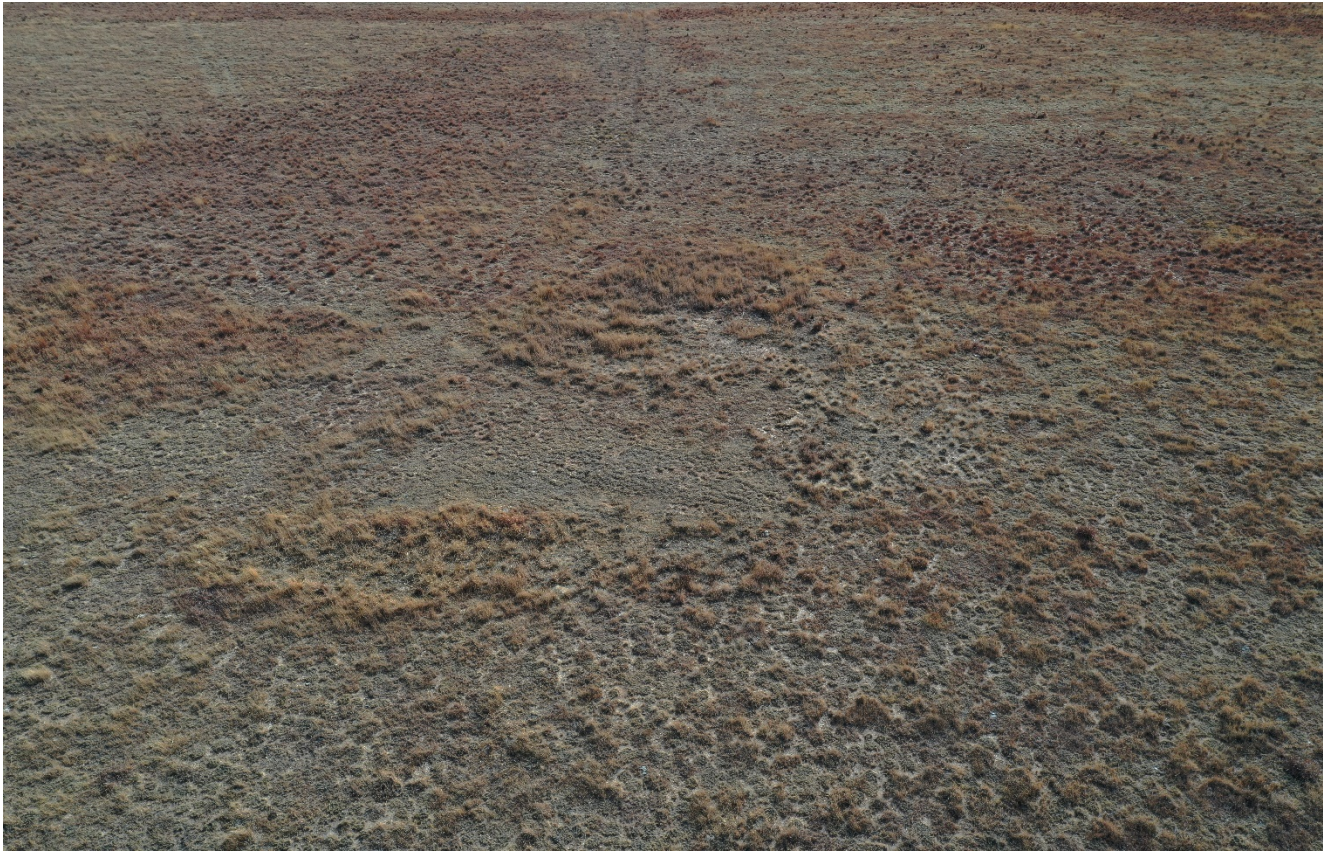
Photo 6. Drone image facing south at the plugged and abandoned wellsite. All equipment has been removed at the well site and the vegetation has re-established.
