Inspection Photos

Location Name: TEP ROCKY MOUNTAIN LLC PA-66S95W /32SWSE

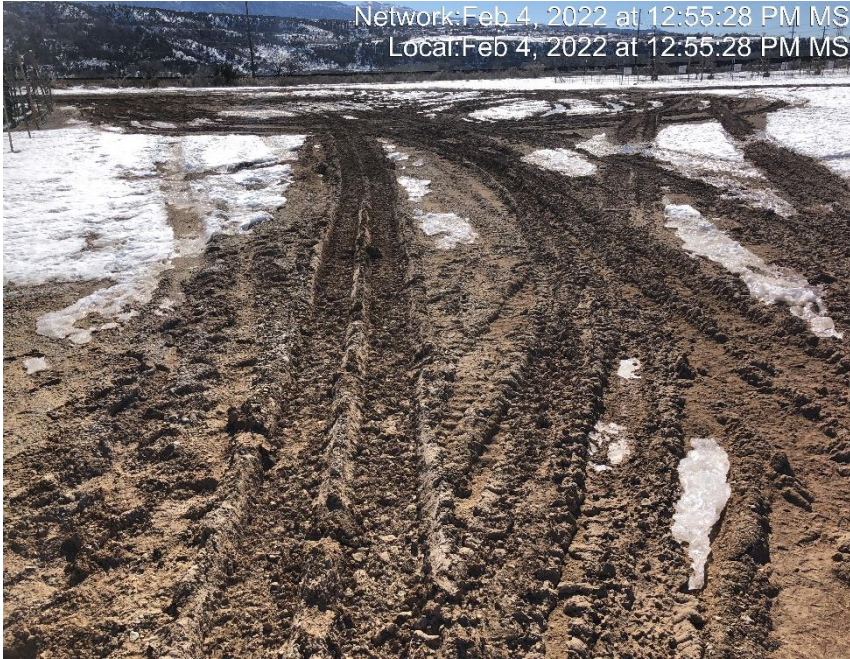
Photo #5872 Location lacks stabilization.

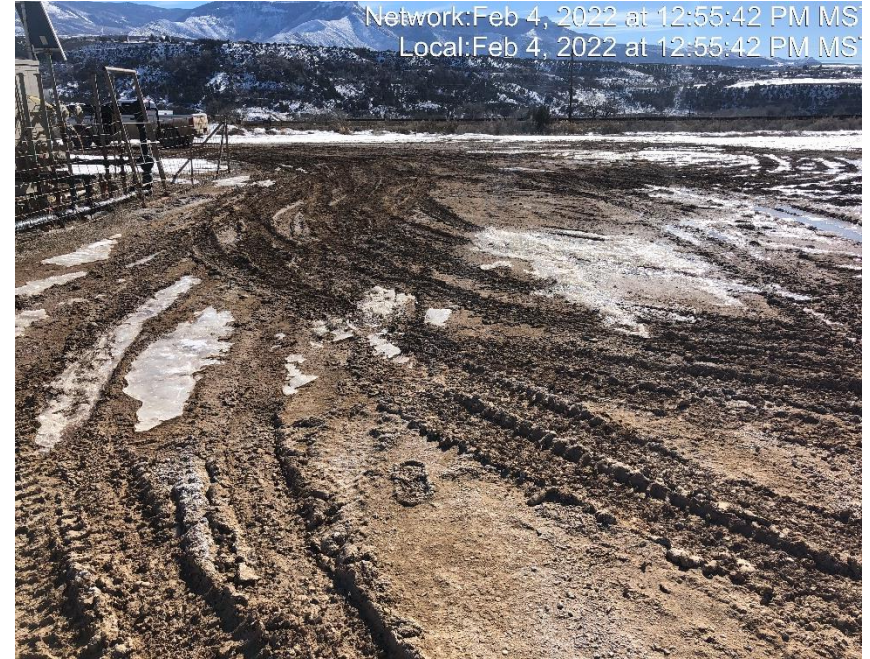
Photo #5873 Location lacks stabilization.

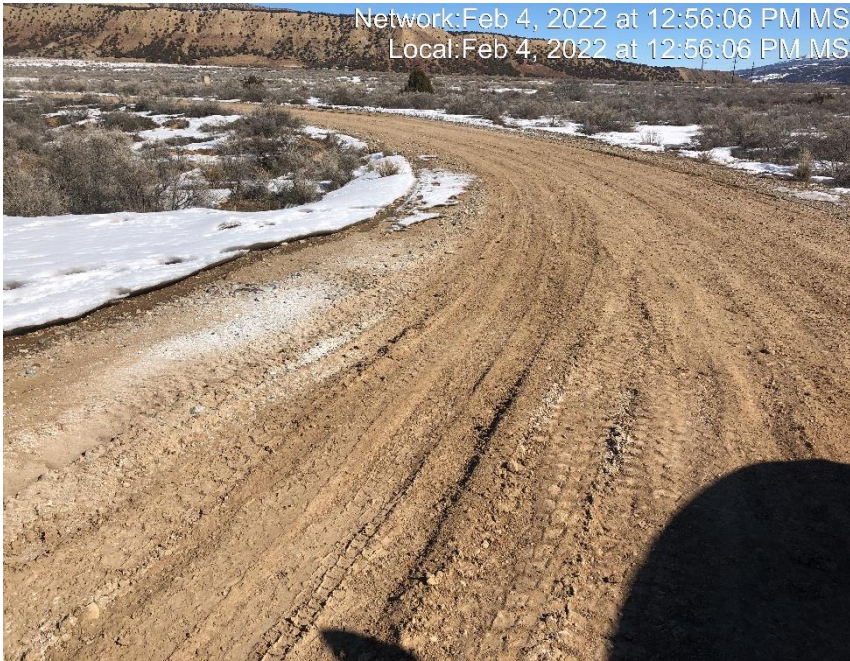
Photo #5874 Insufficient tracking BMP located at the entrance to location.
