Inspection Photos
Operator: Simcoe
API: 067-09482
Date: 2/11/2022

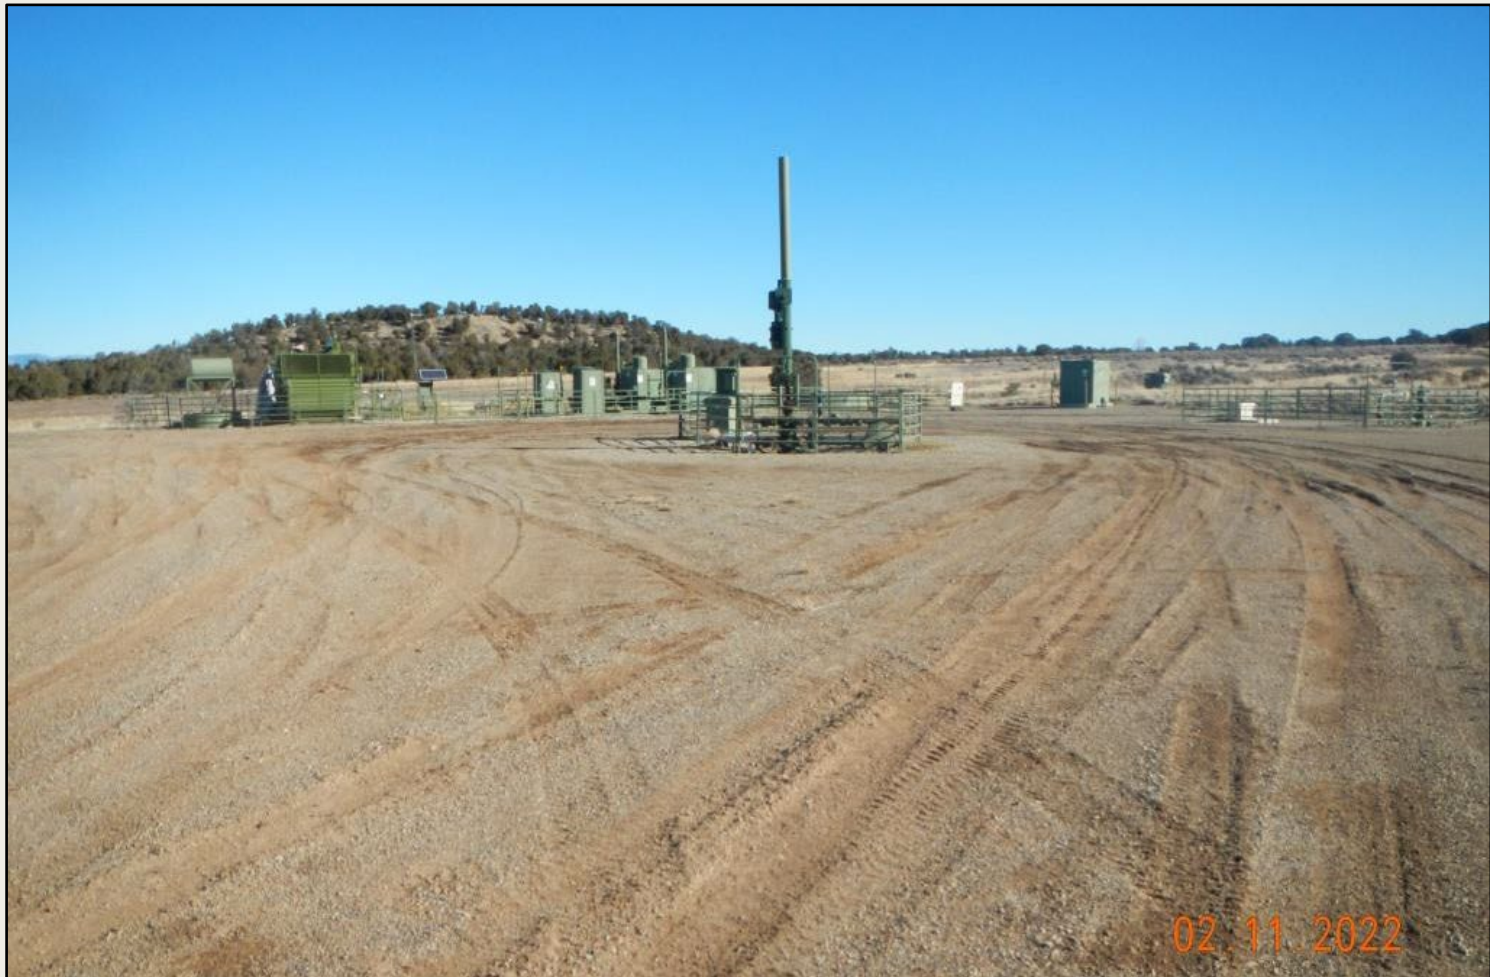
Photo 1. View of project area from the well pad entrance facing center.

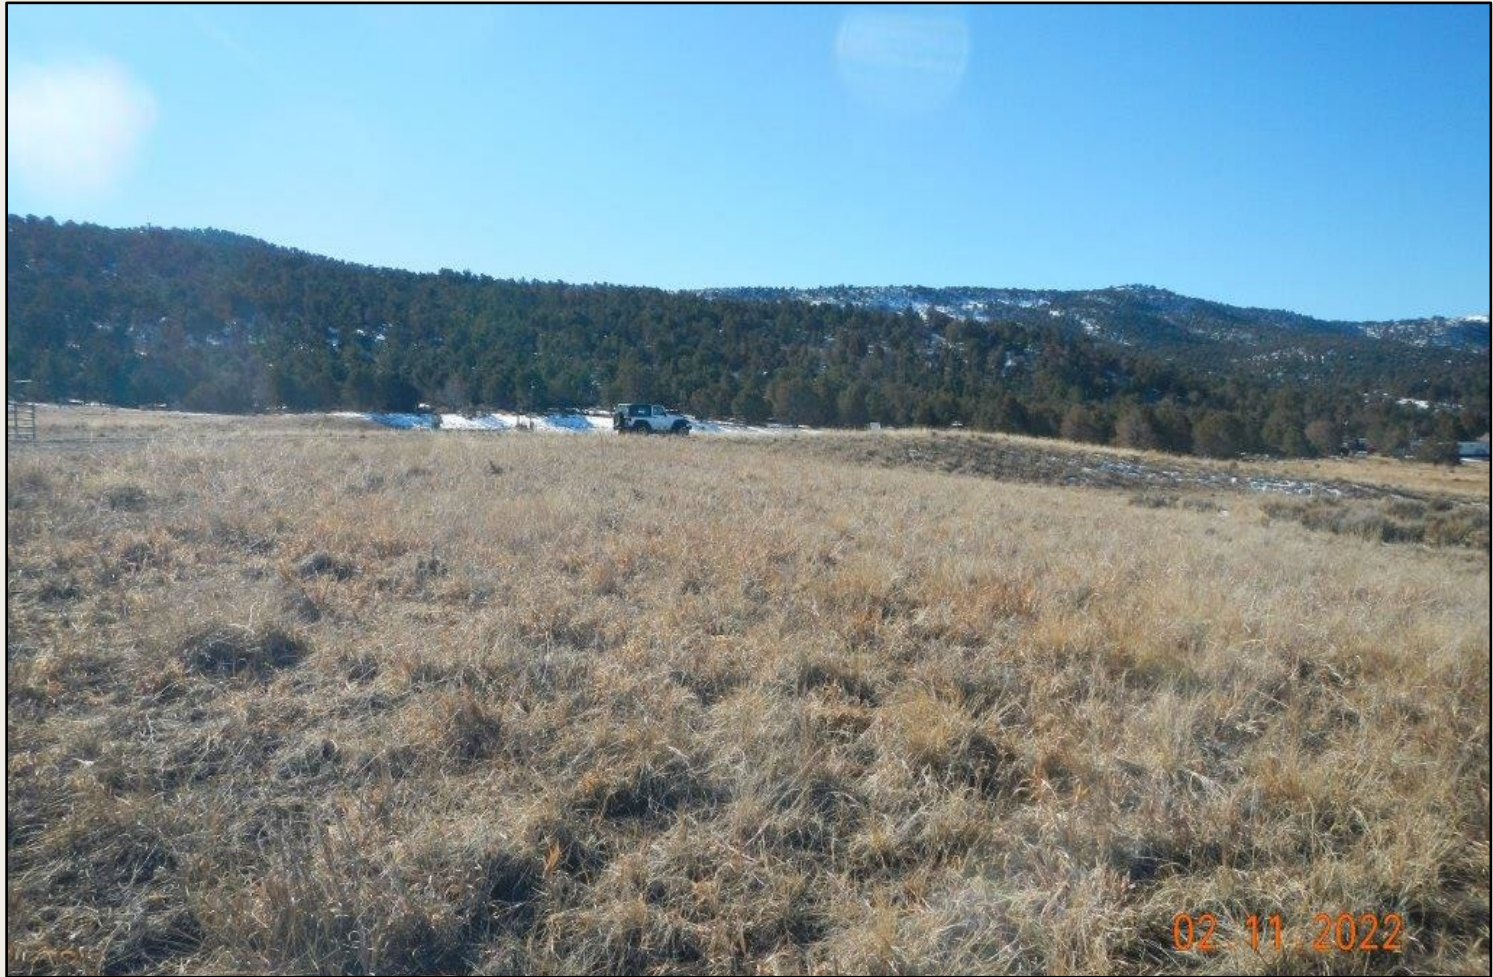
Photo 2. View of the western project area from the northwestern corner facing southward. Revegetation is progressing with smooth brome, crested wheatgrass, and western wheatgrass.

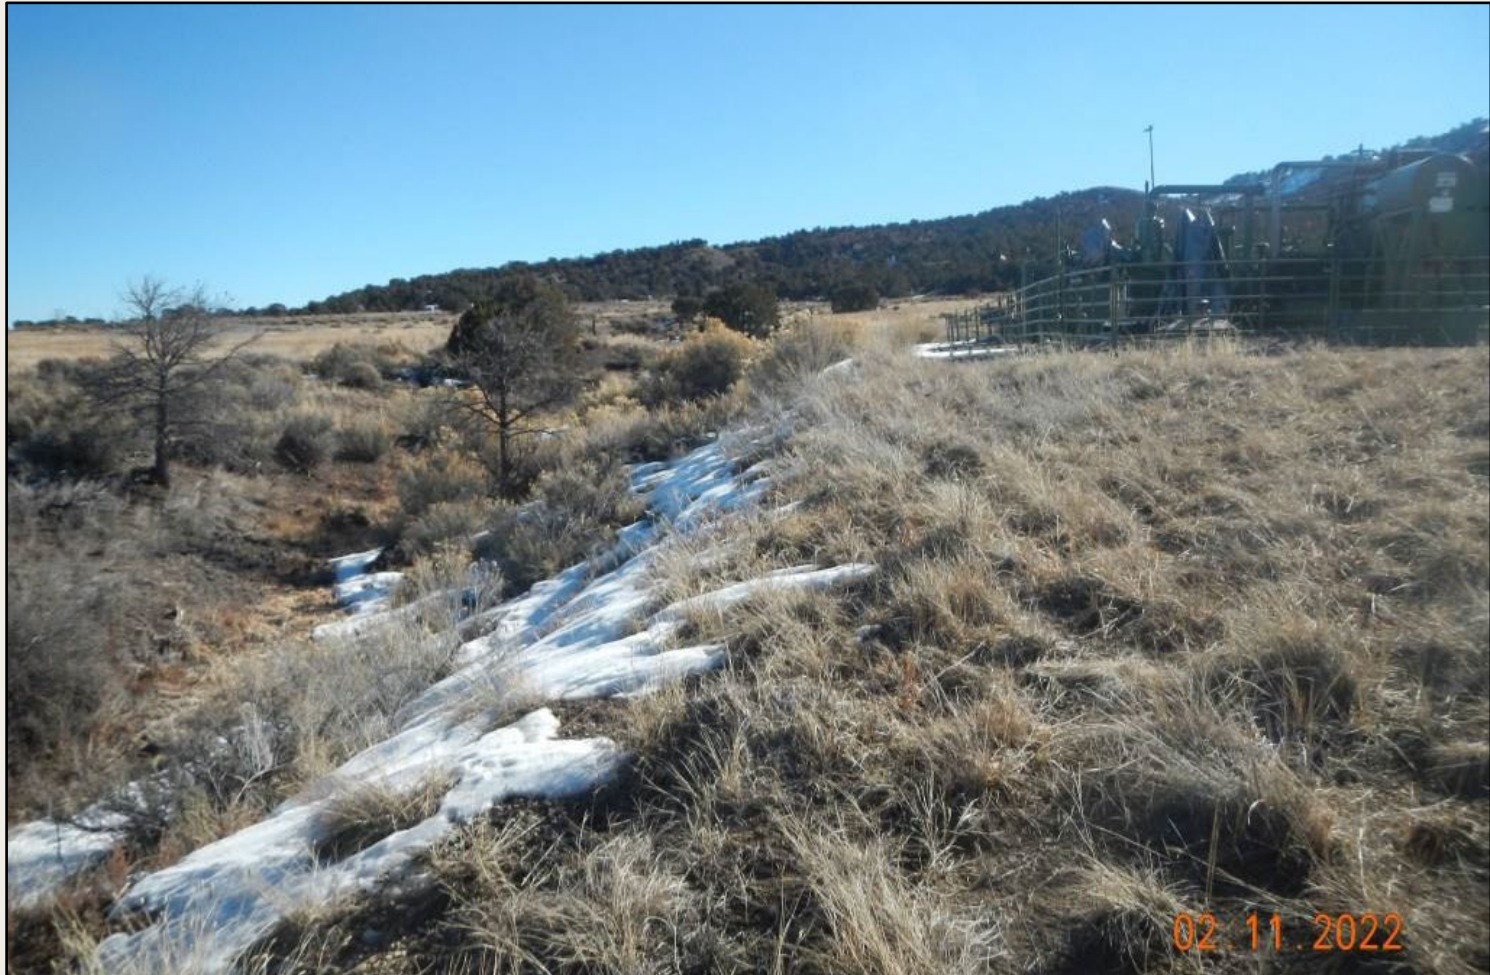
Photo 3. View of the northern project area from the northwestern corner facing eastward.

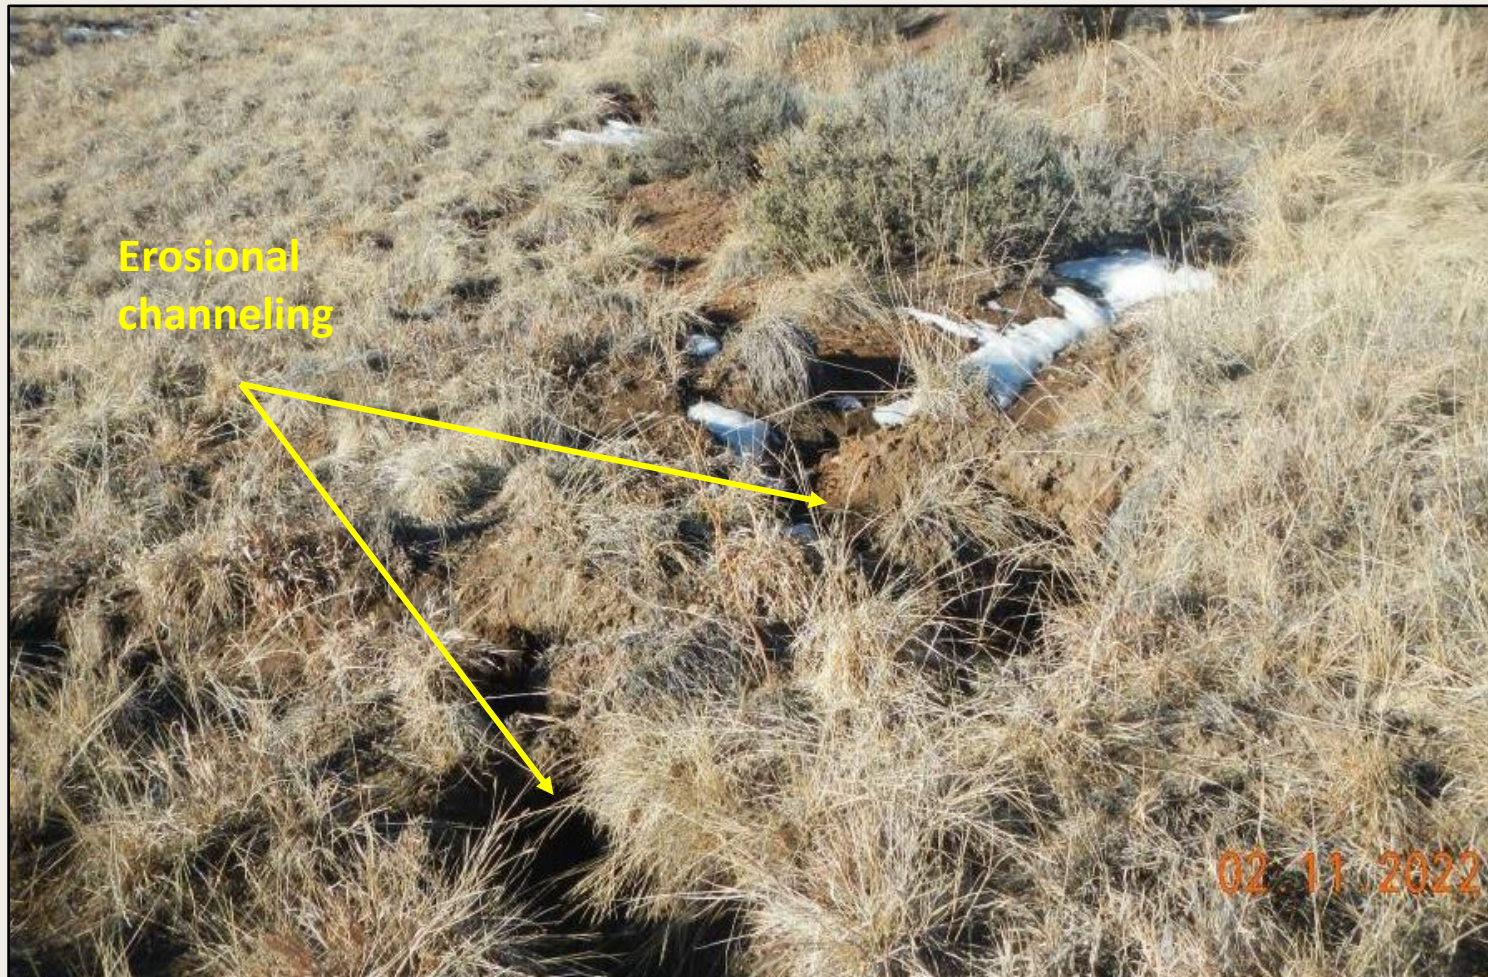
Photo 4. Erosional channel approx. 1ft wide and 2.5ft deep observed in the western project area, deepening as it flows toward the edge of the project area. Stabilization measures are needed here.

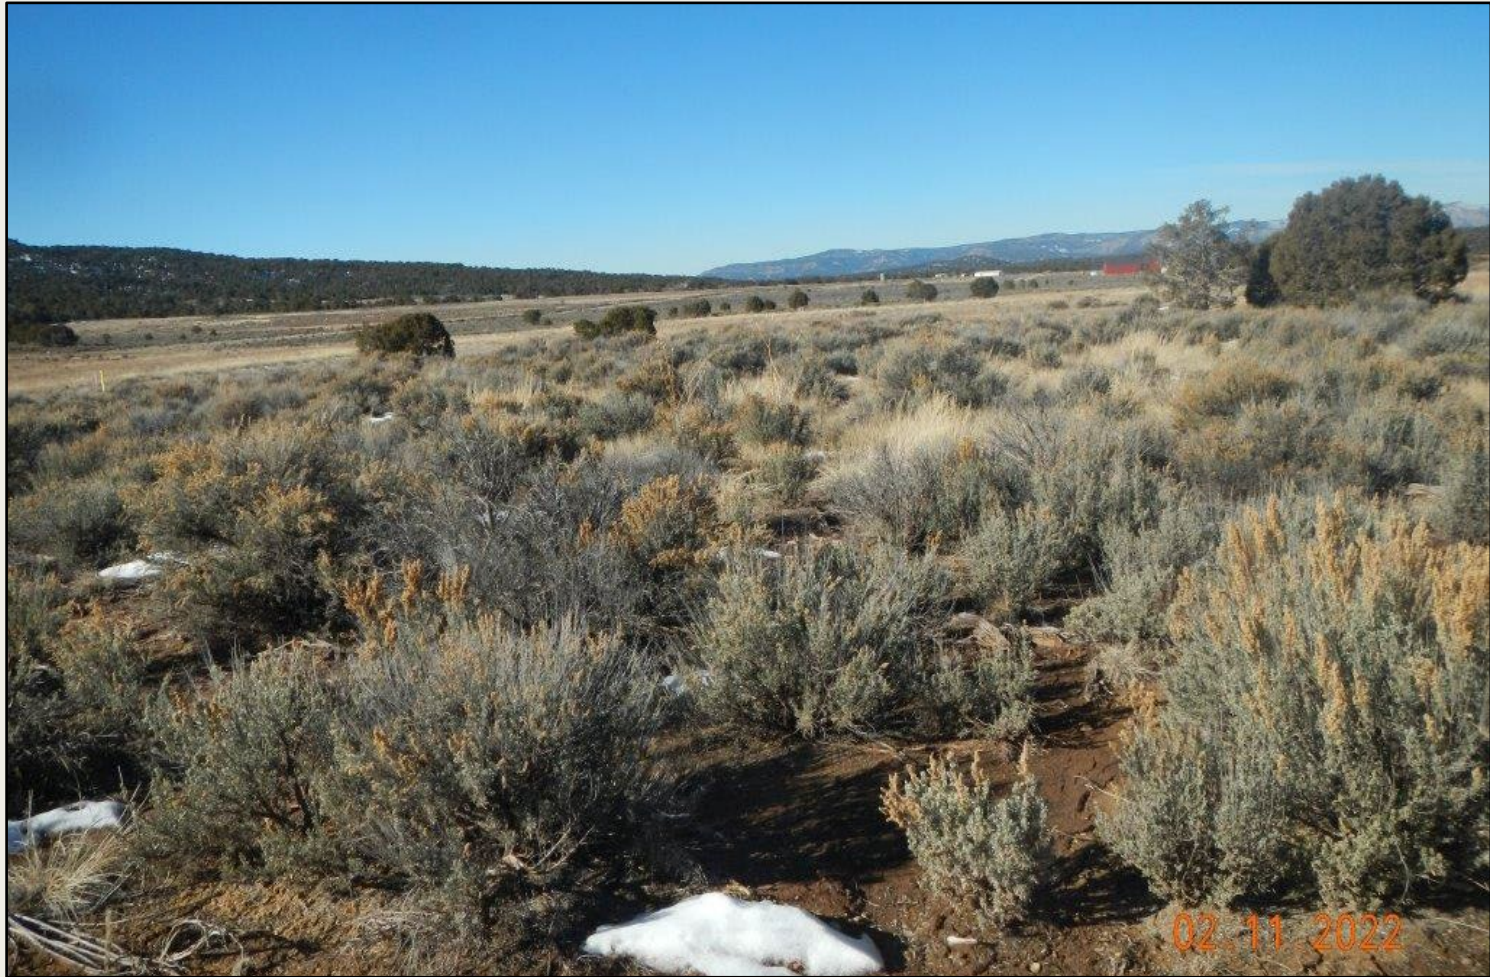
Photo 5. View of reference area comprised of sagebrush shrubland with Indian ricegrass, squirreltail, blue grama, and snakeweed.
