Tecate Federal 24-22

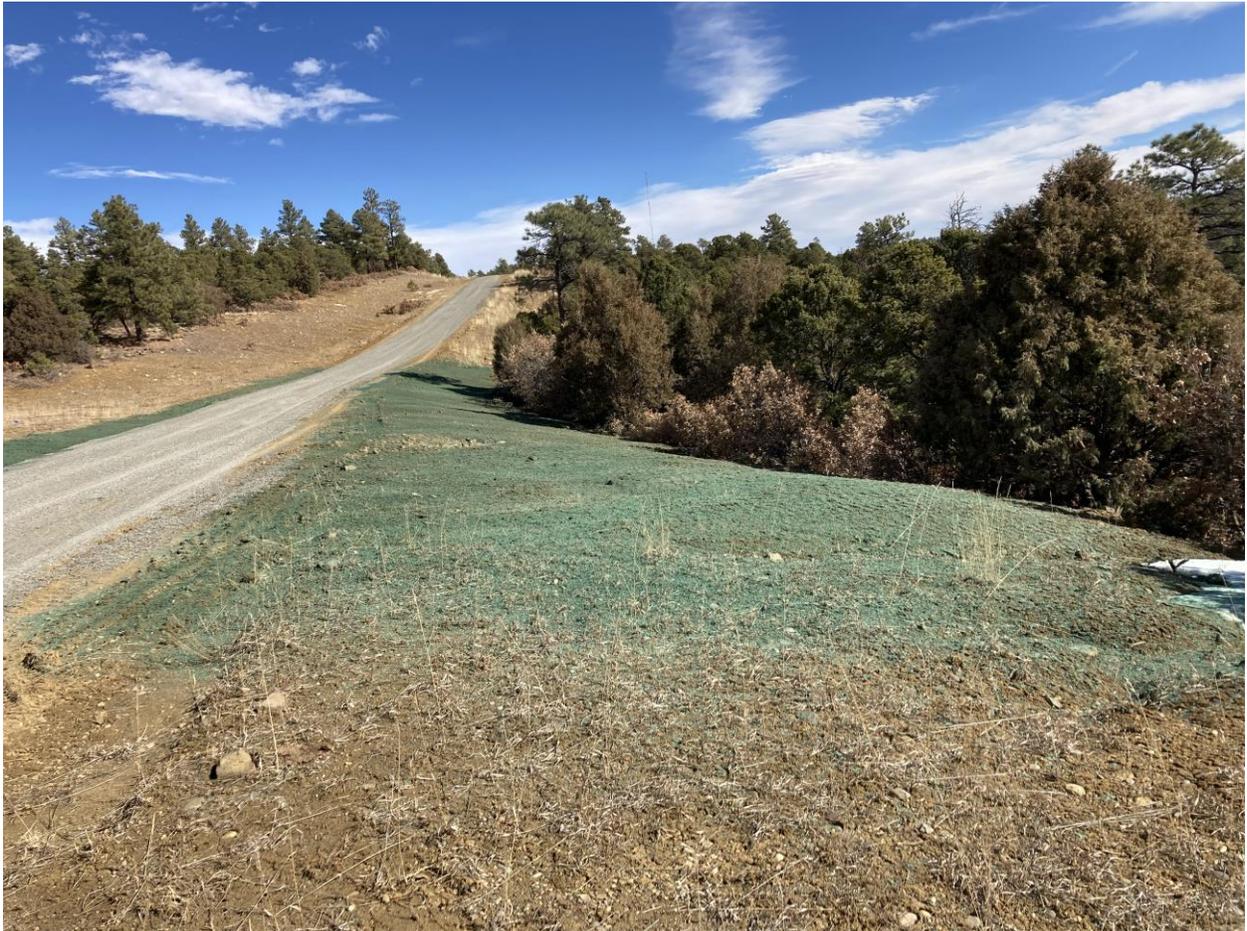
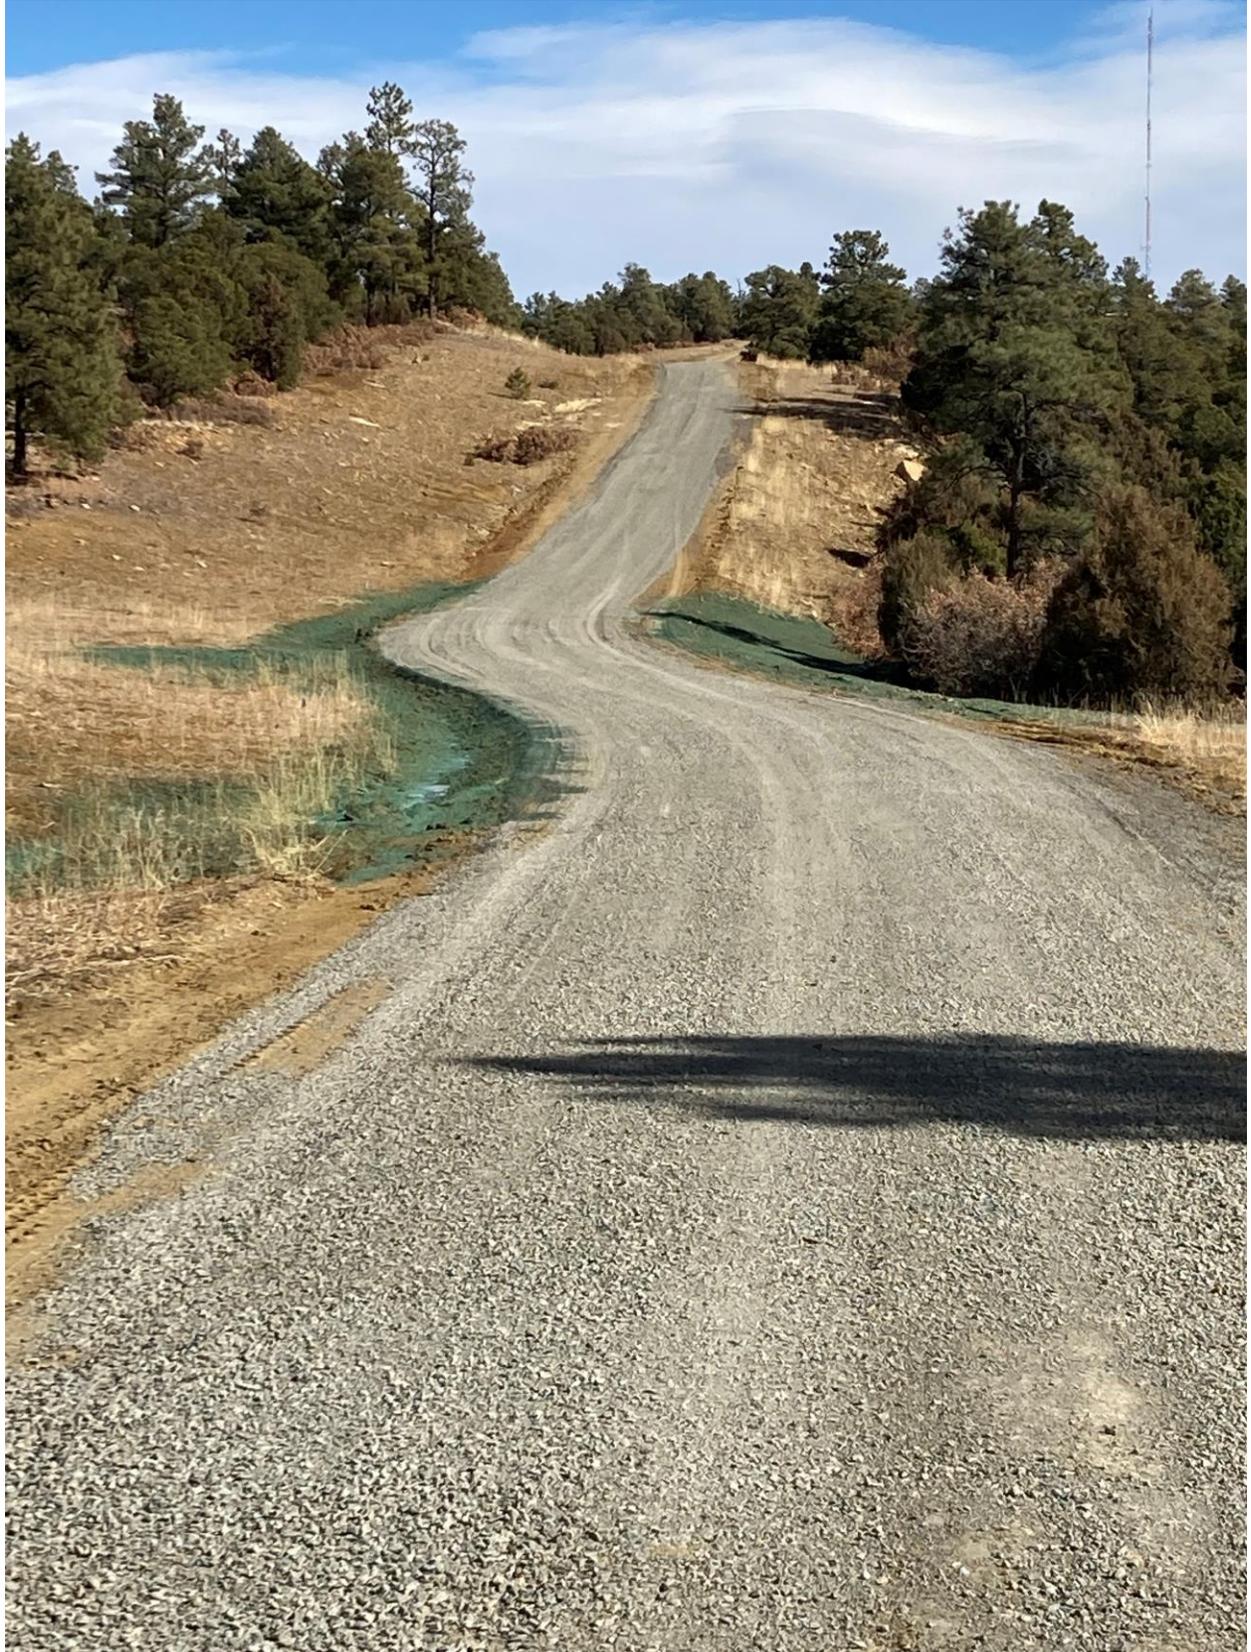
The road near the well site has been repaired. The erosion and the side of the side of the road has been stabilized. Stormwater was diverted toward the culvert. Areas of erosion repaired and stabilized. Repairing required BMPs per Rule 1002.f.(2)C.
