## LAW OFFICE OF MATTHEW SURA

RE: Formal complaint and report of suspected spill or release

2/24/2022

YES is the owner of a vacant parcel at 7781 Mountain View Drive, Frederick, CO. The legal description is Section 31 SE/4, 2 North, 67 West of the 6<sup>th</sup> Meridian.

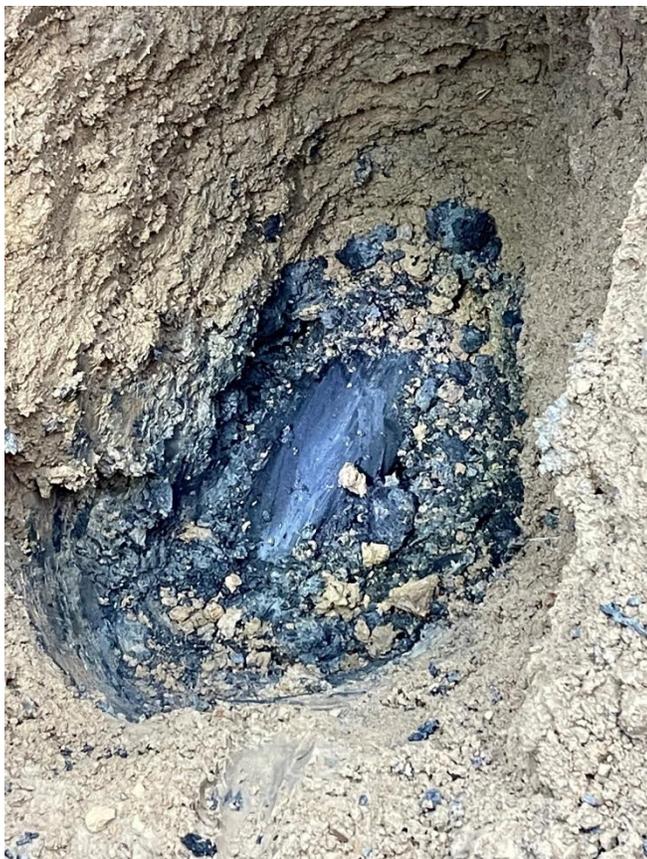
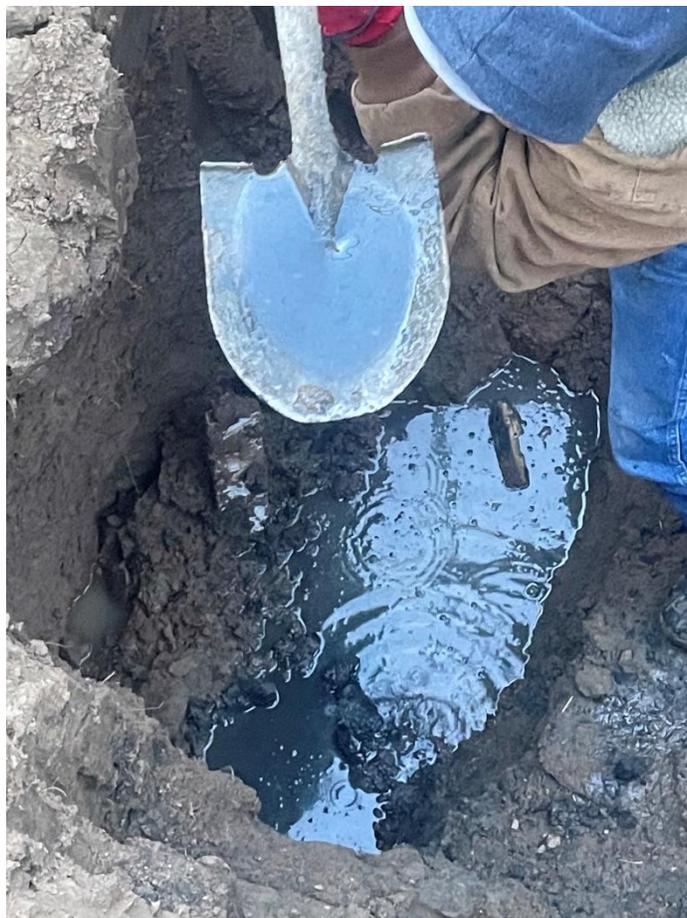
On or about January 10, 2022, while conducting pot holing to locate utilities, employees discovered some soil and water that appeared to be contaminated with oil. Please see photos 1 and 2 attached.

Two samples were collected and were found to be contaminated with what appears to be unrefined oil. The attached analysis by DHL Analytical found the soil samples contained total hydrocarbons of 3,160 mg/kg – well above the acceptable total petroleum hydrocarbon concentrations limit of 500mg/kg found in COGCC Table 915. (See Exhibit 1, page 15).

*Photos 1 and 2. Photos taken upon discovery of the suspected soil and water contamination on or about January 10, 2022.*

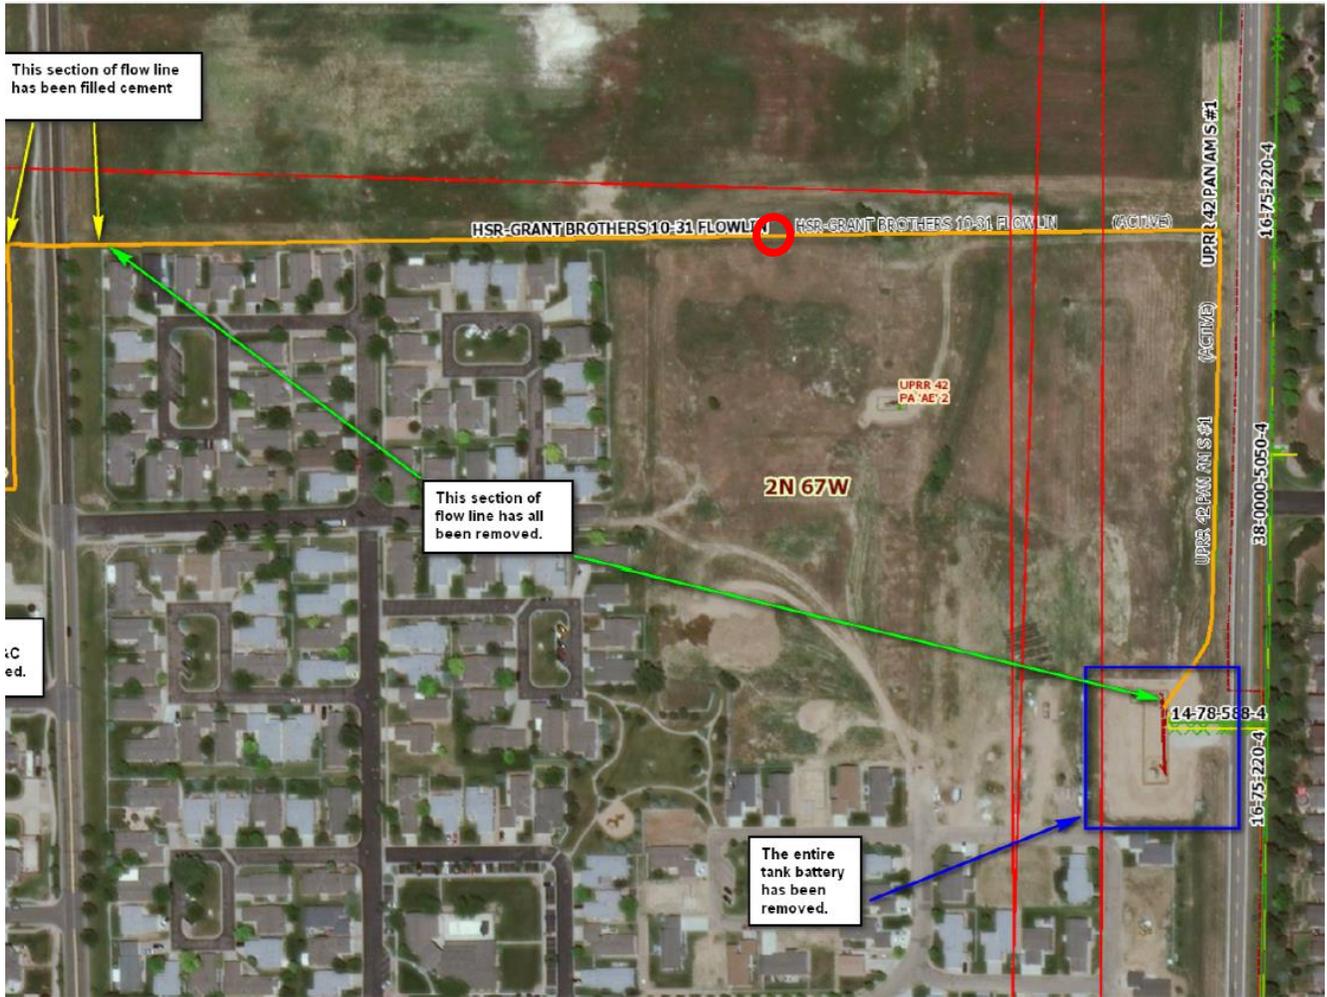
After some research, the Surface Owner learned that Kerr McGee Oil and Gas (now wholly owned by Occidental Petroleum) plugged the HSR Grant Brothers 19-31 well on 1/3/2019 and removed the associated flow line on 1/17/2019. (COGCC Doc# 401955131). The Kerr McGee flow line passed through the exact location of the contaminated soil. The black contaminated soil should have been evident to Kerr McGee when the flowline was removed. The locations of the flowline and the contaminated soil can be seen on the attached maps below.

Map 2. Map of Kerr McGee flowline route from the HSR Grant Brothers 19-31 well to the tank battery. The red circle is the approximate location of the oil contamination.
