Inspection Photos

Location Name: TEP ROCKY MOUNTAIN LLC EXXON-66S95W /32SESE

Location ID: 323885

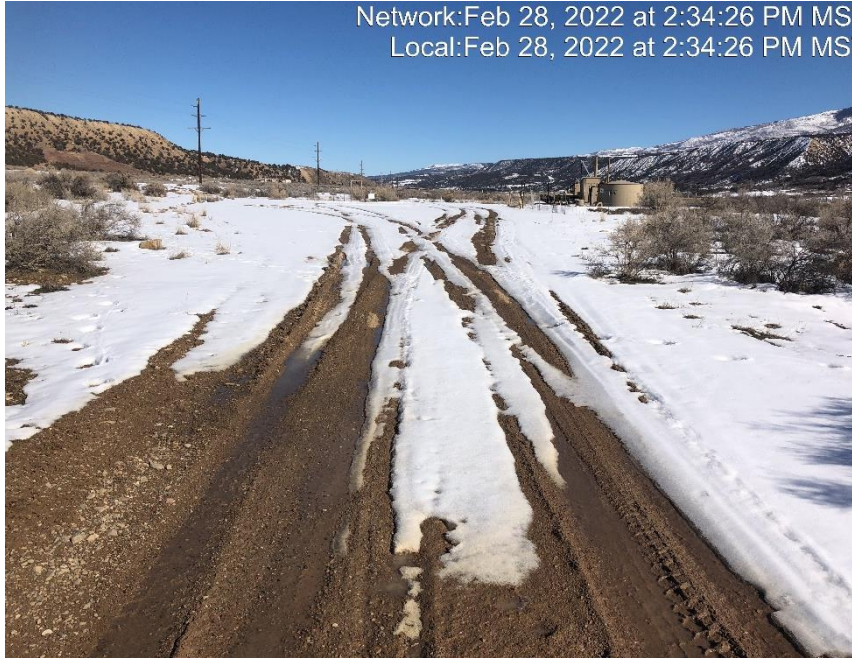
Photo #6053 from entrance to location.

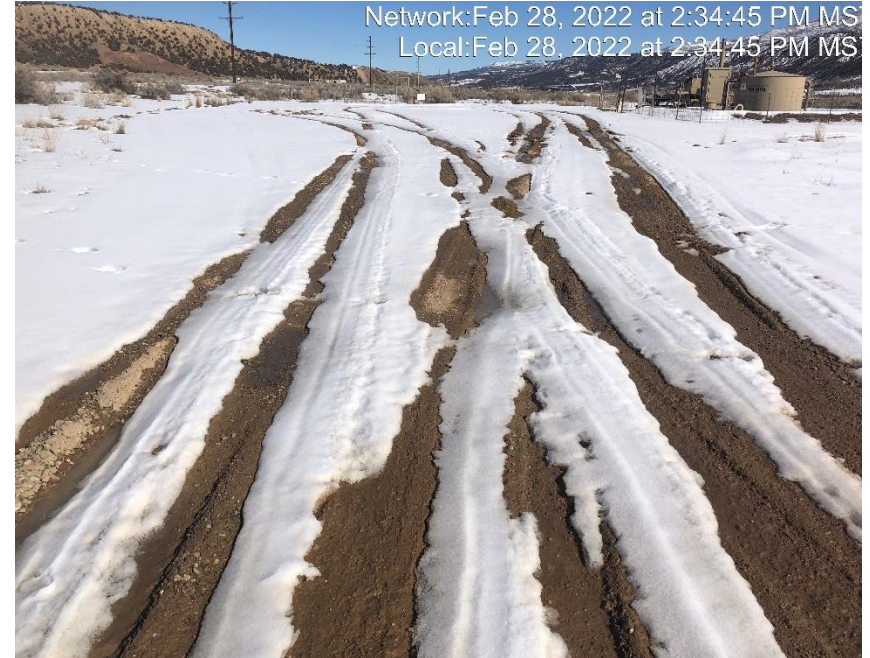
Photo #6054 Location lacks stabilization.

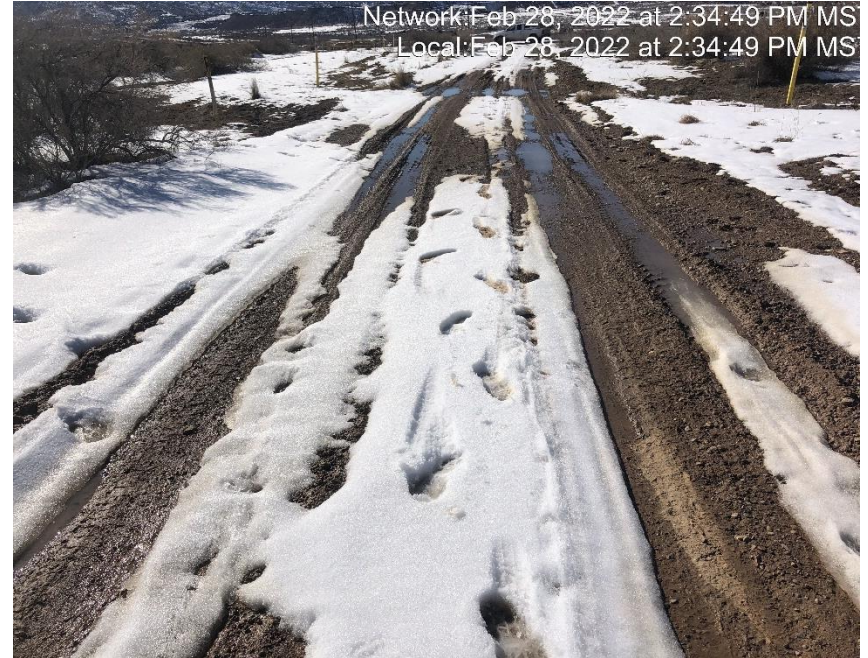
Photo #6055 Insufficient tracking control at entrance to location.
