Inspection Photos

03/09/2022

Operator: TEP ROCKY MOUNTAIN LLC - 96850

Location ID: 335145

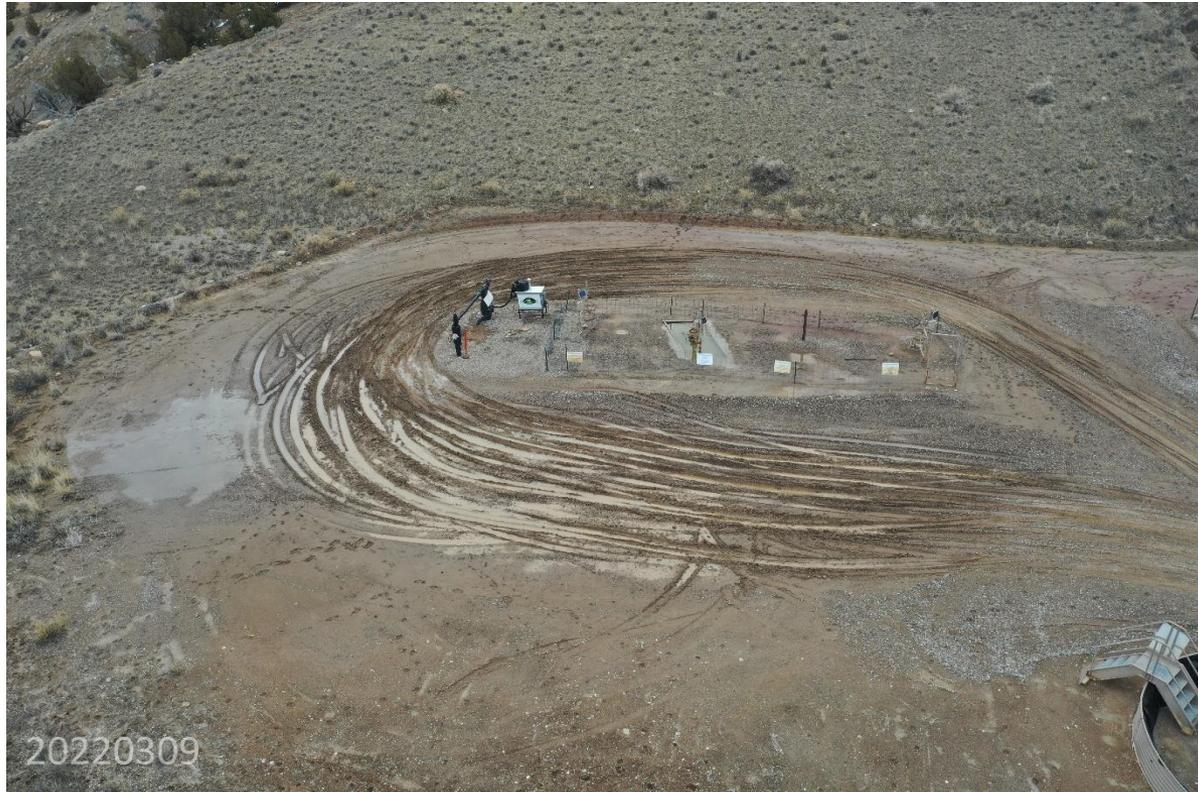
Photo 1: Photo taken with use of a sUAS. Photo taken from southwest end of the Location, facing northeast. Photo provides an overview of the Location showing control measures to stabilize the working pad, minimize rutting, tracking and sediment transport remains missing or insufficient.

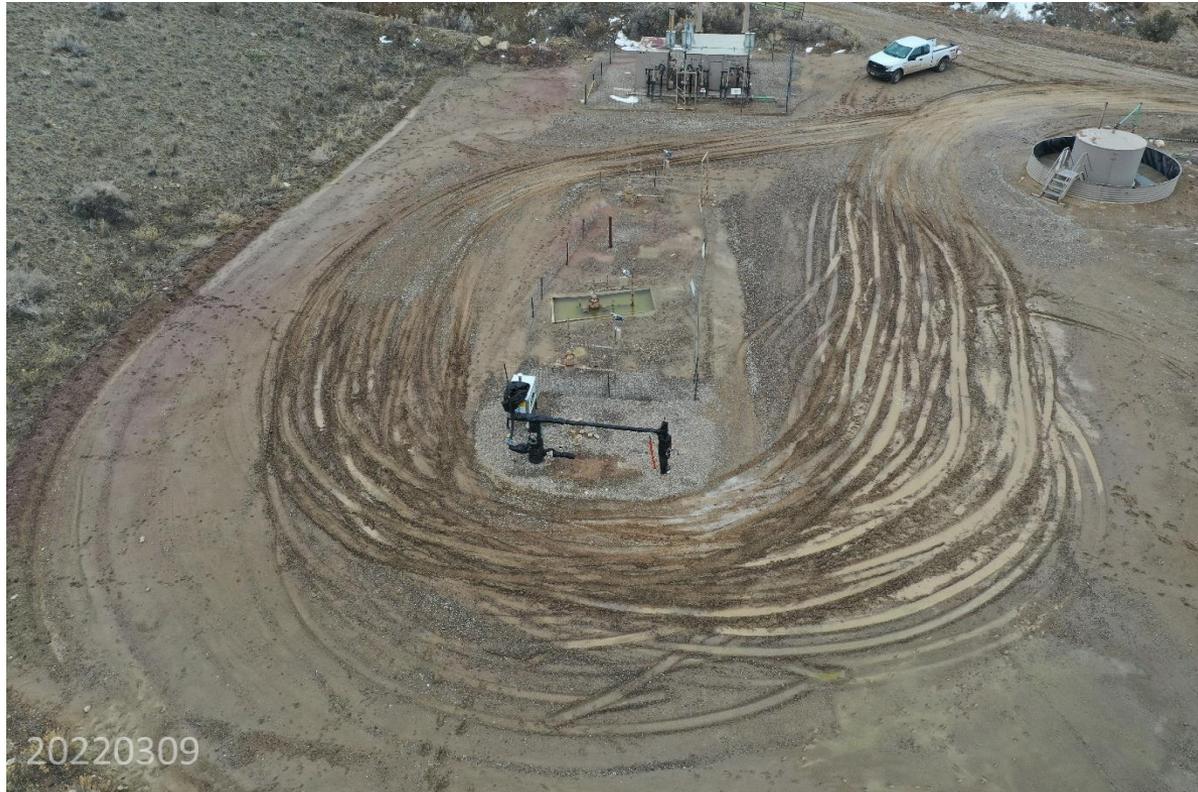
Photo 2: Photo taken with use of a sUAS. Photo taken from northwest end of the Location, facing southeast. Photo provides an overview of the Location showing control measures to stabilize the working pad, minimize rutting, tracking and sediment transport remains missing or insufficient.

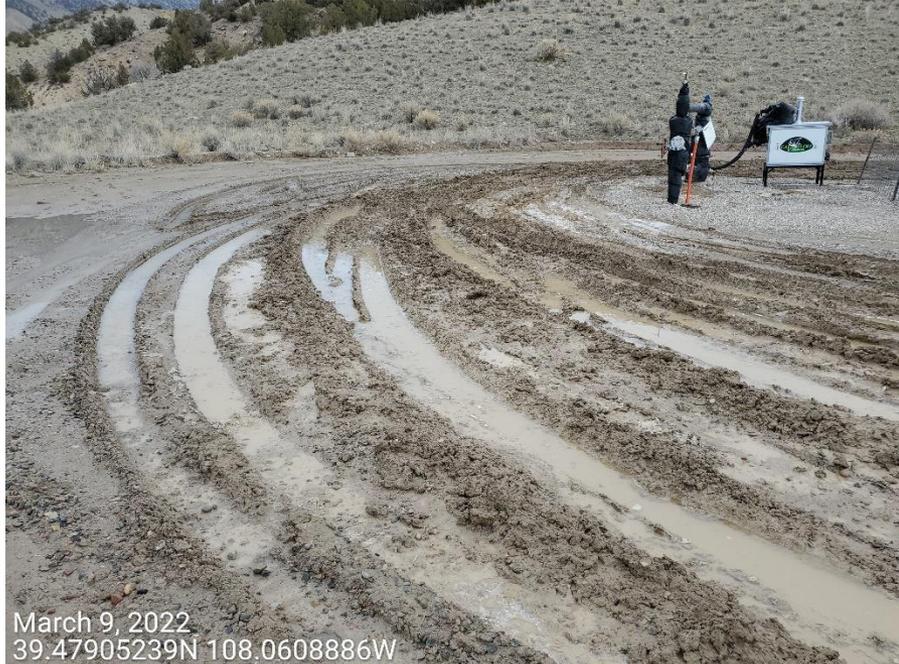
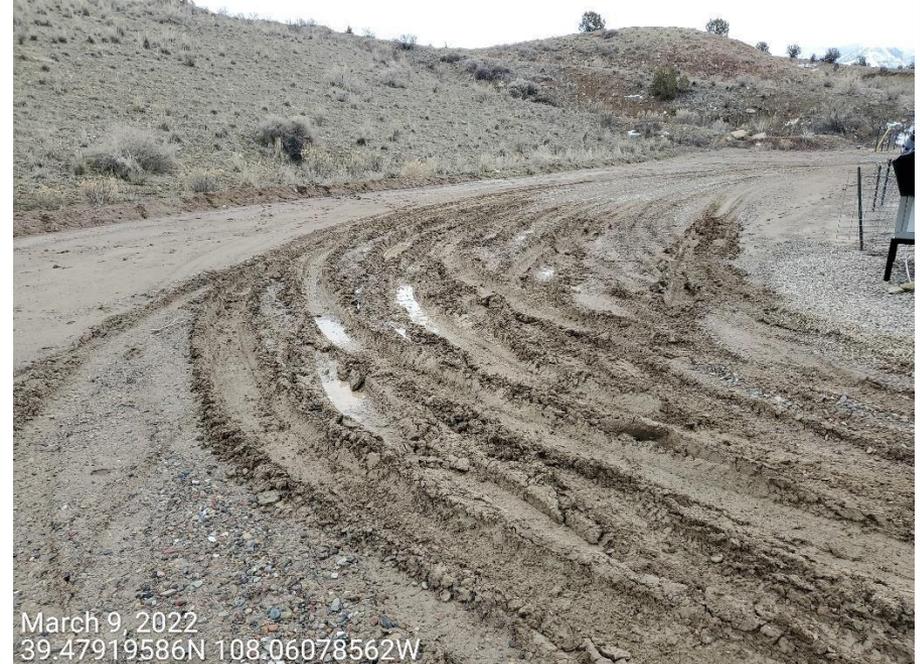
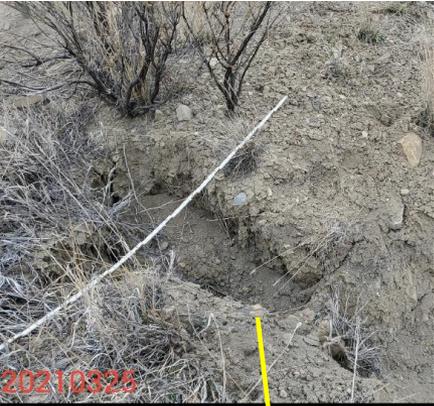
Photo 3: Photos taken from the working pad of the Location. Photos provide examples showing control measures to stabilize the working pad, minimize rutting, tracking and sediment transport remains missing or insufficient.

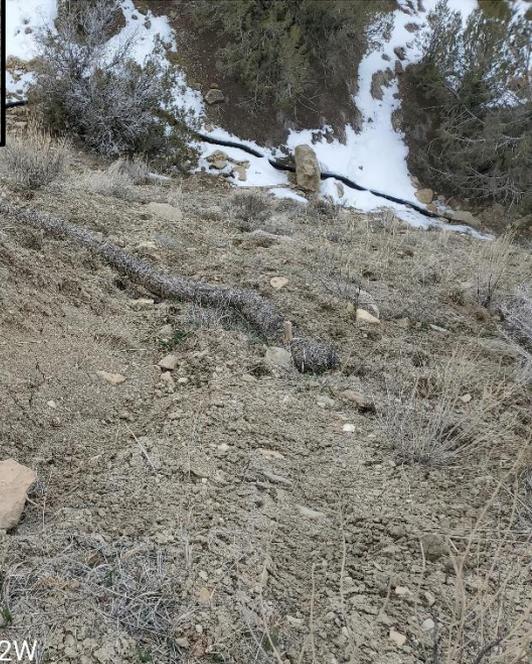
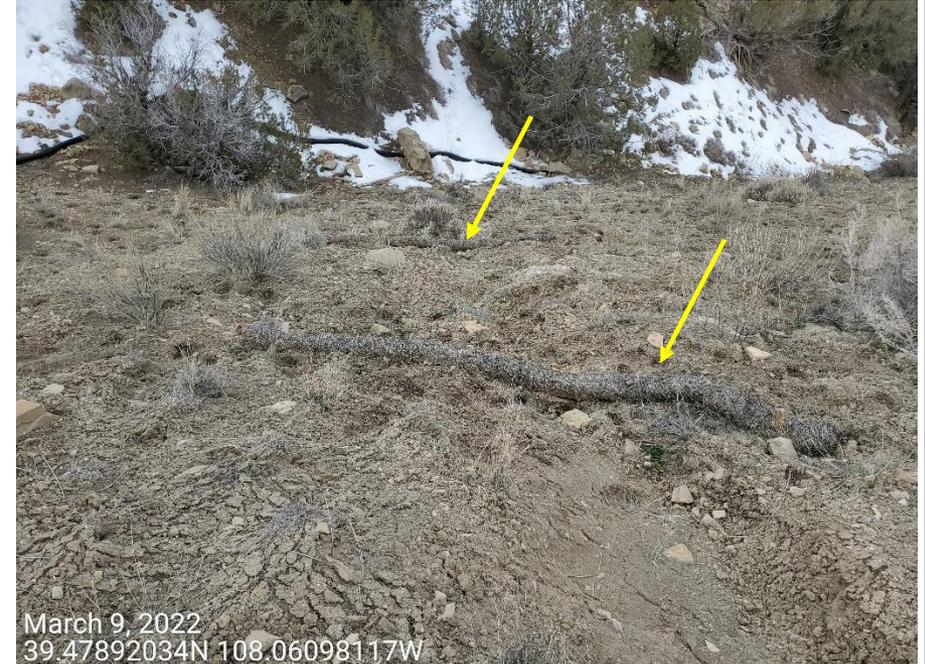
Photo 4: Photo taken from the slopes on the west end of the Location. Photos show erosion degradation documented in the 3/25/2021, 4/30/2021 and 6/10/2021 inspections. Operator appears to have placed two straw wattles within eroding areas of the slope, as well as a single large rock; controls are inadequate per good engineering practices to address stabilization and erosion degradation issues on the slope. Additionally, wattles do not appear to have been correctly installed (trenched and backfilled).

Controls measures to address the gully erosion, and to stabilize the remaining, unstabilized slopes of the Location remain missing or insufficient in accordance with good engineering practices.

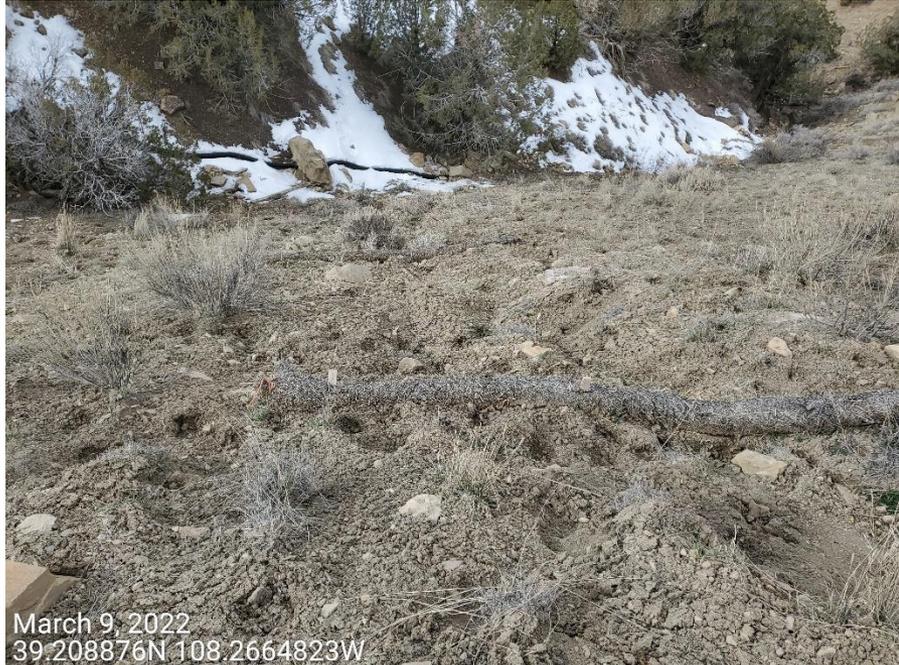
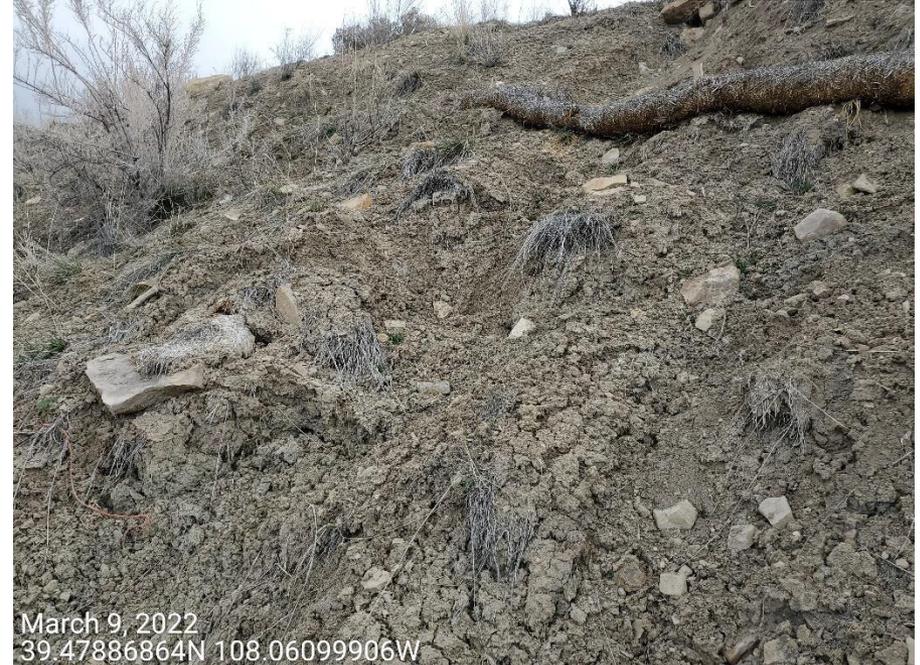
Photo 5: Photo taken from the slopes on the west end of the Location. Photos show erosion has persisted on the slopes. Photos also show the two straw wattles placed by Operator within areas of the erosion; controls are inadequate per good engineering practices to address stabilization and erosion degradation issues on the slope. Additionally, wattles do not appear to have been correctly installed (trenched and backfilled), and stormwater has cut beneath sections of the wattles.

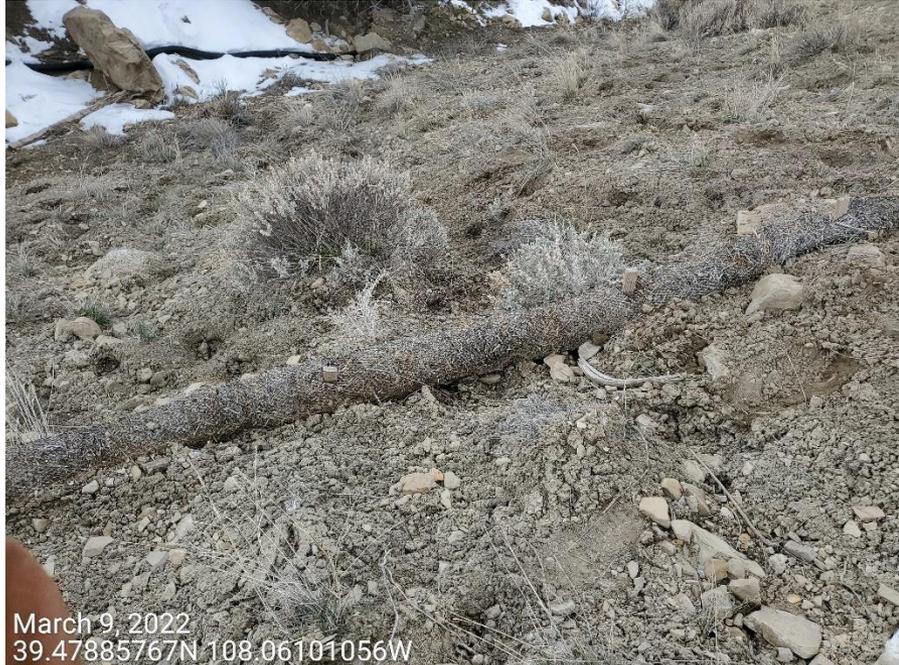
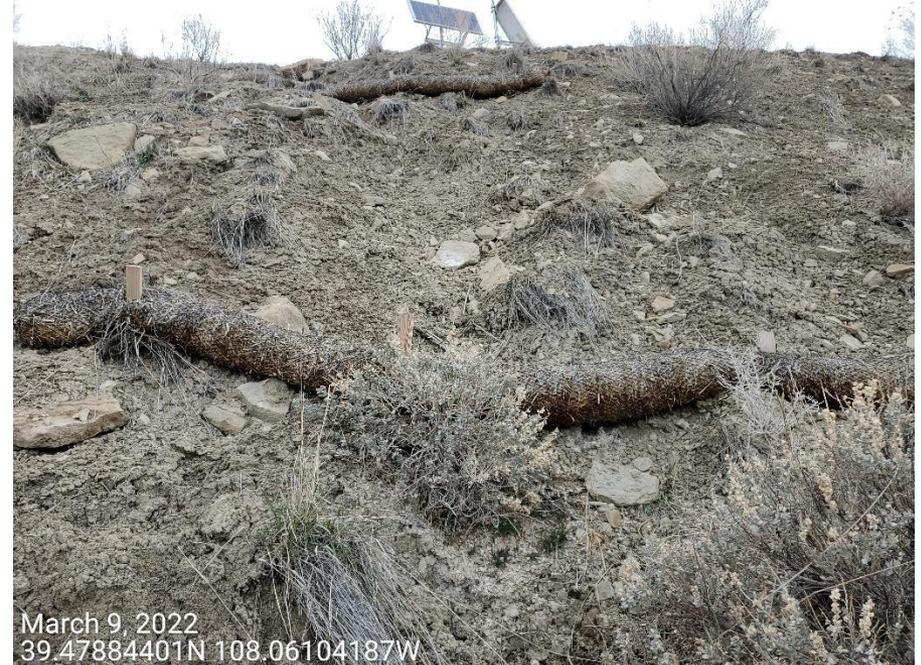
Photo 6: See comments under photo 5.

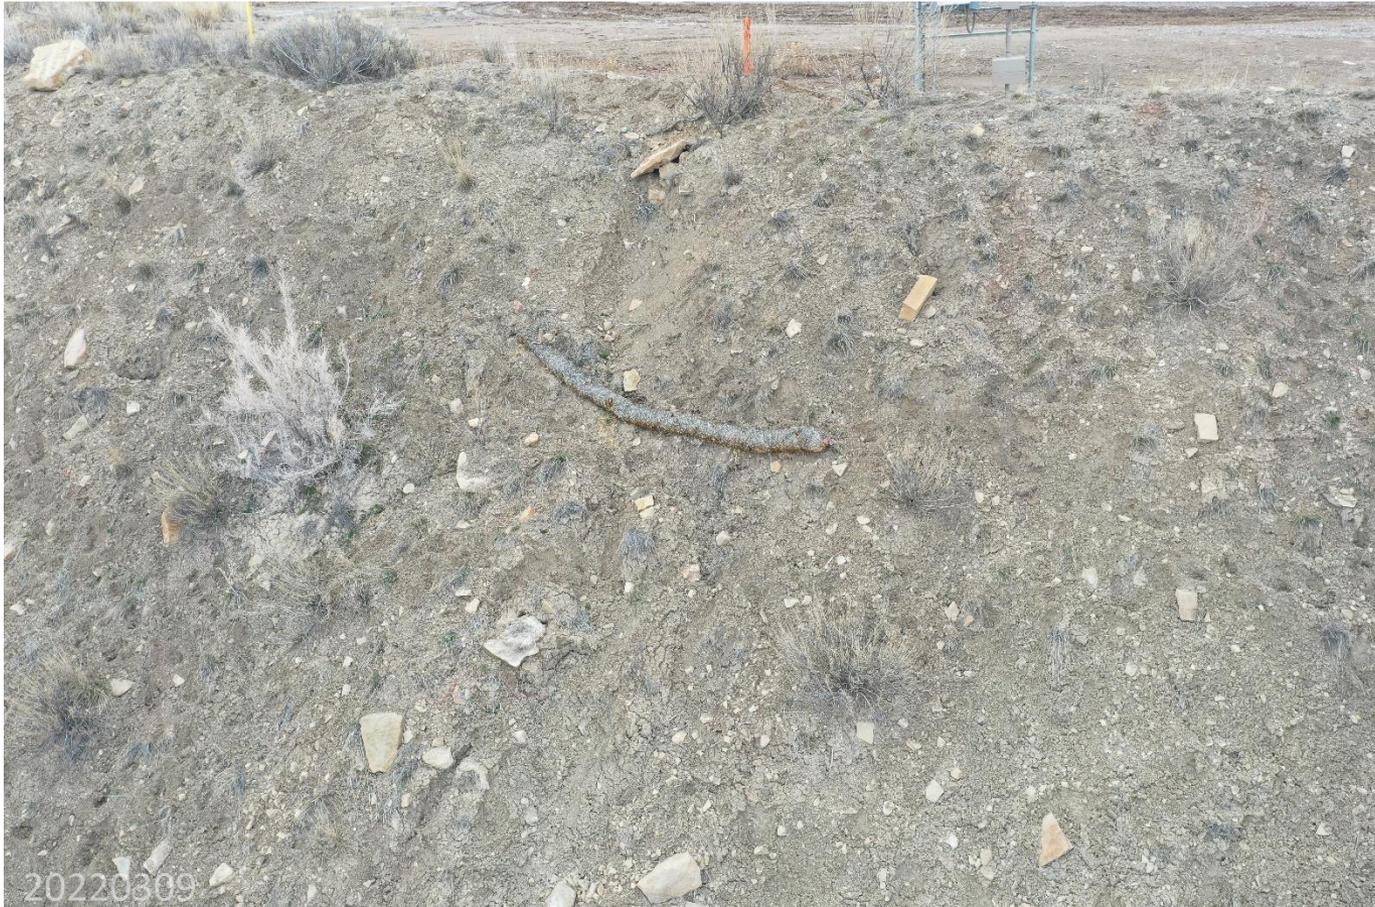
Photo 7: See comments under photo 5. Photo also shows slopes remain predominantly bare and unstabilized soils; slopes lack long-term stabilization and prior seeding efforts have been insufficient; control measures to protect and stabilize slopes remain missing or insufficient.

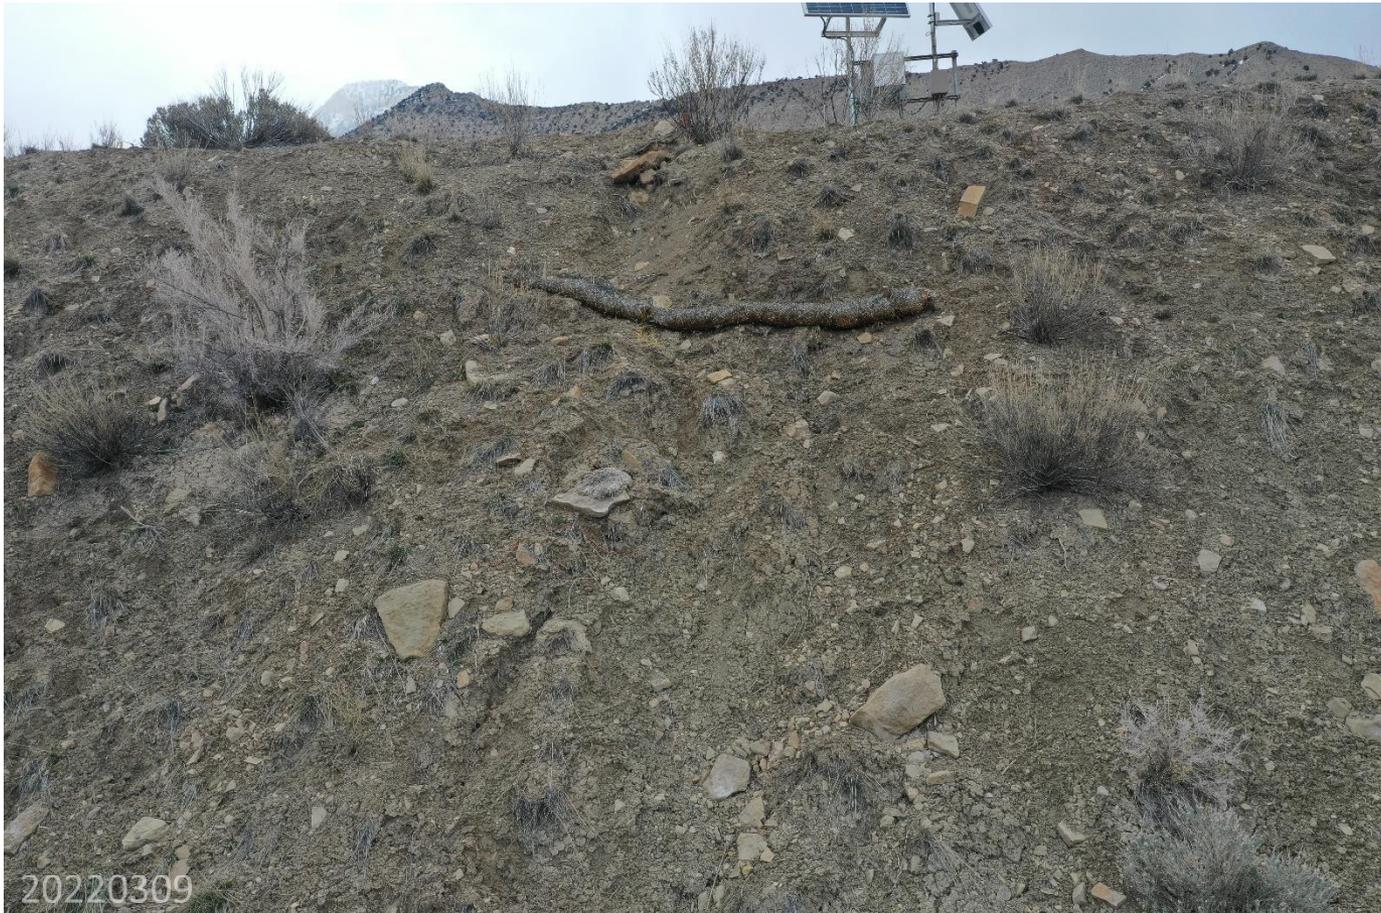
Photo 8: Photo taken with use of a sUAS. Photo taken from northwest end of the Location, facing southeast. Photo provides an overview of the Location showing control measures to stabilize the working pad, minimize rutting, tracking and sediment transport remains missing or insufficient.

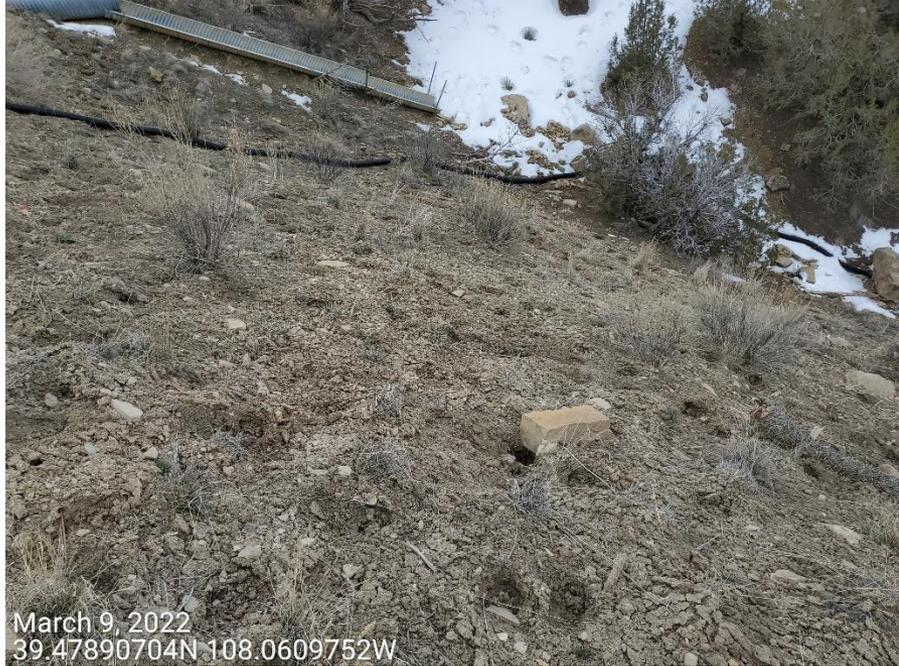
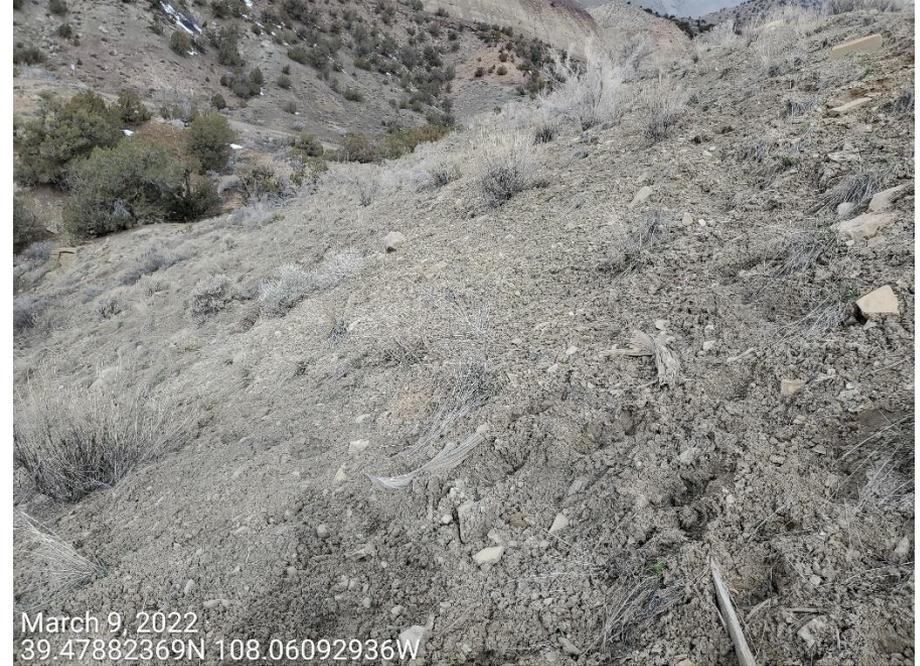
Photo 9: Photo taken from the slopes on the west end of the Location. Photos show slopes remain predominantly bare and unstabilized soils; slopes lack long-term stabilization and prior seeding efforts have been insufficient; control measures to protect and stabilize slopes remain missing or insufficient.
