Collection Station 29,
facility ID 117365 and 117285
Inspection Date: 3/8/2022
All Photos taken by Kris Neidel

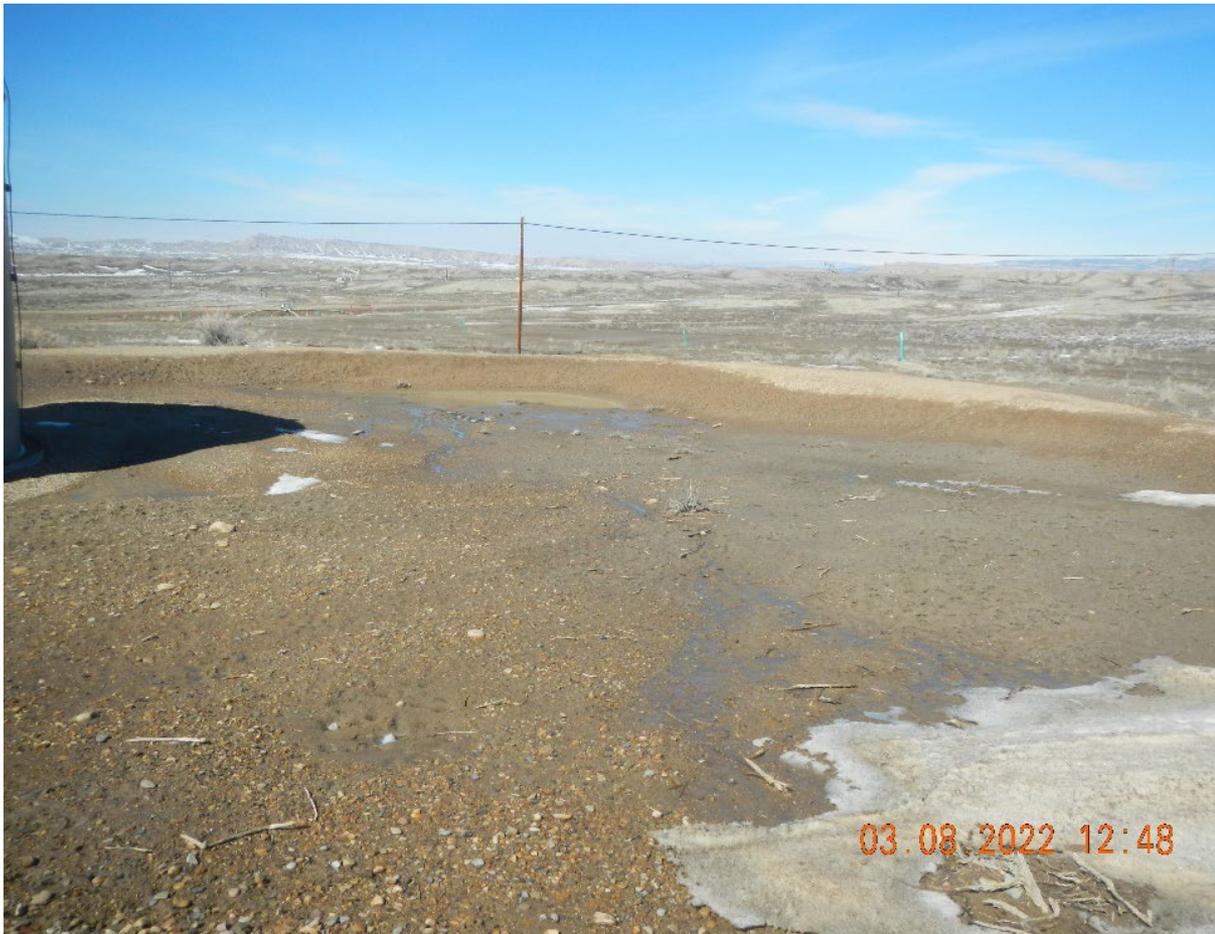
Photo #3 Secondary containment area, of photo#2

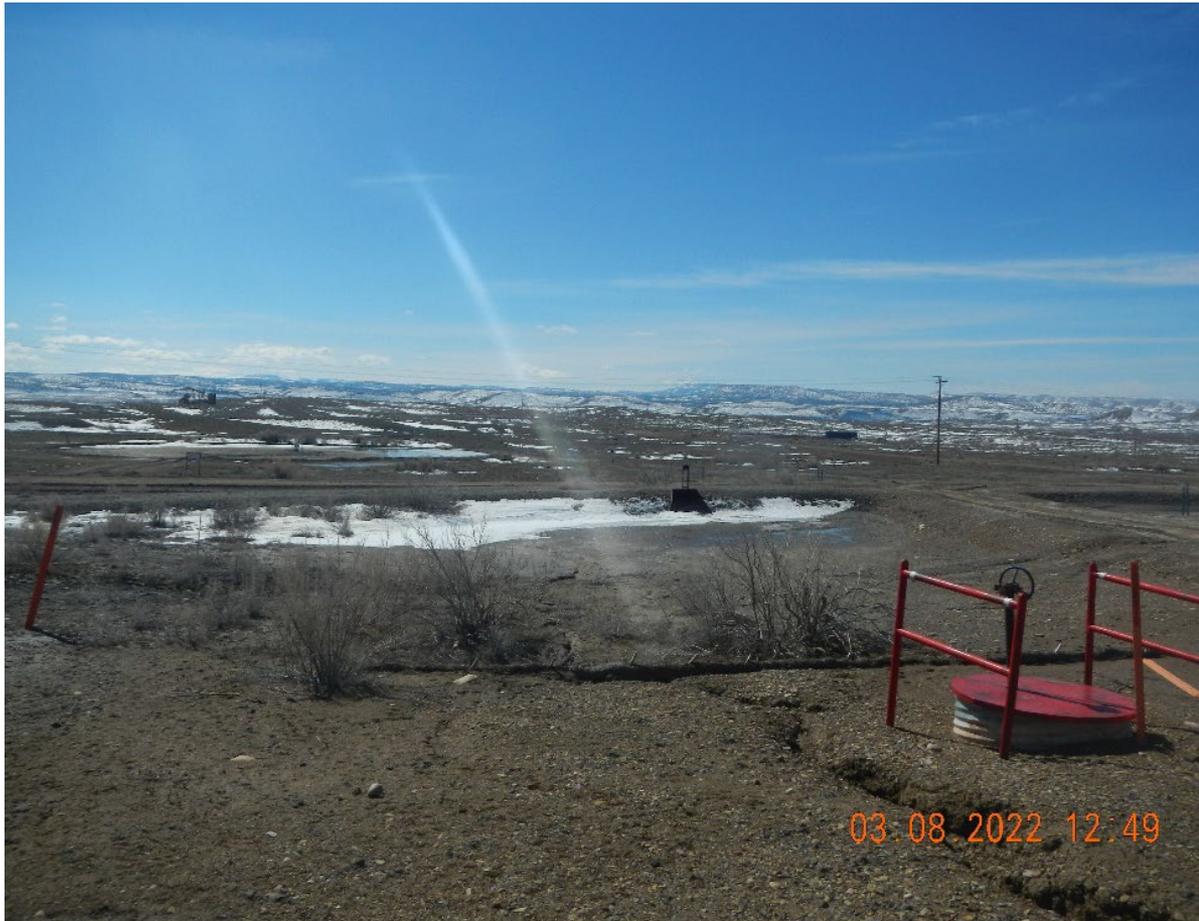
Photo #4 stormwater feature. It appeared the gate was closed. It was too muddy to walk down.

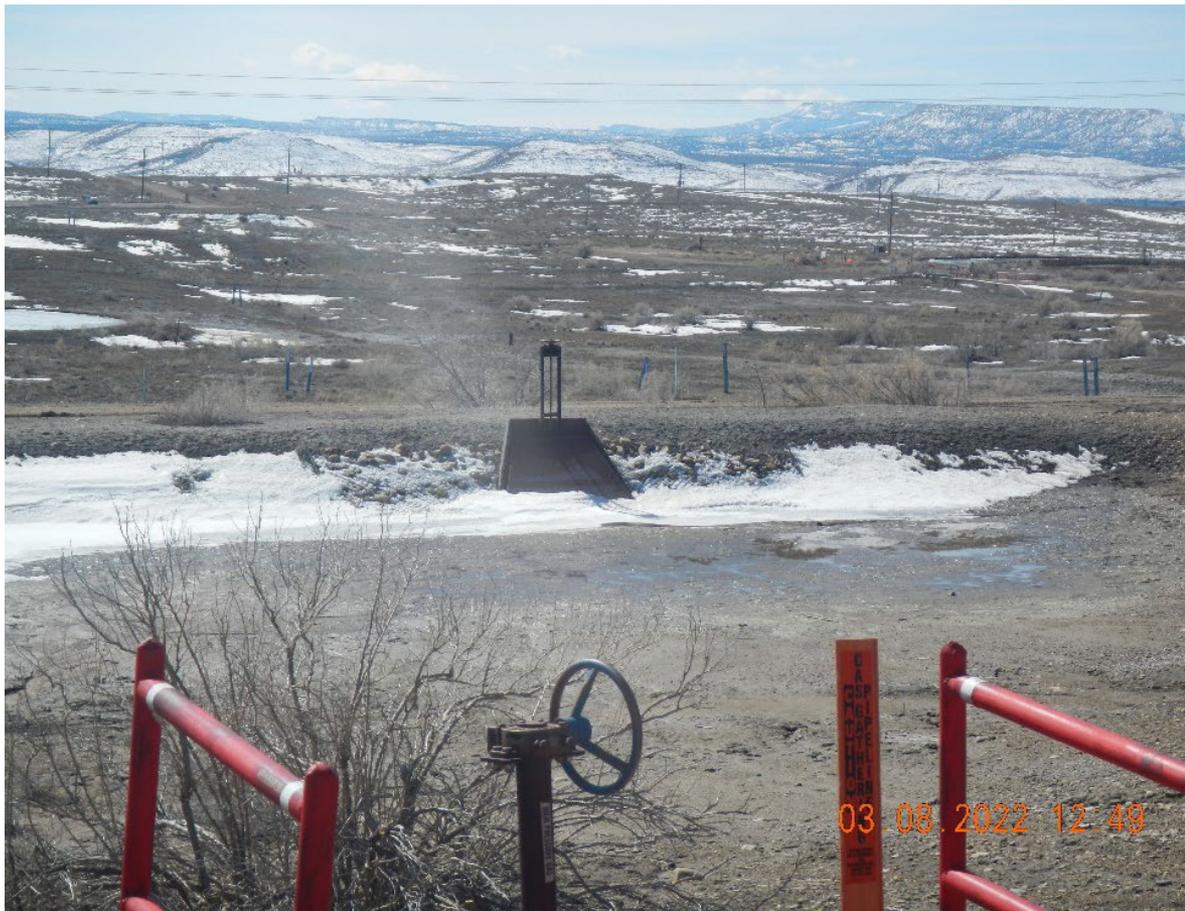
Photo#5 close-up of photo #4
