## Inspection Photos

Location Name: TEP ROCKY MOUNTAIN LLC PA-66S95W /34NESW

Location ID: 335299

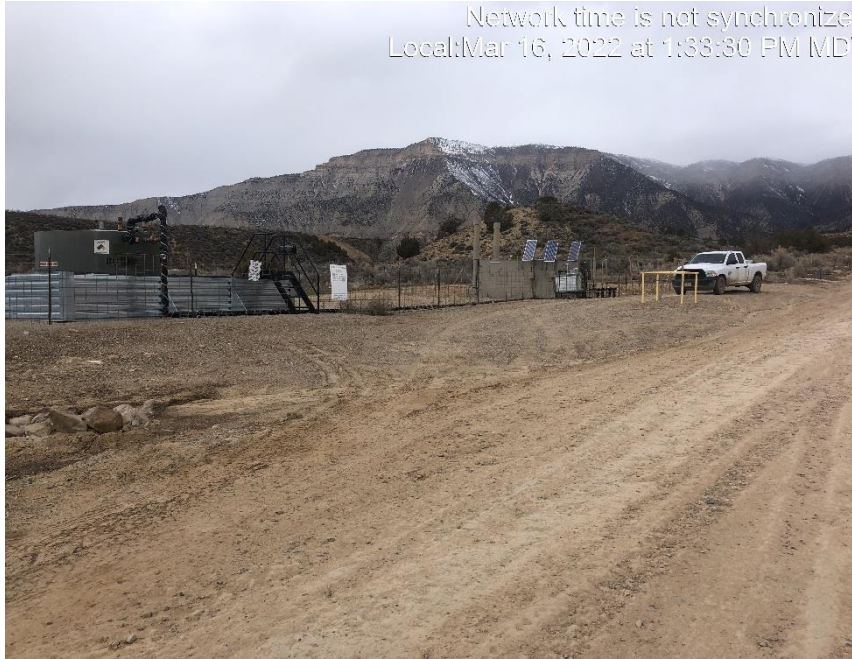
Photo #6175 from entrance to location.

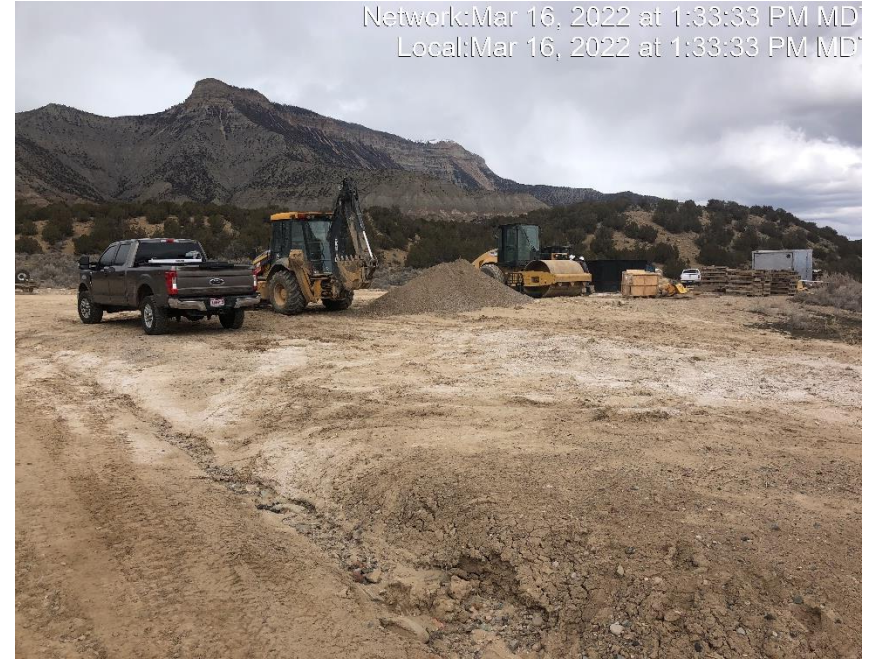
Photo #6176 from entrance to location.

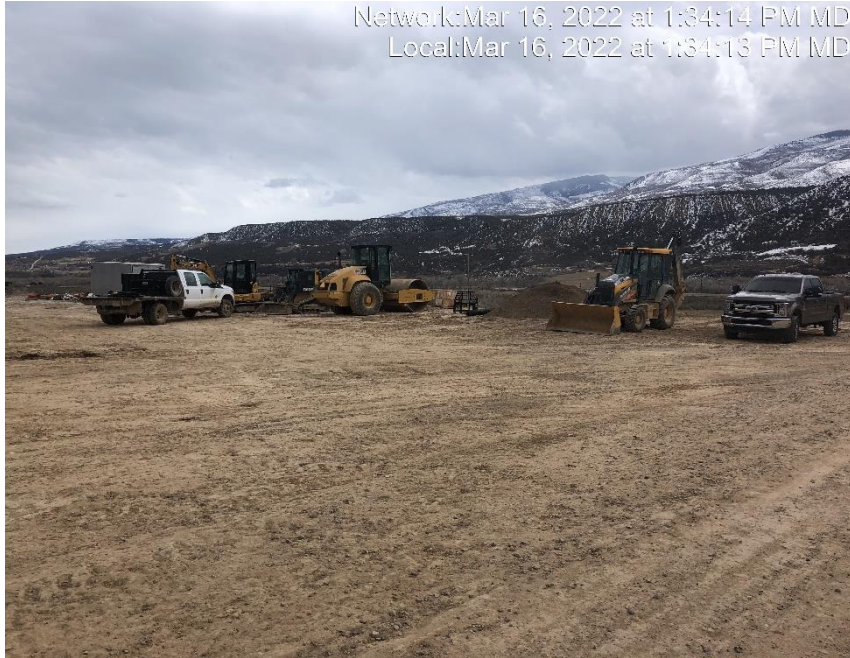
Photo #6177 from entrance to location.

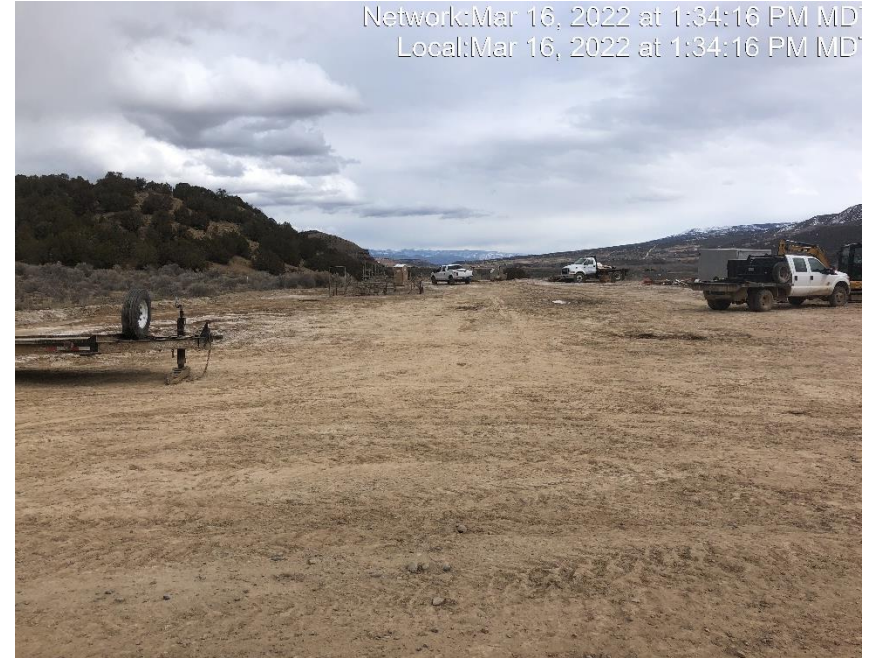
Photo #6178 from entrance to location.

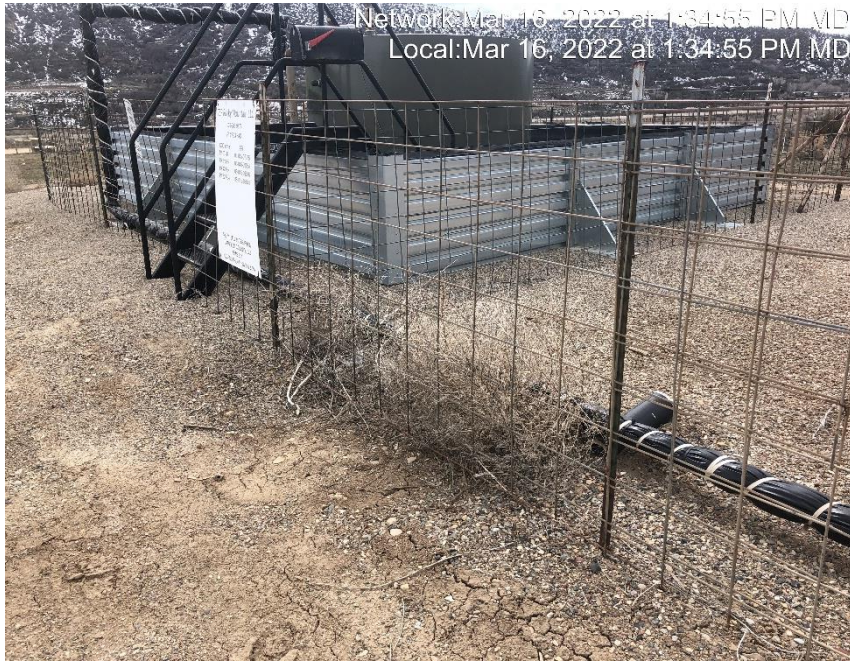
Photo #6179 Multiple places with debris on location.

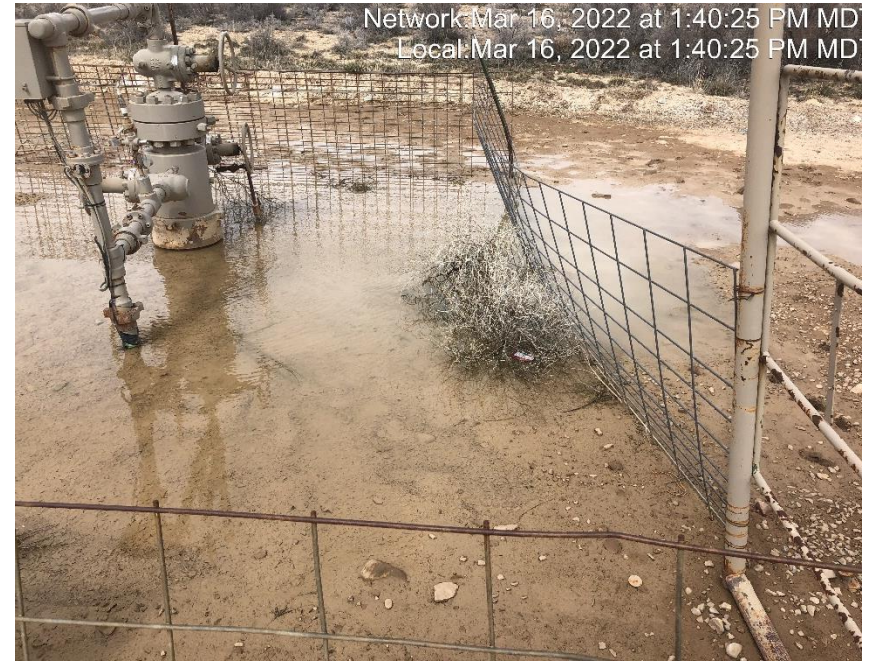
Photo #6190 Multiple places with debris on location.

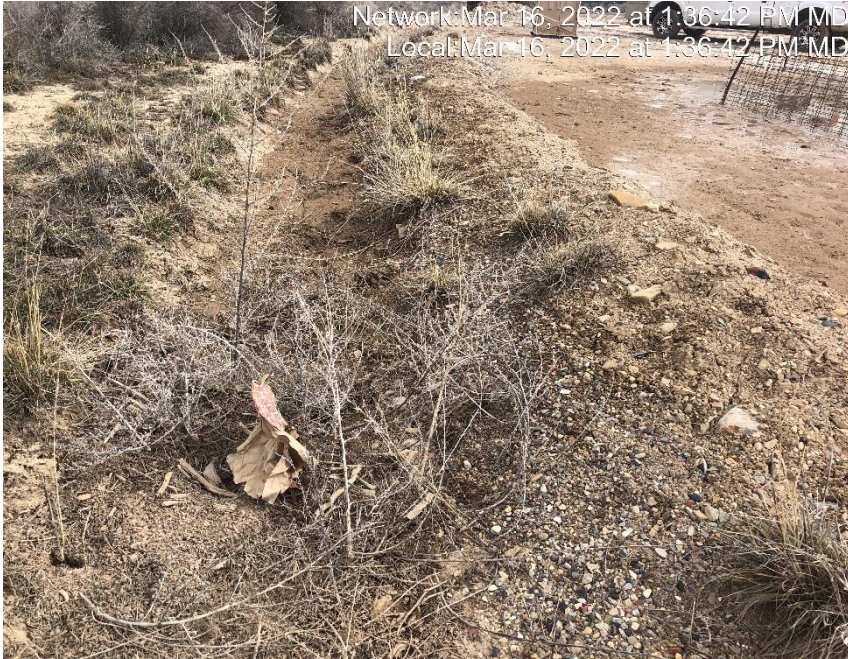
**Photo #6182 Multiple places with trash on location.**

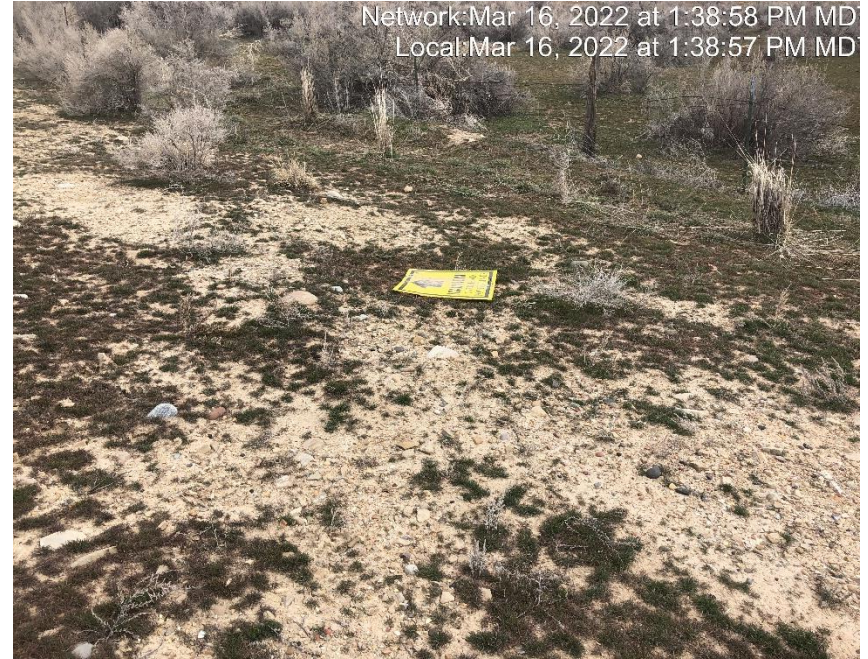
**Photo #6186 Multiple places with trash on location.**

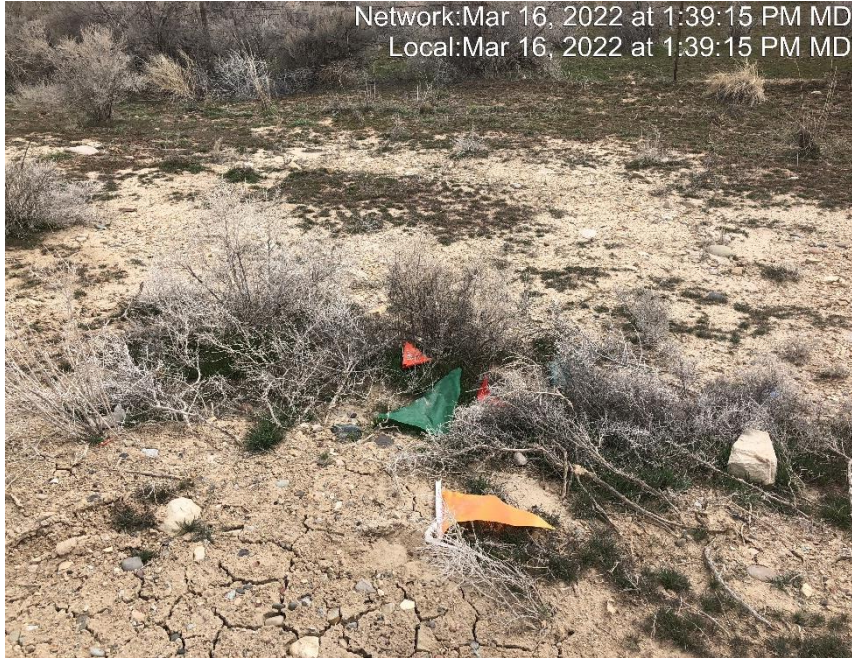
**Photo #6187 Multiple places with trash on location.**

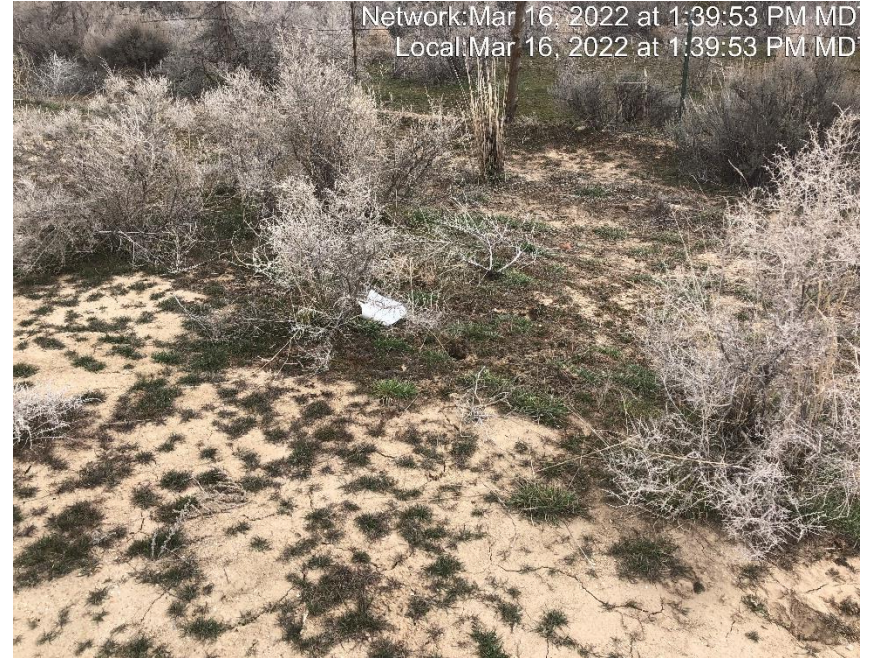
**Photo #6189 Multiple places with trash on location.**

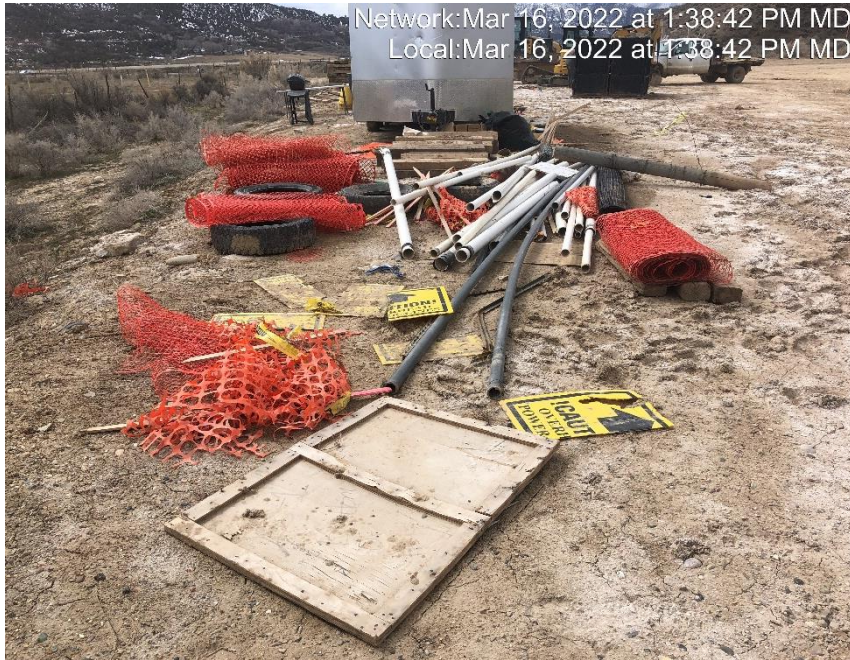
**Photo #6185** Multiple places with equipment and stored supplies on location.

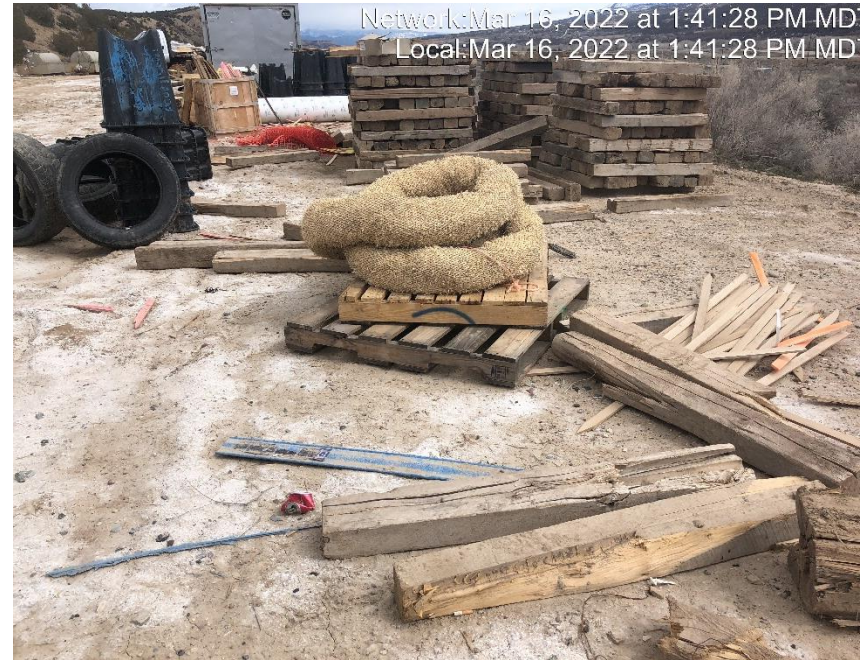
**Photo #6192** Multiple places with equipment and stored supplies on location

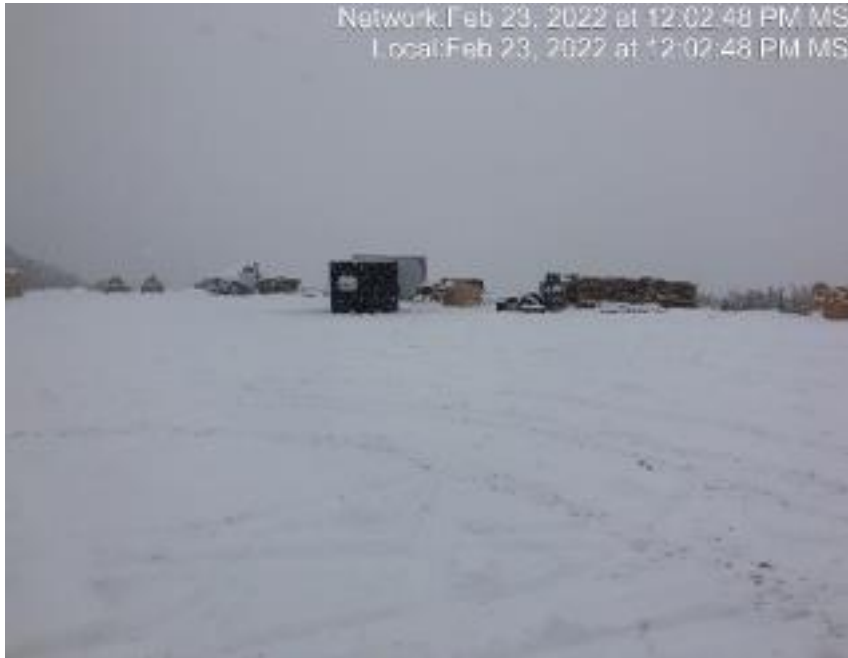
Photo #6003 from inspection #699804184 conducted on 2/24/22.

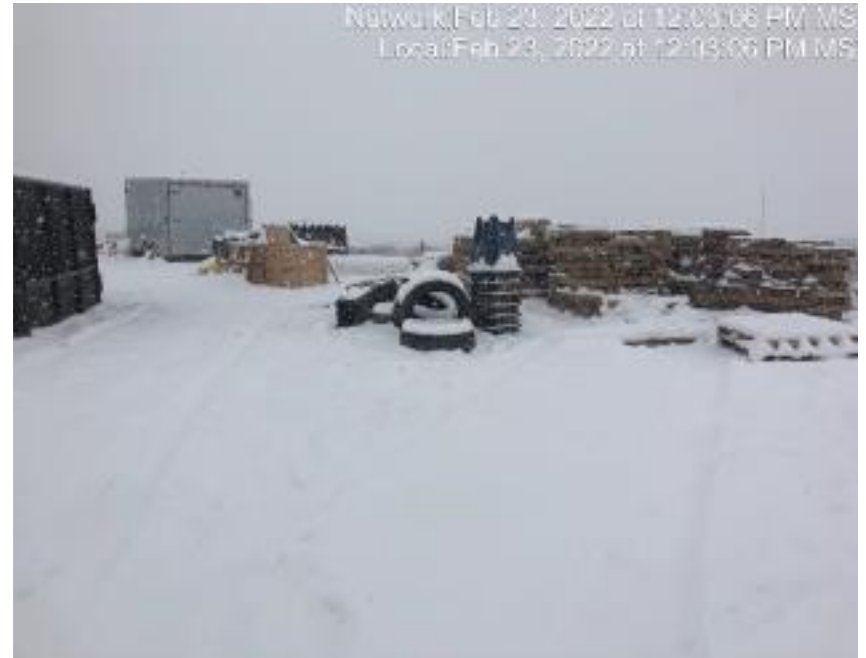
Photo #6004 from inspection #699804184 conducted on 2/24/22.

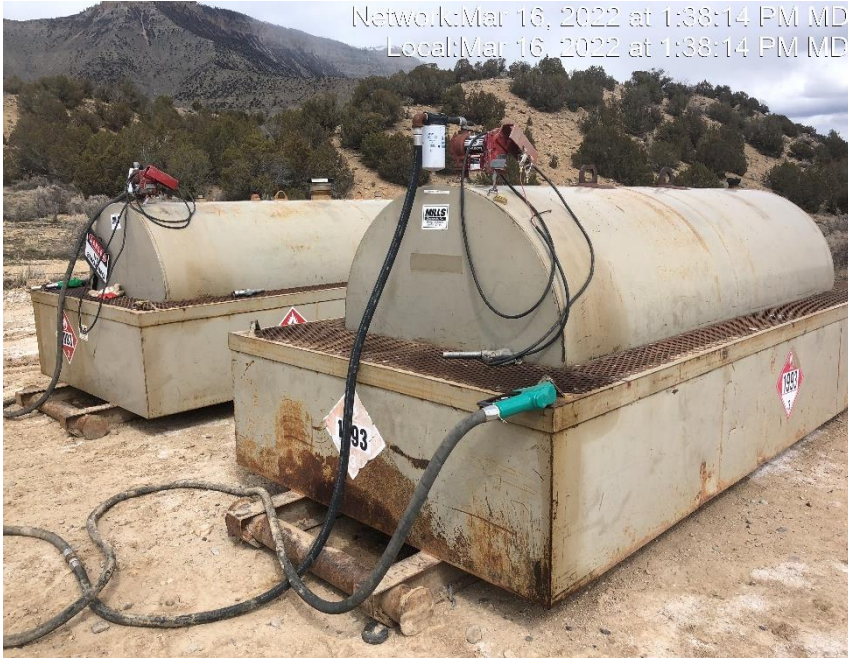
**Photo #6184 Tanks missing required information.**

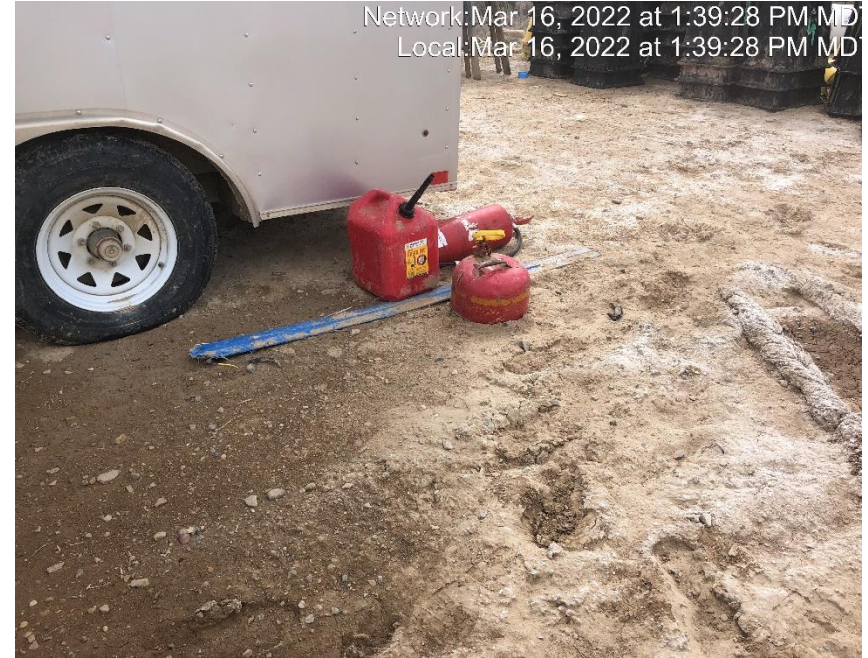
**Photo #6188 Material handling and spill prevention BMP's have not been implemented.**

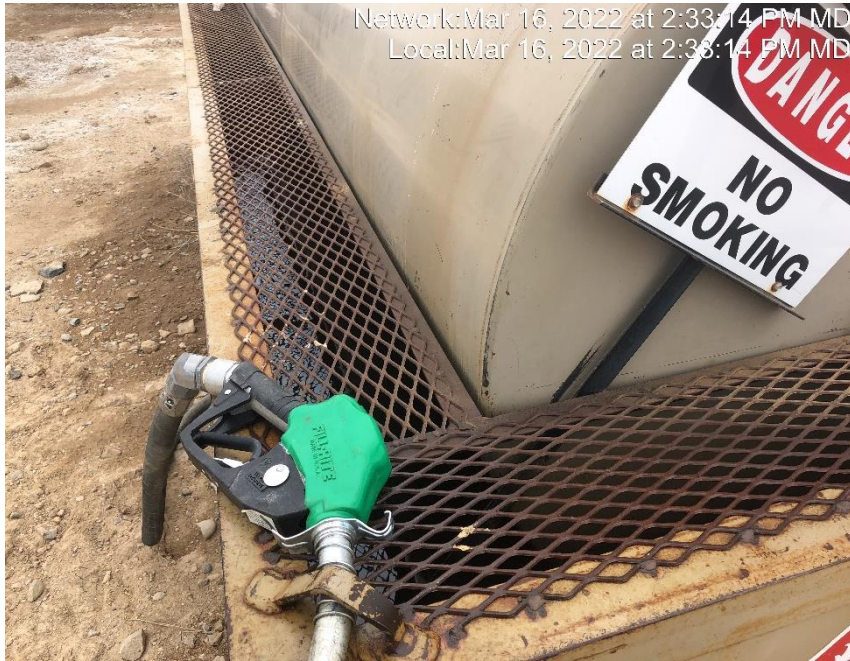
**Photo #6204 . Insufficient maintenance of material handling and spill prevention BMP's. Containment full of an unknown fluid.**

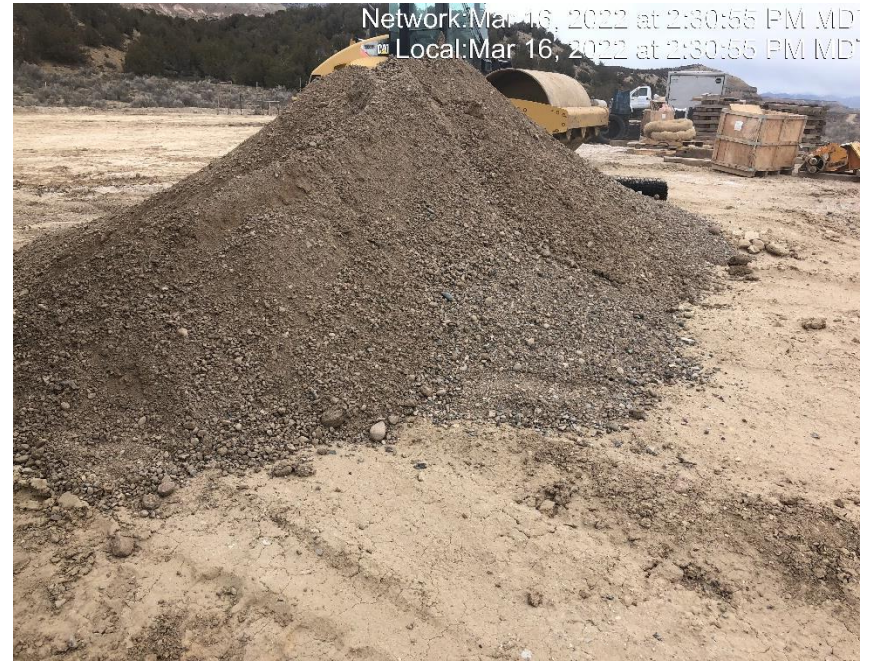
**Photo #6202 Insufficient materials covering and BMP implementation.**

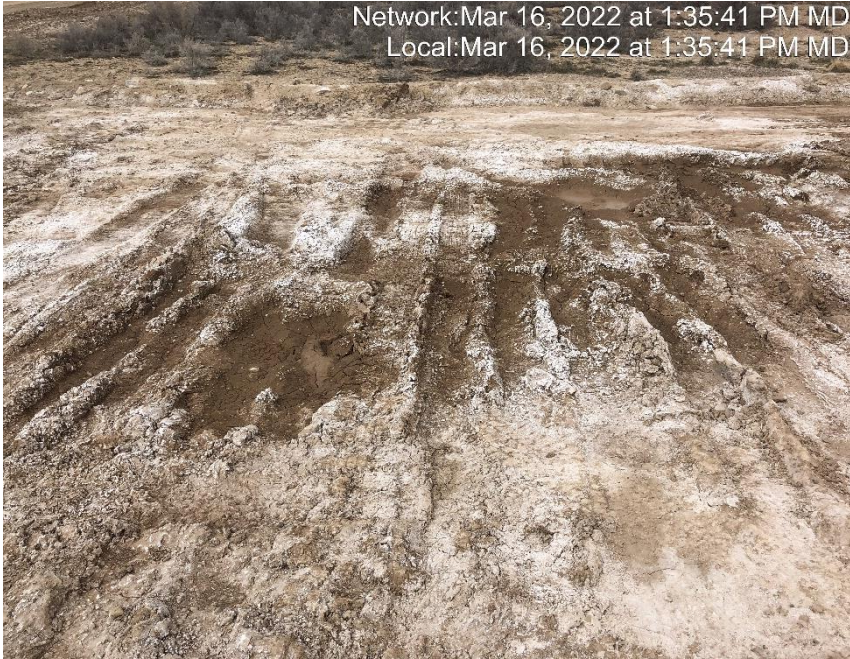
**Photo #6180 Location lacks stabilization.**

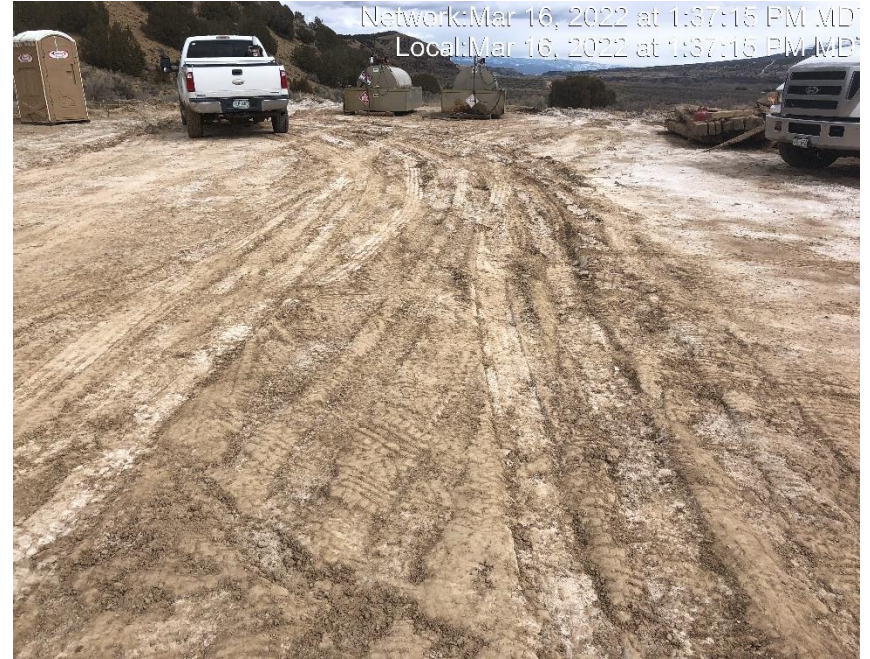
**Photo #6183 Location lacks stabilization.**

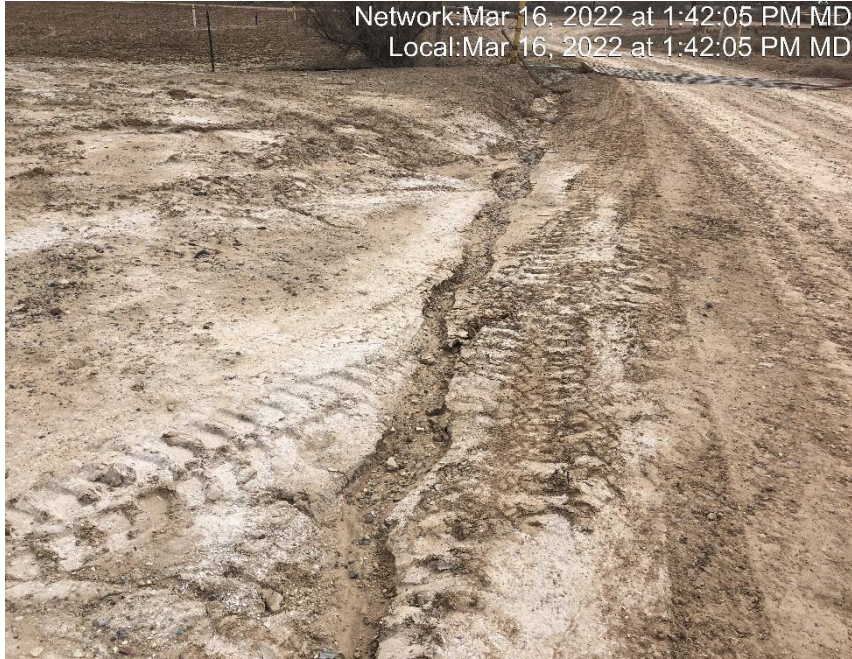
**Photo #6193 Rill erosion occurring on location.**

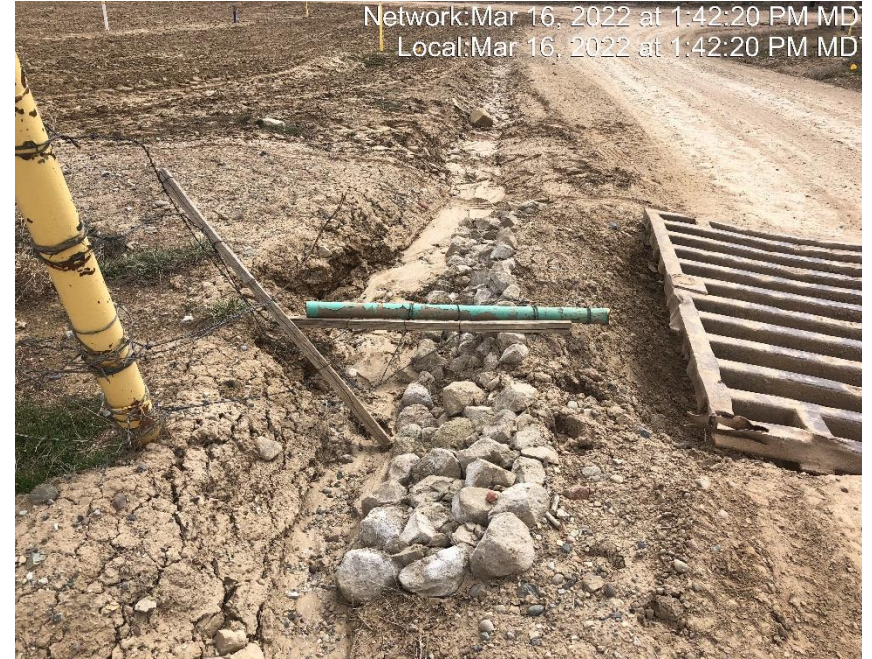
**Photo #6194 Sediment trap insufficient.**

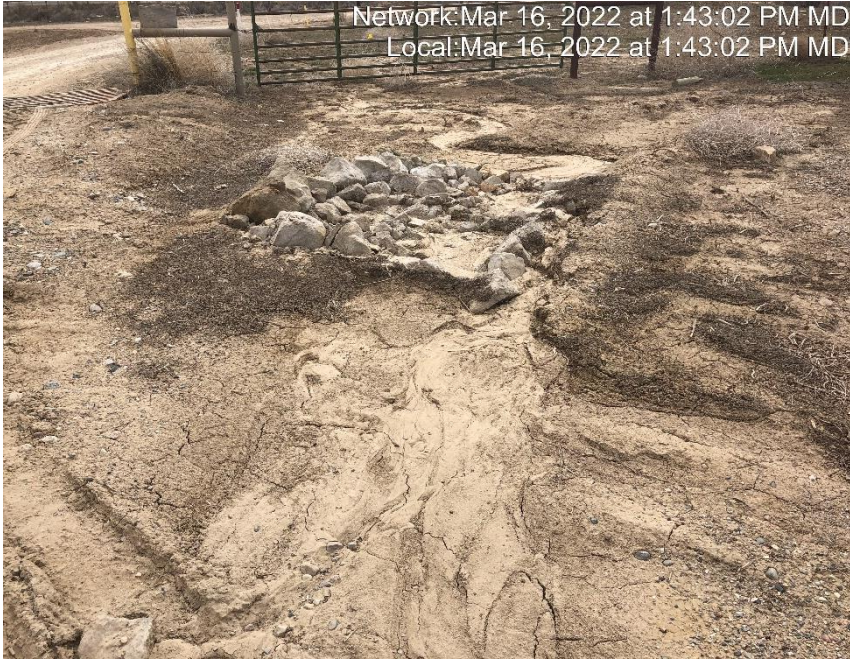
**Photo #6195 Sediment trap insufficient.**

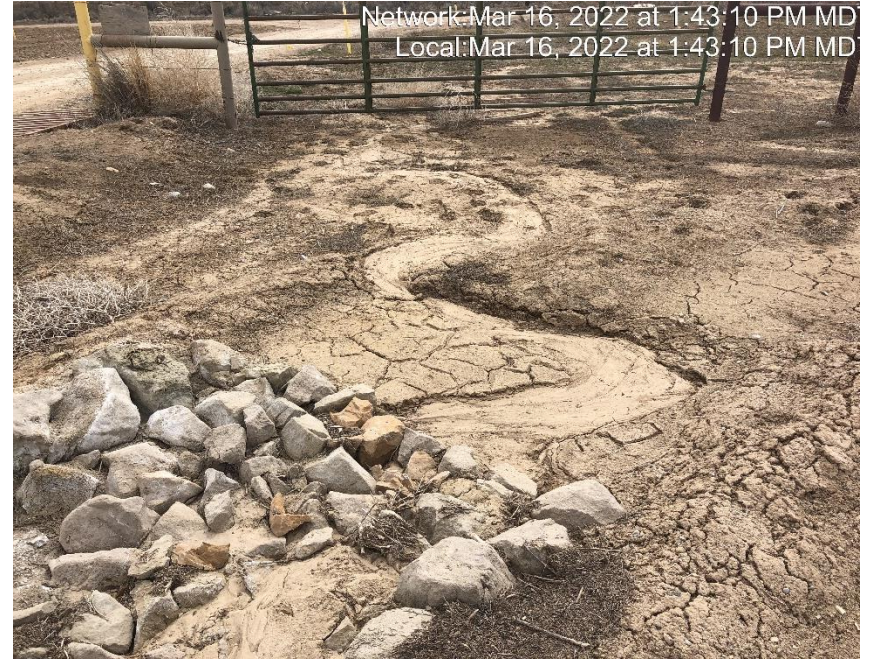
**Photo #6196 sediment trap insufficient.**

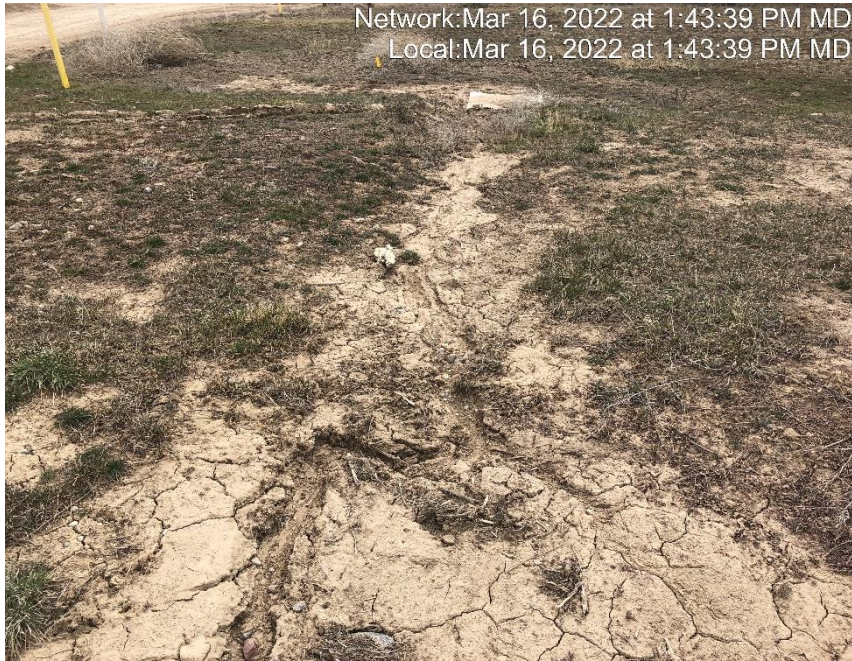
**Photo #6197 Sediment migration continued. Trash has been transported off location.**

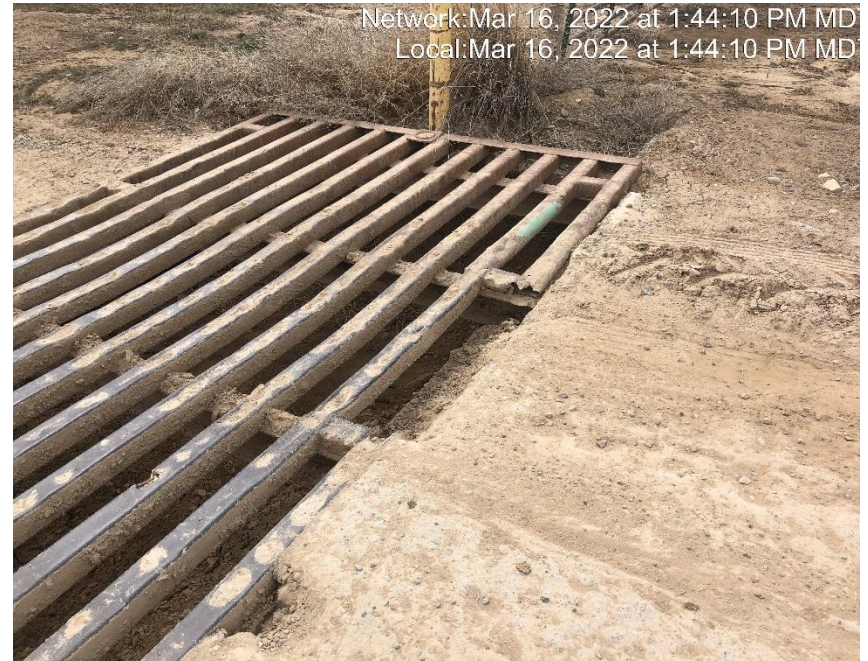
**Photo #6199 Insufficient tracking BMP at entrance to location.**

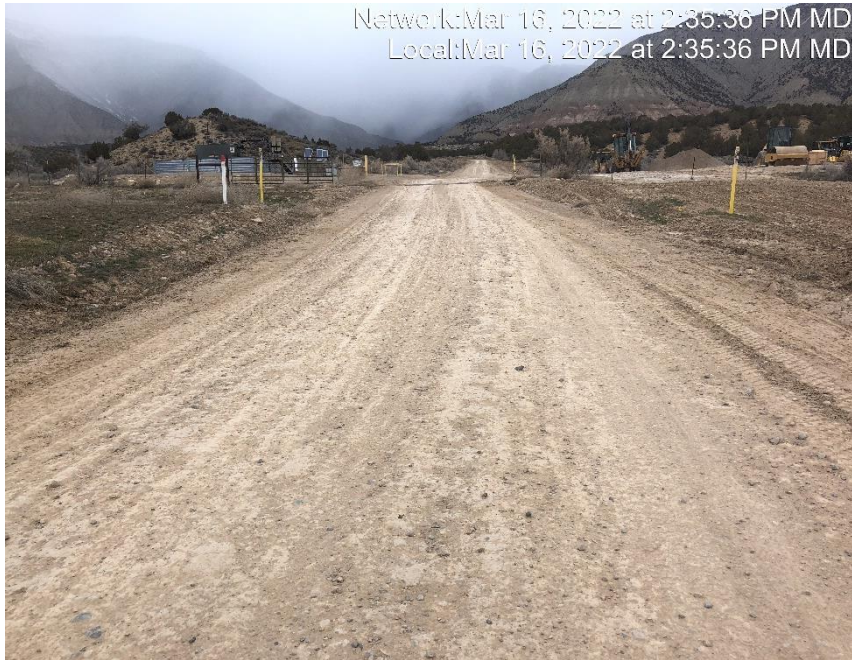
**Photo #6205 Insufficient tracking BMP at entrance to location.**
