Inspection Photos

Location Name: TEP ROCKY MOUNTAIN LLC PUCKETT/TOSCO /PA 443-34

Location ID: 428684

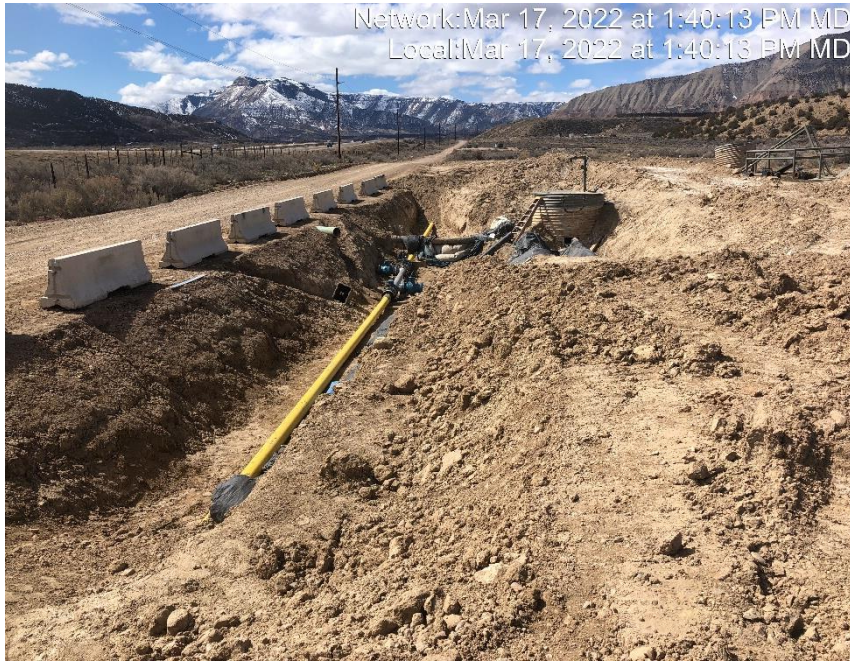
Photo #6227 Pipeline right of way.

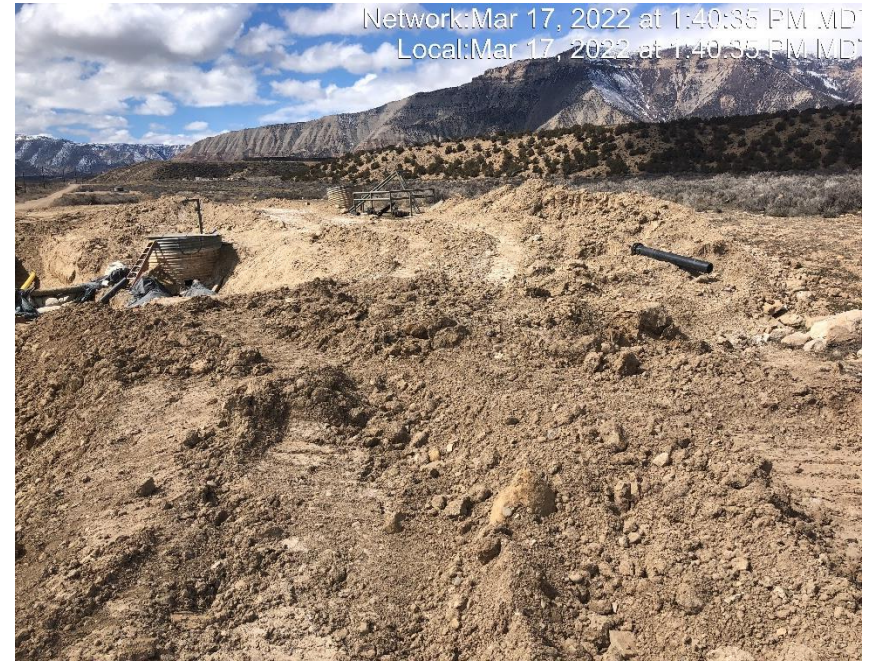
Photo #6228 Pipeline right of way.

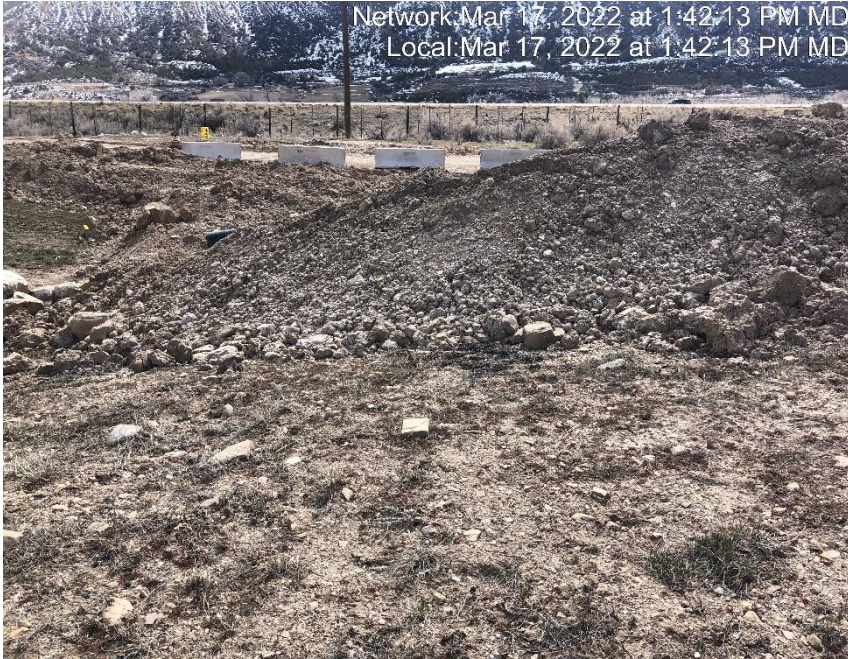
Photo #6233 Insufficient materials covering and BMP implementation.

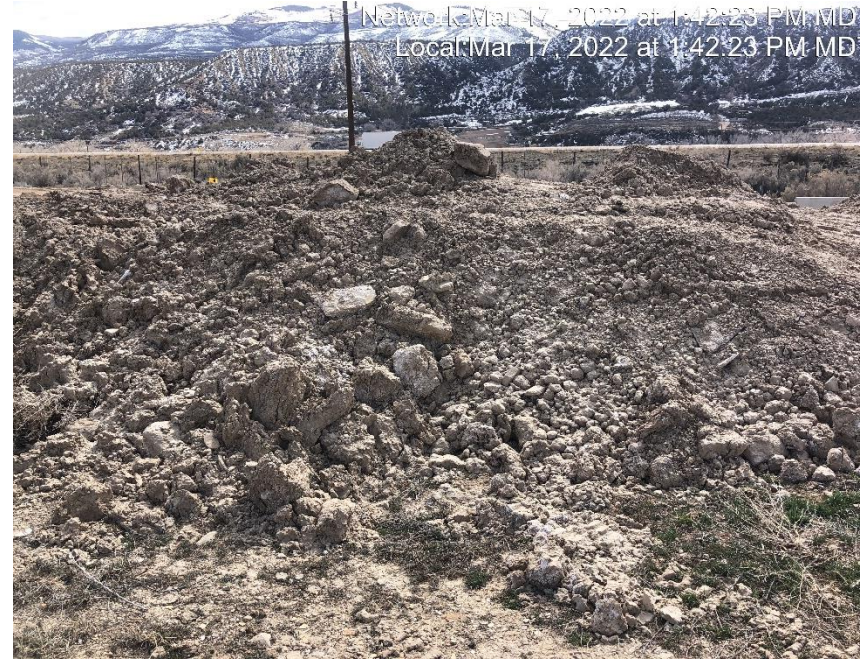
Photo #6234 Insufficient materials covering and BMP implementation

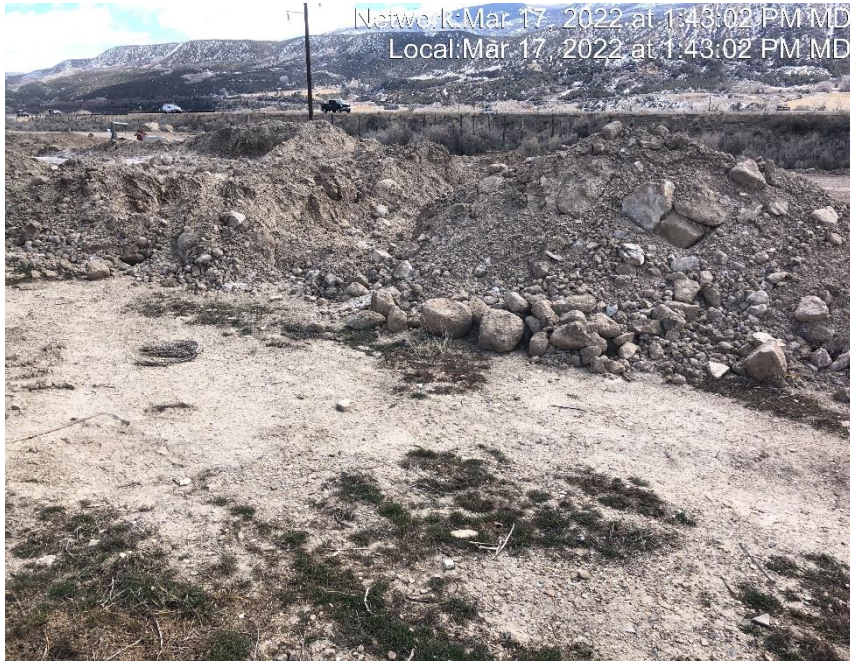
Photo #6235 Insufficient materials covering and BMP implementation.

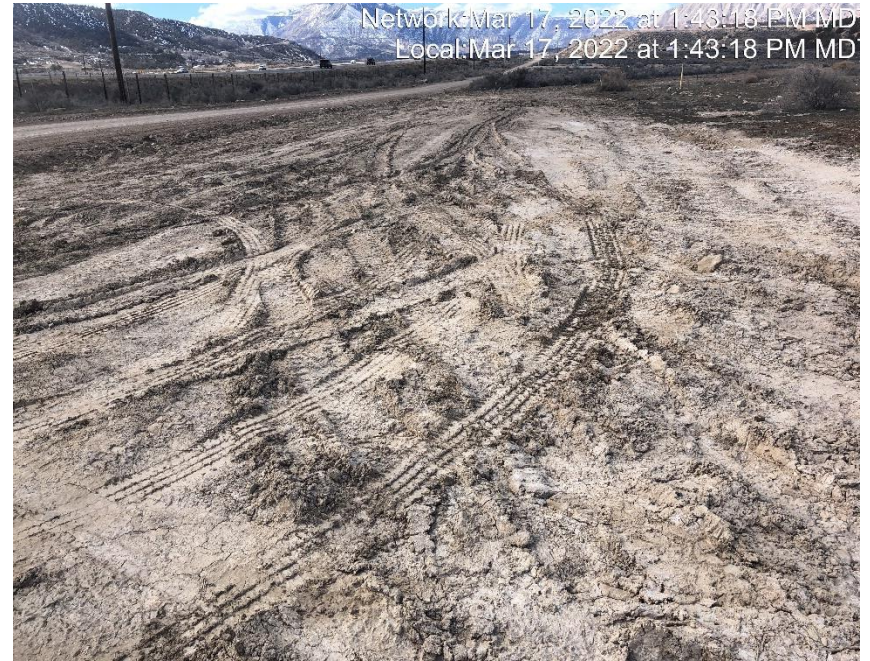
Photo #6236 Pipeline right of way lacks stabilization.

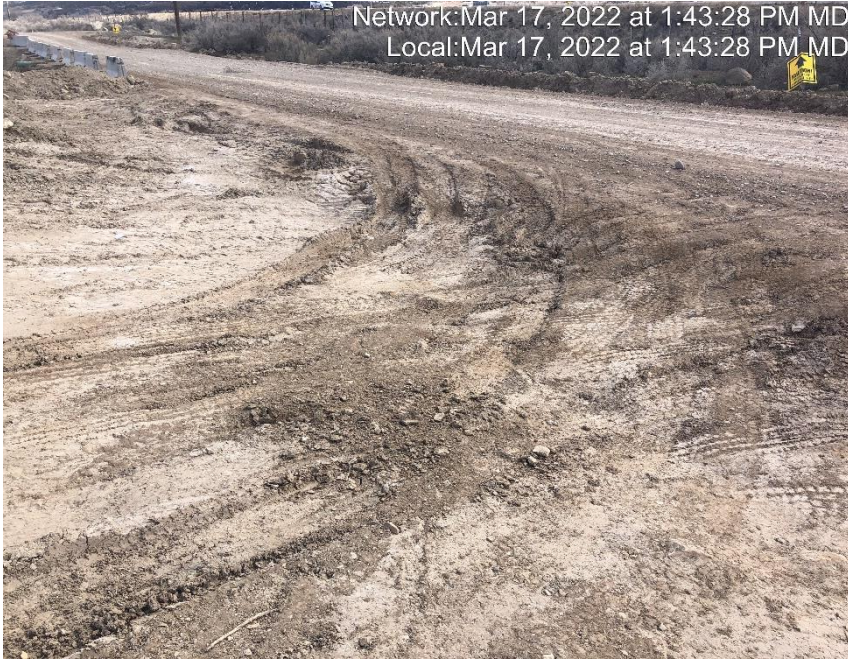
Photo #6237 Insufficient tracking BMP's from pipe line right of way to access road.

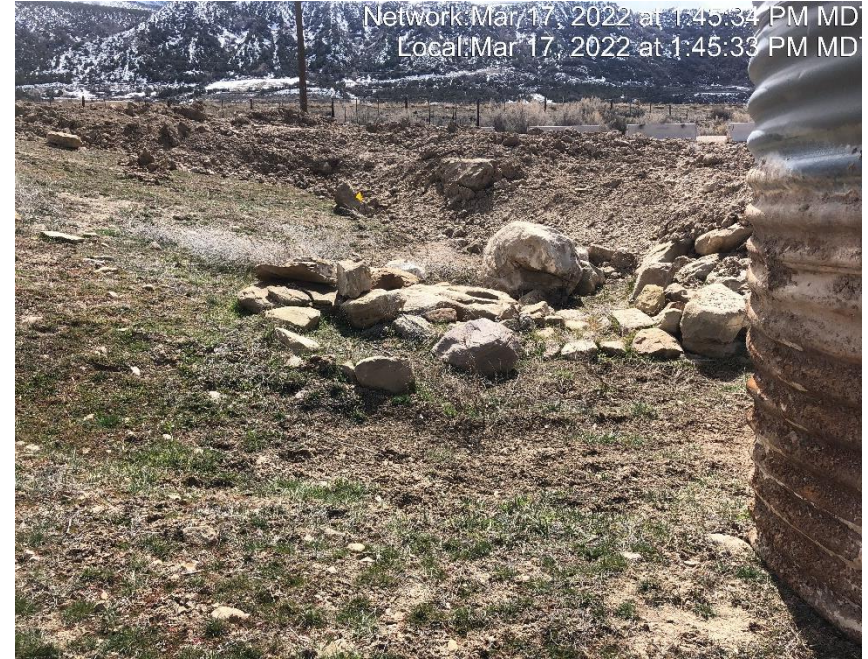
Photo #6240 Drainage blocked by dirt pile.
