# Inspection Photos

March 15, 2022

Location Name: Gentry-66S92W /17SESE

Inspection Document #: 702800045

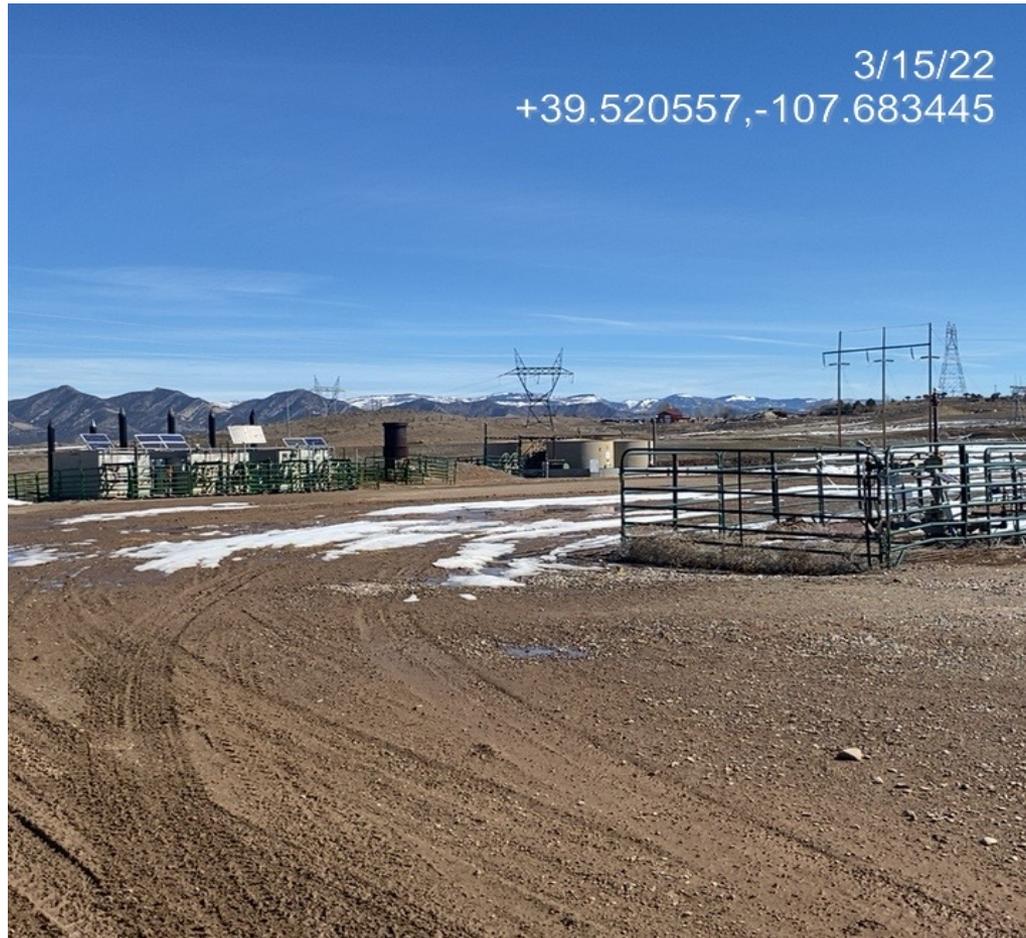
**Photo 1.** Photo taken from the Location entrance facing northeast shows an overview of the Location.

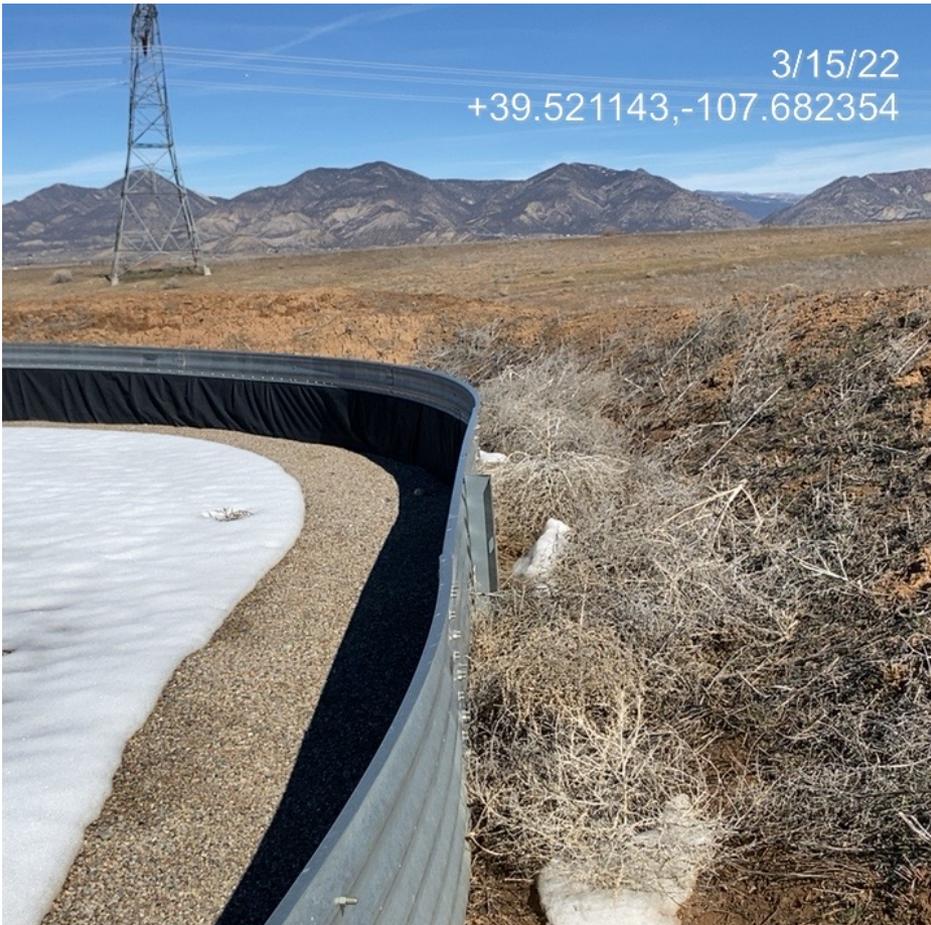
**Photo 2.** Photo taken from the north of the Location facing north shows undesirable plant species/weed debris accumulating in production areas.

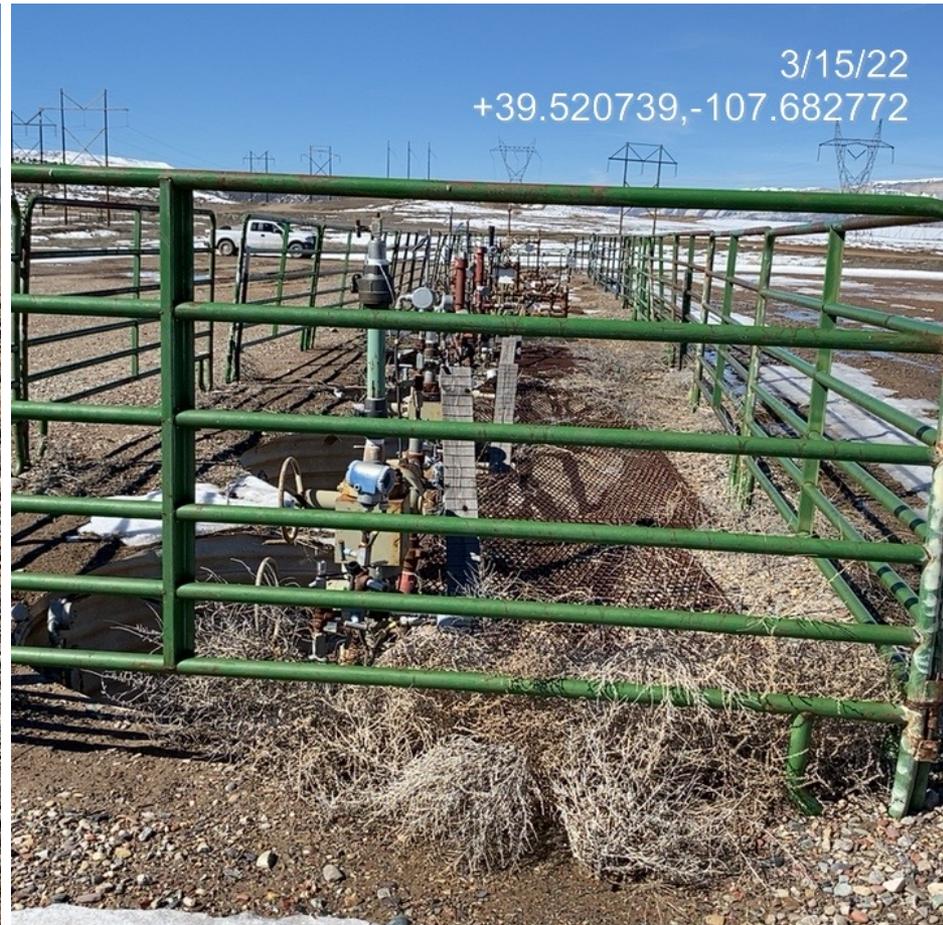
**Photo 3.** Photo taken from the well equipment facing west shows undesirable plant species/weed debris accumulating in production areas.

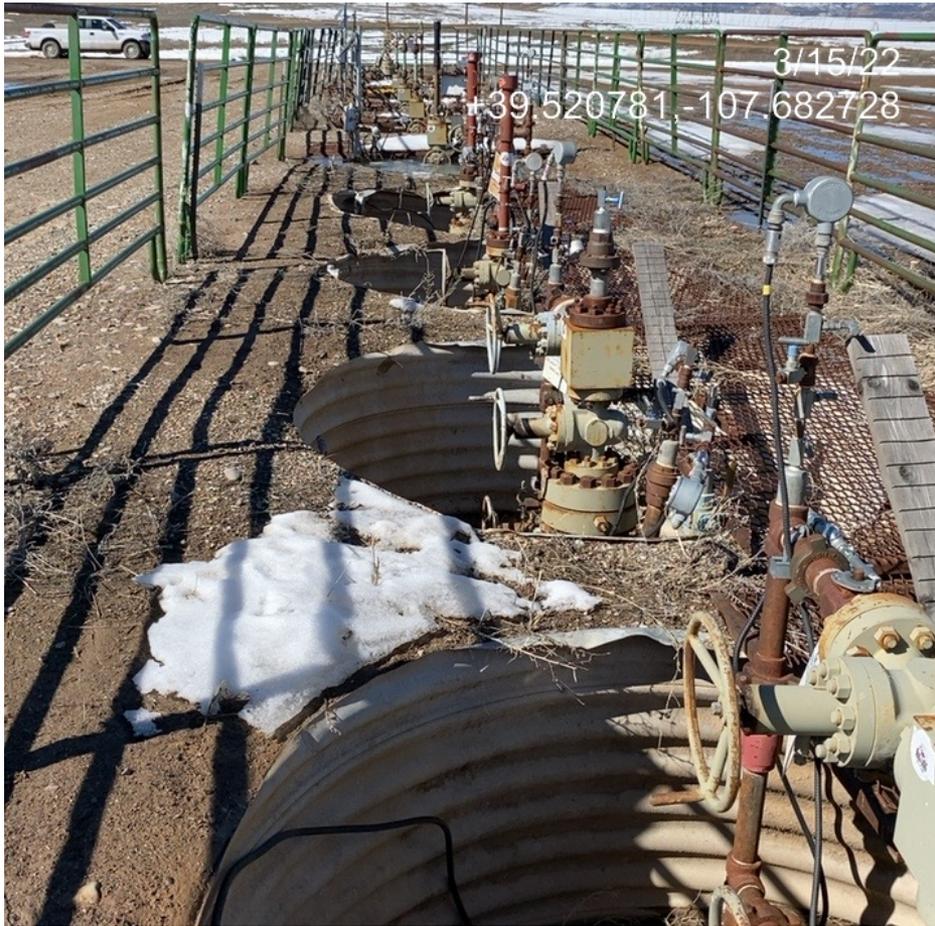
**Photo 4.** Photo taken from the well equipment facing west shows BMPs to prevent wildlife access to the well cellars were missing or insufficient.

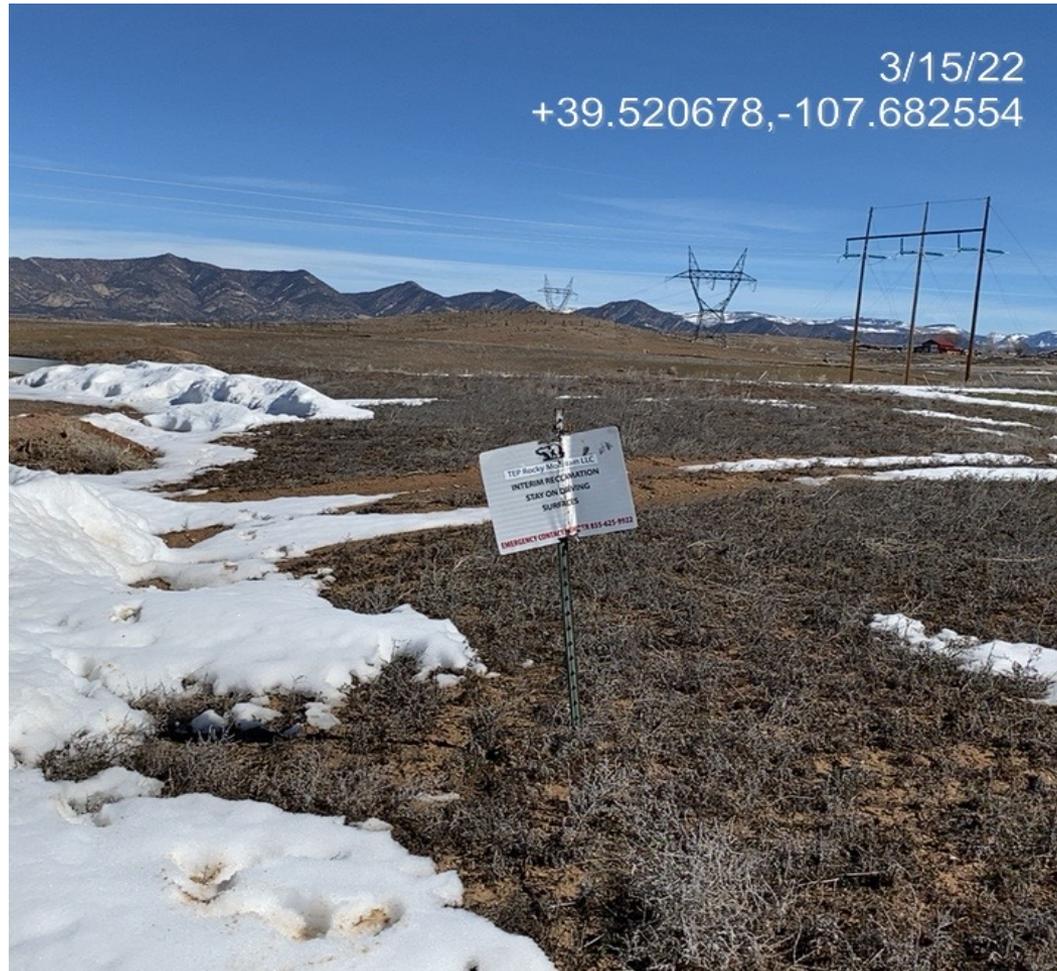
**Photo 6.** Photo taken from the southeastern interim area of the Location facing northeast shows interim areas dominated by the annual undesirable plant species/weed, Kochia.

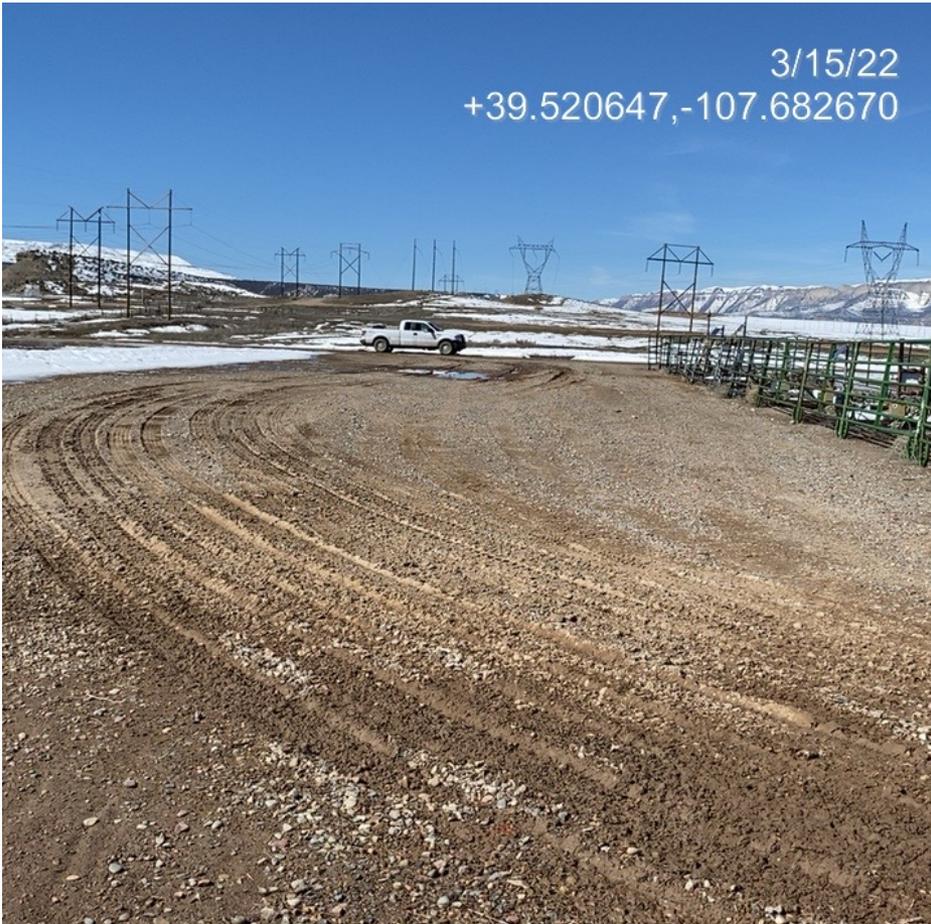
**Photo 7.** Photo taken from the east of the Location facing west shows rutting occurring on the pad.

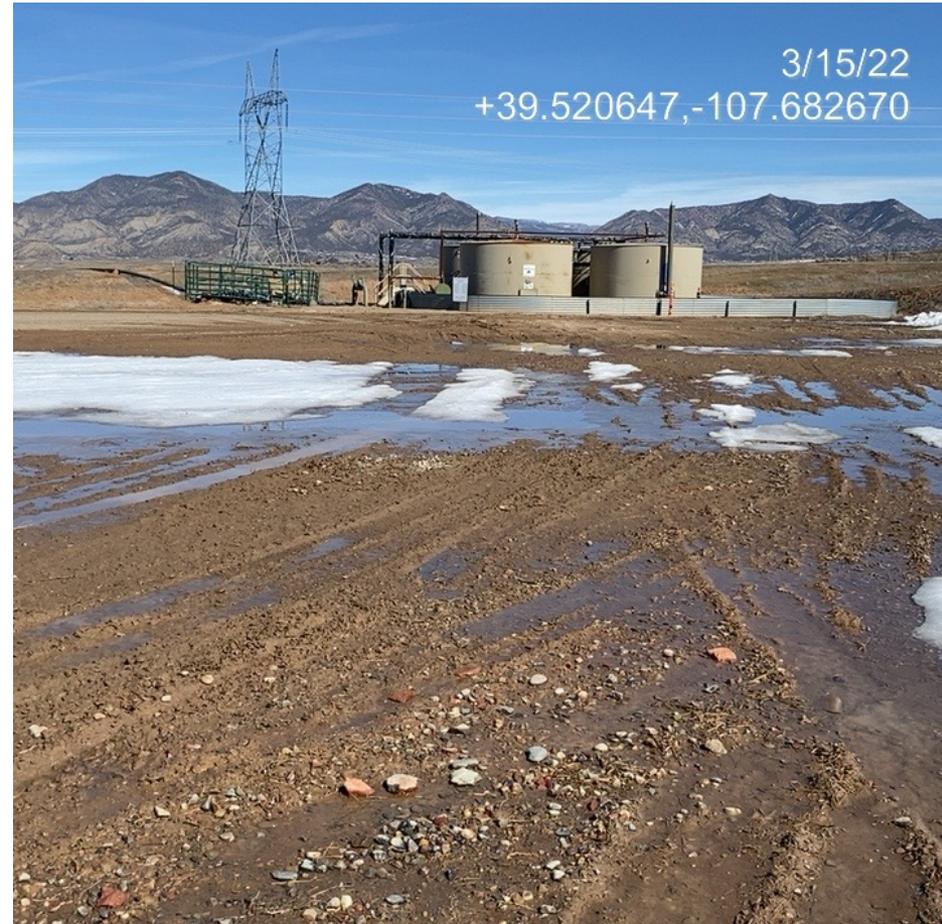
**Photo 8.** Photo taken from the east of the Location facing north shows rutting occurring on the pad.
