Inspection Photos  
UPRR 42 Pan Am D 2 battery  
Facility ID: 470886

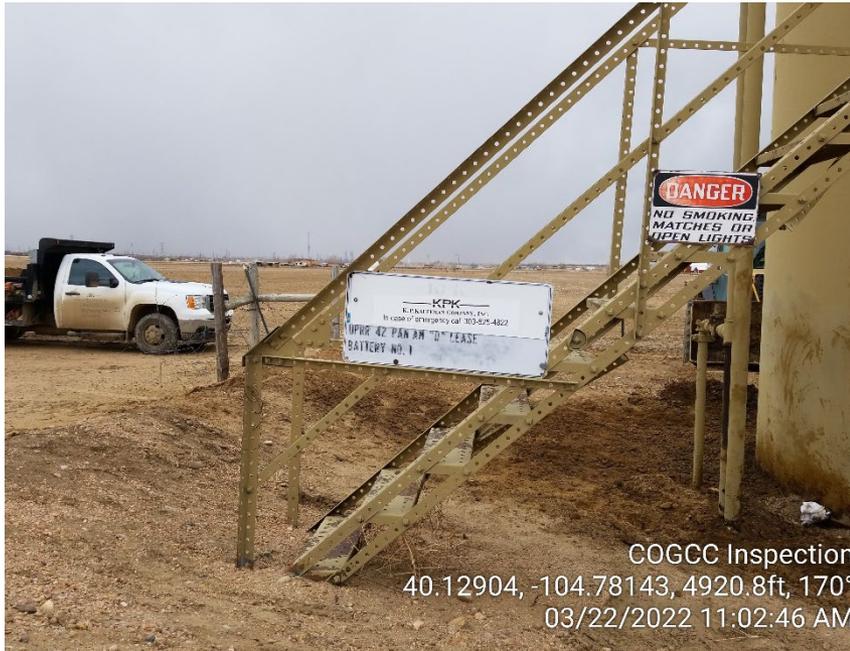
Photo 1 – Battery sign. Impacted soil surrounding crude oil tank.

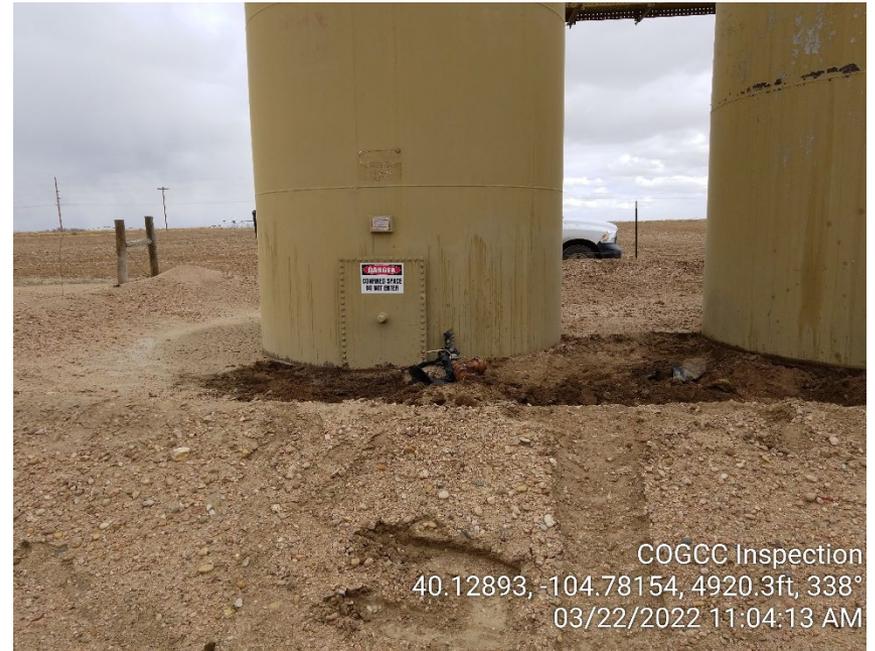
Photo 2 – Spill area on south side of produced water tank.

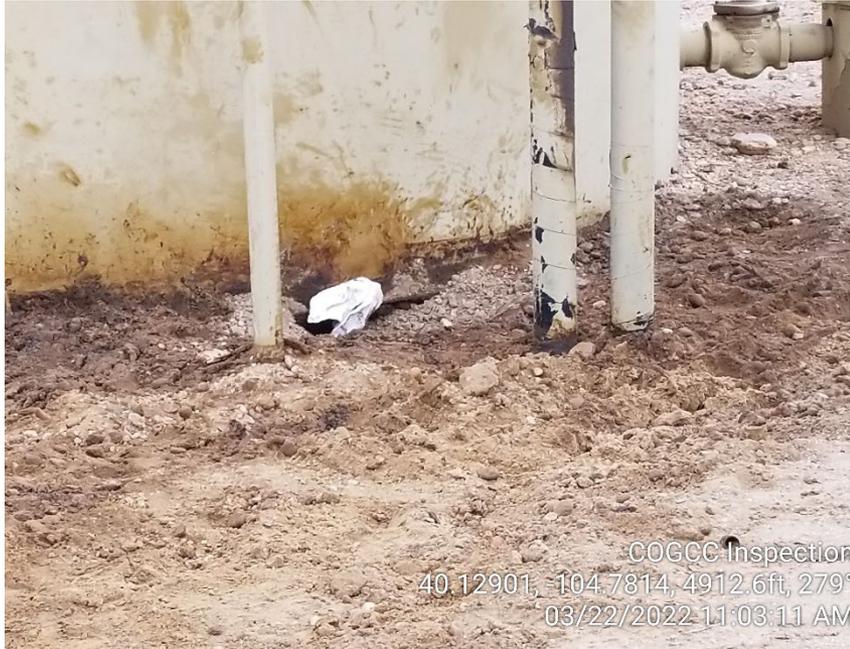
Photo 3 – Spill source on east side of crude tank.

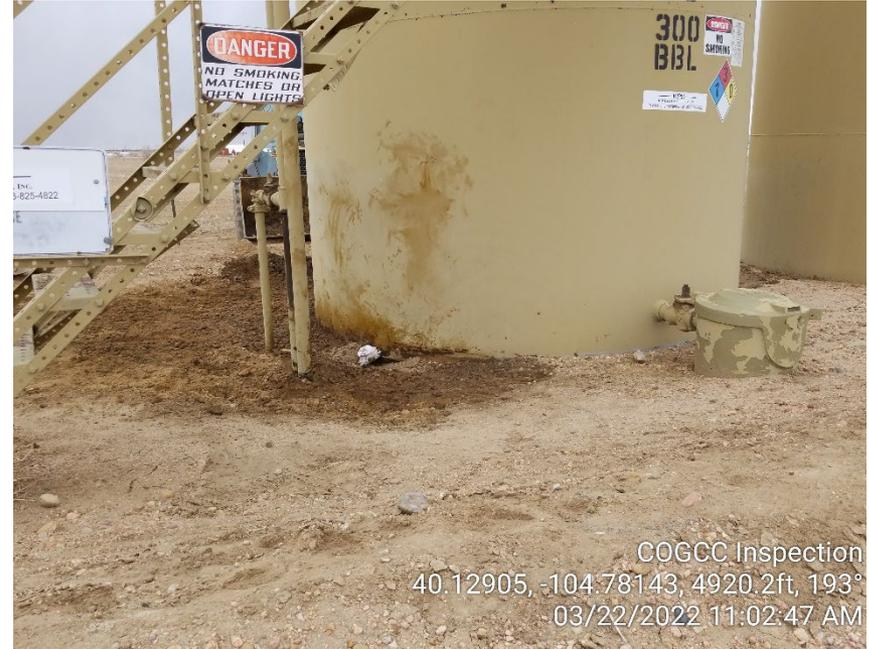
Photo 4 – Spill source on east side of crude tank.

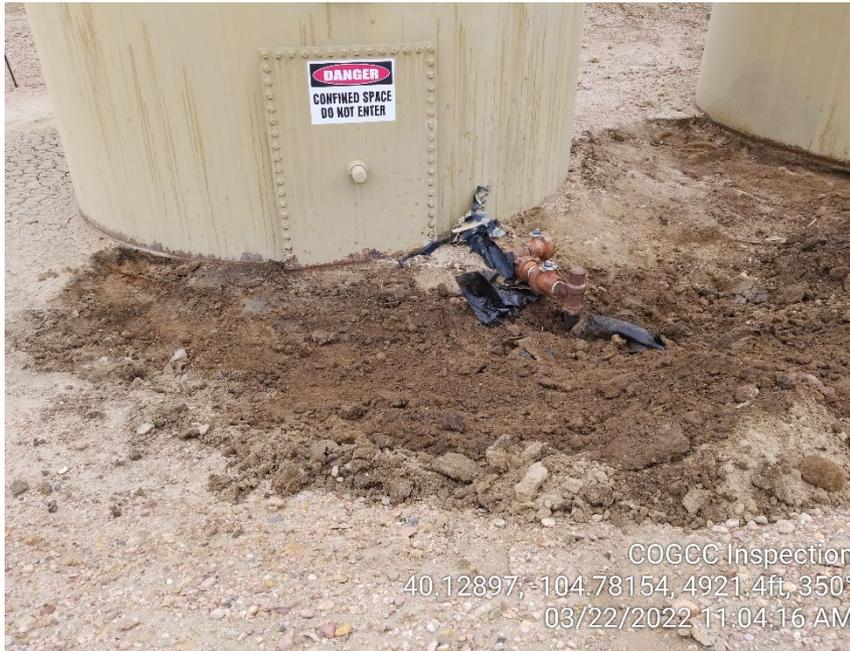
**Photo 5 – Spill area on south side of produced water tank.**

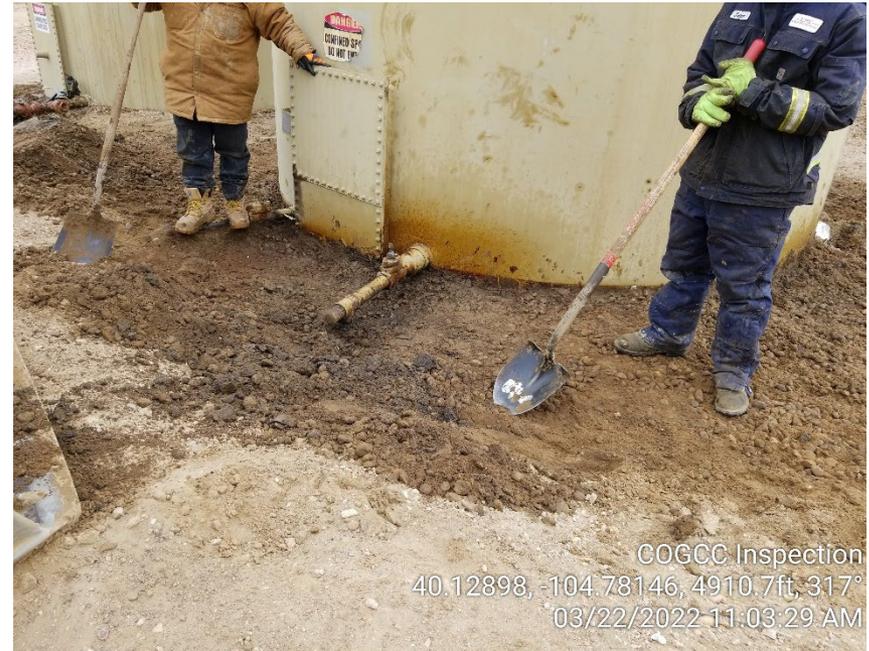
**Photo 6 – Spill area on south side of crude tank.  
Spill clean up in process.**

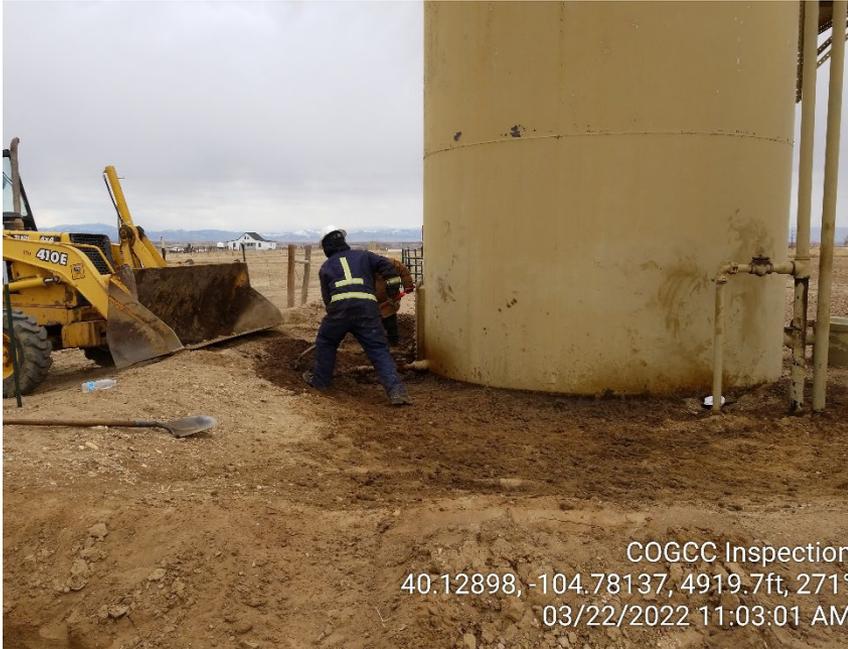
**Photo 7 – Spill clean up in process. Impacted soil being cleaned up by shovels and placed into loader.**

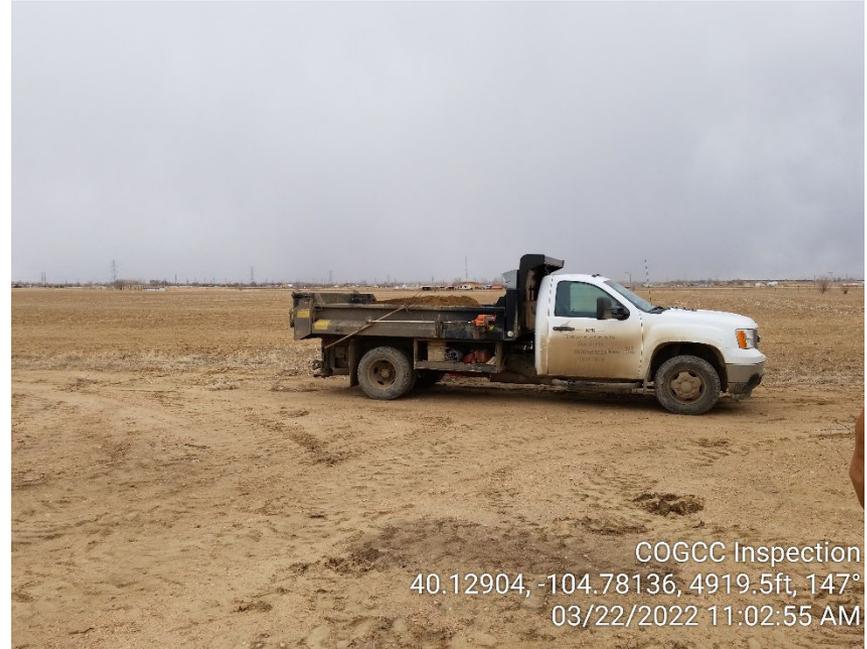
**Photo 8 – Impacted soil loaded onto flat bed truck.**

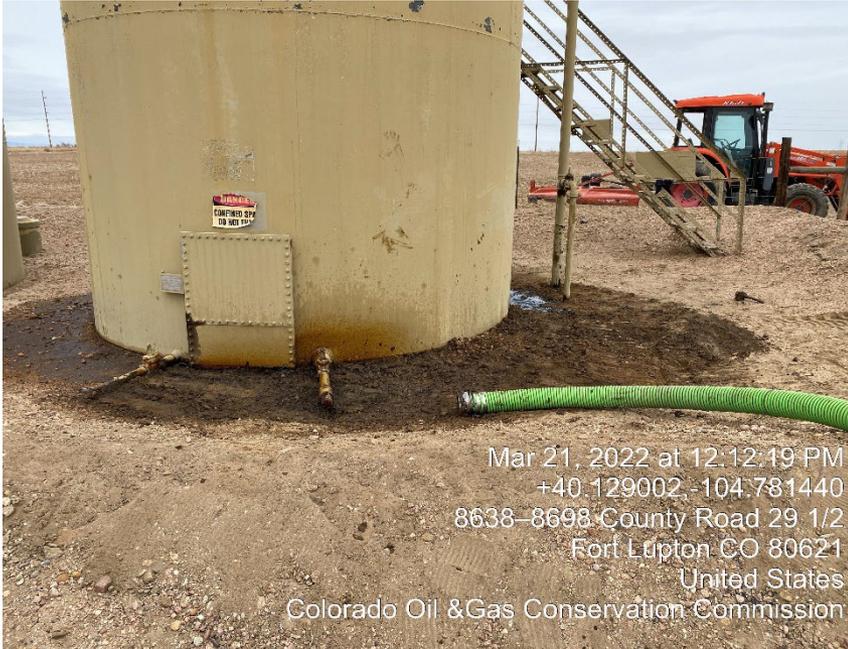
**Photo 9 – Active spill observed by COGCC inspector  
3/21/2022.**

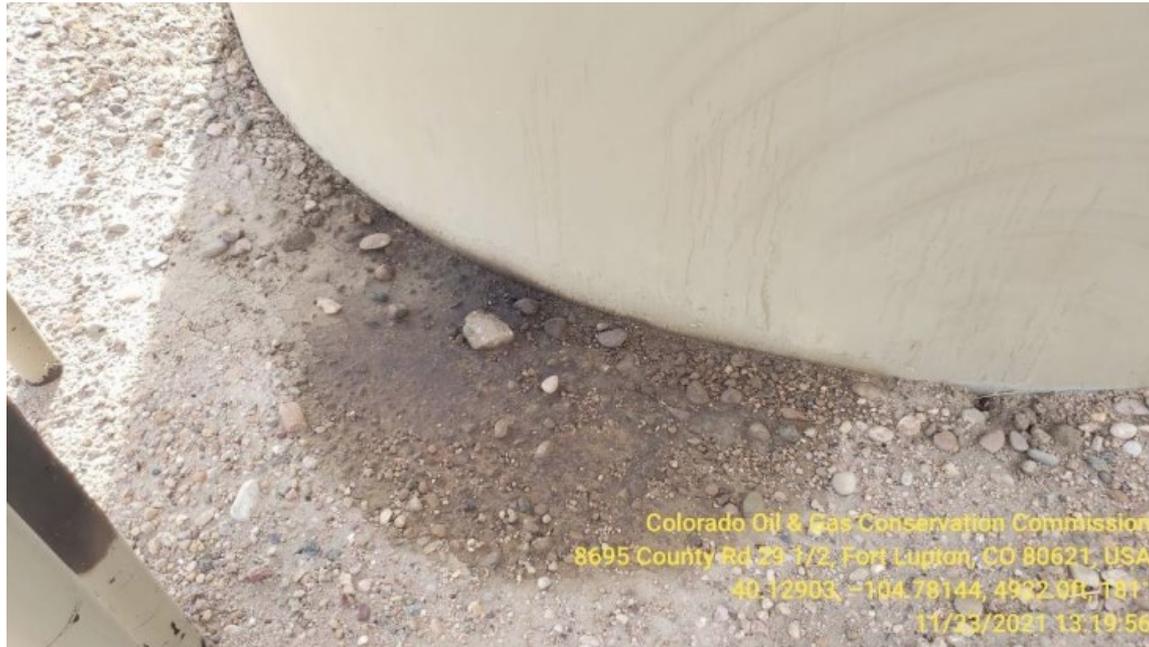
**Photo 11 – Oily soil on east side of crude tank documented in Inspection #699304532 on 11/23/21**
