TEP  
RMV 116-33  
Location # 334780

**COLORADO**  
Oil & Gas Conservation  
Commission  
Department of Natural Resources

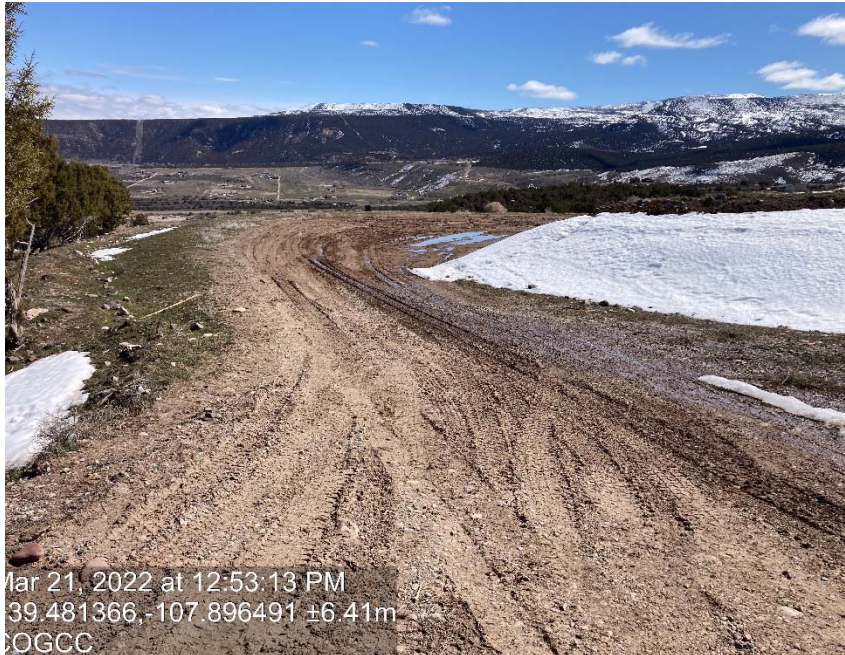
**Lack of stabilization/compaction**

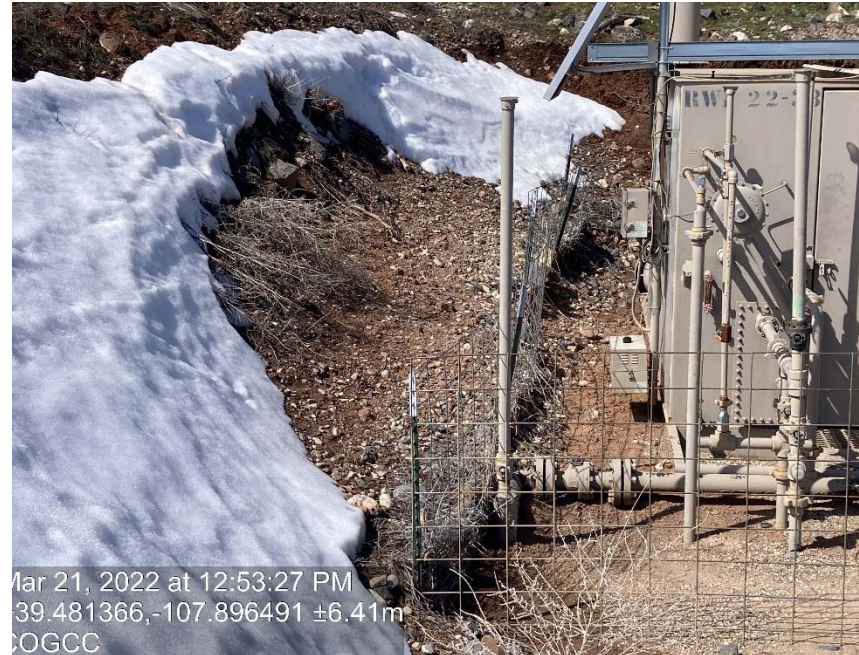
**Lack of stabilization/compaction**

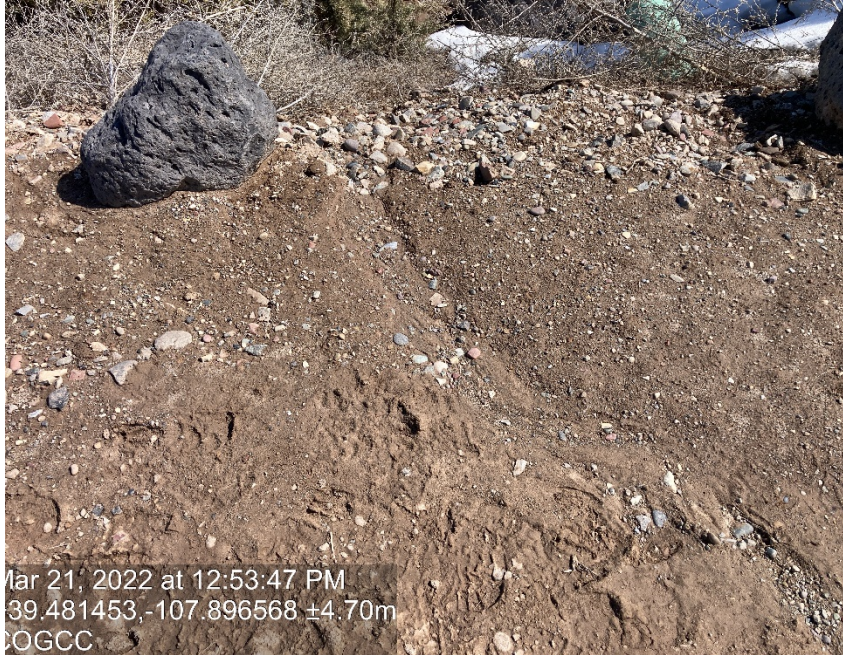
**Lack of stabilization/compaction/erosion and sediment migration**

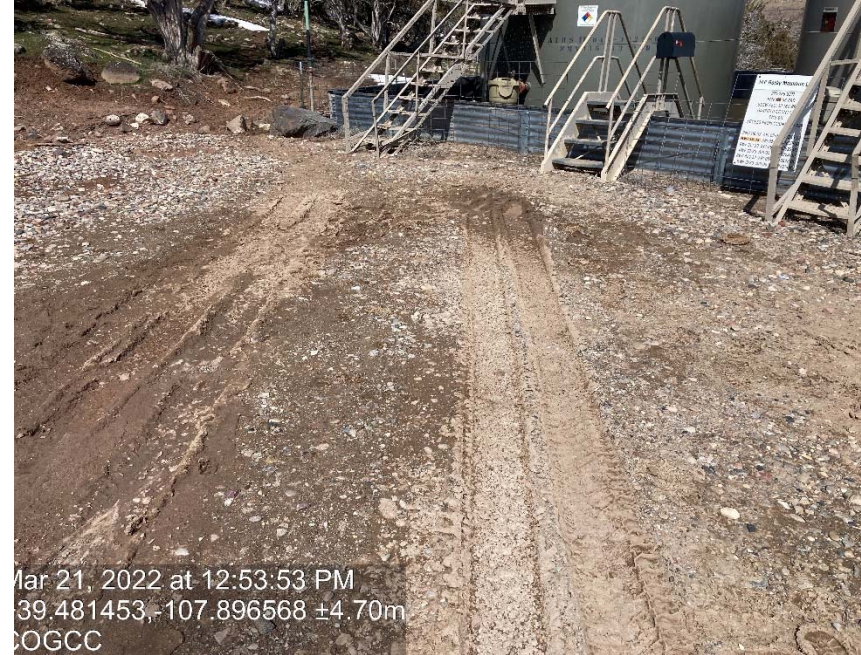
**Lack of stabilization/compaction**

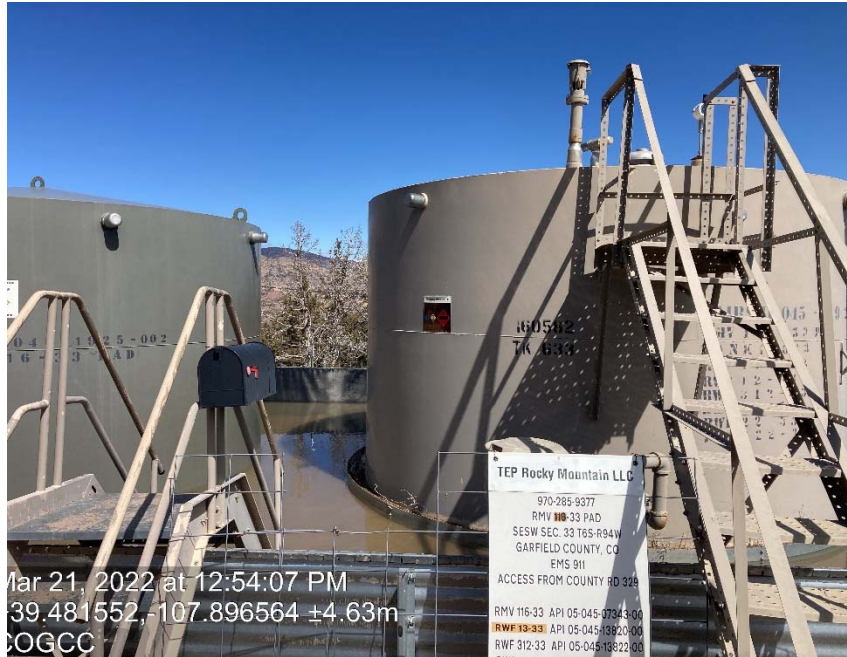
Labeling illegible

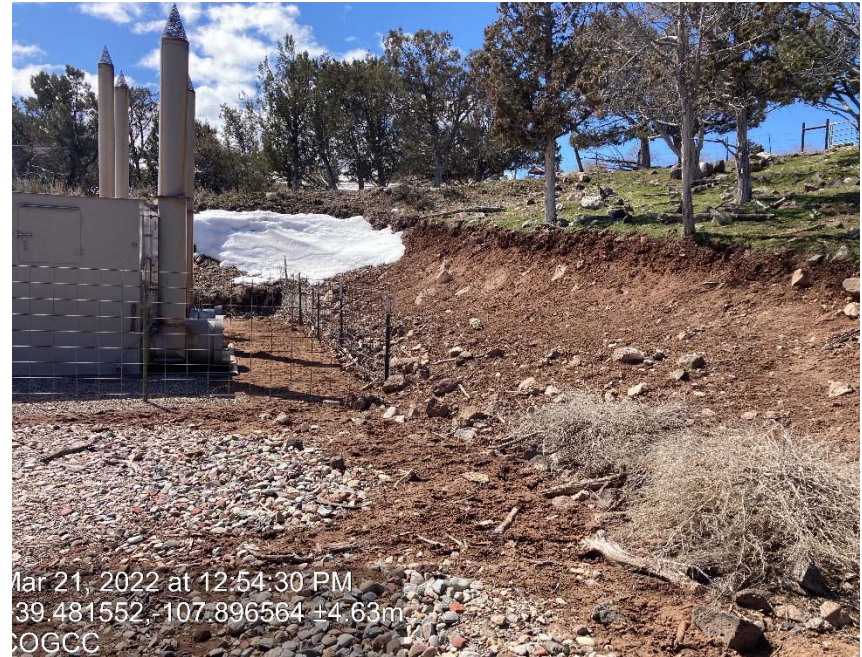
Lack of stabilization/compaction

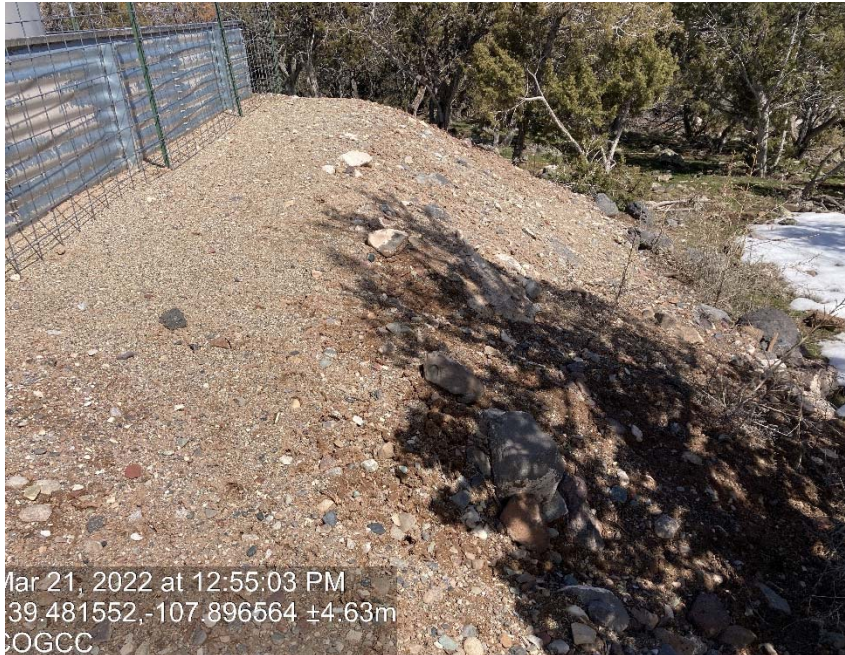
**Lack of stabilization/compaction**

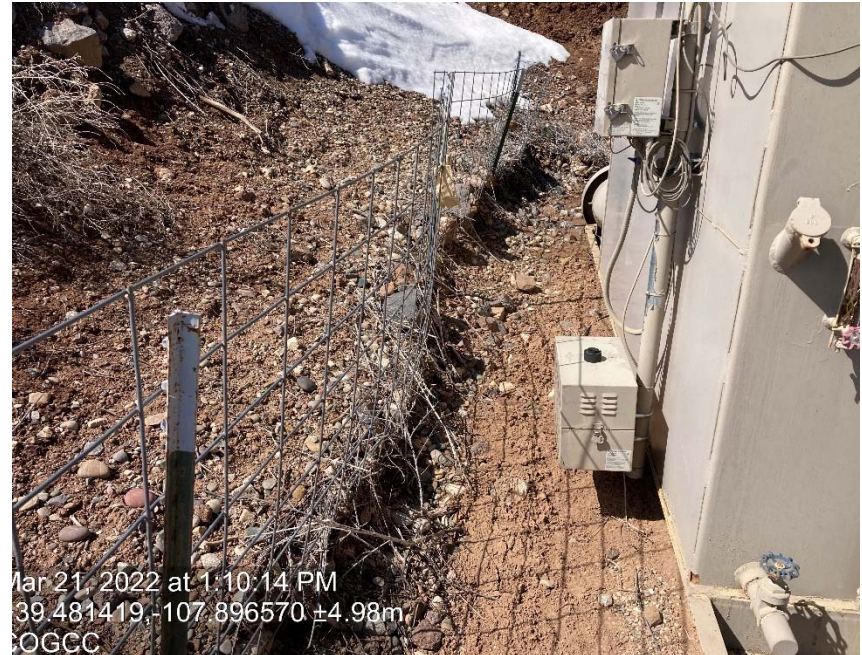
**Lack of stabilization/compaction**

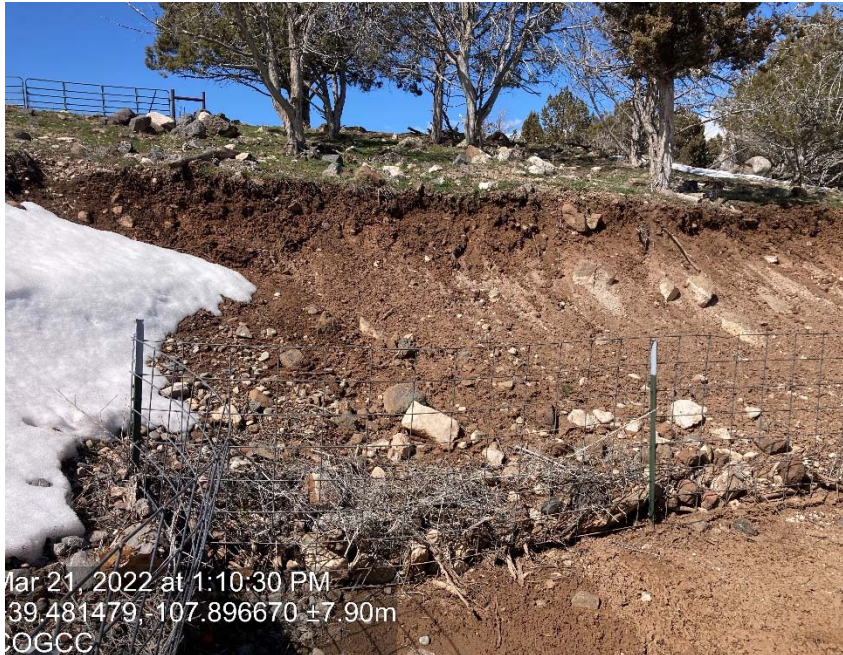
**Lack of stabilization/compaction**

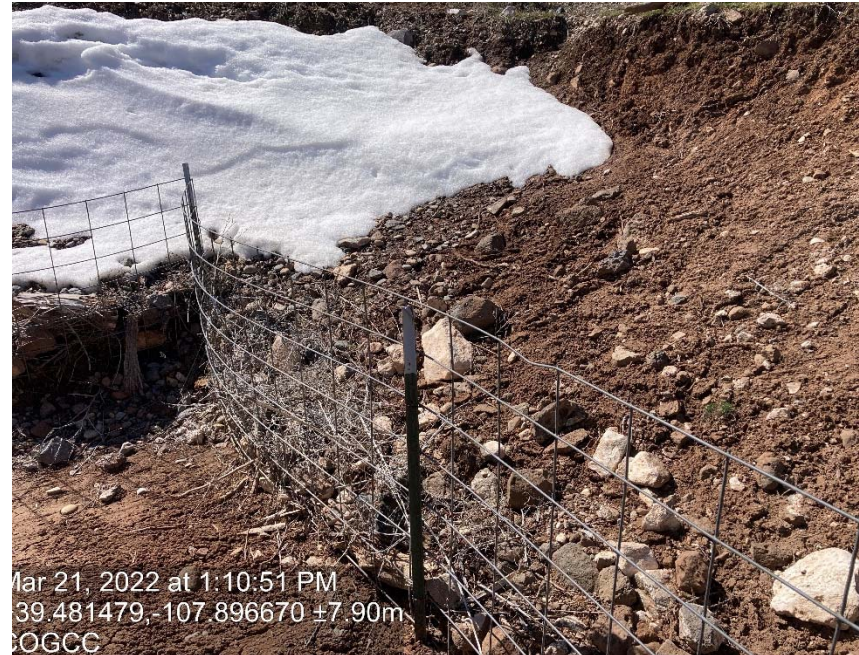
**Lack of stabilization/compaction**

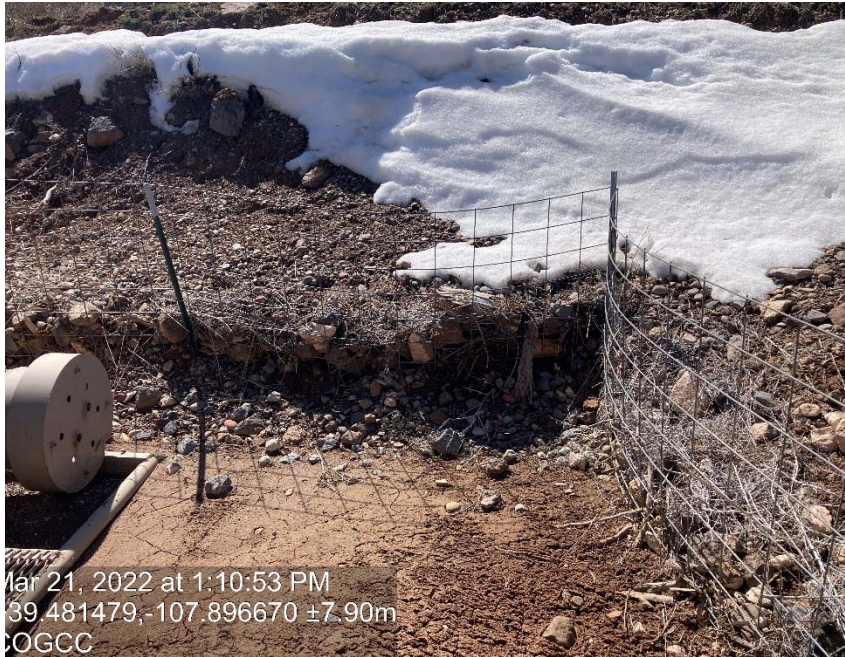
**Lack of stabilization/compaction**

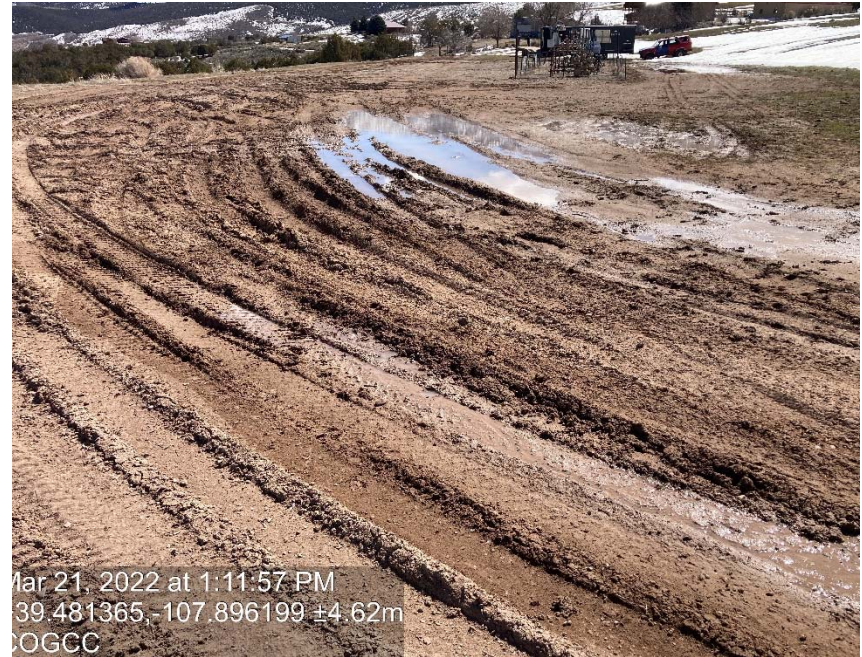
**Lack of stabilization/compaction**

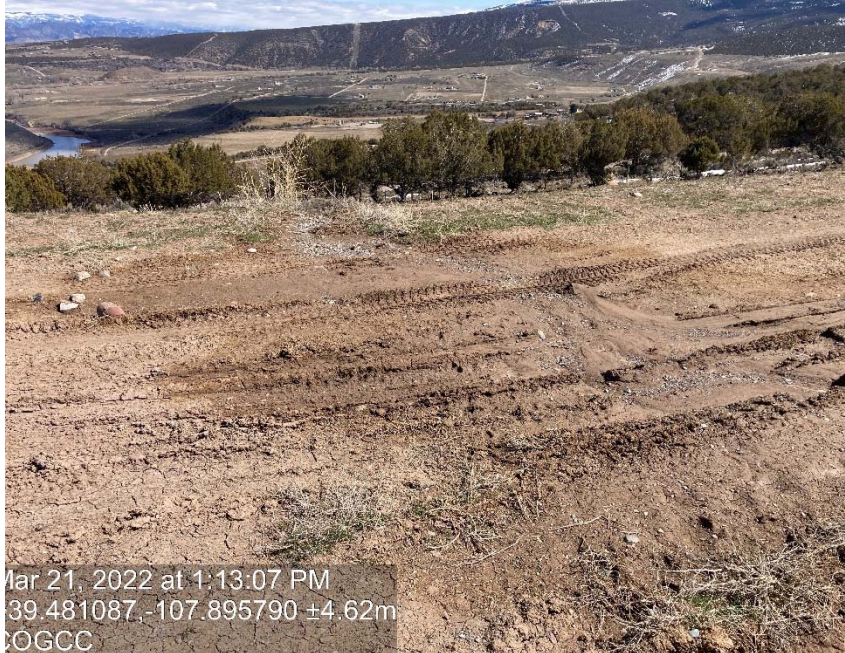
**Lack of BMP's**

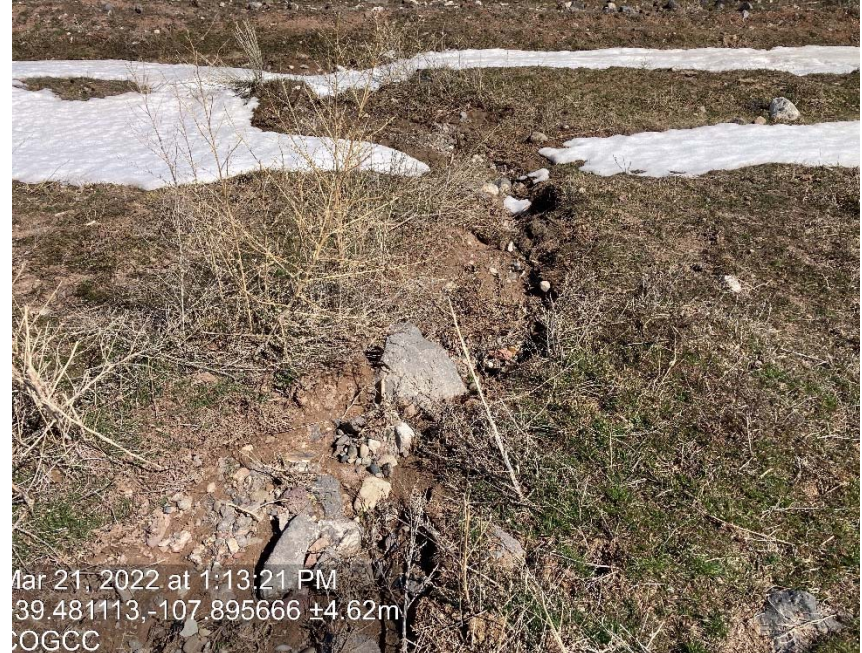
**Lack of BMP's**

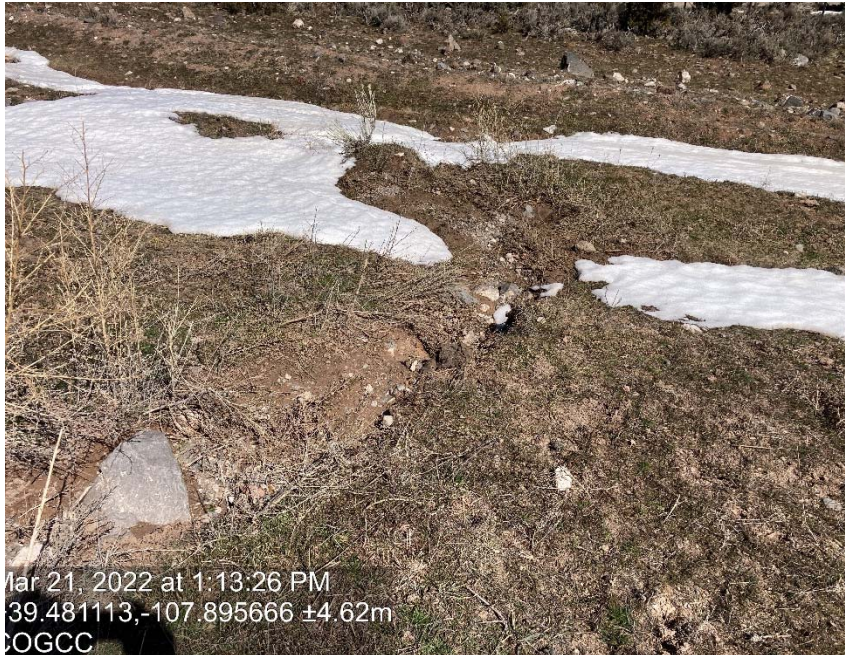
**Lack of BMP's**

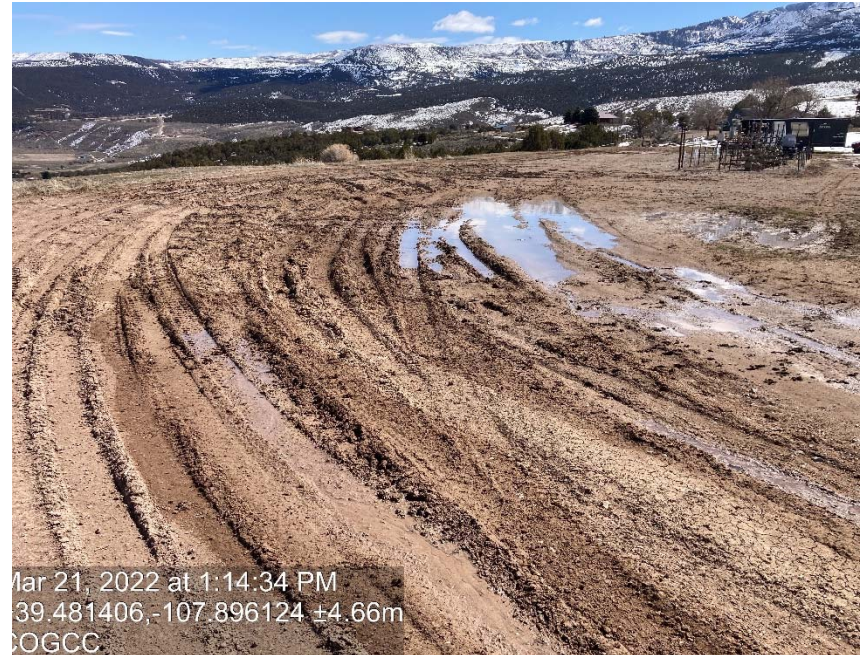
**Lack of stabilization/compaction**
