Inspection Photos
Location Name: Coyote Canyon 33-9 #20-3
API: 05-067-08485

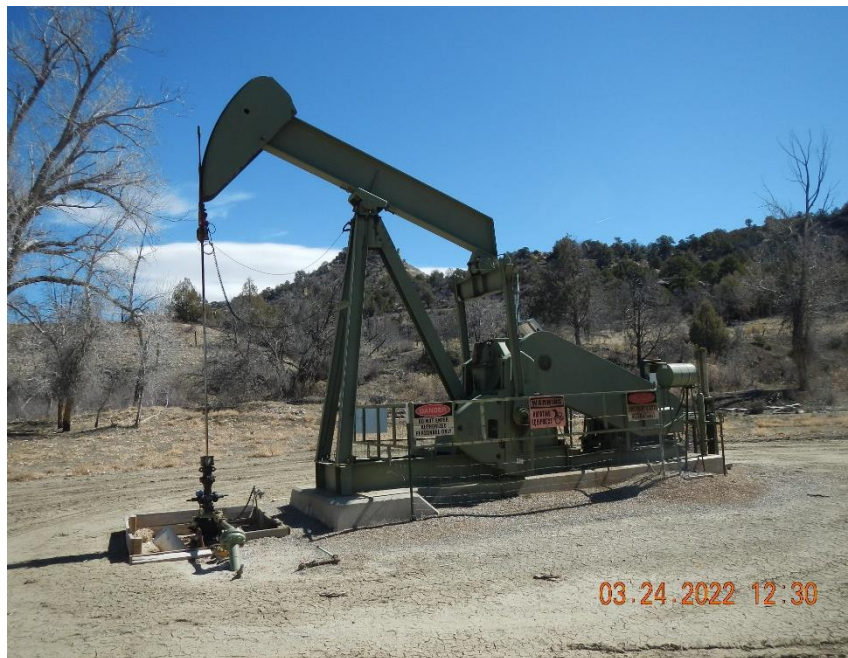
Coyote Canyon 33-9 #20-3 well head and pump jack.

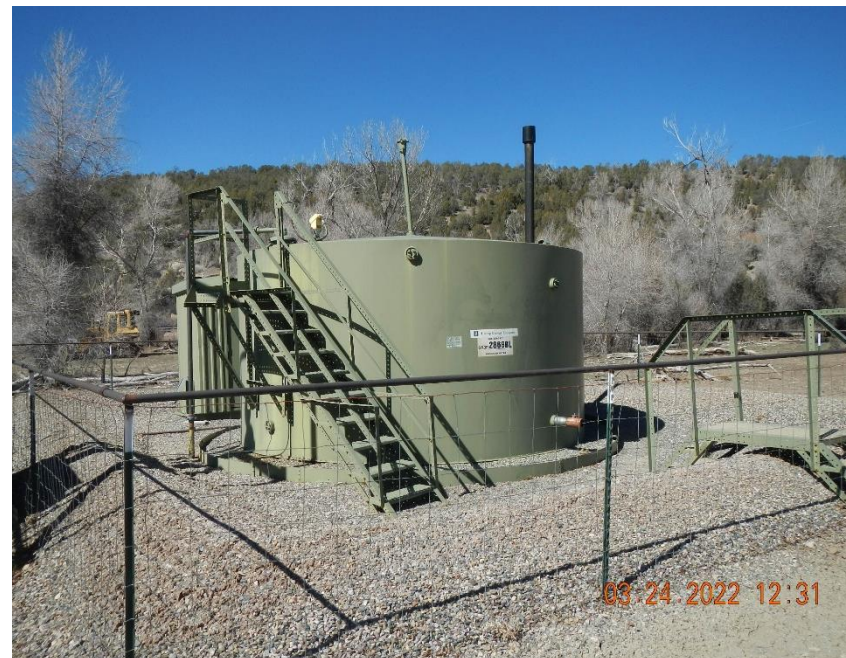
286 bbl. heated steel AST.

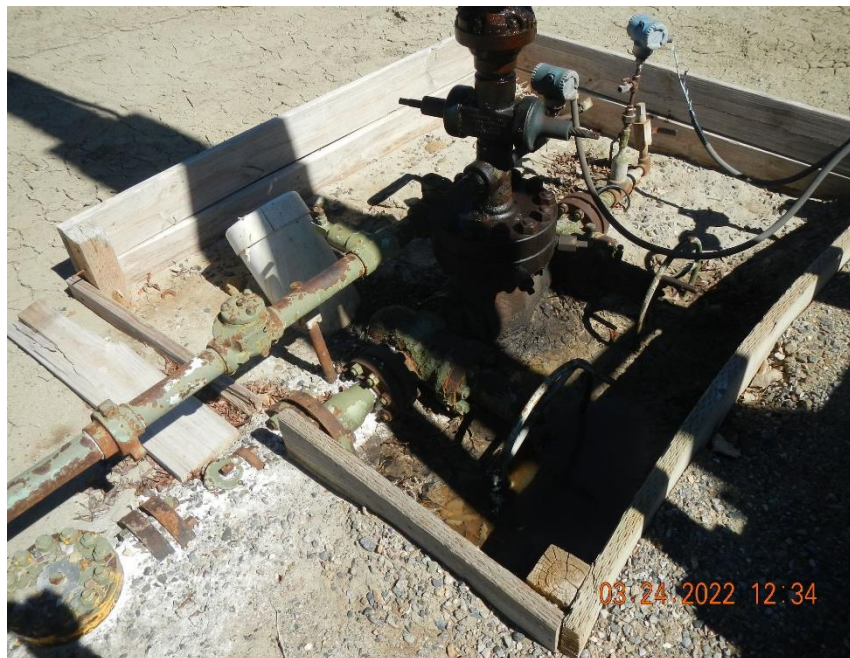
Well head is wet and stained. Surrounding area is stained. Puddle of fluids present within wooden cellar.

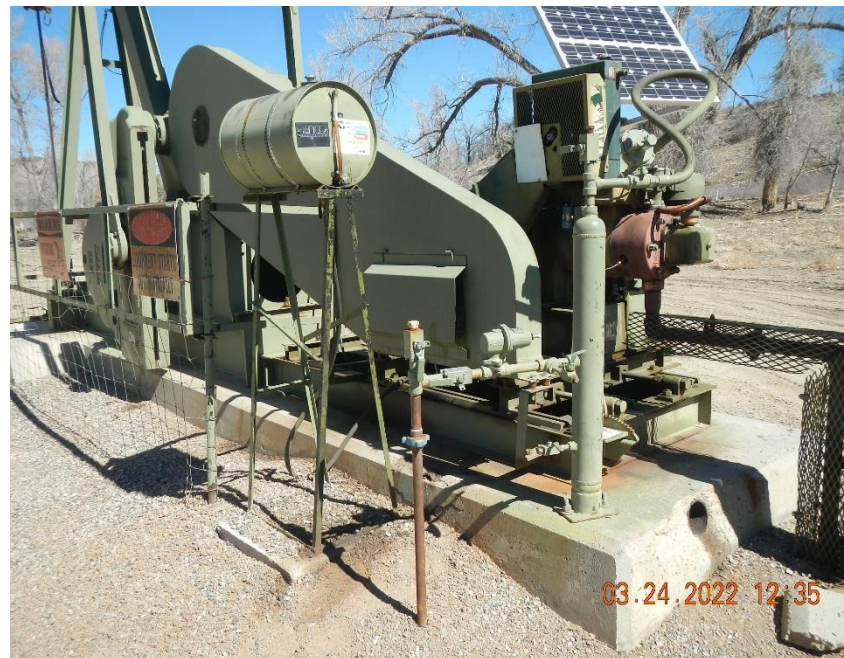
Lube oil container appears to be leaking. Stand and soil beneath are wet and stained.

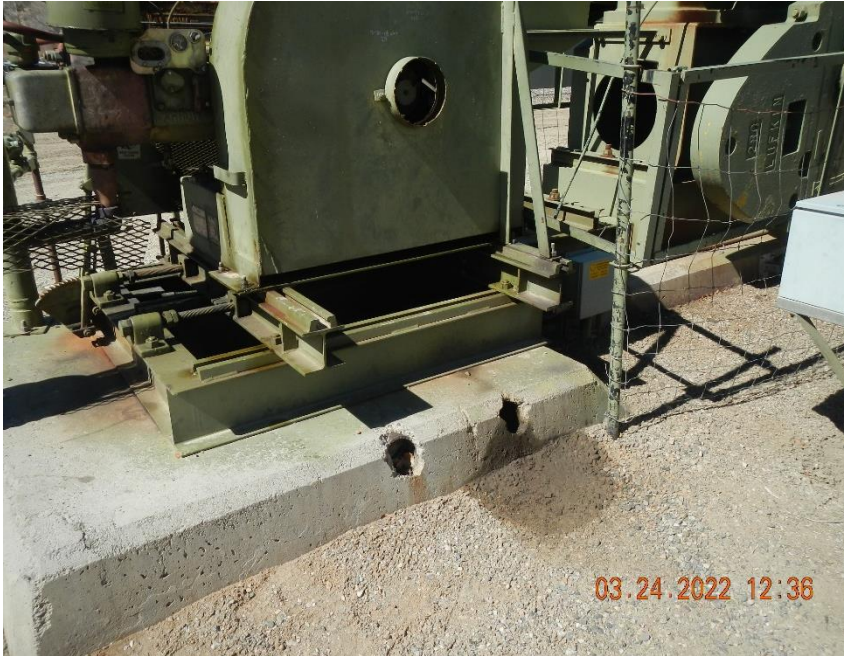
Concrete pad is wet and stained beneath prime mover. Soil adjacent to prime mover is stained.

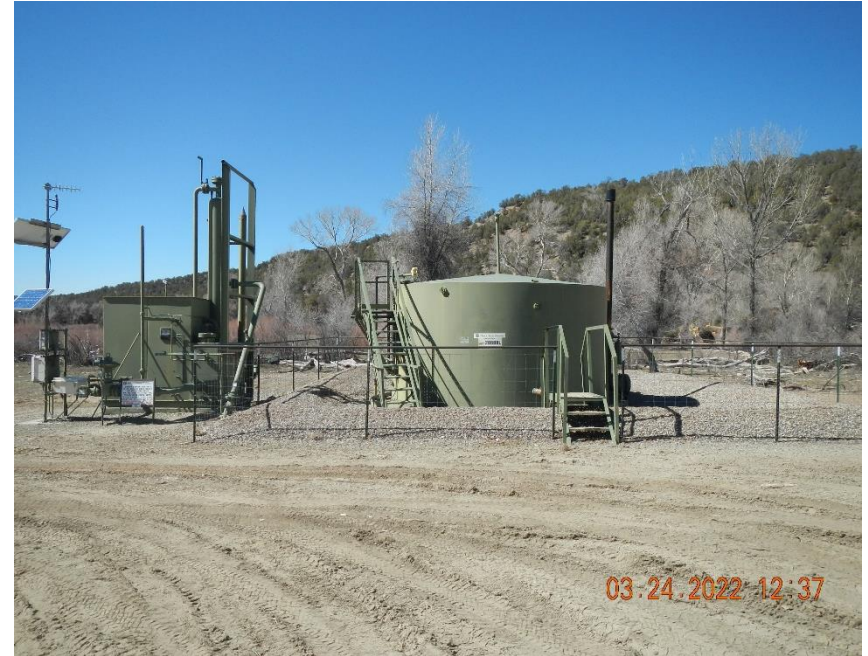
Coyote Canyon 33-9 #20-3 production equipment.
