# Inspection Photos

API: 071-07915

Operator: WAPITI OPERATING LLC

Inspection Date: 3/29/2022

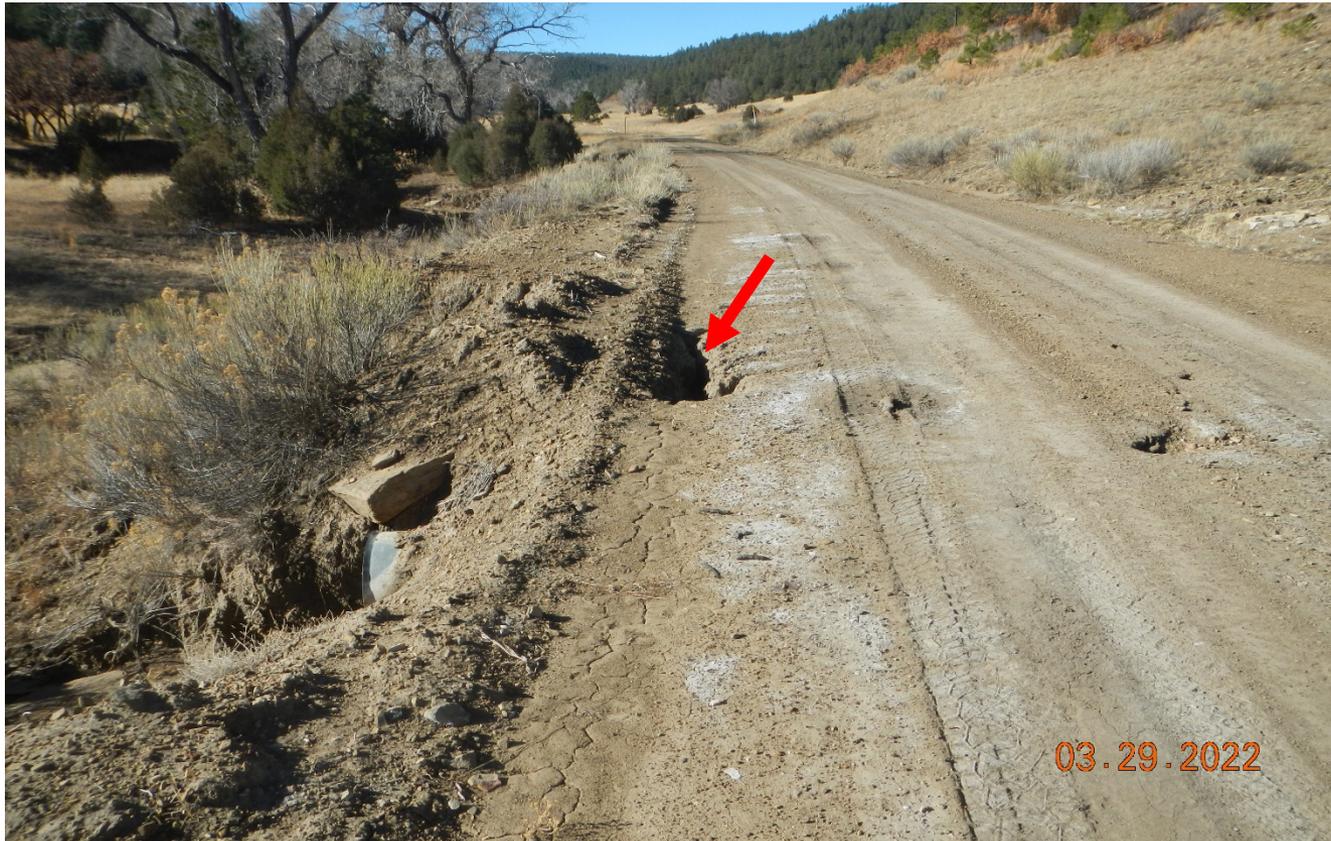
**Photo 1.** Facing southwest along the main road in the canyon. The road has been graded however, there is still culvert maintenance needed. Red arrow points to erosion undercutting by the culvert which will end up eroding the culvert outlet.

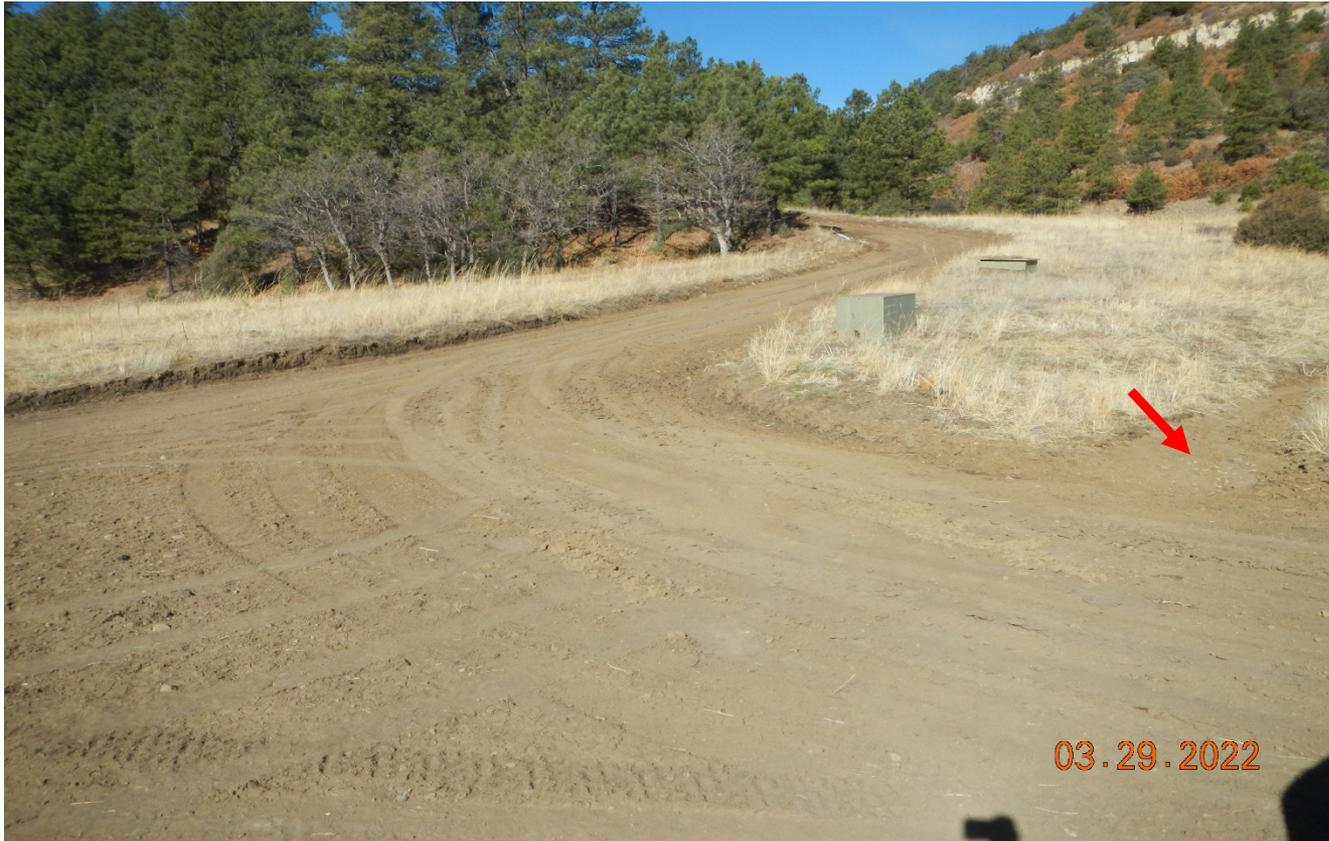
**Photo 2.** Facing west toward the access road ascending the hillside. The road has been graded. The culvert inlet shown at red arrow and the outlet is shown in photo 4.

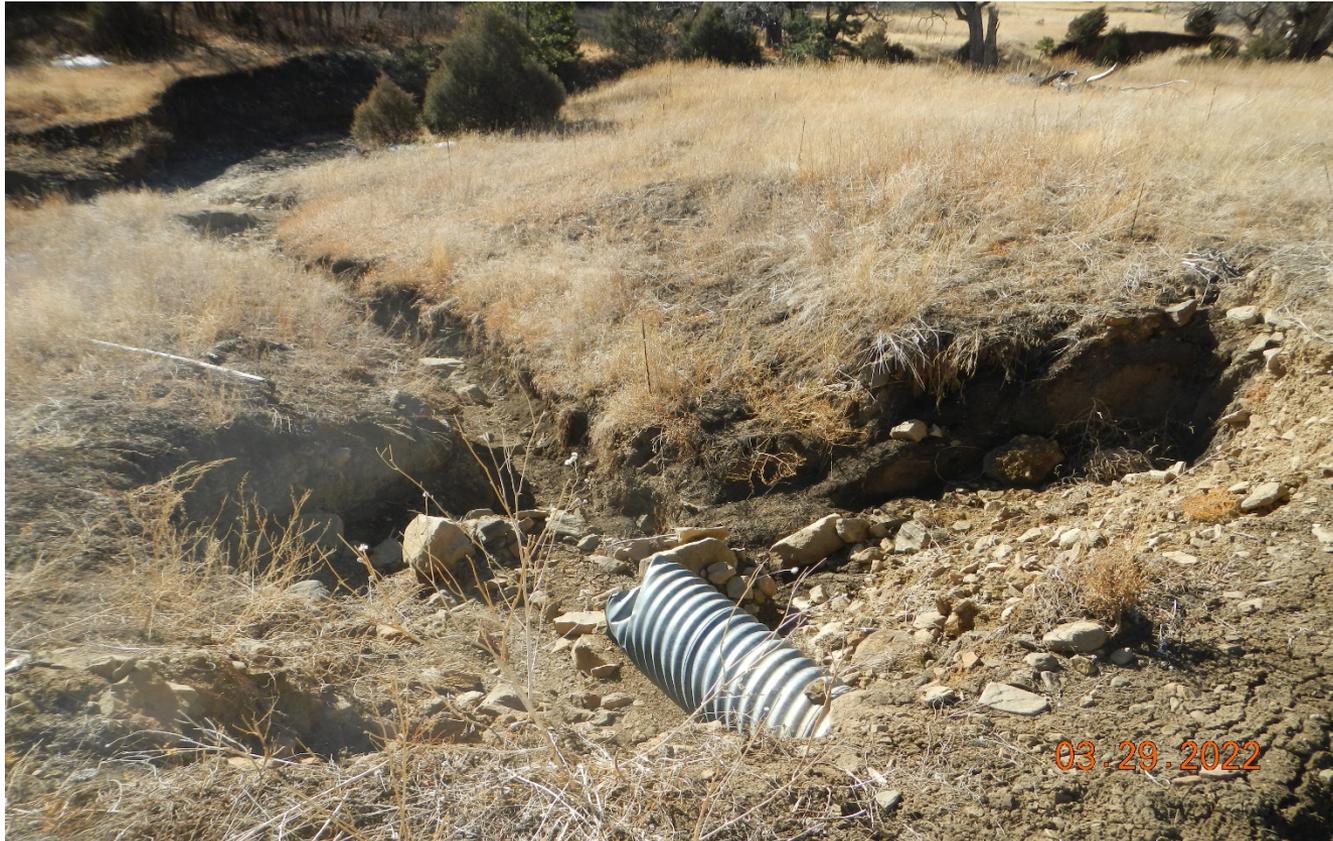
**Photo 3.** The culvert outlet is eroded and does not have outlet protection. Previous corrective action not completed.

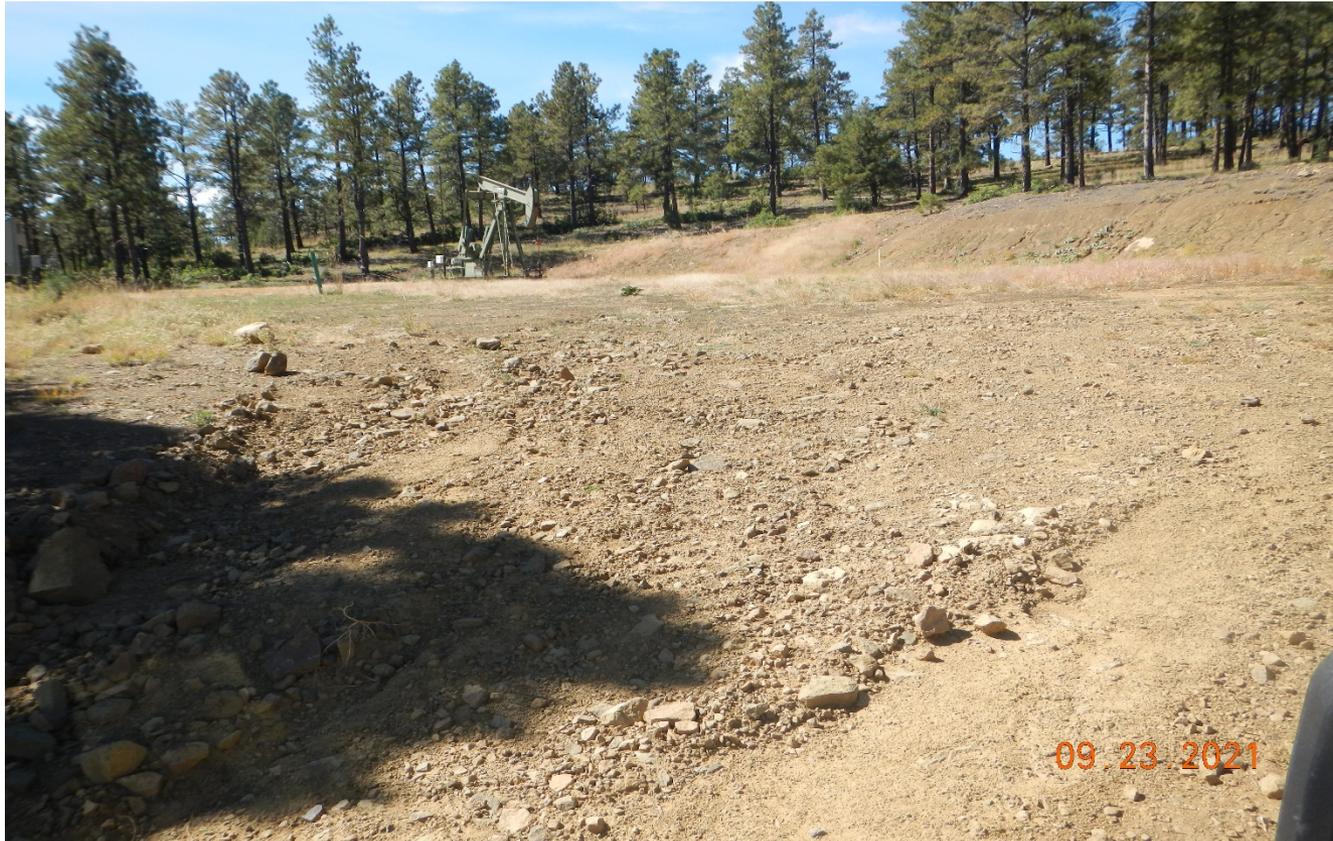
**Photo 4.** Facing southwest toward the location. The well site was not inspected. This photo was taken from prior inspection.
